Asbestos Inspection Report

Commercial Building

103 N US 287

Decatur, Texas 76234

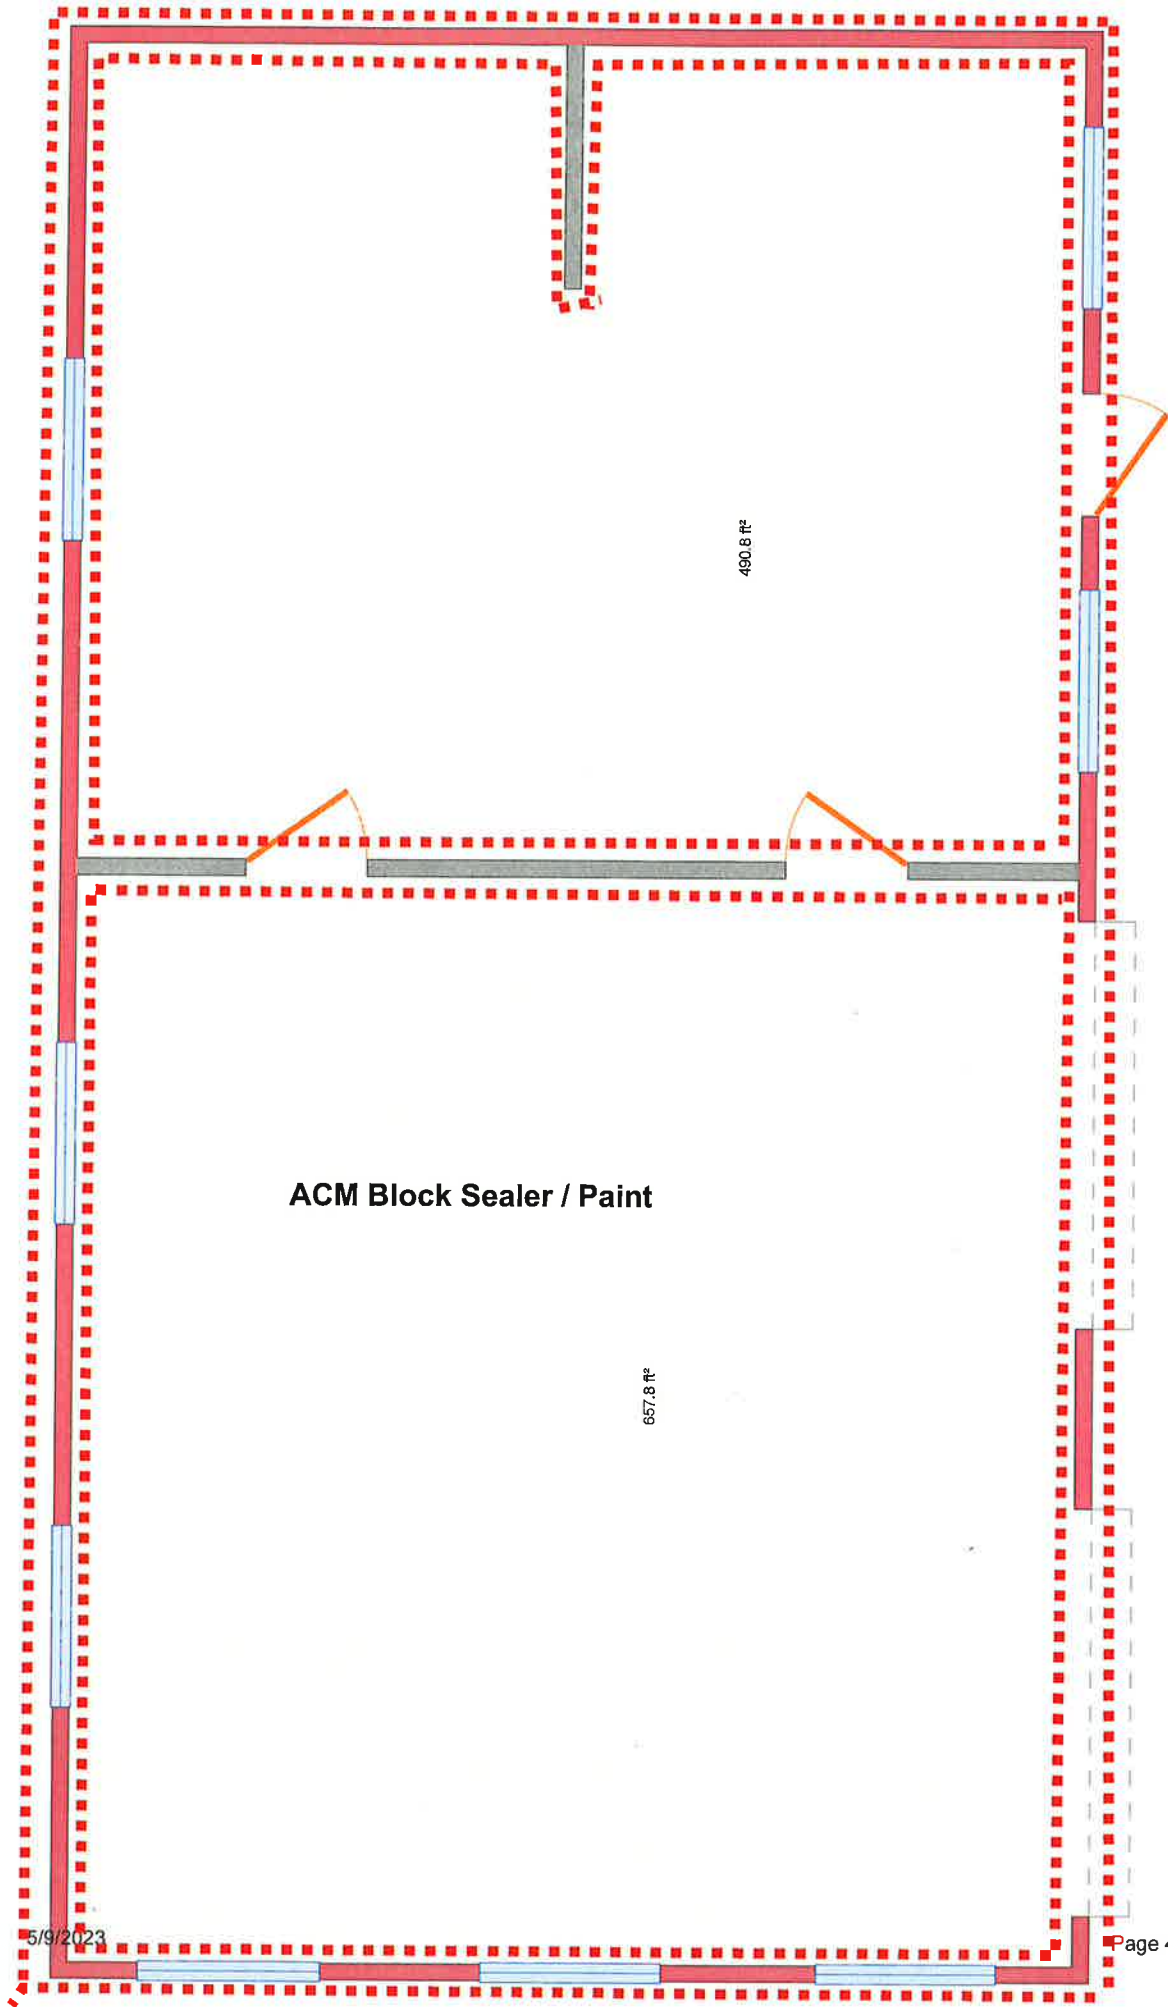
1. **CMU / Concrete Sealer and paint: Non-Friable Miscellaneous, Category II Asbestos Containing Material. Damaged condition**

Assessment: 7 Response Action: 4

Quantity: Approximately 2,350 SF

The sealer / paint used to seal the CMU walls on the inside and outside contains asbestos fibers in concentrations greater than 1 percent. The material is peeling away from the walls in some places.

ACM Block Sealer / Paint

For renovation purposes, this material should be abated prior to renovation.

For demolition purposes, the building can be wet demolished. A NESHAP trained person must be present during demolition and loading of the waste. All material and associated waste will need to be disposed of as asbestos containing materials.

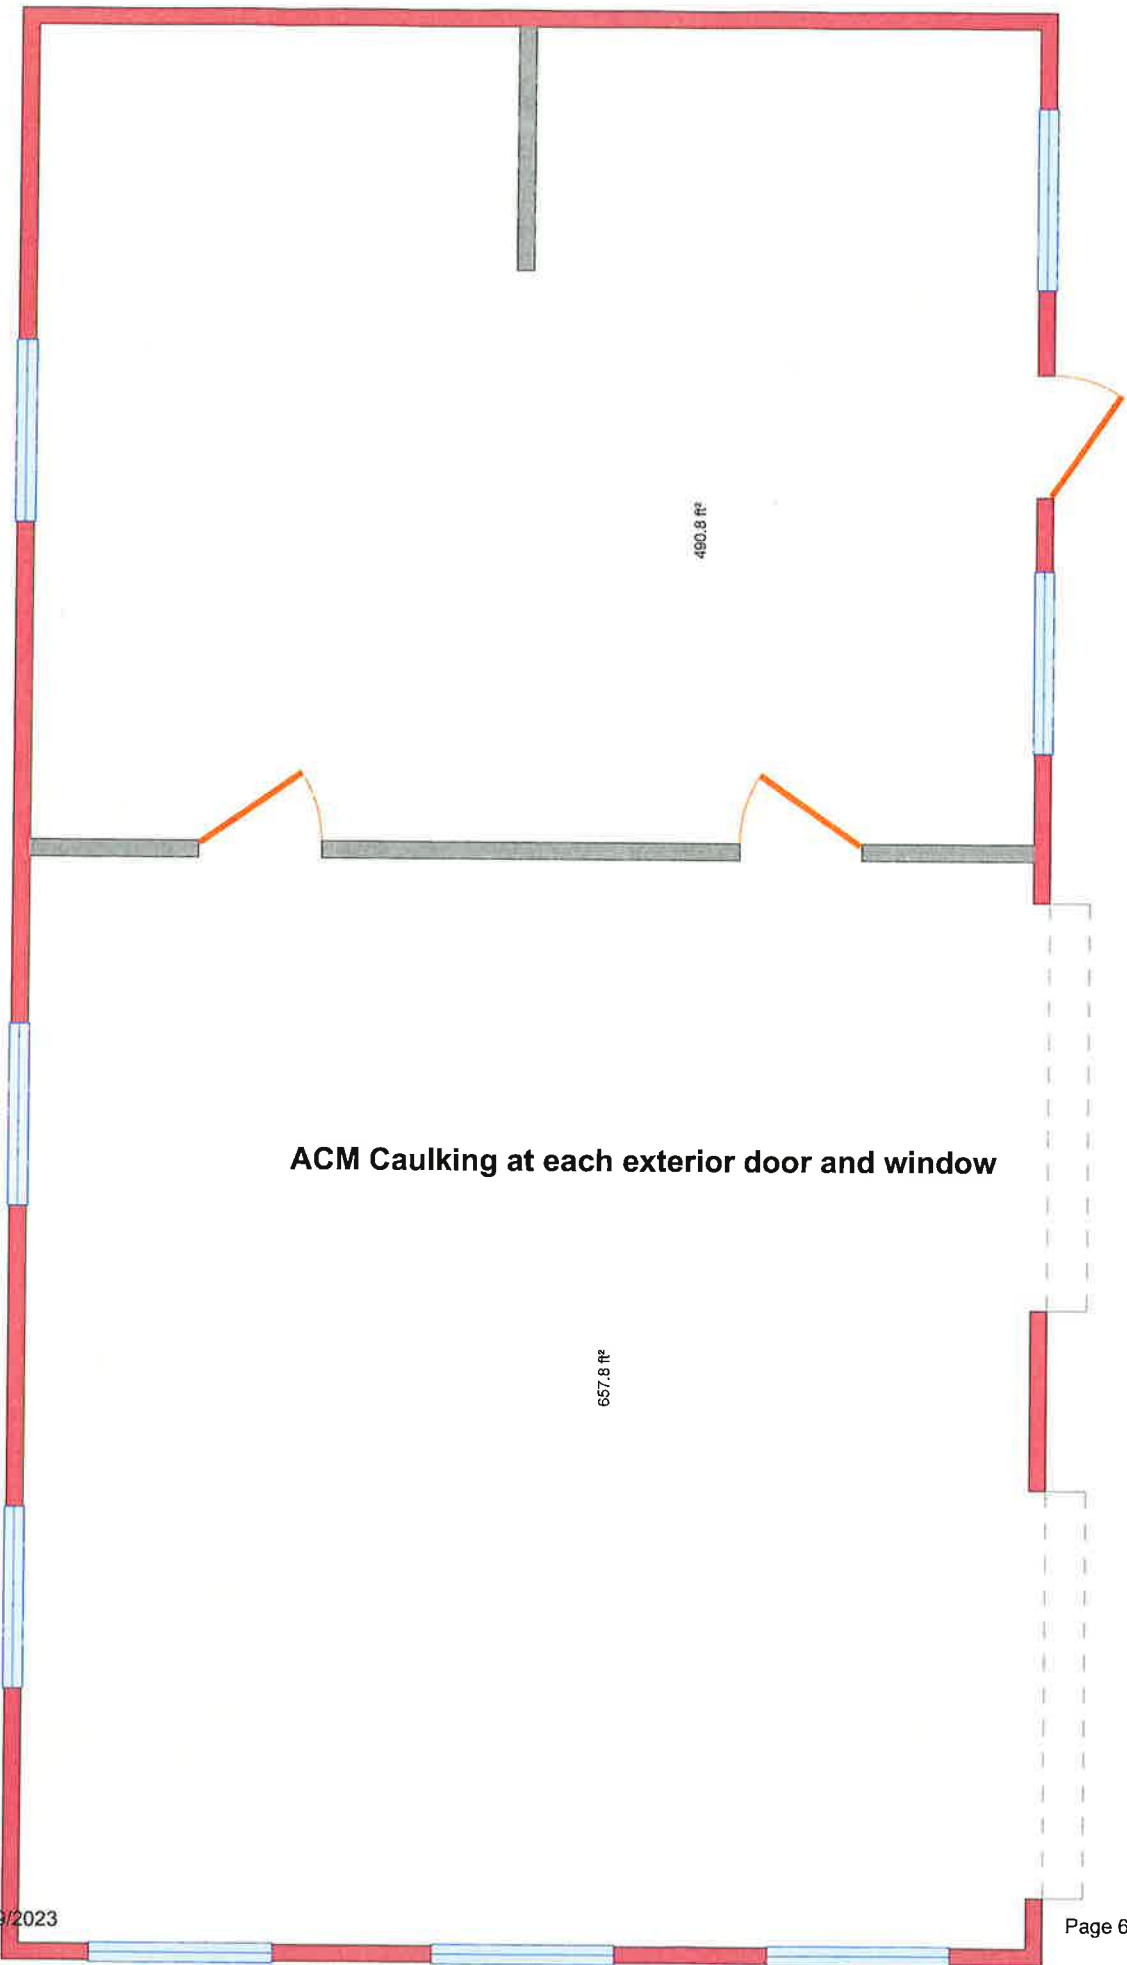
2. Window and Door Caulking: Miscellaneous Category II Non-friable asbestos containing material. Damaged Condition

Assessment 7 Response Action 1/4

The caulking applied around doors and windows, contain chrysotile asbestos fibers in the reported quantities greater than 1 percent.. The handling and management of this material is governed under Federal, State and local rules. The material should only be disturbed by a duly licensed and trained asbestos removal contractor. All disturbance is to be monitored by an asbestos consultant.

ACM Caulking at each exterior door and window

For renovation purposes, this material should be abated prior to renovation.

For demolition purposes, the building can be wet demolished. A NESHAP trained person must be present during demolition and loading of the waste. All material and associated waste will need to be disposed of as asbestos containing materials.
