Date: March 9, 2023

Subject: Post-Repair Foundation Repair Evaluation
Slab Foundation
13814 Klaus Ln., Elgin, TX

13814 KLAUS LN., ELGIN, TX

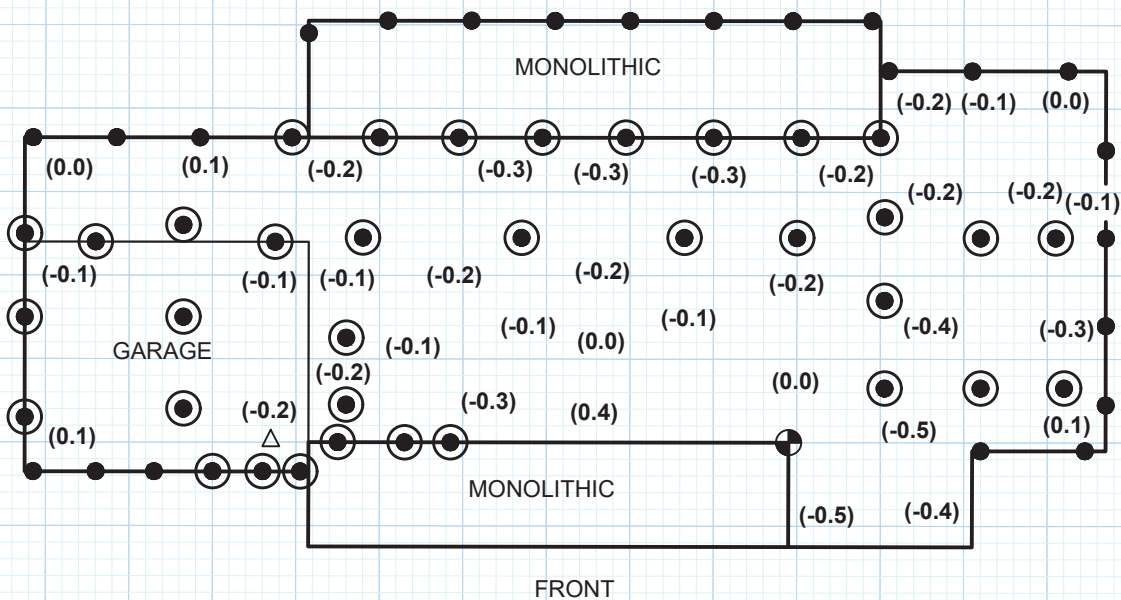
LIMITED REPAIR PLAN

- INSTALLED 58 TOTAL PILINGS (23 EXTERIOR, 35 BREAKOUTS).
