April 11, 2023

**RE: YOUTH ACHIEVEMENT CENTER
312 DELAWARE STREET
LEAVENWORTH, KANSAS 66048**

JOB #2023-0168

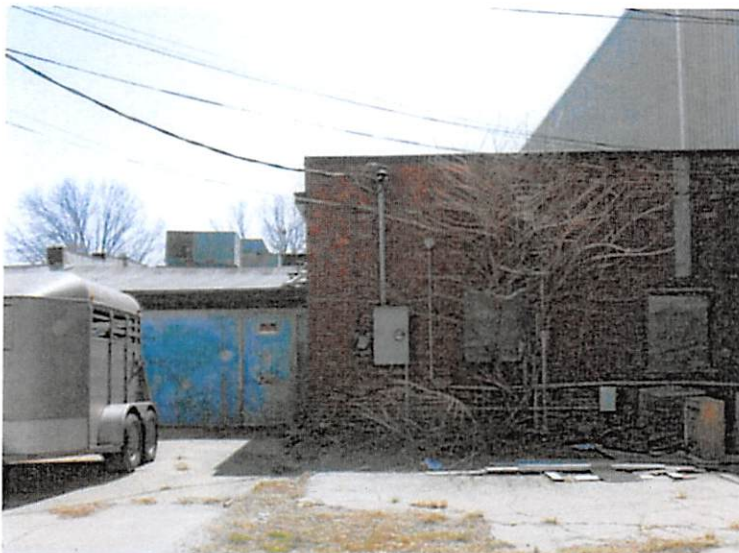
4. Building as seen from the northwest. The brick is the western half, and the blue finish is the eastern half.

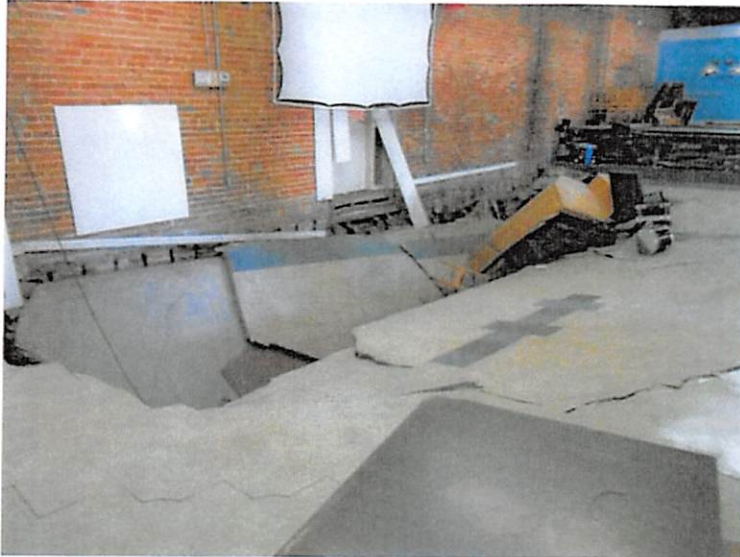
Observations of the collapsed area of floor framing beneath the middle of the western building area revealed that there is significant deterioration and rot in various framing members. It appears that support posts and beams in the middle part of the western section of the building failed, allowing the floor joists to collapse downward and break. The floor joists themselves were also found to be in poor condition due to significant deterioration and rot problems.

5. Collapsed floor in the western half of the building as seen from the southeast.

The extent of deterioration, rot, termite damage, etc. has created an unsafe condition for the floors of the building. I recommend that all of the floor framing be removed and replaced.

The interior of the building will need to have all stored materials and some of the finishes removed so that the floor system can be safely removed. Once this is done, new wood framing including footings, columns, support beams, joists, and subfloor can be installed. Alternately, the basement could be backfilled, and a concrete slab-on-grade installed. In either situation, the electrical services, water, and sewer services will need to be redone to accommodate whichever new floor system is chosen.

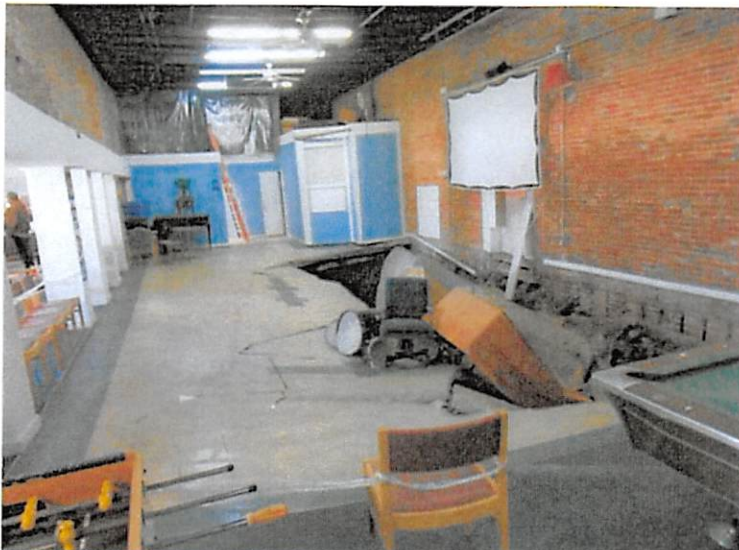
6. Looking south at the collapsed floor in the western half of the building.

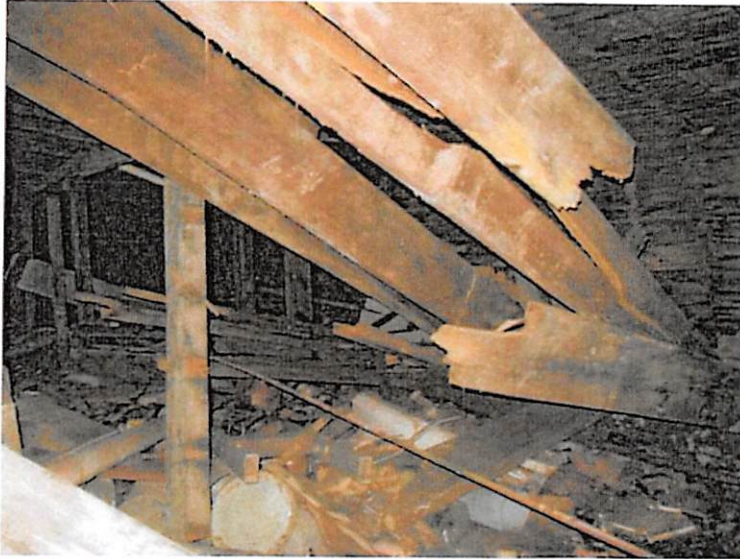
7. Collapsed wood framing as seen in the basement.

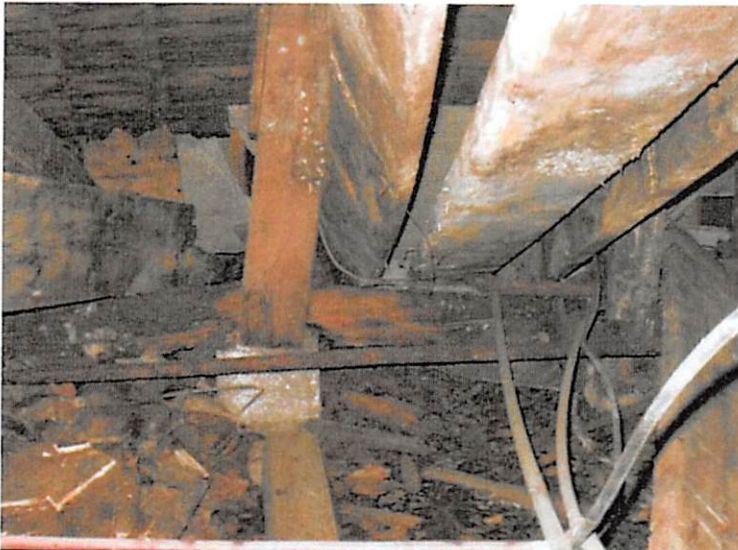
8. Close-up of deterioration and rot in the center support beam.

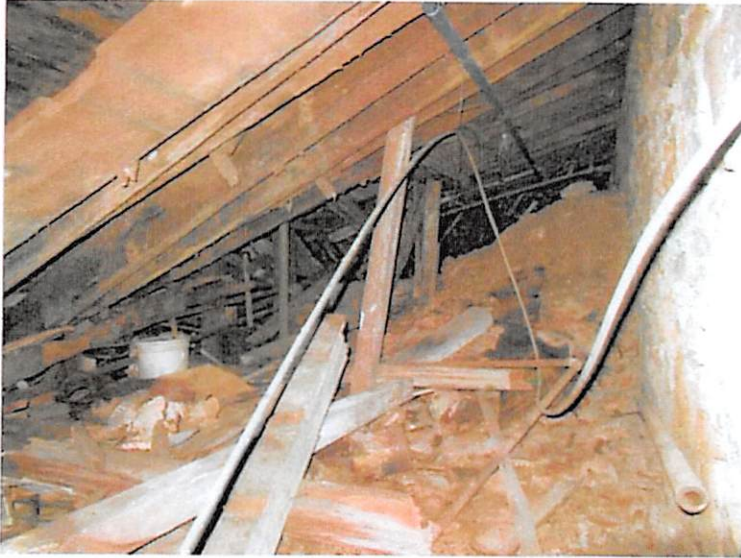
9. Looking north in the basement area at the collapsed framing.

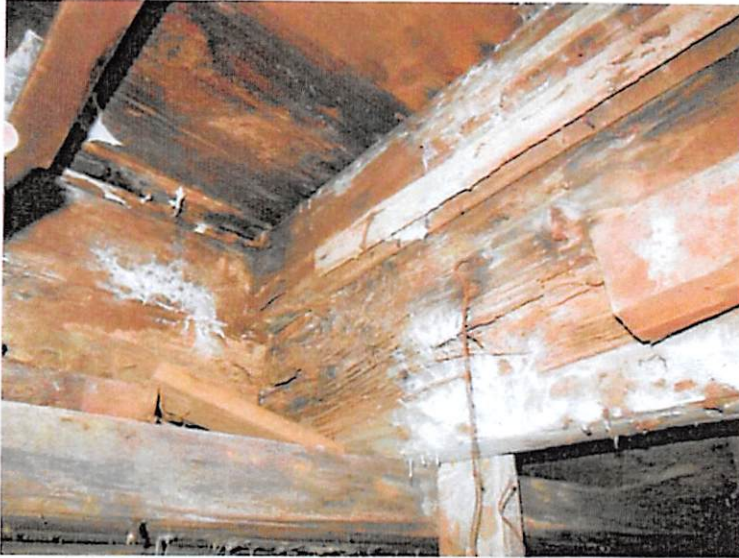
Continued review of the floor framing that was still in place revealed significant deterioration and rot problems as well as extensive termite damages in some areas. Columns, support beams, and joists, were all found to be affected to varying degrees. There are locations where joist ends are partially crushed due to the extensive termite damage or rot conditions that are present. Support beams are twisted/rolled and/or sagging due to deterioration in the columns, or the support beams themselves. Generally, all of the floor framing for both building sections was found to be in very poor condition.

11. Extensive deterioration, rot, and termite damage in the floor joist framing along the east wall.

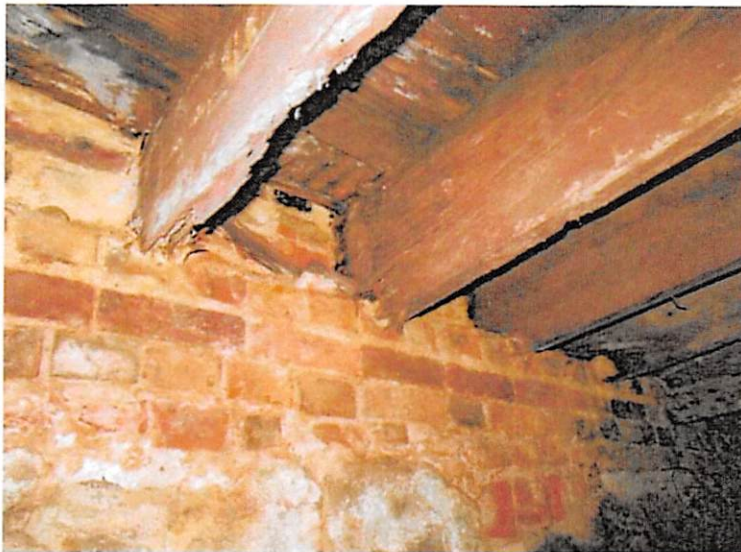
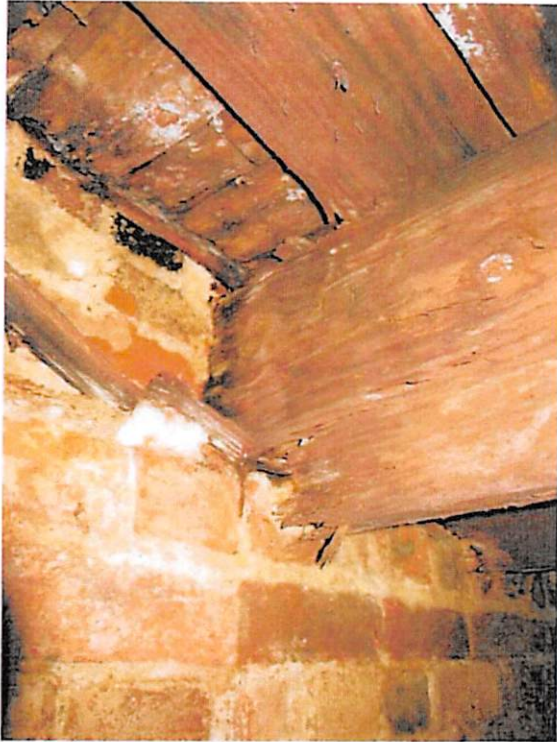
12. Extensive deterioration, rot, and termite damage in the floor joists along the east wall. Note the ends of the joists are crushing.

13. Close-up of Photo #12.

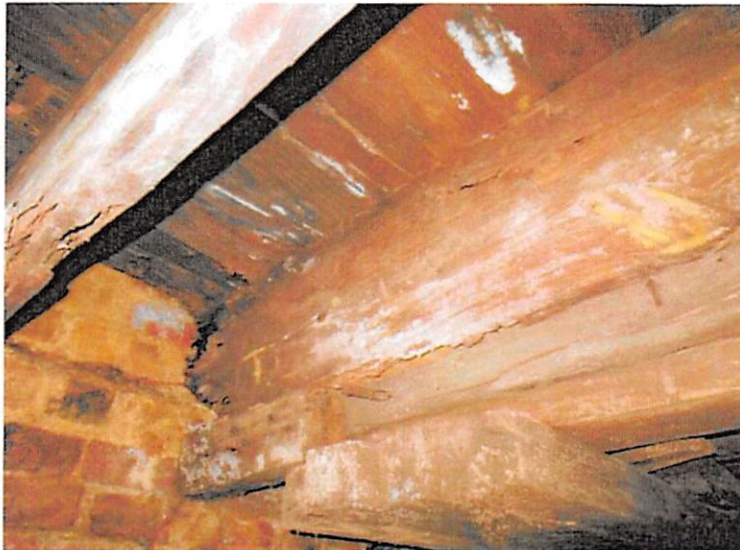
14. Extensive deterioration, rot, and termite damage in the joists closer to the south end of the east side.

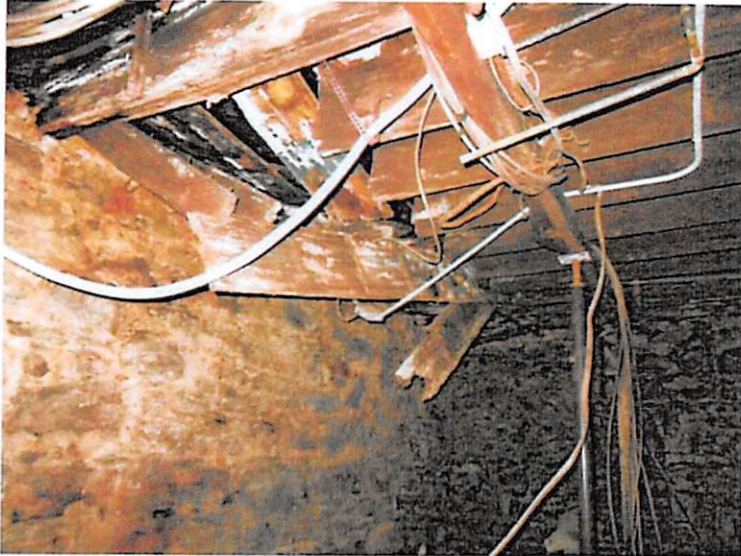
At the southeast end of the east building, the floor framing had been modified to close off the old basement stairway access location. Some of the framing in this area has failed and partially collapsed.

15. Partially collapsed floor framing at the old stairway location located at the southeast corner.

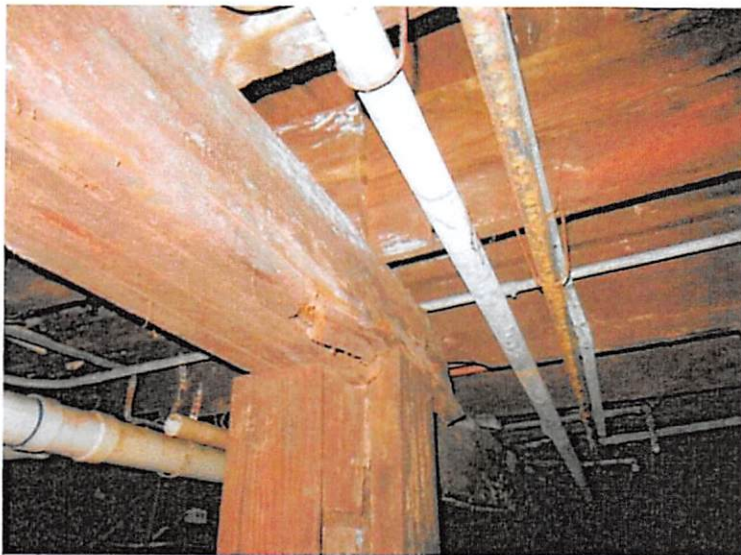
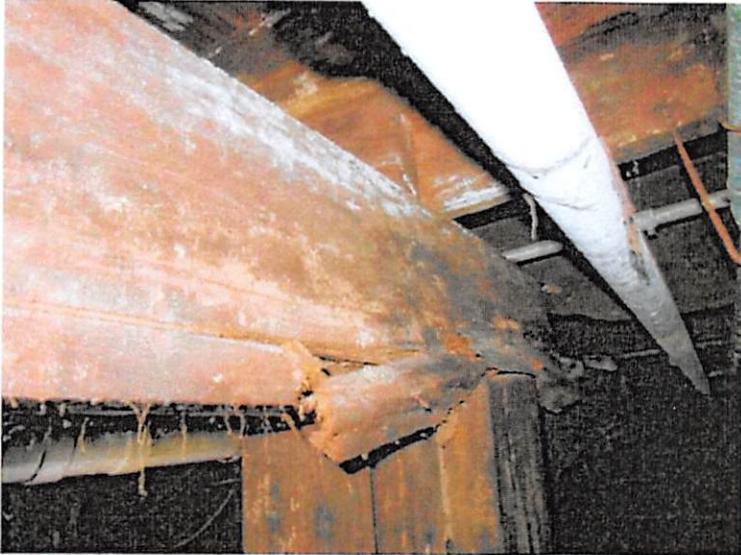
16. Extensive deterioration, rot, and termite damage in a support beam at a support post location.

17. Close-up of Photo #16.

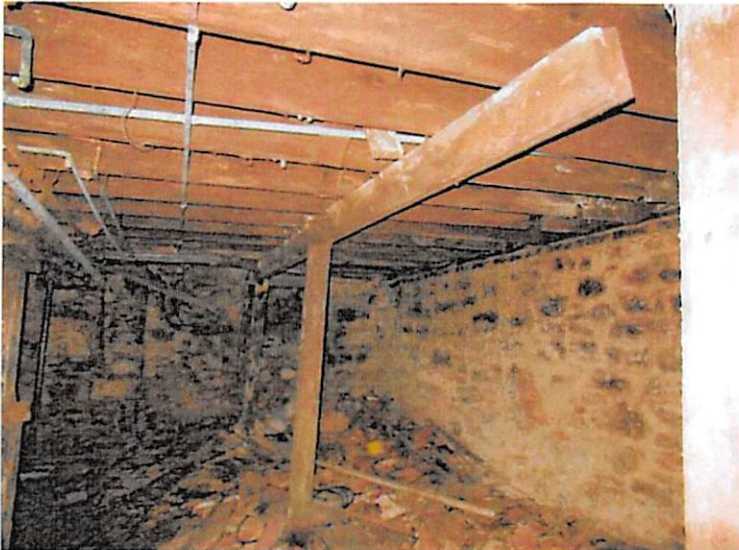
18. Another support post and column location that are rolling and tipping due to the extensive deterioration and rot problems.

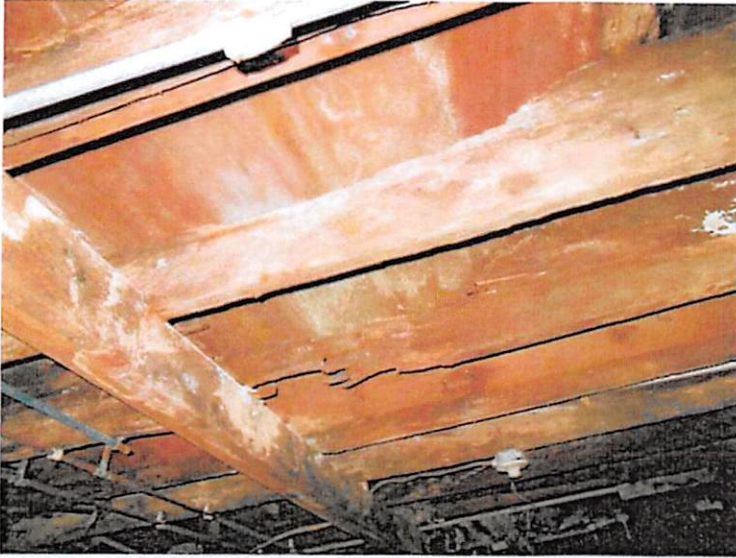
19. Floor joists that are partially missing due to extensive deterioration, rot, and termite damage. Note there is also damage in the support beam.

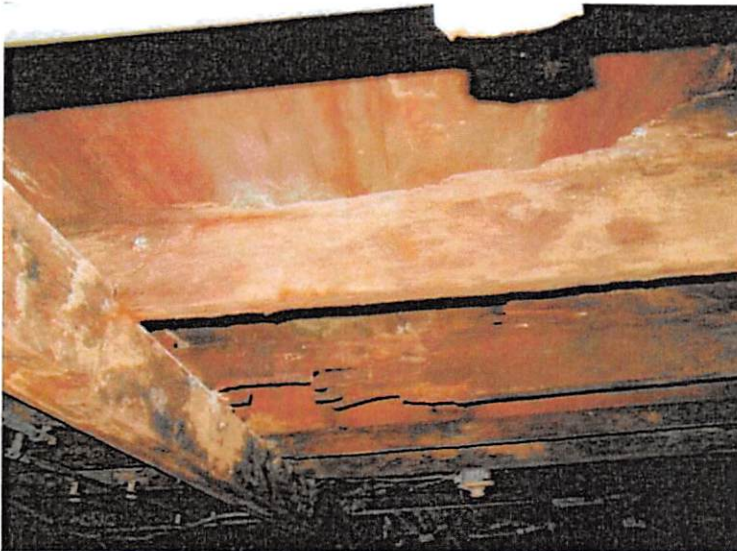
20. Another view of damages and missing portions of the floor joists.

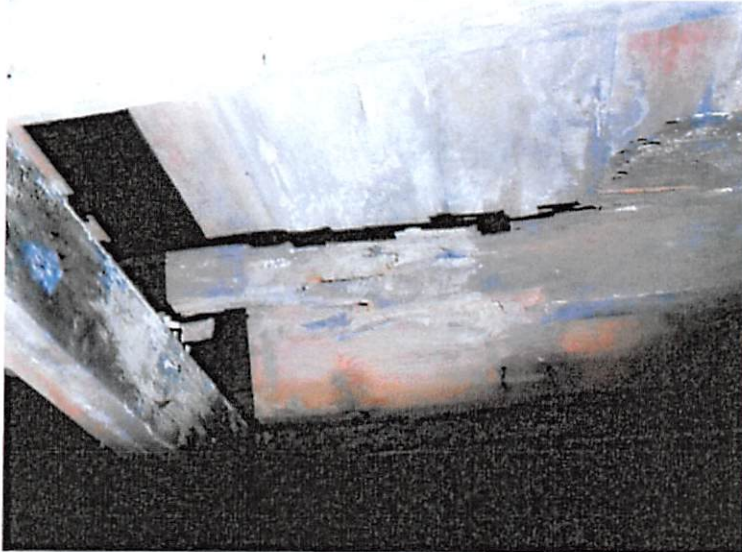
21. Close-up of a floor joist where the upper portions are missing due to extensive deterioration and rot problems.

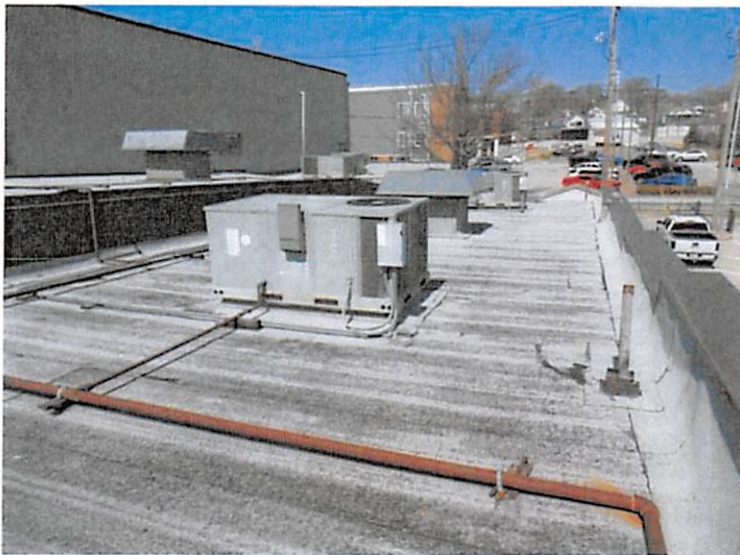
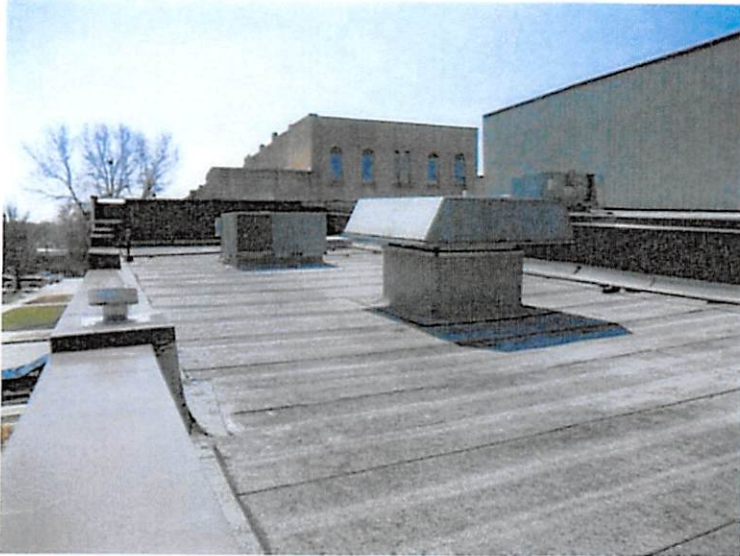
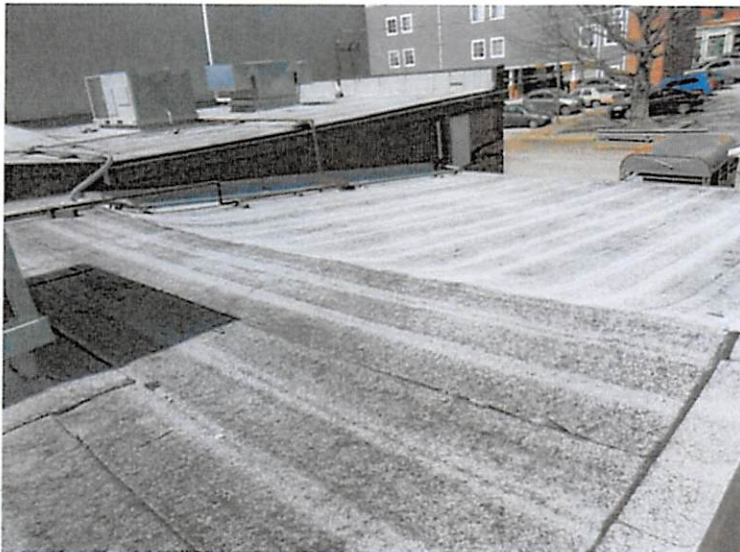
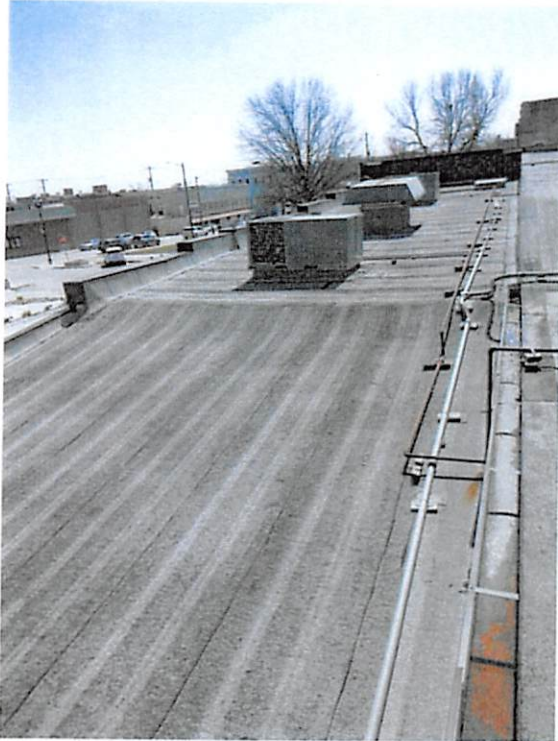
Access was gained up onto the roof and I found that both the eastern and western halves of the building are covered with granular surface modified bitumen roofing (SBS). This roofing shows signs of significant aging, and the granule surfacing is worn off significantly in many areas. These conditions indicate that this roofing is many years old and nearing the end of its useful life. I would estimate that there is less than five years of useful life left in the roofing membranes on the buildings.

22. Looking north on the roof of the east half of the building.

23. Looking south at the roofing on the east half of the building.

24. Northern portion of the east roof with the western half of the building in the background.

25. Looking south over the entire east half of the roof.

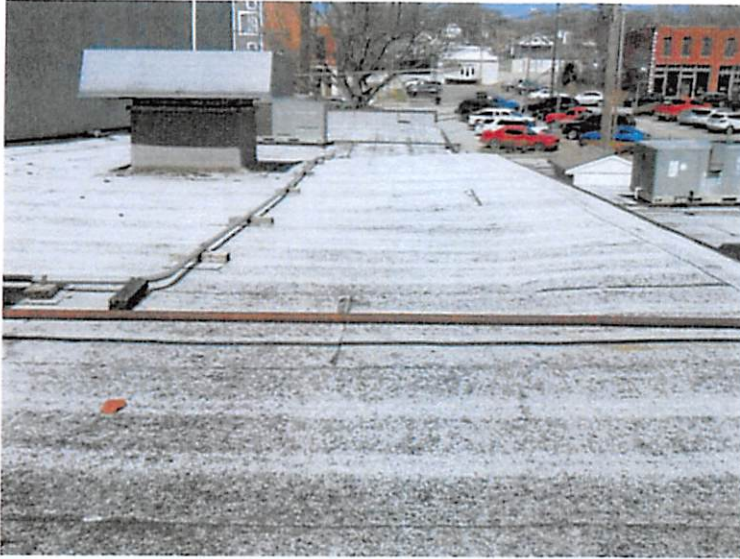
The roof is framed with conventional joists in the eastern portion and with field constructed trusses in the western portion. There is notable sag in the truss framing on the west side. When repairs are made to the building, I recommend that the joists on the east side of the building be reviewed and that any individual joists that are cracked, split, or otherwise damaged be repaired/sistered on an as-needed basis. Truss framing on the west side of the building should also be reviewed due to the sagging that is present. It is likely that some repair in the form of additional truss framing members and connection improvements will be needed for each of the individual trusses to ensure structural soundness.

27. Low angle view of the roof showing the sag present in the roofing.
