LIMITED STRUCTURAL INSPECTION

6678 River Road
Fuquay-Varina, NC

January 11, 2024

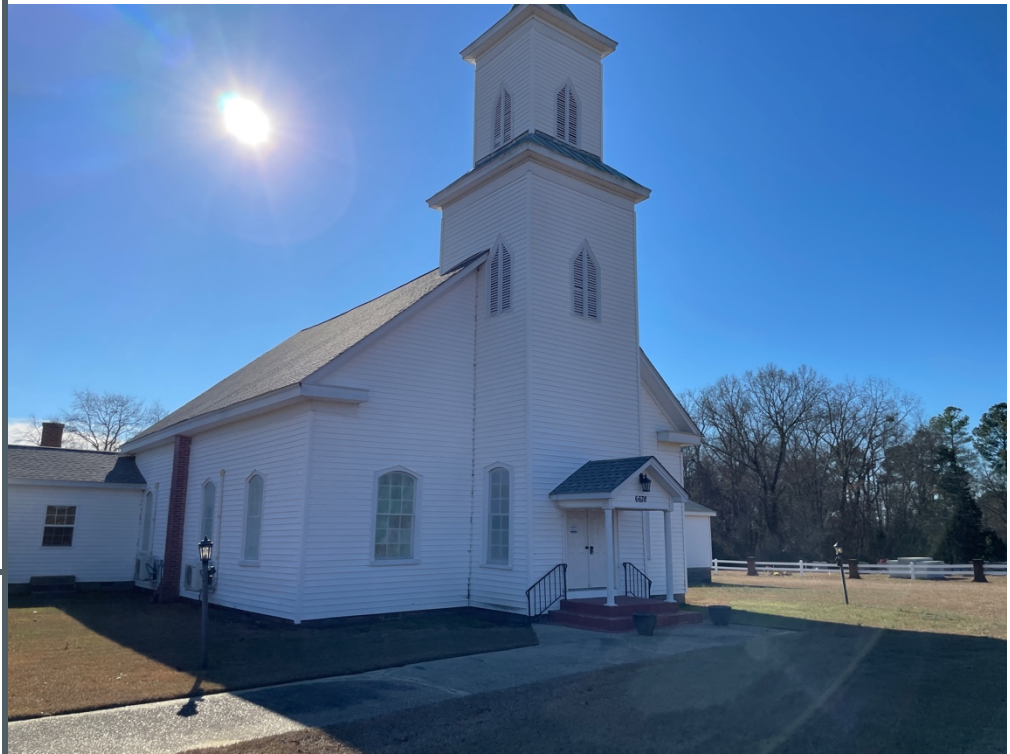
Photo No.
1

View of the front of the building.

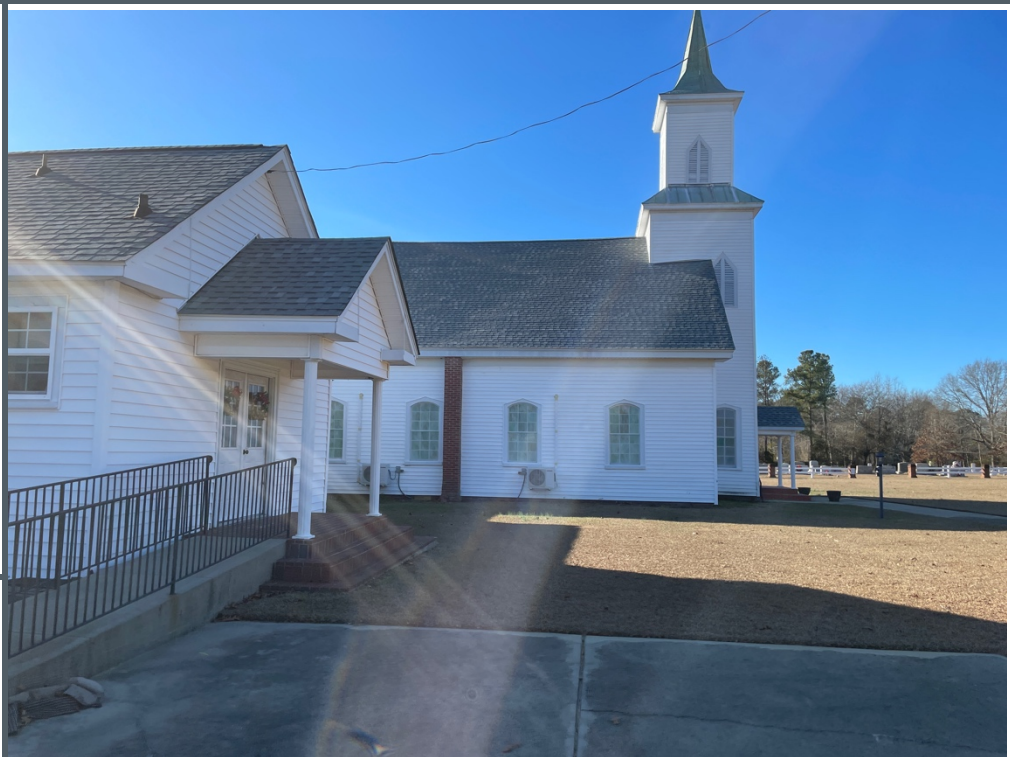
Photo No.
2

Side view of the building.

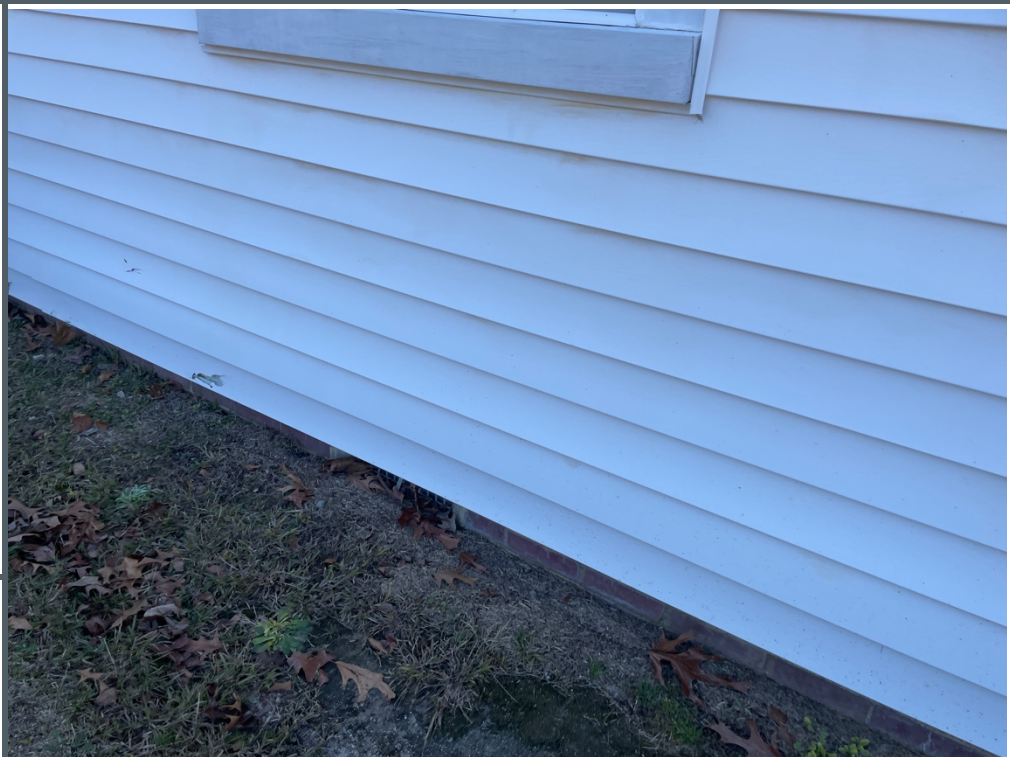
Photo No.
3

11. The soils in the crawlspace were wet/damp at the time of the inspection and no vapor barrier was installed in the subject crawlspace area.
12. On the exterior, the grade was relatively flat along the perimeter walls. We noted an area of slight negative slope towards the building on the left side. Note that multiple foundation vents were at or below the perimeter grade elevation. No gutters were installed on the building.

View of a foundation vent at grade.

1. We recommend installing vent wells along the foundation vents within 6" of grade.
2. We recommend adjusting the site grade along the perimeter as possible to achieve positive slope away from the foundation (ideally 6" of fall within the first 10 feet). Grade adjustments shall be achieved by cutting soils.
3. We recommend the installation of gutters (6" K style seamless with 3x4 corrugated downspouts) on the original church building. The gutters shall be extended away from the building (minimum 5-feet) using leader pipes (discharging into an area of positive slope away from the building).
4. The installation of foundation drains may be required in the future if water infiltration issues persist.

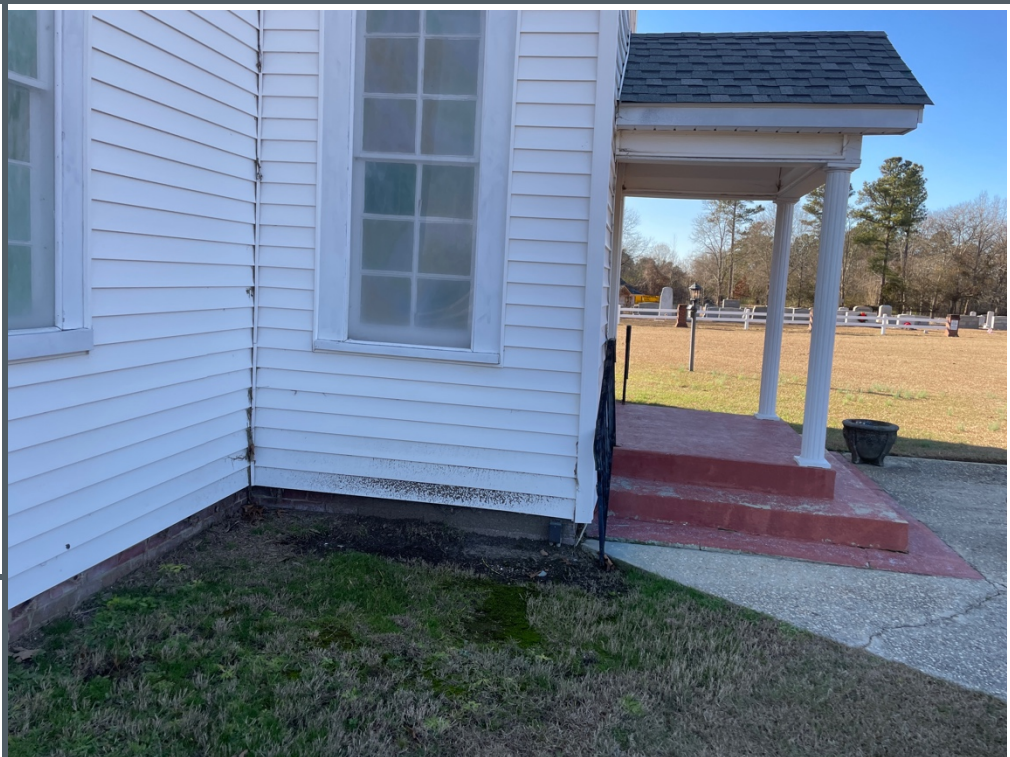
Photo No.
4

9. We noted a missing pier at the front-right corner of the building.
10. We noted indications of significant water infiltration on the left side, which appeared to be originating near the front. Various erosion was observed along the left side of the subject crawlspace from the front all the way to the rear.

View of erosion at the front-left corner.

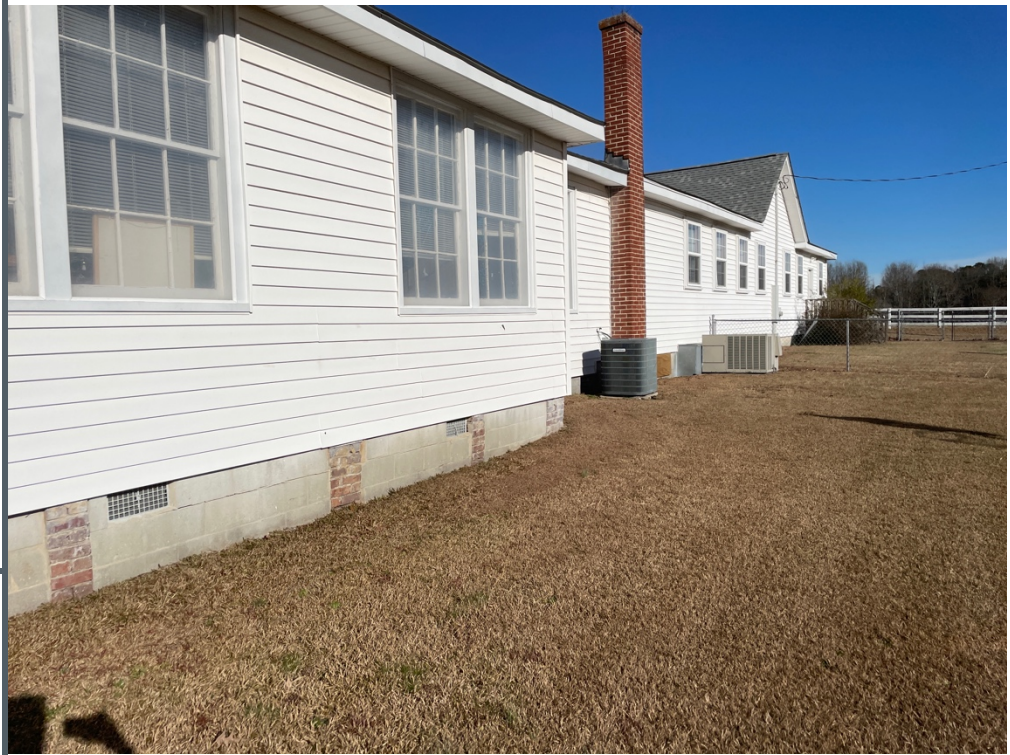
Photo No.
5

View of the rear
classroom/office area.

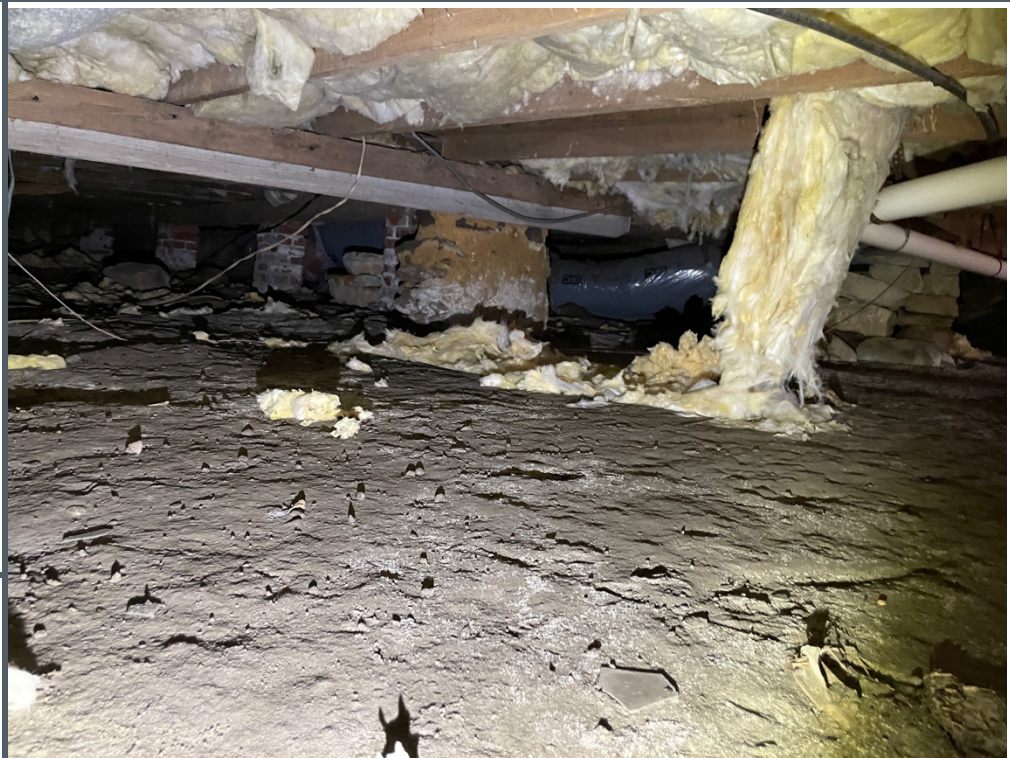
Photo No.
6

Typical view of the
crawl space.

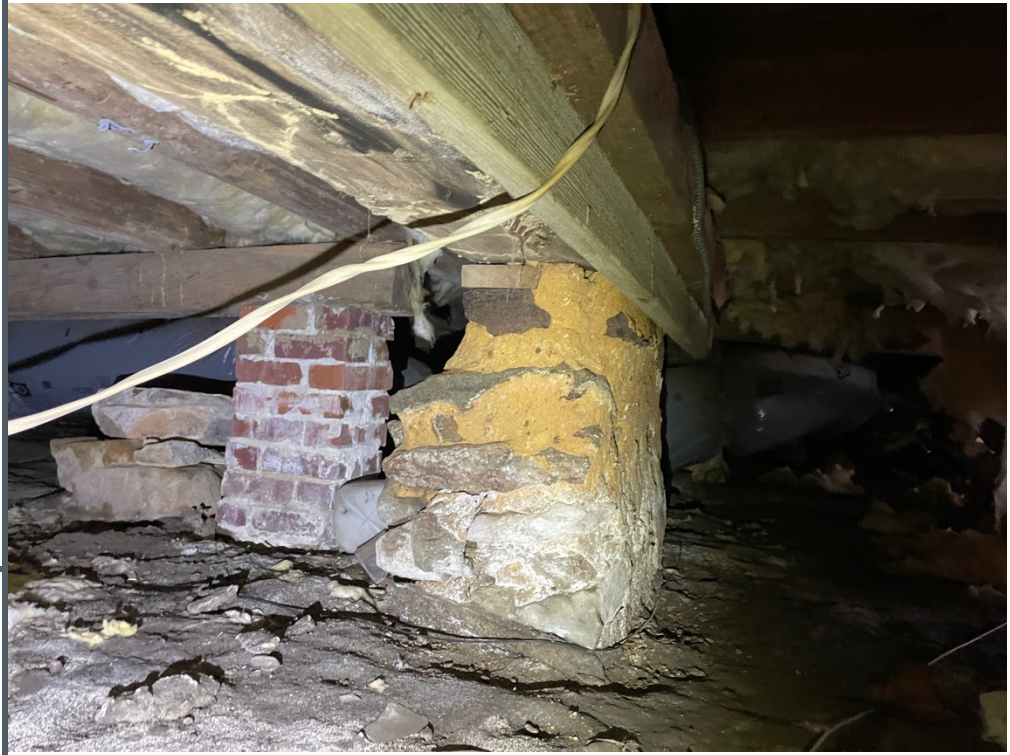
Photo No.
7

6. We noted a joist on the left side which was rotted through the full cross-section and had fallen to the ground.
7. The original stone piers were observed to be deteriorated/cracked in numerous locations and the mortar within the piers was observed to be very soft. The masonry walls along the perimeter of the building were observed to be deteriorated and cracked in multiple locations.

Concerning the foundation components, the original stone piers are in poor condition, and this is likely related to the prolonged moisture conditions in the crawlspace. The stone piers will require replacement over the long term. The brick piers and sections of curtain wall will require re-pointing in some areas. We have provided recommendations below.

Typical view of a stone pier.

8. We recommend replacing the following piers with new 16x16 solid grouted CMU block piers on 24"x24"x10" thick concrete footings. Provide pressure-treated blocking or flashing between non-treated wood members.

- a) The original stone piers throughout the crawlspace.
 - b) The missing pier at the front-right corner of the crawlspace (Observation #9).
 - c) The leaning pier below the right intermediate girder (Observation #8).

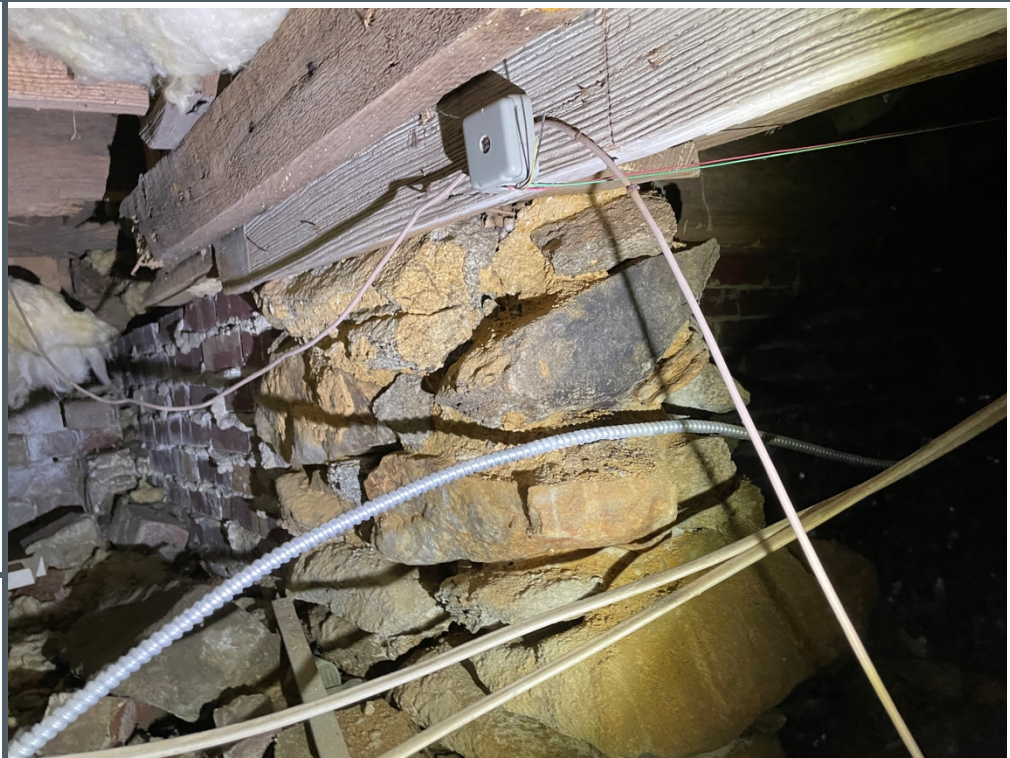
Photo No.
8

Typical view of stone pier.

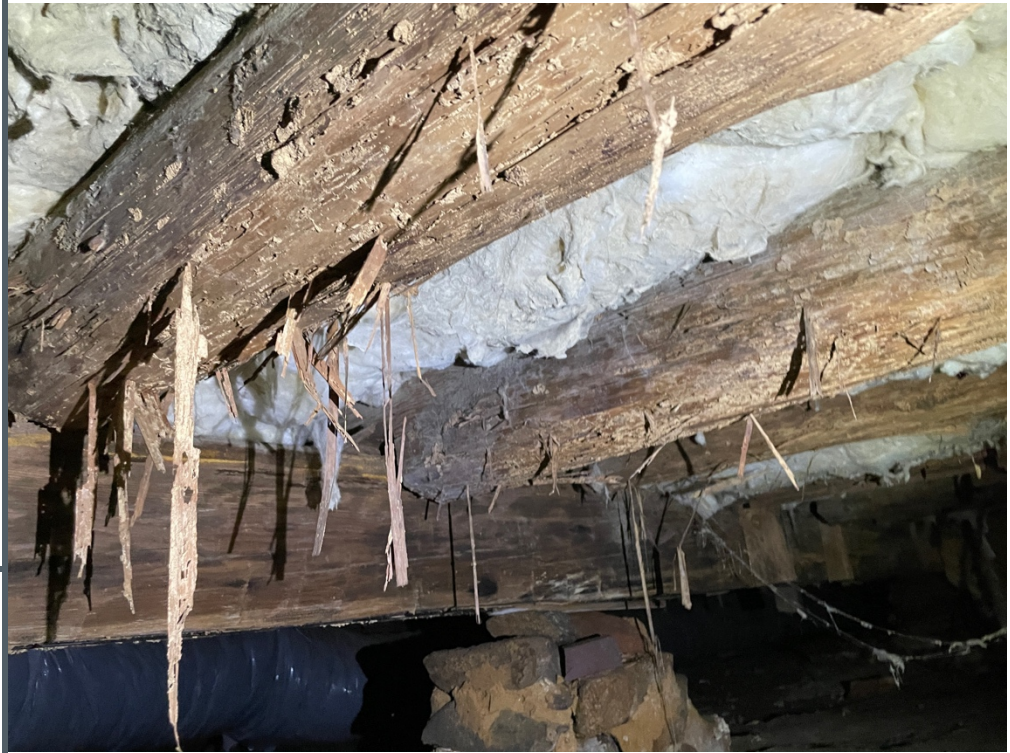
Photo No.
9

3. The floor framing was comprised of round wood joists (approximately 8" in diameter) spaced approximately 24" on-center.
4. We noted extensive damage to the floor framing below the sanctuary building of varying amounts. The damage appeared to be due to a combination of wood-destroying insect infestation and moisture damage. Samples of the framing and joists were probed in each section, to help determine the extent of the damages. The extent of the damages varied significantly depending on the location but varied between approximately ¼" and 2" of damage into the cross-section of the subject joist. Note that the damages were generally limited to the round timber framing and intermediate drop girders in the center and left side.

Typical damage to the floor joists.

5. We recommend fully sistering (bearing point to bearing point) the damaged joists with 2x8 pressure-treated members on **both** sides. Attach the new joists to the round member with 4" long Simpson SDWS screws at 16" on-center. At the bearing points of the new joists at the girders, provide 2x4 pressure-treated ledgers below the joist with (3) 16d nails below each joist.

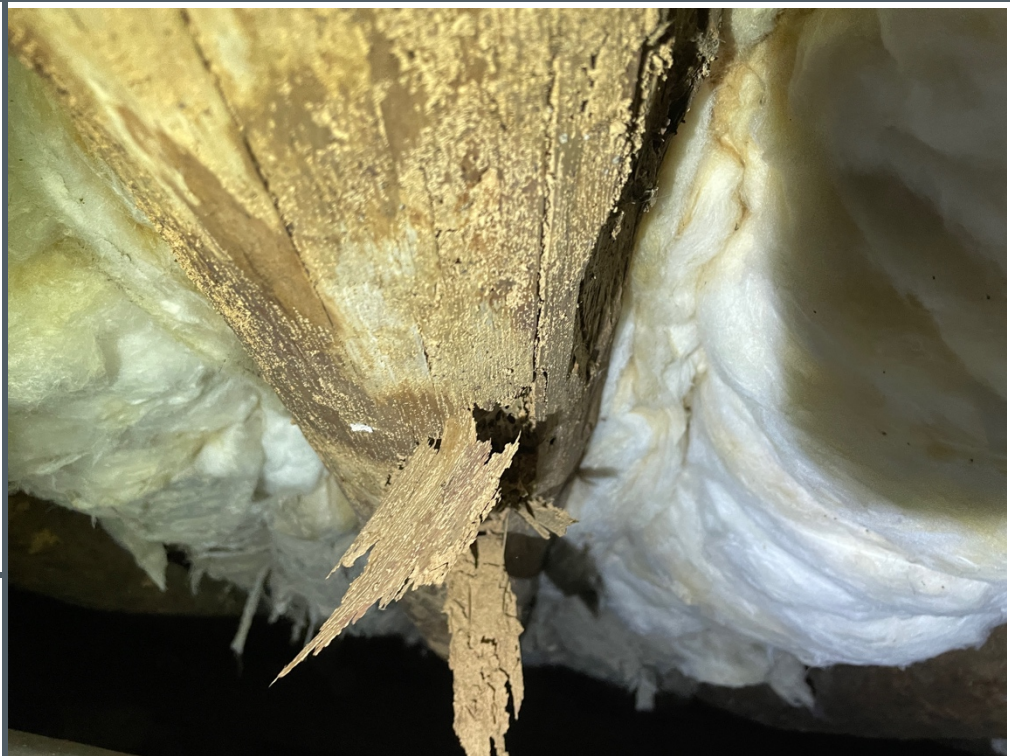
Photo No.
10

Typical damage to the floor joists.

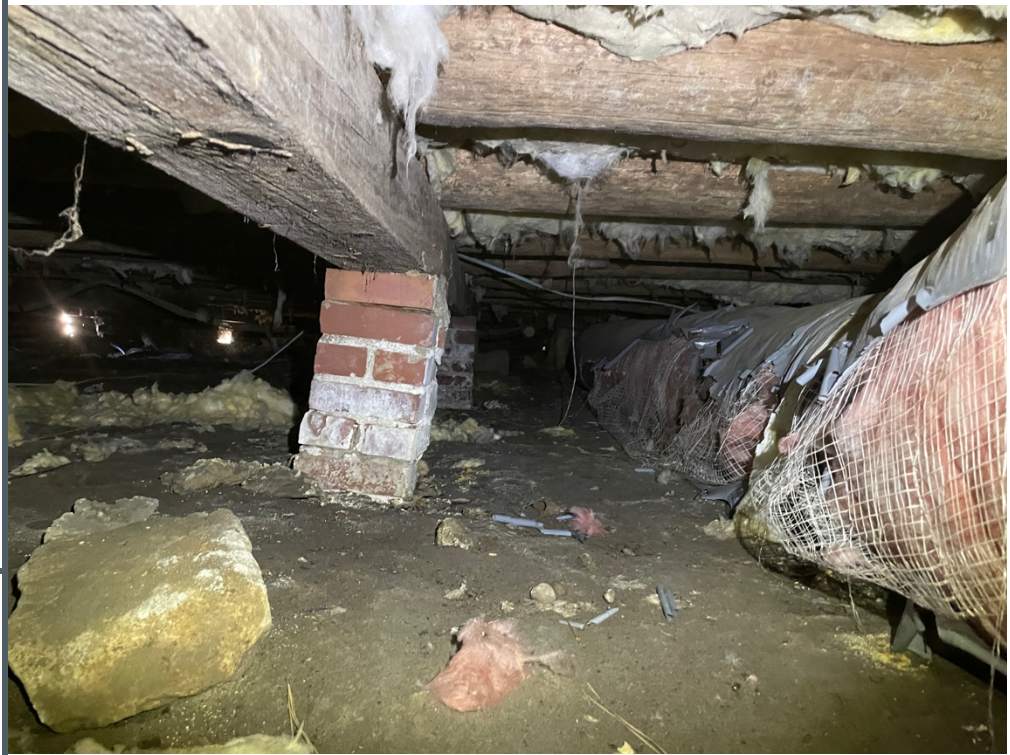
Photo No.
11

8. We noted a leaning pier below the right intermediate girder on the right side, at the third span from the rear band of the original sanctuary building.

View of the leaning pier below the right intermediate girder.

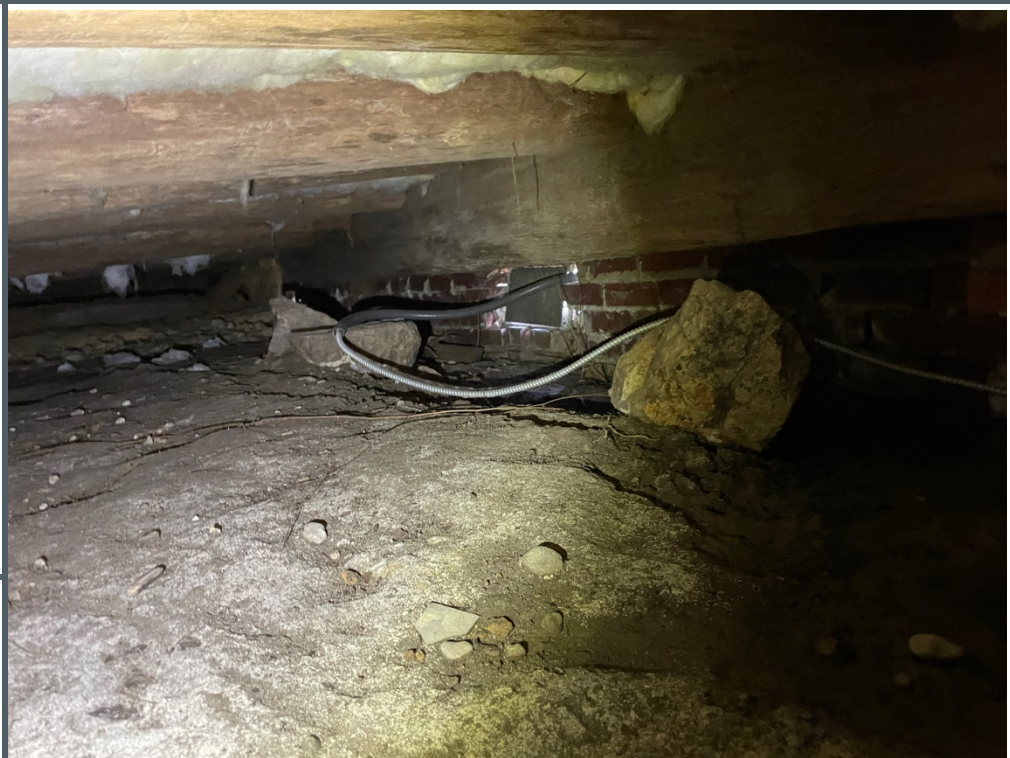
Photo No.
12

View of erosion and wet soils on the right side.

7. We recommend installing a new 6 mil vapor barrier in the crawlspace to cover 100% of the exposed soils. We recommend the foundation vents be opened in the warm season to promote air circulation. The moisture levels in the crawlspace should be monitored. If moisture levels remain high, the installation of a dehumidifier may be required.

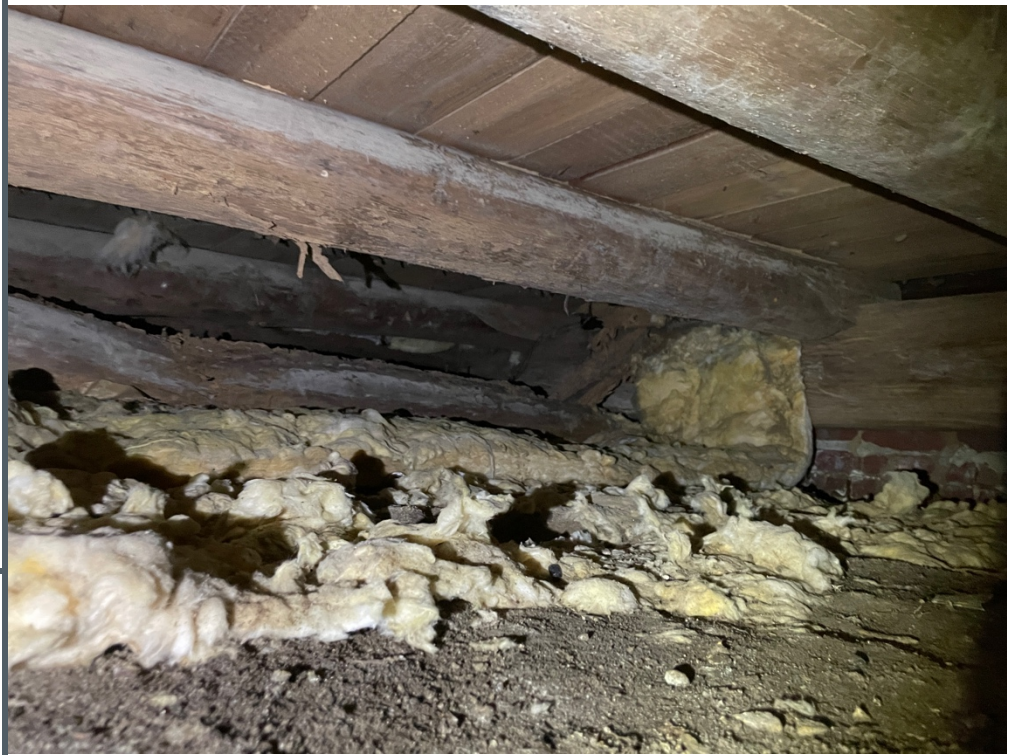
Photo No.
13

View of the fallen joist near the front-left corner.

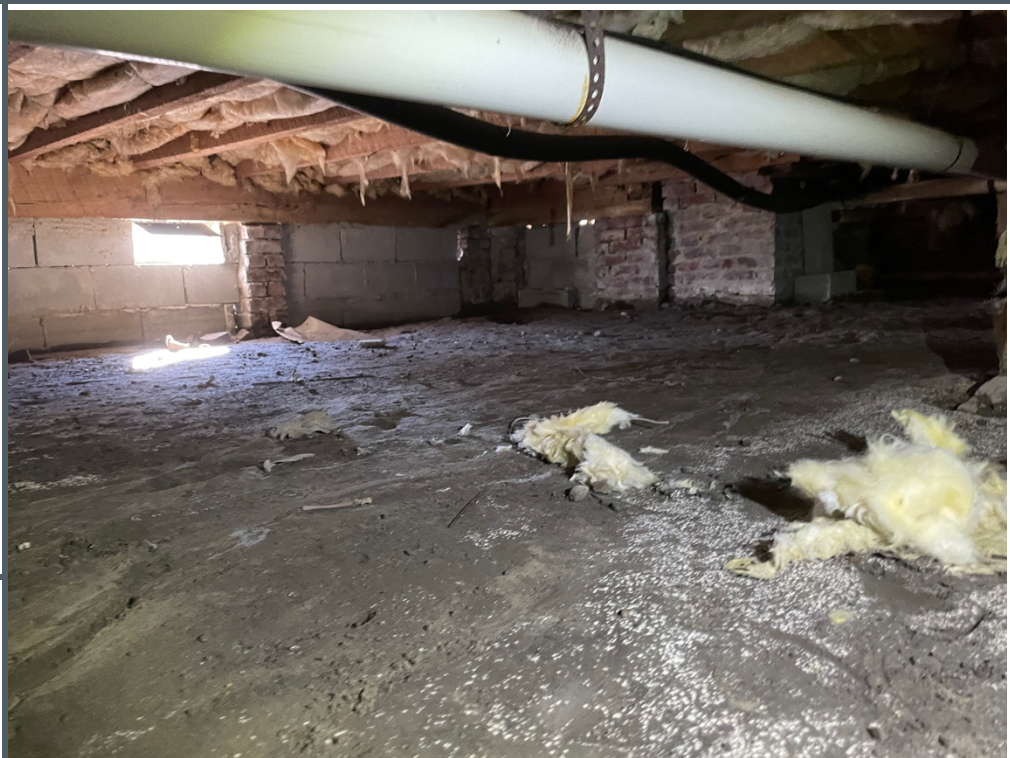
Photo No.
14

Typical view of the rear portion of the crawlspace.
