## PROPERTY CONDITION REPORT

### 64 Union Way

64 Union Way  
Vacaville, California 95687

July 22, 2024

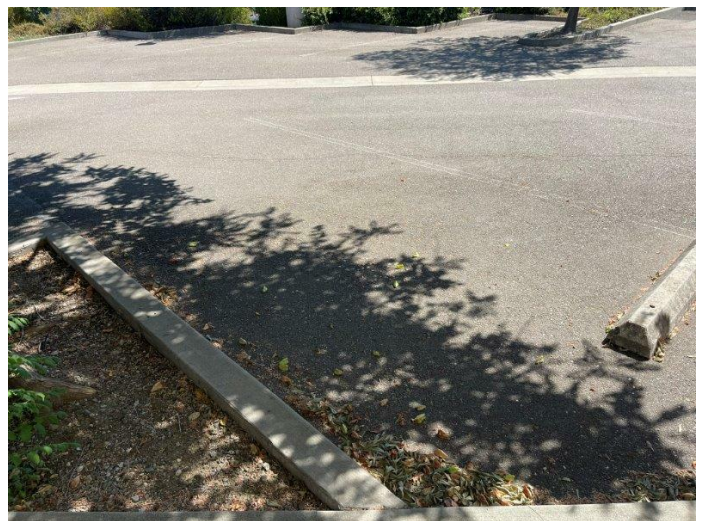
12. Asphalt paving: showing condition.

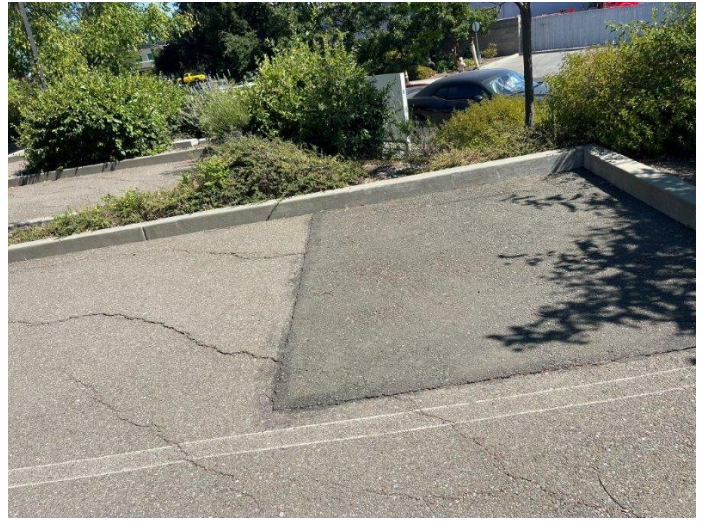
Asphalt pavement appeared to be in good overall structural condition; however, Damaged pavement consisting of linear cracking was noted, particularly at the southeastern corner of the parking area. It is anticipated this cracking can be addressed at the time seal coating is next applied.

50. Linear cracking in asphalt paving and condition of stall striping.

Asphalt seal coat appeared to be in fair condition. It appeared that seal coat has not been applied in the past five years. It is recommended that a regime of periodic seal coating and stall restriping be instituted

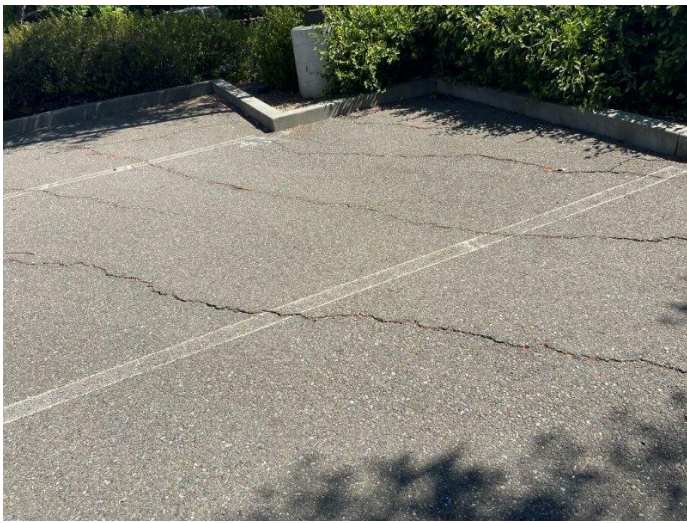
51. Linear cracking in asphalt paving and condition of stall striping.

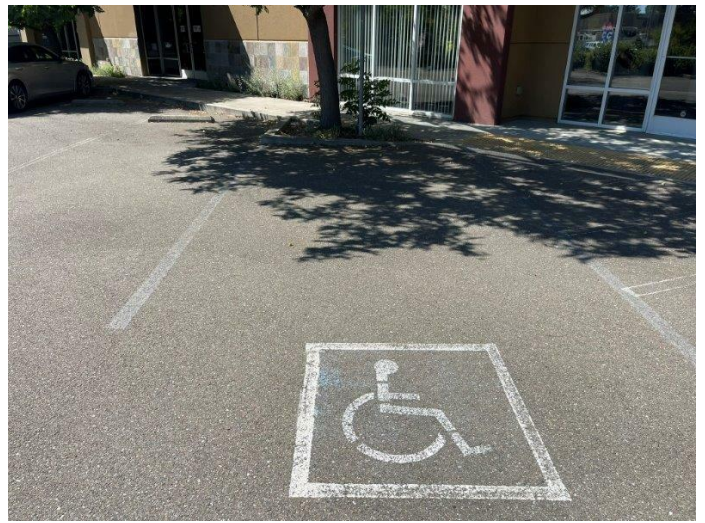
52. Designated ADA parking stall ground markings are faded.

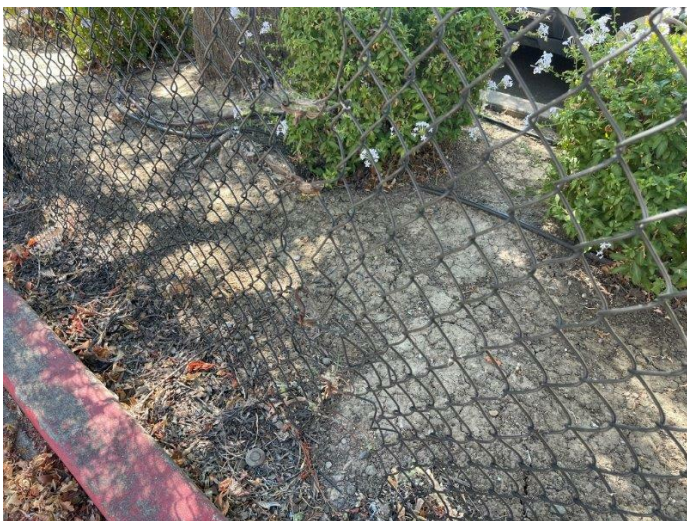
The fencing and gates appeared to be in generally good overall condition; however, one section of fencing at the southwestern parcel corner has been vandalized and makeshift repairs effected. Replacing this section of fencing is recommended. Due to the limited scope of work and a resulting opinion of cost that falls within the definition of a de minimis condition, this issue can be addressed as part of routine maintenance.

53. Southwestern parcel corner: chain-link fencing has been cut.

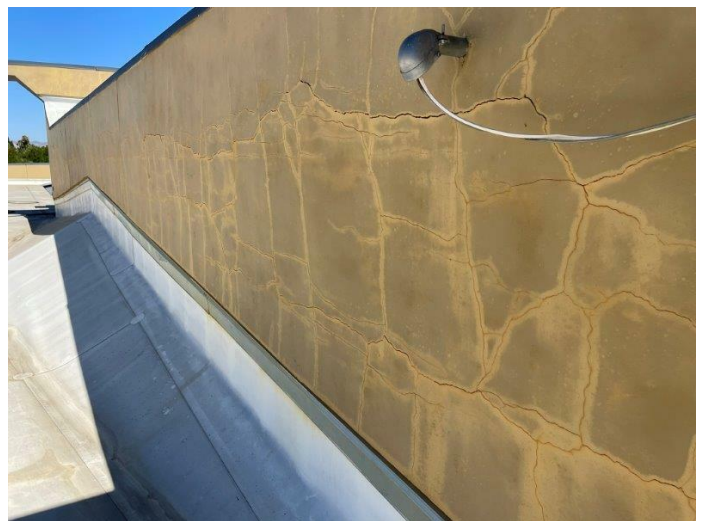
The exterior walls appeared to be in generally good condition; however, the stucco at the rear of the mezzanine penthouse (observable from the rooftop) is extensively cracked. Some of this cracking appears sufficient to permit water intrusion. Repair of this deficiency is recommended in the short term. An opinion of cost for this work is included in Table 1.

54. Rooftop, mezzanine penthouse: damaged stucco.

| Sect No. | Deficiency or Repair Item | Quantity | Unit | Unit Cost | Total Cost |
|---|---|---|---|---|---|
| 4.3.1 | The stucco at the rear of the mezzanine penthouse (observable from the rooftop) is extensively cracked. Some of this cracking appears sufficient to permit water intrusion. Repair of this deficiency is recommended in the short term. | 1,000 | SF | \$3.00 | \$3,000 |

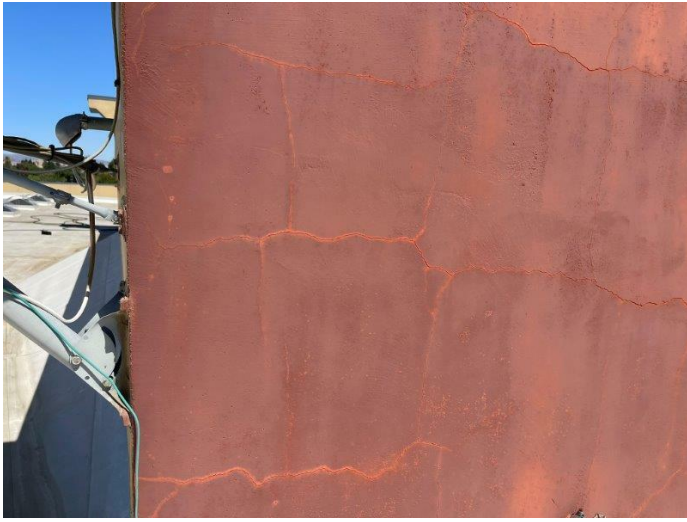
55. Rooftop, mezzanine penthouse: damaged stucco.

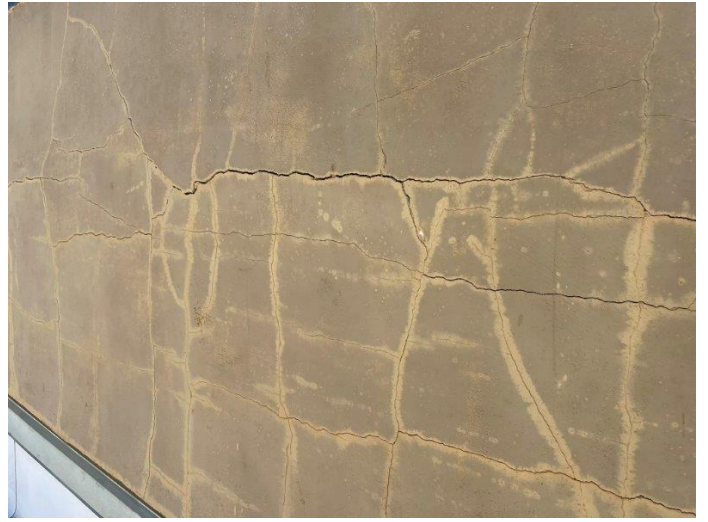
56. Rooftop, mezzanine penthouse: damaged stucco.
