THE ALLIED REPORT

Inspection # **031224-1456**

Inspection Date: **3/12/2024**

Property Address: **14560 NE 3rd Court**

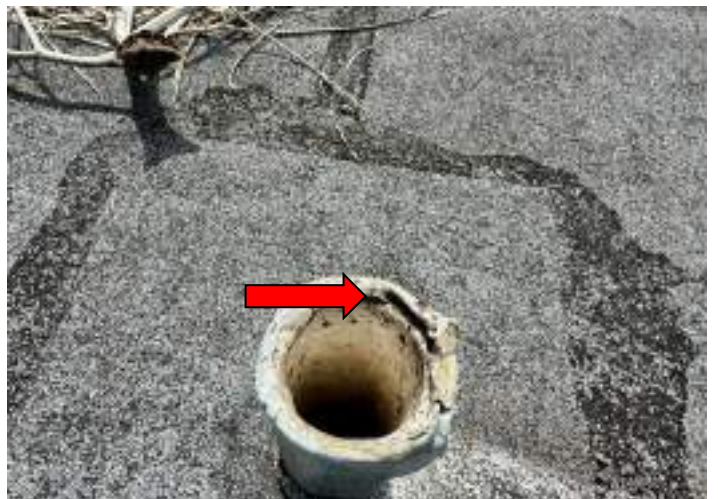
IMPROPERLY TERMINATED VENT PIPE

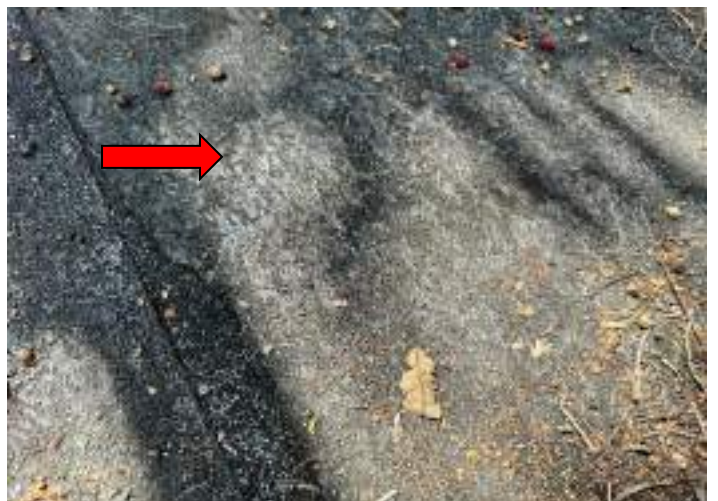
- Membranes were visibly worn at multiple areas as well as excessive loss of surfacing granules.
- Wrinkles were noted in multiple areas. The roof may no longer be watertight because a lap has failed.
- Accumulated organic matter including leaves, tree branches, etc. are present at multiple areas on the roof surface.
- Based on the above noted findings, the subject roof systems are beyond the economic life expectancy and at the point of replacement. We recommend further evaluation of roofing contractors prior to expiration of the due diligence period to determine replacement options, scope, and actual costs.

ROOF DAMAGE/EXPOSED FELT

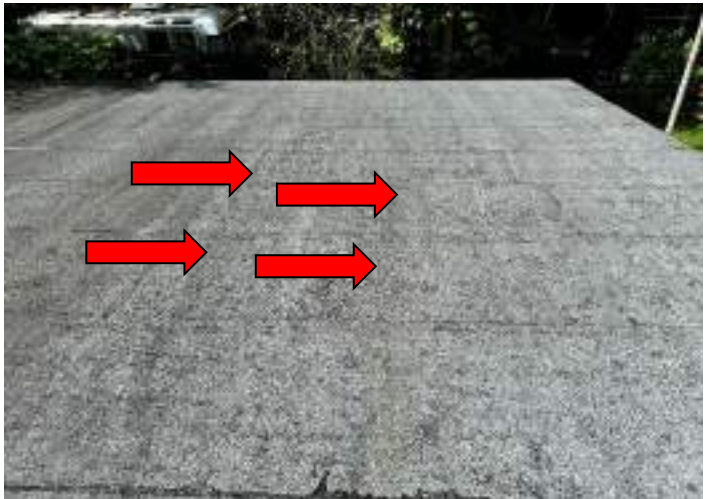
DISCOLORATION/DETERIORATED MEMBRANE

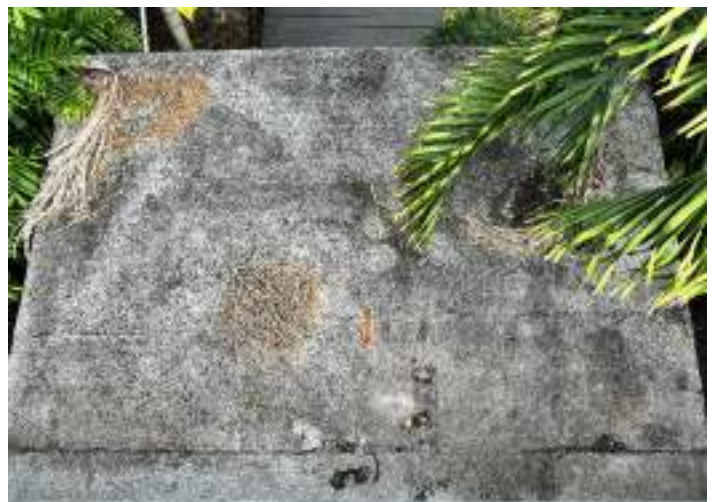
DISCOLORATION/DETERIORATED MEMBRANE

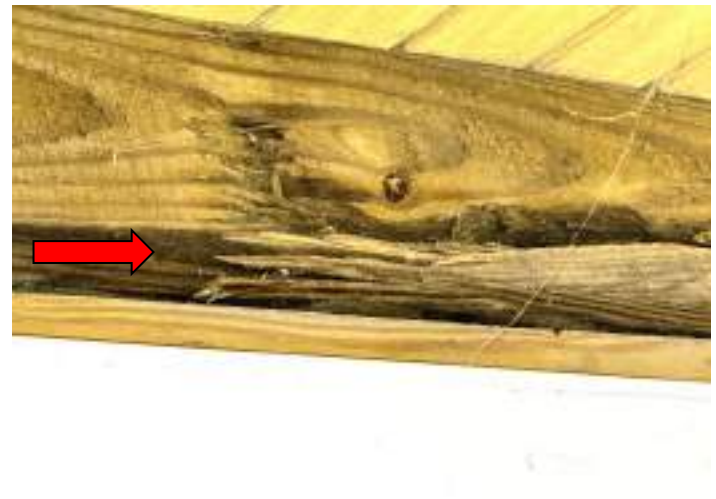
a. **Damaged/slit rafter was noted on the second-floor south bedroom wall. We recommend buyers obtain further evaluation by a structural engineer, prior to expiration of the due diligence period.**

DAMAGED RAFTER

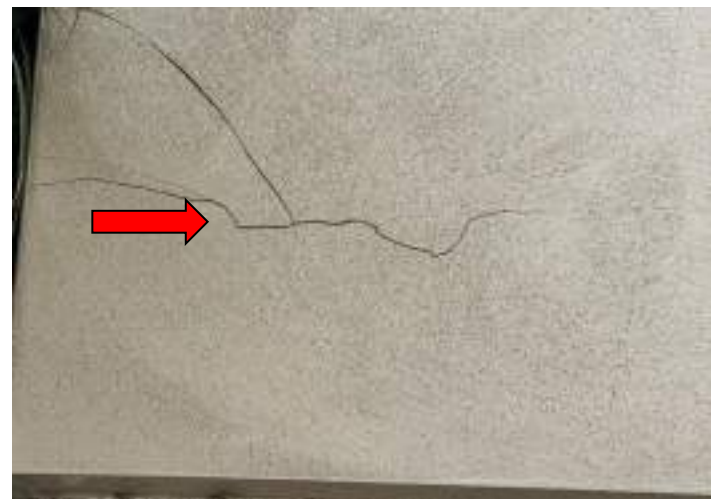
c. Hairline cracks were visible at multiple areas of the exterior walls, these cracks/openings are typically settlement/expansion cracks and are considered cosmetic. All exterior cracks should be sealed to prevent water intrusion and possible further damage due to moisture intrusion. These cracks should be monitored for further expansion and development.

HAIRLINE CRACKS

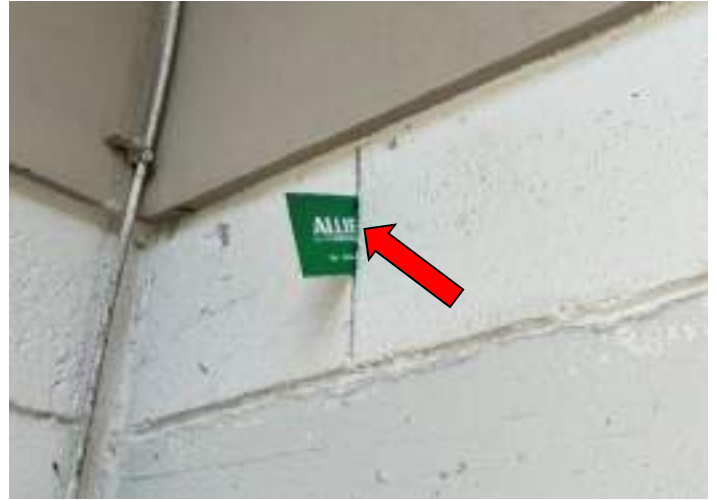
d. Previous repairs were observed in multiple areas.

PREVIOUS REPAIRS

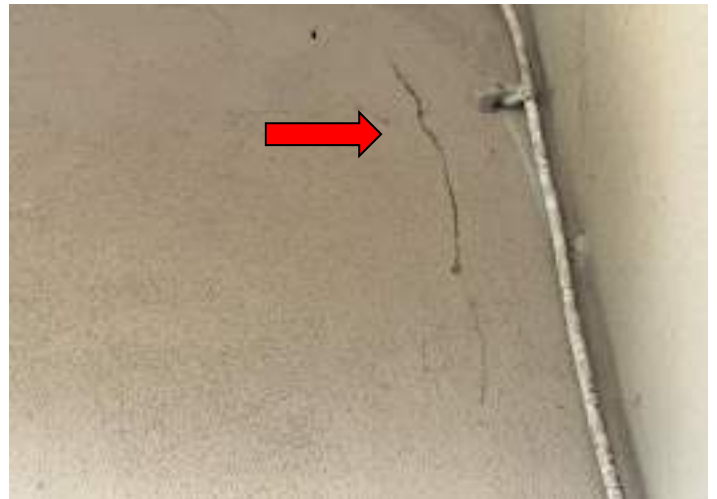
HAIRLINE CRACKS

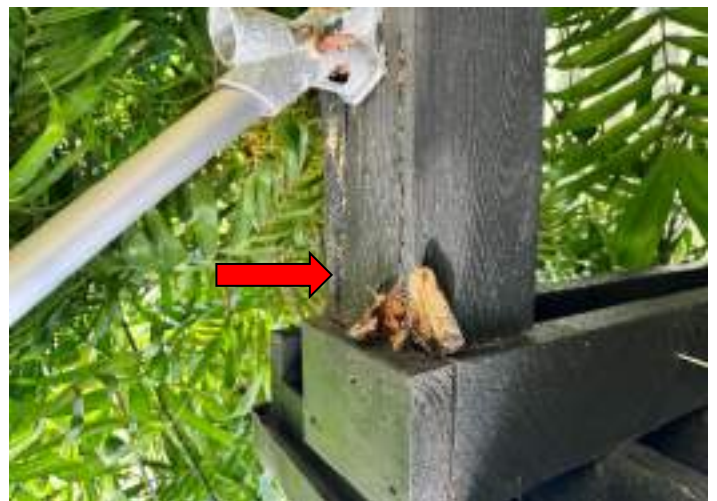
f. Wood decaying fungi damage was visible on multiple areas of the wooden walkway planks, multiple columns/posts, wooden beams, fencing and decks.

WOOD DECAYING FUNGI (WOOD ROT)

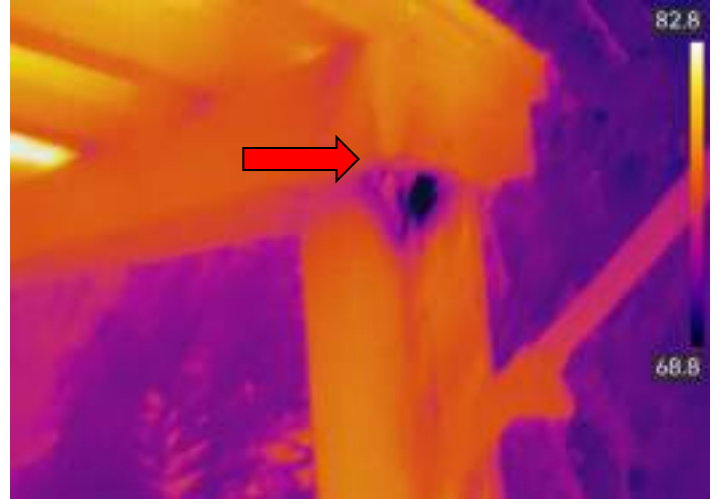
WOOD DECAYING FUNGI (WOOD ROT)

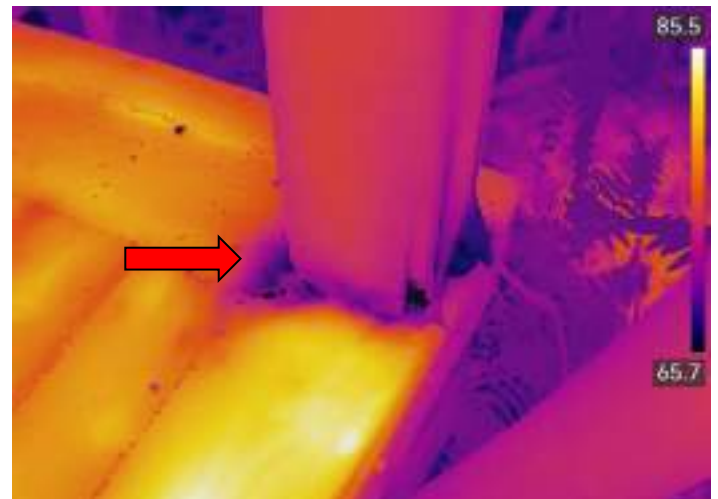
WOOD DECAYING FUNGI (WOOD ROT)

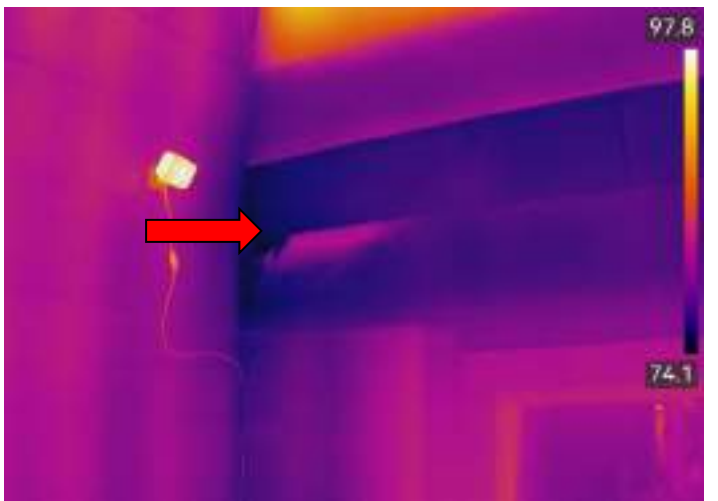
g. Bulges, exposed rebar possible spalling and thermal anomaly was noted at the left side of the window header near the main entry door left window.

SPALLING/EXPOSED REBAR/BULGES

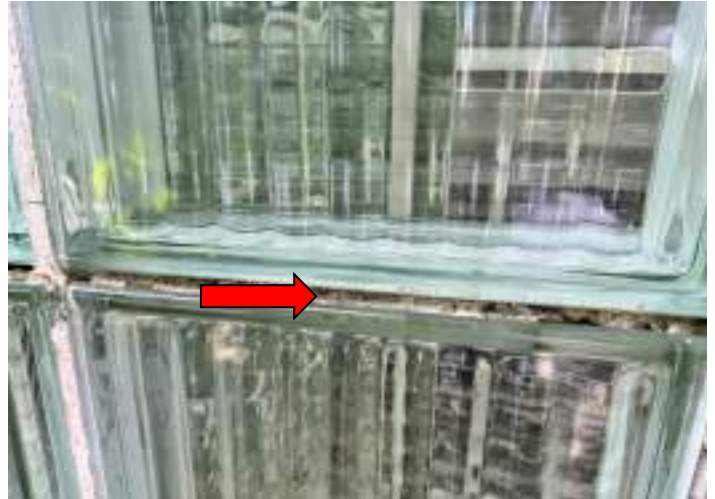
DETERIORATED/MISSING GROUT

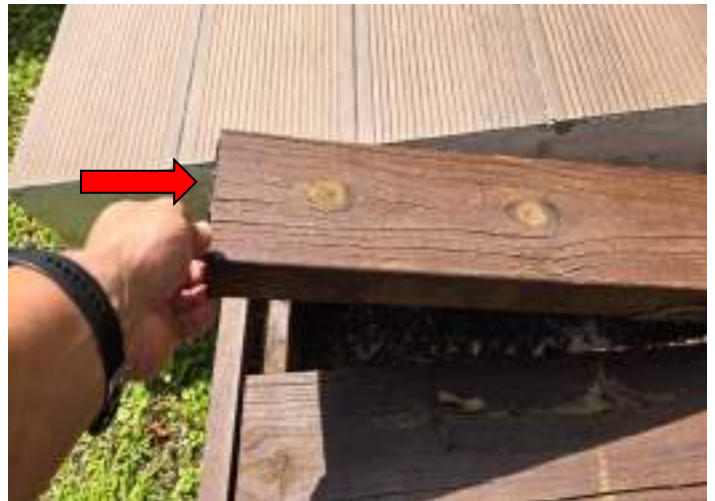
LOOSE WOODEN PLANKS

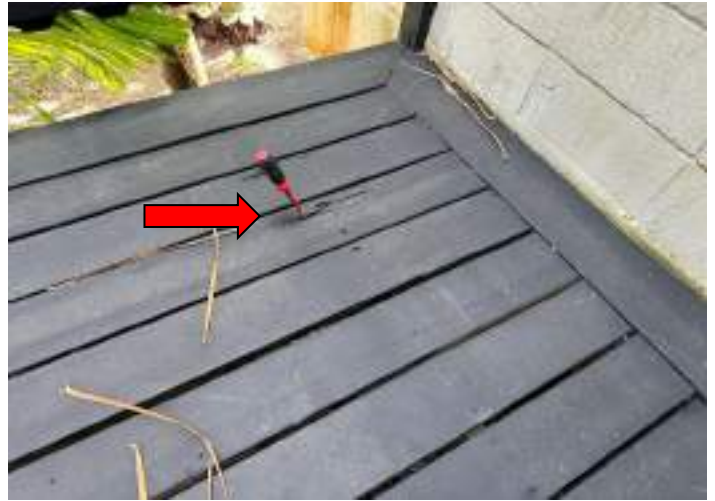
WOOD DECAYING FUNGI (WOOD ROT)

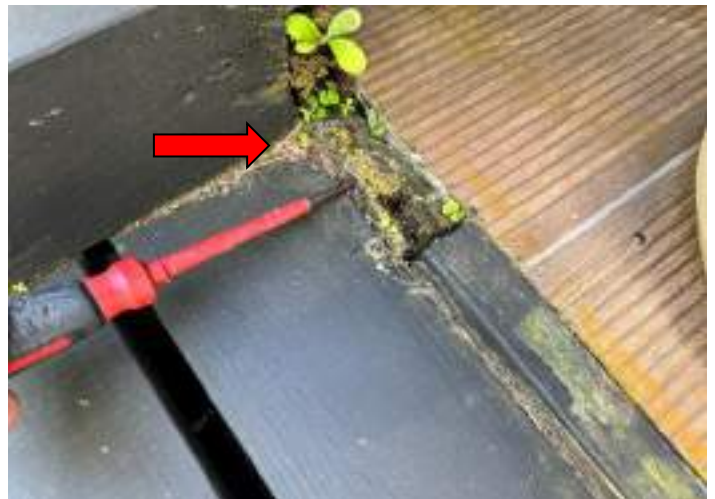
WOOD DECAYING FUNGI (WOOD ROT)

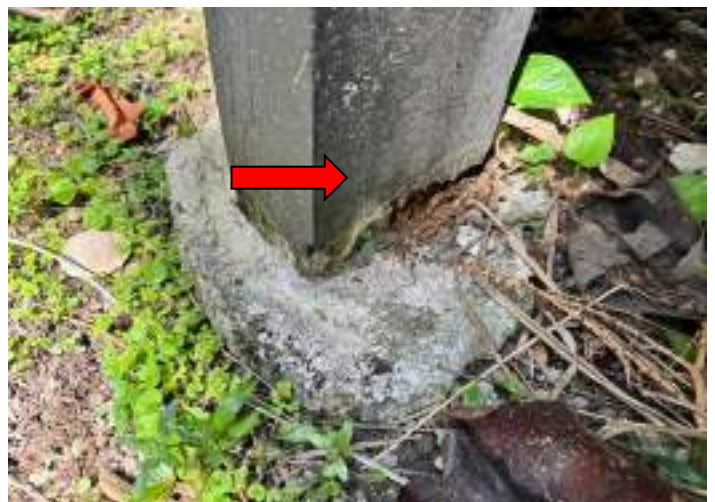
WOOD DECAYING FUNGI (WOOD ROT)

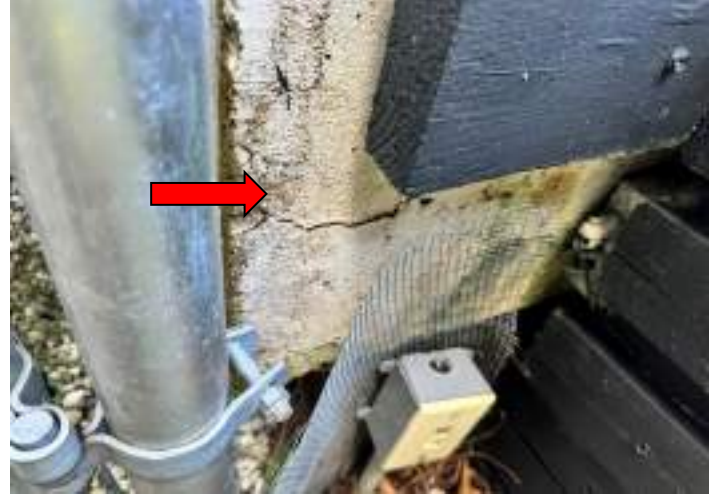
i. At the time of the inspection we observed structural/settlement cracking at multiple concrete blocks. As well as thermal anomalies indicating hollow/damaged concrete blocks at various corners.

STRUCTURAL SETTLEMENT/CRACKING

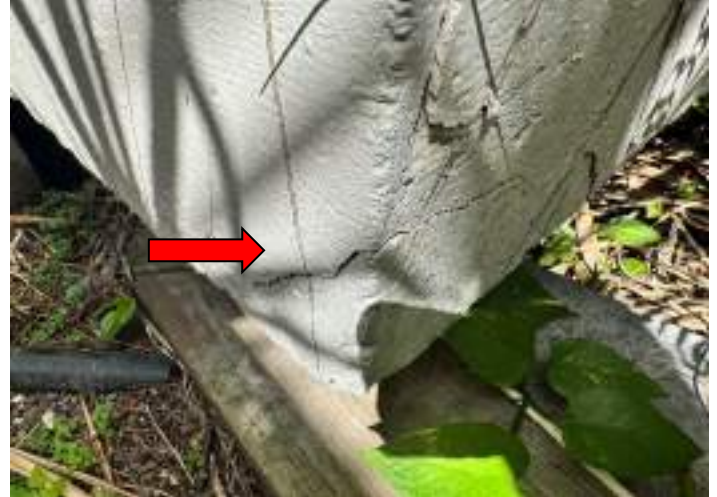
STRUCTURAL SETTLEMENT/CRACKING

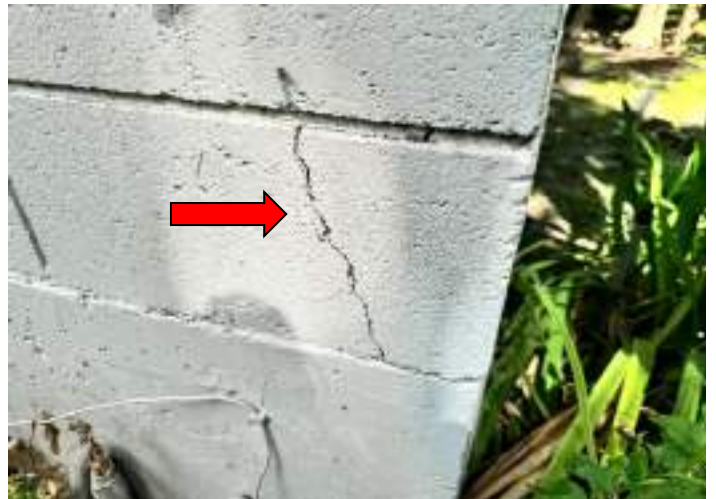
STRUCTURAL SETTLEMENT/CRACKING

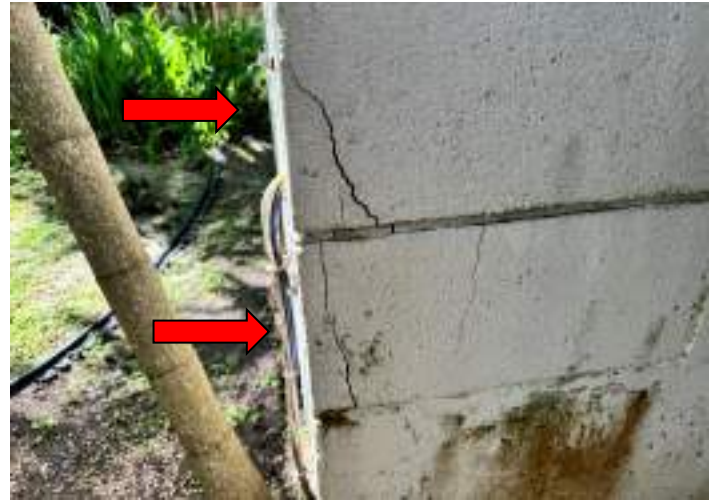
STRUCTURAL SETTLEMENT/CRACKING

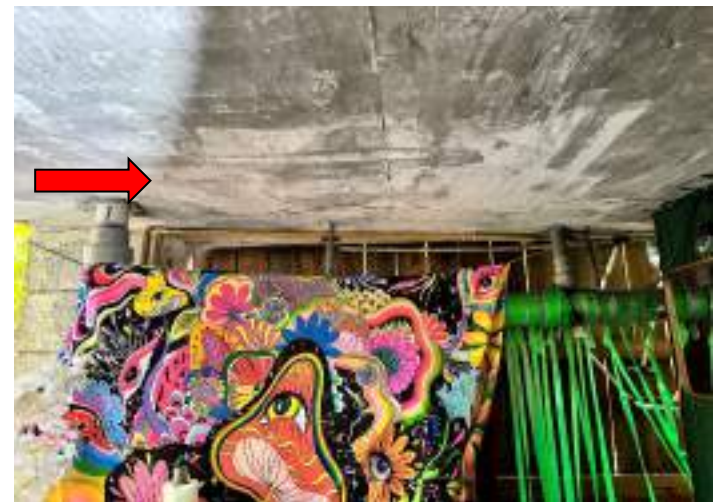
- Honeycombing was noted on the storage room door concrete door frame.

HONEYCOMBING

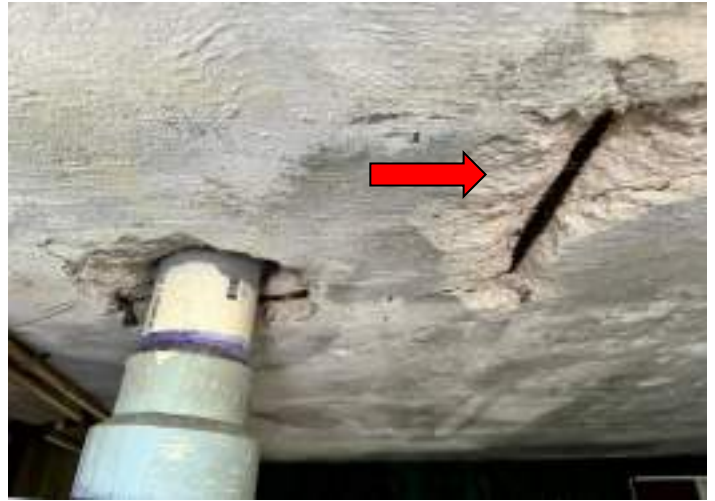
- Spalling, exposed rebars and alterations were noted on the ceiling at the left ground level.

SPALLING/EXPOSED REBAR

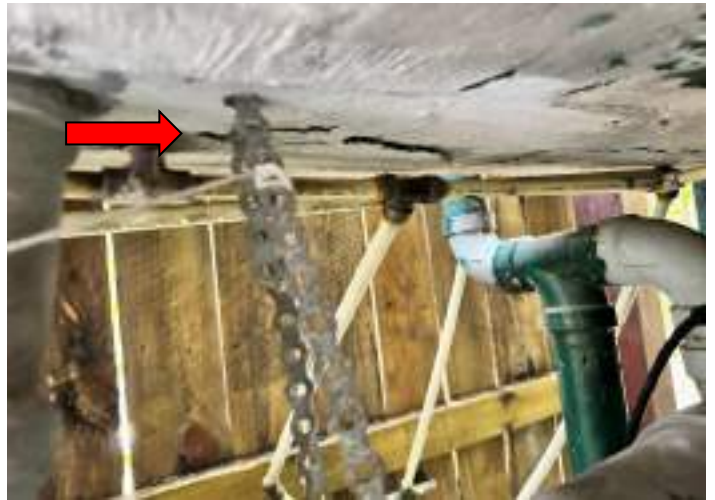
SPALLING/EXPOSED REBAR

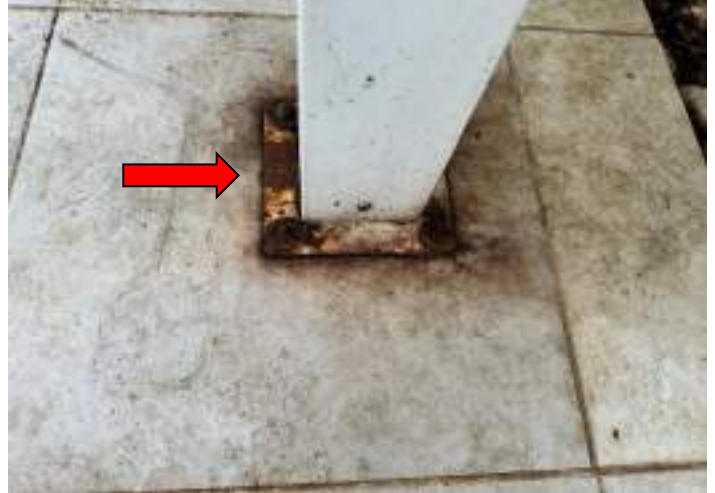
PERGOLA

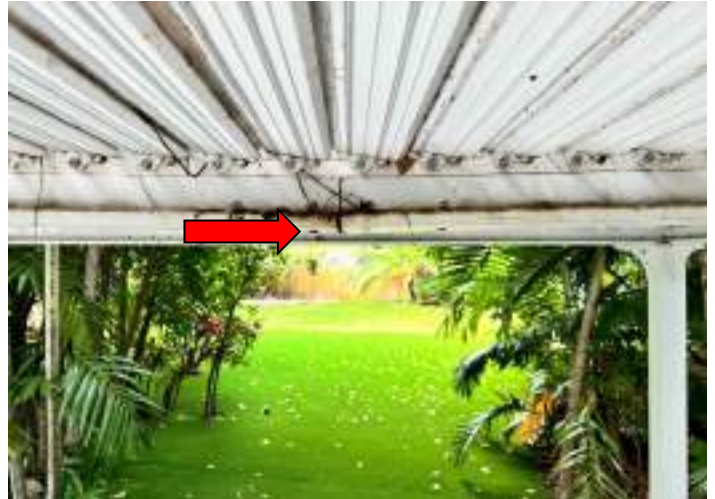
RUST/CORROSION - LOOSE JOINT

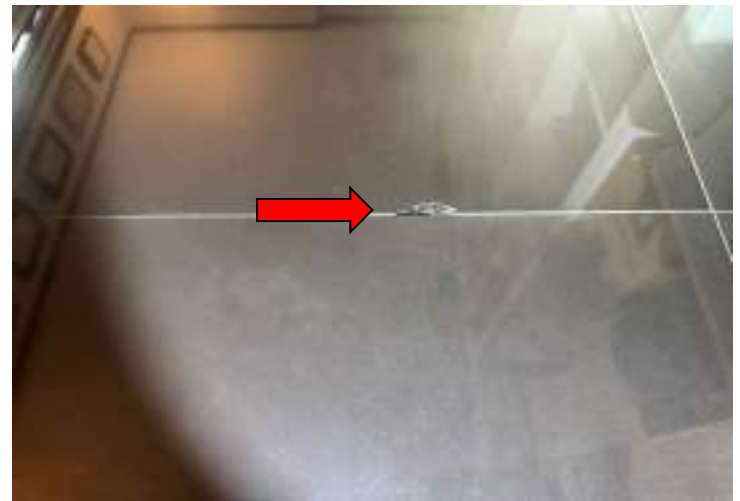
CRACKED/DAMAGED TILE

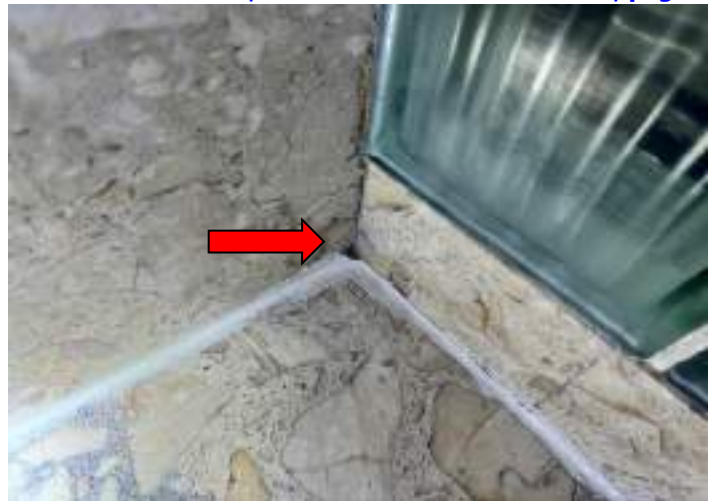
MISSING TILE

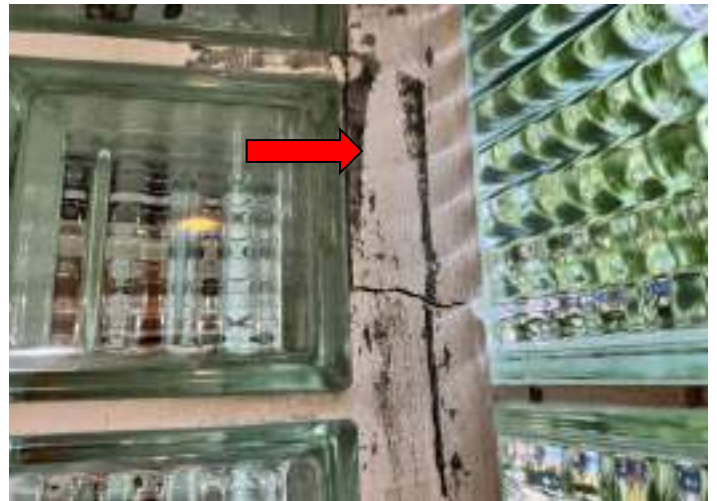
DETERIORATED/MISSING GROUT

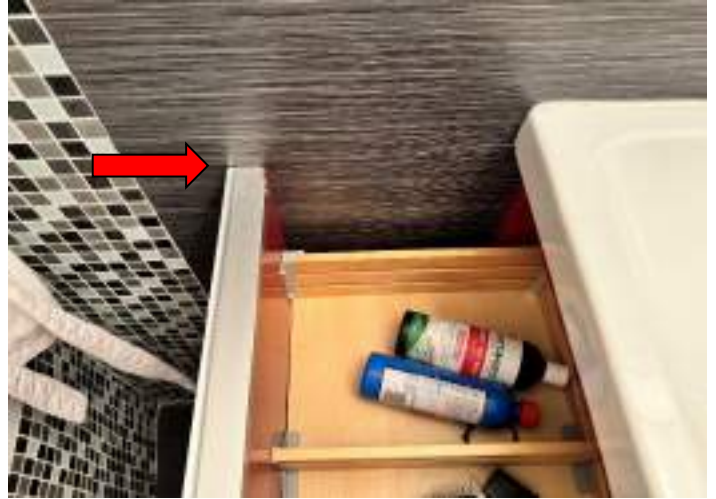
DETERIORATED/MISSING GROUT

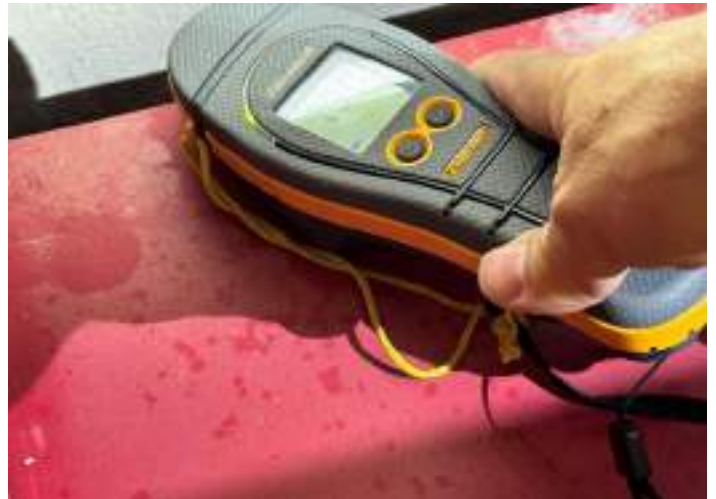
MOISTURE STAIN

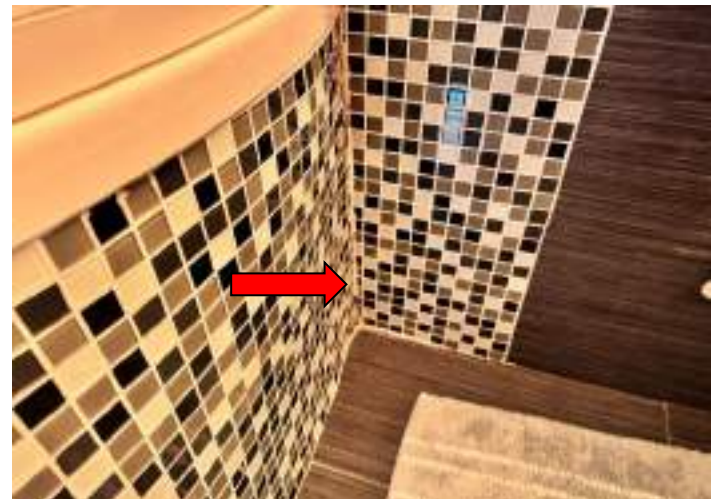
MISSING GROUT/TRIM

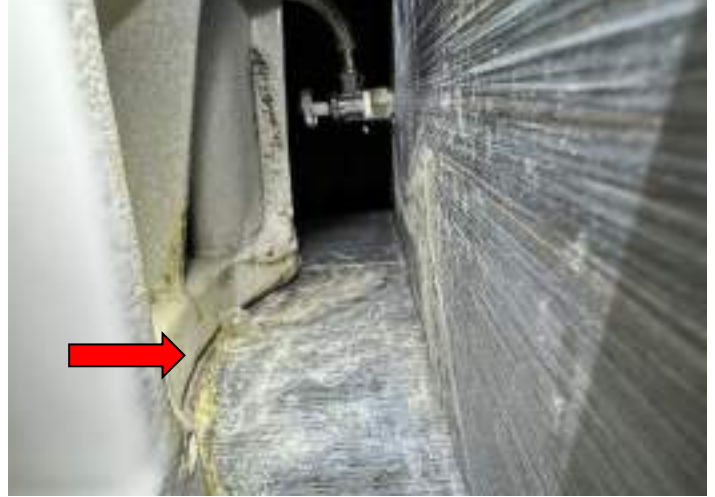
MISSING/DETERIORATED CAULK

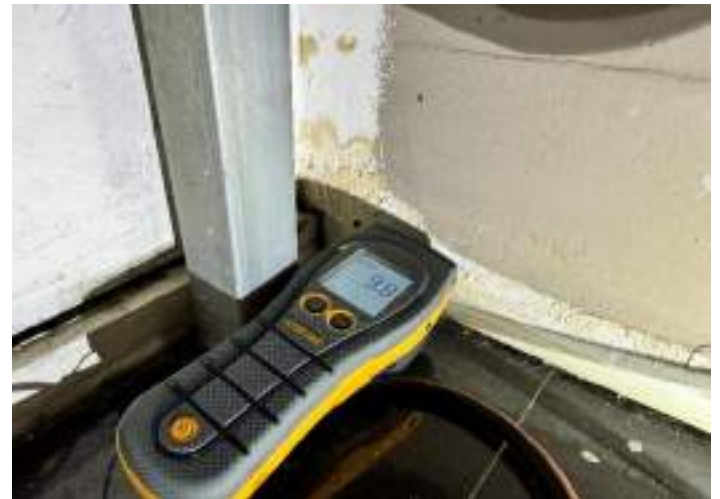
MOISTURE STAIN

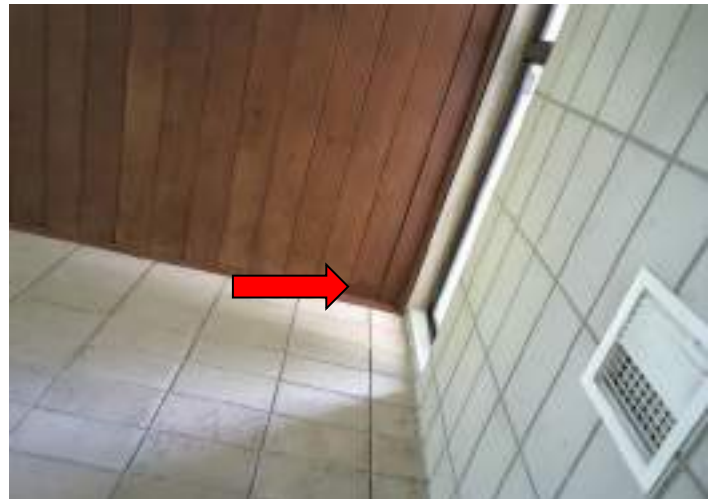
MOISTURE STAIN

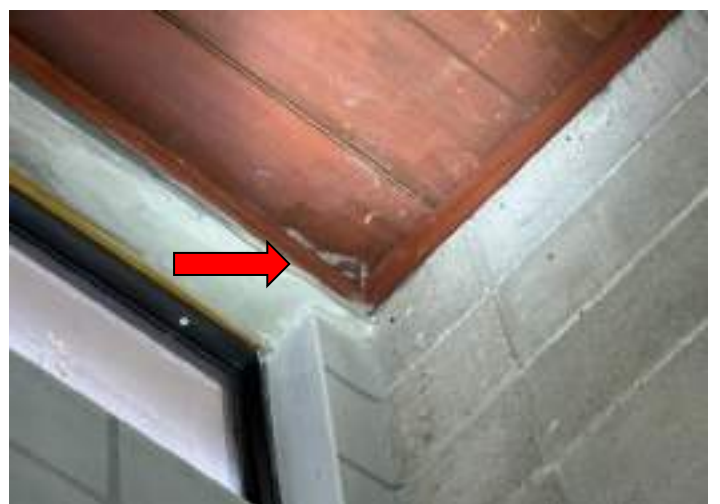
MOISTURE STAIN

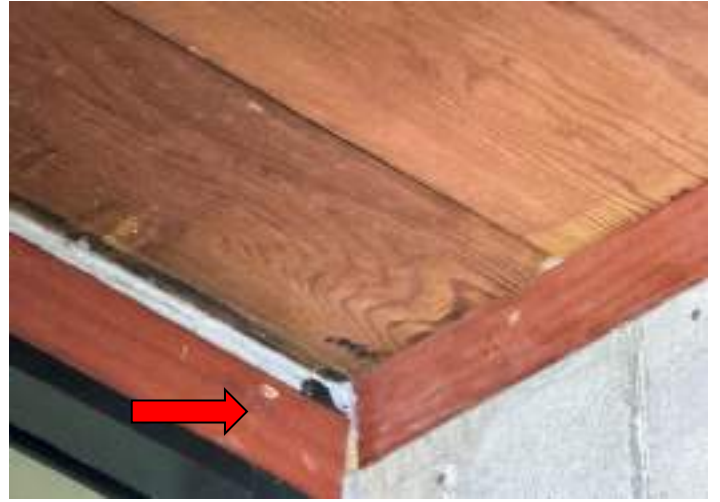
LOOSE CROWN MOLDING

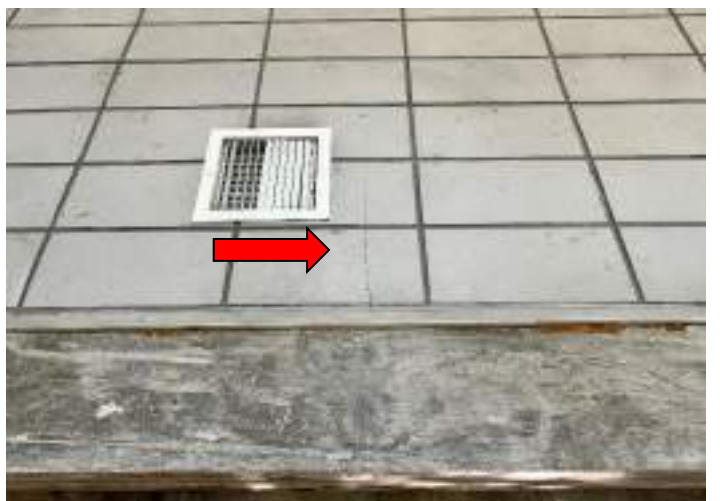
DAMAGED/CRACKED CONCRETE BLOCK

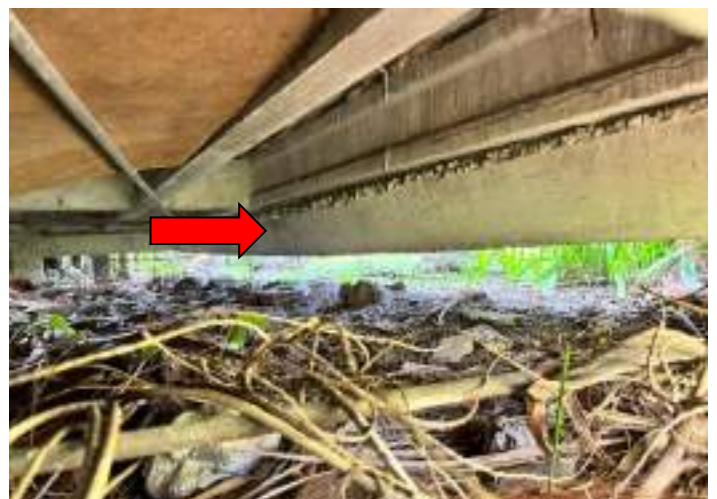
SPALLING/EXPOSED REBAR/BULGES/SETTLEMENT

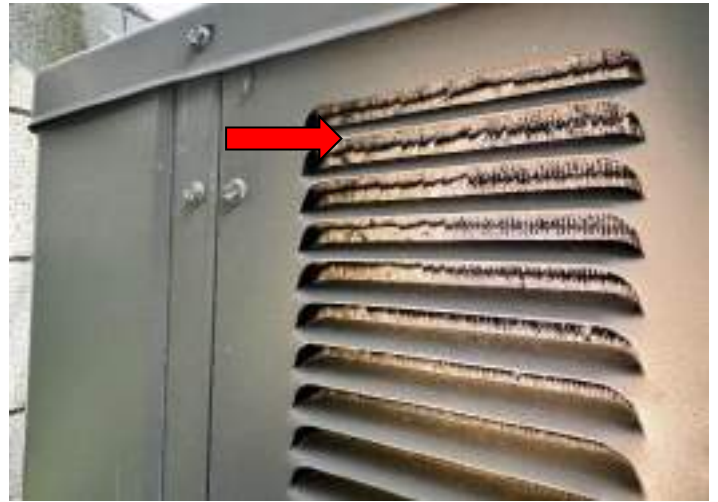
DAMAGED COIL

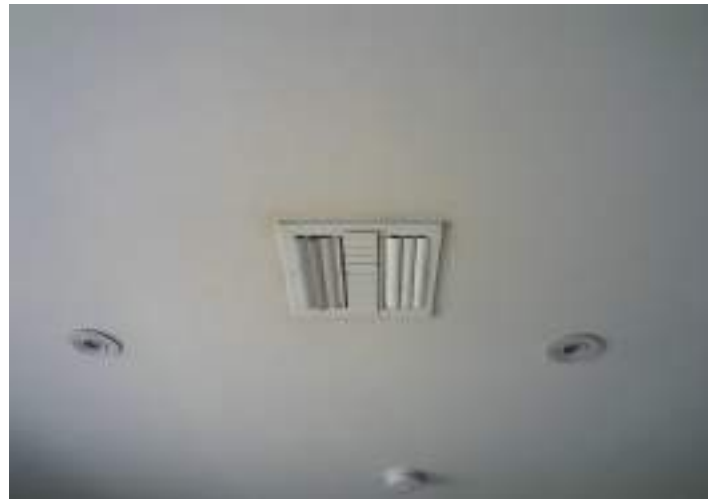
THERMAL ANOMALY/IMPROPERLY INSTALLED SUPPLY REGISTER/AIR LEAK

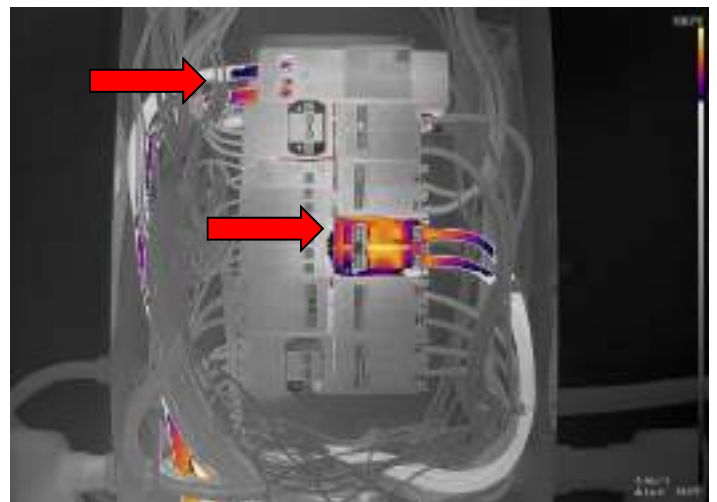
MISMATCHED CIRCUIT BREAKERS

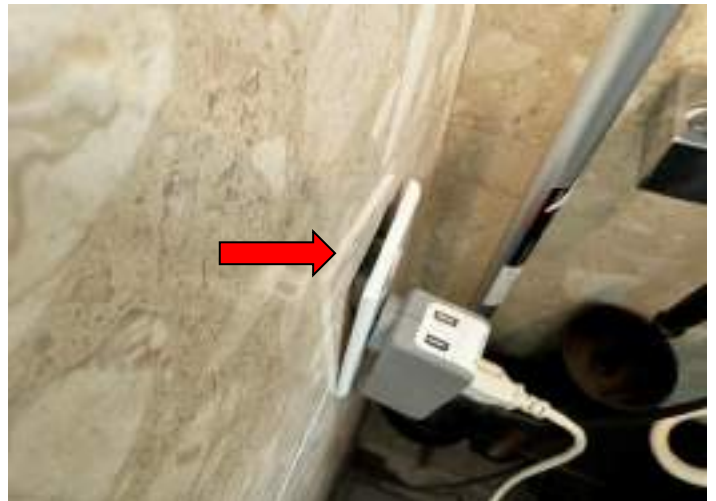
IMPROPERLY SEATED OUTLET

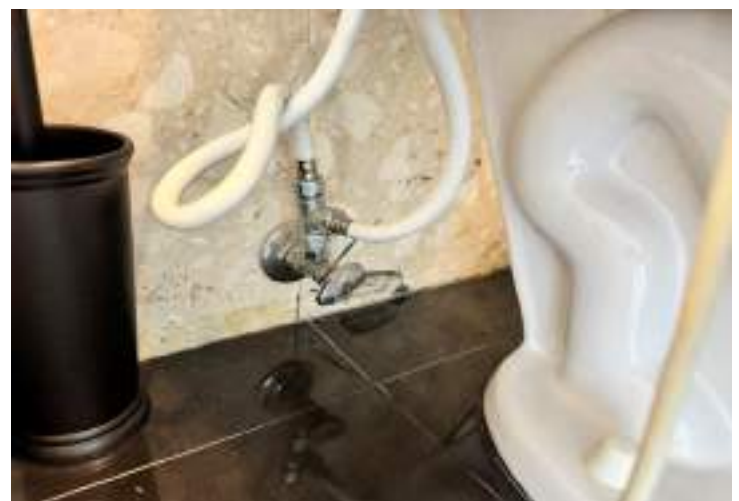
DAMAGED FAUCET

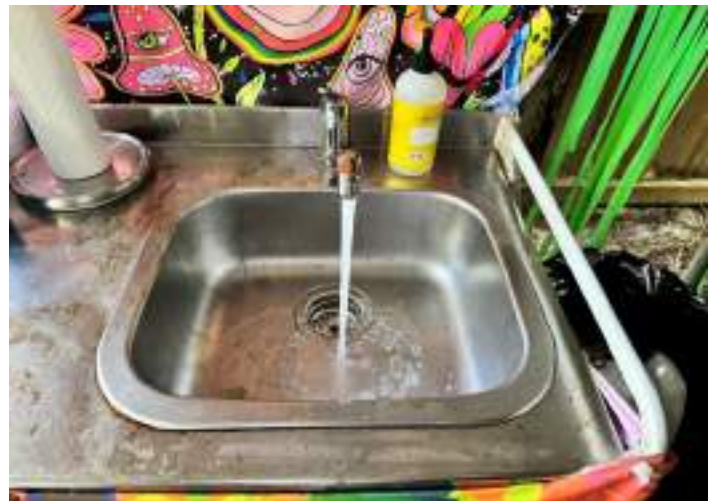
LEAKING FAUCET

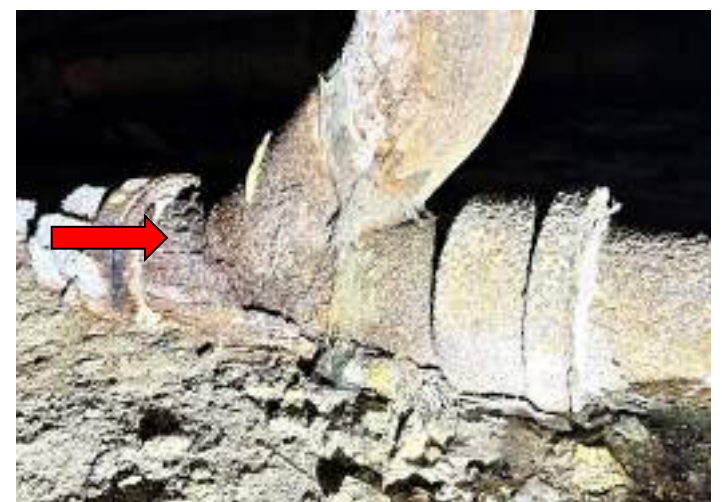
DETERIORATED CAST IRON PIPE

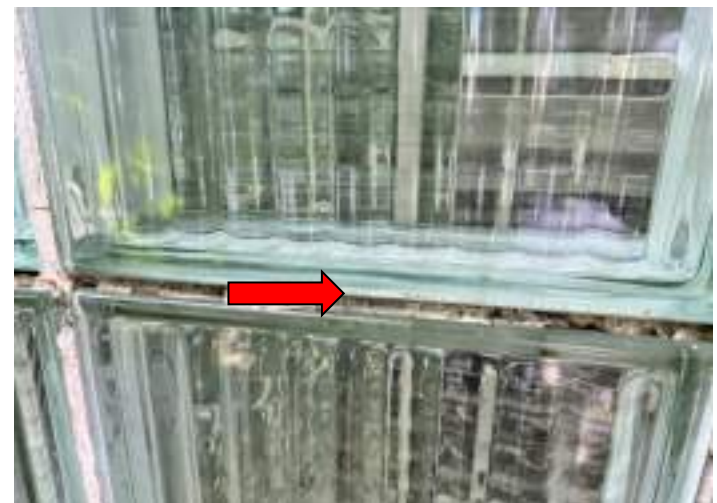
DAMAGED GLASS BLOCKS

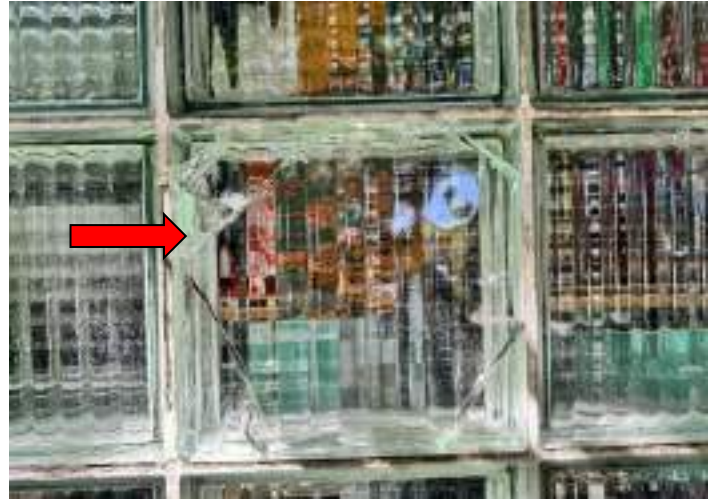
DAMAGED GLASS BLOCKS

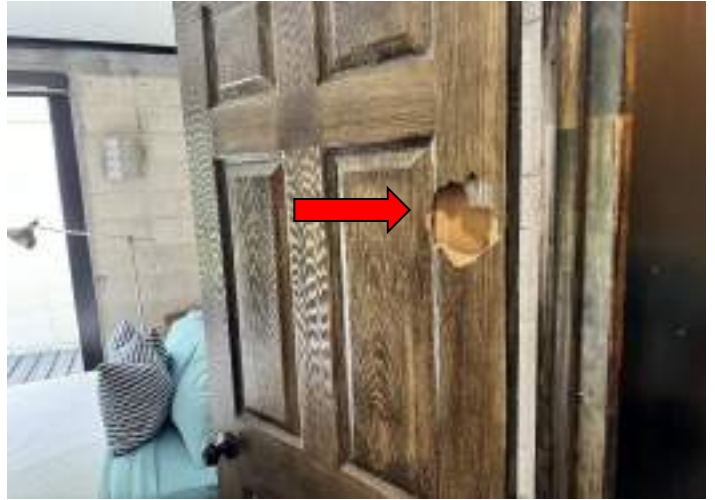
MAIN ENTRY DOOR NOT PROPERLY CLOSING

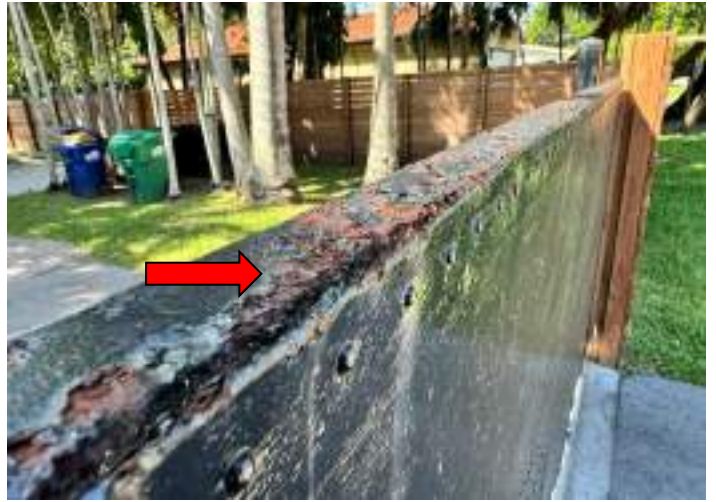
RUST/CORROSION

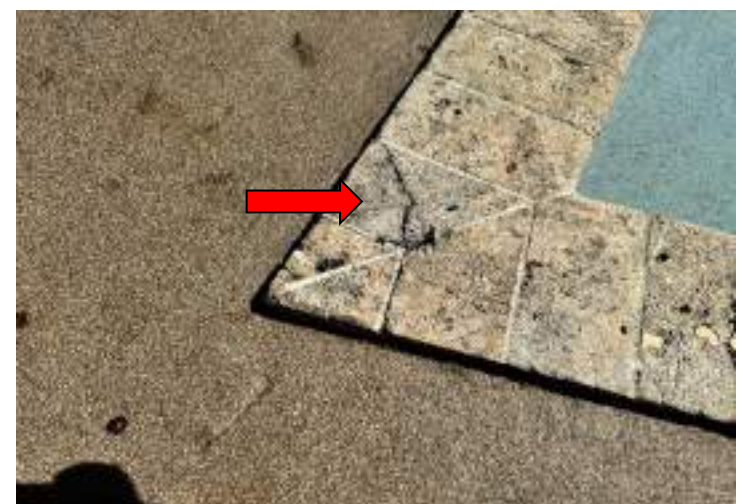
DAMAGED COPING

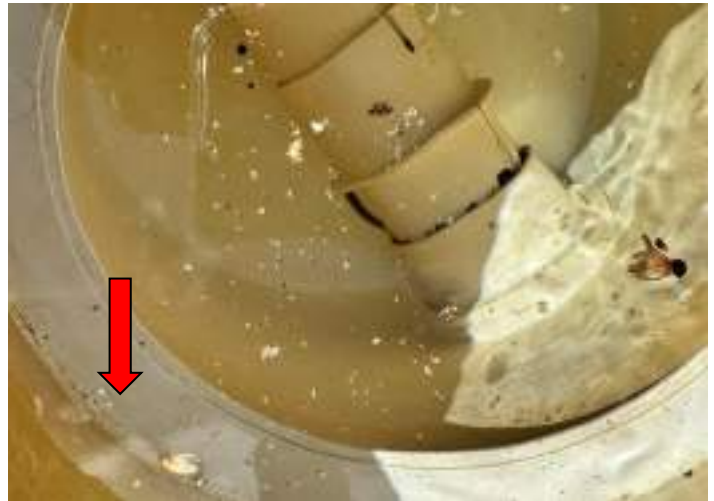
CRACK AT THE BASE

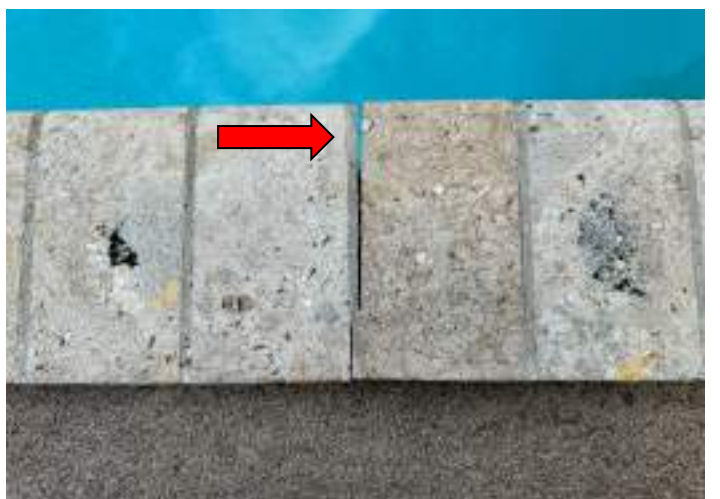
SETTLEMENT CRACKS

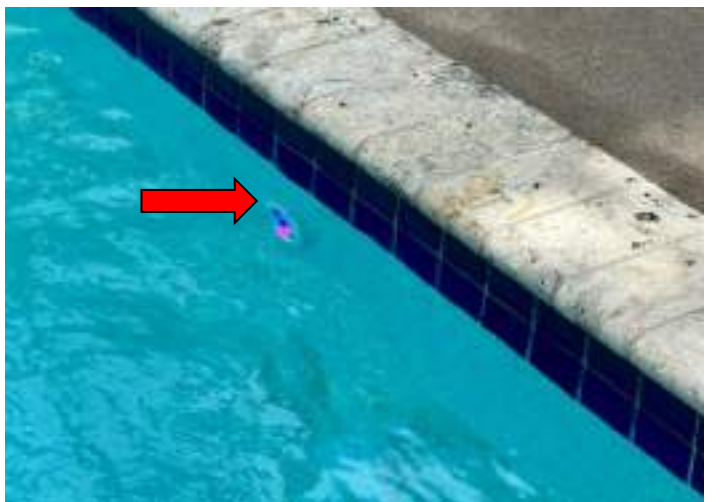
DAMAGED POOL SURFACE
