Confidential Inspection Report

LOCATED AT:
1106 Mission St.,
South Pasadena, California

INSPECTED ON:
Wednesday, February 19, 2025

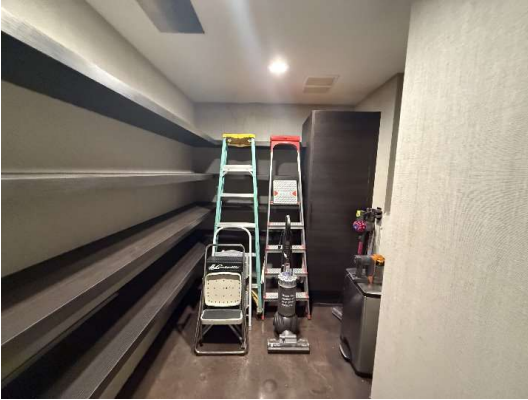
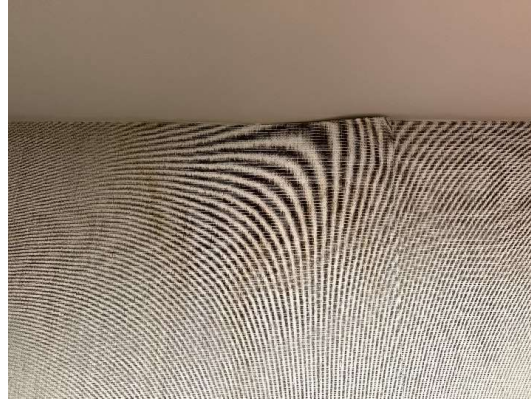
NDSA Needs attention, there is moisture stains on the ceiling in the pantry.

NDSA 119: Needs attention, there is moisture stains on the ceiling in the pantry....[more](#)

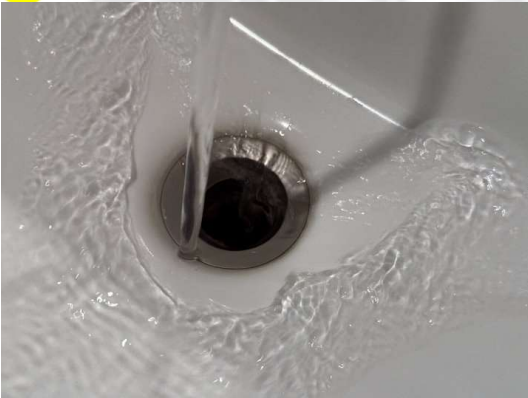
NDSA The bathroom sink stopper is missing.

NDSA 120: The bathroom sink stopper is missing....[more](#)

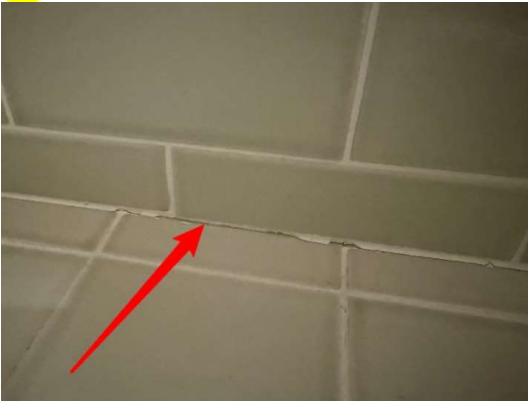
NDSA The base of the shower has a deteriorated seal.

NDSA 121: The base of the shower has a deteriorated seal....[more](#)

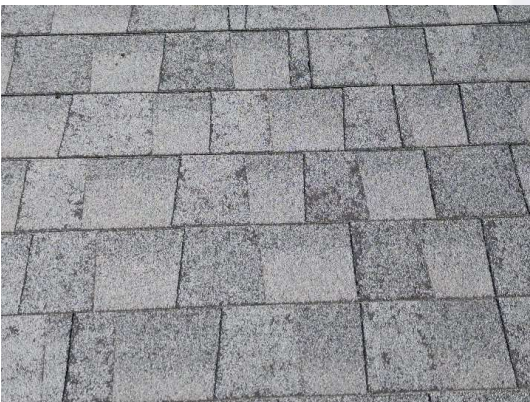
NDSA The pitched roof material is starting to show signs of aging. It appears to be about half way through its expected life of 25 years.

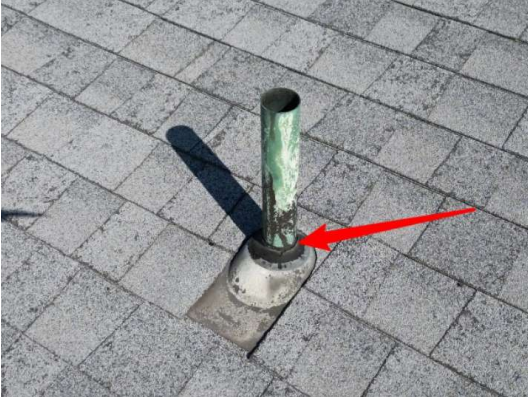
NDSA The mastic is cracked in areas and is not reliable to ensure a watertight seal.

NDSA 126: The mastic is cracked in areas and is not reliable to ensure a watertight seal....[more](#)

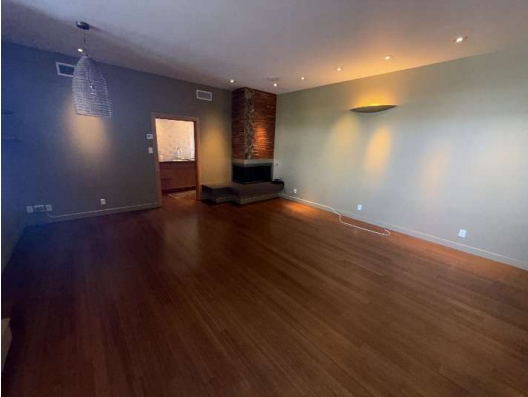
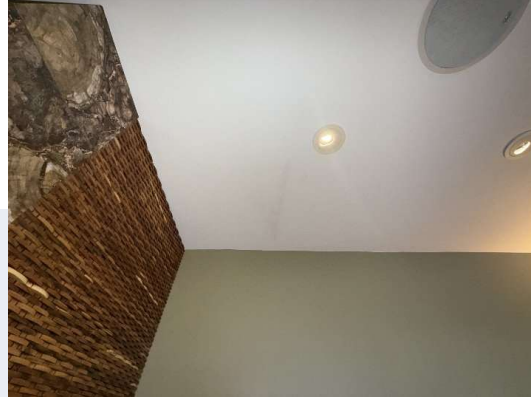
ACPT Acceptable, though it is noted there is a small moisture stain on the ceiling near the fireplace

ACPT 71: Acceptable, though it is noted there is a small moisture stain on the ceiling near the fireplace...[more](#)

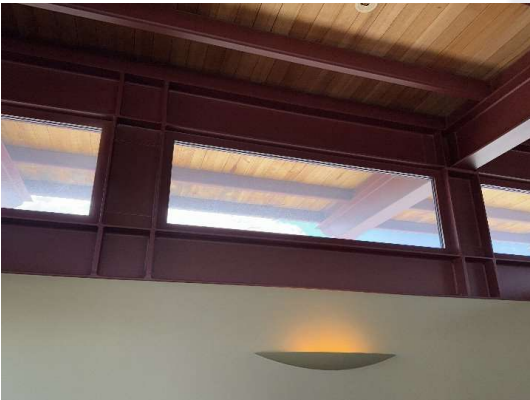
There was condensation between the panes of glass in the dual glazed window. This indicates a broken seal between the panes of glass and replacement is usually necessary to correct the condition. This was found in.

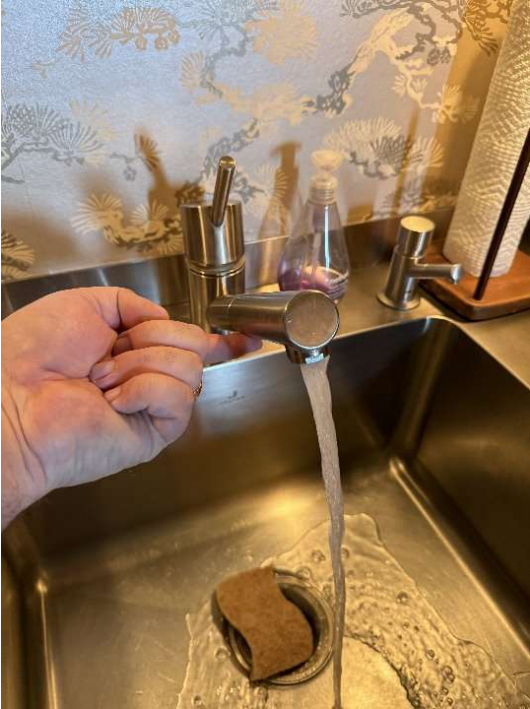
NDSA The kitchen faucet is loose and not properly attached to the sink.

NDSA 132: The kitchen faucet is loose and not properly attached to the sink....[more](#)

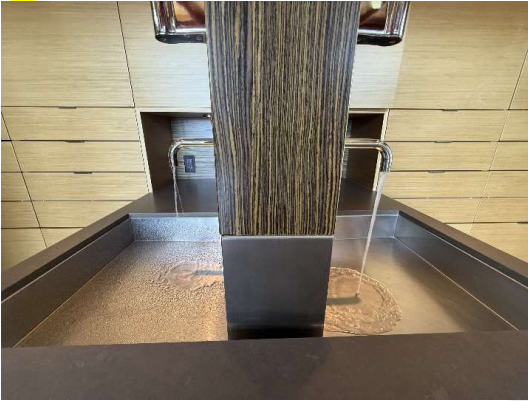
NDSA Needs Attention, the left faucet has poor water floor and may be clogged

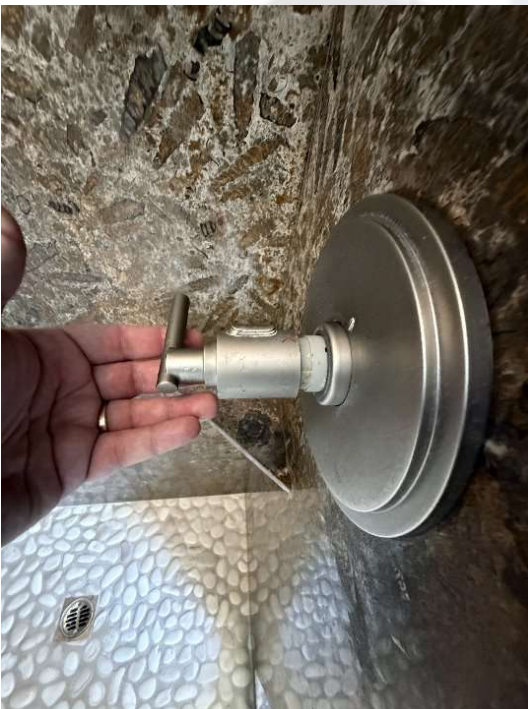
NDSA Needs Attention, the shower handle does not stop turning and can spin off completely. It should stop at the max temperature

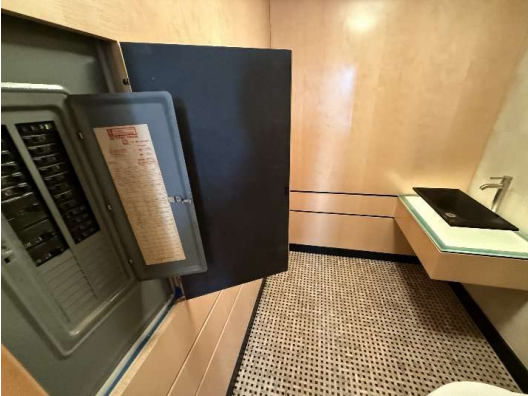
In the bathroom.

NOTA Not Acceptable, electric panels are not allowed in bathrooms and should be relocated for safety
