INSPECTION PERFORMED BY

INSPECTOR:
John Howard
Breakwater Inspections

PREPARED FOR:
Alex Rowe

PROPERTY ADDRESS:
84 School Street, Waldoboro, ME 04572

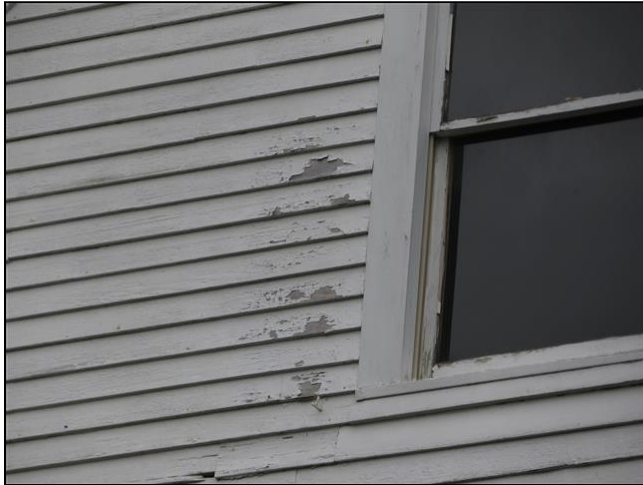
1.2 Item 1(Picture) Left side

(1) The wood siding and trim generally appeared to be in a condition at least as good as would be expected for a building of this age and in this environment. Small areas require some maintenance, particularly with paint. Nothing of significant concern was noted.

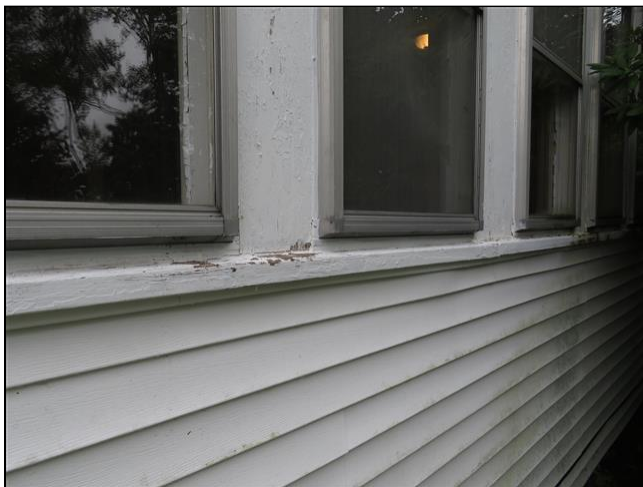
1.2 Item 3(Picture) Front

(2) Several areas of the trim and exterior were checked for rot. While small areas of rot were noted, the trim more generally was in need of new paint. Wood trim left unattended will decay and rot and potentially lead to issues such as water leaks, mold, and potential additional more extensive damage. Trim maintenance should be regarded as an ongoing activity and tended to from time to time.

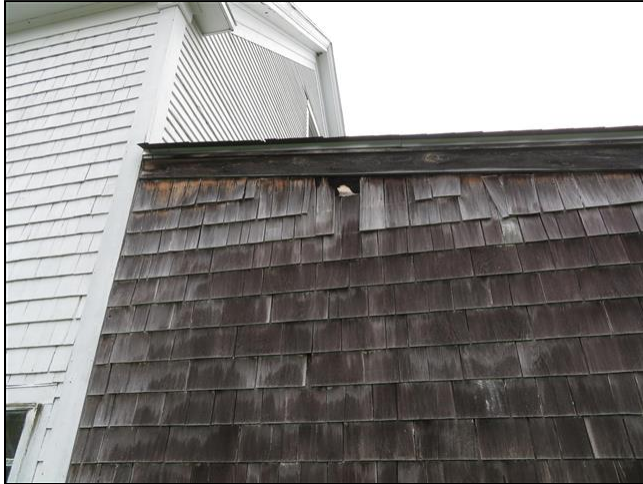
1.2 Item 4(Picture) Rear

(3) The siding on the structure is or includes wood shingles. Areas of the shingles presented in a condition reflecting moderate to advanced age and varying degrees of decay. The decay is in the form of discoloration, some rot, some splitting, and some curling. This is not unusual for older shingles. It is recommended that the most affected areas be repaired, and that repairs be effected to other areas as the decay continues. Some areas require repair now, and others will in the near future. It would also not be

unreasonable to expect that ongoing maintenance and repairs will be required unless or until the siding is replaced.

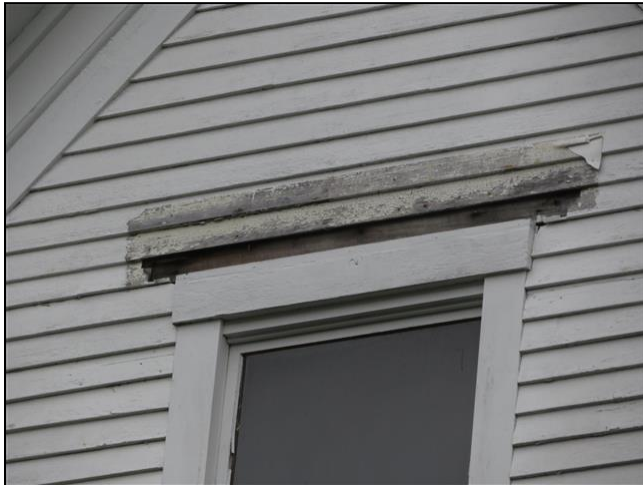
1.2 Item 5(Picture) Left side

(4) Areas of perforated siding were noted on the left side. Such defects can allow access for pest, moisture and other such issues, which can lead to infestations and potential compromise of the underlying structure. It is recommended that repairs be effected.

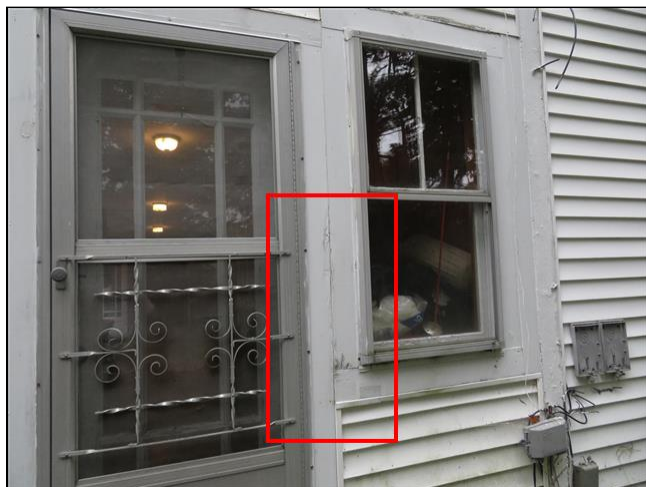
1.2 Item 6(Picture) Right side

(5) Areas of the trim and exterior were noted to have areas of rot and decay. This is not unusual. Painted or not, wood trim will eventually rot when it is outdoors. Trim maintenance should be regarded as an ongoing activity and tended to from time to time. It is recommended that the issue be further assessed and required repairs effected.

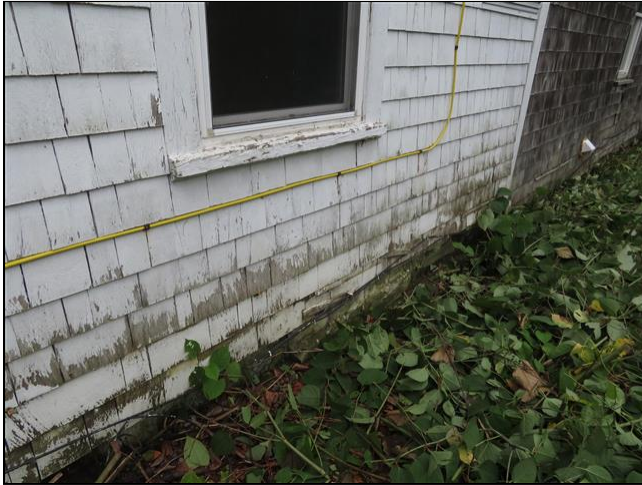
1.2 Item 9(Picture) Rear

(6) The shingle siding generally presented in an acceptable condition and one that is not unexpected for the age of the house. Some areas of softness, damage, curling, and splitting were noted. From time to time repairs should be effected to repair finding damage so as to prevent water and pests from potentially gaining access to the sheathing and structure

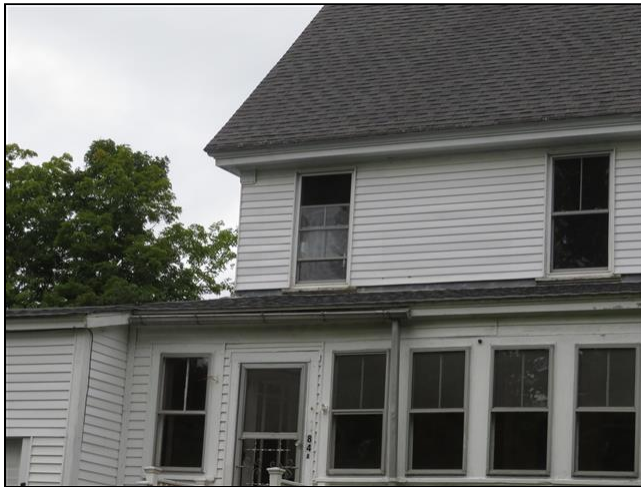
1.3 Item 1(Picture) Front

(2) A degree of decay and rot was noted with the front exterior window trim. While the issue did not appear significant at the time of the inspection, continued decay may lead to issues of water intrusion and damage to adjacent components. It is recommended that repairs be effected and that these components be monitored from time to time for further such issues in the future. (Note: The photos are not an exhaustive list of the affected areas, but a representation.)

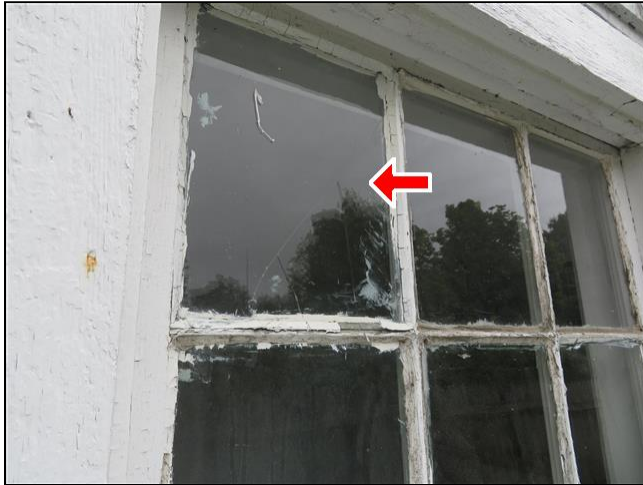
1.3 Item 5(Picture) Rear

(3) There is a crack in one of the rear windows. Cracked or broken windows are considered a potential safety concern as they present the risk of injury. Repairs should be effected to this an all occurrences of cracked glass.

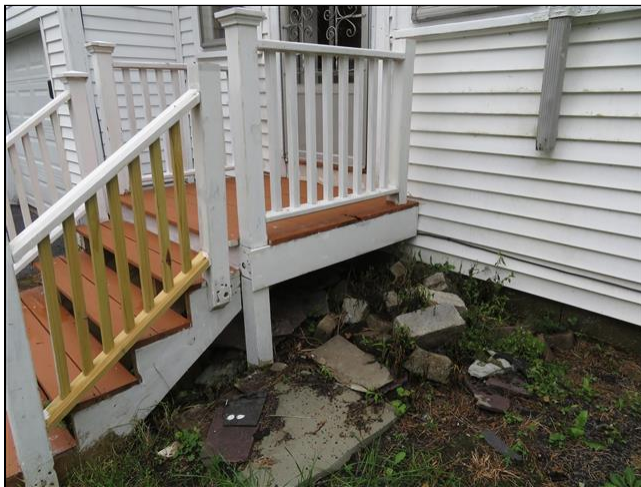
1.5 Item 1(Picture) Front

(1) The front deck presented generally without significant issues or concerns. It was noted that the deck is older, and over time will require periodic repairs and maintenance. While no significant specific defects were noted, the deck should be monitored for issues from time to time. The type of issues that it would not be unreasonable to expect include:

- buckling, decay, and/or splitting handrails;
- splitting guard spindles;
- splintering, rotting, and/or splitting deck boards; and/or
- nails popping.

- Apply sealants from time to time as required (and according to manufacturer recommendations)
- To the extent possible, maximize the sun exposure of the deck
- Use algaecides to reduce or eliminate algae growth
- Effect repairs as soon as they are needed
- Eliminate or reduce standing water
- Clear snow, however avoid using metal shovels as they can catch in the deck boards and create splinters

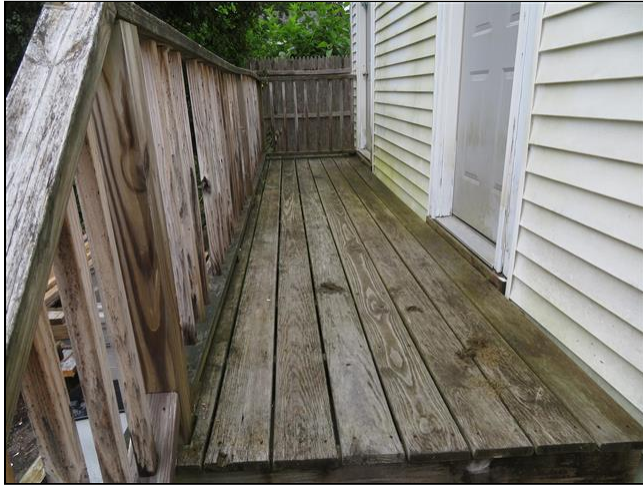
1.5 Item 3(Picture) Left side

(2) The left side deck presented generally without significant issues or concerns. It was noted that the deck is older, and over time will require periodic repairs and maintenance. While no significant specific defects were noted, the deck should be monitored for issues from time to time. The type of issues that it would not be unreasonable to expect include:

- buckling, decay, and/or splitting handrails;
- splitting guard spindles;
- splintering, rotting, and/or splitting deck boards; and/or
- nails popping.

- Apply sealants from time to time as required (and according to manufacturer recommendations)
- To the extent possible, maximize the sun exposure of the deck
- Use algaecides to reduce or eliminate algae growth
- Effect repairs as soon as they are needed
- Eliminate or reduce standing water
- Clear snow, however avoid using metal shovels as they can catch in the deck boards and create splinters

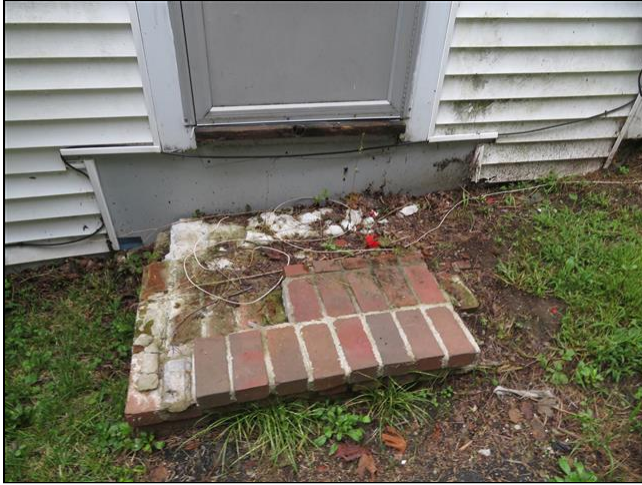
1.5 Item 5(Picture) Right side

(4) The right side steps were noted to be in a state of disrepair. There is a risk that the steps may become unstable and hazardous. It should be expected that the condition will deteriorate over time. It is recommended that the issue be further assessed and repairs effected.

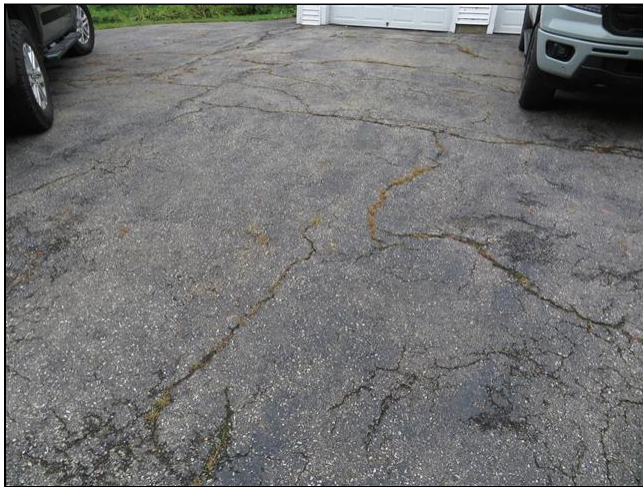
1.6 Item 1(Picture) Front

(3) The asphalt driveway exhibited some cracks and defects. These are most likely the result of normal aging and weathering. Left unrepaired, such cracks can worsen eventually resulting significant deterioration, potential trip hazards, and with a potential significant cost to repair. It is recommended that the cracks be repaired and the area monitored on a routine basis for further deterioration. This type of maintenance activity should be regarded and routine and should be expected on an ongoing basis.

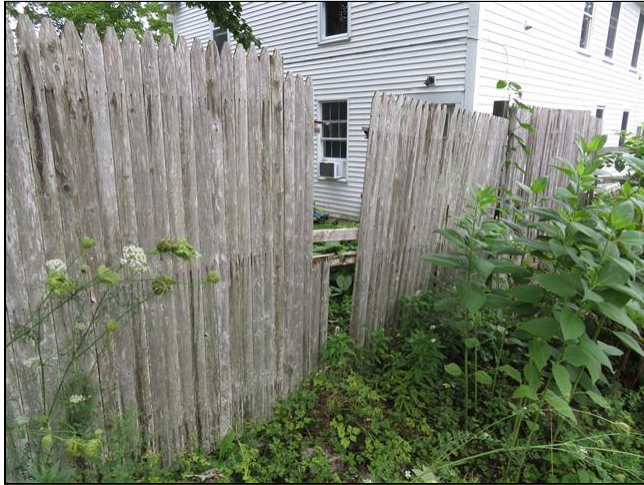
1.6 Item 5(Picture) Rear

(4) The fence was noted to be in a state of disrepair. It will likely worsen with time and eventually fail. It is recommended that the issue be further assessed and repairs planned.

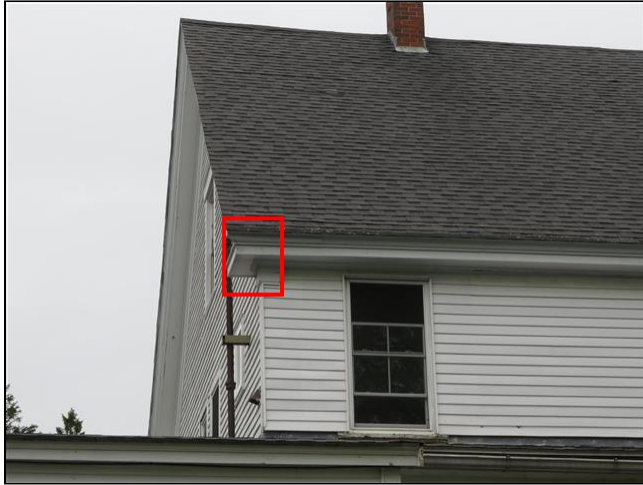
1.7 Item 4(Picture) Front

(2) Some minor areas of rot and decay were noted on the fascia in areas around the building. The extent of the damage that was observed would not yet be regarded as significant or large-scale. While this type of deterioration is not unexpected with wood components, it does require periodic maintenance and repair. When left unattended, such areas can develop and require significant repair and reconstruction. It is suggested that repair and maintenance of the wood be considered as a regular ongoing maintenance activity and be attended to. (Note: The photos are not an exhaustive list of the affected areas, but a representation.)

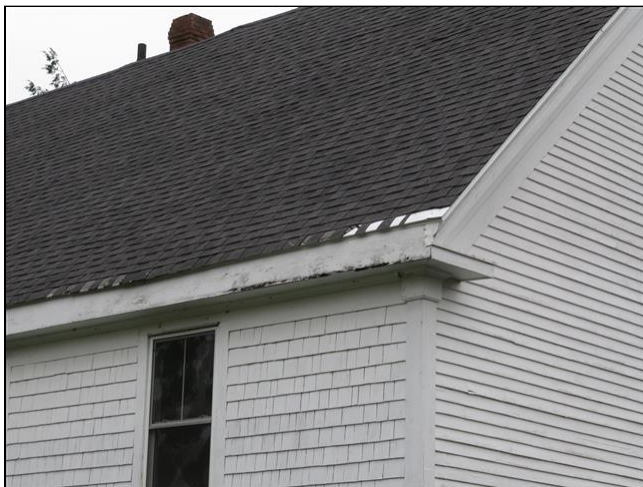
1.7 Item 6(Picture) Rear

(3) Some areas of rot and decay were noted on the fascia in areas around the building. The extent of the damage that was observed would not yet be regarded as large-scale. While this type of deterioration is not unexpected with wood components, it does require periodic maintenance and repair. When left unattended, such areas can develop and require significant repair and reconstruction. It is suggested that repairs be effected and maintenance of the wood be considered as a regular ongoing maintenance activity and be attended to. (Note: The photos are not an exhaustive list of the affected areas, but a representation.)

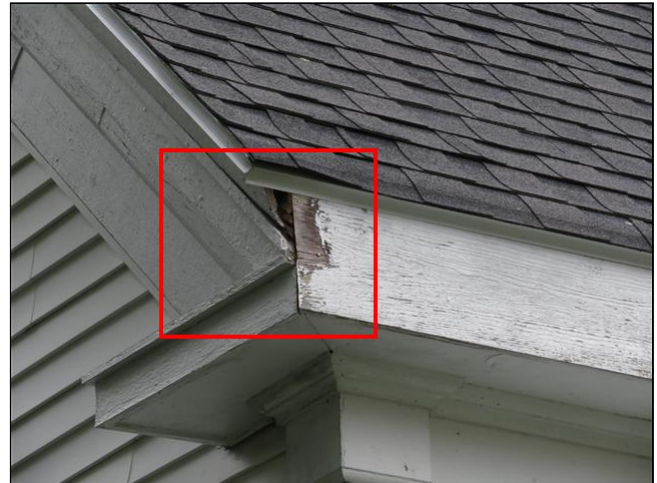
1.7 Item 10(Picture) Rear

(4) Defects (gaps, voids, or opening) were noted in the rear fascia and trim. Such openings can allow pests (insects or rodents) to gain access and nest. There is also a risk of water intrusion that can result in rot or mold issues. It is advisable that repairs be effected.

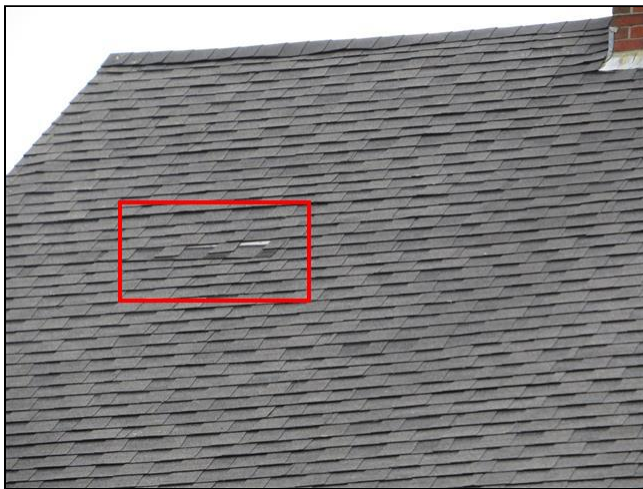
2.1 Item 1(Picture) Front

(1) Areas of the front roof displayed damaged or failed shingles. When roof covering material fails, moisture can enter the structure below potentially causing rot, mold, mildew and potential failure of the underlying structure, as well as water damage to any possessions or property that may become exposed. It is advisable that any areas in question be repaired.

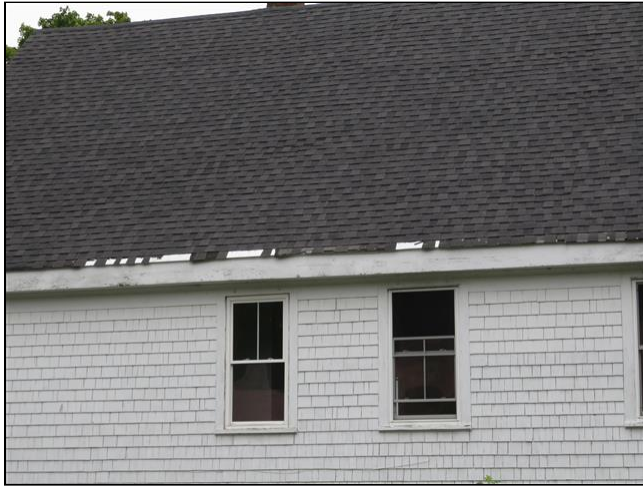
2.1 Item 3(Picture) Rear

(2) Areas of the rear roof displayed damaged or failed shingles. When roof covering material fails, moisture can enter the structure below potentially causing rot, mold, mildew and potential failure of the underlying structure, as well as water damage to any possessions or property that may become exposed. It is advisable that any areas in question be repaired.

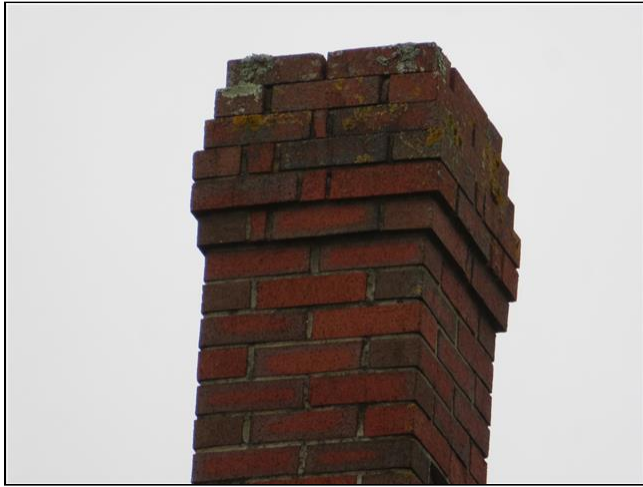
2.3 Item 5(Picture) Left side chimney

(2) The left side chimney was noted to be in a minor state of disrepair. Loose brick(s) were noted. Left unrepaired, there is a risk of the bricks falling and causing damage. Missing bricks can also result in further damage to the chimney. It is recommended that the issue be further assessed and required repairs effected.

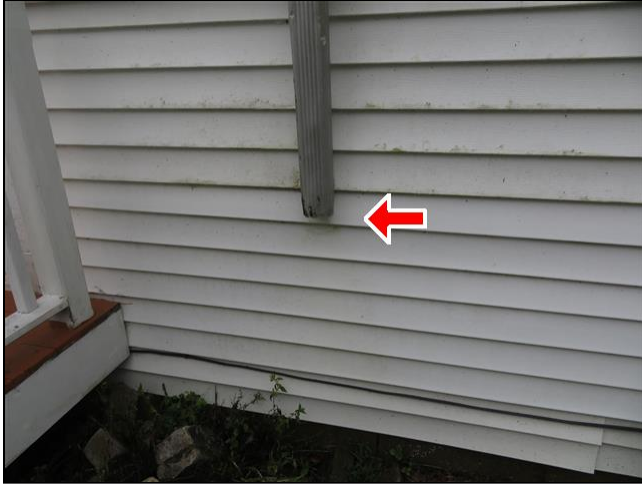
2.4 Item 1(Picture) Front

(1) The downspouts were observed to drain at the foundation of the building. Best practices suggest that downspouts should be directed to drain 4 to 6 feet away from foundations. Not doing so can lead to the foundation being exposed to excessive water and moisture and might result in water penetration, leaks, and excessive moisture in the basement. It is recommended that modifications and repairs be effected.

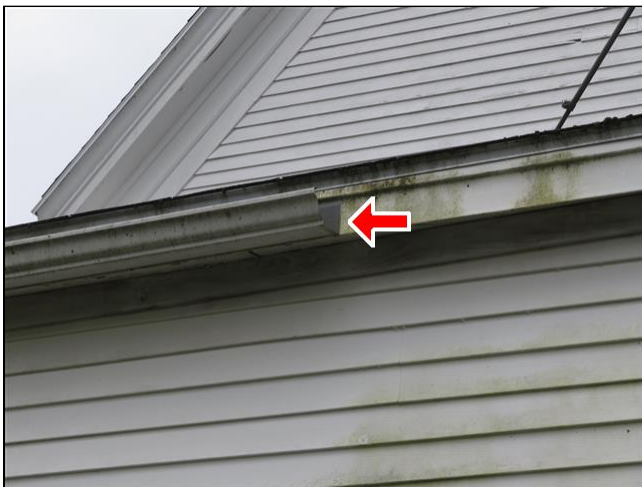
2.4 Item 2(Picture) Left side

(2) The end cap is missing on the left side gutter. Gutters should be in good working order in order to perform their intended function of directing water away the perimeter of the building. It is recommended that repairs be effected (and repairs be effected for all such occurrences).

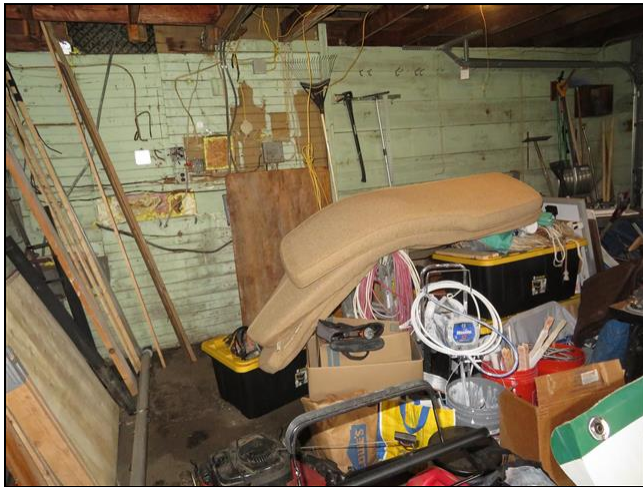
3.1 Item 1(Picture) Attached garage

In all cases it is expected that there is a degree of air sealing to inhibit the seepage of gasses from the garage into the adjacent living spaces. While the specific requirements of areas may vary, it is widely accepted that the above standards are regarded as a life and safety issue, and should be complied with (regardless of the age of the house). It is recommended that the issue be further assessed (e.g. consult the authority having jurisdiction) and any required repairs effected.

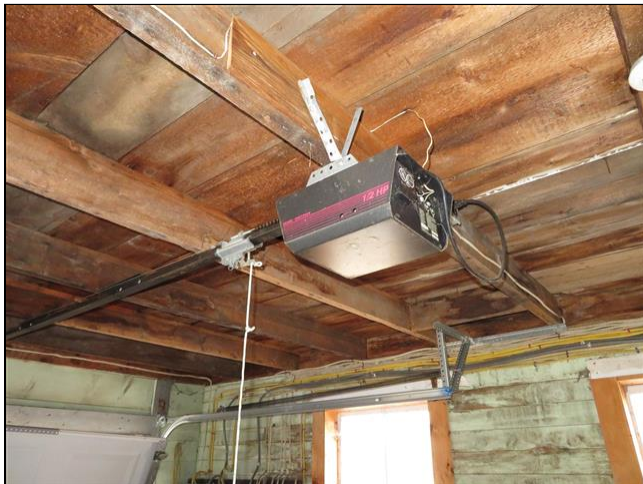
3.8 Item 1(Picture) Attached garage

It was noted that the left garage operator was not working at the time of the inspection. It is recommended that the issue be further assessed and required repairs effected.

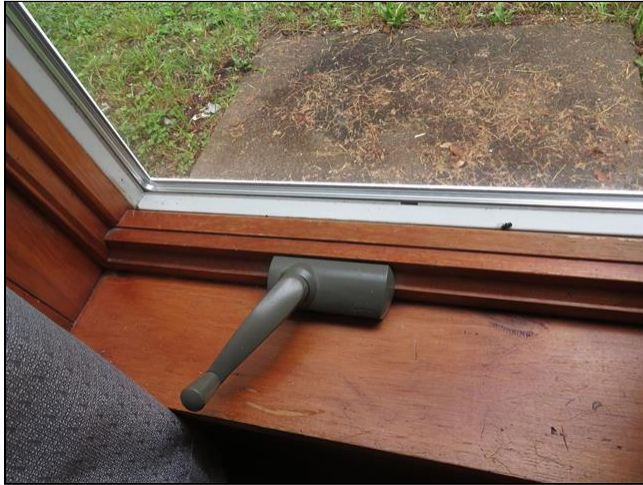
4.5.A Item 1(Picture) Living room

The mechanisms that operate the windows in the living room was in a state of disrepair. It is recommended that the mechanism (and all other inoperable mechanisms) be repaired or replaced.

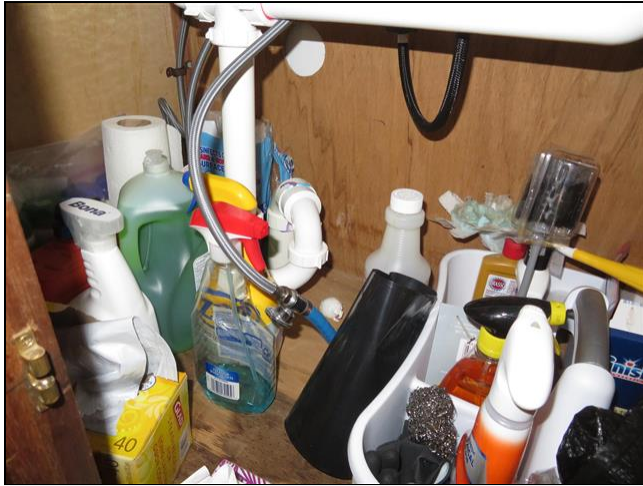
4.7.A Item 1(Picture) Kitchen

(1) The style of drain trap in the kitchen is called an "S-trap". This type of trap is not used as there is a risk of it being evacuated which can result in sewer gasses leaking into the living space. Properly functioning are important components that help prevent sewer gasses from escaping into living spaces from sewer system. It is recommended that the issue be further assessed and required repairs effected. There are two common approaches to resolving the issue. The first is to replace the trap with a "P-trap" and connect it to a vent. This can be a complicated and costly repair. The other common approach is to replace the S-trap with a drum trap (picture in the second illustration) or to use an air admittance valve. Finally, there are instances where the installation of an "air admittance valve" can be an option. It should be noted that there is an argument made that when the drain line is 2" or larger, the issue of an "S-trap" is not as much of a concern as pipe that large is difficult to evacuate.

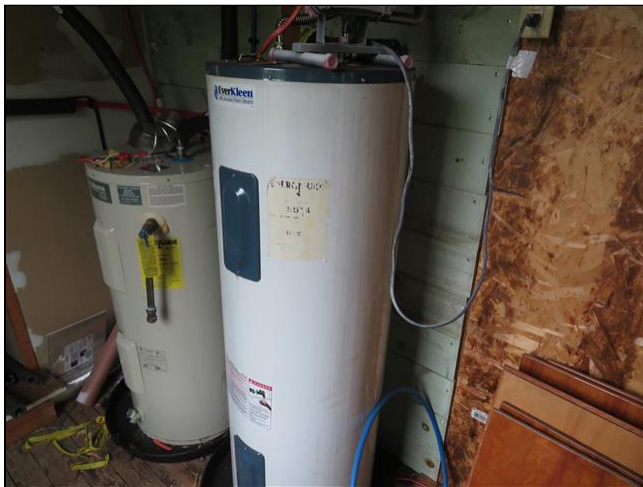
4.9.A Item 1(Picture) Utility room

(4) No significant observable issues were noted with the operation of the water heater. The water heater appeared to have been manufactured in 2008. Typical electric water heater life expectancy is in the range of 10 to 12 years. There are exceptions where a water heater can fail earlier or last significantly longer than the expected lifespan. It appears possible that the water heater is at the end of or past the end of its expected service life.

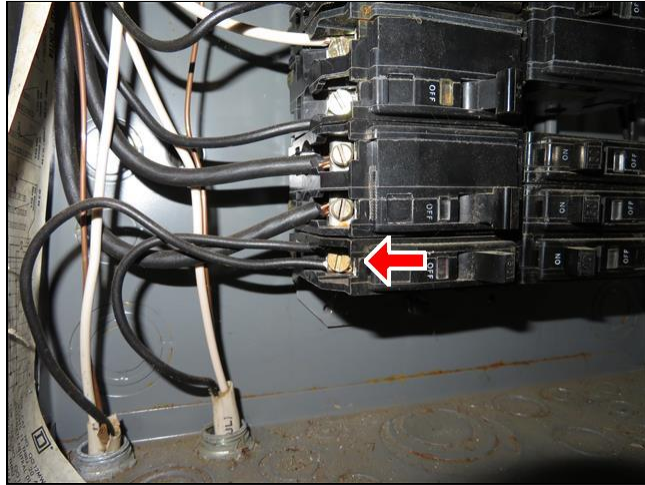
4.12.A Item 2(Picture) Attached garage

(5) Instance(s) of "double-tapping" were observed in the electrical panel. Double-tapping is the installation of two or more branch circuit wires to a single circuit breaker. While not a significant issue (under certain circumstances), there are considerations. There is a risk of the branch circuit wires becoming loose over time (due to heating and cooling) and then arcing. Arcing in electrical panels can be a serious issue as it can result in electrical fires. While some circuit breakers are designed to accommodate two branch circuit wires, many do not. One common example of a breaker that allows double-tapping is the Square D QO breaker. In situations where the two (or more) of the wires are of different gauges (sizes), the practice of double-tapping is not acceptable. It is also possible to have "nuisance" circuit breaker tripping when there are double-tapped breakers.

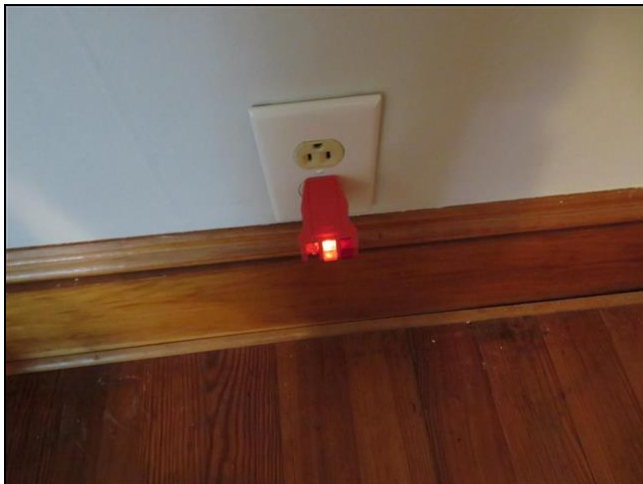
4.15.A Item 1(Picture) Living room

(2) Ungrounded 3-pin receptacles were observed in the living spaces. Such receptacles are regarded as potentially unsafe as it is possible for appliances to malfunction resulting in injury or damage to a person or object. The risks posed can be mitigated to an extent by exercising caution when using such a receptacle and ensuring that electrical appliances are in good working order. While a more significant issue in wet areas, ungrounded outlets should be replaced with grounded ones when possible. It is recommended that the issue be further assessed and any required repairs effected.

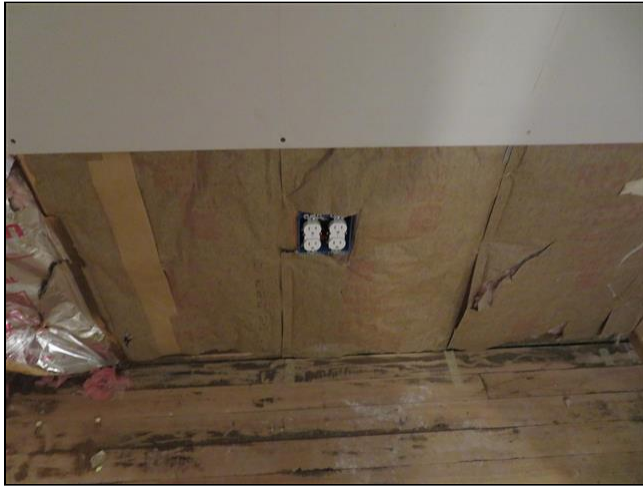
4.15.A Item 2(Picture) Utility room

(3) Electrical boxes without covers were noted in the utility room. Uncovered electrical boxes are safety hazards as they pose a risk of electric shock. It should also be noted that all metal electrical boxes should be grounded. It is advisable that all open/uncovered electrical boxes have an appropriate cover installed and any missing grounding installed.

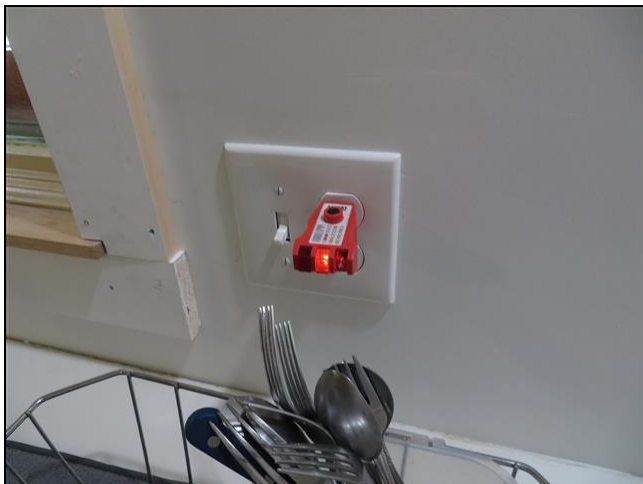
4.16.A Item 1(Picture) Kitchen

The receptacles noted over or near the kitchen counter were not GFCI (Ground Fault Circuit Interruption) protected. Receptacles in wet areas (such as kitchens, bathrooms, garages, outside, and unfinished basements) can pose shock hazards if they are not on GFCI-protected circuits. Additionally, all receptacles over kitchen counters are supposed to be GFCI-protected (regardless of proximity to a water source). It is advisable that repairs or modifications be made by installing GFCI protection to this receptacle (and all other required receptacles).

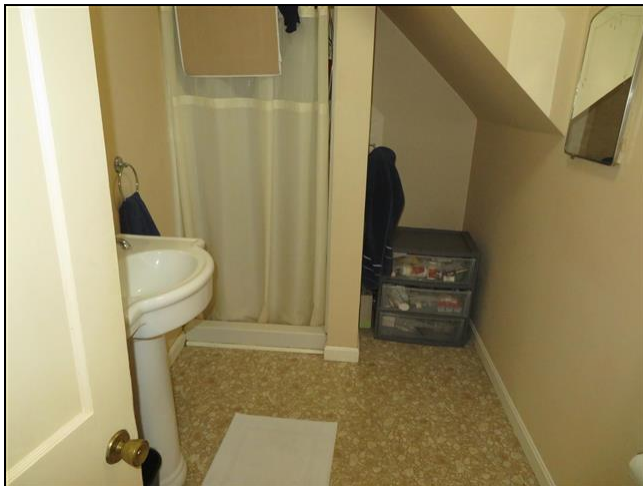
4.18.A Item 1(Picture) Hall bath

(2) The hall bath did not have an exhaust or ventilation fan. They are particularly beneficial when there are no windows, and in fact are required. Bathrooms can introduce a substantial amount of moisture into the air in a home, and excess air moisture can potentially lead to issues relating to mold, mildew and unhealthy indoor air quality. It is recommended that a bathroom exhaust fan be installed.

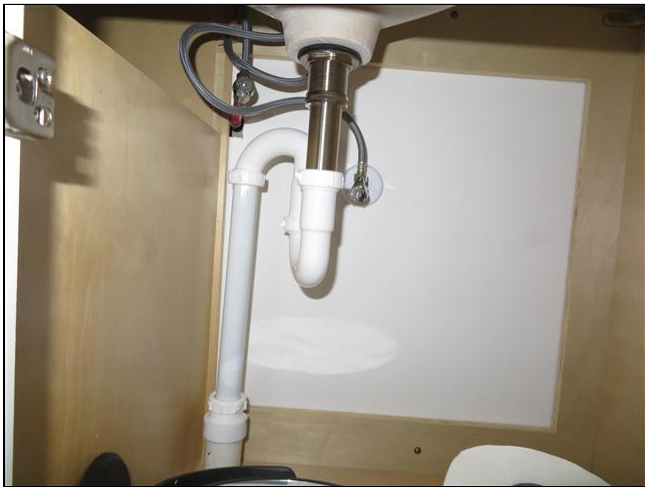
4.8.B Item 1(Picture) Bathroom

(1) The style of drain trap in the hall bath is called an "S-trap". This type of trap is not used as there is a risk of it being evacuated which can result in sewer gasses leaking into the living space. Properly functioning are important components that help prevent sewer gasses from escaping into living spaces from sewer system. It is recommended that the issue be further assessed and required repairs effected. There are two common approaches to resolving the issue. The first is to replace the trap with a "P-trap" and connect it to a vent. This can be a complicated and costly repair. The other common approach is to replace the S-trap with a drum trap (picture in the second illustration) or to use an air admittance valve.

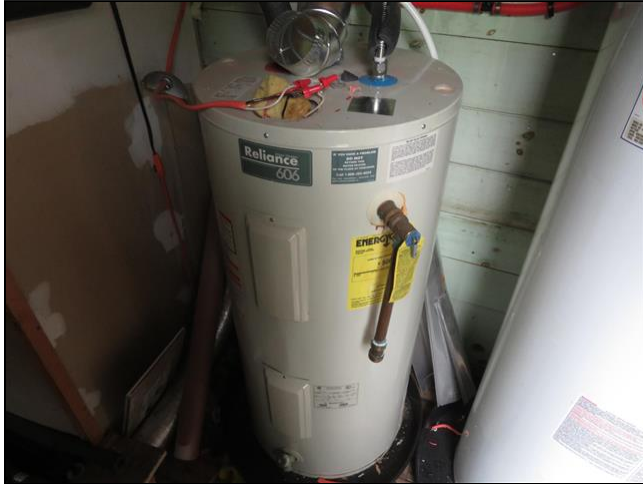
4.10.B Item 1(Picture) Utility room

(4) The water heater appeared to be leaking. While it is possible for water heaters to leak for reasons such as poor seals around heating elements, and leaking TPR valves, it is not uncommon for leaks to develop as the tank approaches the end of its expected service life. The water heater appeared to have been manufactured in 2010. Typical electric water heater life expectancy is in the range of 10 to 12 years. There are exceptions where a water heater can fail earlier or last significantly longer than the expected lifespan.

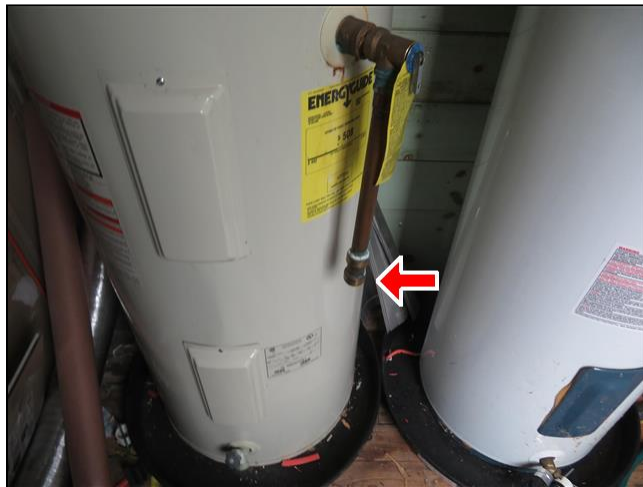
4.10.B Item 2(Picture) Utility room

TPR valves and their related plumbing are a safety feature that divert hot water and/or steam out of a water heater and safely to the ground. It is recommended that repairs be effected. Further information may be available from the authority having jurisdiction.

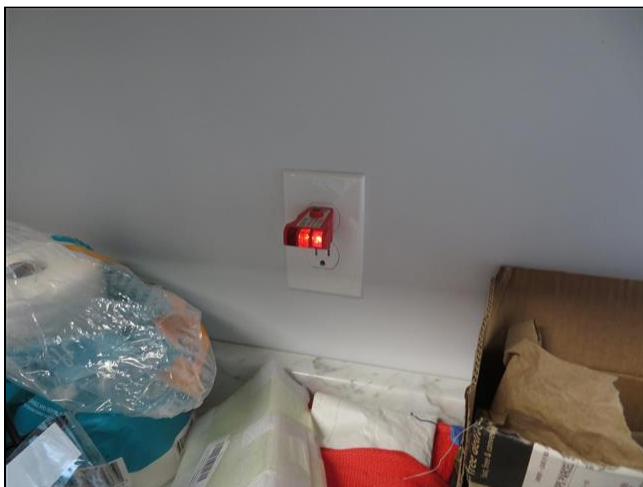
4.17.B Item 1(Picture) Kitchen

(1) The receptacles noted over or near the kitchen counter were not GFCI (Ground Fault Circuit Interruption) protected. Receptacles in wet areas (such as kitchens, bathrooms, garages, outside, and unfinished basements) can pose shock hazards if they are not on GFCI-protected circuits. Additionally, all receptacles over kitchen counters are supposed to be GFCI-protected (regardless of proximity to a water source). It is advisable that repairs or modifications be made by installing GFCI protection to this receptacle (and all other required receptacles).
