## *Property Inspection Report*

**Brian Moss as Trustee of Cosco Family Trust**

729 S Main St  
Salinas, CA 93901

Inspection Date: 08/03/2026

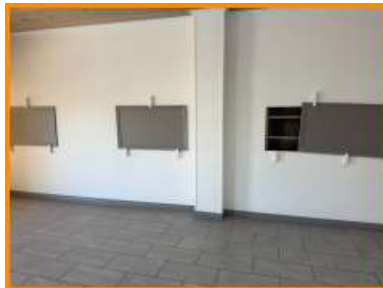
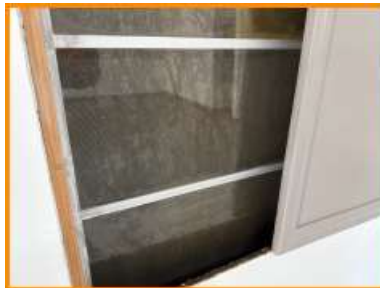
[NOTE]. Six single pane windows were present at the left and right walls, but had been covered at the exterior and interior.

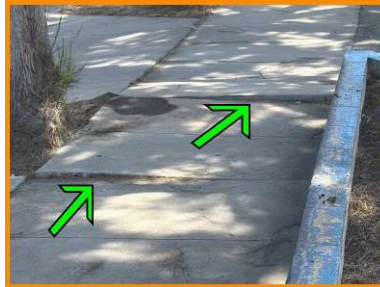
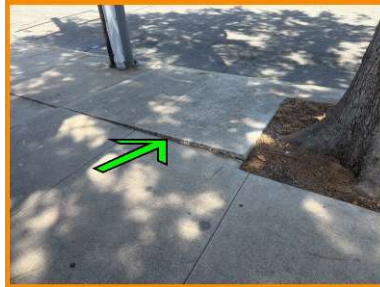
[SC] Uneven surfaces were noted in the adjacent public walkways. This condition is considered a trip hazard. Although many believe that the local jurisdiction has liability, this is increasingly being shifted by the jurisdictions to the property owner. We recommend you check with your local authority.

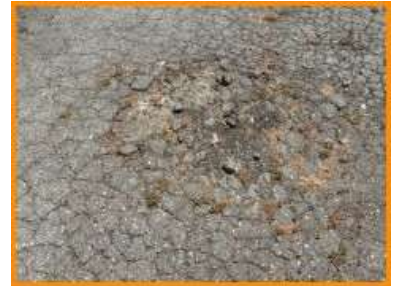
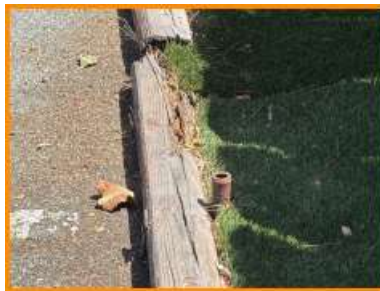
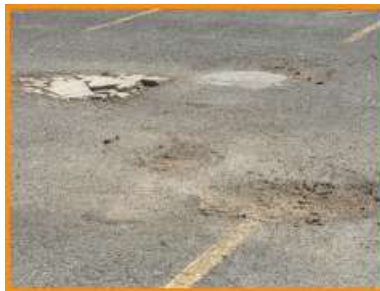
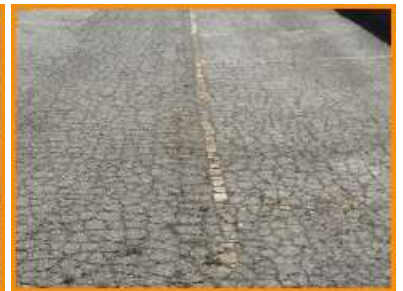
[CR] Pot holes were noted in the parking lot. This condition is a trip hazard and is conducive to promoting further deterioration.

[SC] Parking blocks were noted to be damaged at the rear parking area. This condition may result in damage to tires and is a trip and fall hazard for people.

[SC] Cracks as well as open gaps were noted in the parking lot. These conditions are a trip hazard and is conducive to moisture intrusion which promotes additional movement and deterioration.

[CR] Ruts had developed in several areas of the parking lot. This allows water to pool. This condition is conducive to moisture intrusions and deterioration.

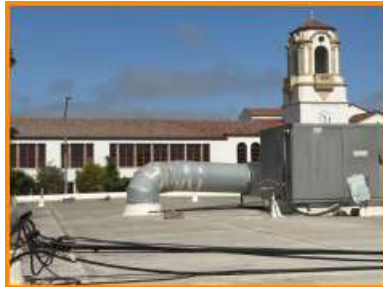
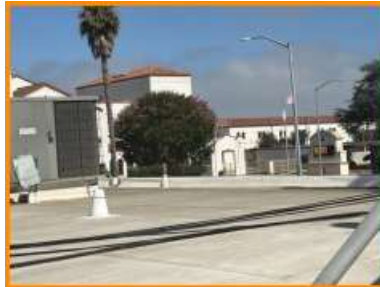
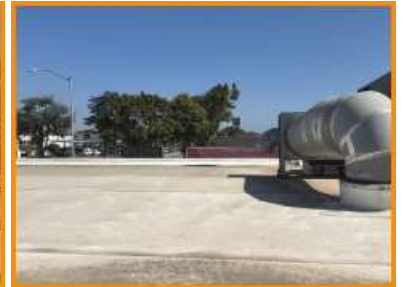
The visible areas of the low slope roofing materials showed no signs of leakage or damage.

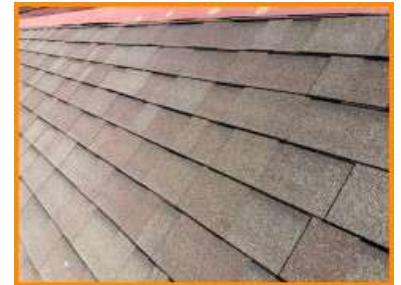
[NOTE] The composition roofing showed no signs of leakage or damage.

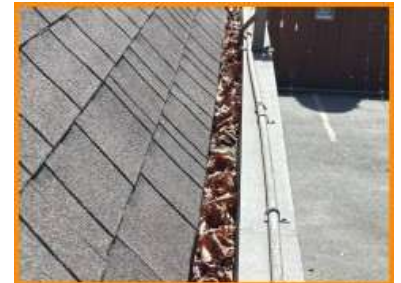
[CR] The rain-gutters were clogged with debris. Continued use in this condition may lead to damage.

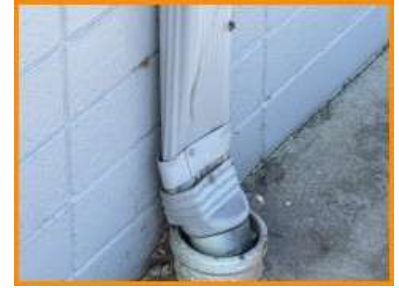
[CR] The downspouts were damaged at the left. This condition allows water to accumulate at the foundation and is conducive to moisture related damage.

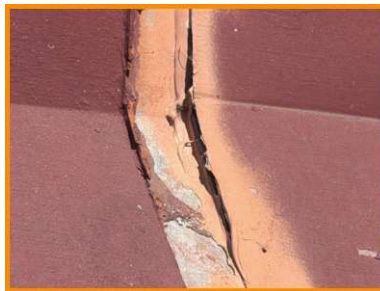
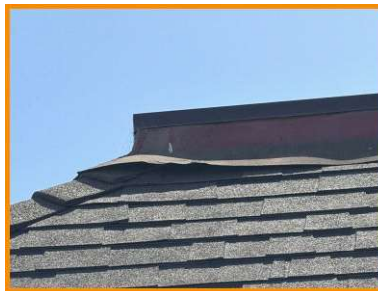
[CR] Roof flashing materials were elevated above the roofing material rather than lying flat. This condition allows for the penetration of driving rain and is conducive to moisture intrusion and damage to the building components.

[CR] Paint on the flashing material was deteriorated. This condition is conducive to premature aging and failure.

[CR] Roof flashing materials were open at the seams rather than sealed. This condition allows for the penetration of driving rain and is conducive to moisture intrusion and damage to the building components.

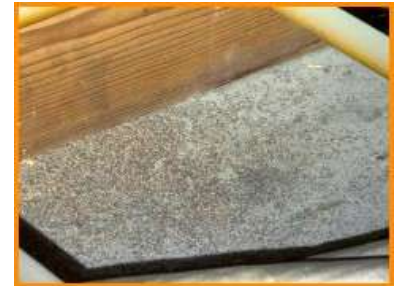
[FE] We observed evidence that suggests the need for a full pest inspection. We recommend a pest (termite) inspection.

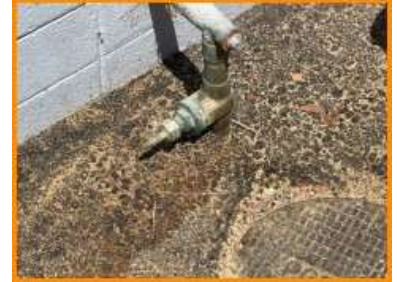
[CR] The main water shutoff-valve was missing. This condition restricts the valves operation for maintenance and emergency needs.

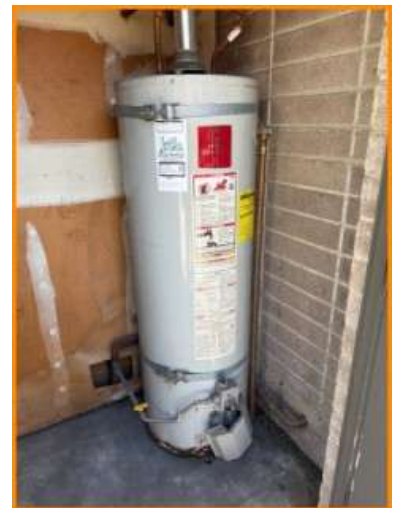
[FE] The water heater requires replacement. We recommend you consult with a plumber to fully understand the costs.

**The seller will replace the water heater**

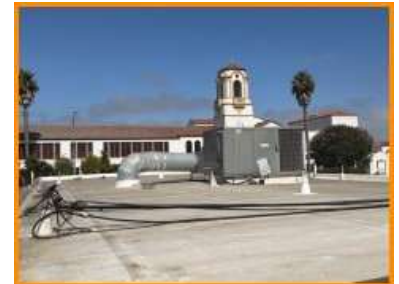
[SC] The overhead service entrance cables at the rear area of the building were hung too low over the roof. Low-hung cables are subject to mechanical damage and are a trip and fall hazard. (These are NOT electrical service wires, they are cable or other such cables.)

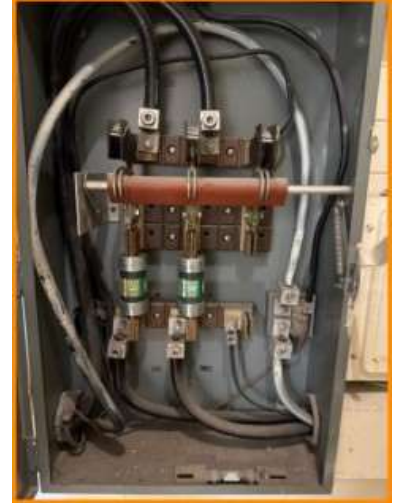
[NOTE] The visible components of the panel showed no signs of damage, arcing, etc. and appeared to be in good working order.

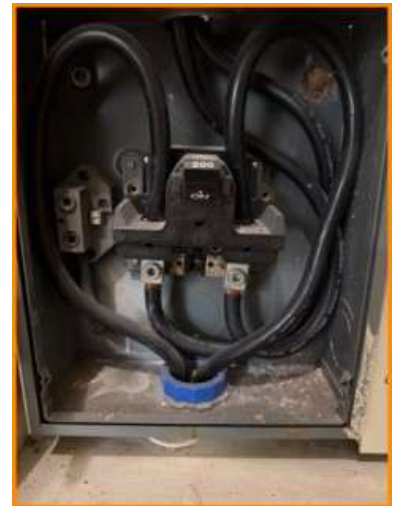
[NOTE] The visible components of the panel showed no signs of damage, arcing, etc. and appeared to be in good working order.

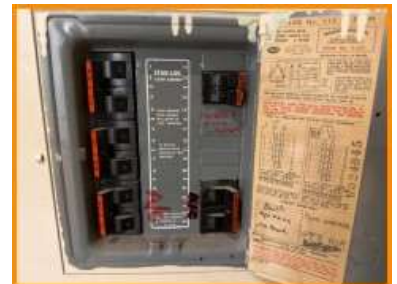
[SC] A Federal Pacific / Stab-Lok panel was in place. These panels are older/obsolete and have a known history of failure and fire. These panels should be removed and replaced by a licensed and qualified electrical contractor. Investigate the costs and other requirements prior to the close of contingencies.

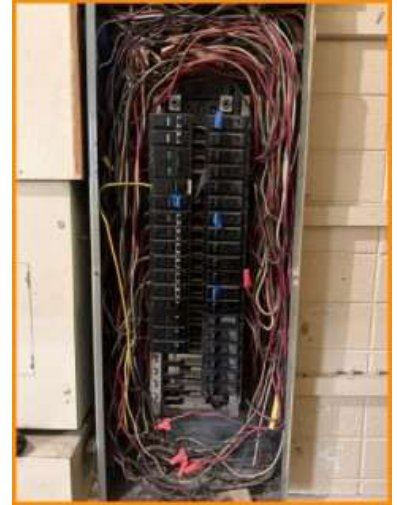
[NOTE] The visible components of the panel showed no signs of damage, arcing, etc..

[NOTE] The circuit wiring in the panel was installed in a substandard manner (messy/excessive wire). This condition may pose a safety hazard when accessing the panel for maintenance or emergencies.

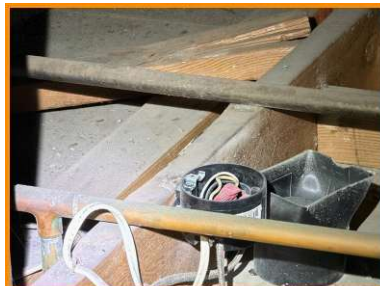
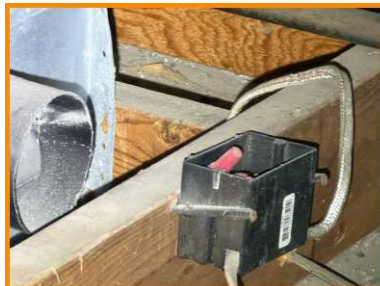
[SC] Junction-box cover plates were missing in/at the attic. This condition is a shock, and fire hazard due to exposed electrical components; all electrical junction boxes should have an approved spark-proof cover.

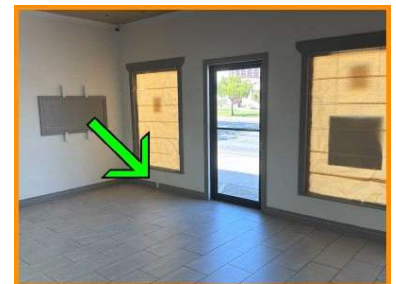
[CR] Some accessible receptacle in/at the large room, left front room, right middle room and hall were noted to have open grounds. This condition may limit the proper function of some sensitive devices (such as computers and stereos) and pose a possible electrical shock hazard for appliances with metal housings (such as washer, dryer, refrigerator, dishwasher, etc).

[NOTE] In the event the receptacles which were found to have open grounds are later determined to have no equipment ground wire - they should be converted back to 2 prong receptacles, be properly grounded, or be properly labeled and protected by a Ground Fault Circuit Interrupt (GFCI).

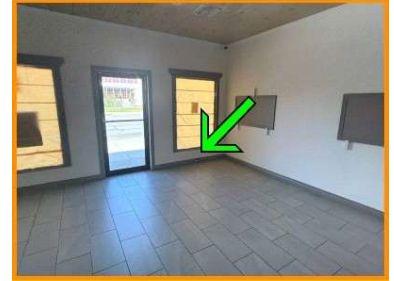
[CR] There was no electrical power at some of the receptacles in/at the hall, large room, right front room right rear room. This condition may be an indication of defective circuit wiring; all receptacles should provide constant power unless switch operated for plug-in lamps/lights.

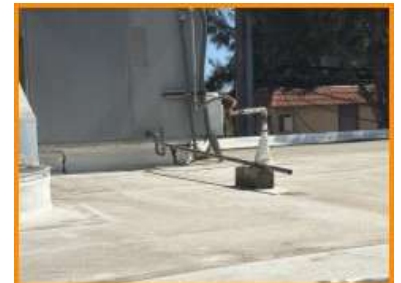
[CR] The condensate discharge drain line for the HVAC unit was installed improperly. The drain piping would allow the condensate to drain directly onto the roof - this condition could result to the single ply roofing material.

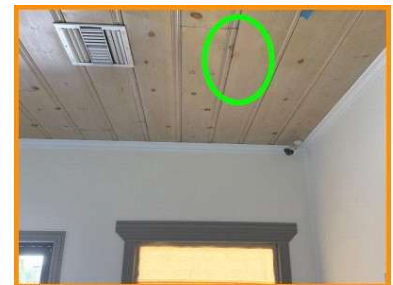
[FE] Dry moisture stains were noted on the ceiling in the large room. These may be old, thus we recommend inquiring with the current owner regarding the nature and history of these stains. Should they be current or uncorrected they could lead to additional damage.

Example - Moisture Stain

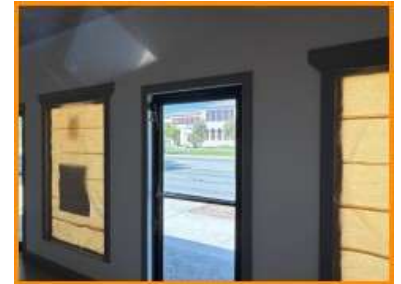
[CR] An entry door rubbed the jamb in the large room. Continued use in this condition may lead to damage.

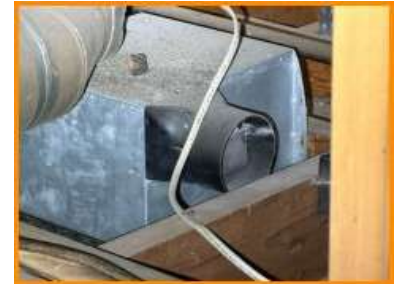
[CR] One of the lavatory exhaust fans failed to function and the vent ducting was disconnected in the attic.
