Commercial Inspection Report

Inspection Date:
03/25/2024

Report Number:
20240325

**1655 San Carlos,
San Carlos, CA**

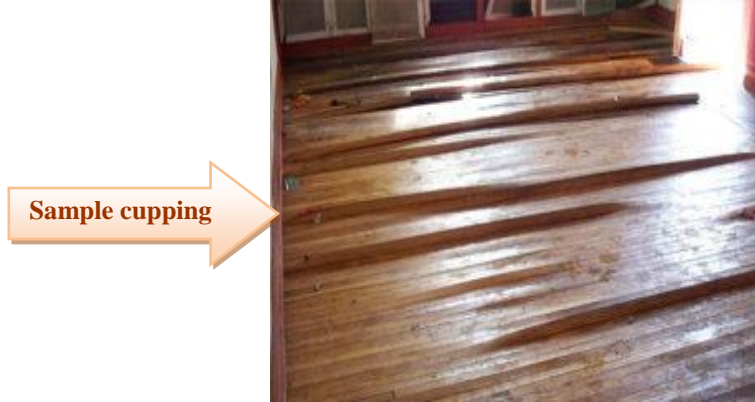
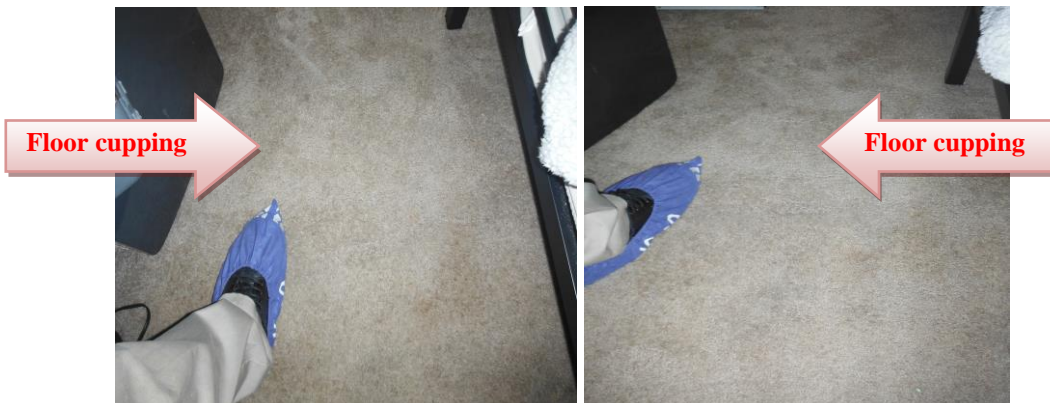
One or more sections of the flooring located in unit 6 was damaged and cupping. The damage and cupping underneath the carpet could potentially lead to more problems if not addressed. It's important to investigate the extent of the damage and take appropriate measures to repair or replace the affected sections of the flooring to prevent further issues. We recommend the advice of a licensed professional; followed by corrective action as needed to improve its current condition.

The portions of the sub-flooring where not visible, the construction methods appear consistent with a dwelling of this type and current era, with exception noted. **One or more sections of the flooring located in unit 6 was damaged and cupping. The damage and cupping underneath the carpet could potentially lead to more problems if not addressed.**

It's important to investigate the extent of the damage and take appropriate measures to repair or replace the affected sections of the flooring to prevent further issues.

We recommend the advice of a licensed professional; followed by corrective action as needed to improve its current condition.

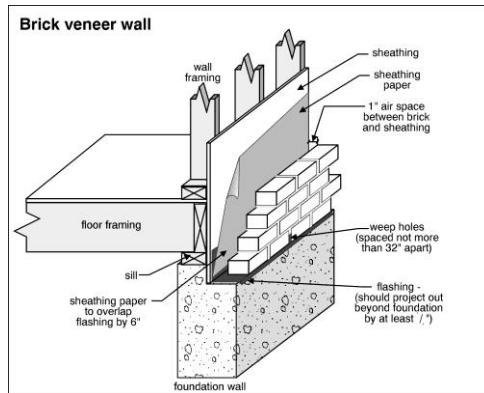
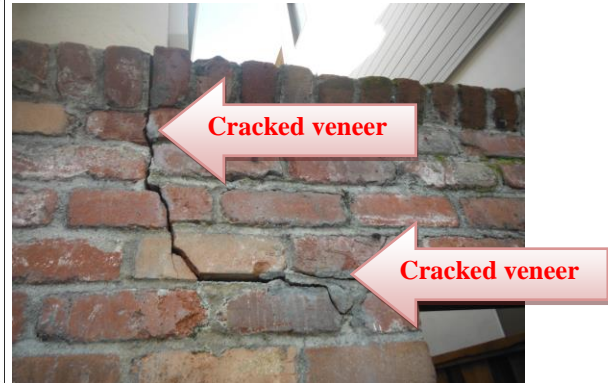
Large cracks have been observed within the brick veneer, indicating structural instability. It is essential to take immediate action as this poses a safety hazard. Standing nearby is not recommended due to the risk of collapse or further damage. We recommend the advice of a licensed professional, followed by corrective action as needed to improve its current condition and safety.

Large cracks have been observed within the brick veneer, indicating structural instability. It is essential to take immediate action as this poses a safety hazard. Standing nearby is not recommended due to the risk of collapse or further damage.

We recommend the advice of a licensed professional, followed by corrective action as needed to improve its current condition and safety.

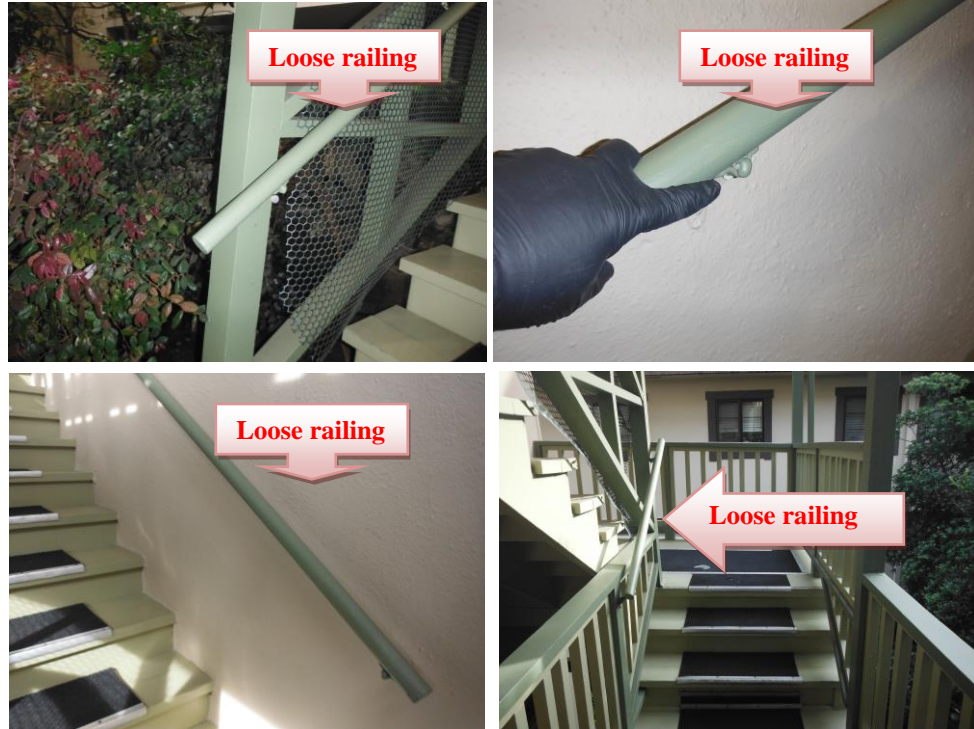
The handrails located on both sides of the staircase are not properly secure and are loose. This poses a safety risk as handrails are essential for providing support and stability while ascending or descending stairs. Loose handrails increase the likelihood of accidents or falls, particularly for individuals who rely on them for balance and support. It's important to promptly address this issue by securely fastening the handrails to ensure they provide the necessary stability and safety for anyone using the staircase.

The handrails and raisers located for the units were in serviceable condition, with exception noted. **The handrails located on both sides of the staircase are not properly secure and are loose. This poses a safety risk as handrails are essential for providing support and stability while ascending or descending stairs. Loose handrails increase the likelihood of accidents or falls, particularly for individuals who rely on them for balance and support. It's important to promptly address this issue by securely fastening the handrails to ensure they provide the necessary stability and safety for anyone using the staircase.**

We recommend the advice of a licensed professional, followed by next corrective action as needed to improve their current condition.

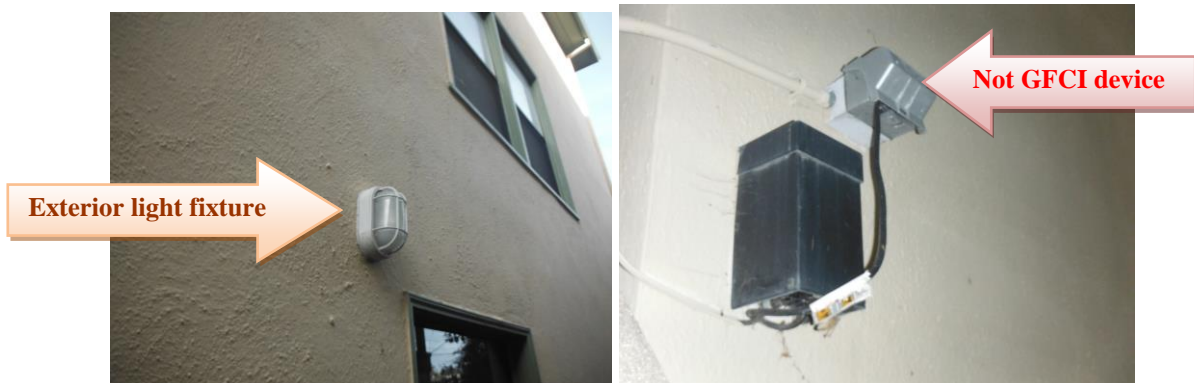
The presence of a non-GFCI (Ground Fault Circuit Interrupter) receptacle in the courtyard, where GFCI devices are required by industry standards, poses a safety concern. GFCI outlets are essential for protecting against electrical shocks in outdoor or damp environments like courtyards where there's an increased risk of water exposure. It's crucial to ensure compliance with industry standards by replacing the non-GFCI receptacle with a GFCI device. This corrective action will enhance electrical safety in the courtyard and reduce the risk of electrical accidents or injuries. We recommend the advice of a licensed professional, followed by next corrective action as needed to improve their current condition.

The exterior light fixtures surrounding the building appear to be in serviceable condition; however, they were not tested, since they are on a sensor system. **The presence of a non-GFCI (Ground Fault Circuit Interrupter) receptacle in the courtyard, where GFCI devices are required by industry standards, poses a safety concern. GFCI outlets are essential for protecting against electrical shocks in outdoor or damp environments like courtyards where there's an increased risk of water exposure. It's crucial to ensure compliance with industry standards by replacing the non-GFCI receptacle with a GFCI device. This corrective action will enhance electrical safety in the courtyard and reduce the risk of electrical accidents or injuries.**

We recommend the advice of a licensed professional, followed by next corrective action as needed to improve their current condition.

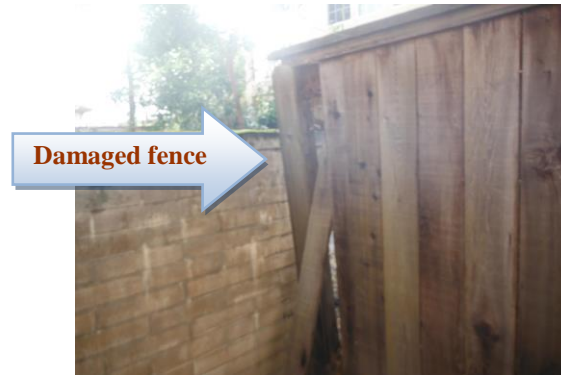
The left and right gates when tested were in satisfactory working condition. The retaining wall located to the left was in satisfactory condition. *Sections of the rear fencing were damaged and leaning. Corrective action is recommended.*

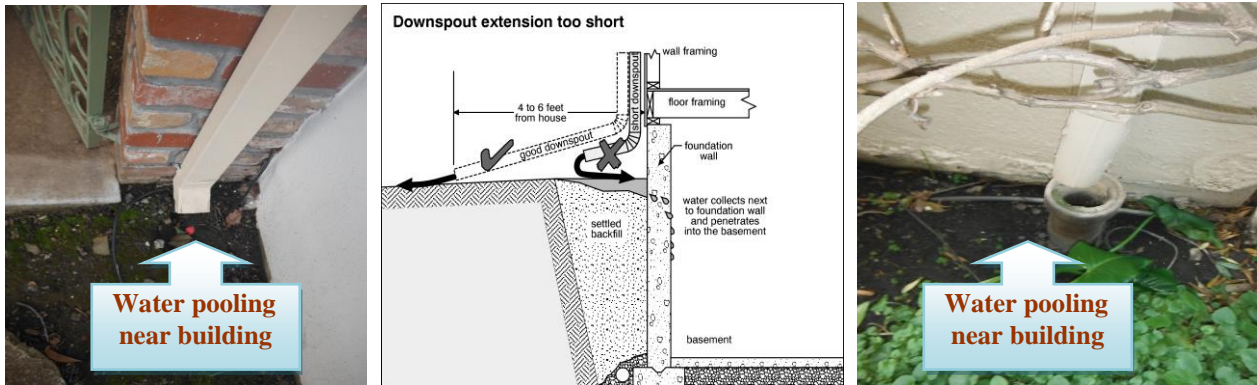
Several of the exterior scuppers and downspouts were in fair condition. Several of the exterior downspouts did not properly extend within the underground. Allowing roof water to pool near the foundation, often leading to excess moisture around the foundation or in the basement and/or the under building. This condition will allow roof water to pool near the foundation, often leading to excess moisture around the foundation or in the basement and/or the under building crawl space.

The discharge from this downspout should be routed sufficiently away from the structure (usually at least 6' to 10') to prevent puddling, pooling, and saturation of the soil around the building.

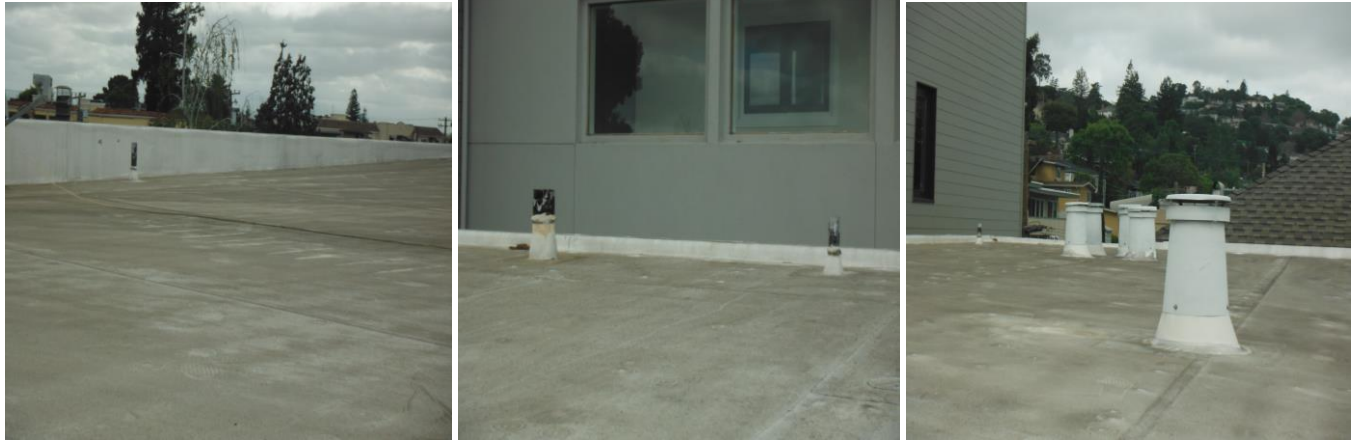
The roof field did provide the required slope to allow water to discharge to the nearby scuppers (drainage system), thus, the water is trap causing black stains through-out the roof. Any roof that still has water on it forty-eight hours after a rain is defined as a ponding roof and can cause additional damaged in those areas.

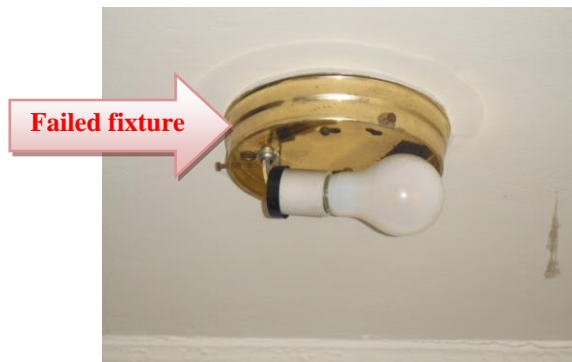
The light fixture in unit 6 failed to function as intended when tested. This issue needs to be addressed promptly to ensure proper lighting within the unit. A malfunctioning light fixture not only affects visibility but also poses potential safety hazards, such as increased risk of trips and falls in poorly lit areas.

The light fixtures in this dwelling were operational and in serviceable condition, with exception noted below. Choosing the right light bulb can help save energy dollars. Deciding between compact fluorescent light bulbs, halogen light bulbs, or LED light bulbs can make more sense when you know what to look for. **The light fixture in unit 6 failed to function as intended when tested. This issue needs to be addressed promptly to ensure proper lighting within the unit. A malfunctioning light fixture not only affects visibility but also poses potential safety hazards, such as increased risk of trips and falls in poorly lit areas.**

We recommend the advice of a licensed professional, followed by corrective action where needed to improve its current condition.

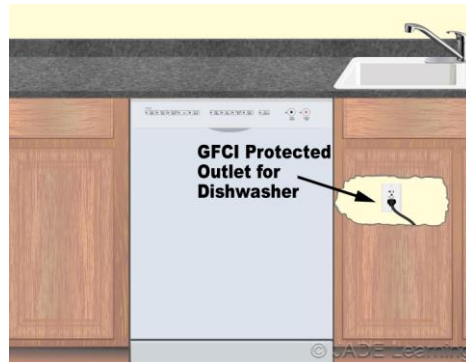
One GFCI located in the washrooms for 7 and 10 unit 2 when tested failed to function as intended. This device was noted with reverse polarity is the opposite of normal polarity. Normal polarity in electronics is when you have the positive hooked up to the positive terminal and the negative to the negative terminal. Reverse polarity would be having the positive hooked up to the negative terminal and the negative to the positive terminal.

GFCI's located in the washrooms and kitchens when tested were function as intended, with exception noted. **One GFCI located in the washrooms for 7 and 10 unit 2 when tested failed to function as intended. This device was noted with reverse polarity is the opposite of normal polarity. Normal polarity in electronics is when you have the positive hooked up to the positive terminal and the negative to the negative terminal. Reverse polarity would be having the positive hooked up to the negative terminal and the negative to the positive terminal.**

As of the latest safety standards and regulations, GFCI outlets are now required to be installed underneath the kitchen sink. This update is aimed at enhancing electrical safety in kitchens, where the proximity of water sources increases the risk of electrical hazards.

We recommend the advice of a licensed professional, followed by corrective action where needed to improve its current condition.

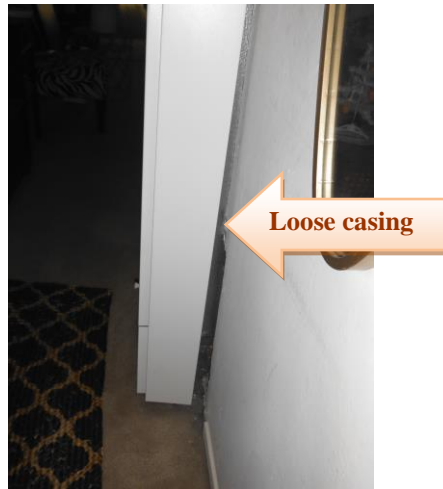
The casing for the wall heater located in units 8, 1 was found to be improperly secured. This is a safety concern as loose casings can pose various risks including potential fire hazards or physical harm to occupants. Properly securing the casings is essential to ensure the safe operation of the wall heater and to prevent any accidents or damage. It's advisable to promptly address this issue by securely fastening the casings according to manufacturer's instructions or with the assistance of a qualified technician to ensure compliance with safety standards and the overall safety of the premises. Regular maintenance checks should also be conducted to identify and address any similar issues in the future.

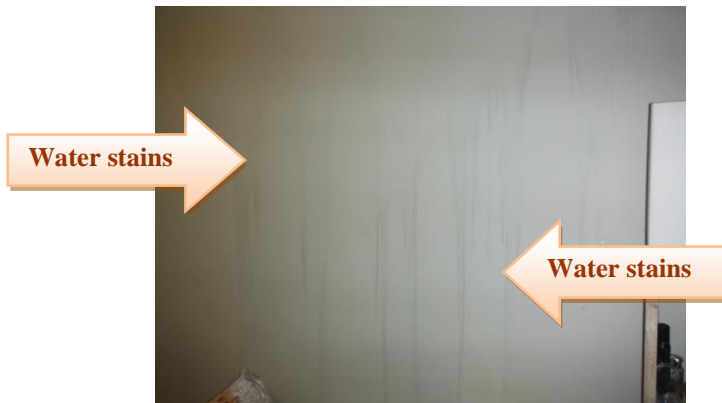
The walls and ceiling or the underside of the roof in this dwelling was in serviceable condition, with exception noted below. Any blemishes or slight wall stains found on the ceilings and walls are cosmetic and should be, repaired for a better appearance. The units in 1, 6, 9, were noted with surface cracks and blistering for ceiling and walls. ***Unit 6 has been noted with water stains on one of the bedroom walls, indicating past water leaks from the roof. Water stains are not only unsightly but also indicate potential damage to the structural integrity of the wall and ceiling. It's crucial to address this issue promptly to prevent further water damage and potential fungus growth, which can pose health risks to occupants.***

We recommend the advice of a licensed professional, followed by next corrective action as needed improve its current condition.

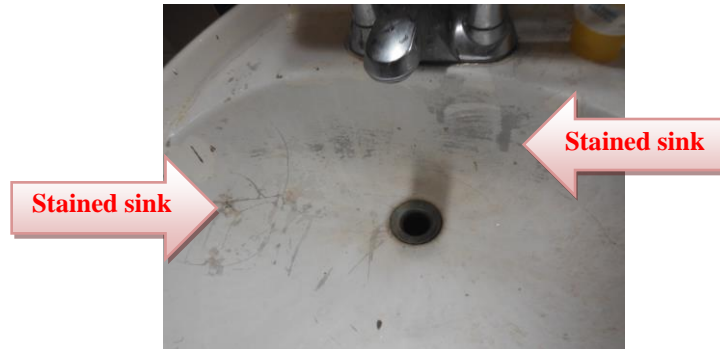
Unit 1 washroom pedestal was not properly secure. Unit 6 washroom sink was noticeably stained and chipping.

The washbasin, stopper, overflow drain and water supply lines when operated, were fully functional and in serviceable condition. The pedestals for each unit were properly secure to the wall, with exception noted. **Unit 1 washroom pedestal was not properly secure. Unit 6 washroom sink was noticeably stained and chipping.**

We recommend the advice of a licensed professional, followed by next corrective action as needed to improve its current condition.

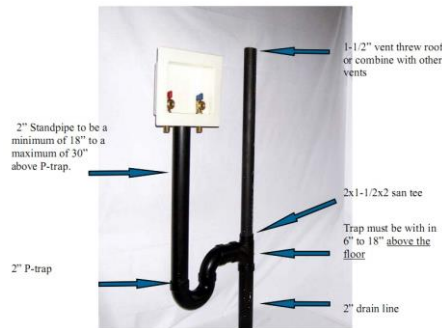
The laundry room in the garage was not inspected as it's a public coin operated. The utility connections (water) for the clothes washer were in serviceable condition, no leaks were noted. **The absence of a water line discharge, or standpipe, for the washer as required poses a significant concern. Instead, dark water is being drained into a tub, which can lead to cross contamination. Cross contamination is a serious issue that can compromise the cleanliness and safety of water sources. Installing a proper water line discharge, such as a standpipe, for the washer is essential to ensure that wastewater is safely and effectively removed from the unit without risk of contamination. Additionally, addressing the drainage issue promptly is crucial to prevent further potential health hazards.**

We recommend the advice of a licensed professional; followed by corrective action as needed to improve its current condition.

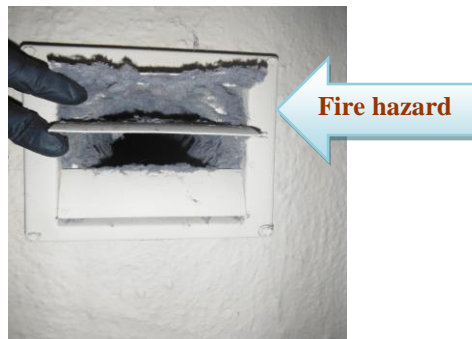
The clothes dryer was vented to the exterior and found to be in poor condition. The accumulation of heavy lint in the dryer hood and louvers poses a significant fire hazard. Lint is highly flammable, and when it accumulates in dryer vents, it restricts airflow and can lead to overheating.

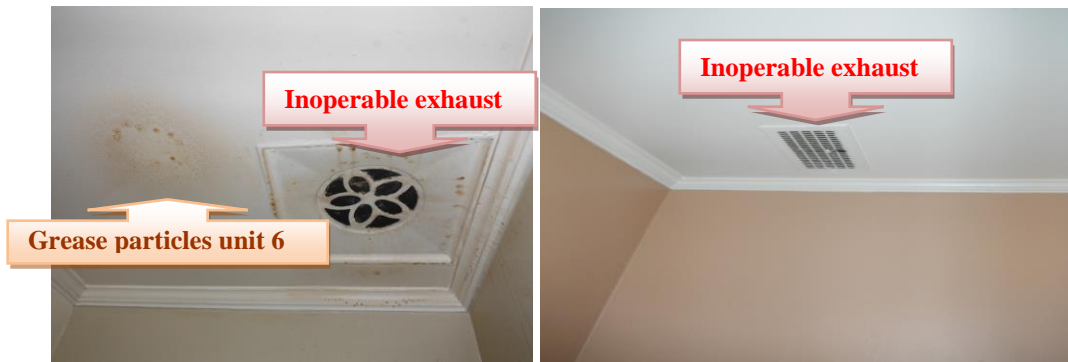
The remaining kitchen exhaust located on the ceiling was found to be non-functional when tested. This is a significant issue as kitchen exhaust systems play a crucial role in removing cooking fumes, odors, and potentially harmful airborne particles from the kitchen area. A malfunctioning kitchen exhaust can lead to poor indoor air quality, increased risk of grease buildup, and potential fire hazards. It's essential to address this issue promptly by diagnosing the cause of the malfunction and repairing or replacing the exhaust system as needed.

The cooktop exhaust for unit 8 was installed above the cooking surface. When tested it was in satisfactory working it provided exterior ventilation as required by industry standards, with exception noted. **The remaining kitchen exhaust located on the ceiling was found to be non-functional when tested. This is a significant issue as kitchen exhaust systems play a crucial role in removing cooking fumes, odors, and potentially harmful airborne particles from the kitchen area. A malfunctioning kitchen exhaust can lead to poor indoor air quality, increased risk of grease buildup, and potential fire hazards. It's essential to address this issue promptly by diagnosing the cause of the malfunction and repairing or replacing the exhaust system as needed.**

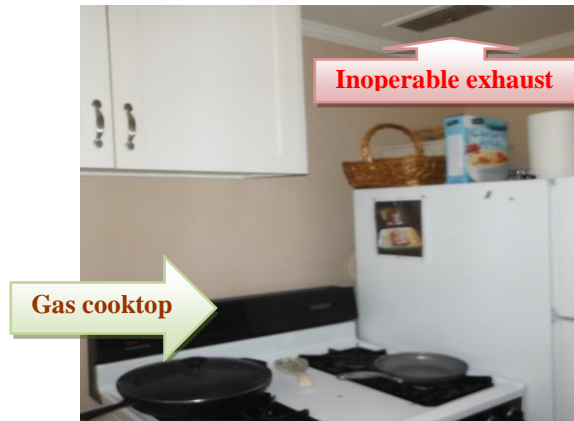
The absence of an exhaust ceiling fan located directly above the gas cooktop in unit 3 poses a significant safety concern. Kitchen exhaust systems, including ceiling fans, are crucial for removing smoke, grease, and other pollutants generated during cooking. Without proper ventilation directly above the gas cooktop, there's an increased risk of indoor air pollution, accumulation of cooking odors, and potential fire hazards underneath the exposure cabinets.

The absence of an exhaust ceiling fan located directly above the gas cooktop in unit 3 poses a significant safety concern. Kitchen exhaust systems, including ceiling fans, are crucial for removing smoke, grease, and other pollutants generated during cooking.

We recommend the advice of a licensed professional; followed by corrective action as needed to improve its current condition.
