## ROOF INSPECTION REPORT

OCT 08, 2025

**MARINA GABUNIA**

1980 Route 209  
Brodheadsville, PA  
18322

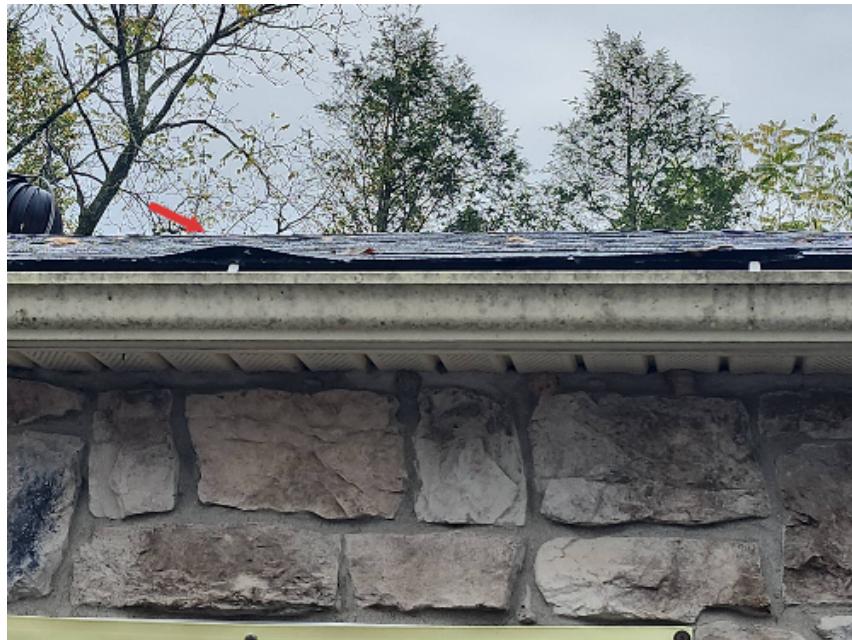
Some lifting of shingles at roof edge caused by nails securing gutter straps pulling out.

Can be remedied with screws in the straps.

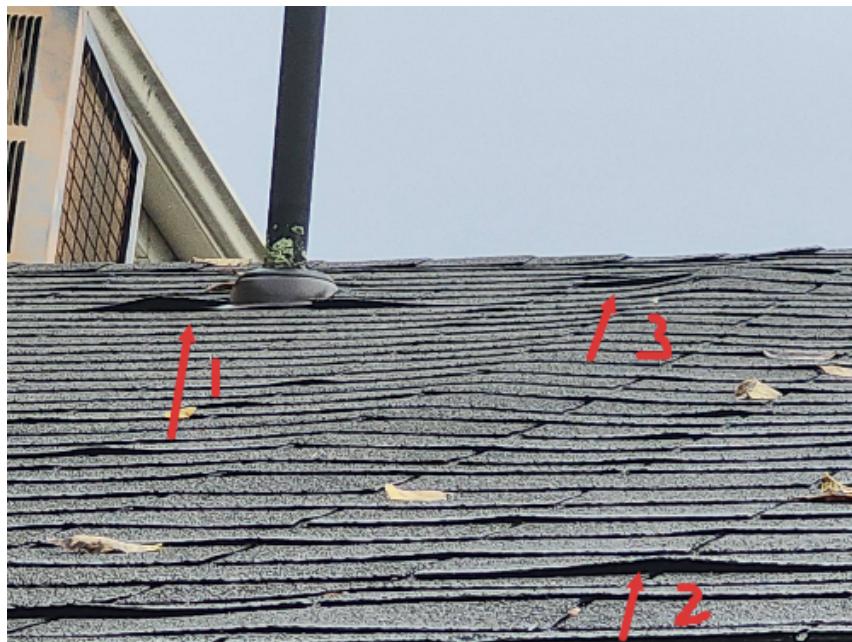
Shingle lifting arrows 1 & 2  
Rippling under the shingles as in arrow 3  
This can be from improper underlayment installation or in this case from improper ventilation of the roof.

Shingle seal failure resulting in shingle lifting

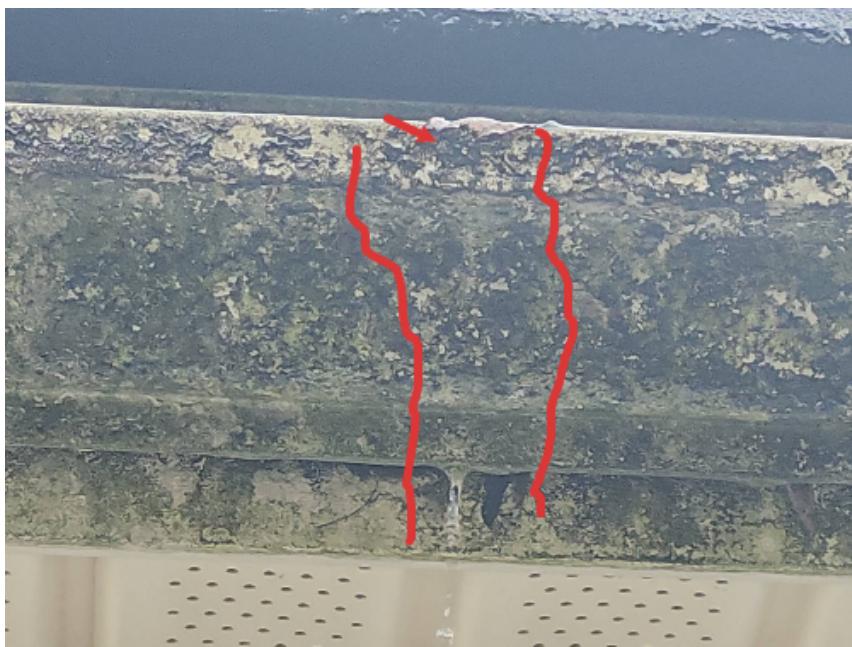
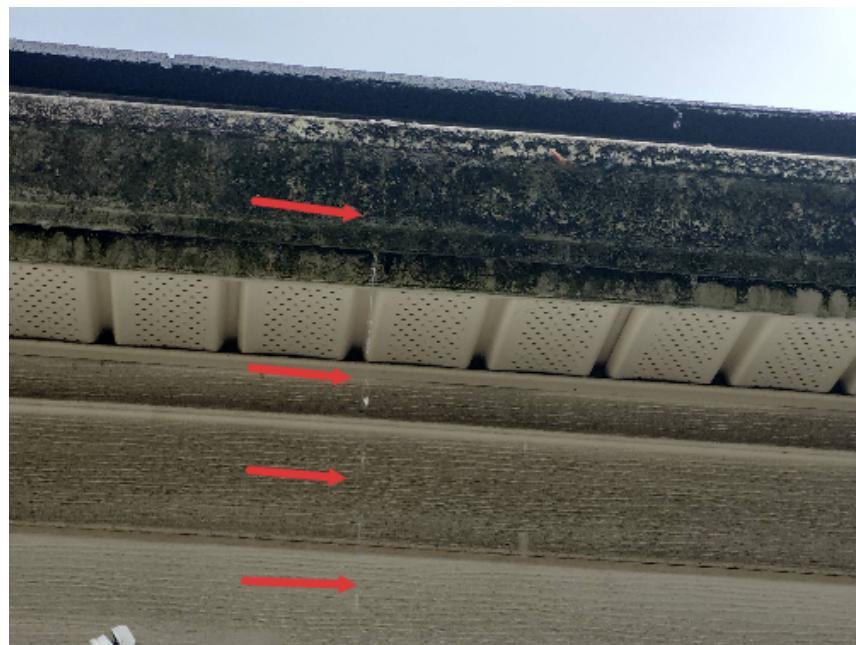
Gutter overflow

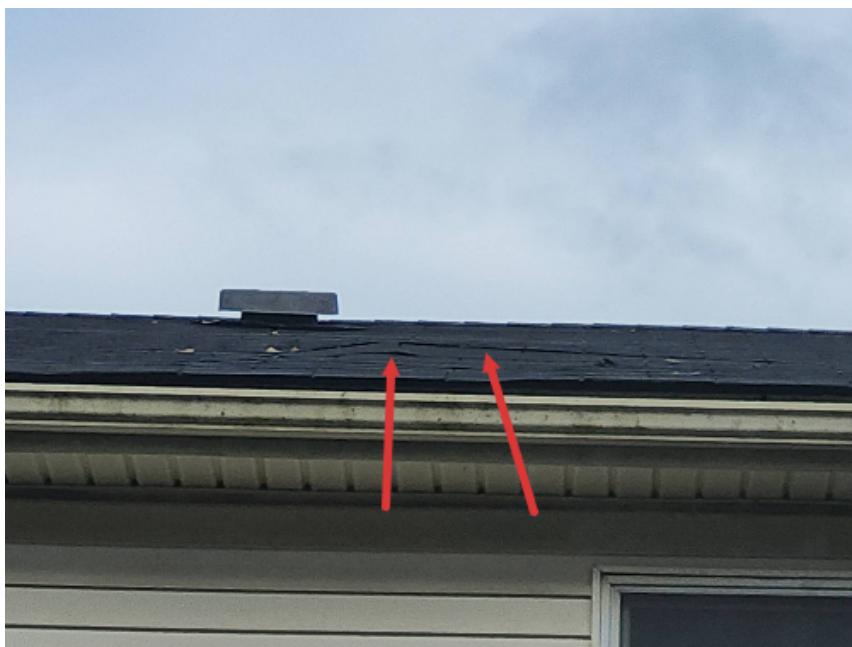
Additional shingle lifting

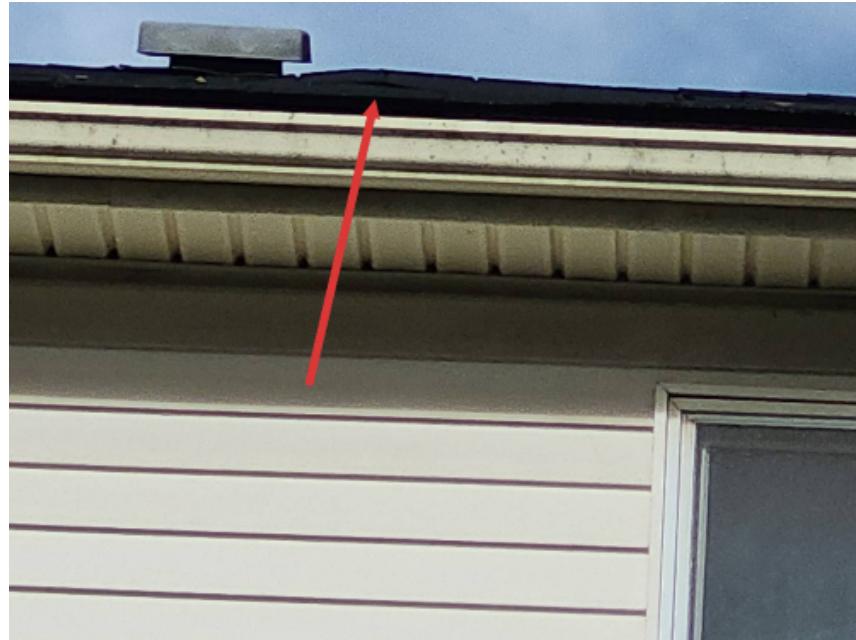
Additional rippling

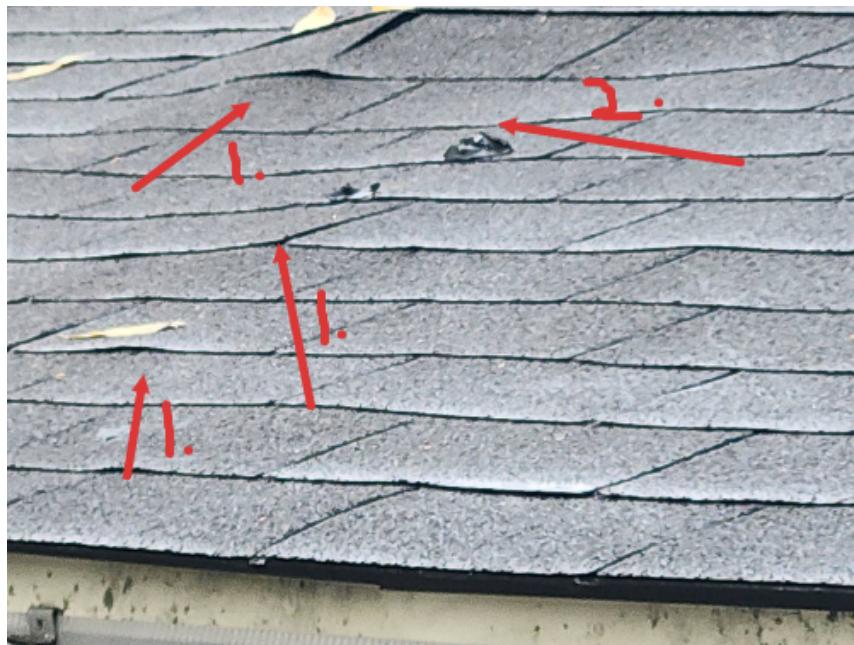
More rippling (1) and some soft spots (2) in deck of roof were observed.

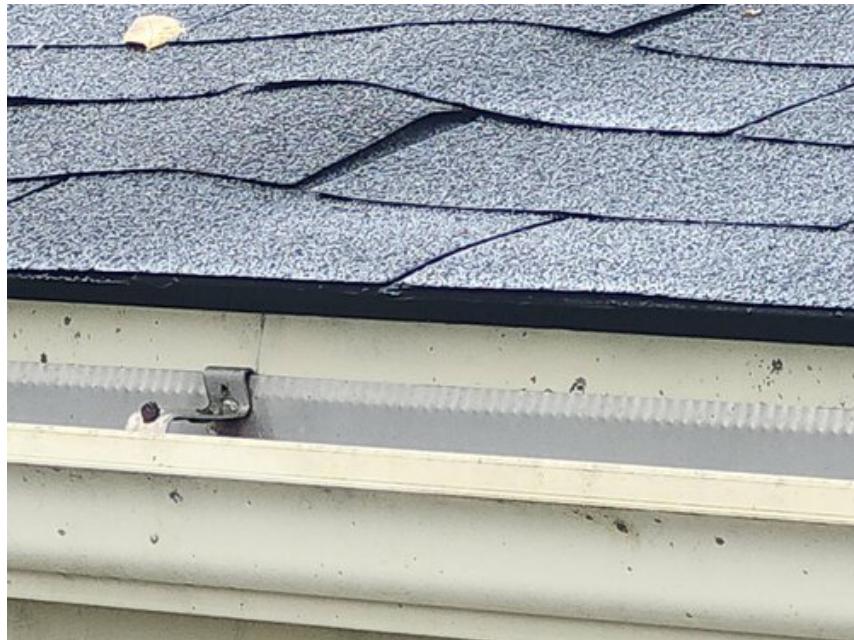
Rippling

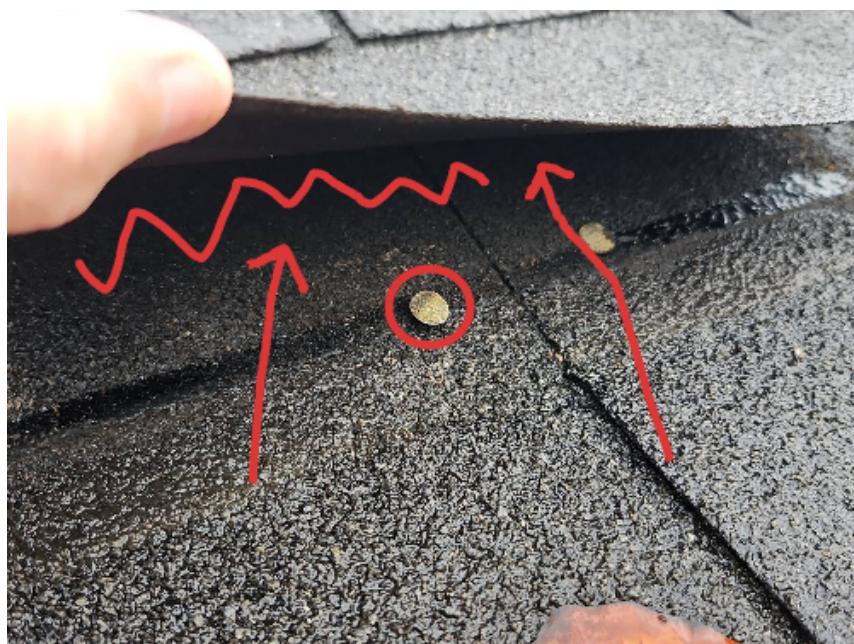
Seal failure and nail pop. Nails are installed properly in nailing strip in this picture.

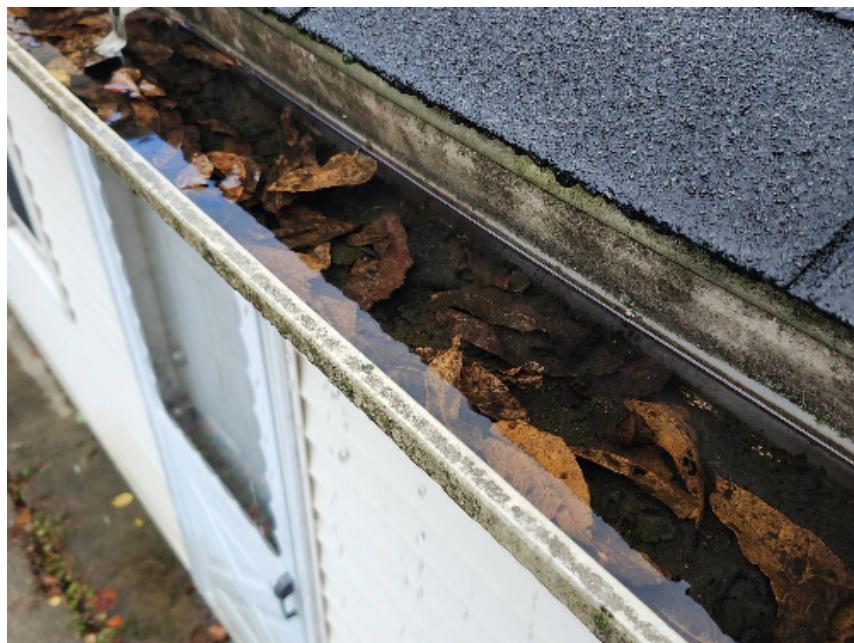
Gutter filled with water

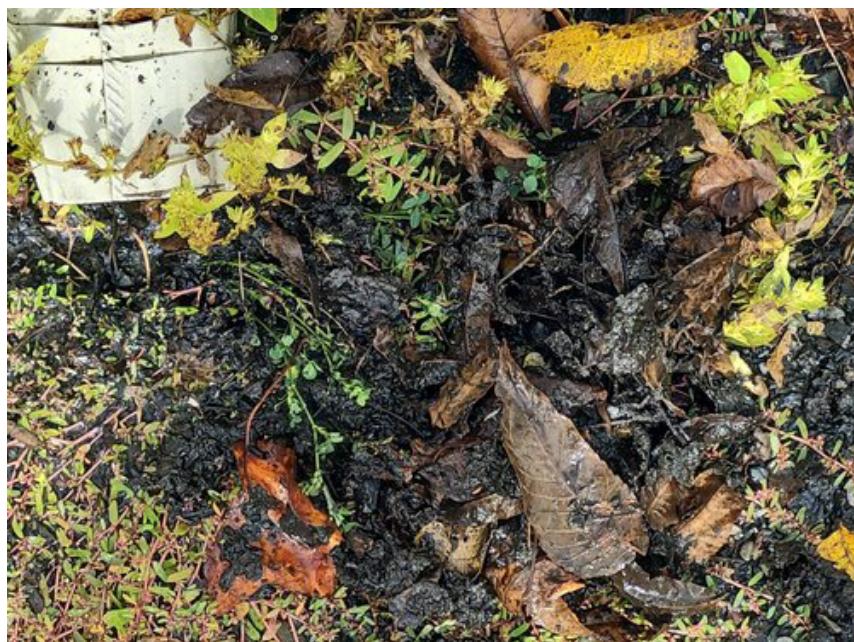
Debris from gutter when clogged removed

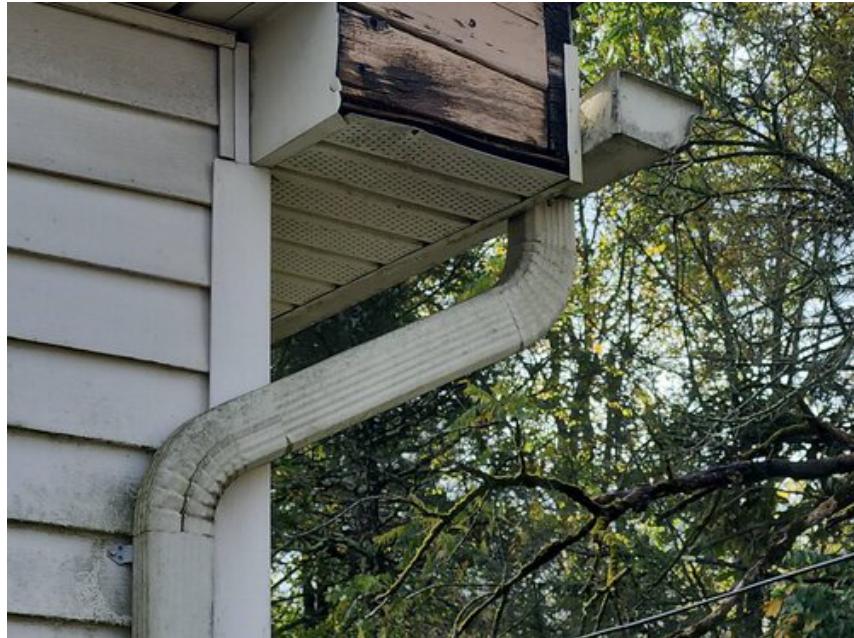
Missing fascia that will lead to wood rot

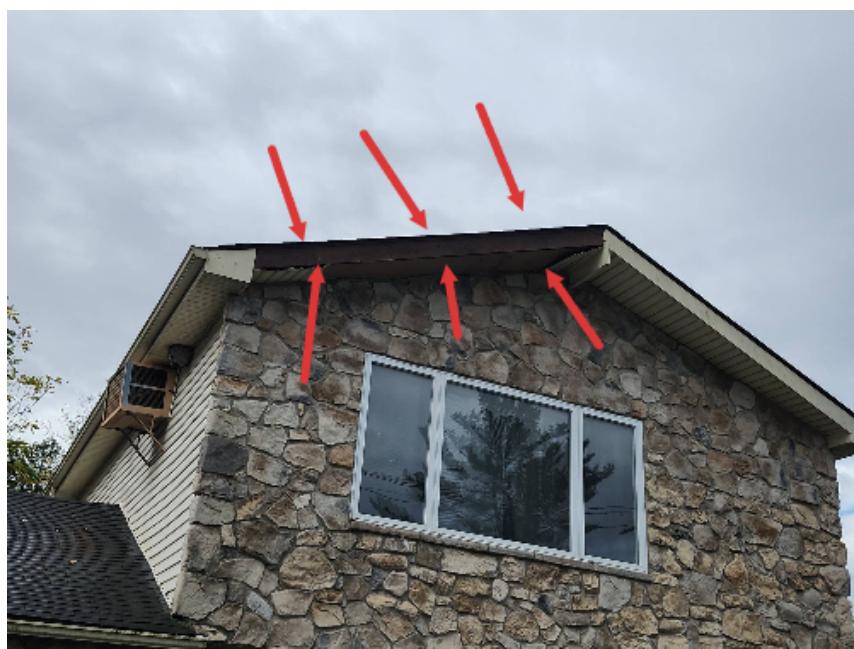
Missing soffit and fascia

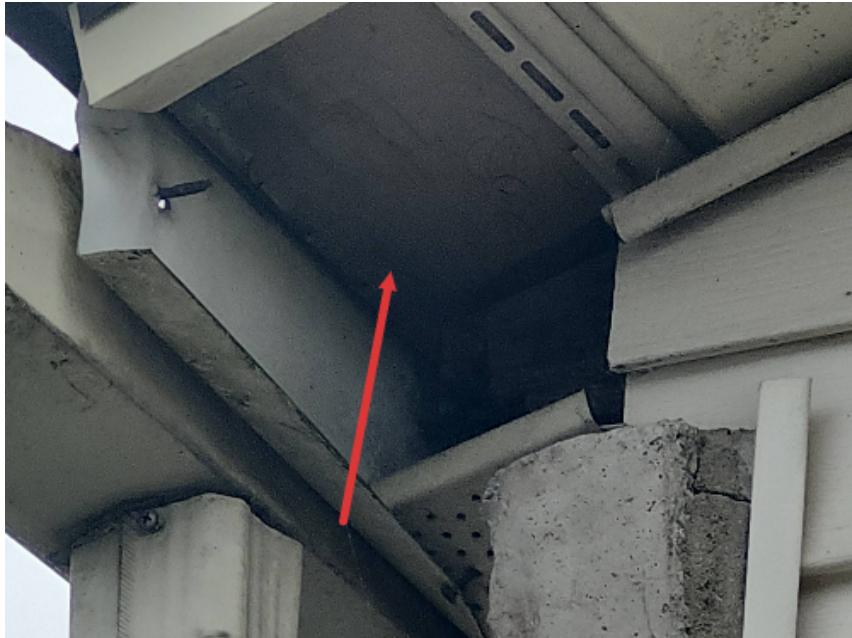
Missing soffit
