INSPECTION REPORT

For the Property at:
4090 CLEVELAND AVENUE
COLUMBUS, OH 43224

RE: Report No. 8437, v.2
4090 Cleveland Avenue
Columbus, OH
43224

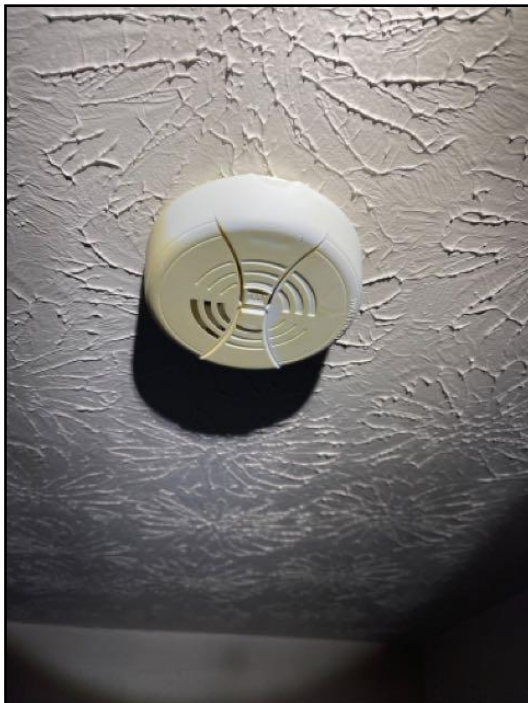
Condition: • Smoke detectors/CO are present, but do not meet minimum building standards. Any smoke detectors that are inoperative or missing should be remedied as soon as possible. Smoke alarms and CO detectors are often required by city code, so be sure you are following any local guidelines too. Lastly, many insurance policies require working smoke detectors as a "protective safeguard" in order to honor a fire claim, so be sure to review your policy.

1. Smoke detectors/CO are present, but do not...

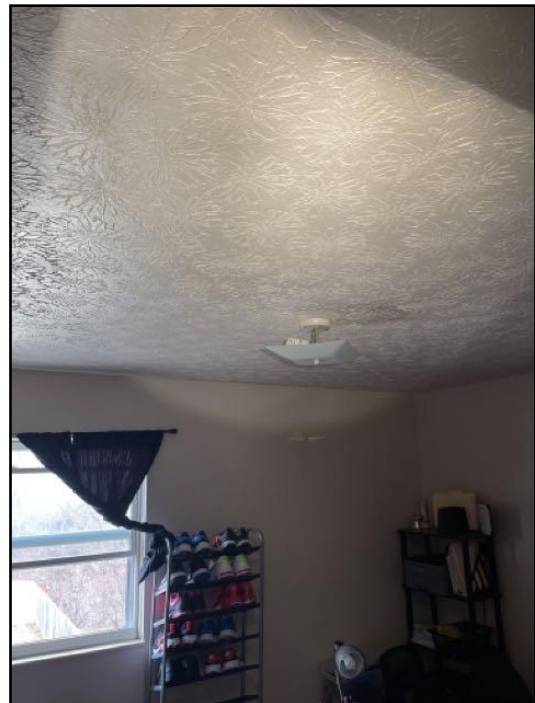
2. Smoke detectors/CO are present, but do not...

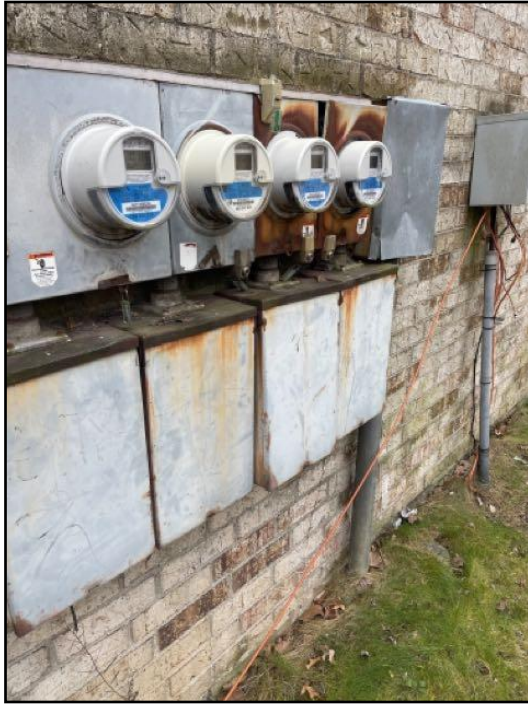
Condition: • Electric panels, meter boxes, junction boxes and splitter boxes with rust converting primer is expected to operate satisfactorily for 30 years in an outdoor or indoor environment while extremes of loading work to weaken the insulation systems inside the electrical equipment. This high expectation demands the best in state-of-the-art design, metal processing, and coating technologies. This issue is an indicator that a qualified technician should evaluate the equipment and make any and all repairs as necessary before you close
Structure 2401, 2415, 2441 meter boxes were missing components and not securely mounted to the structure which is a potential electrical hazard.

4. Electric panels, meter boxes, junction...

Cost: Exterior 4 Bank Service Upgrade W/disconnect \$8K +/- 10% each building

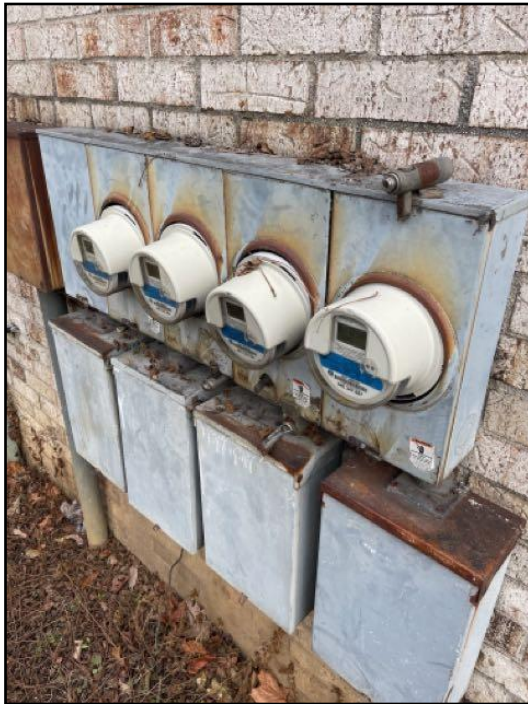
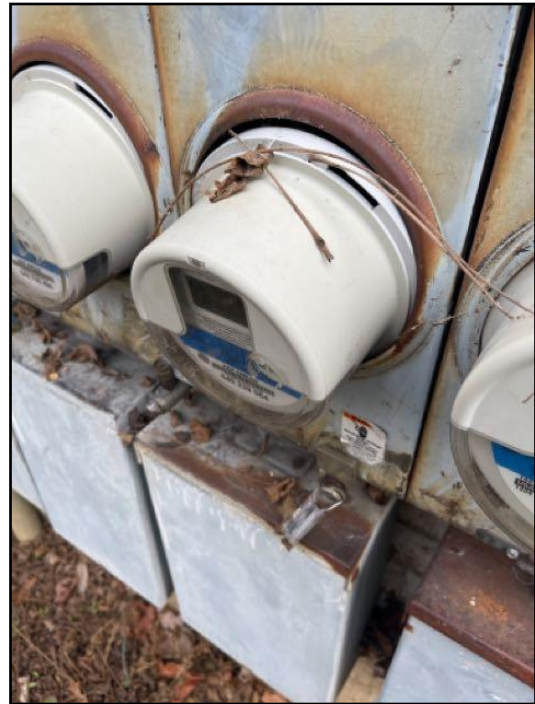
6. Condition: • The meter socket is not weathertight, this could moisture to enter the meter box and/or main disconnect. I recommend consulting a qualified electrician to make the necessary repairs.

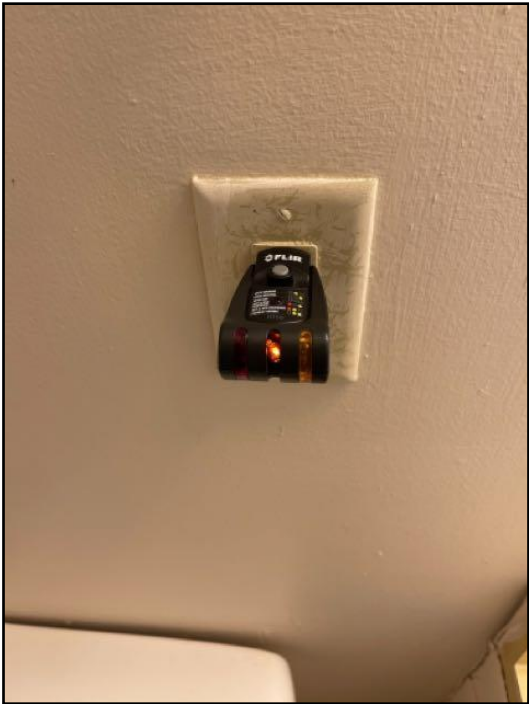
13. Condition: • The GFCI is not tripping (shutting off the electric) when tested at the outlet or with a testing device. I recommend that a qualified electrician perform repairs as needed for safe use.

29. .The GFCI is not tripping (shutting off the...

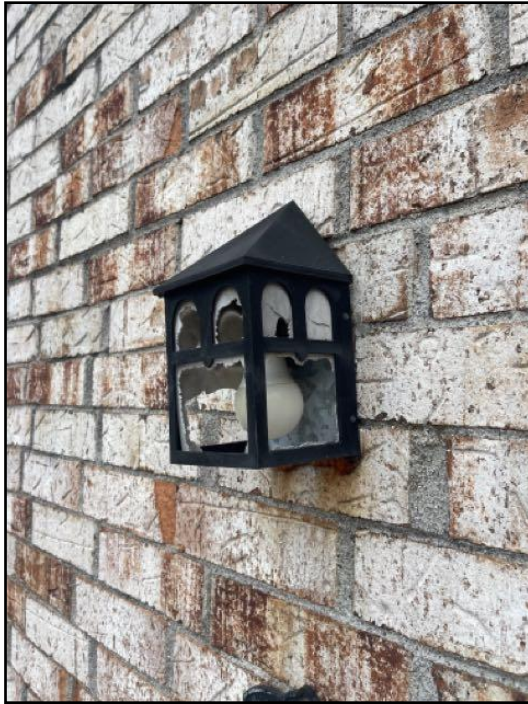
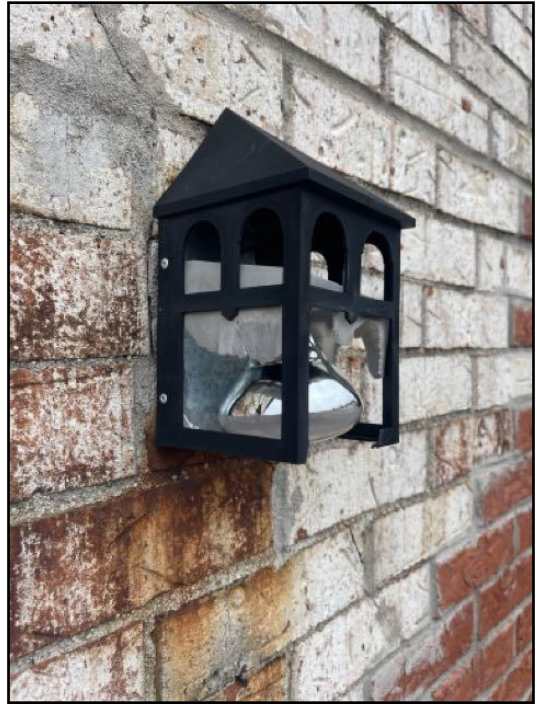
Light fixture deficiencies were present at the time of inspection, scheduled contractual maintenance is recommended for common repairs.

30. Damaged

31. Damaged

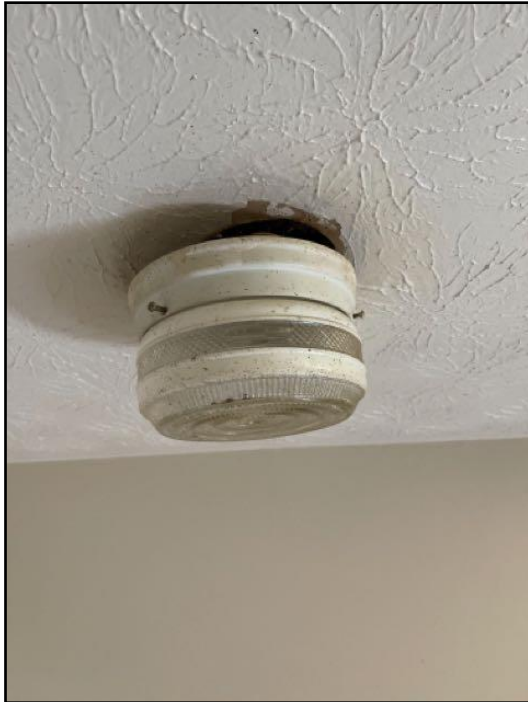
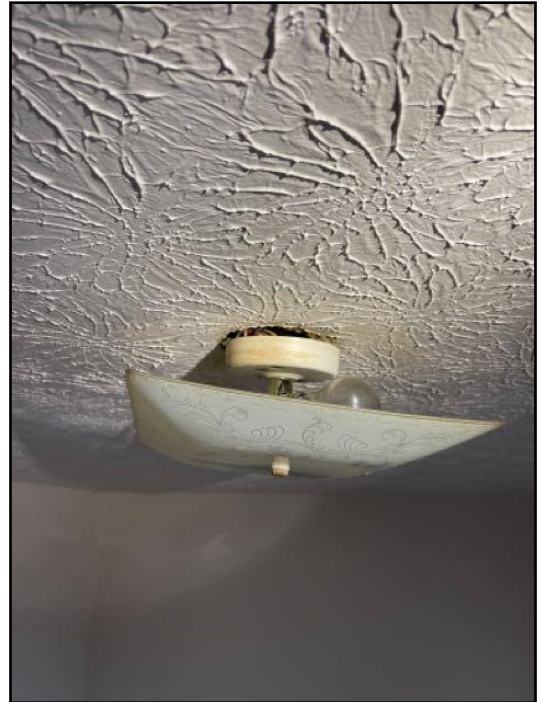
Light fixture deficiencies were present at the time of inspection, scheduled contractual maintenance is recommended for common repairs.

33. Damaged

34. Damaged

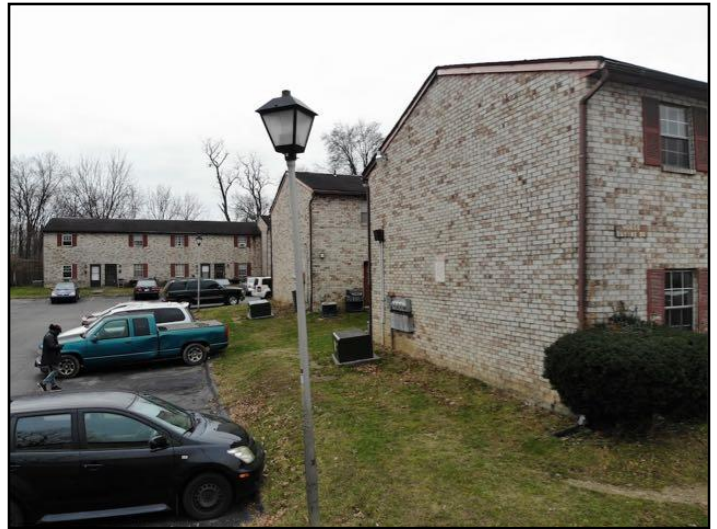
16. Condition: • The exterior lights are leaning. I recommend contacting a qualified contractor to make the necessary repairs.

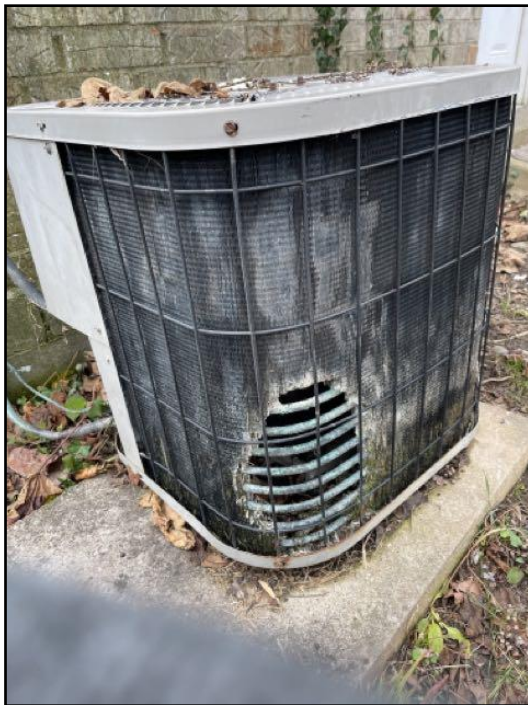
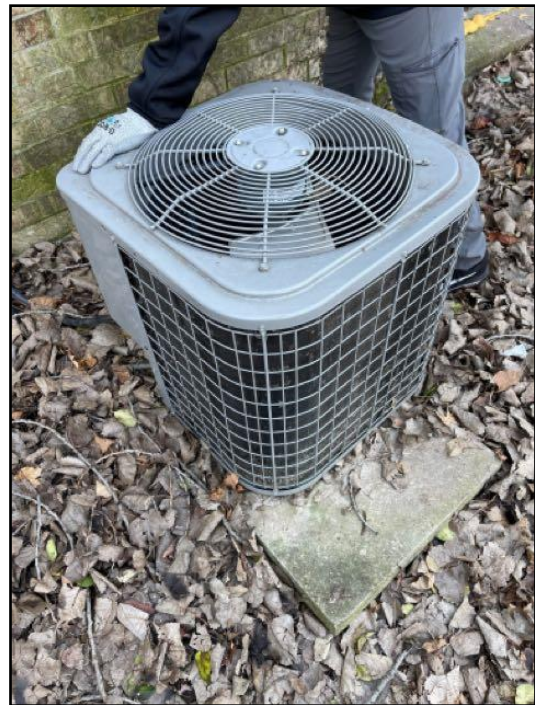
37. Beyond typical life expectancy

38. Beyond typical life expectancy

Cost: \$2,500 +/- 20%

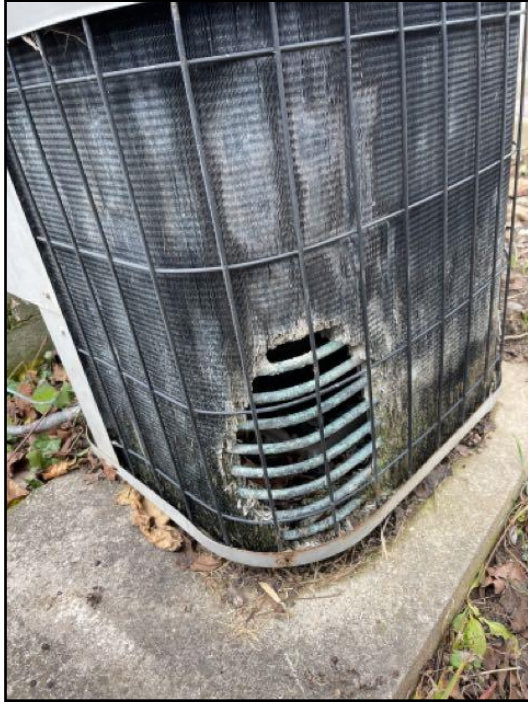
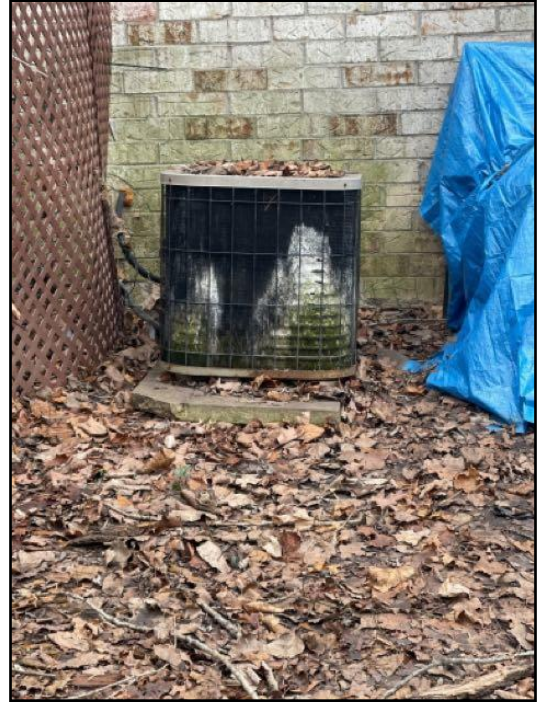
22. Condition: • Condenser coil damaged / obstructed / dirty

39. Condenser coil damaged / obstructed / dirty

40. Condenser coil damaged / obstructed / dirty

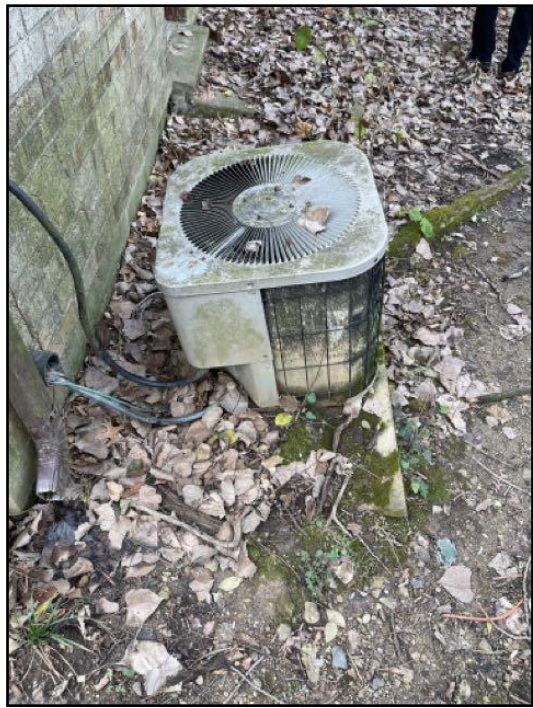
42. The condensing units should be within...

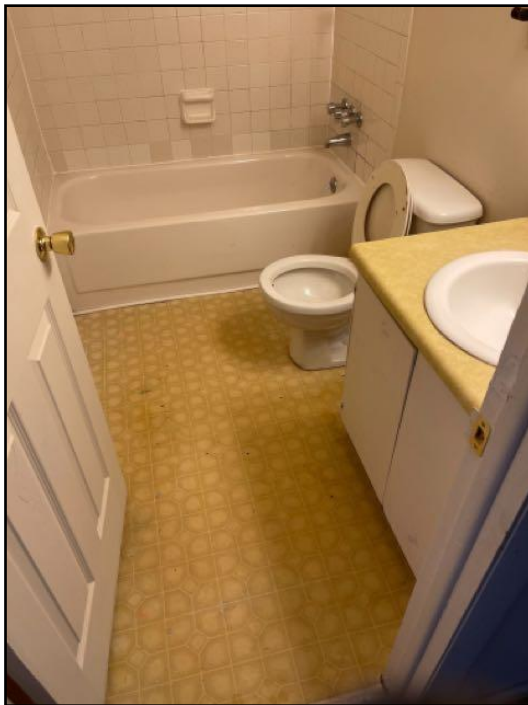
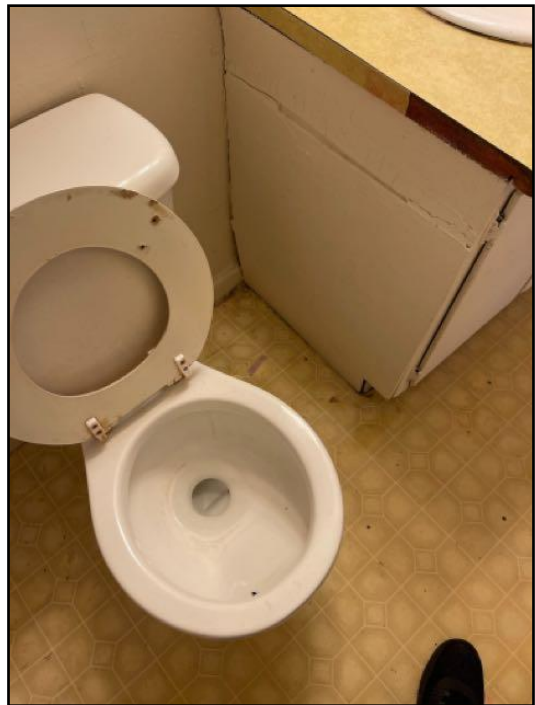
49. The overall condition of the structure was...

50. The overall condition of the structure was...

Cost: Basic bathroom restoration \$7k +/- 10%

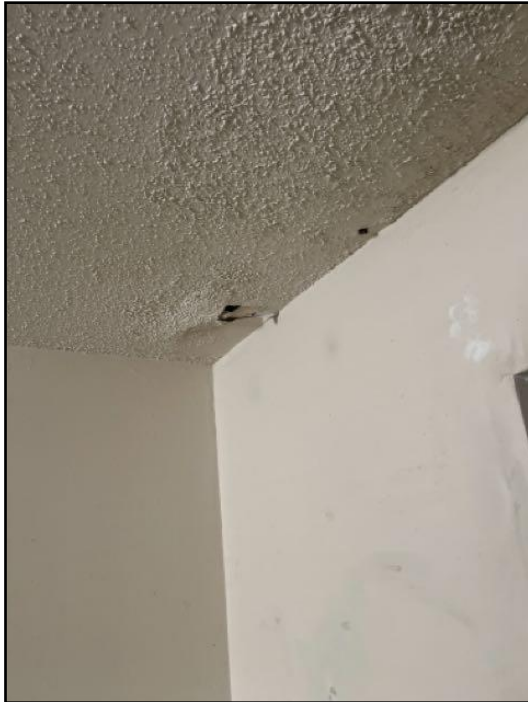
77. Water stains observed on the ceiling could...

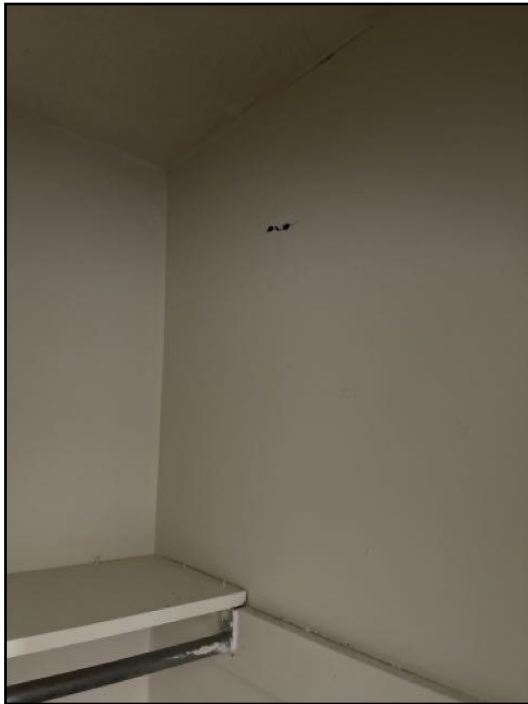
79. Water damage was found at this location....

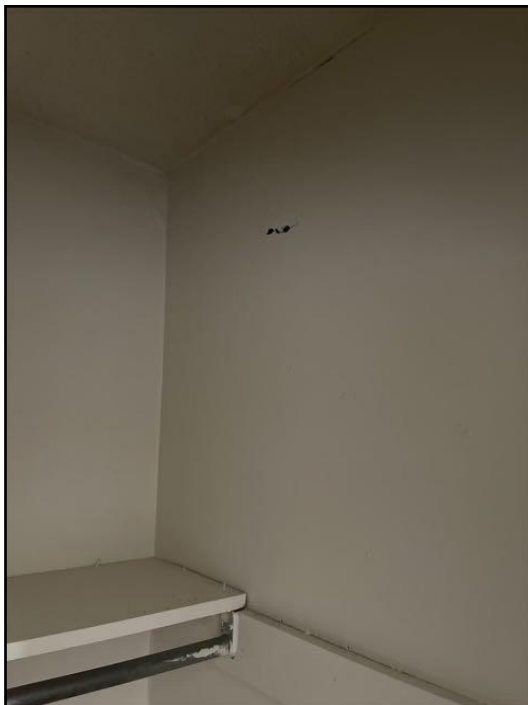
81. Water damage was found at this location....

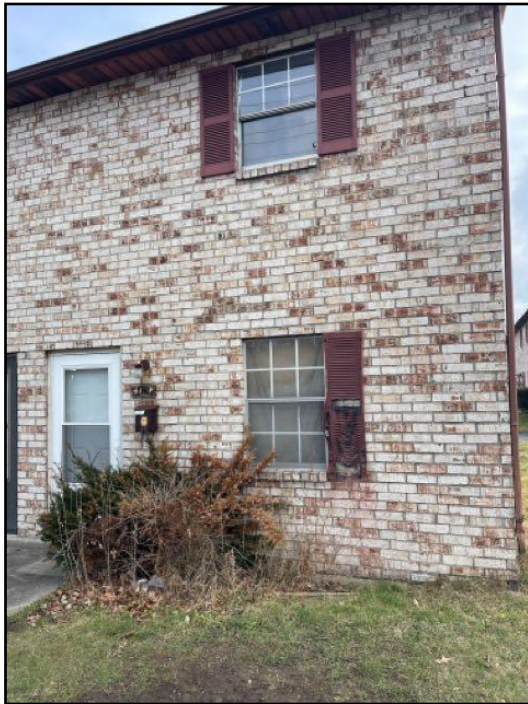
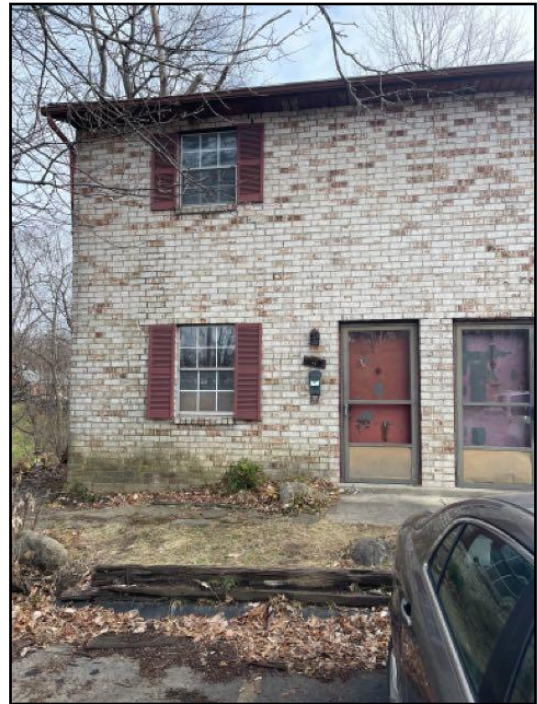
45. Condition: • Fire damage was found. Consult the owner for extent of damage and occurrence period. The proper municipal authority should supply documents in review of this occurrence with recommendation of correction if any. ASTM E 119 (ASTM International 2000) For wood members that have charred, the char layer can be easily scrapped off. Obviously, any charred portion of a fire-exposed wood member has no residual load capacity. The wood beneath the char layer has residual load capacity; but, this residual capacity will be less than the load capacity prior to the fire. Members that have only visual smoke damage or slight browning of the surface also have significant residual load capacity. I recommend further investigation be made into this incident to insure structural integrity of the building.

Implication(s): Possible Decreased Load Capacity

88. Fire damage was found. Consult the owner fo...

89. Fire damage was found. Consult the owner fo...

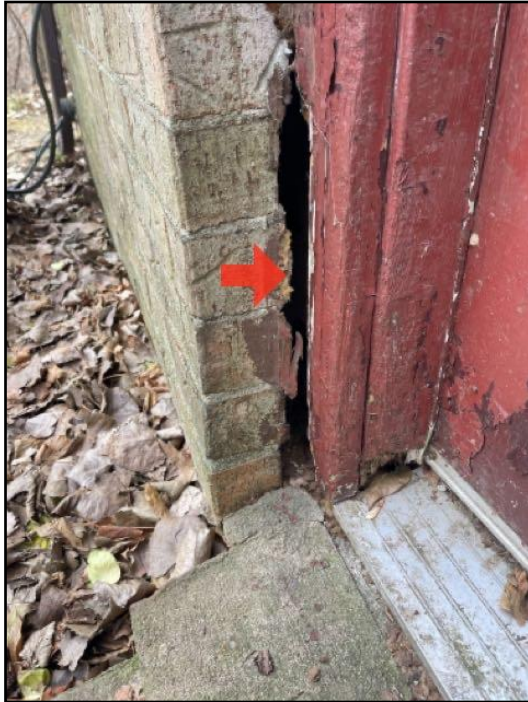
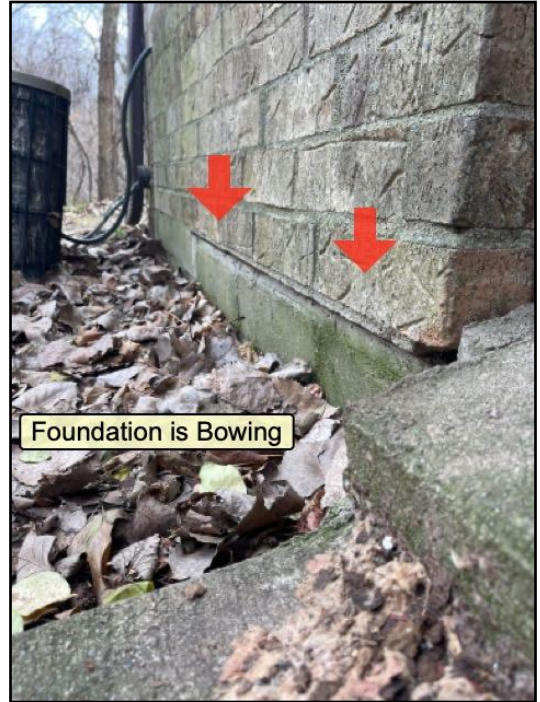
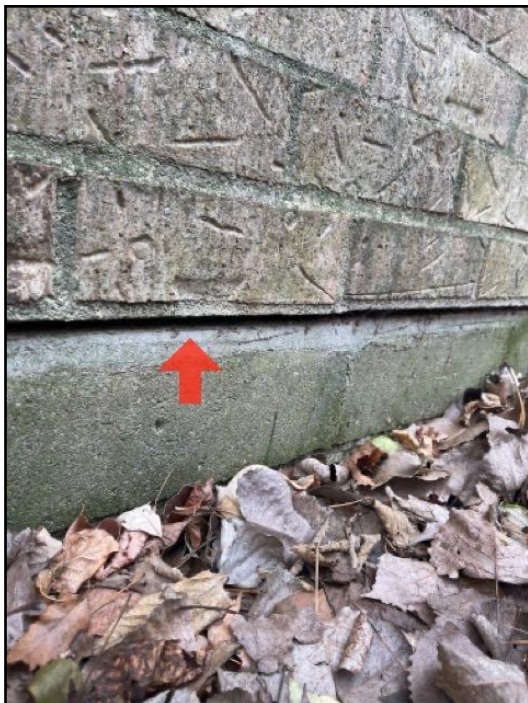
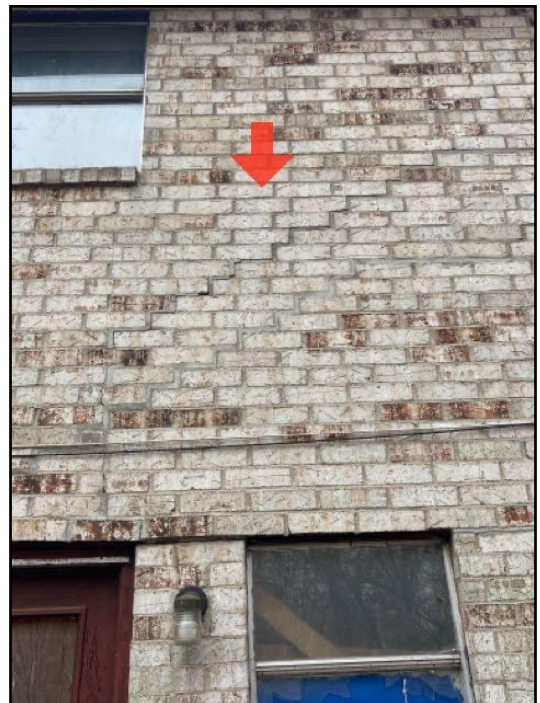
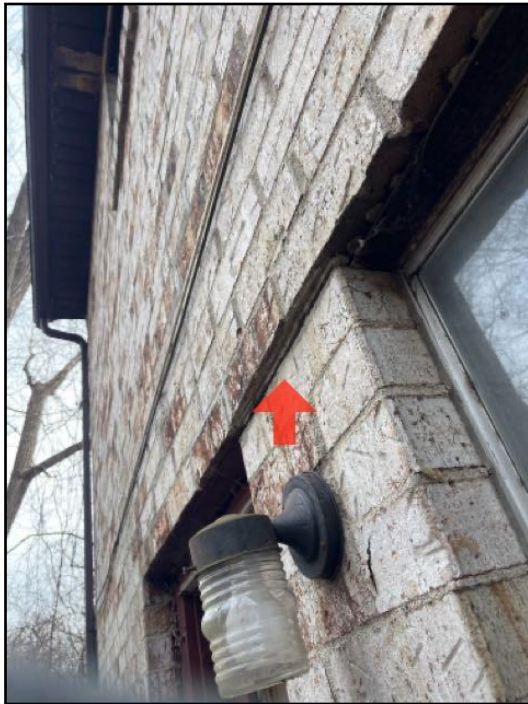
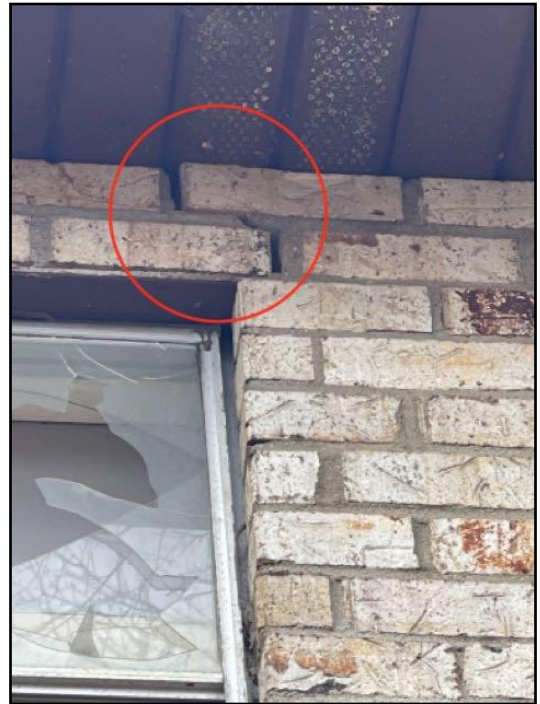
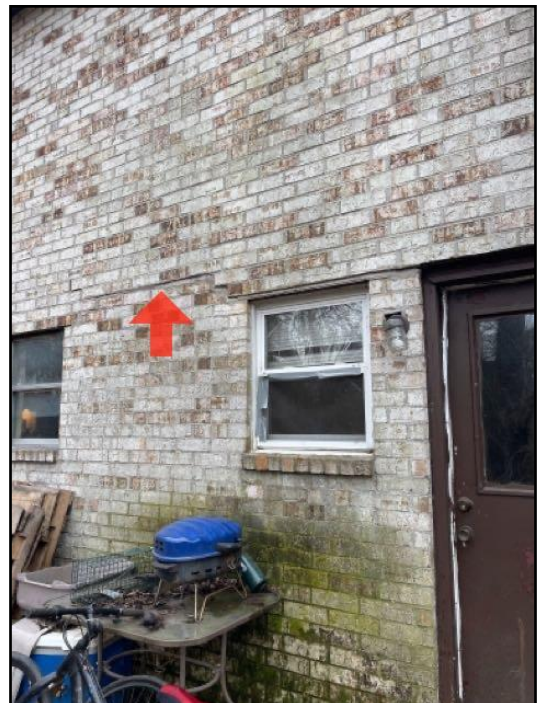
92. Cracked - settlement

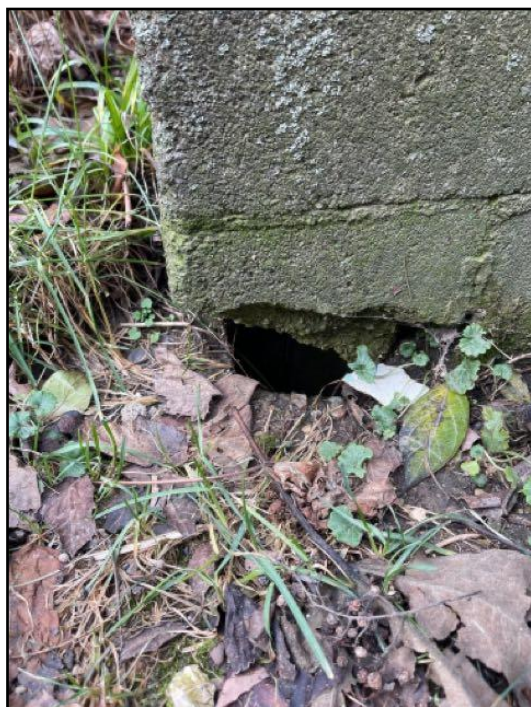
48. Condition: • Surface deterioration (spalling, crumbling material) was observed on the masonry. This condition is caused by water intrusion entering behind the material. It does not usually represent a serious structural concern unless there is substantial loss of material. In an effort to prevent long term deterioration, the recommendation would be to

100. Surface deterioration (spalling, crumbling...

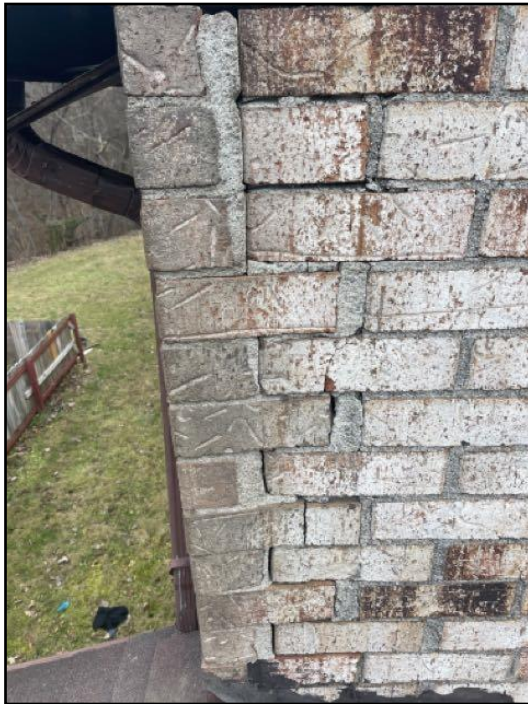
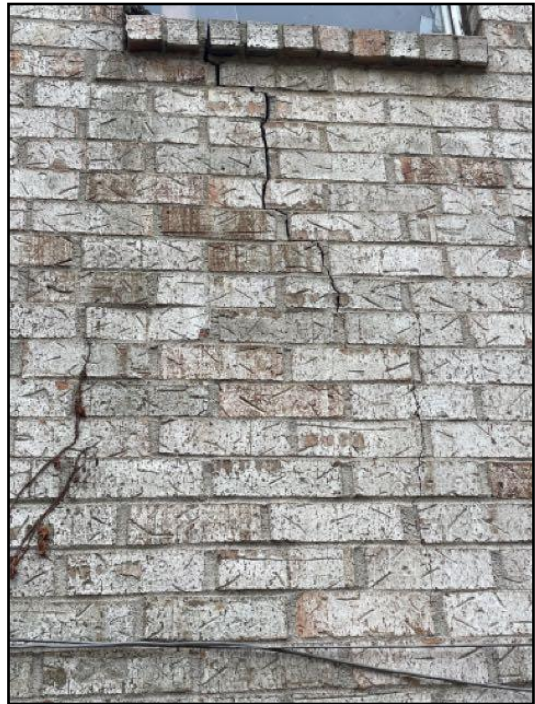
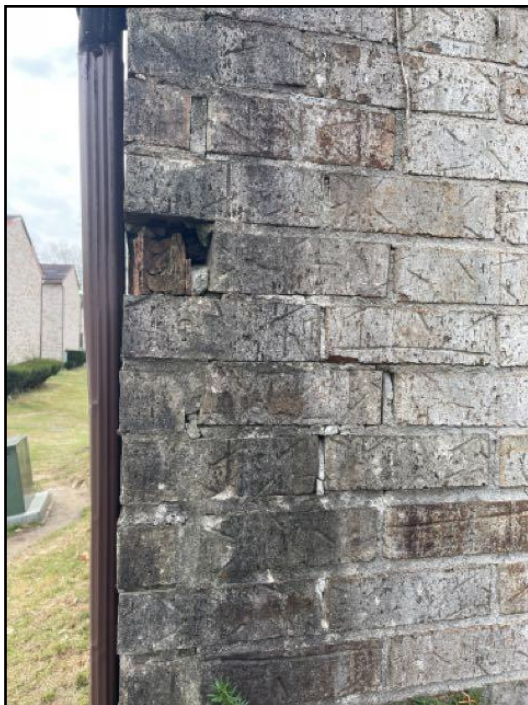
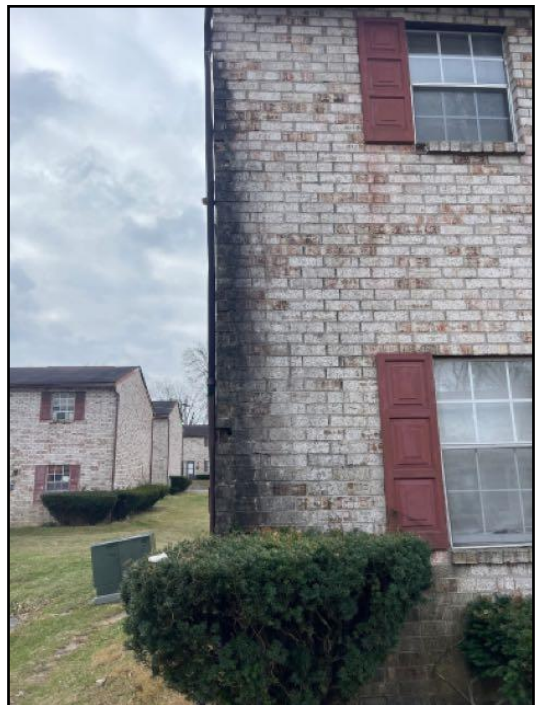
103. Mortar deterioration

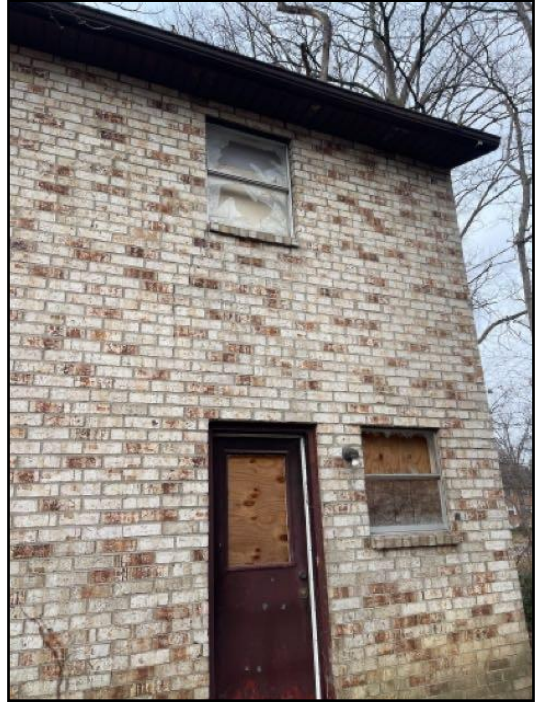
108. Cracked - settlement

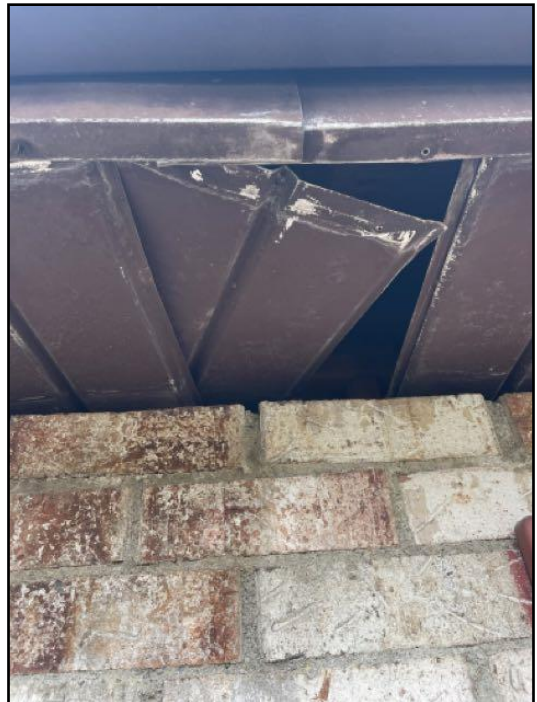
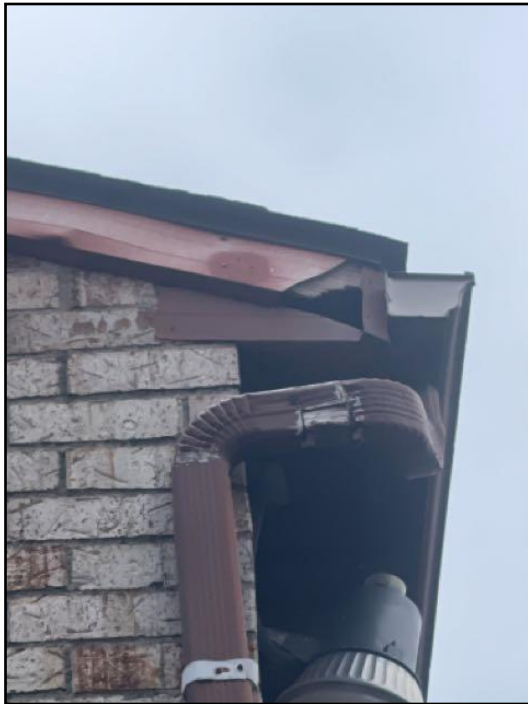
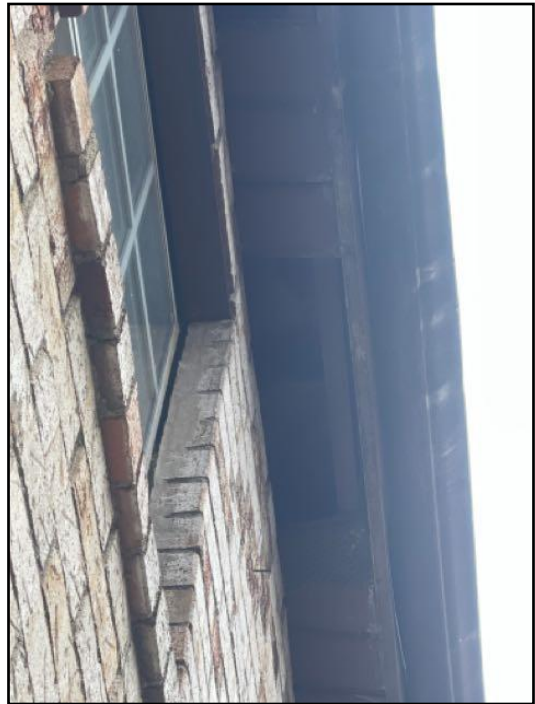
111. Siding has minor damage. Any opening should...

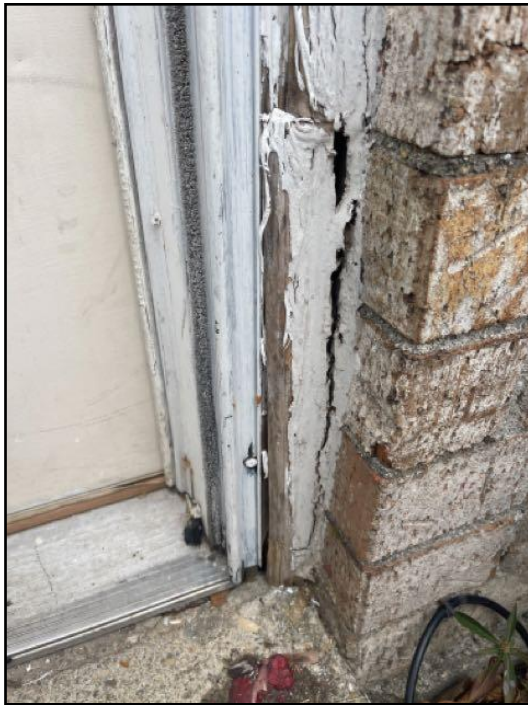
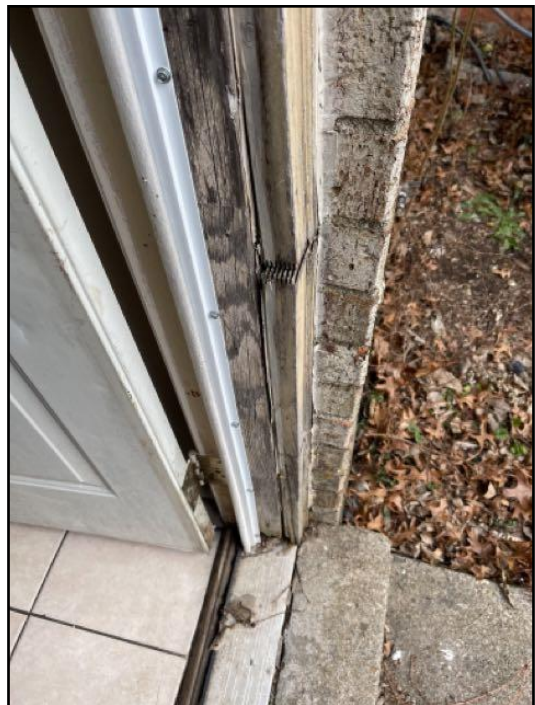
121. Rotted

Task: Replace

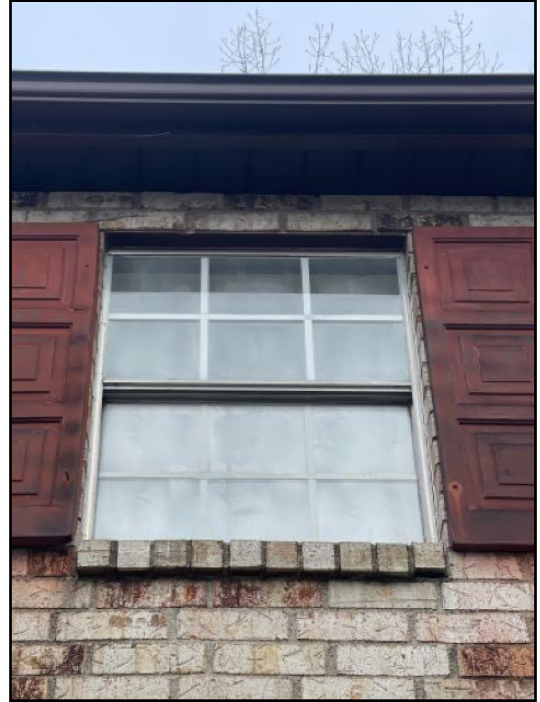
130. Lost seal; formation of condensation between...

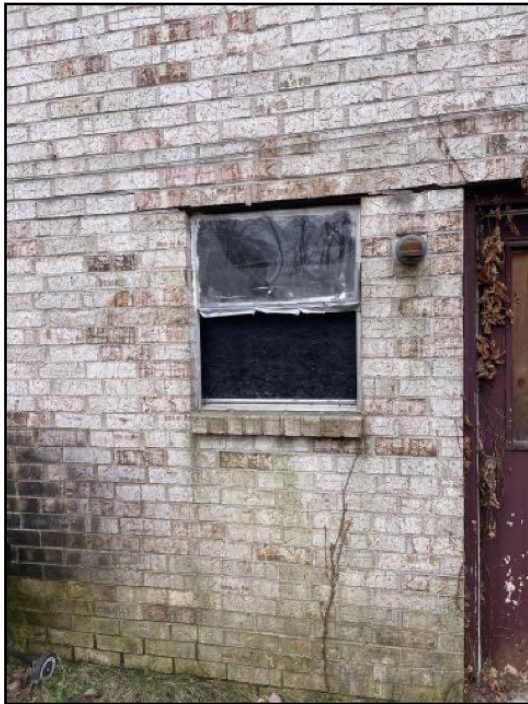
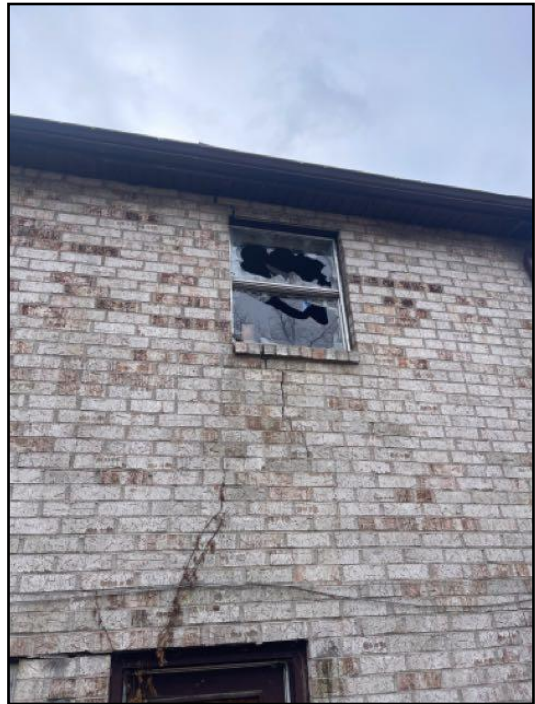
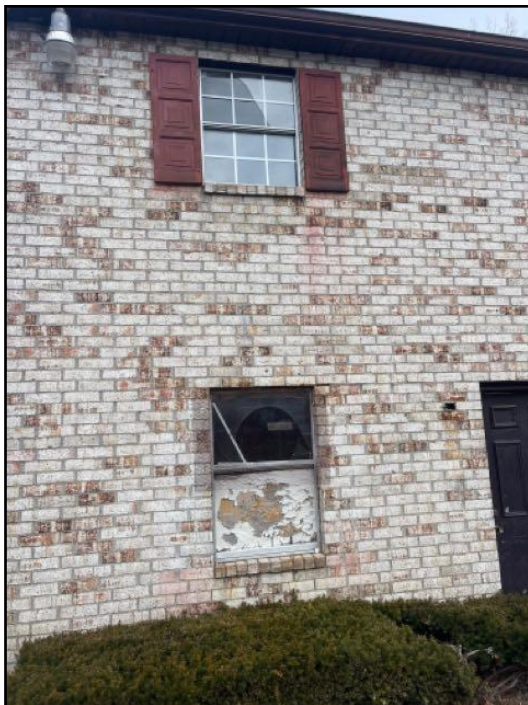
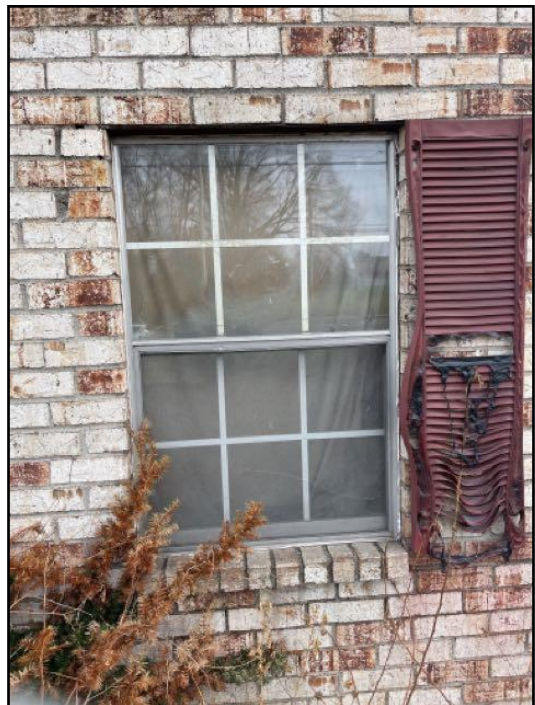
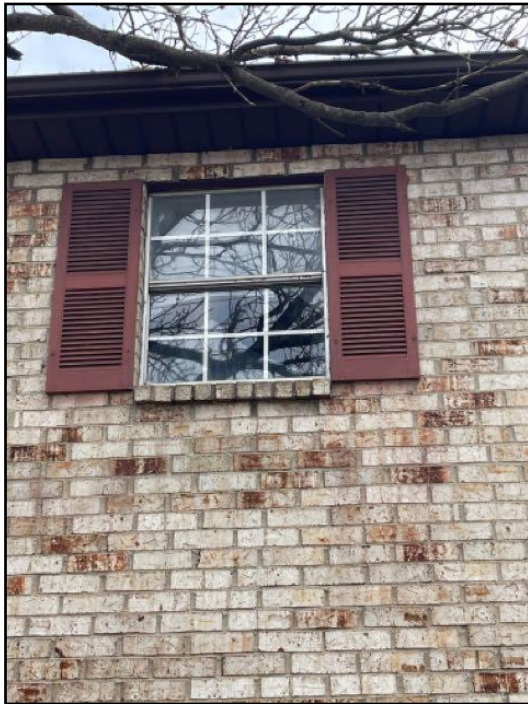
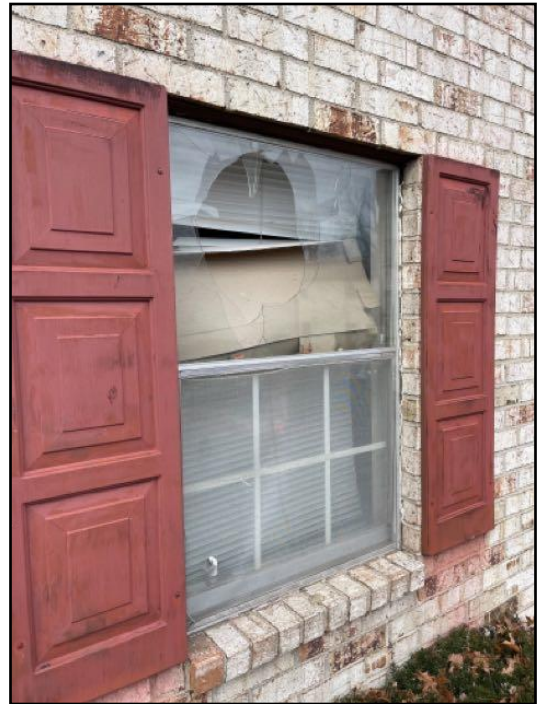
58. Condition: • The window will cause loss of energy efficiency and could cause physical injury. I recommend contacting a qualified contractor to make the necessary repairs.

131. The window will cause loss of energy...

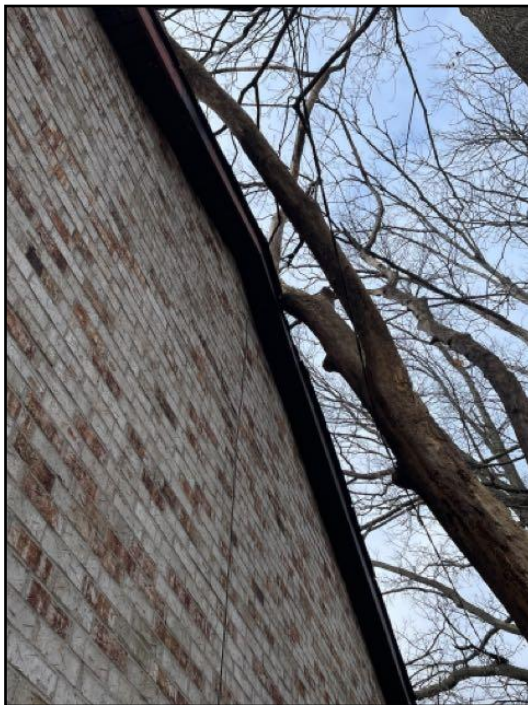
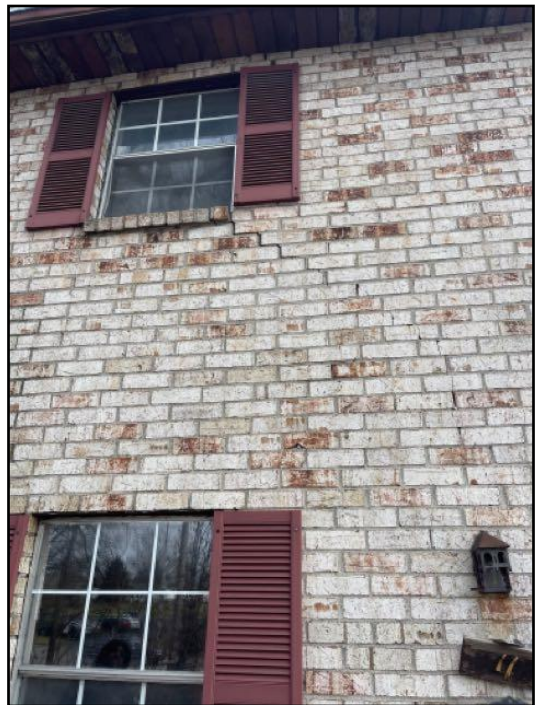
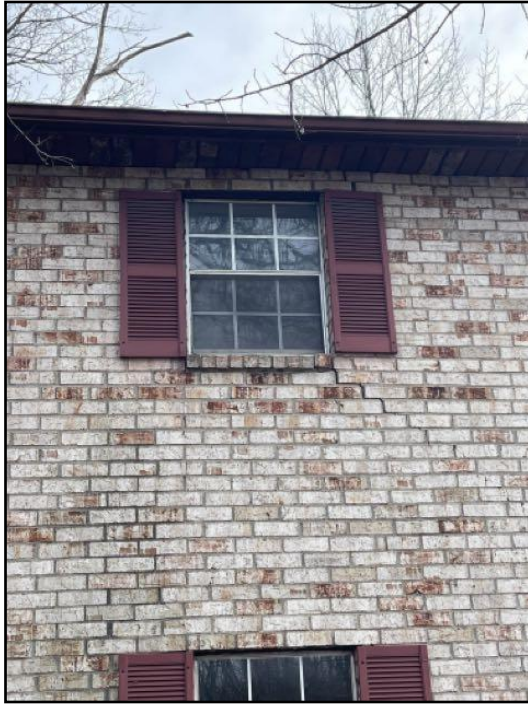
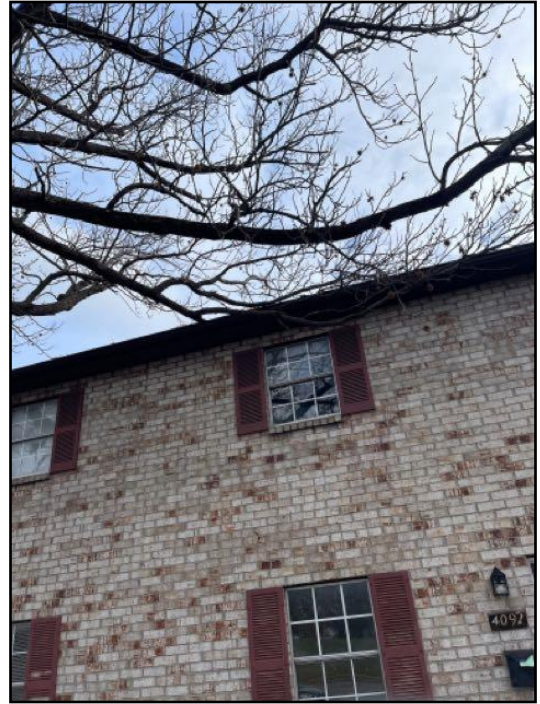
137. I recommend all vegetation be cut back from...

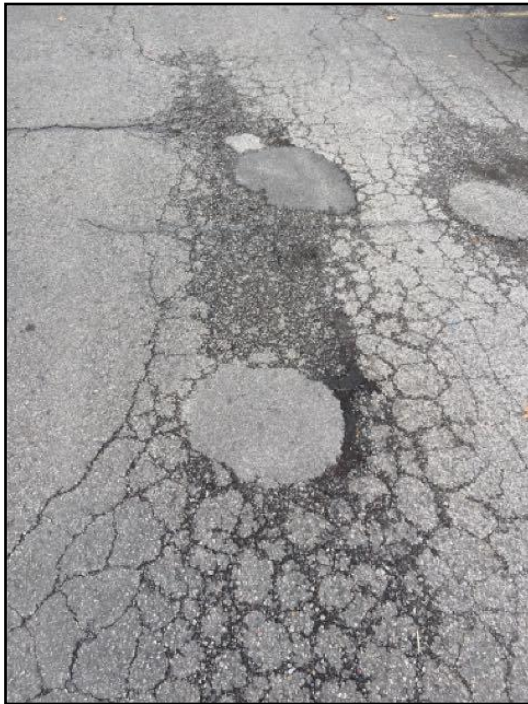
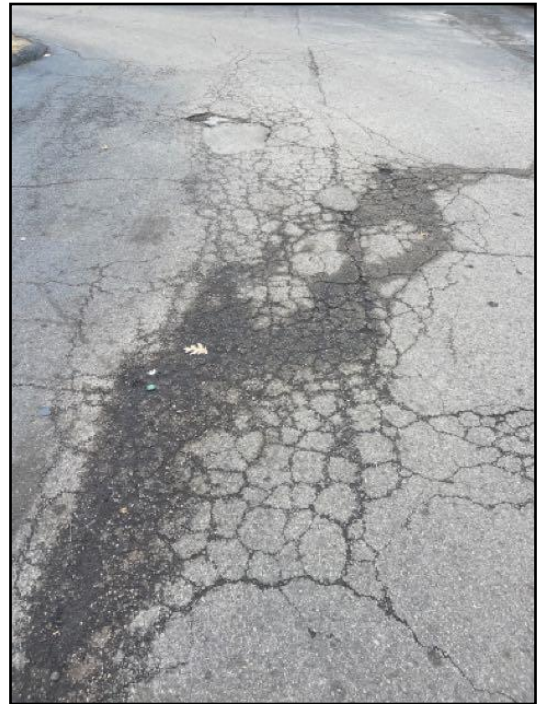
148. Cracking
