WOOD DESTROYING PESTS AND ORGANISMS INSPECTION REPORT

BUILDING NO. 61	STREET, CITY, STATE, ZIP Main St , Isleton CA 95641	Date of Inspection 10/23/2023	No. of Pages 7
  <div style="display: inline-block; vertical-align: middle; margin-left: 20px;"> <p>2450 Armstrong Street Livermore, CA 94551 Tel: (925) 724-9433 Email: bros.reports@gmail.com www.brothersinspections.com</p> </div>			
Firm Registration No. PR 7778	Report No. 19307	Escrow No.	
Ordered By: Compass 900 Main Street Pleasanton, CA 94566 Attn: Kris Moxley (925) 519-9080	Property Owner/Party of Interest Owner of Record 61 Main St Isleton, CA 95641	Report Sent To: Compass 900 Main Street Pleasanton, CA 94566 Attn: Kris Moxley (925) 519-9080	
COMPLETE REPORT <input checked="" type="checkbox"/> LIMITED REPORT <input type="checkbox"/> SUPPLEMENTAL REPORT <input type="checkbox"/> REINSPECTION REPORT <input type="checkbox"/>			
General Description: Commercial. One story brick building.		Inspection Tag Posted: Garage

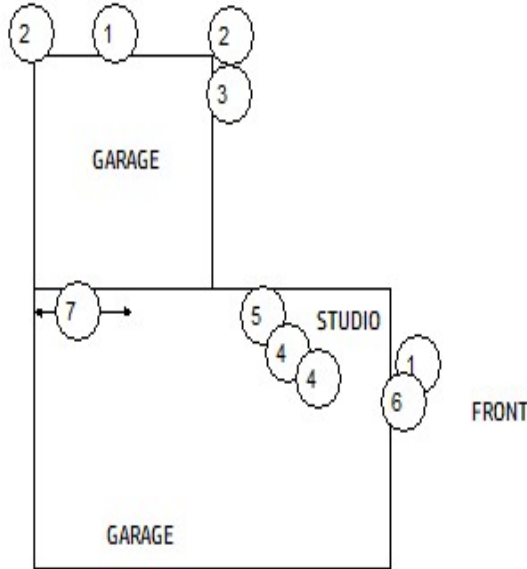
NOTE : DIAGRAM IS DISPLAYED ON PAGE 2

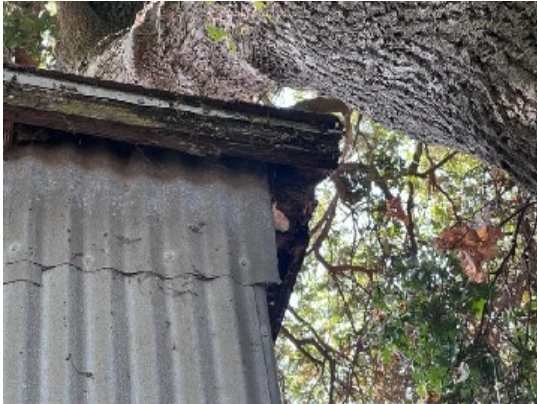
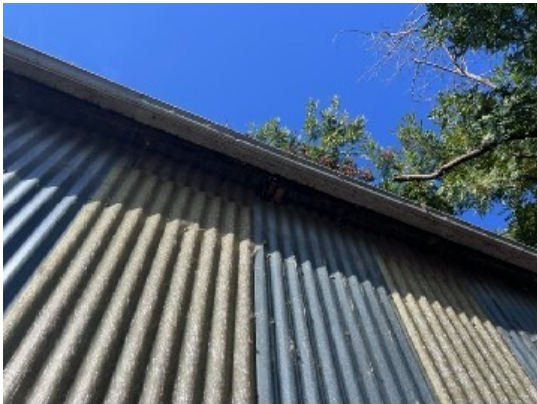
***** This is a Section 2 Item *****
- ITEM 2 FINDING: The rafter and fascia has been damaged by fungus at the area indicated on the diagram.
- RECOMMENDATION: Remove and replace all damaged wood members. If the damage is found to extend into an inaccessible area a supplemental report will be issued with additional findings recommendations and bids. Paint to match as close as possible. No guarantees are made on color match.

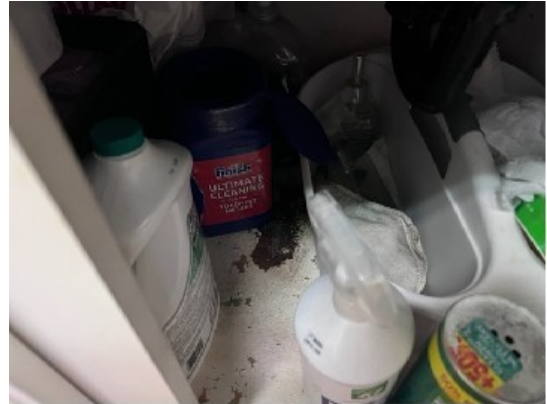
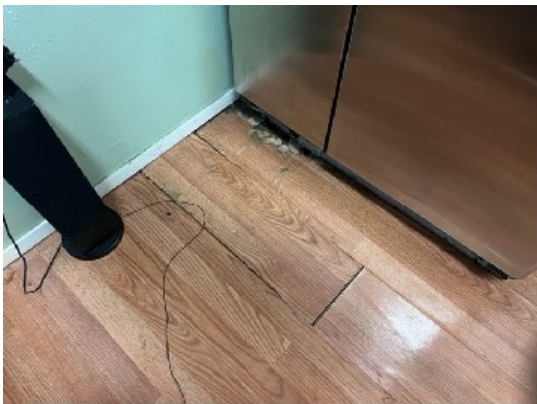
***** This is a Section 2 Item *****
- ITEM 4 FINDING: Fungus damage was noted to the flooring at the kitchen and bathroom in the studio area.
- RECOMMENDATION: The owner is advised to have the flooring replaced.

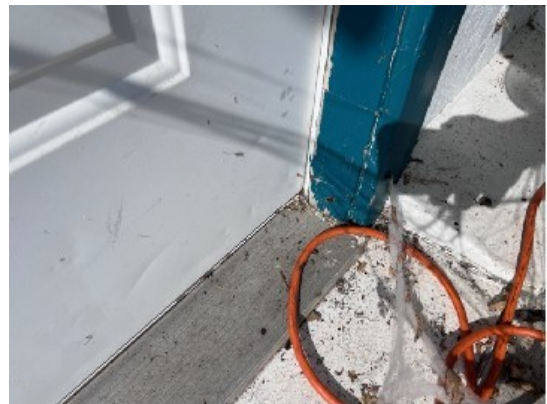
***** This is a Section 1 Item *****
- ITEM 6 FINDING: The door jamb has been damaged by fungus at the area indicated on the diagram.
- RECOMMENDATION: Remove and replace all damaged wood members. If the damage is found to extend into an inaccessible area a supplemental report will be issued with additional findings recommendations and bids. Paint to match as close as possible. No guarantees are made on color match.
