**STOREHOUSE
PHASE I SITE
ASSESSMENT**

PHASE I ENVIRONMENTAL SITE ASSESSMENT

Former Central State Storehouse
3302 Kirkbride Way
Indianapolis, Marion County, Indiana

December 13, 2023

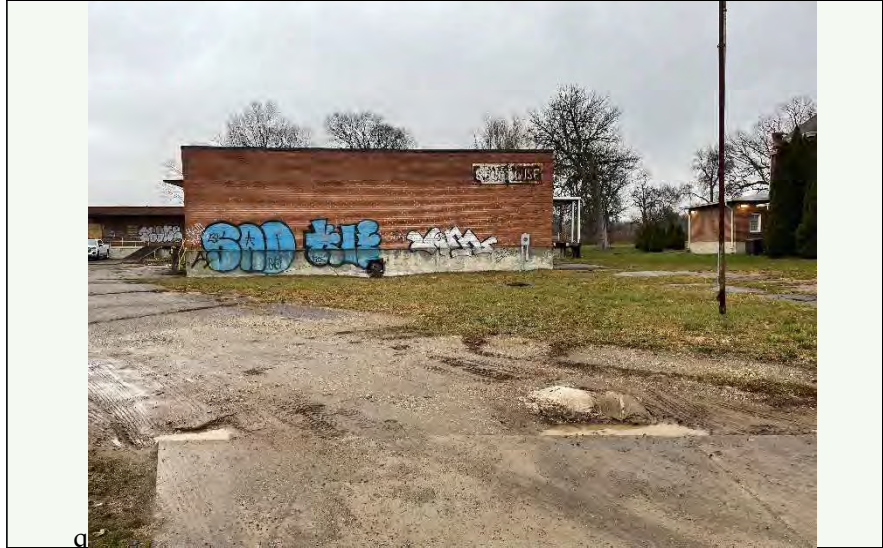
Photo 1

View of the southern portion of the subject property building, facing north

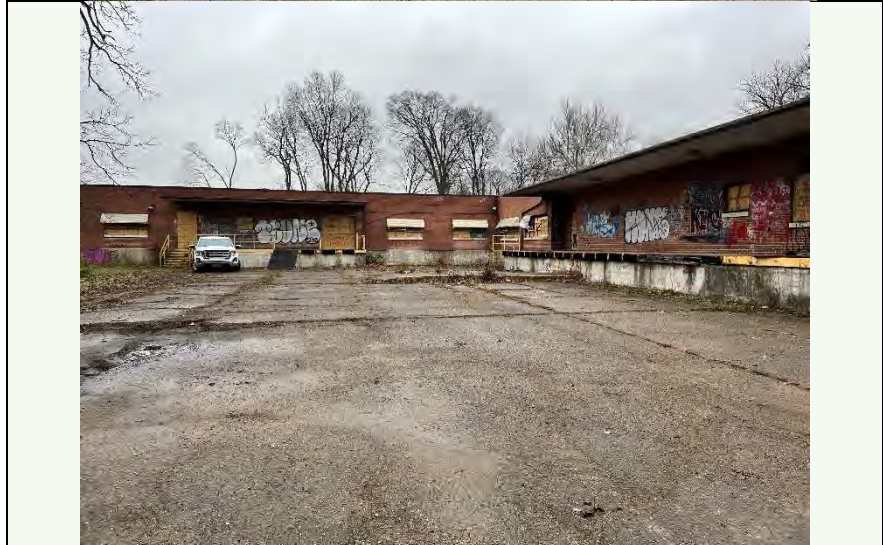
Photo 2

View of the loading dock portion of the subject property building, facing north

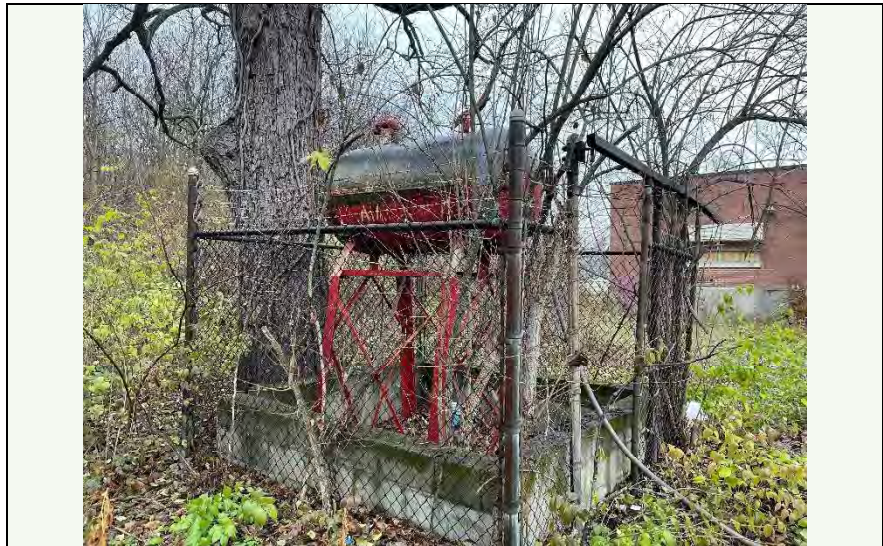
Photo 8

- concentrations in soil present at the Central State Hospital, and subsequent ERC restricting groundwater use is considered a CREC.
3. During site reconnaissance, a 500-gallon AST was observed on the west side of the parking lot, in a concrete berm surrounded by barbed wire and chain link fence. According to a Phase I ESA conducted by Keramida in 2007, the AST previously contained gasoline.

- The AST and its reported contents of petroleum products is considered a REC.
 4. Floor drains were observed throughout the interior of the subject property.

View of AST located on the western portion of the subject property

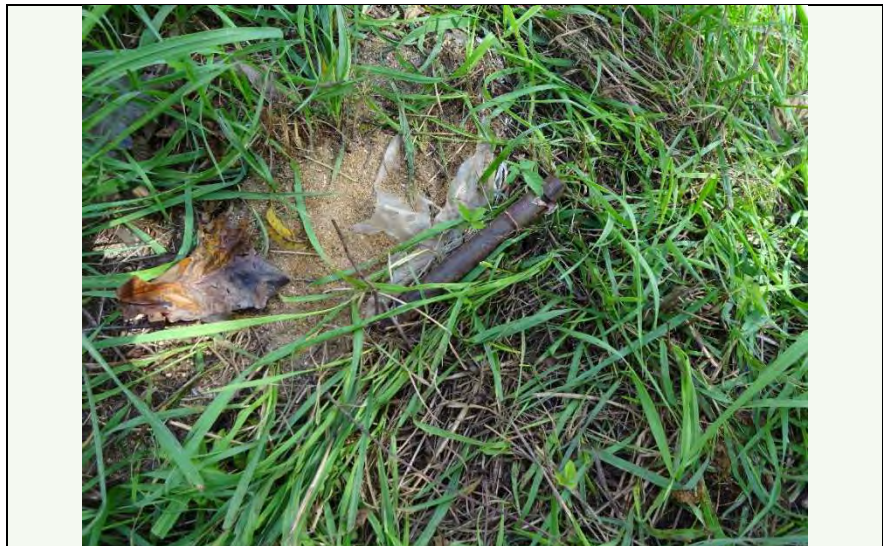
Photo 9

Common indicators of USTs, such as fill ports, vent pipes or dispensers, were not observed on the property during site reconnaissance. A UST was removed prior to 2003, confirmed by investigations conducted by Keramida which could not locate the UST during a geophysical

View of metal conduit observed near the location of the former UST, likely from a former fuel dispenser

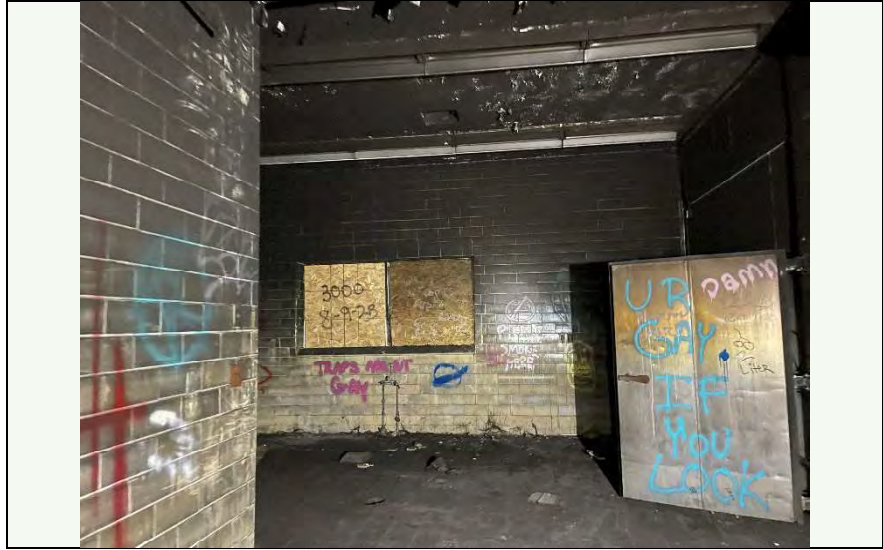
Photo 10

Signs of vagrants were observed. Several fires occurred throughout the building, with fire damage, ceiling collapse, and soot observed. Electrical equipment was observed in the basement, with a motor inside a containment and numerous connected pipes. Various light fixtures, both troffer style fluorescent lamp and metal halide style, which may be affixed with PCB-bearing ballasts were observed throughout the building, along with exit signs, thermostats, electrical panels, and electrical switches. Paint in poor condition from the fires was observed, and based on the age of construction, may contain lead. Asbestos containing pipe wrap was observed throughout the building and in noticeably poor condition. Additionally, other suspect ACM, in the form of resilient floorings, ceiling tiles, and mastics were observed. Further description of the subject property is provided in **Section 5.0**.

View inside the building,
soot and evidence of fire
visible

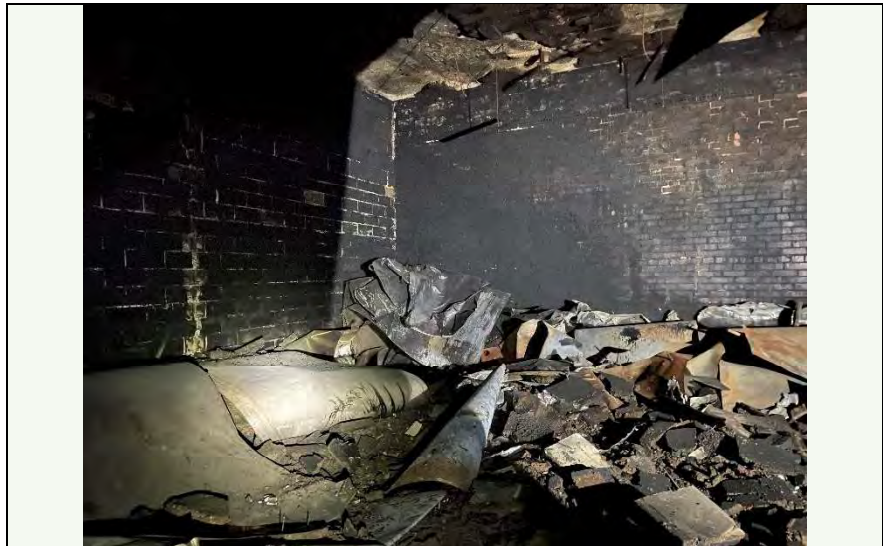
Photo 11

View of interior of the
building, with evidence of
fires observed

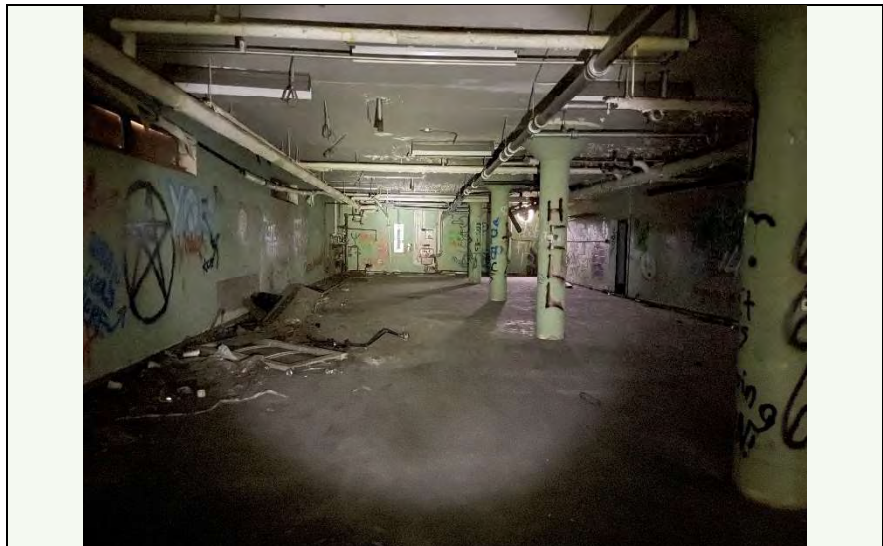
Photo 12

View inside the basement

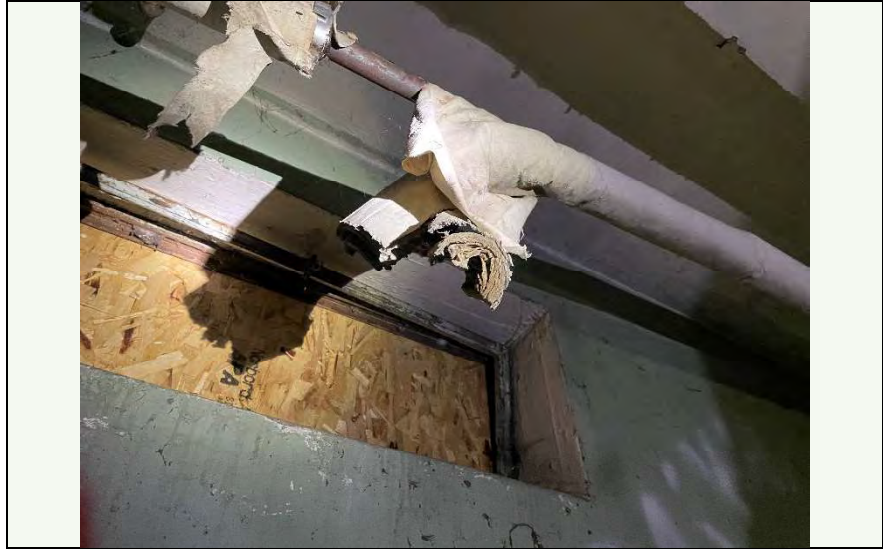
Photo 13

5. Deteriorating asbestos pipe insulation was observed throughout the building. Additional suspect asbestos containing materials (ACMs) were also observed throughout the building, including resilient floorings, ceiling tiles, and mastics. The presence of ACMs is a business environmental risk (BER).

View of deteriorating asbestos pipe insulation

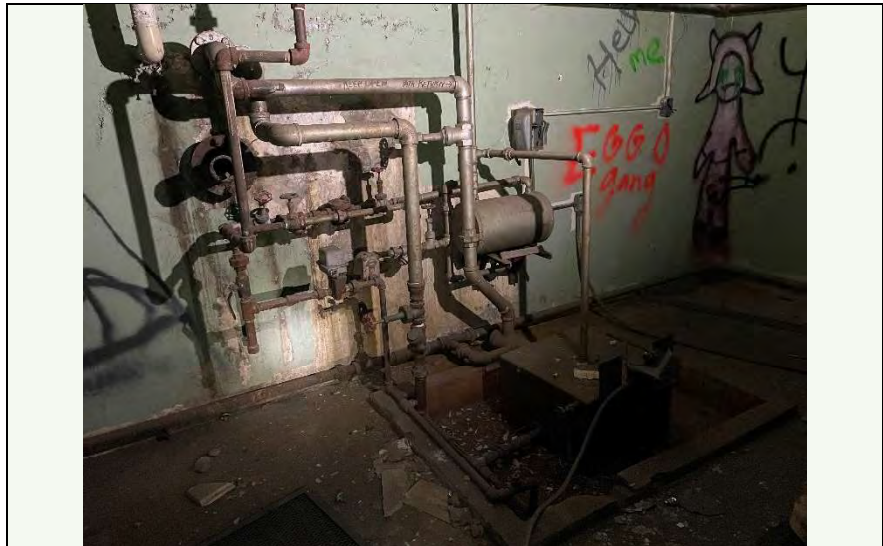
Photo 14

View of mechanical equipment within the basement

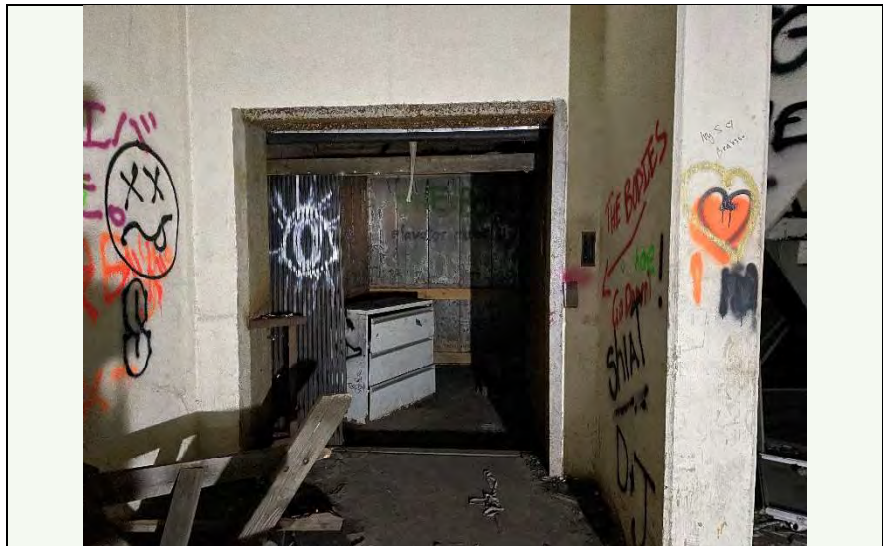
Photo 15

View of freight elevator connecting the basement and first floor
