# Diagnostic Inspection Report

DATE OF INSPECTION:	09/18/2024
JOB #:	57516640
CLIENT:	Spectrum Realty Services, LLC Attn: Bianca Vargas
HOMEOWNER'S NAME:	Minnie Street Apartments- Units 821, 823, & 831
PROPERTY INSPECTED:	821 Minnie Street Jacksonville, FL 32204
INSPECTION AND REPORT BY:	Austin Keen
LICENSE NUMBER:	CGC1522600/CFC1428610/HCI-R#202205016

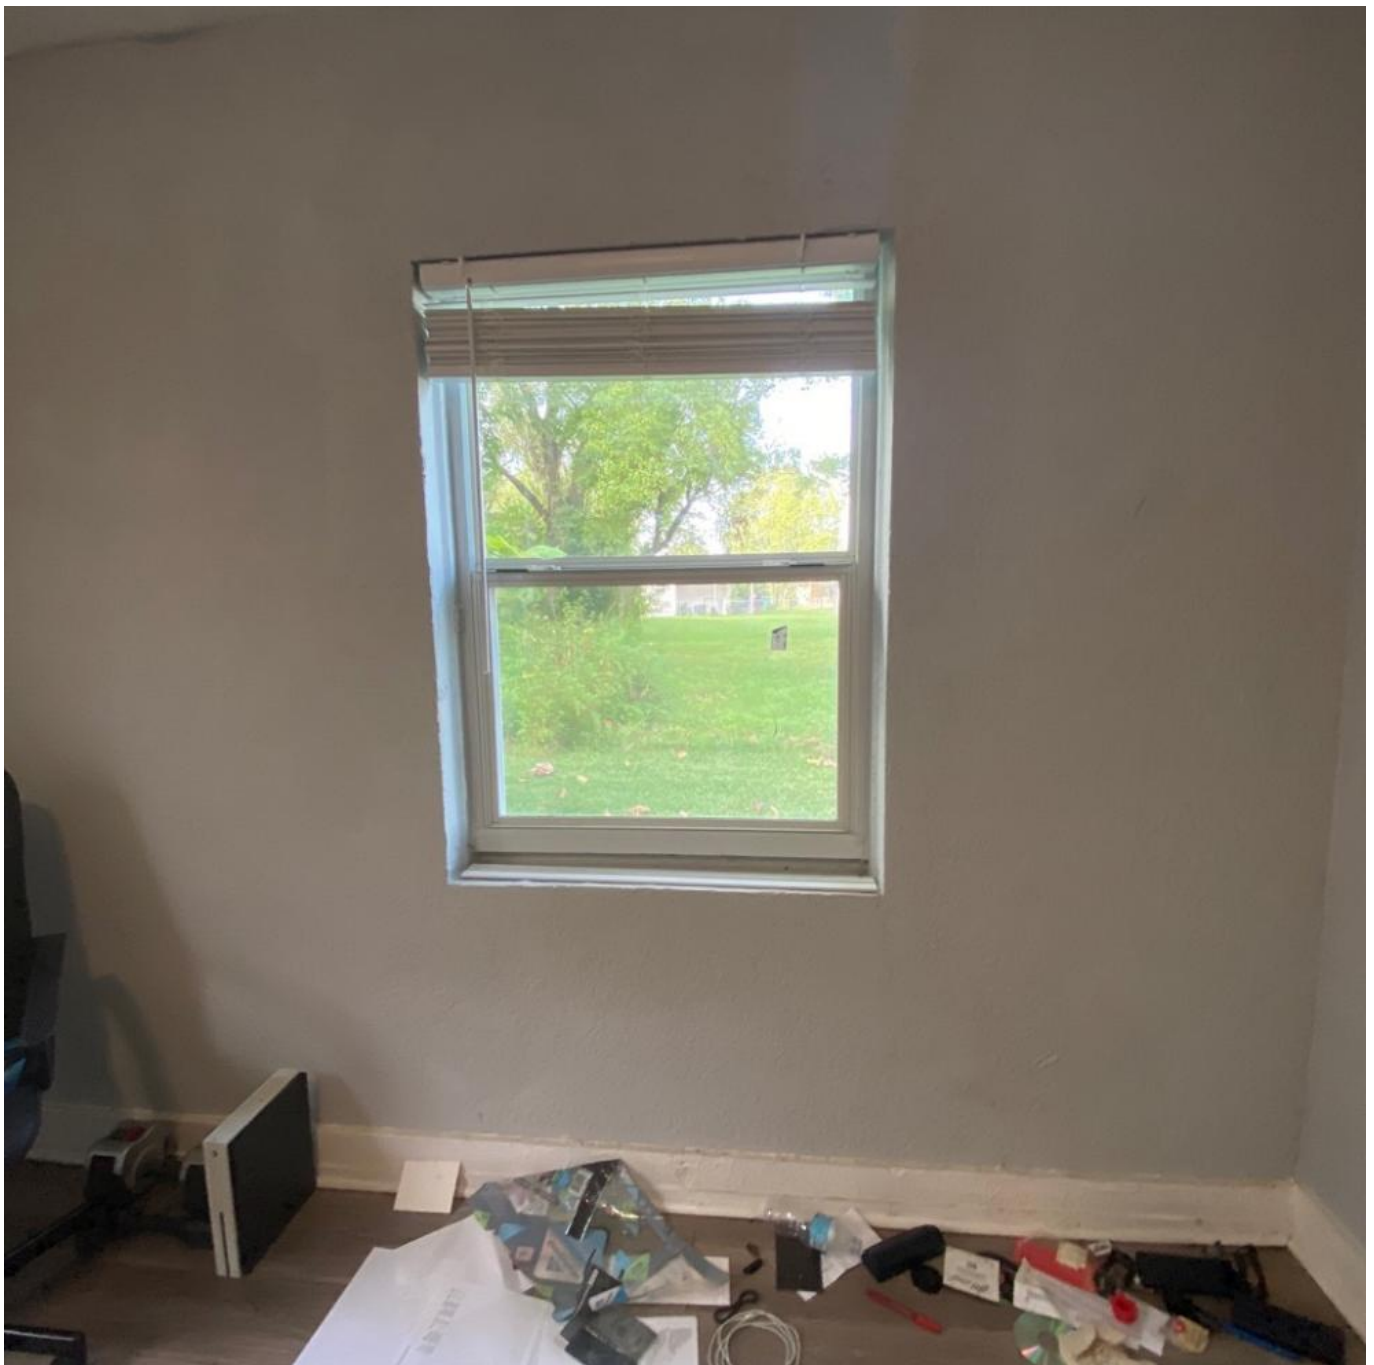
Overview of the affected window in the master bedroom of unit 821.

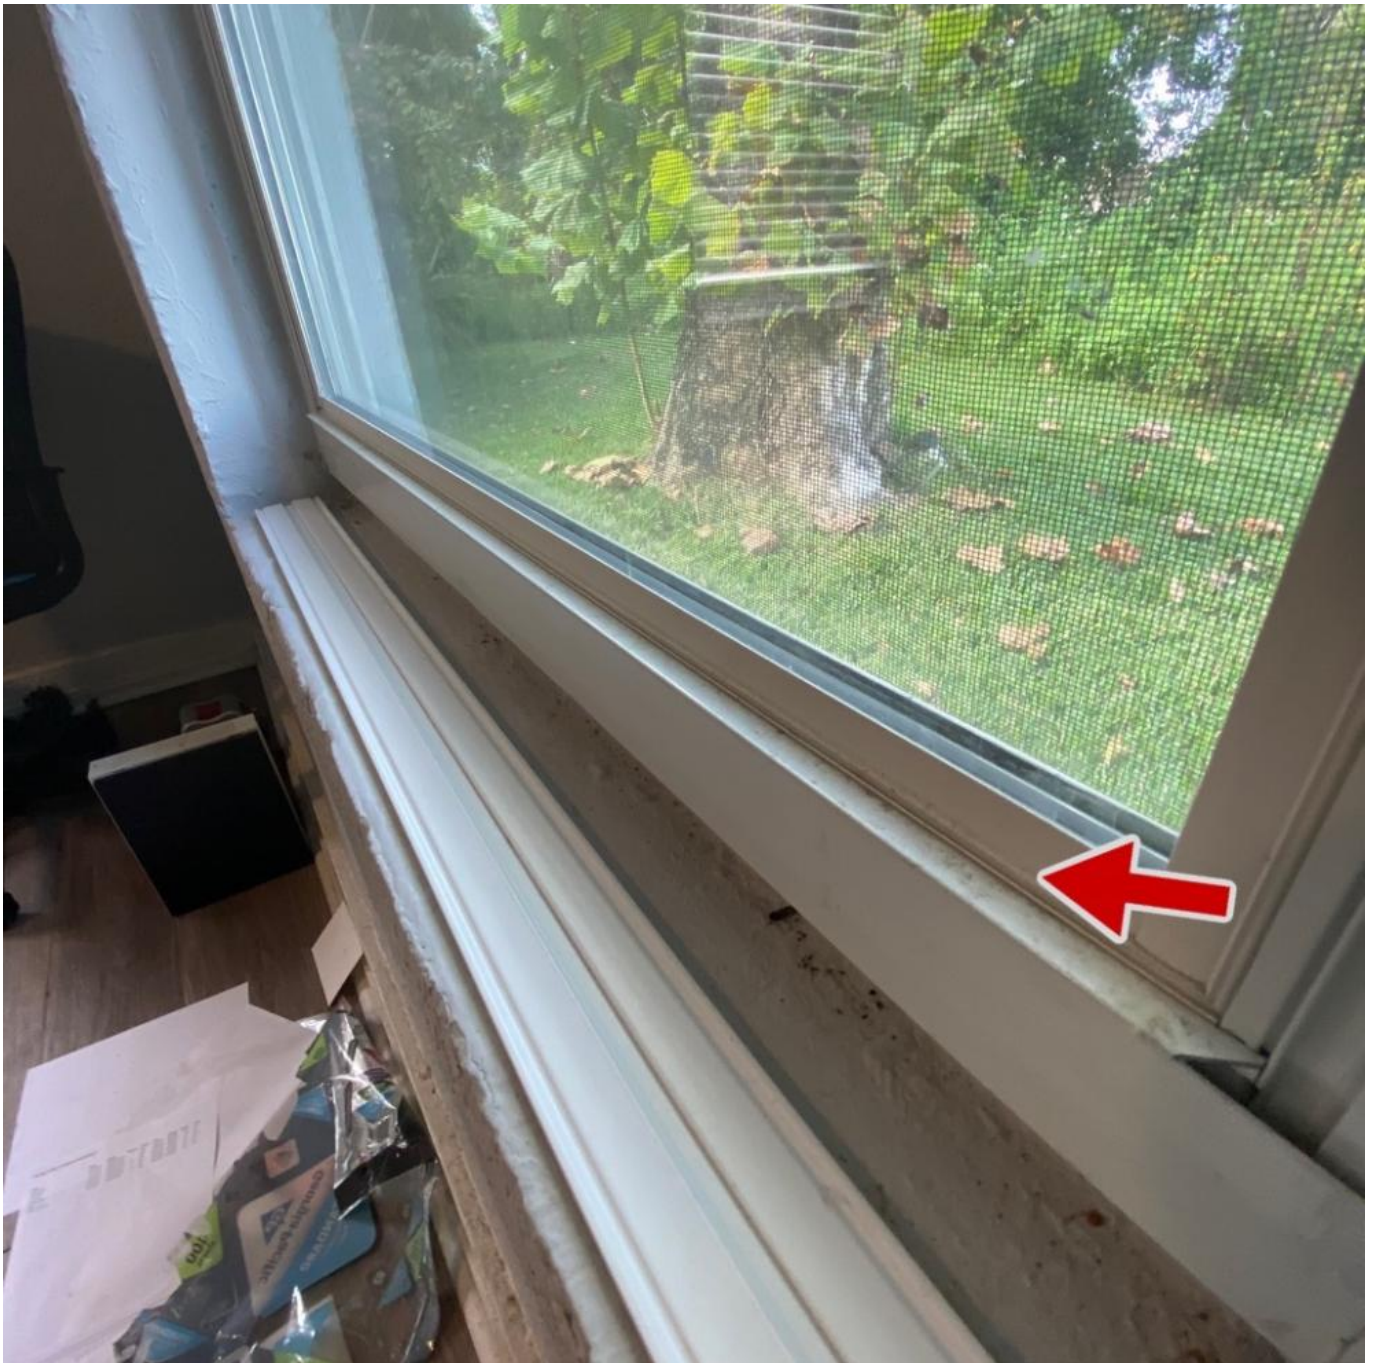
Suspected microbial growth observed around inside perimeter of the windows in unit 821.

1. The suspected microbial growth observed in all three units has been caused by warm air infiltration, leading to the formation of condensation on the aluminum window frames when the surface temperatures reach the Dew point, resulting in this loss.
2. The HVAC thermostats in the affected units were set at 80 degrees Fahrenheit. This temperature does not provide enough dehumidification, as the units are not in operation for an adequate period of time.
3. The pressure test of the potable water system confirmed there were no active pressurized potable water leaks at the time of our inspection.
4. No other issues were found to be contributing to this loss.

1. Maintain indoor relative humidity levels of 50 percent or less as recommended by industry standards.
2. Repair/replace the weatherstripping/windows to prevent warm air infiltration as per industry standards.

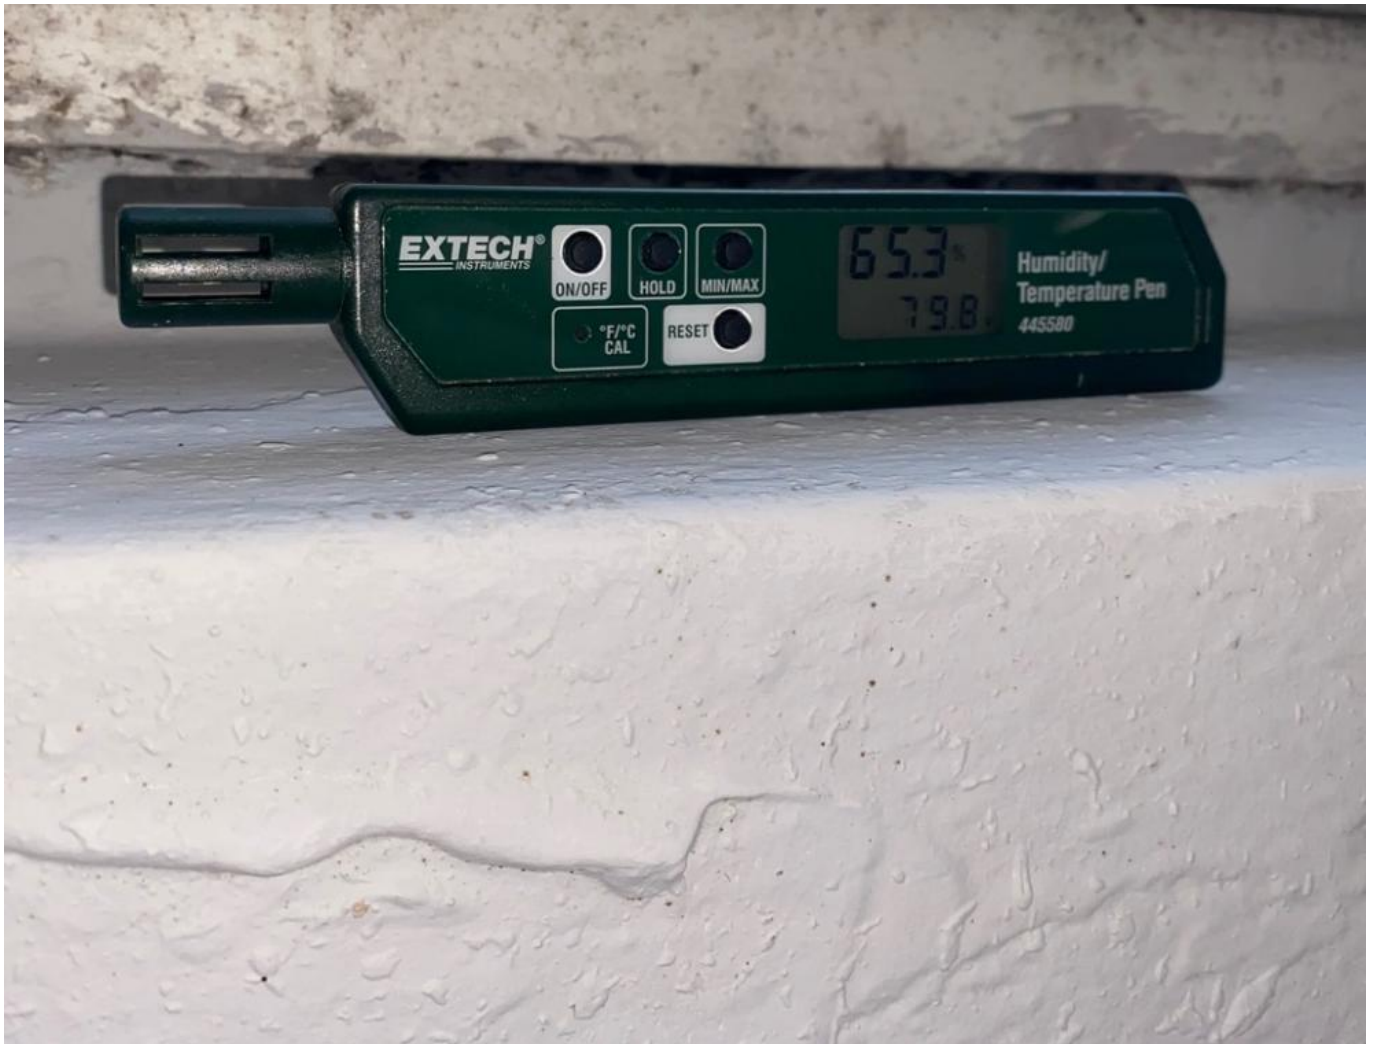
Elevated humidity levels were detected inside the master bedroom of unit 821.

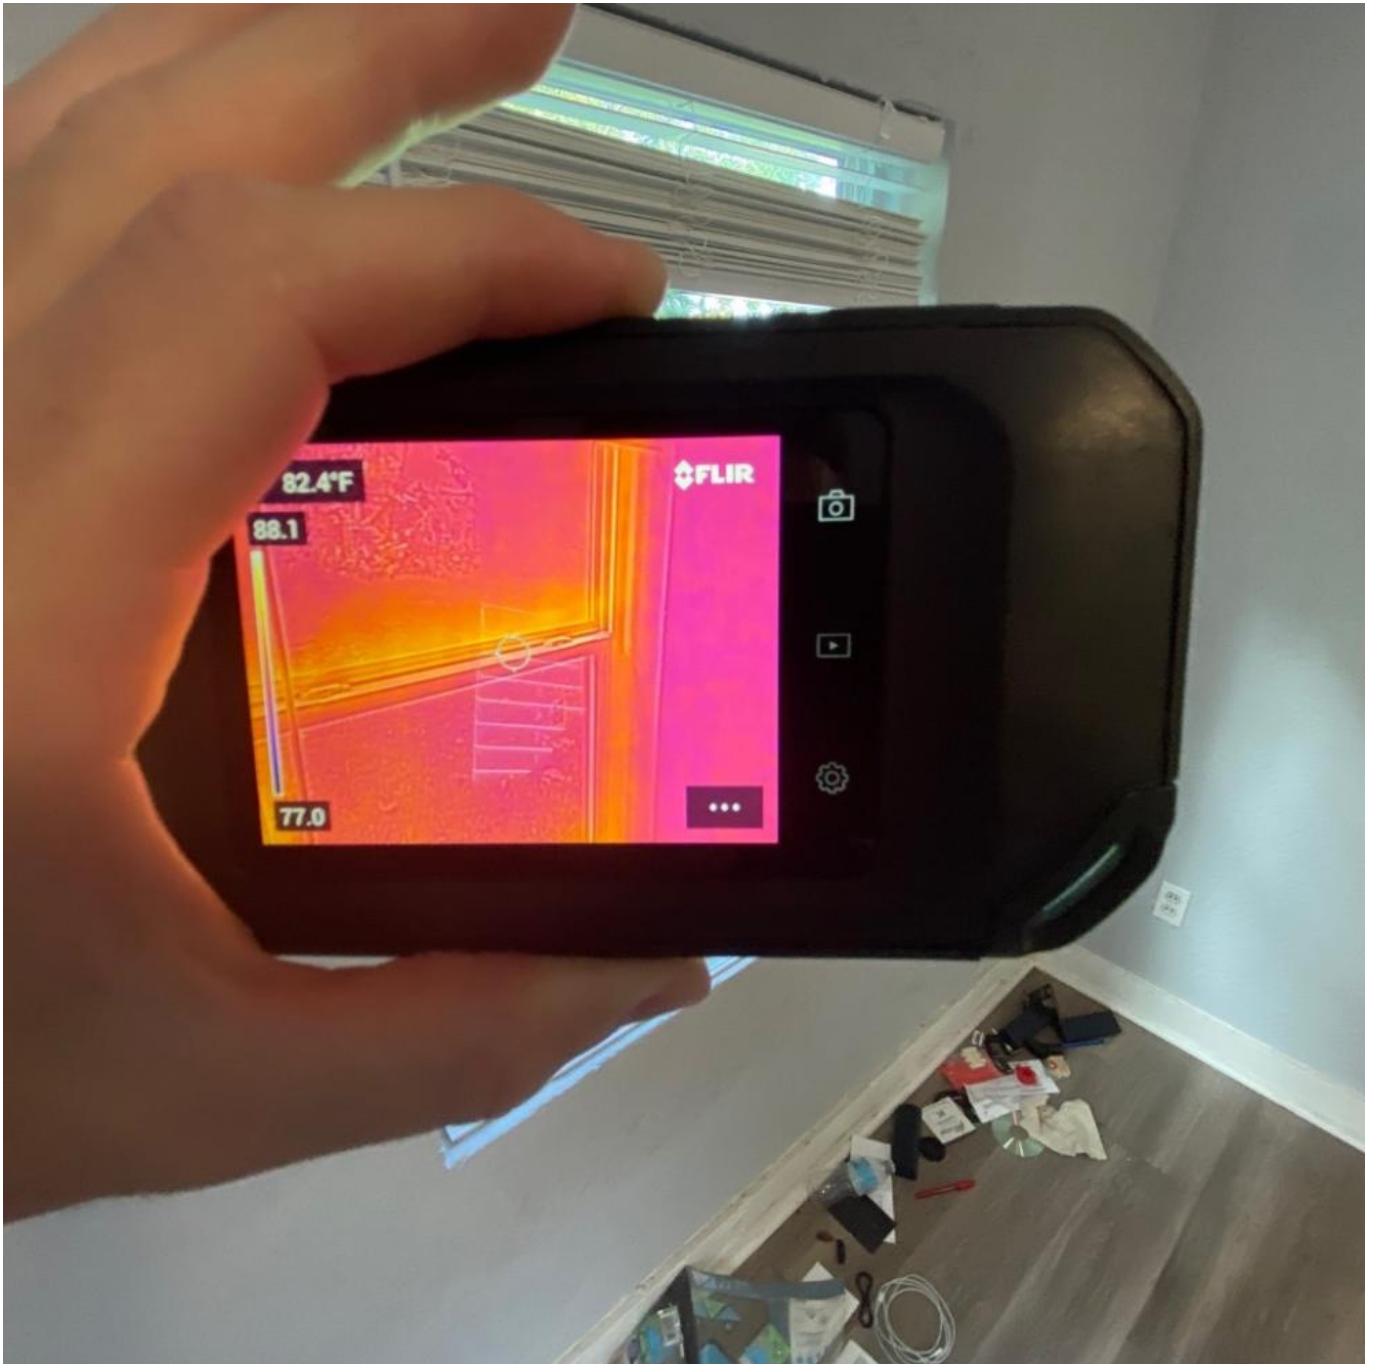
Infrared thermography revealed temperature variances (hot spots) around the perimeter of the master bedroom windows in unit 821.

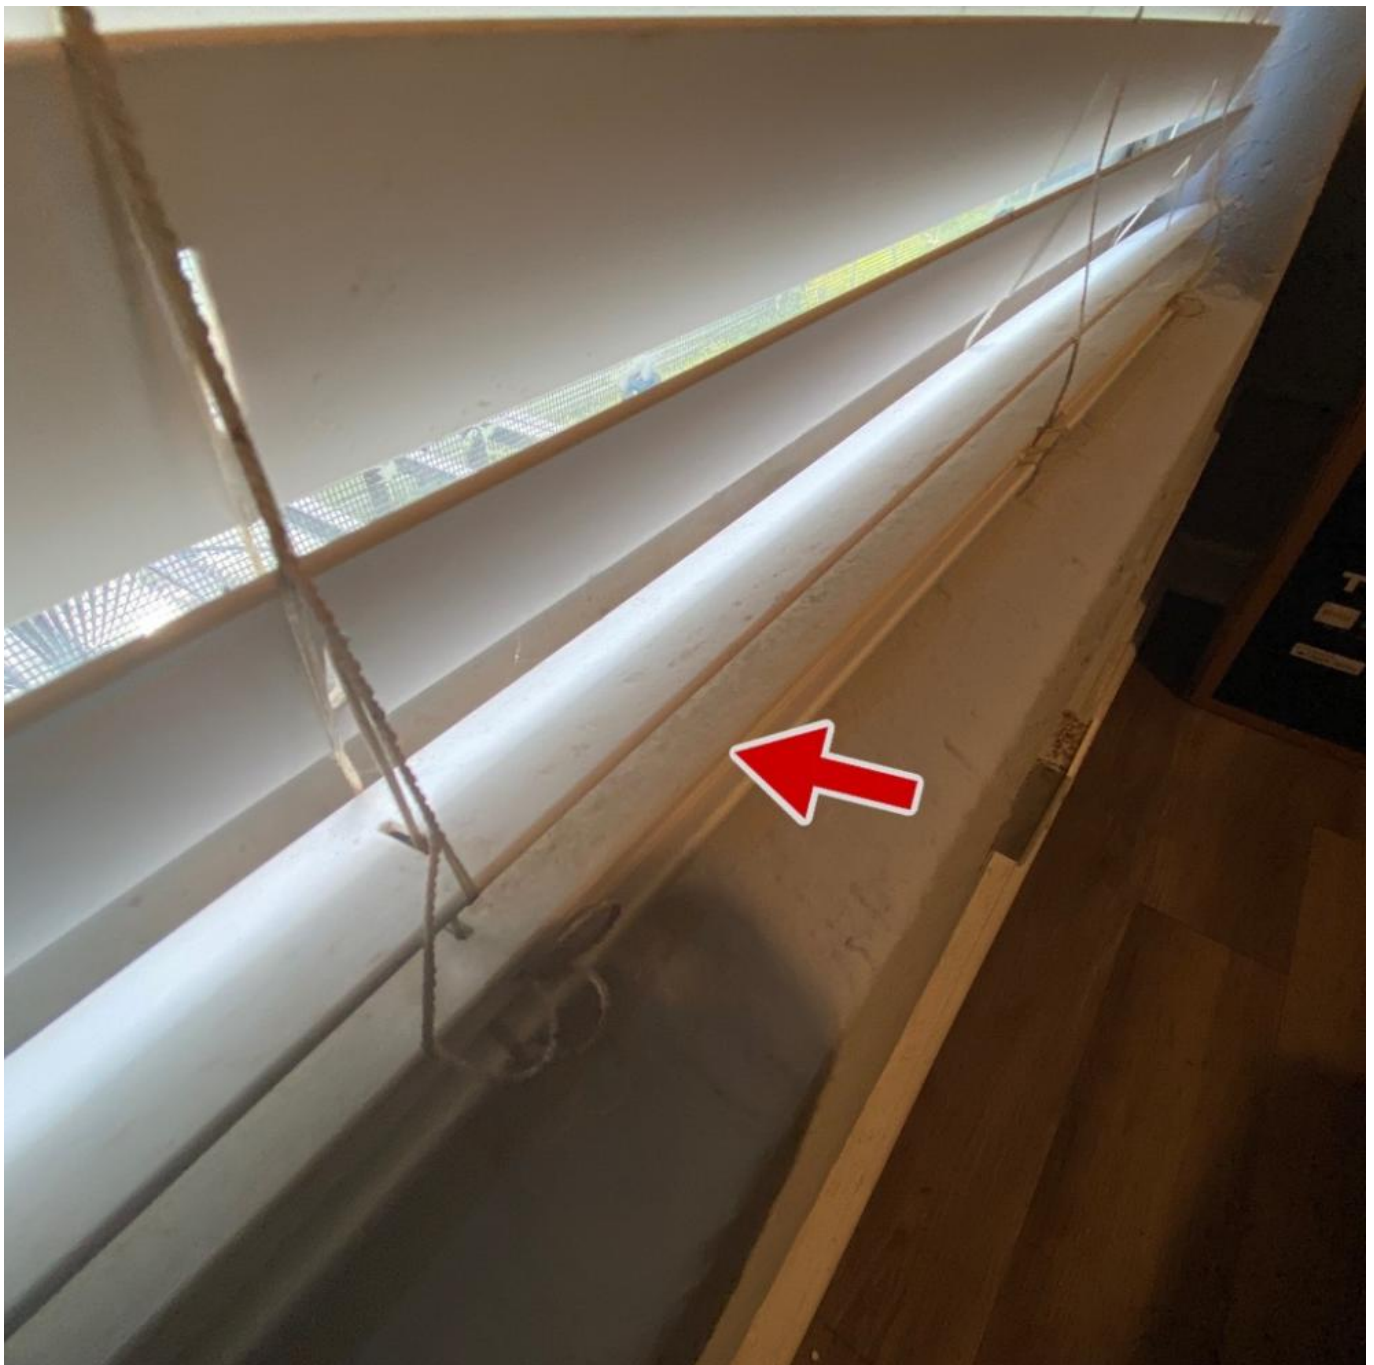
Suspected microbial growth was observed around the perimeter of the window in the guest bedroom of unit 823.

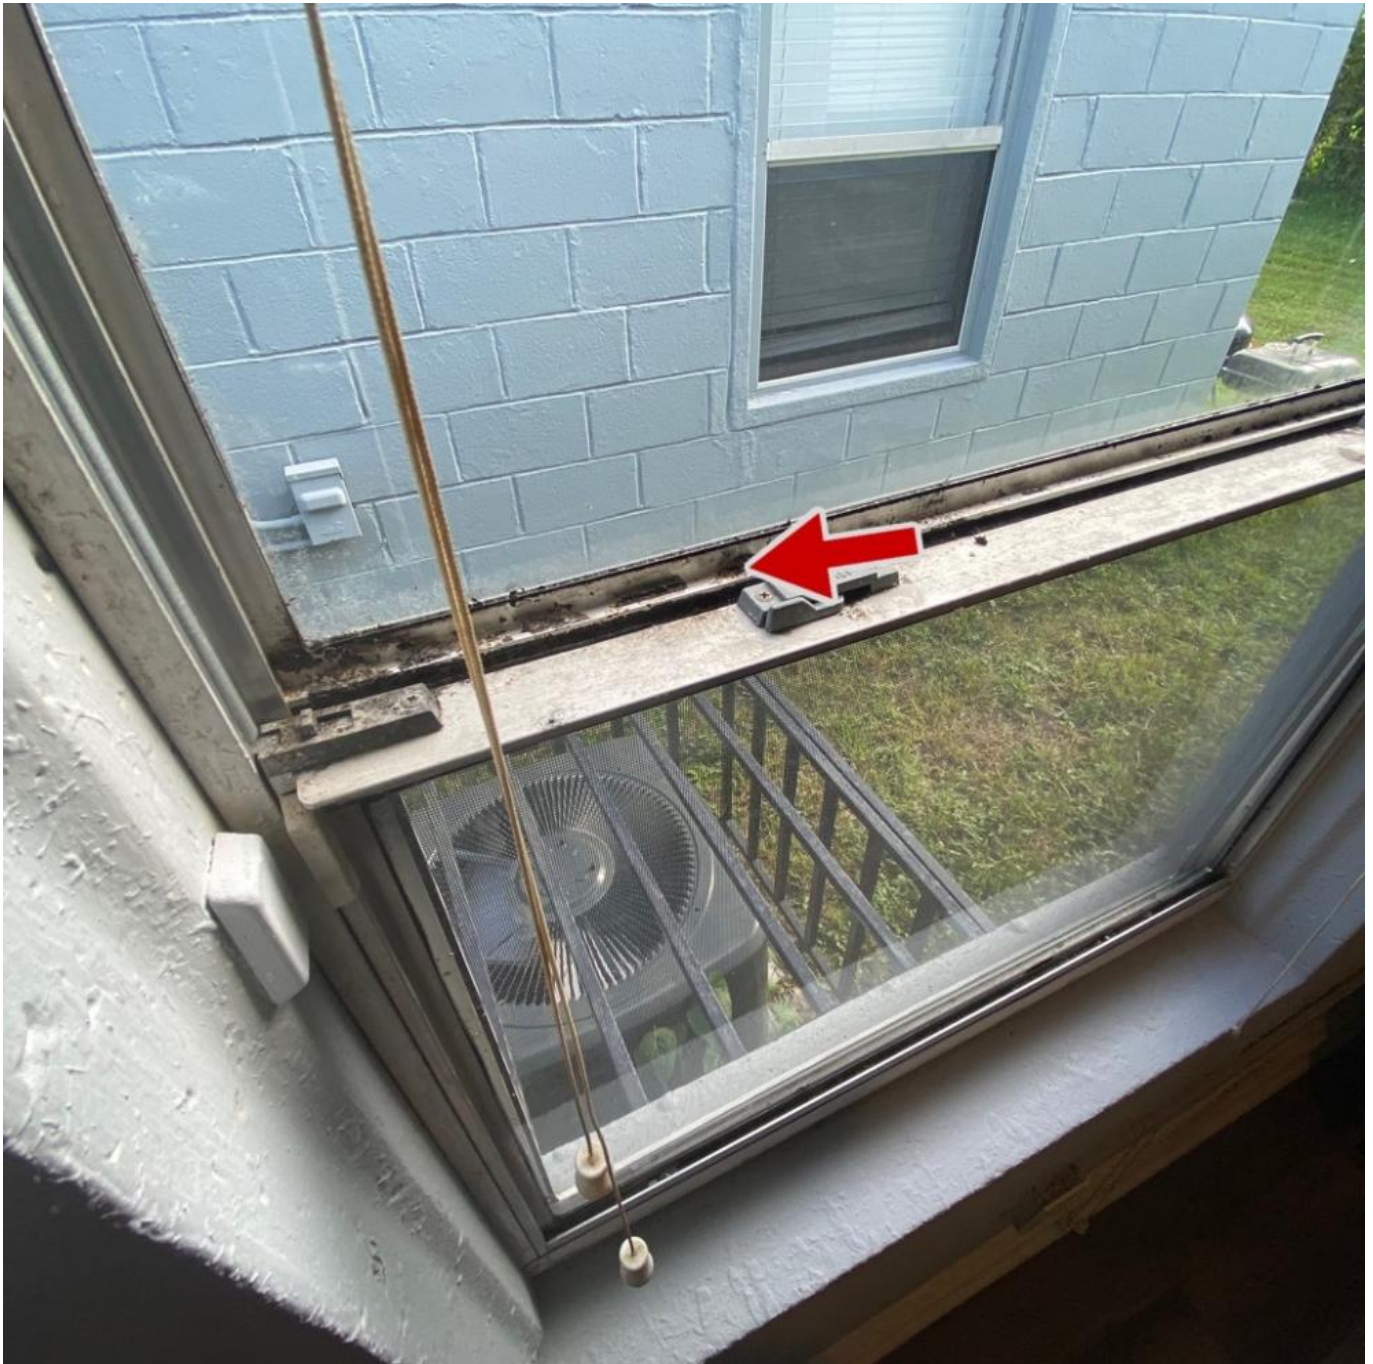
Suspected microbial growth was observed around the perimeter of the window in the guest bedroom of unit 823.

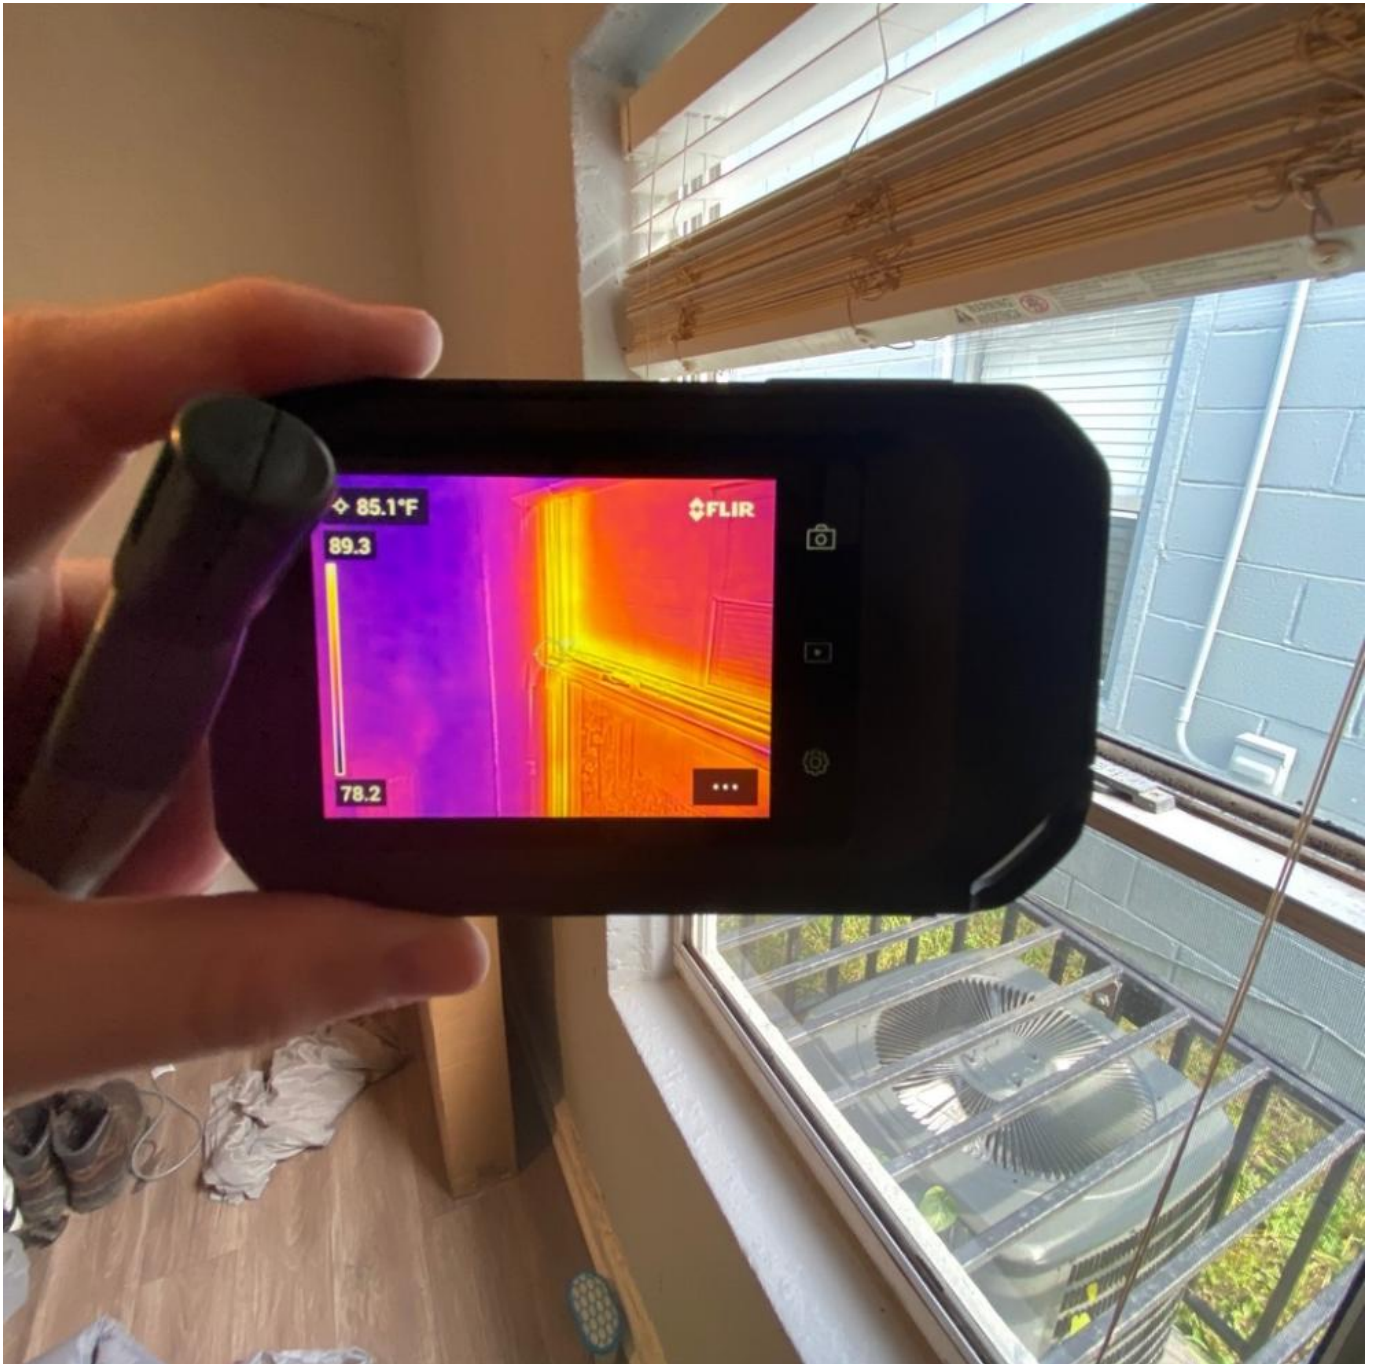
Infrared thermography revealed temperature variances (hot spots) around the perimeter of the guest bedroom window in unit 823.

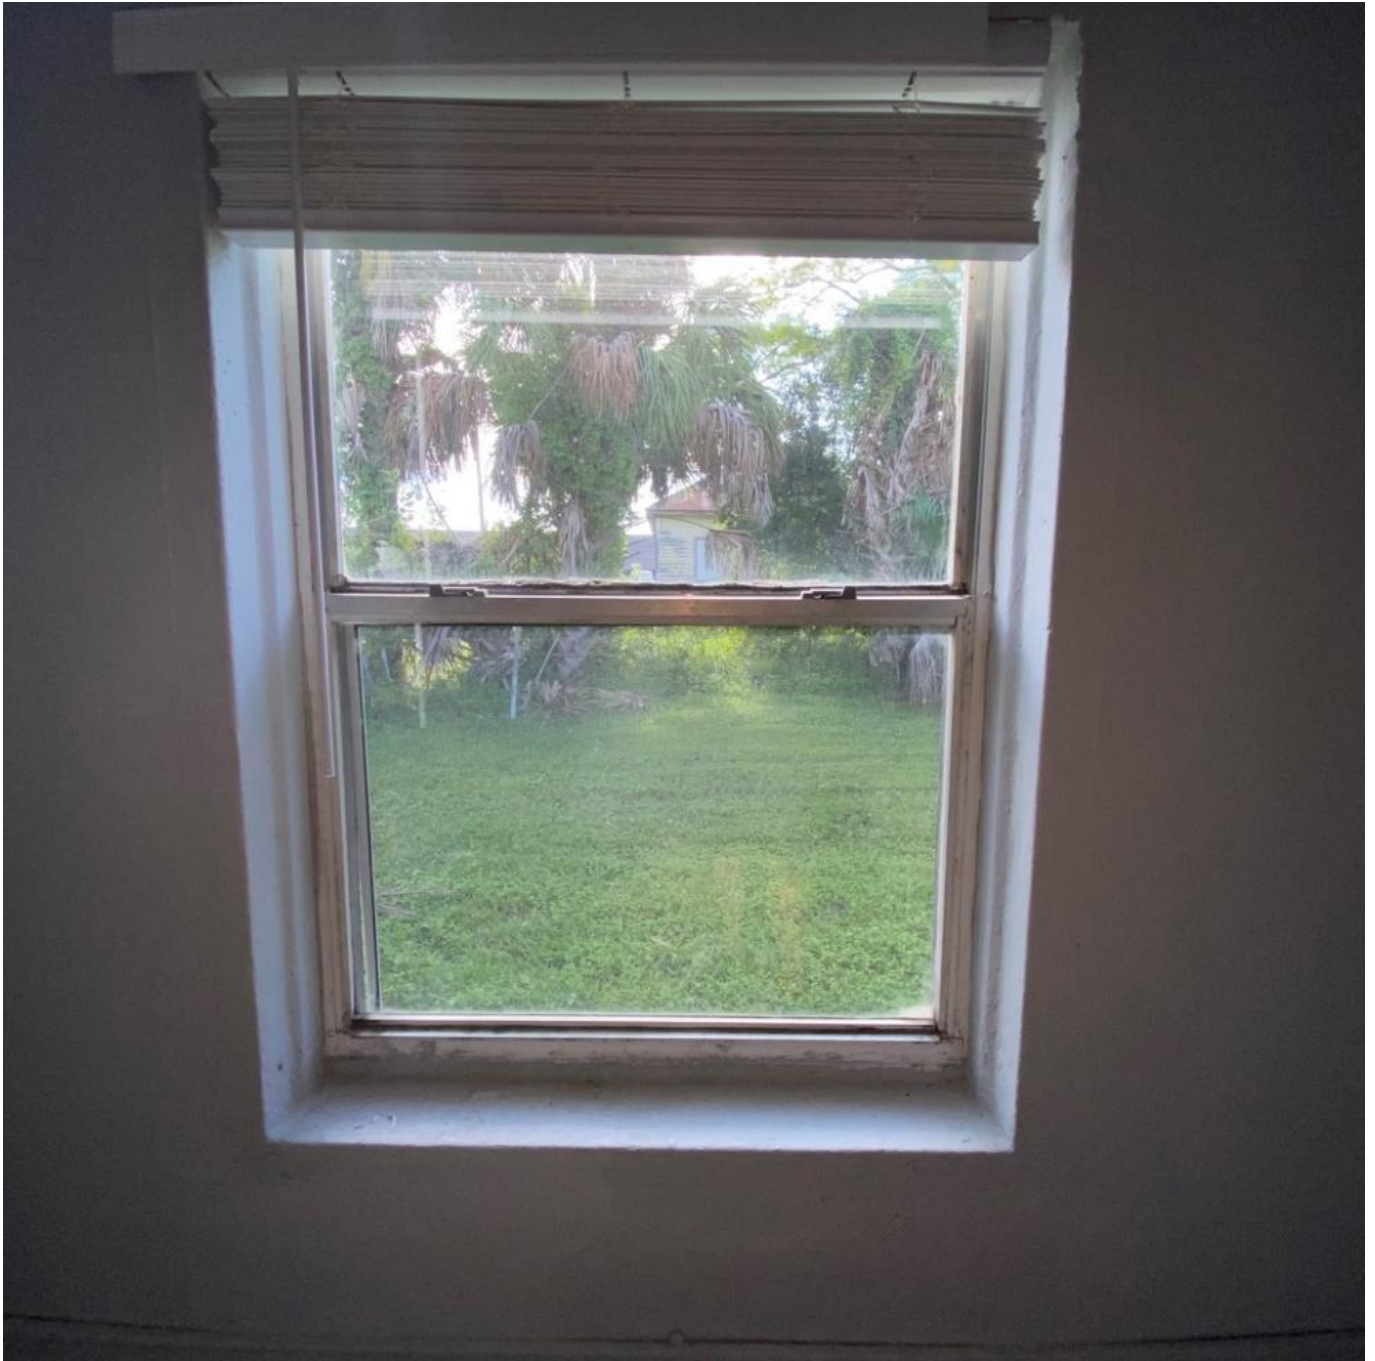
Overview of the affected window in unit 831.

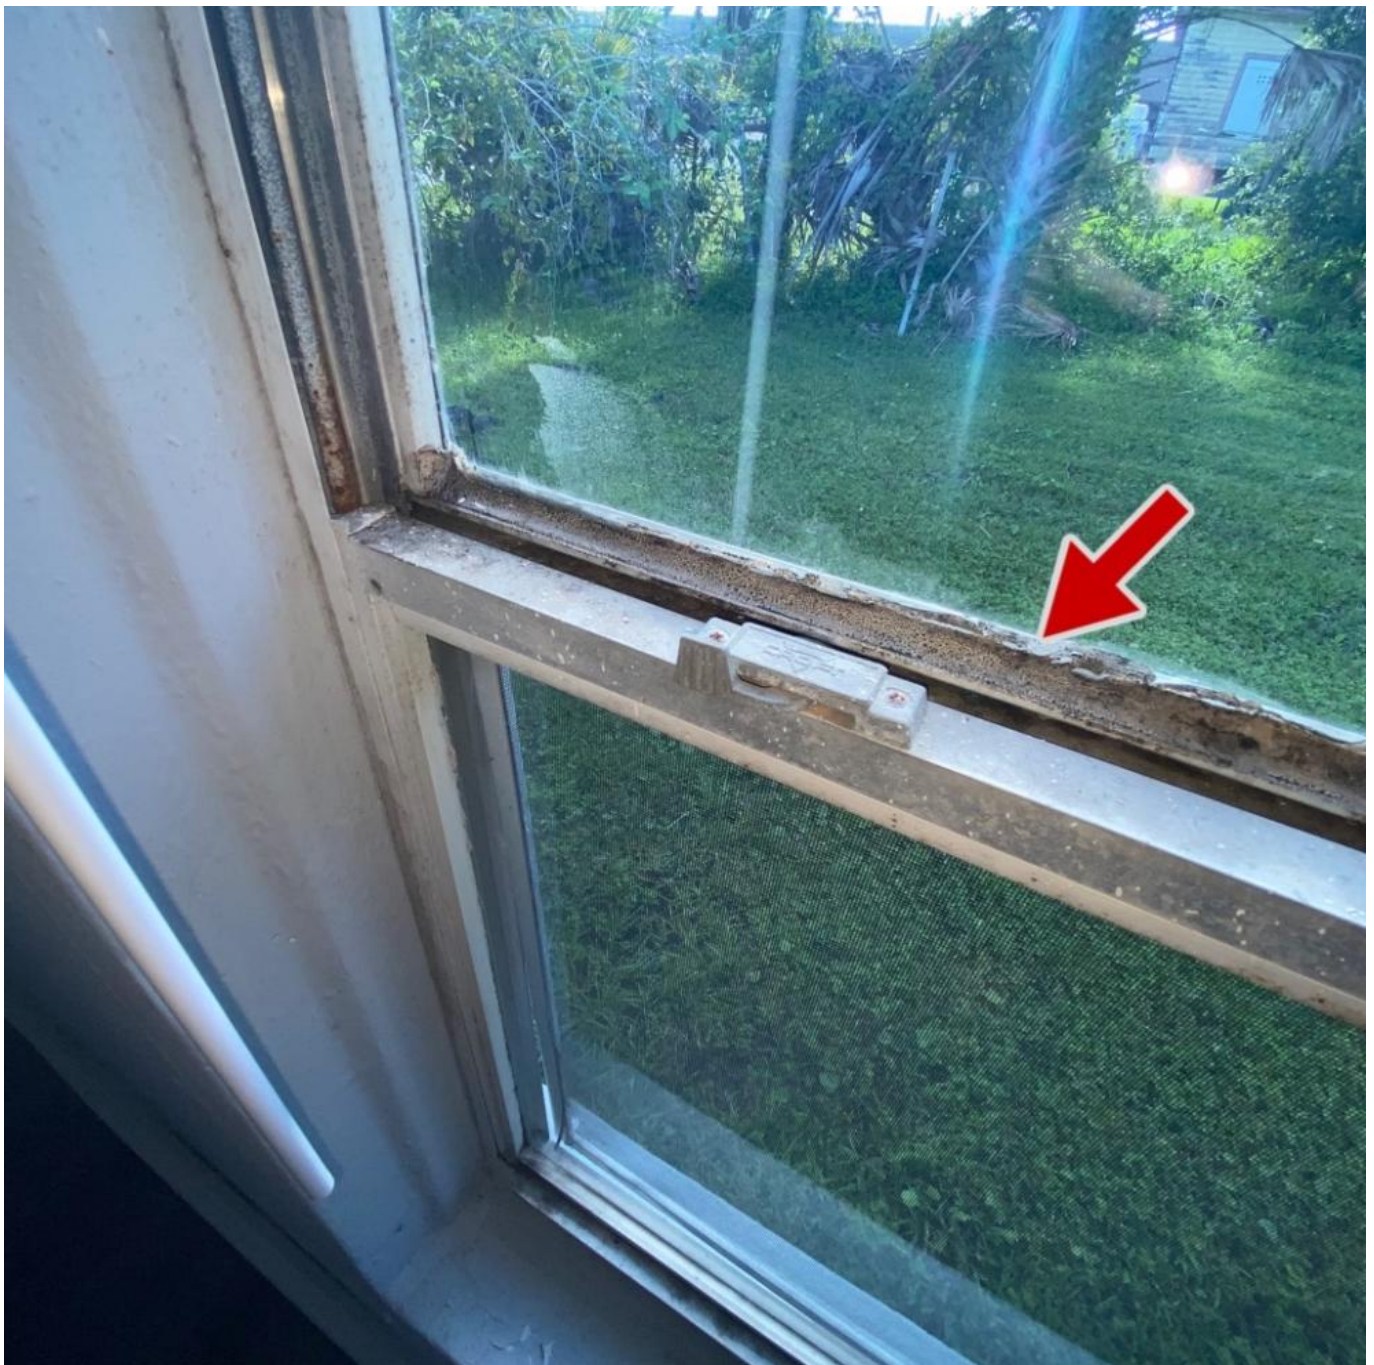
Suspected microbial growth was observed around the perimeter of the window in the master bedroom in unit 831.

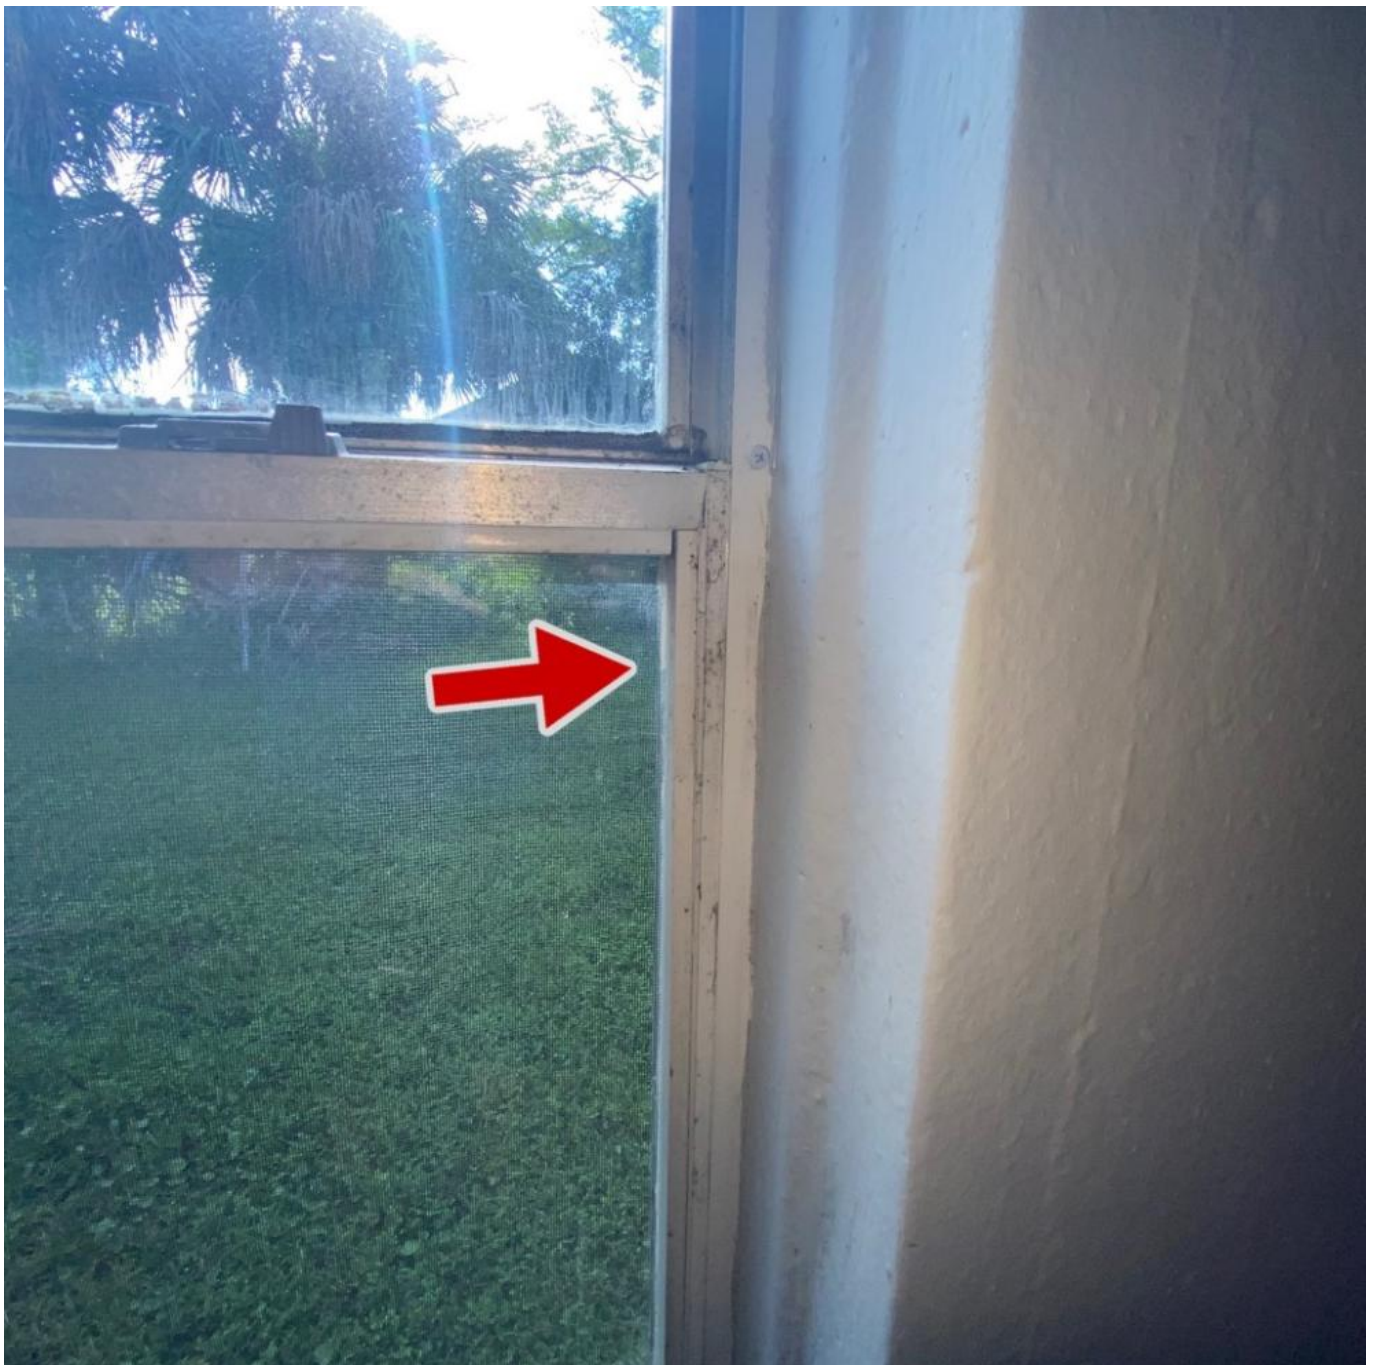
Suspected microbial growth was observed around the perimeter of the window in the master bedroom in unit 831.

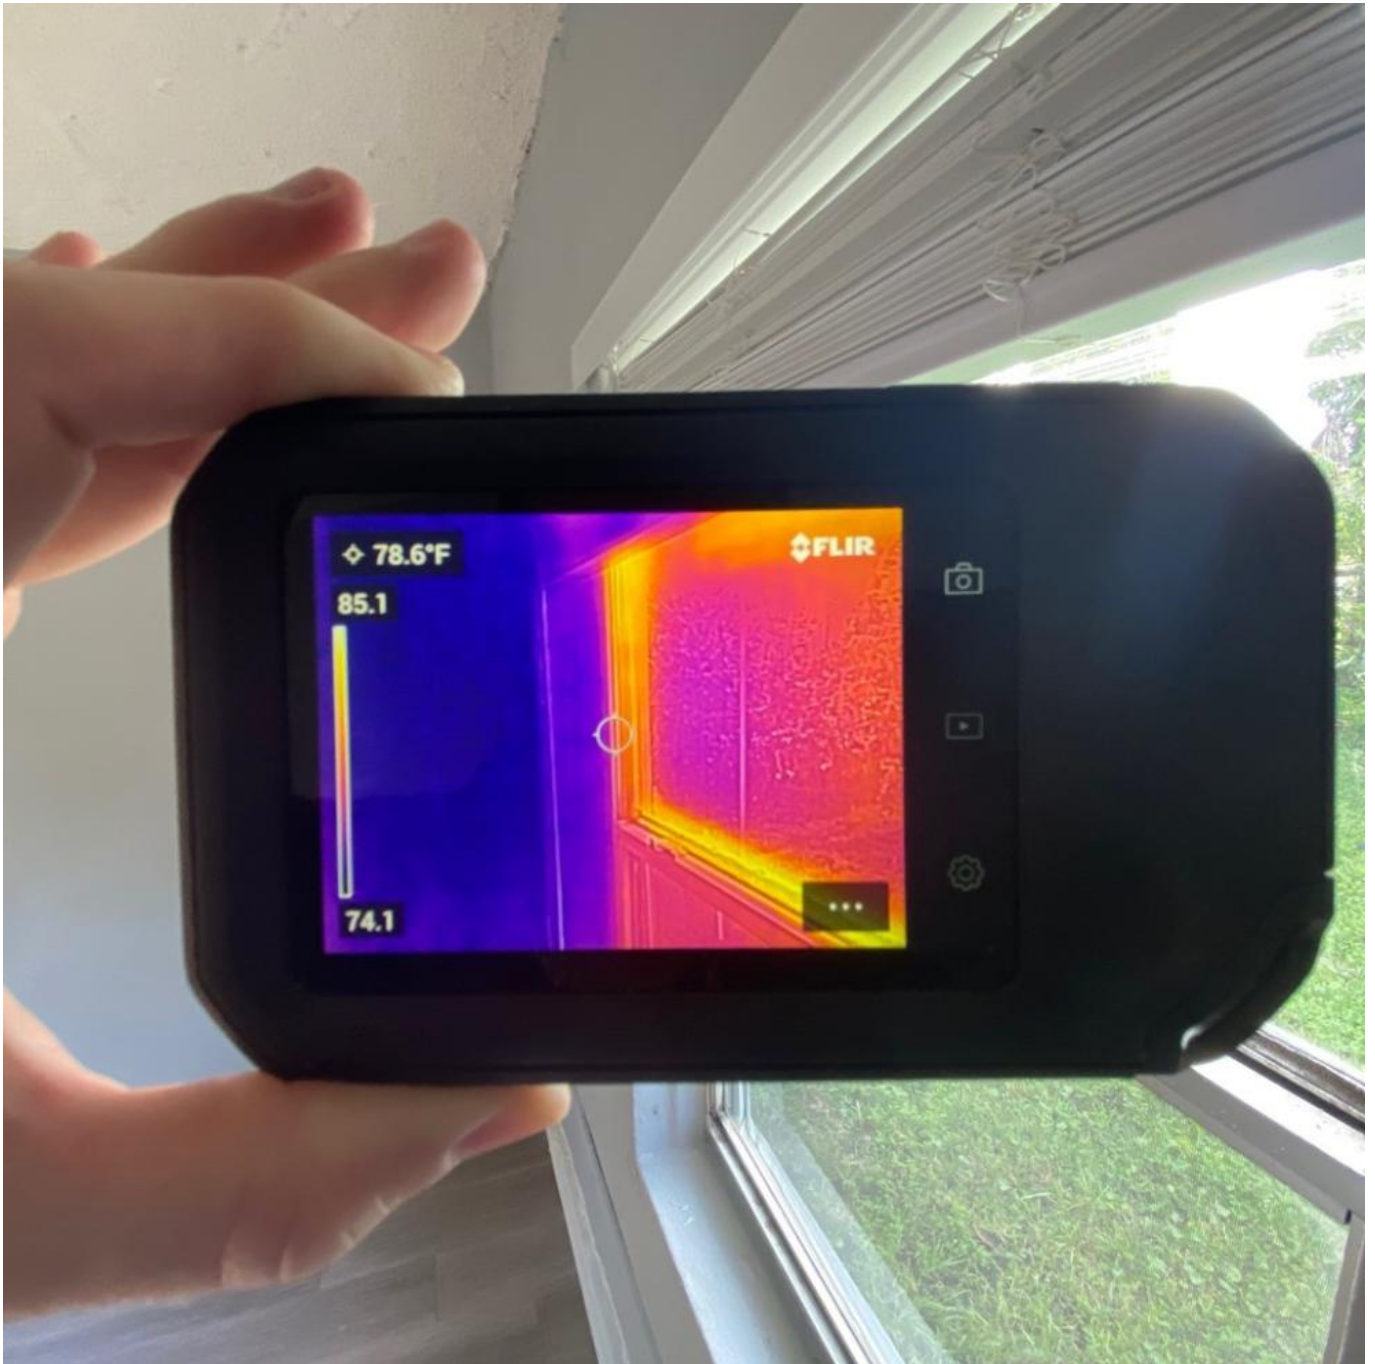
Infrared thermography revealed higher temperature variances (hot spots) around the perimeter of the master bedroom window.

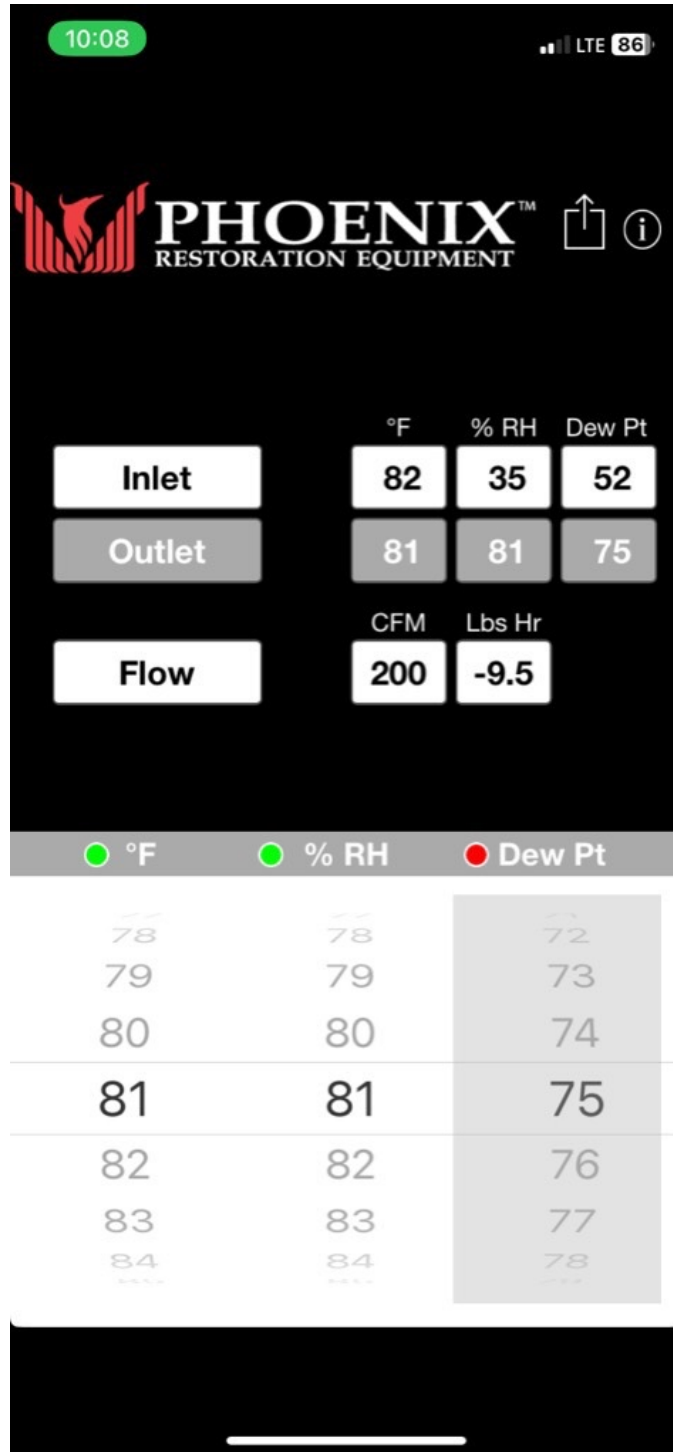
The suspected microbial growth observed in all three units has been caused by warm air infiltration, leading to the formation of condensation on the aluminum window frames when the surface temperatures reach the Dew point, resulting in this loss.

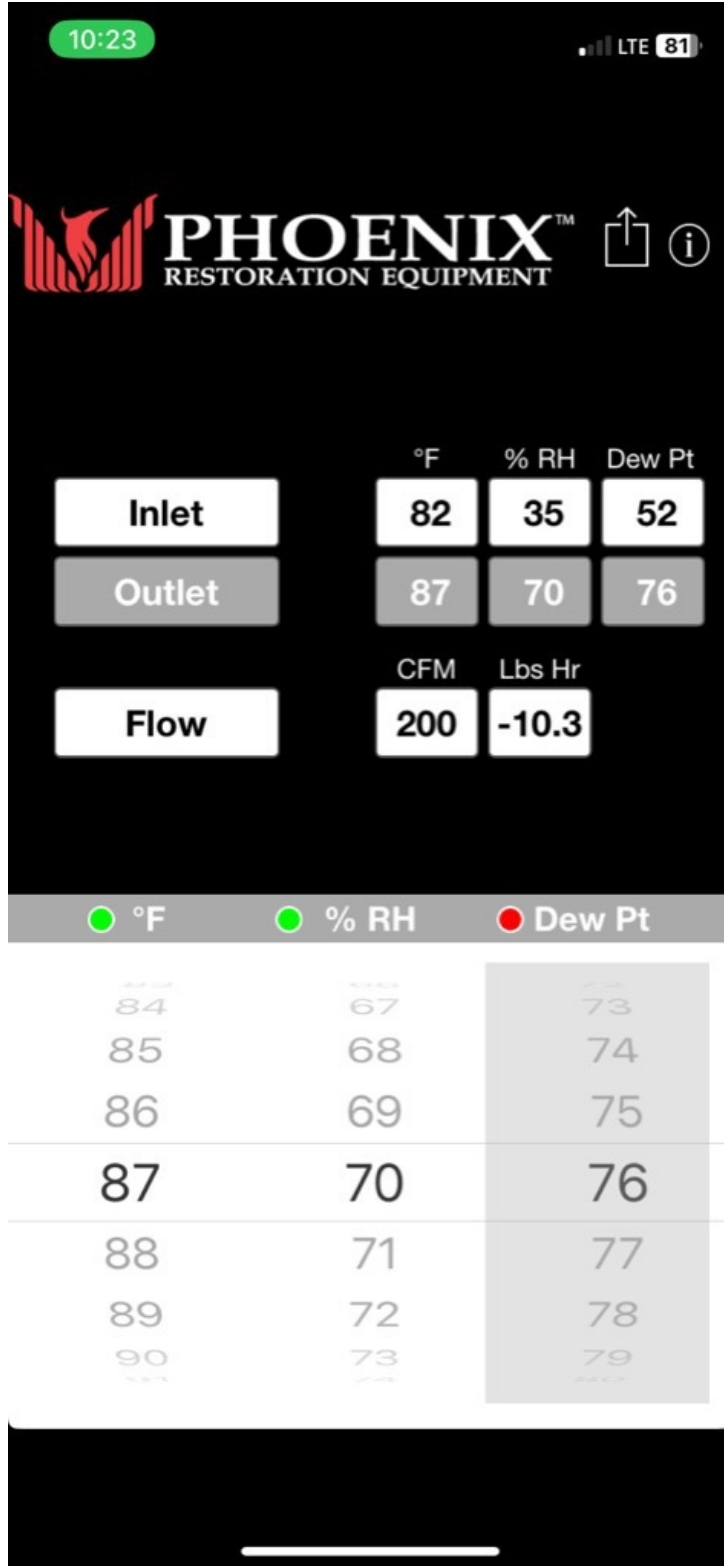
The suspected microbial growth observed in all three units has been caused by warm air infiltration, leading to the formation of condensation on the aluminum window frames when the surface temperatures reach the Dew point, resulting in this loss.
