# Diagnostic Inspection Report

DATE OF INSPECTION:	09/18/2024
JOB #:	57516640
CLIENT:	Spectrum Realty Services, LLC Attn: Bianca Vargas
HOMEOWNER'S NAME:	Minnie Street Apartments- Units 821, 823, & 831
PROPERTY INSPECTED:	821 Minnie Street Jacksonville, FL 32204
INSPECTION AND REPORT BY:	Austin Keen
LICENSE NUMBER:	CGC1522600/CFC1428610/HCI-R#202205016

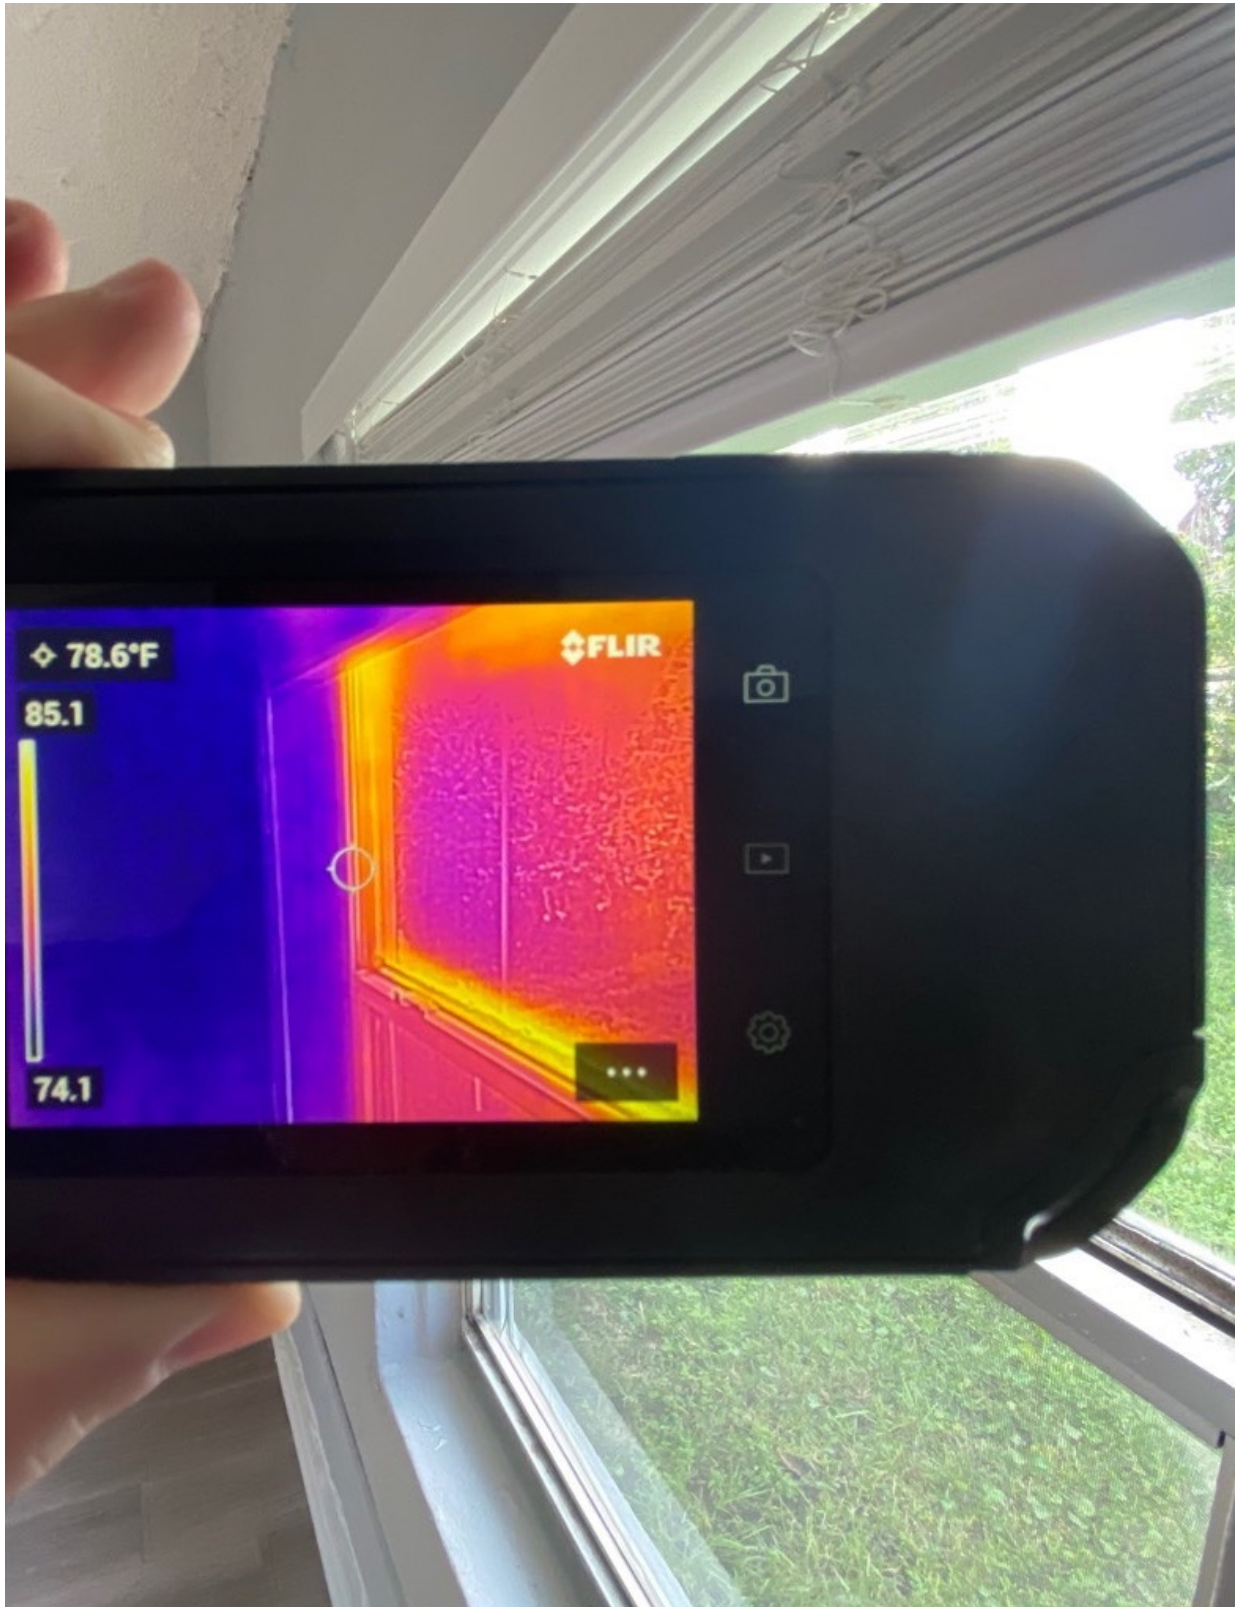
Infrared thermography revealed temperature variances (hot spots) around the perimeters of the window frames in the affected units consistent with warm air infiltration.

1. Maintain indoor relative humidity levels of 50 percent or less as recommended by industry standards.
2. Repair/replace the weatherstripping/windows to prevent warm air infiltration as per industry standards.

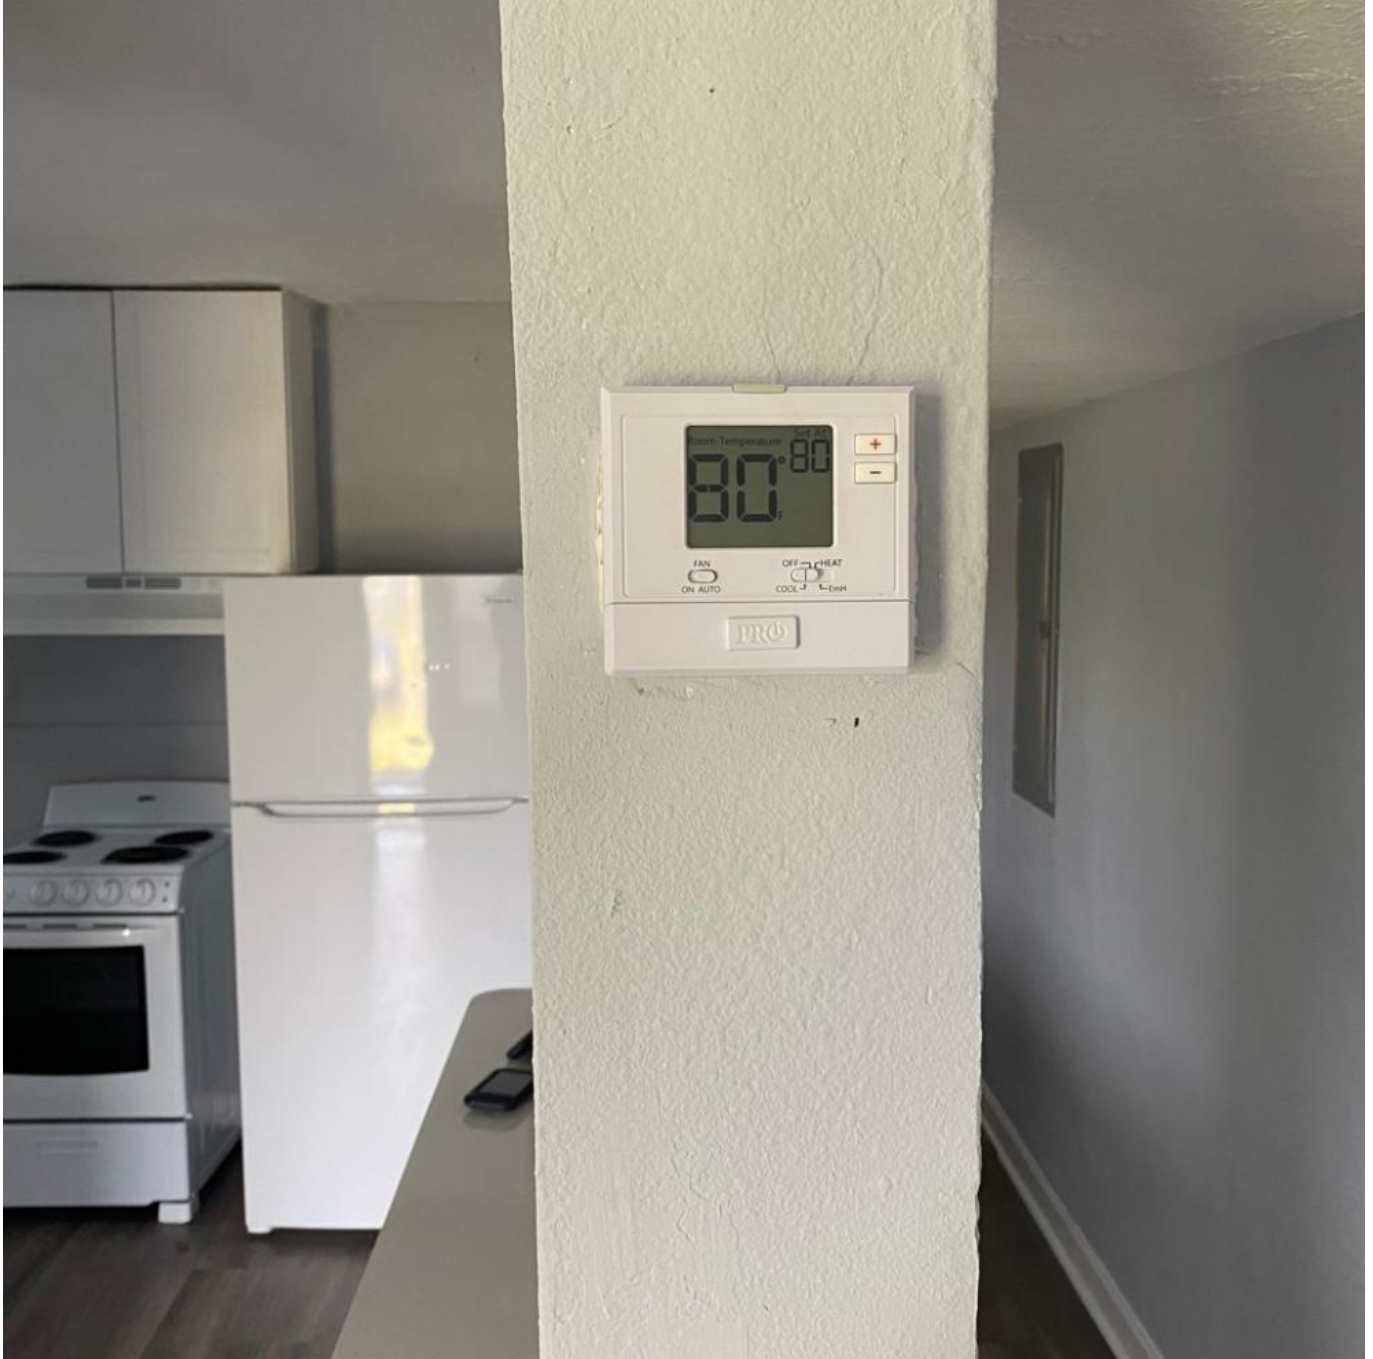
The HVAC thermostats in the affected units were set at 80 degrees Fahrenheit. This temperature does not provide enough dehumidification, as the units are not in operation for an adequate period of time.

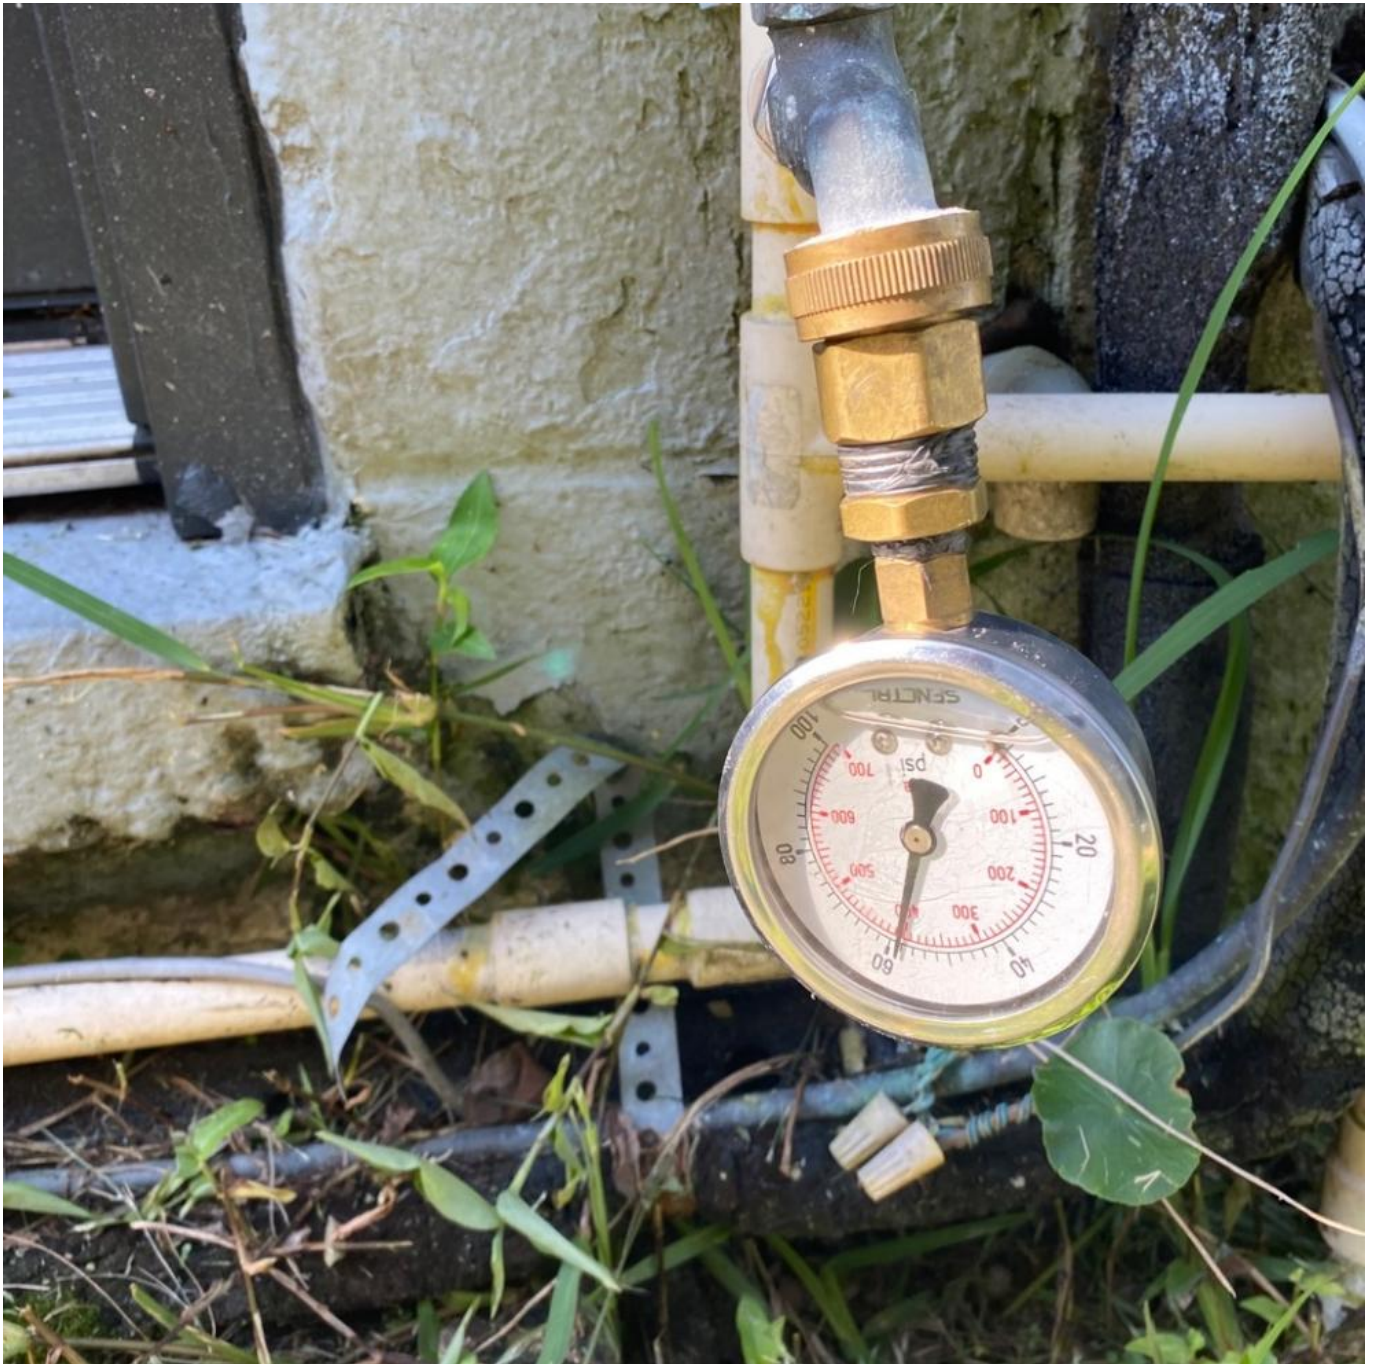
The pressure test of the potable water system confirmed there were no active pressurized potable water leaks at the time of our inspection.
