SewerLine Check Professionals, LLC

Sewer Line Inspection Report

2912 Adams St. La Crescenta, CA

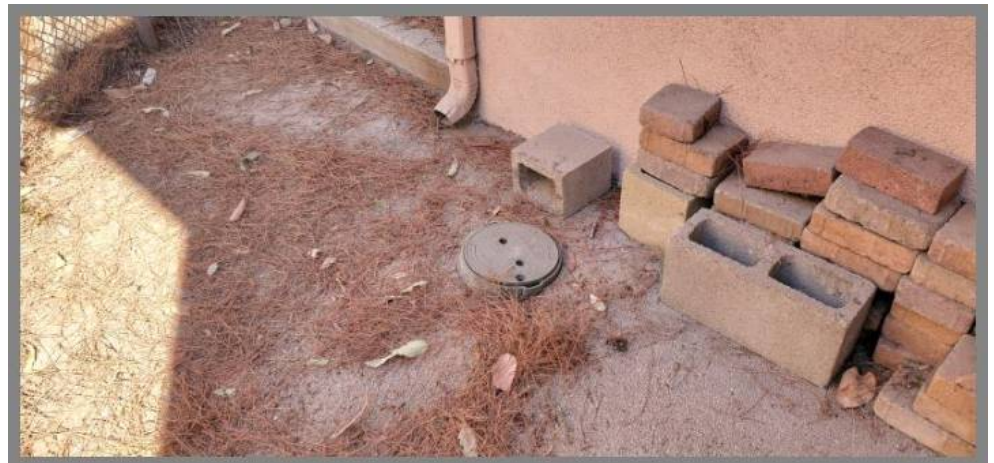
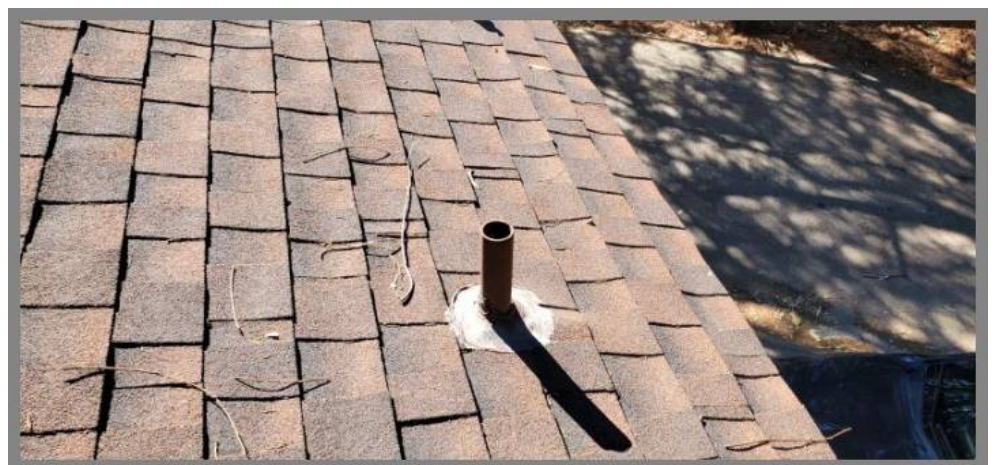
ACCESS LOCATION: The inspection was performed using this main sewer line cleanout at the right rear of the house and this roof vent on the guest house.

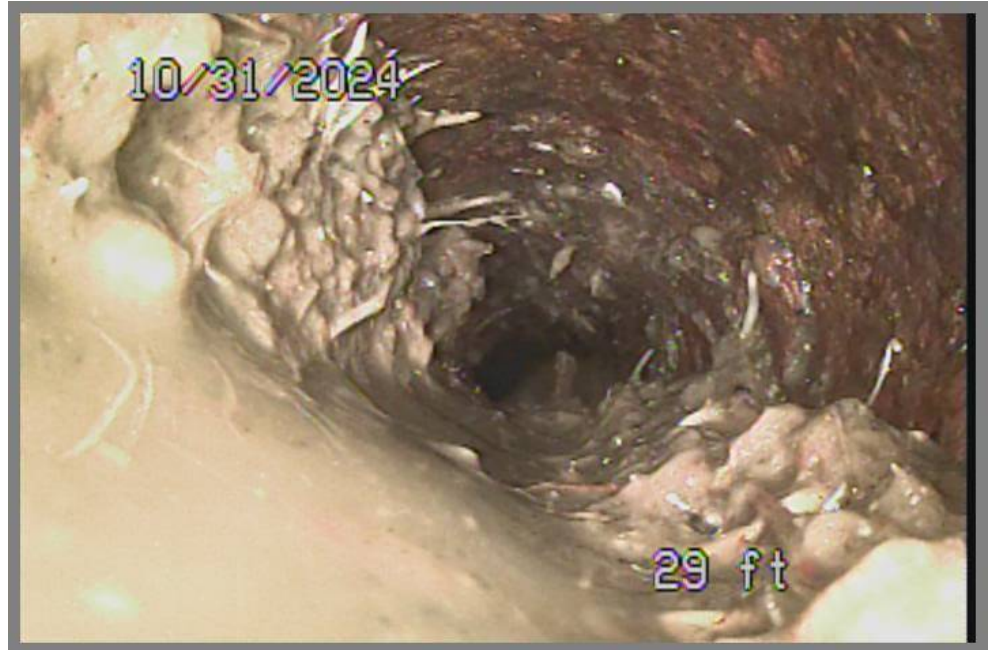
Not Acceptable, there is an area of root intrusion within the guest house sewer line that should be excavated and repaired.

This main sewer line is made of plastic pipe to start and then cast iron pipe as it runs across rear of the property from the guest house to its connection with the front house main sewer line.

As both of these materials are water tight roots should be able to sense the moisture or get into the pipe itself. This suggests damage or an installation flaw in this area and repair is needed.

RECOMMENDED REPAIRS: The root intruded portion of the guest house sewer line should be excavated and repaired.

ESTIMATED COST FOR REPAIRS: This repair may cost in the 2 to 4 thousand dollar range.

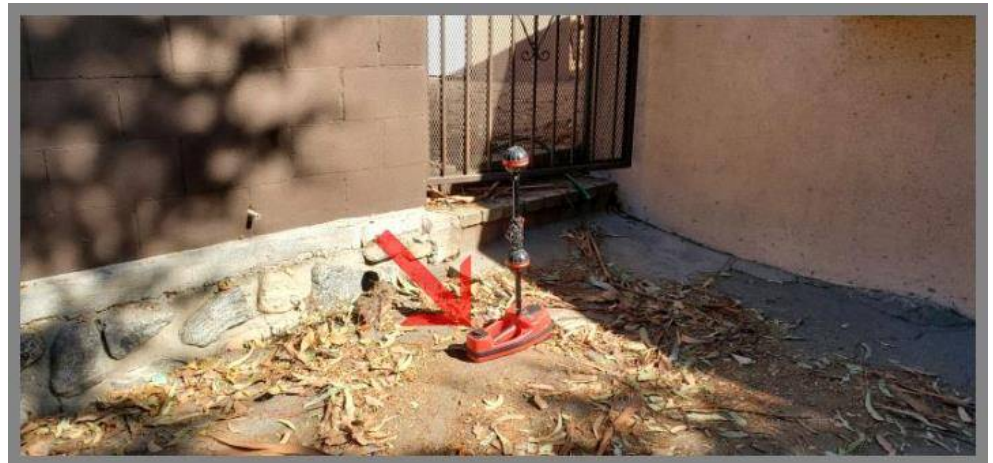
The area is shown here at the middle rear of the property.

The pipe is 2 feet deep here.

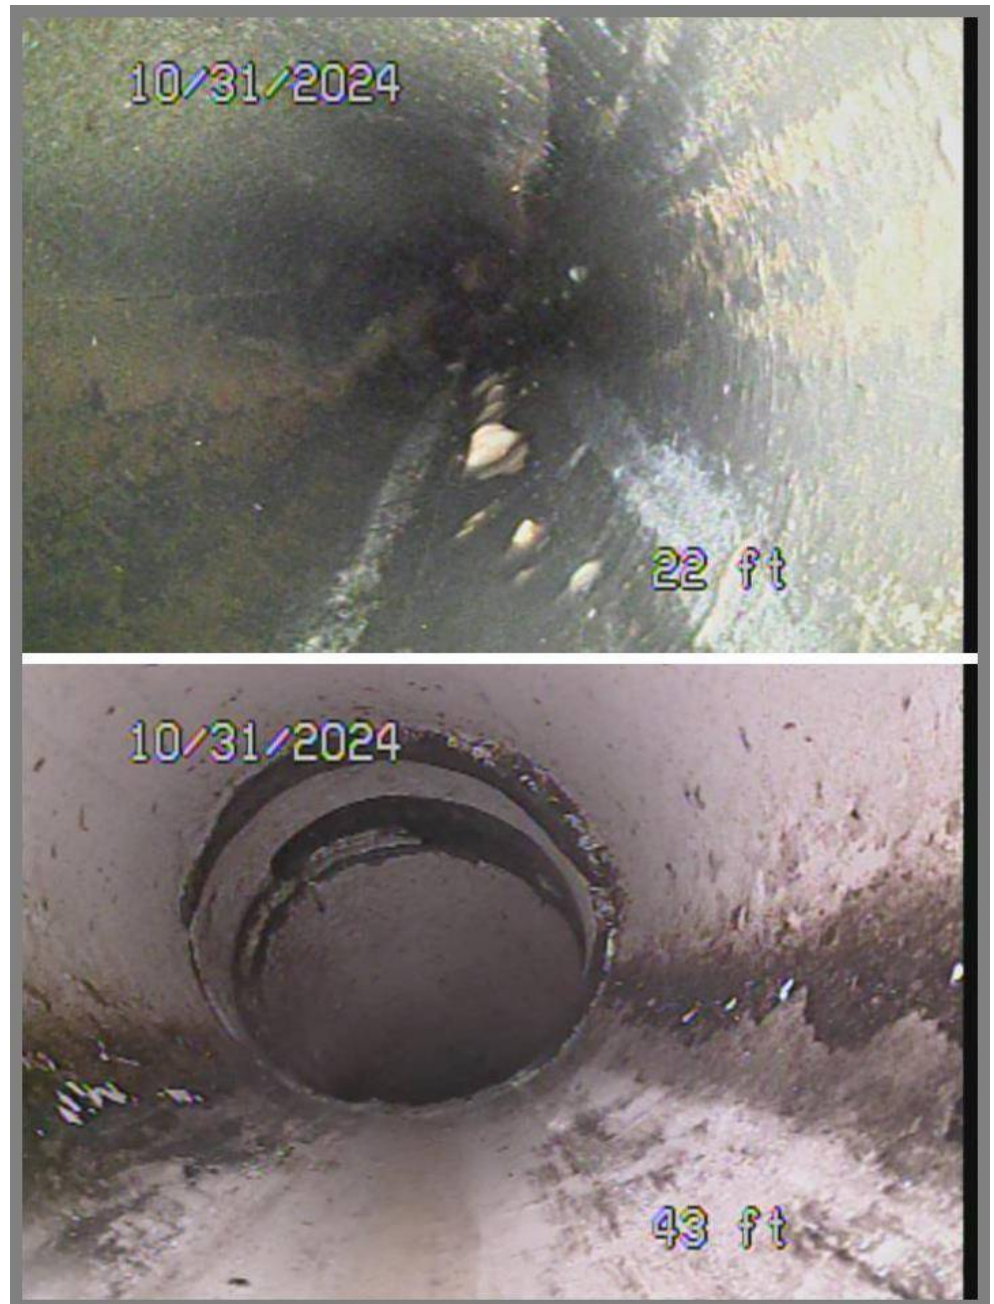
The entirety of the front house main sewer line from the cleanout to the city sewer connection under the alley as well as the beginning of the guest house sewer are made of plastic pipe materials.

Plastic is an excellent material to be used for this type of application as it has slick walls to allow for maximum drainability. It has an indefinite life expectancy as it does not rust or wear out like other pipe materials.

The materials are flexible to allow for some earth movement and if installed properly are virtually impermeable to root intrusion.

The ABS plastic beginning of the guest house line transitions to the cast iron half at the root blockage and continues to the connection with the front house main sewer line.

The cast iron of the system appears to be original to the structure and is in typically deteriorated condition for a pipe of its apparent age with signs of rust and corrosion of the inner walls and a flattening of the pipe bottom.

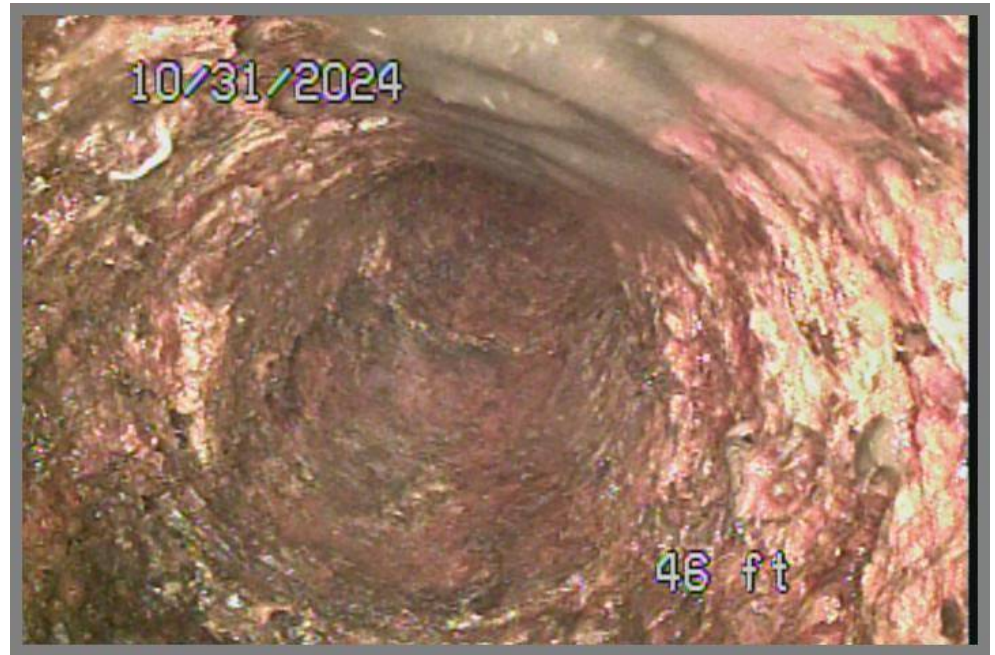
The rest of the cast iron is draining serviceably at this time however with an average useful life expectancy of 60 to 80 years it will need to be replaced in the future as it continues to wear out.

To predict when cast iron will fail is impossible however regular video inspection could be performed on the cast iron system every year for the next few years to monitor its rate of deterioration to be more able to predict a future replacement date of the material.

RECOMMENDED MAINTENANCE: As with any older cast iron system it is advised to have the that portion of the guest house line video inspected every year to monitor its rate of deterioration to be able to more accurately predict a future replacement date.
