Lost Herd Inc.
806 W. 11th Street
Austin, TX 78701

Introduction:

Tree Mann Solutions to inspect, identify, measure DBH, and provide condition rating with supportive notes for 6 designated trees (T806, T807, T808, T809, T810, and T811). TMS to review provided documents and make preservation/removal recommendations where warranted. Summary report with photos provided for team use.

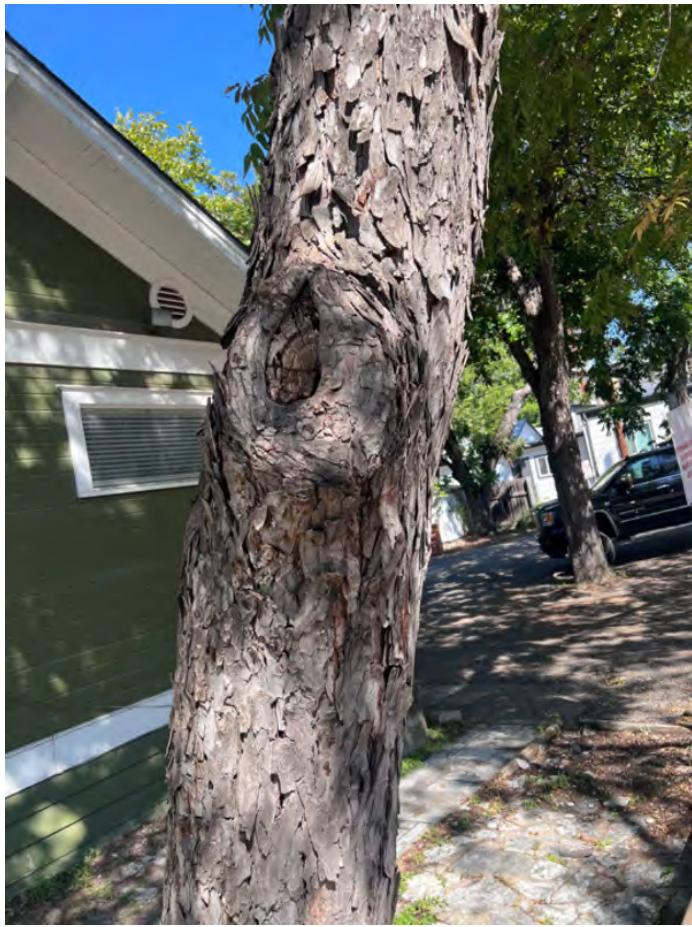
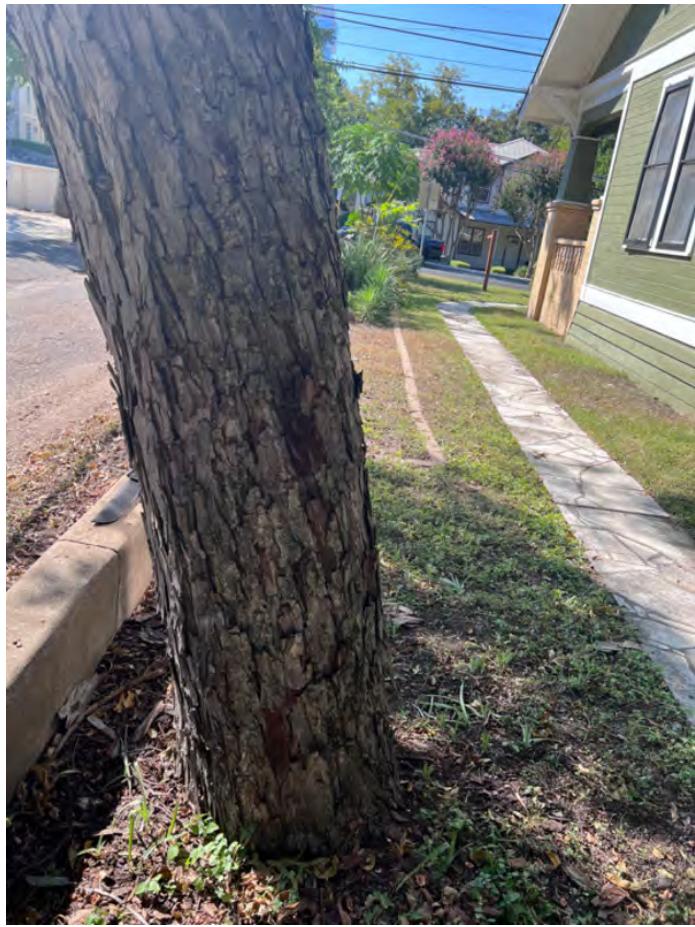
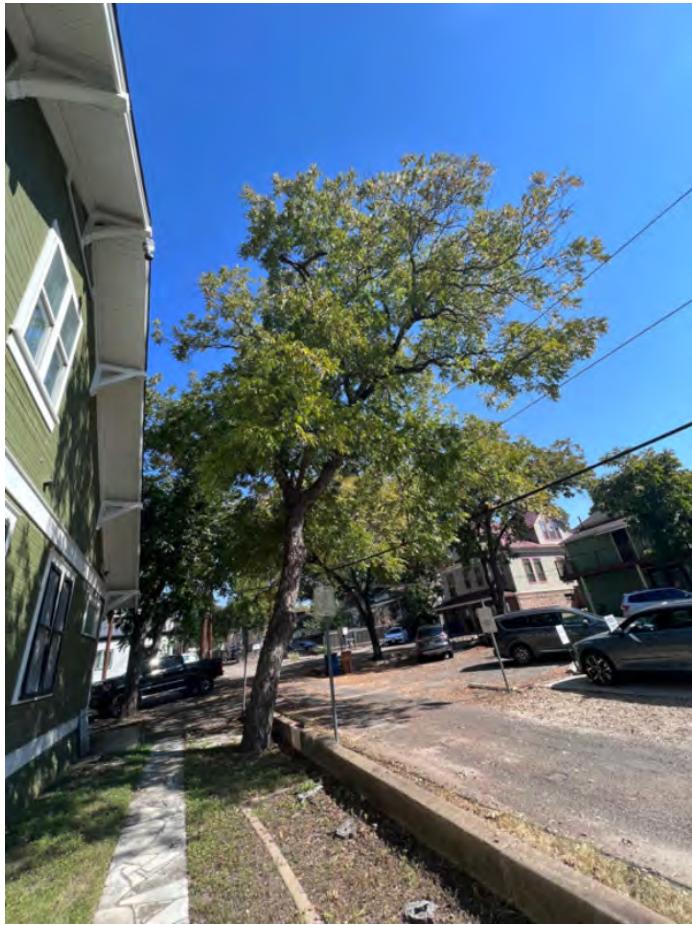
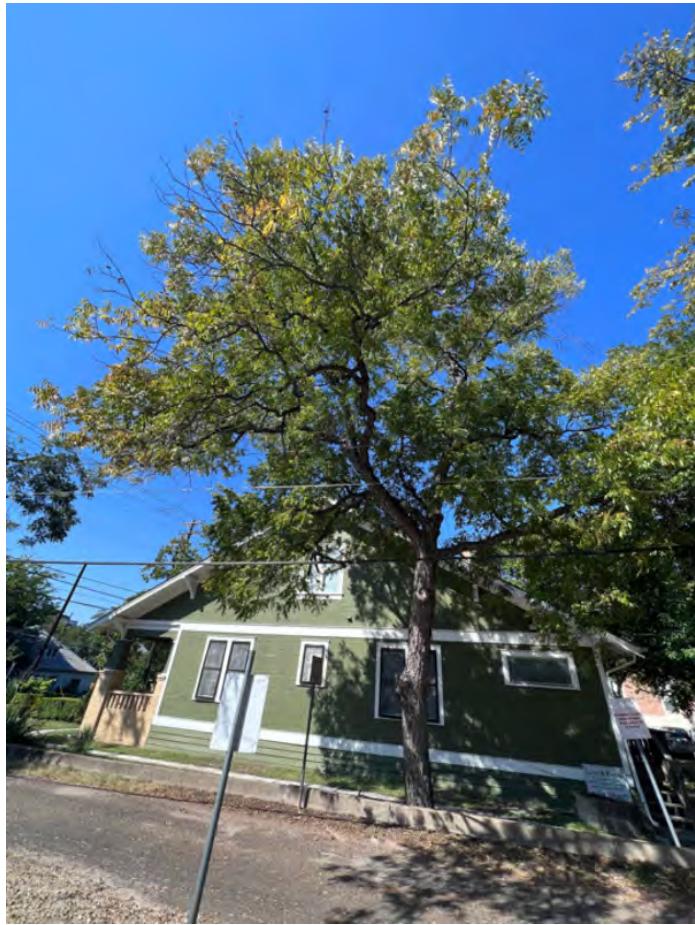
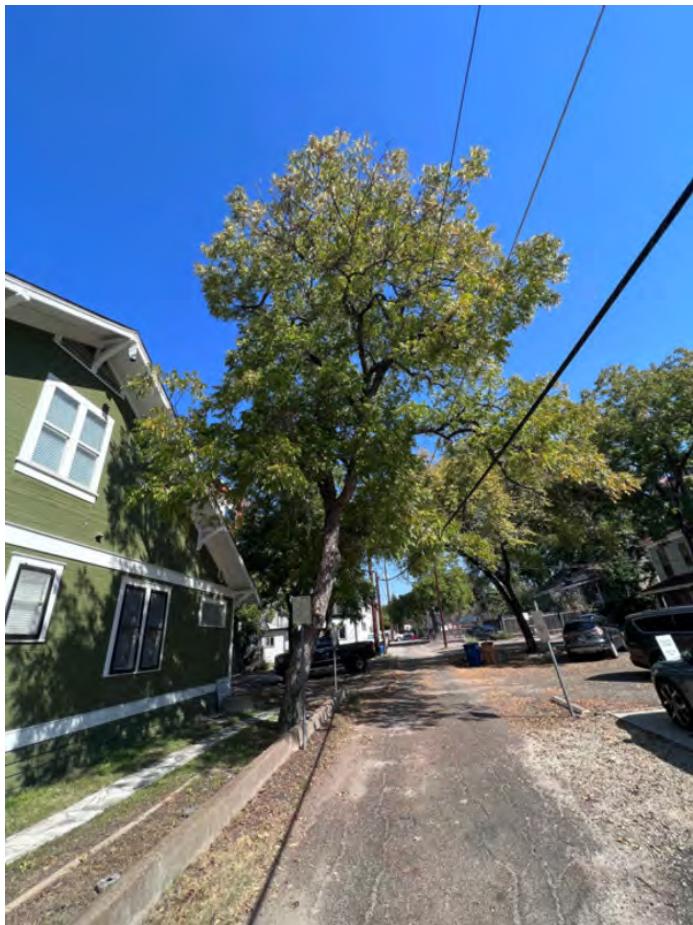
- **T806**, a 20" pecan, is in fair condition. The pecan has a moderate amount of tip dieback throughout the canopy. There are two large pruning wounds on the S and E sides of the tree, but strong response growth is present. There is approximately 60% impervious cover surrounding the CRZ, primarily to the E. The tree is a fair candidate for preservation.

Tree Number	806
Tree Species	Pecan
Diameter (DBH)	20
Multi Stem	
Condition	Fair
Notes	fair structure & vigor, moderate impervious cover
Summary	Tree 806, a 20" pecan, is in fair condition. The pecan has a moderate amount of tip dieback throughout the canopy. There are two large pruning wounds on the S and E sides of the tree, but strong response growth is present. There is approximately 60% impervious cover surrounding the CRZ. The tree is a fair candidate for preservation.

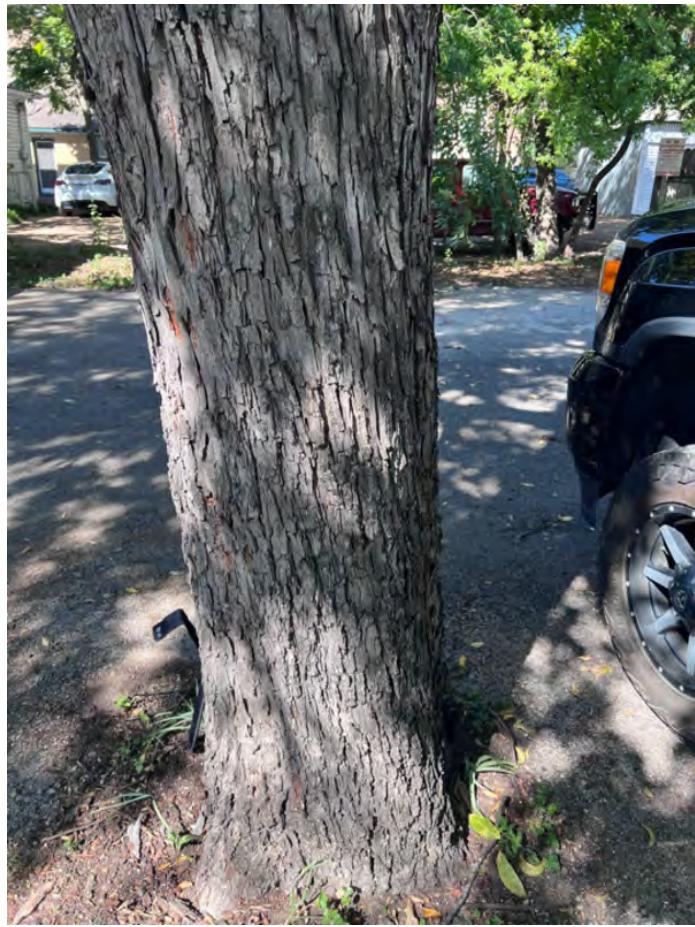
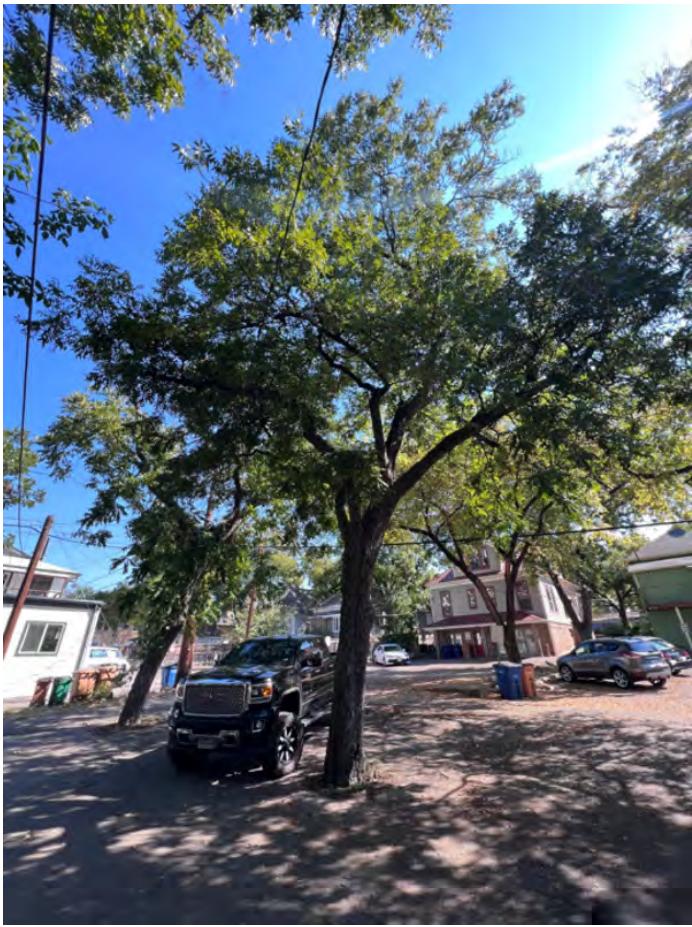
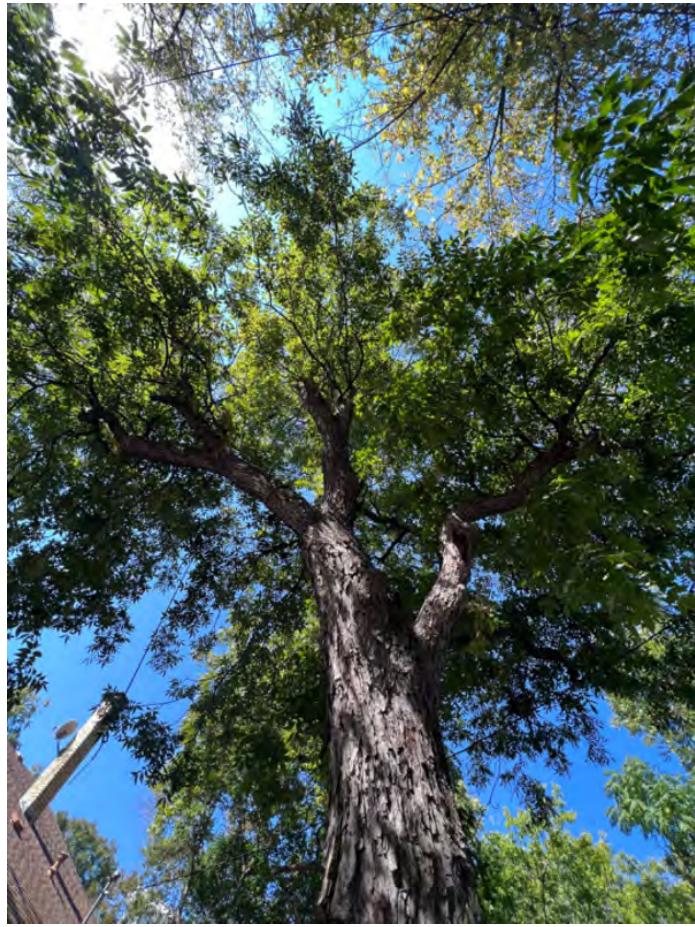
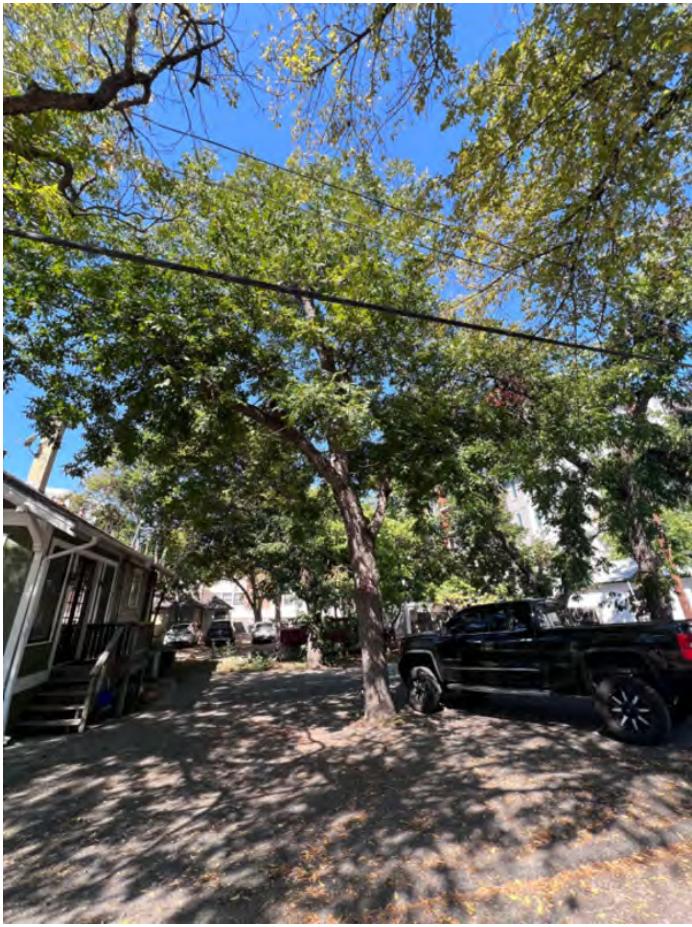
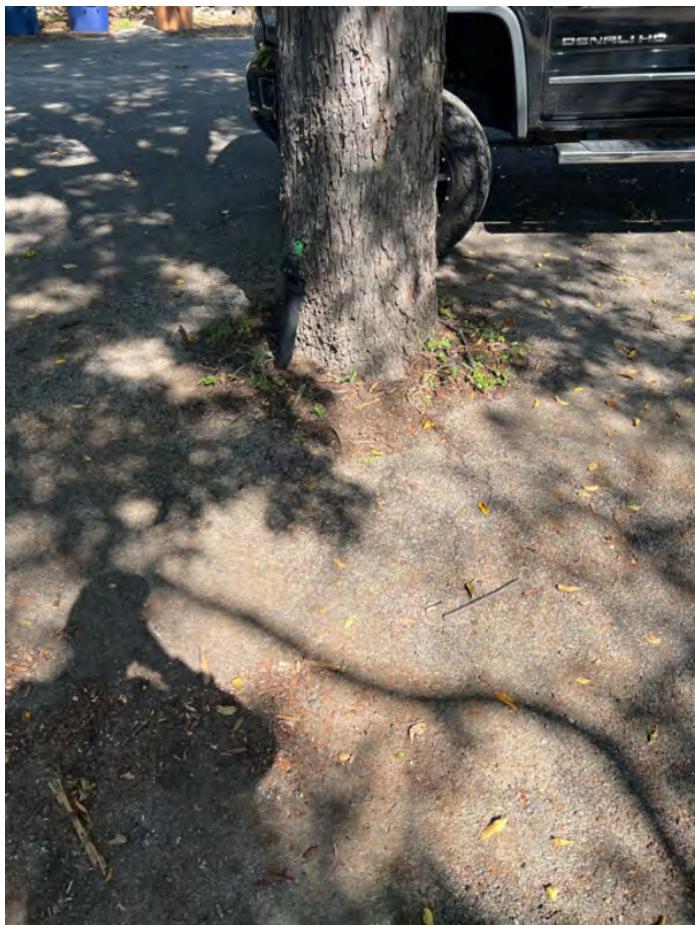
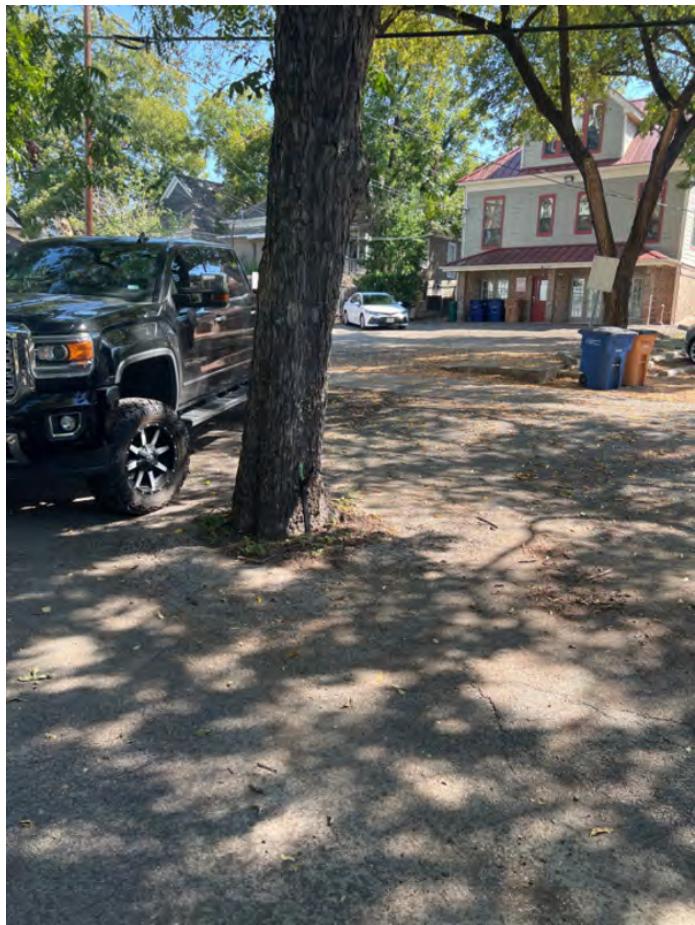
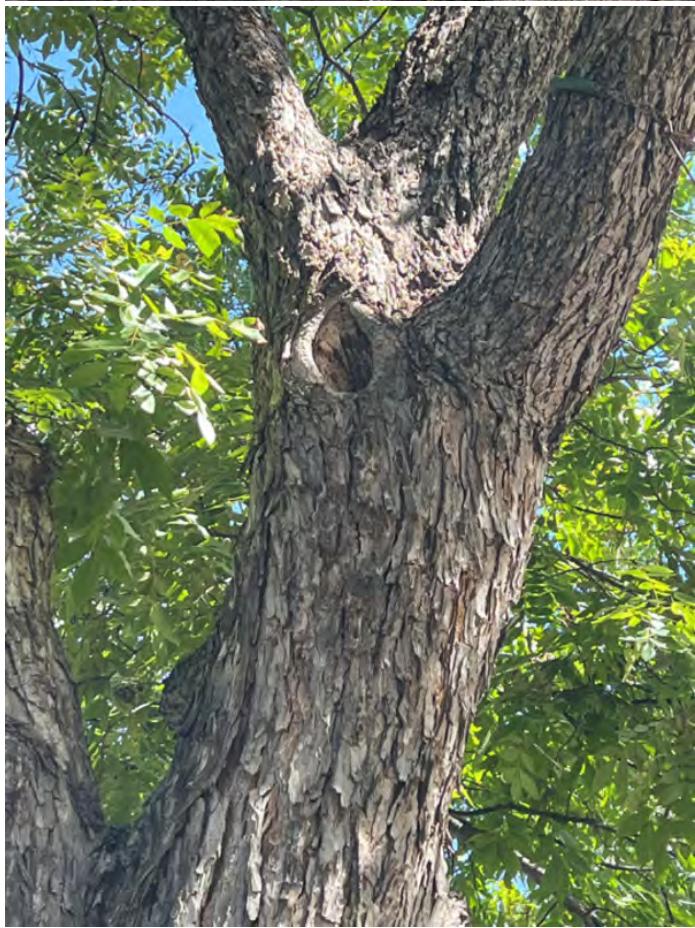
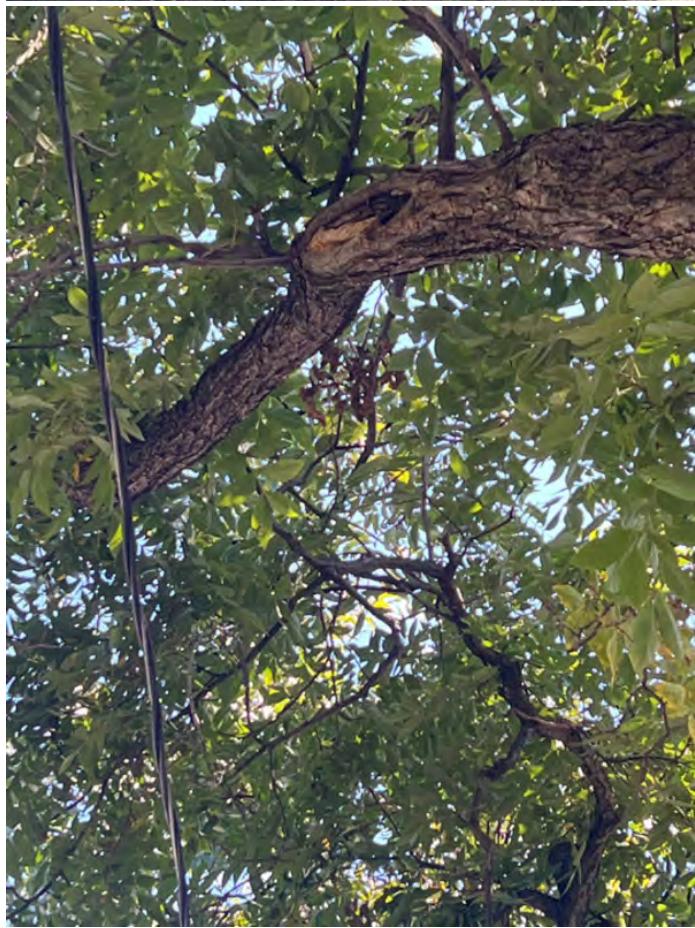
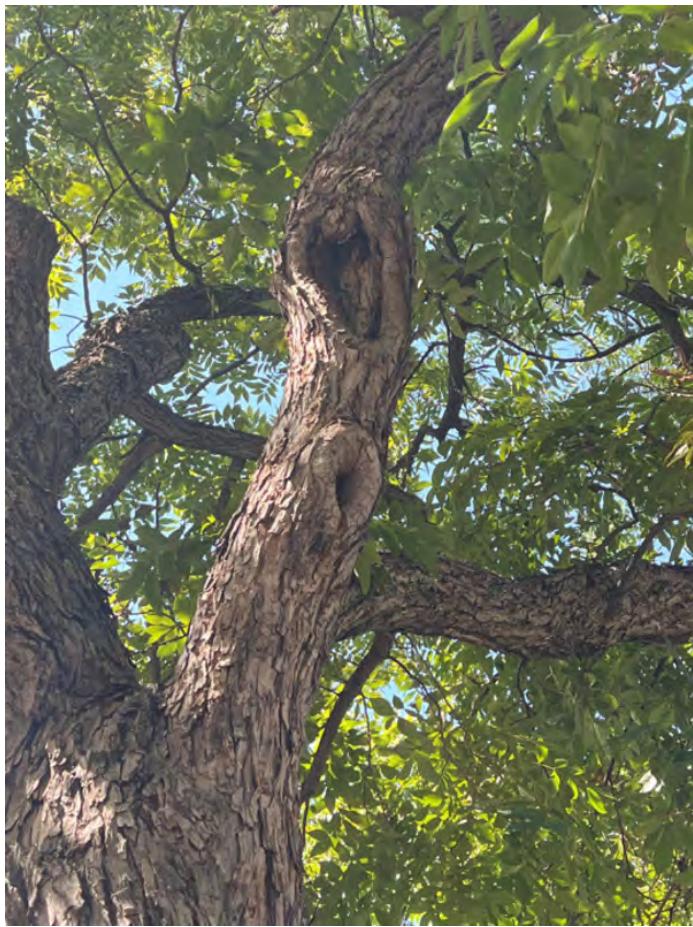
- **T807**, a 20.5" pecan, is in fair condition. Nearly 100% of the CRZ is covered with impervious material. There are small pockets of decay throughout canopy, however strong response growth is present at all these cavities. The pecan has limited amounts of tip dieback. With careful mitigation work, the pecan is a fair candidate for preservation. TMS recommends careful demolition and soil invigoration to promote root growth and to aerate the soil.

Tree Number	807
Tree Species	Pecan
Diameter (DBH)	20.5
Multi Stem	
Condition	Fair
Notes	fair structure & vigor, excessive impervious cover
Summary	Tree 807, a 20.5" pecan, is in fair condition. Nearly 100% of the CRZ is covered with impervious material. There are small pockets of decay throughout canopy. Strong response growth is present at all these cavities. The pecan has limited amounts of tip dieback. With careful mitigation work, the pecan is a fair candidate for preservation. TMS recommends careful demolition and soil invigoration to promote root growth and to aerate the soil.

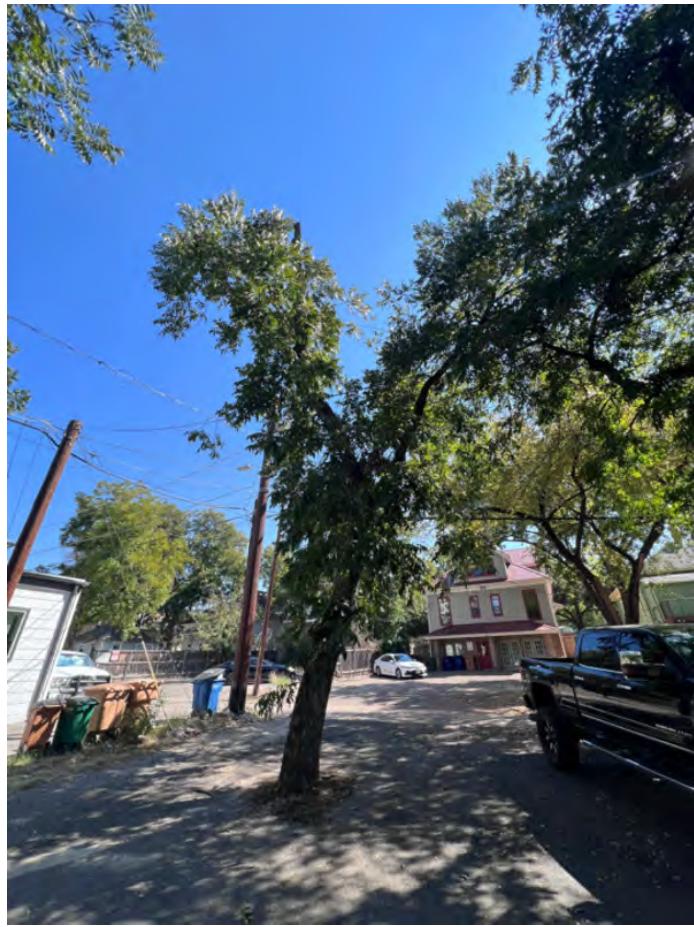
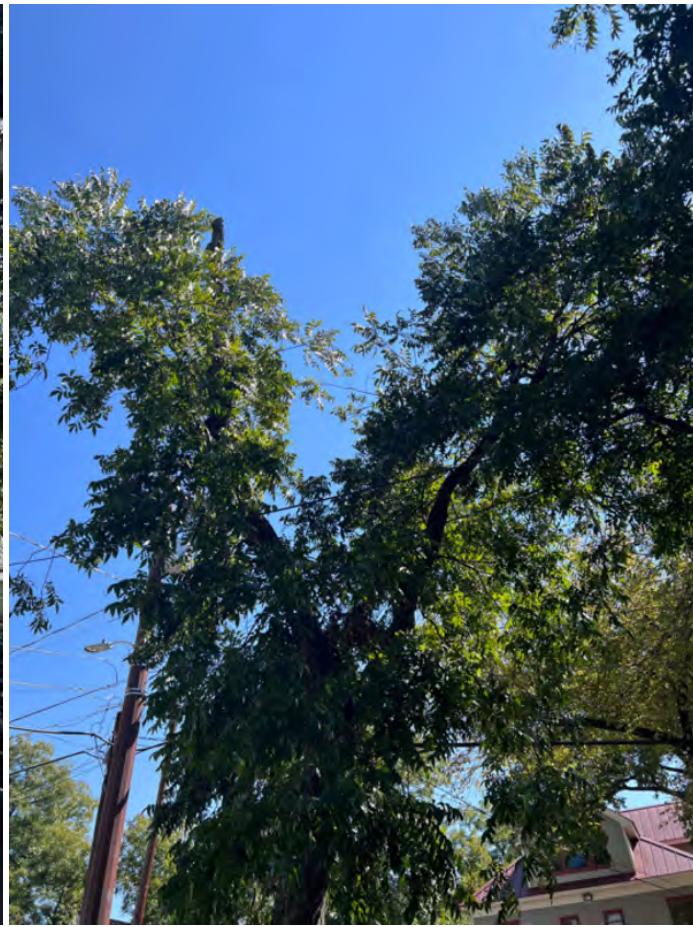
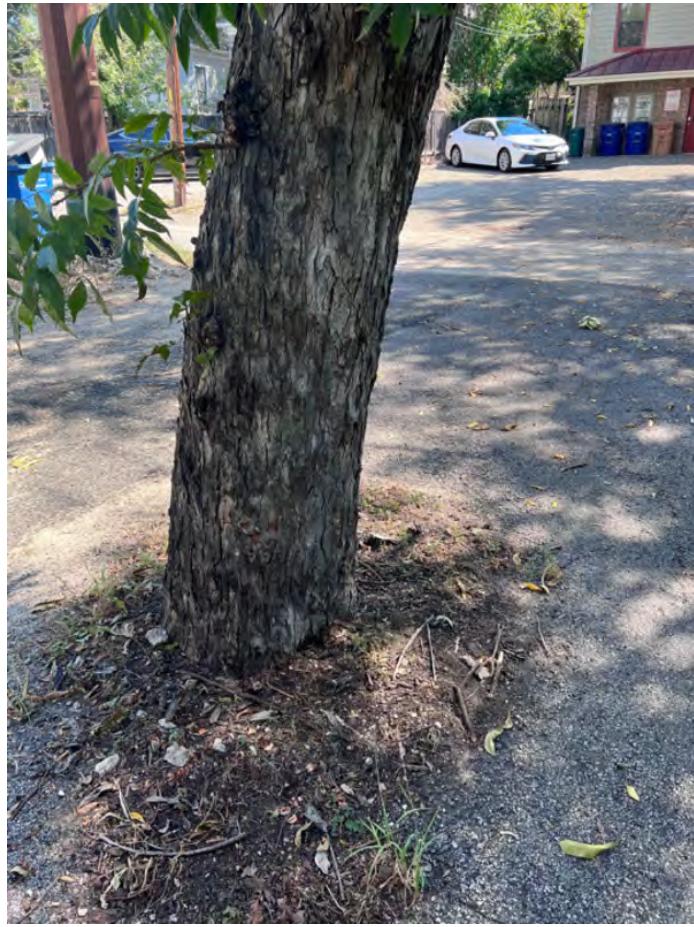
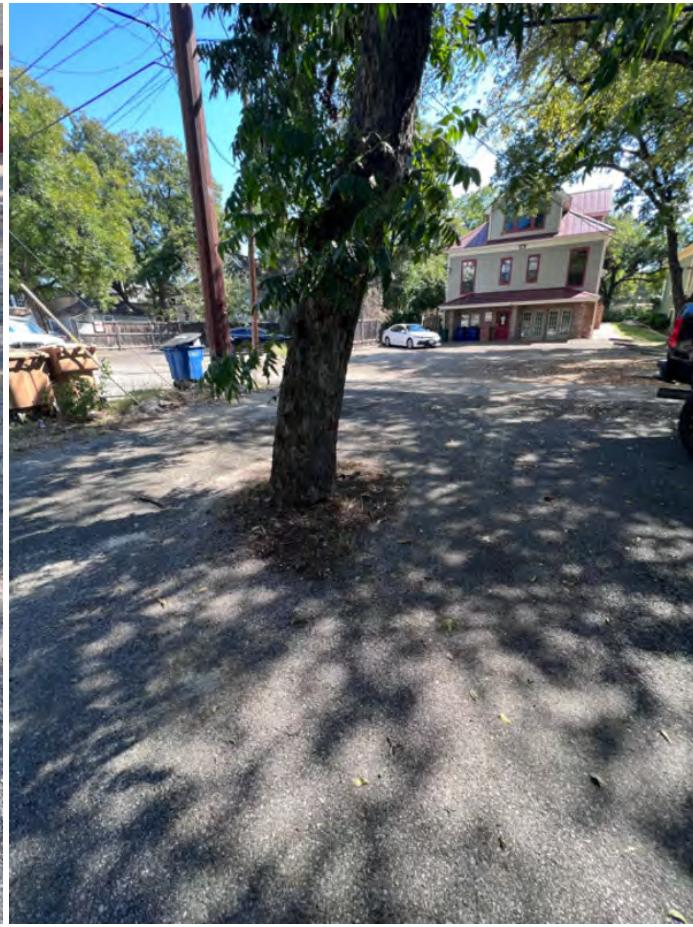
- **T808**, a 19.5" pecan, is in fair condition. Nearly 100% of the CRZ is covered with impervious material. The pecan has limited amounts of tip dieback and has been utility pruned on the E and NE. There is a moderate amount of squirrel damage throughout the canopy. With careful mitigation work, the pecan is a fair candidate for preservation. TMS recommends careful demolition and soil invigoration to promote root growth and to aerate the soil.

Tree Number	808
Tree Species	Pecan
Diameter (DBH)	19.5
Multi Stem	
Condition	Fair
Notes	fair structure & vigor, excessive impervious cover, utility pruned
Summary	Tree 808, a 19.5" pecan, is in fair condition. Nearly 100% of the CRZ is covered with impervious material. The pecan has limited amounts of tip dieback and has been utility pruned on the E and NE. There is a moderate amount of squirrel damage throughout the canopy. With careful mitigation work, the pecan is a fair candidate for preservation. TMS recommends careful demolition and soil invigoration to promote root growth and to aerate the soil.

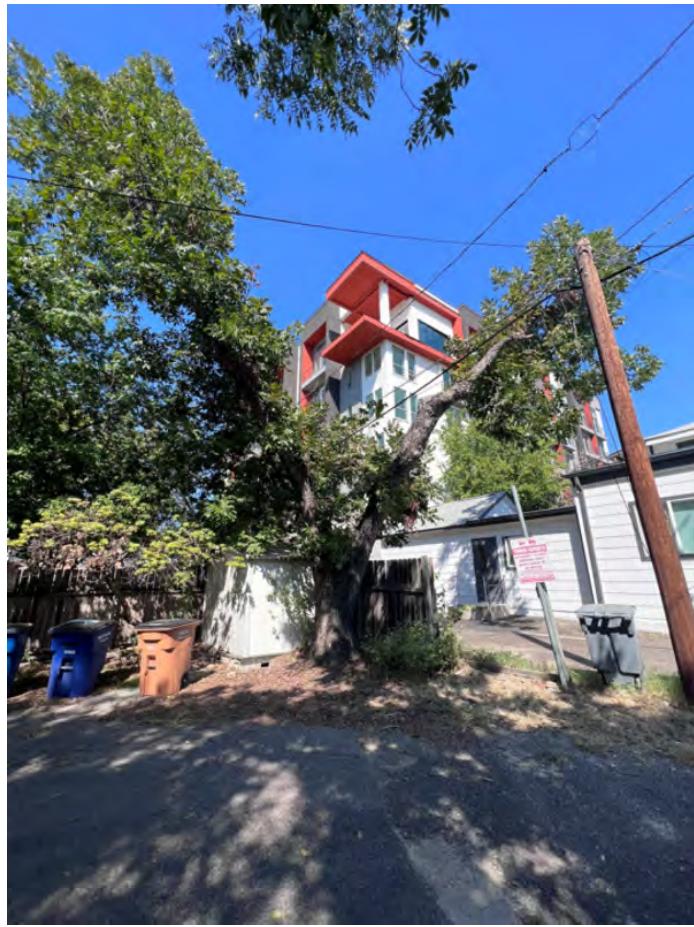
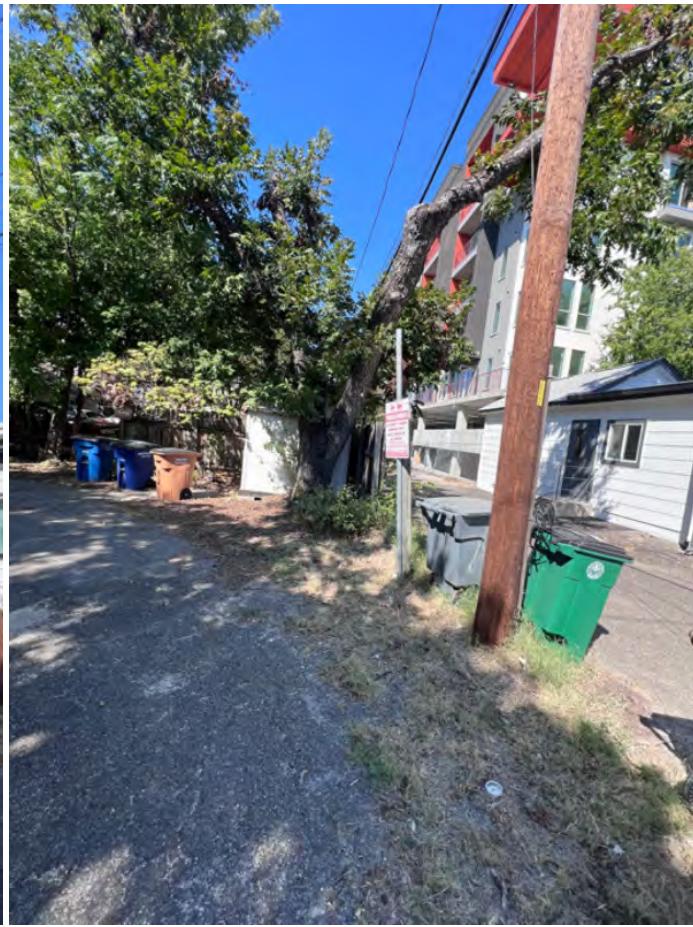
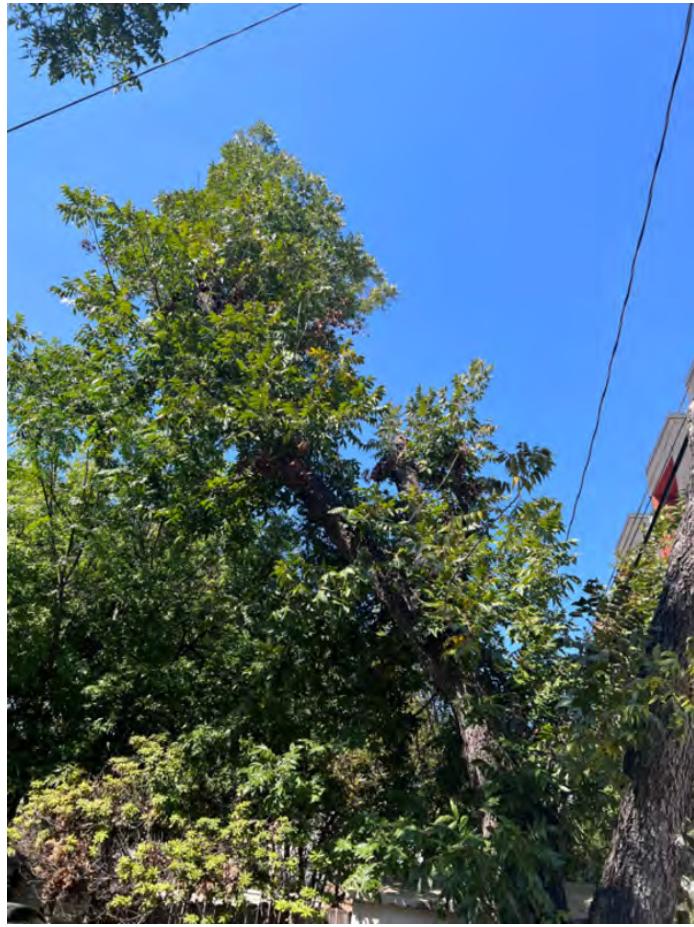
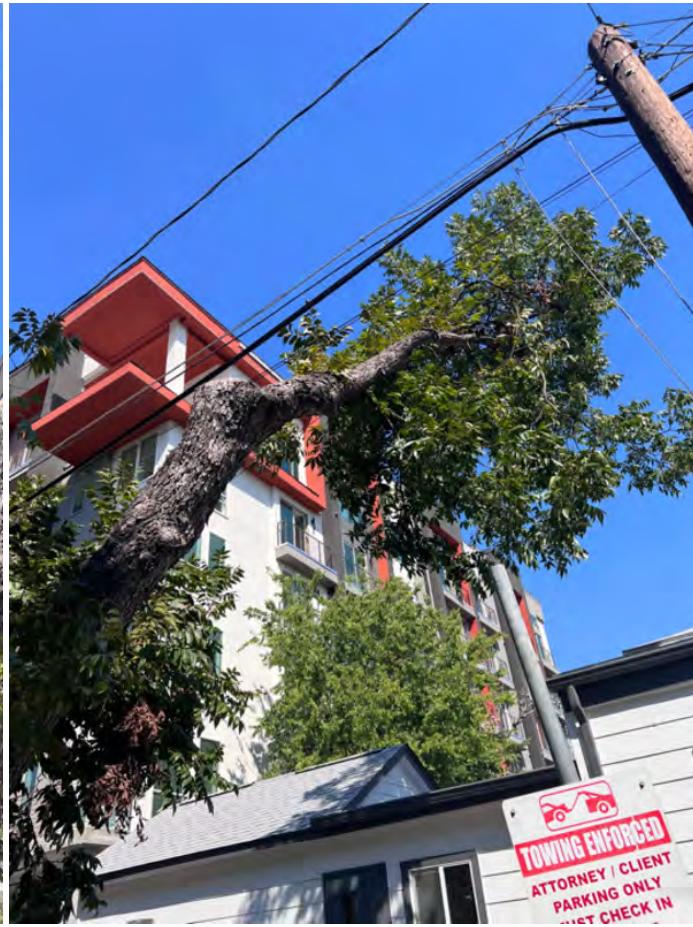
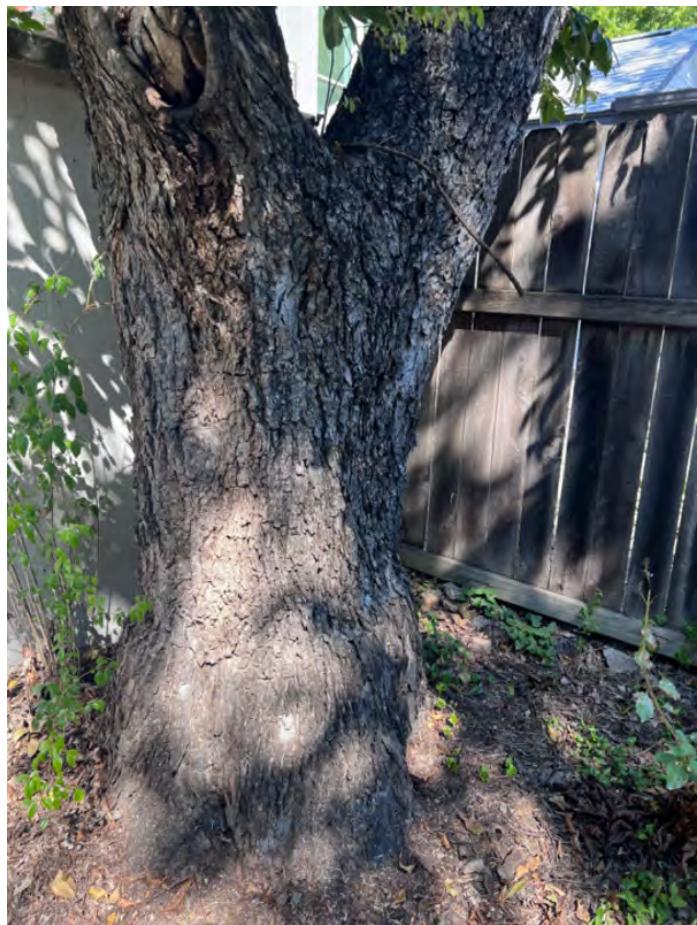
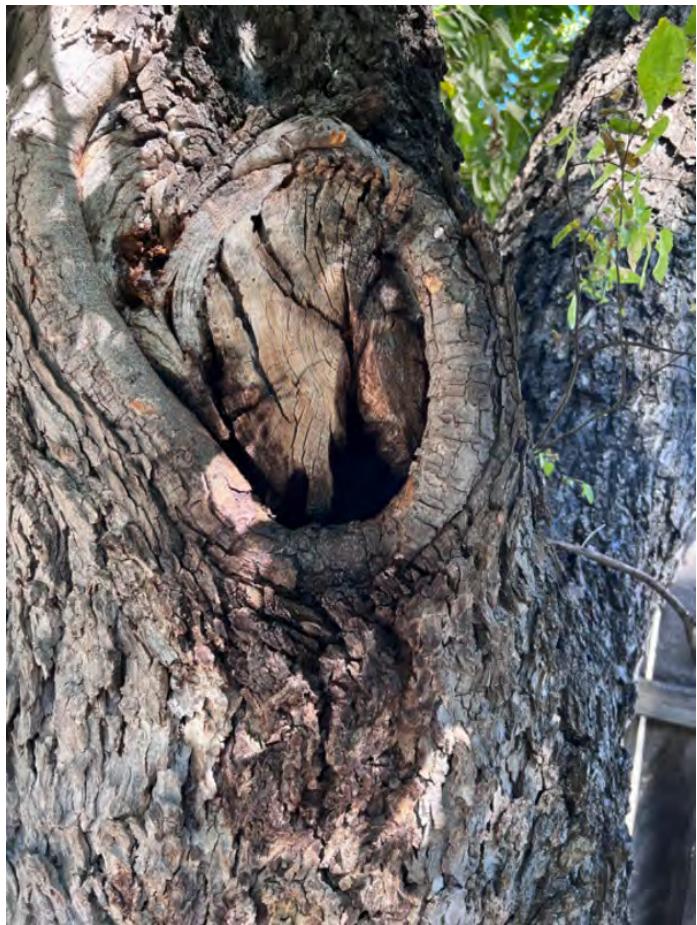
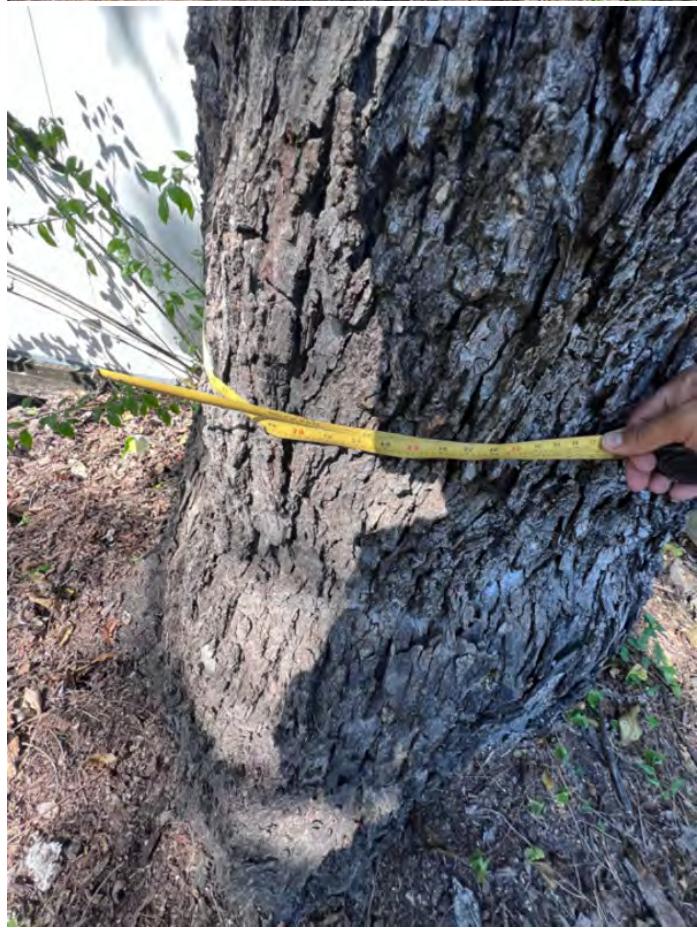
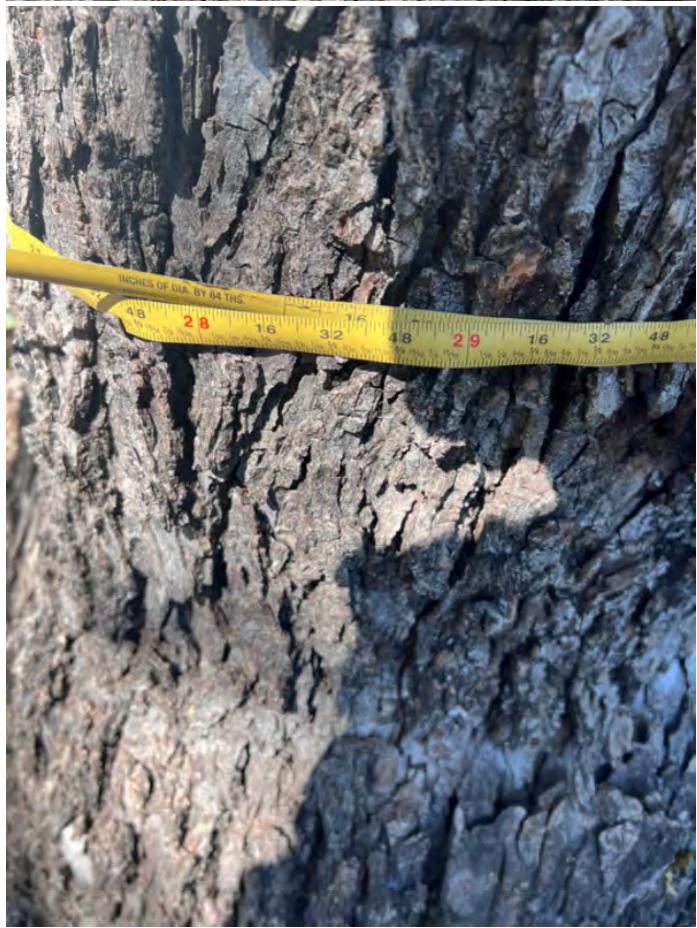
- **T809**, a 28" pecan, is in low fair condition. Approximately 75% of the CRZ is covered with impervious material. The pecan has been heavily utility pruned and has been left with an abnormal structure. The pecan has limited amounts of tip dieback and squirrel damage throughout the canopy. The pecan is a low fair candidate for preservation.

Tree Number	809
Tree Species	Pecan
Diameter (DBH)	28
Multi Stem	
Condition	Fair
Notes	excessive impervious cover, utility pruned, fair vigor, poor structure
Summary	Tree 809, a 28" pecan, is in low fair condition. Approximately 75% of the CRZ is covered with impervious material. The pecan has been heavily utility pruned and been left with an abnormal structure. The pecan has limited amounts of tip dieback and squirrel damage throughout the canopy. The pecan is a low fair candidate for preservation.
