Lost Herd Inc.
806 W. 11th Street
Austin, TX 78701

Introduction:

Tree Mann Solutions to inspect, identify, measure DBH, and provide condition rating with supportive notes for 6 designated trees (T806, T807, T808, T809, T810, and T811). TMS to review provided documents and make preservation/removal recommendations where warranted. Summary report with photos provided for team use.

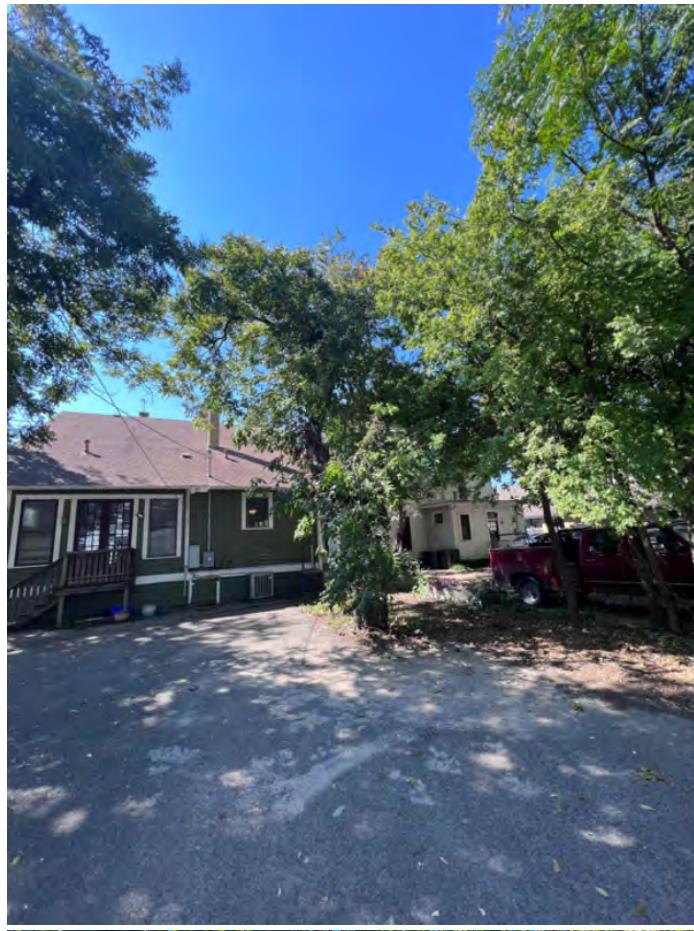
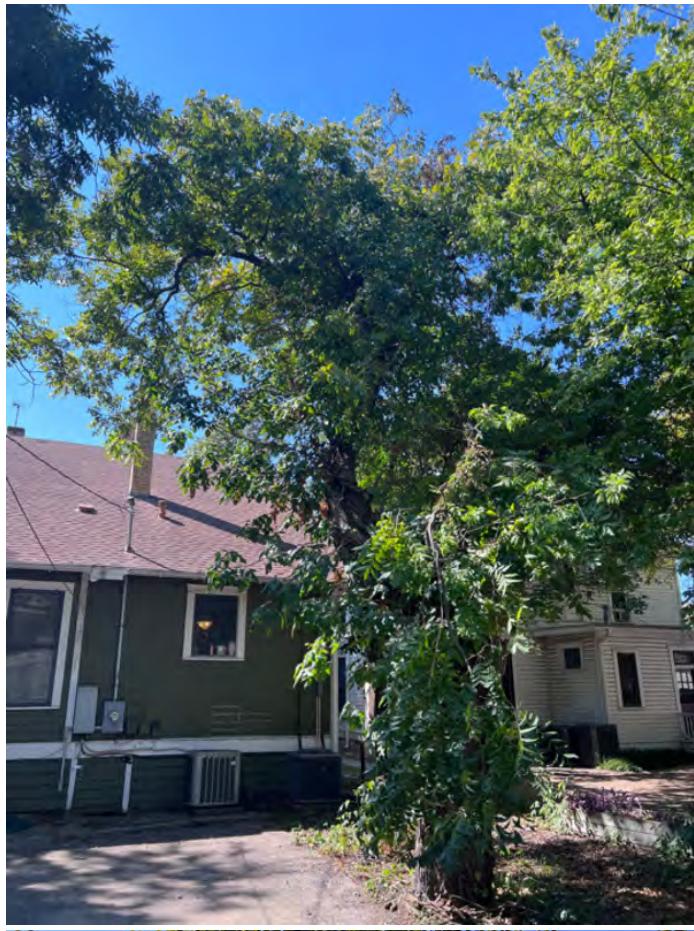
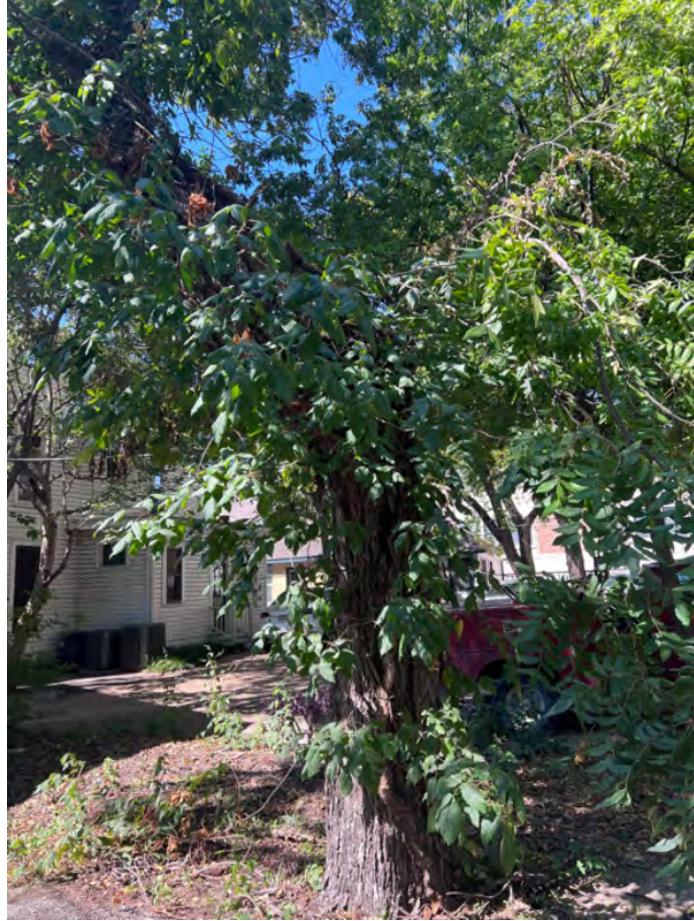
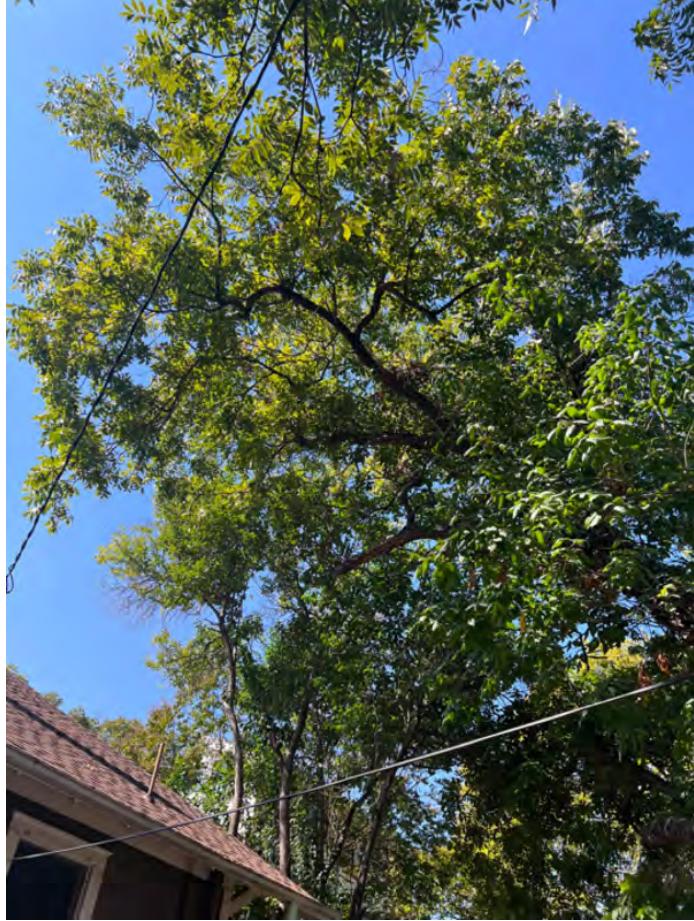
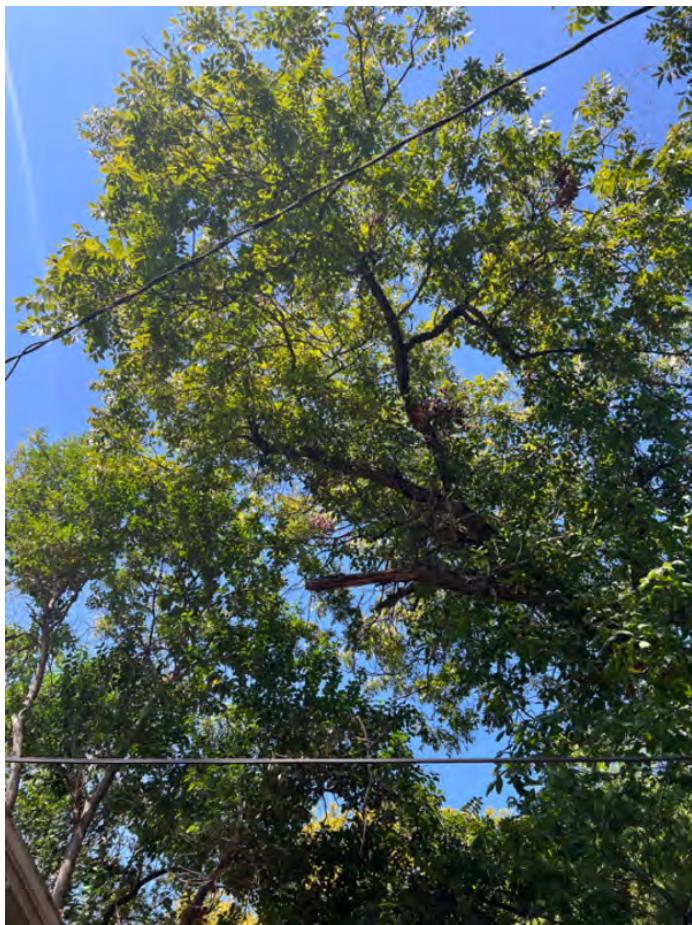
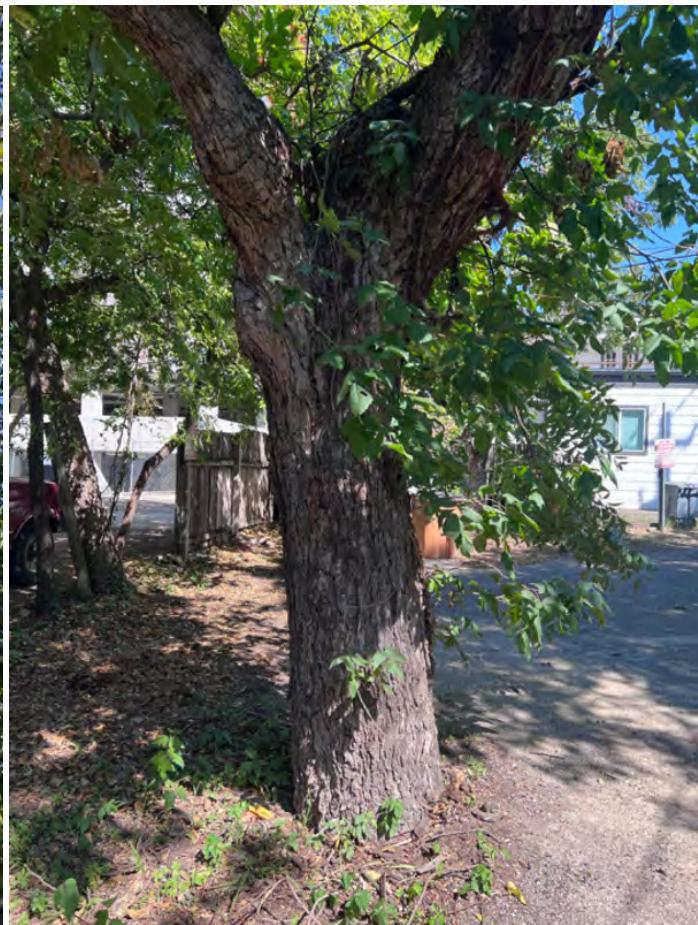
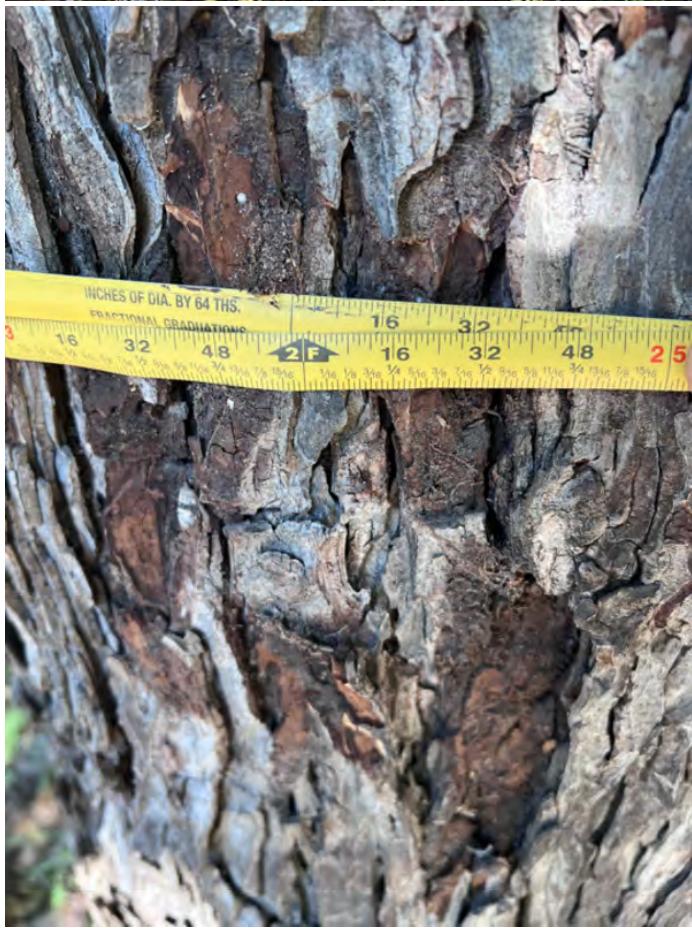
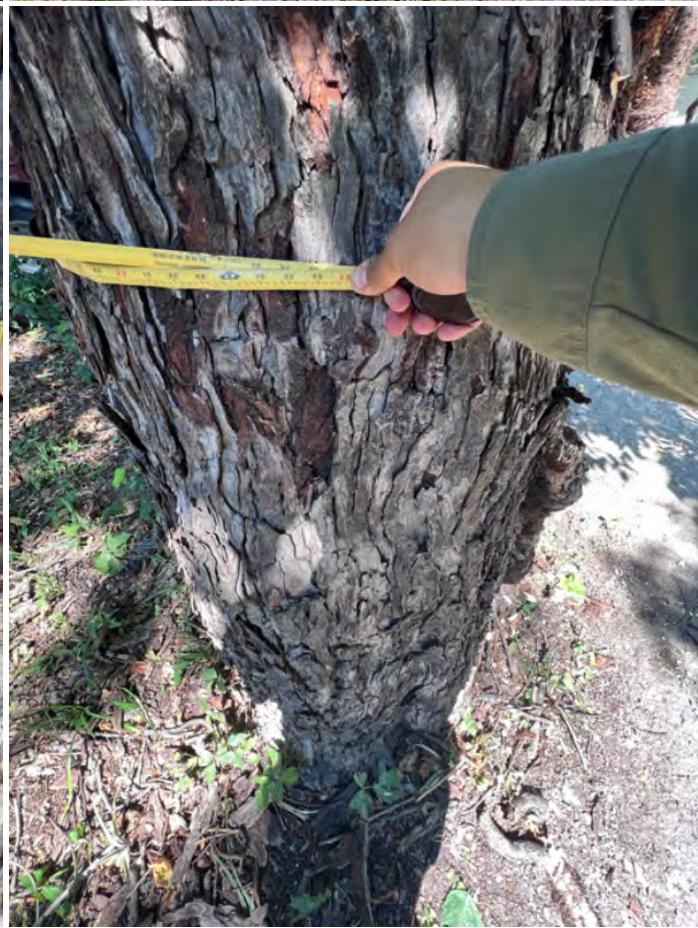
- **T810**, a 23.5" pecan, is in fair condition. Approximately 50% of the CRZ is covered with impervious material. There is significant poison ivy cover in the lower canopy. The pecan is moderately unbalanced SW. The pecan has limited amounts of tip dieback or deadwood accumulation. There are two limbs that have previously failed and should be clean cut. With careful mitigation work, especially on the E side of the tree, the pecan is a fair candidate for preservation. TMS recommends careful demolition and soil invigoration to promote root growth and to aerate the soil.

Tree Number	810
Tree Species	Pecan
Diameter (DBH)	23.5
Multi Stem	
Condition	Fair
Notes	fair structure & vigor, significant impervious cover, significant vine cover
Summary	Tree 810, a 23.5" pecan, is in fair condition. Approximately 50% of the CRZ is covered with impervious material. There is significant poison ivy cover in the lower canopy. The pecan is moderately unbalanced SW. The pecan has limited amounts of tip dieback or deadwood accumulation. There are two limbs that have previously failed and should be clean cut. With careful mitigation work especially on the E side of the tree, the pecan is a fair candidate for preservation. TMS recommends careful demolition and soil invigoration to promote root growth and to aerate the soil.

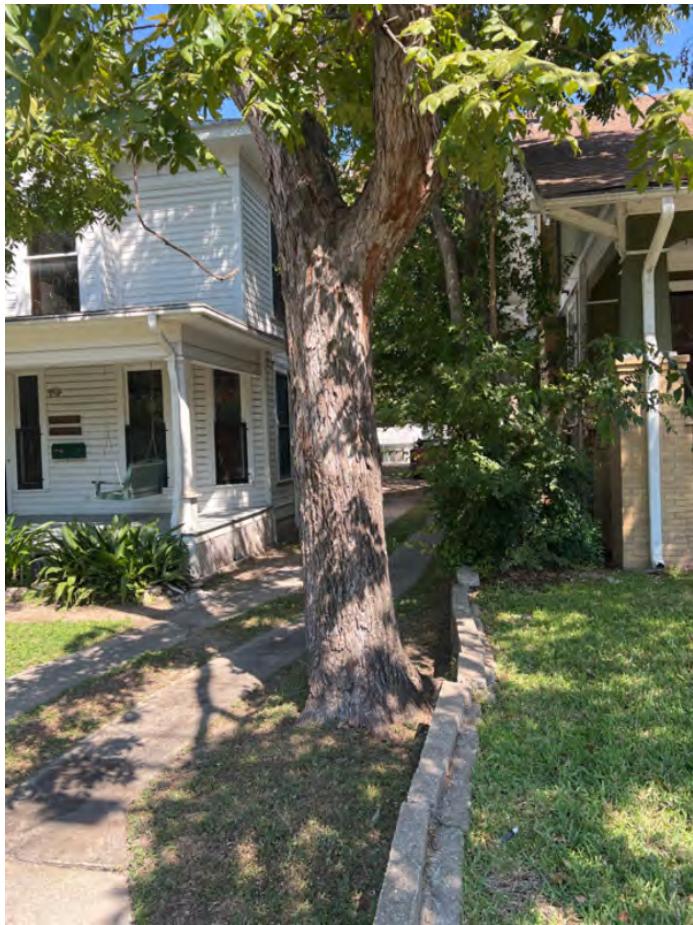
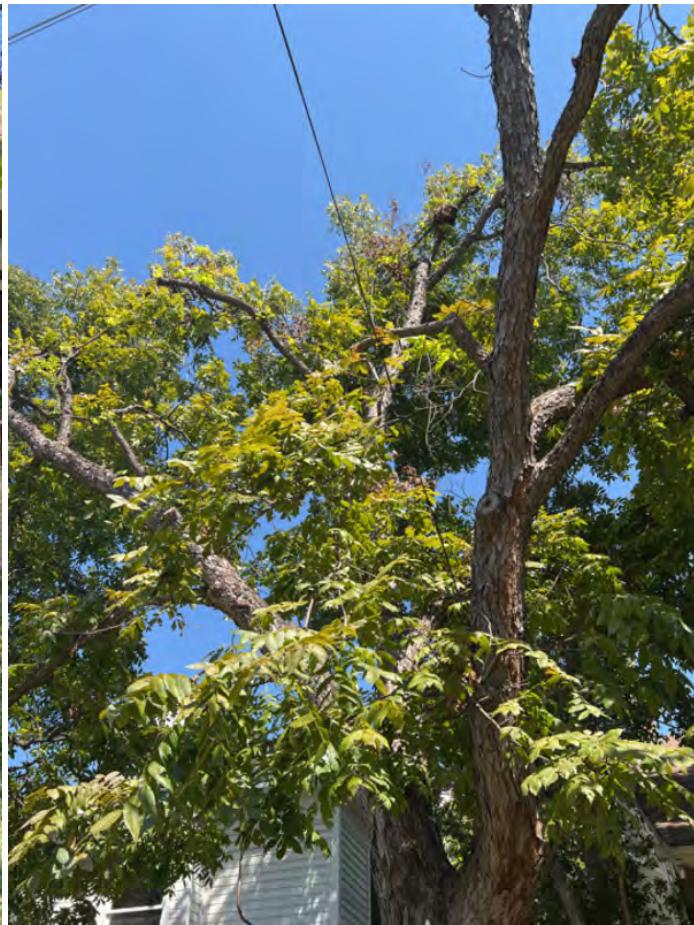
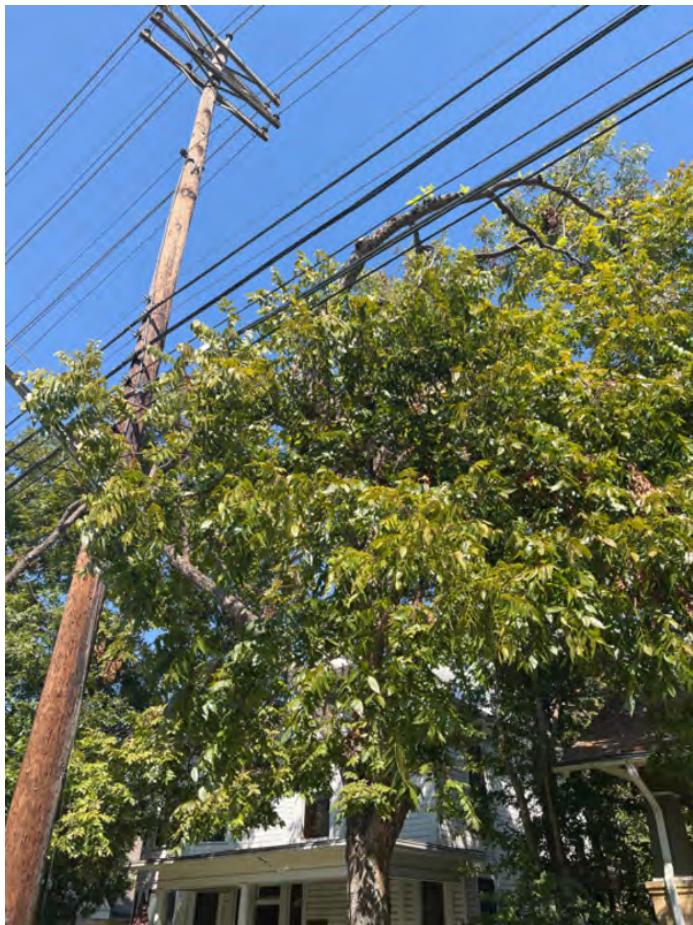
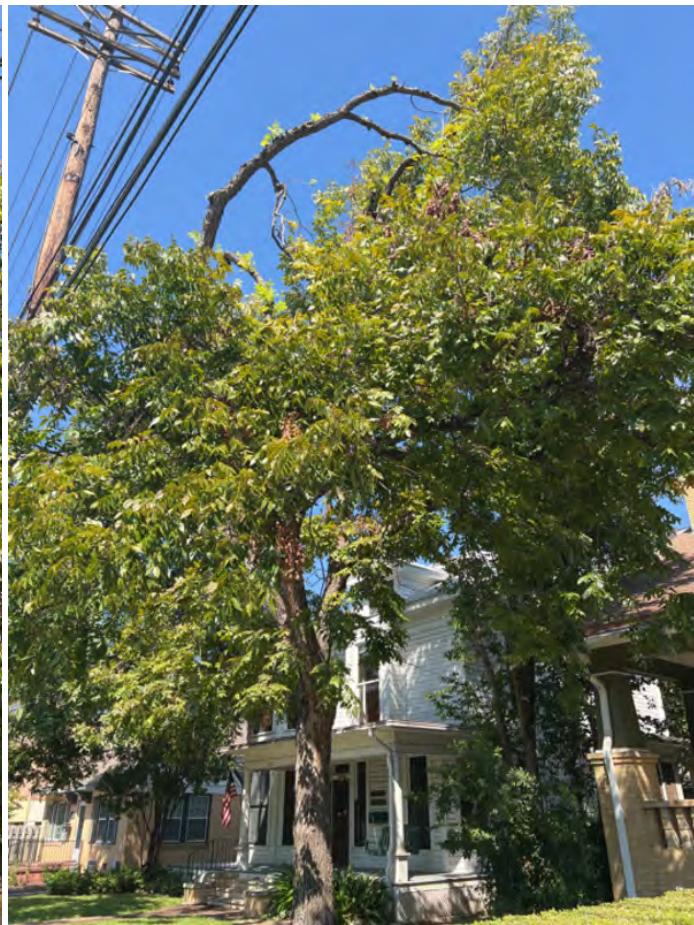
- **T811**, a 22" pecan, is on the neighboring property, but has an overlapping CRZ. The pecan is in fair condition, despite being heavily utility pruned to the S. The tree is a fair candidate for preservation.

Tree Number	811
Tree Species	Pecan
Diameter (DBH)	22
Multi Stem	
Condition	Fair
Notes	
Summary	Tree is in neighboring property, but has an overlapping CRZ. The pecan is in fair condition, despite being heavily utility pruned to the S. Tree is a fair candidate for preservation.
