CONSERVATION EASEMENT DOCUMENTATION REPORT

The 41-Acre El Pico Property

Webb County, Texas

EDR Issued: January 2025

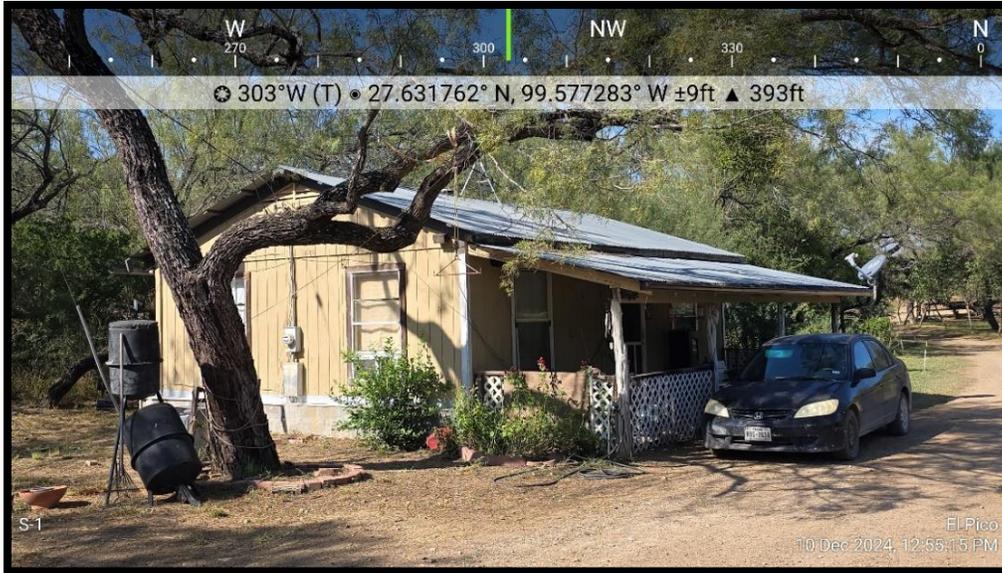
Photo 1. House located at point S-1 in Figure 5

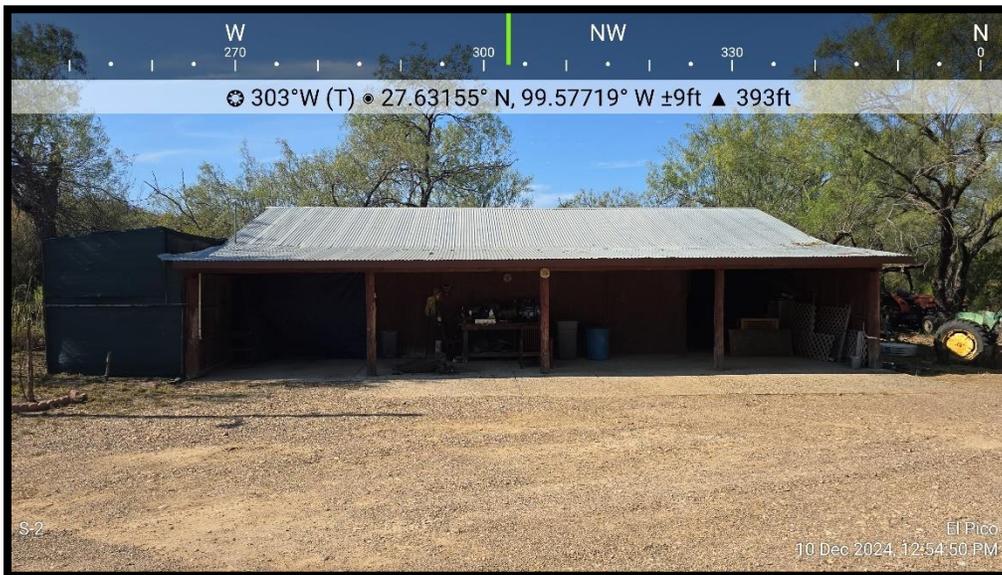
Photo 2. Barn located at point S-2 in Figure 5

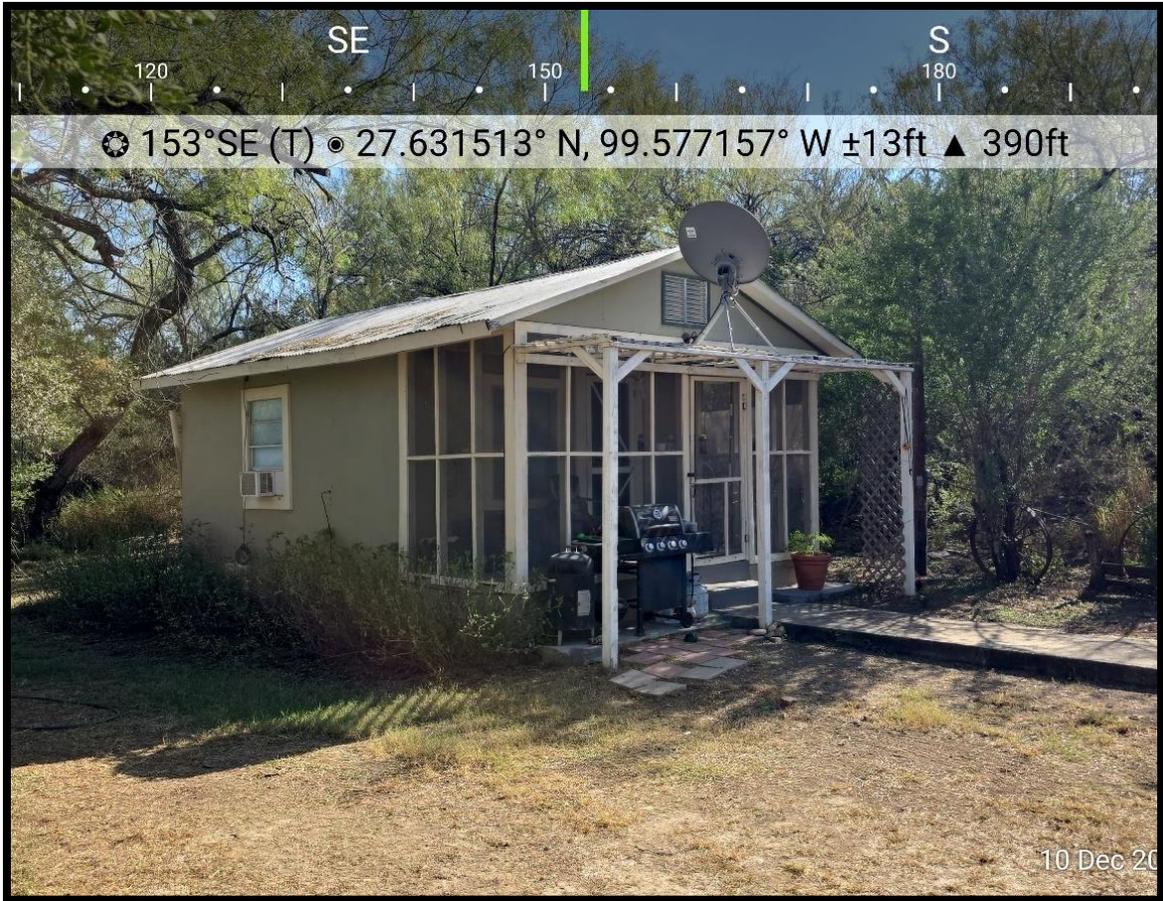
Photo 3. Cottage house located at point S-3 in Figure 5

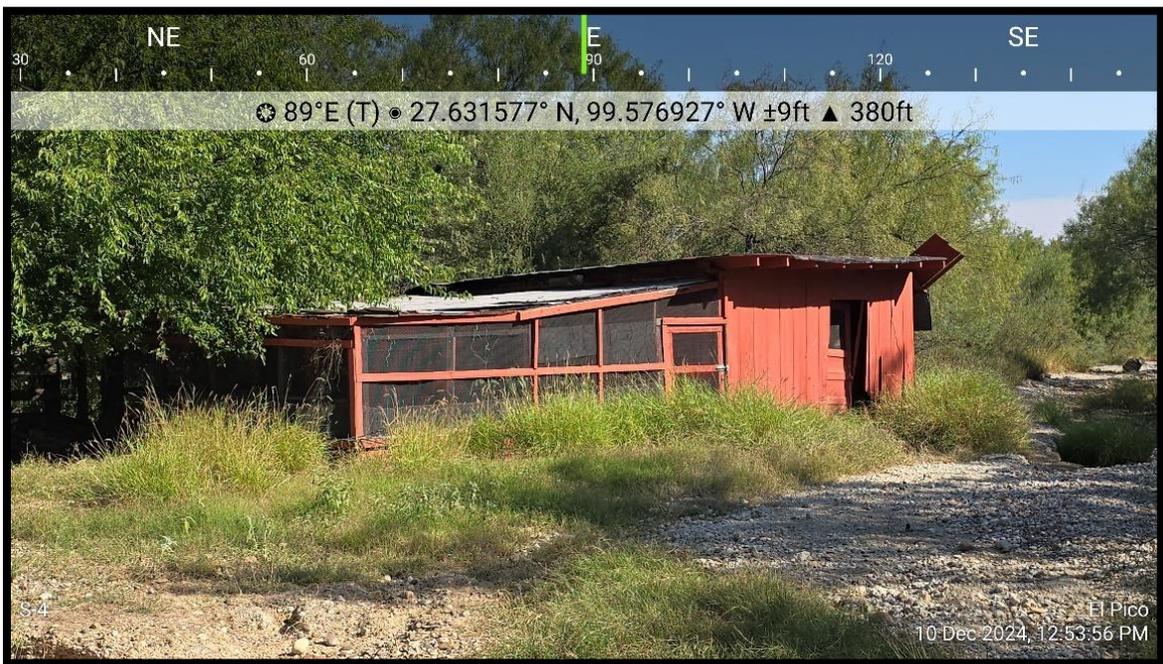
Photo 4. Animal shed located at point S-4 in Figure 5

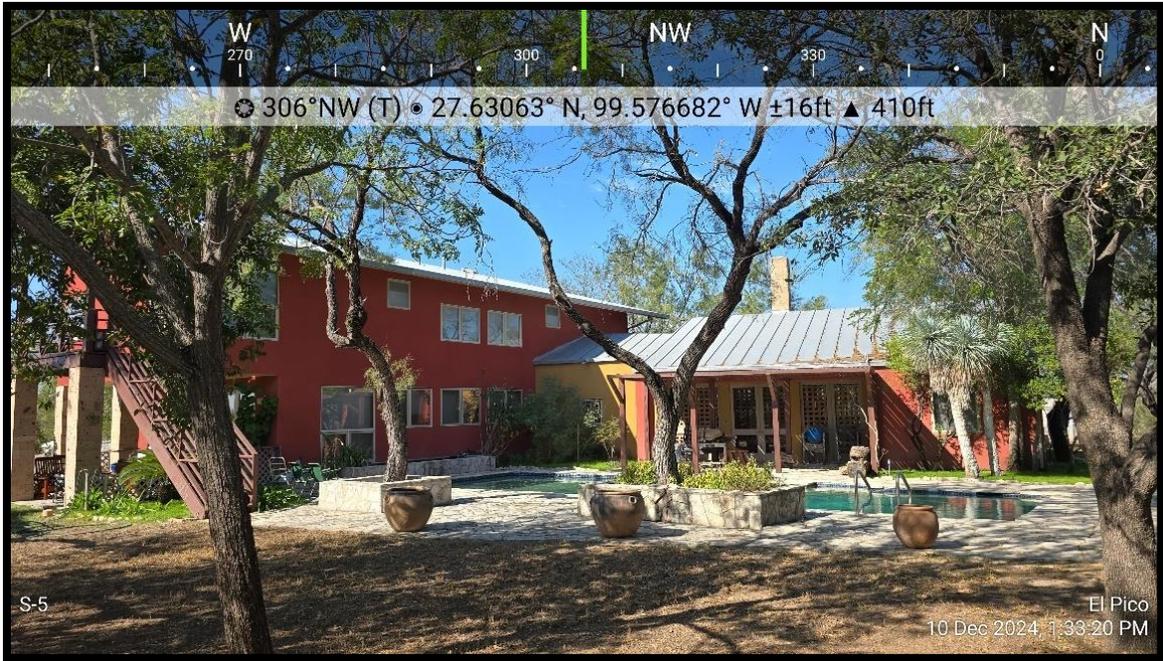
Photo 5. Main residence located at point S-5 in Figure 5

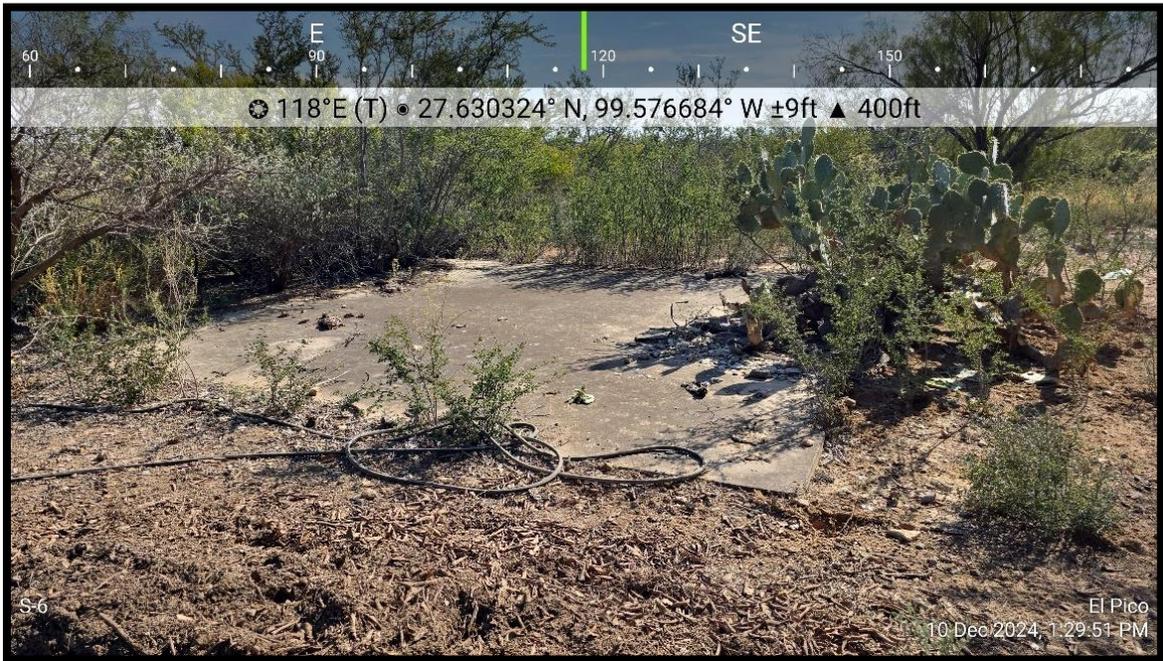
Photo 6. Concrete pad located at point S-6 in Figure 5

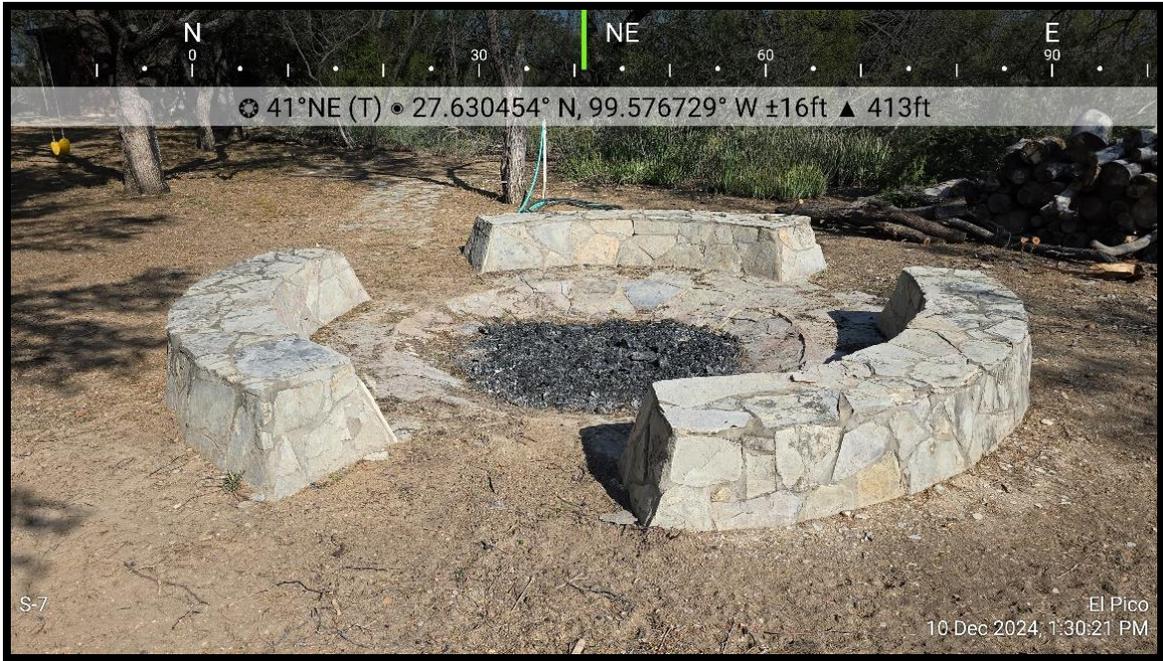
Photo 7. Stone fire pit located at point S-7 in Figure 5

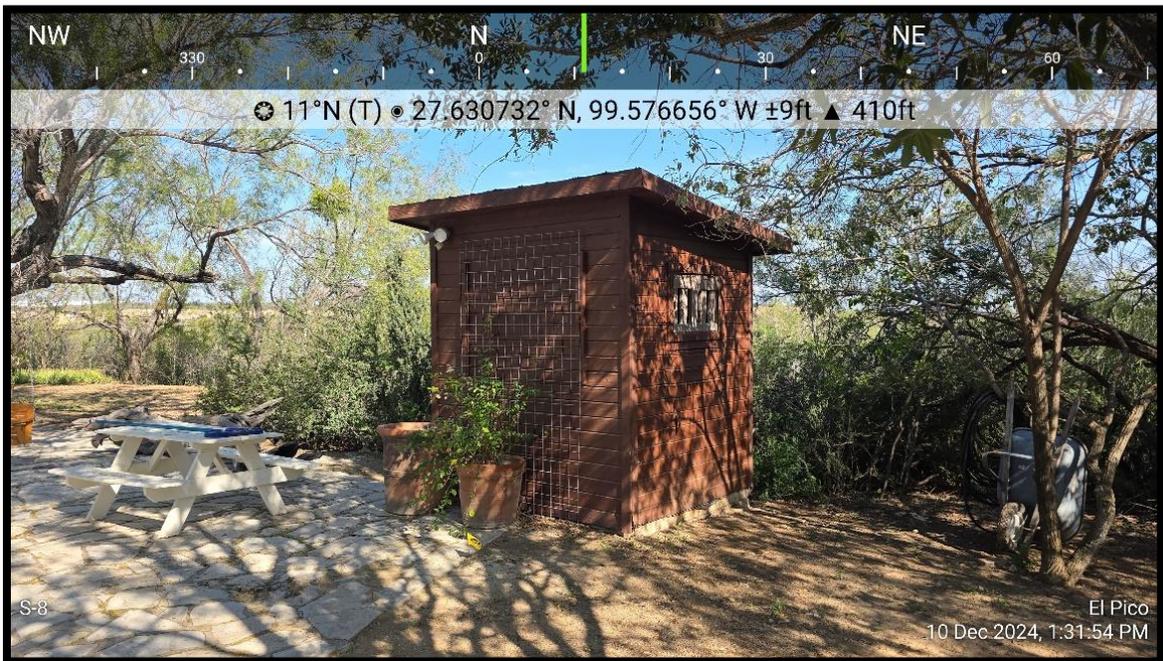
Photo 8. Pool house located at point S-8 in Figure 5

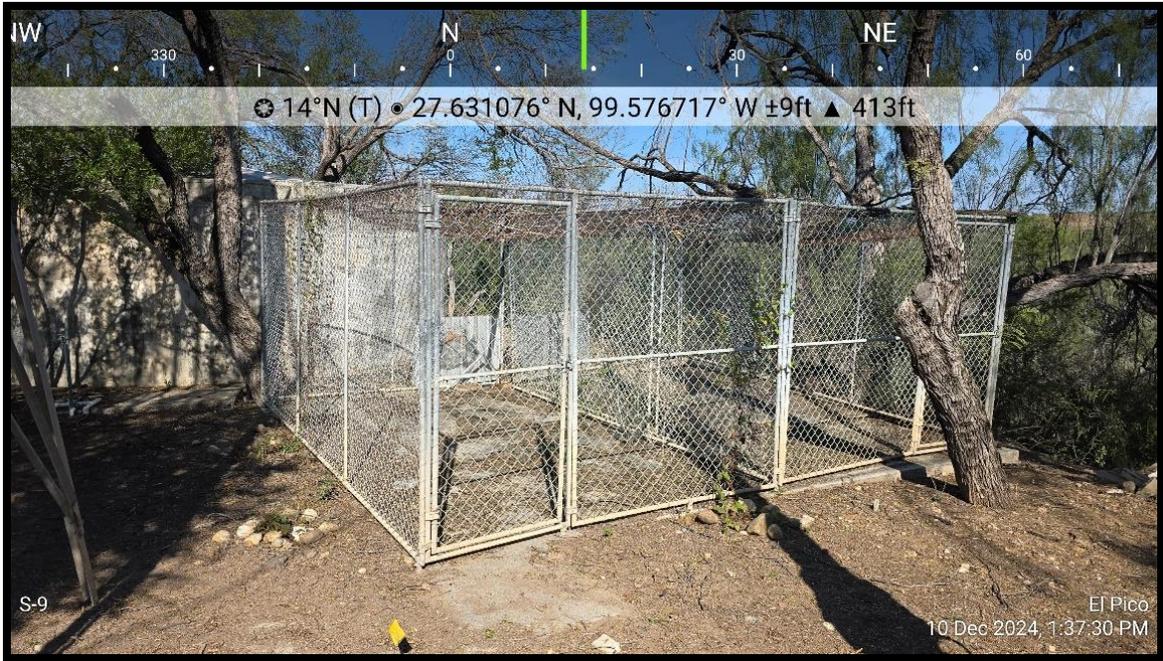
Photo 9. Dog kennel located at point S-9 in Figure 5

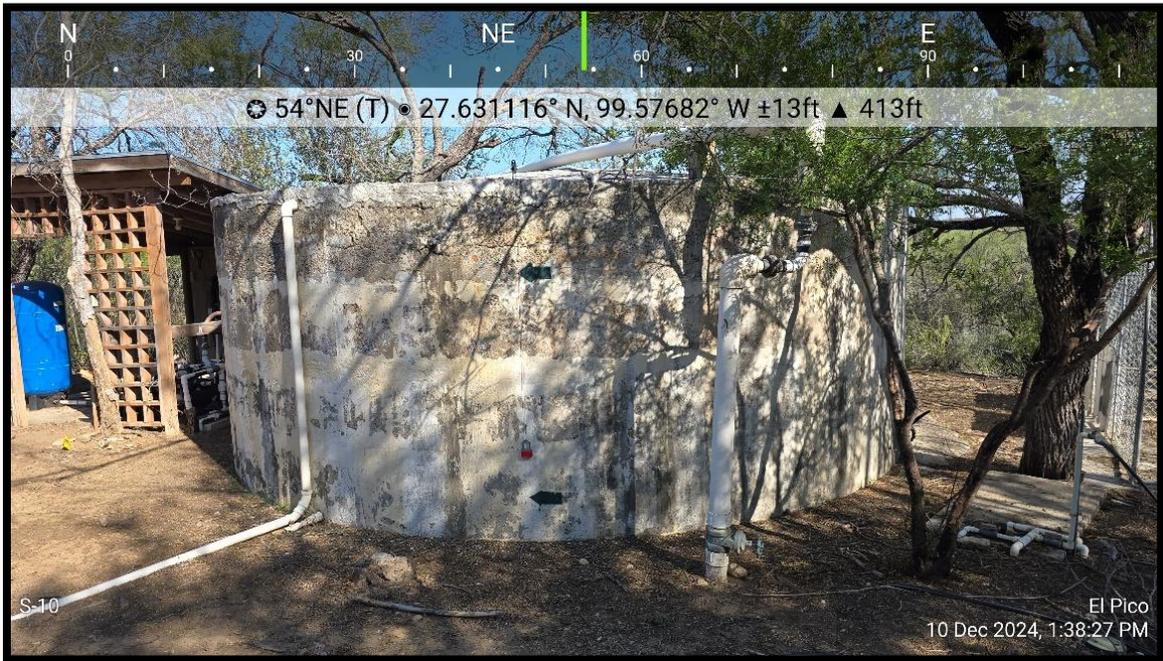
Photo 10. Water tank (cistern) located at point S-10 in Figure 5

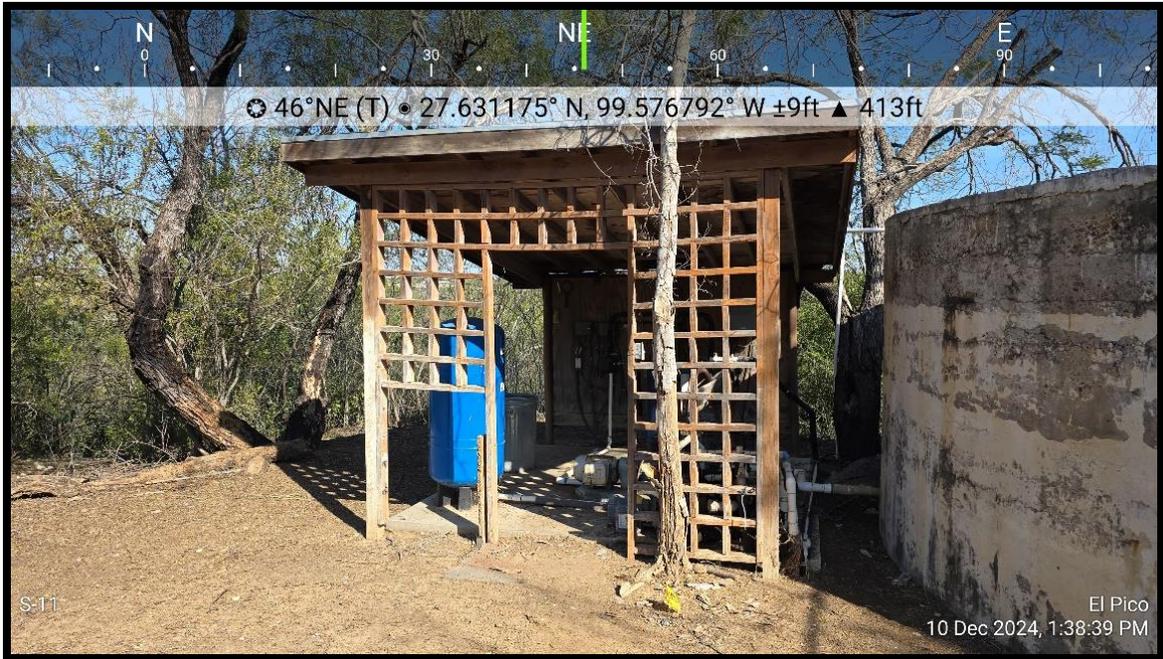
Photo 11. Cistern Pump Slab and Covering located at point S-11 in Figure 5

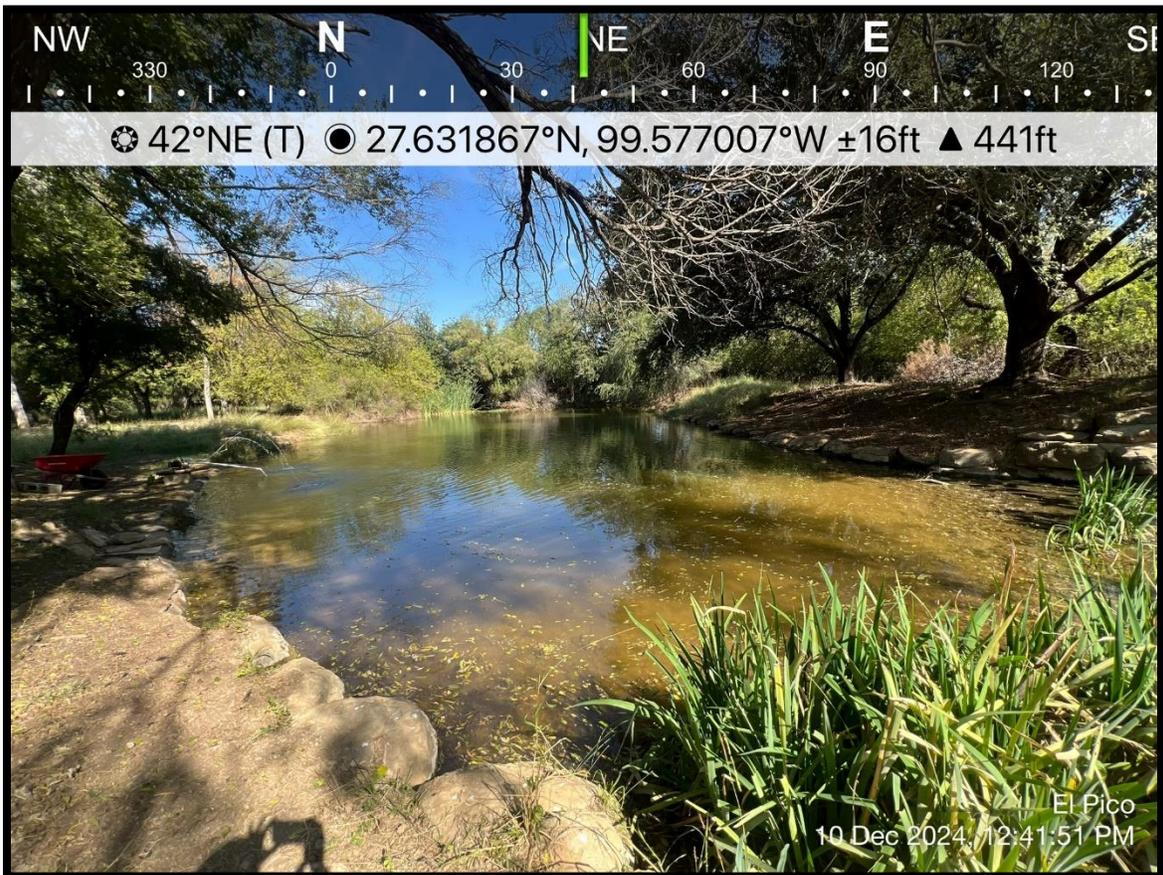
Impervious cover on the property associated with vertical structures is approximately 11,390 ft² (0.26 acres). Two stock tanks are located on the property. One of the tanks is lined and comprises approximately 6,200 ft² (0.14 acres) of impervious cover. Total impervious cover (excluding gravel, caliche, and earthen roads) on the property comprises approximately 0.98% of the entire property (**Table 2**). **Figure 5** shows the general location of these features on the property.

Photo 12. Lined pond located in the northwestern portion of the property

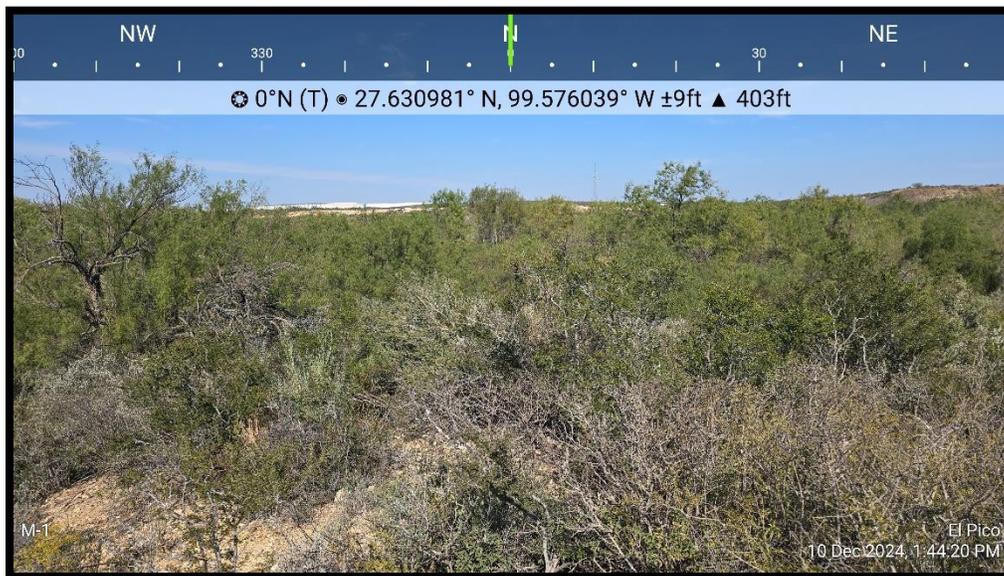
Photo 13. View north from Monitoring Point 1

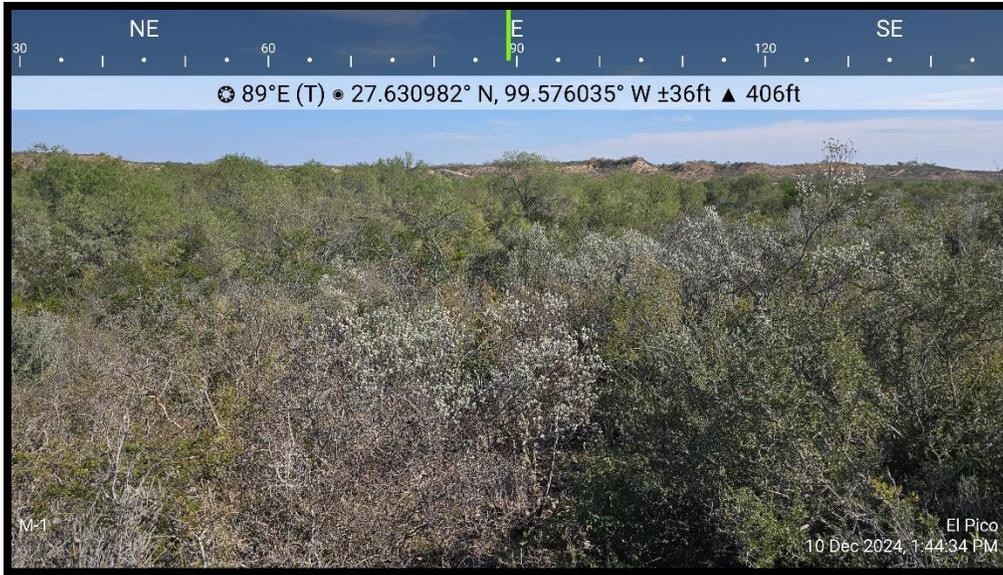
Photo 14. View east from Monitoring Point 1

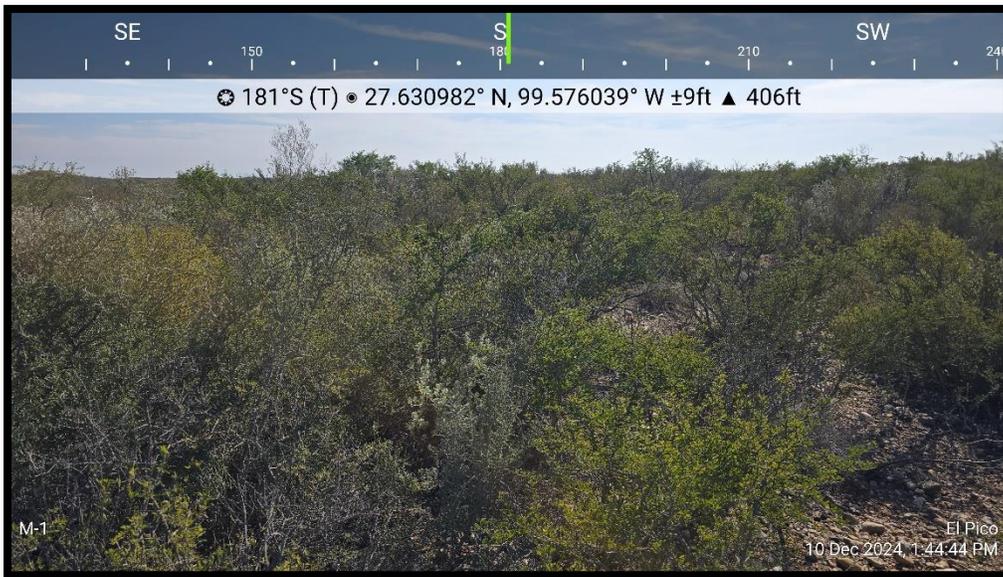
Photo 15. View south from Monitoring Point 1

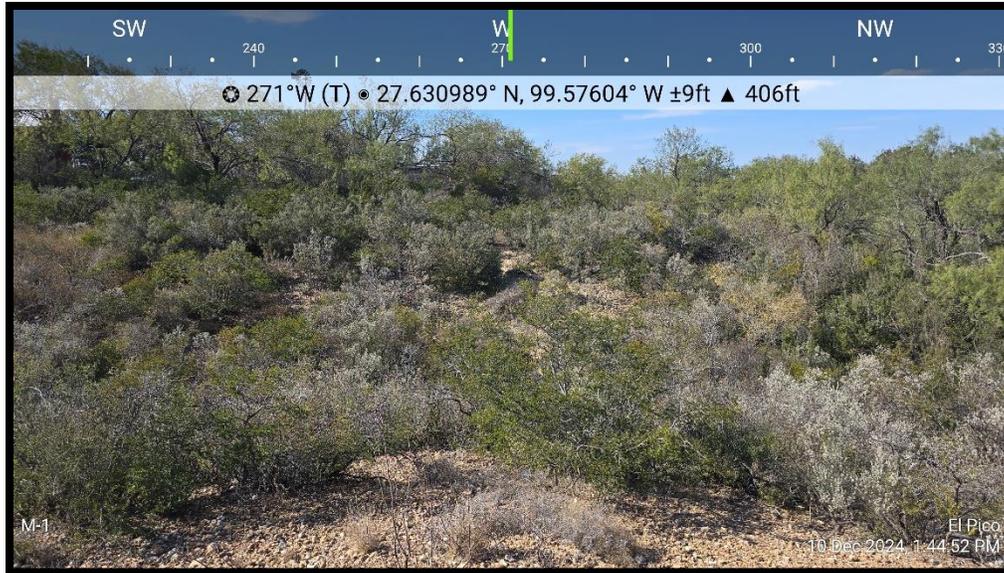
Photo 16. View west from Monitoring Point 1

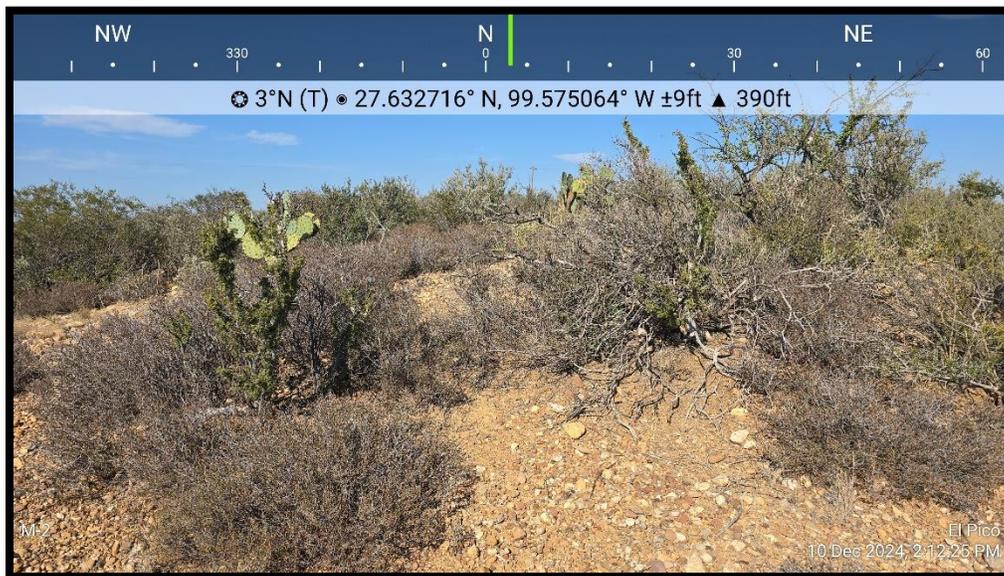
Photo 17. View north from Monitoring Point 2

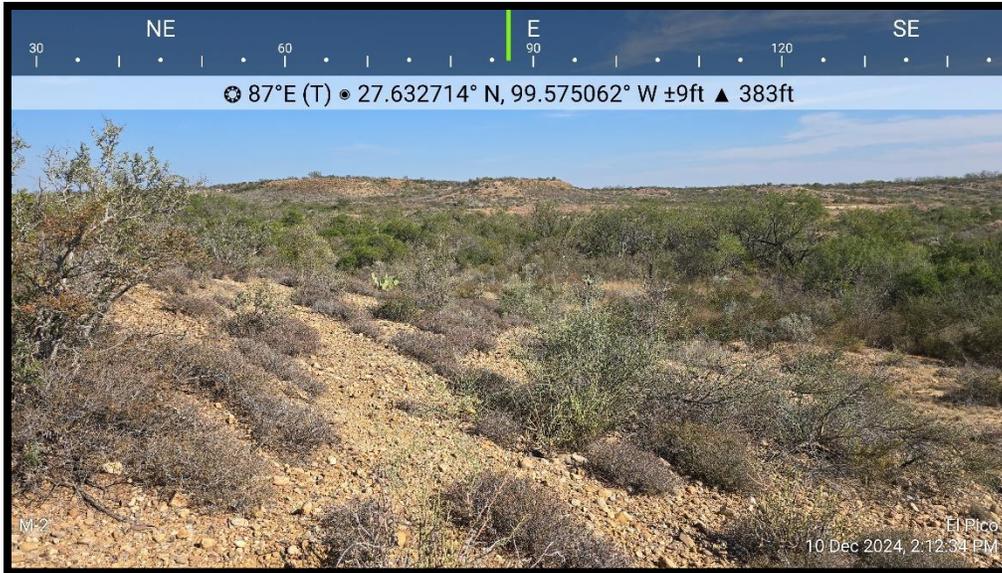
Photo 18. View east from Monitoring Point 2

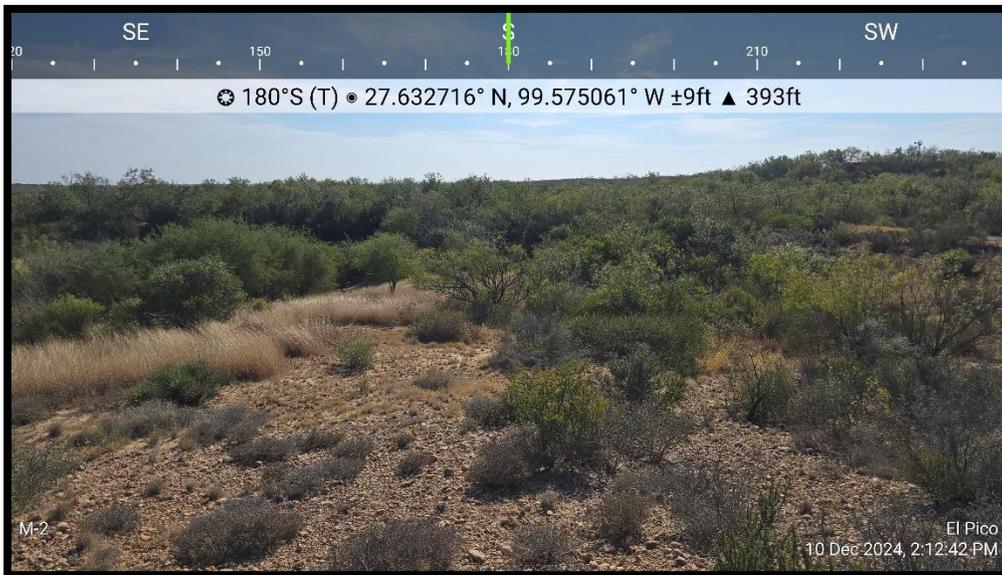
Photo 19. View south from Monitoring Point 2

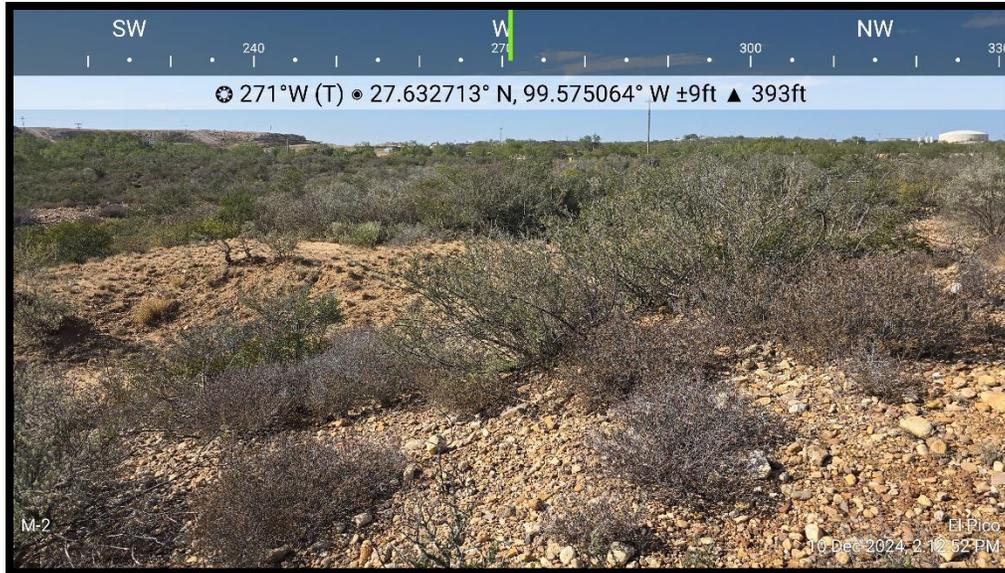
Photo 20. View west from Monitoring Point 2

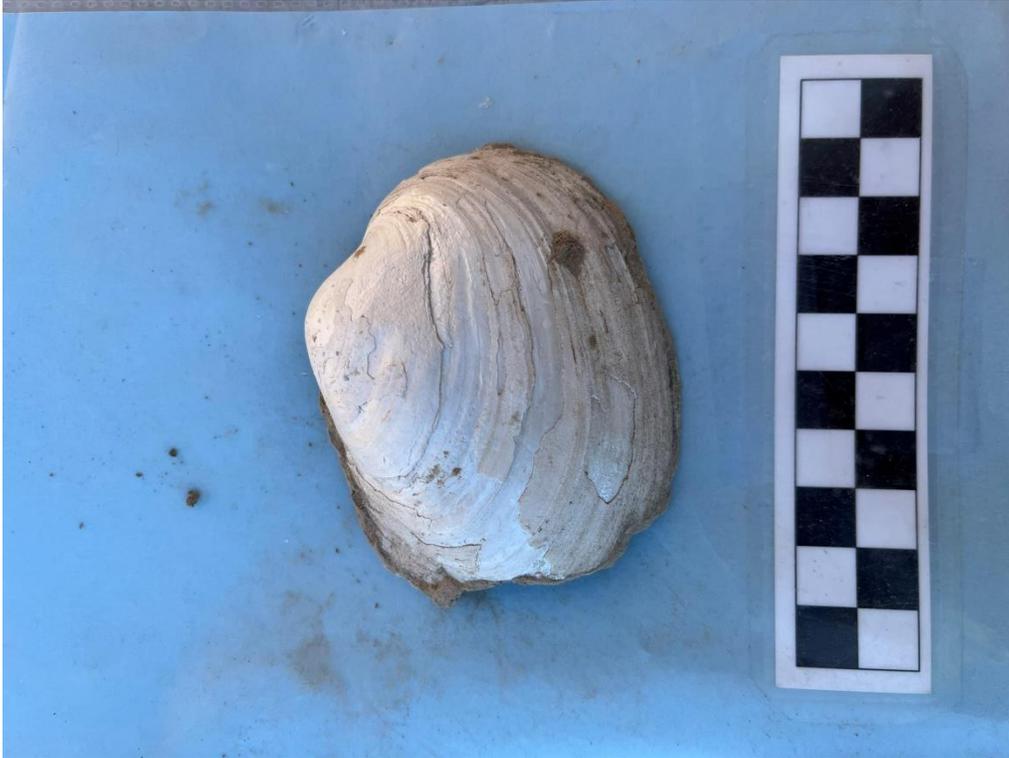
Reconnaissance of the erosional slope between the floodplain and the adjoining terrace/uplands yielded numerous observations of freshwater mussel shell (**Figure 5**) and chipped stone artifacts (**Figure 6**) apparently washing down the slope. Exploration of the surface above the slope resulted in the discovery of abundant similar materials: mussel shells, chipped stone artifacts, cores, and scattered burned rock. Aside from a portion of this first terrace above the floodplain that was obviously pushed into a berm to capture stormwater, there were artifacts scattered across the landform (**Figure 7**). No temporally

Figure 5. Mussel shell observed near transition from floodplain to upland terrace.

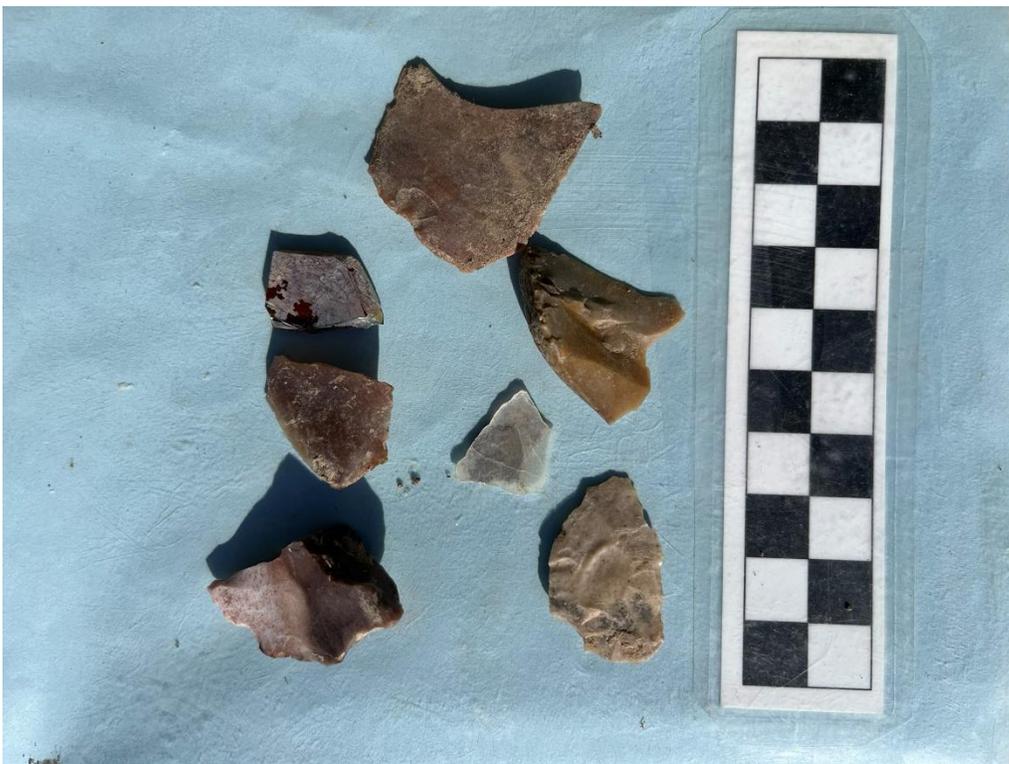
Figure 6. Chipped stone, mussel shell, and glass artifacts observed at the surface from floodplain to upland terrace.

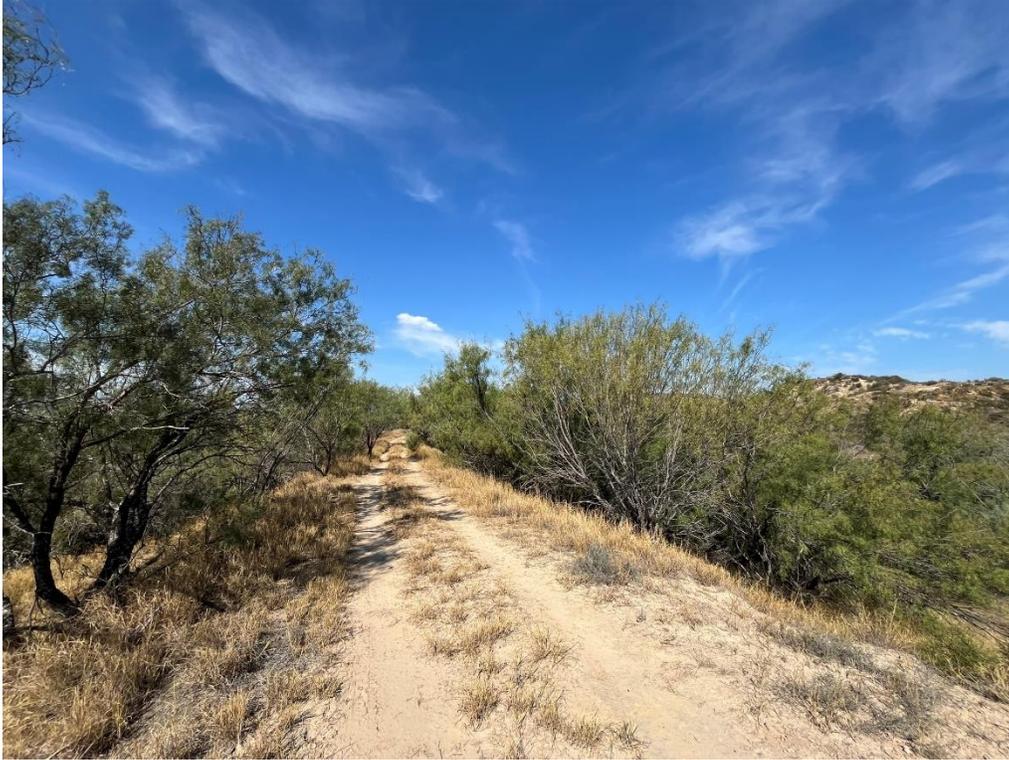
Figure 7. Berm with stormwater catchment to photo right. Note the lack of gravels in roadway.

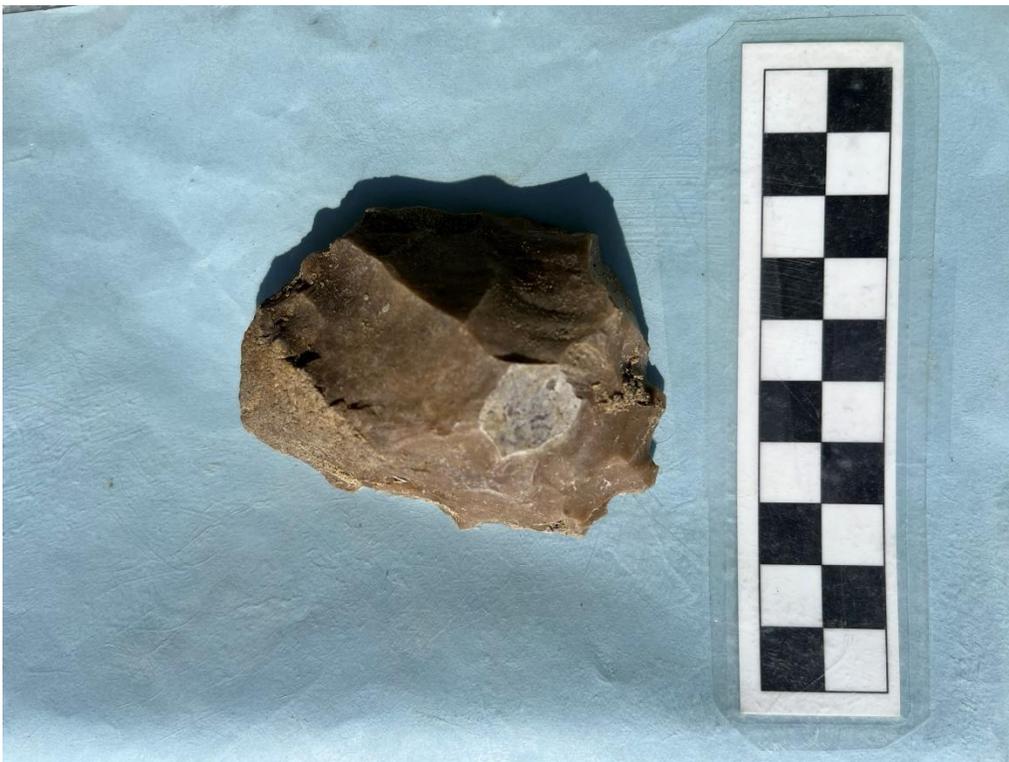
Figure 8. Scraper, unifacially worked chipped stone tool.

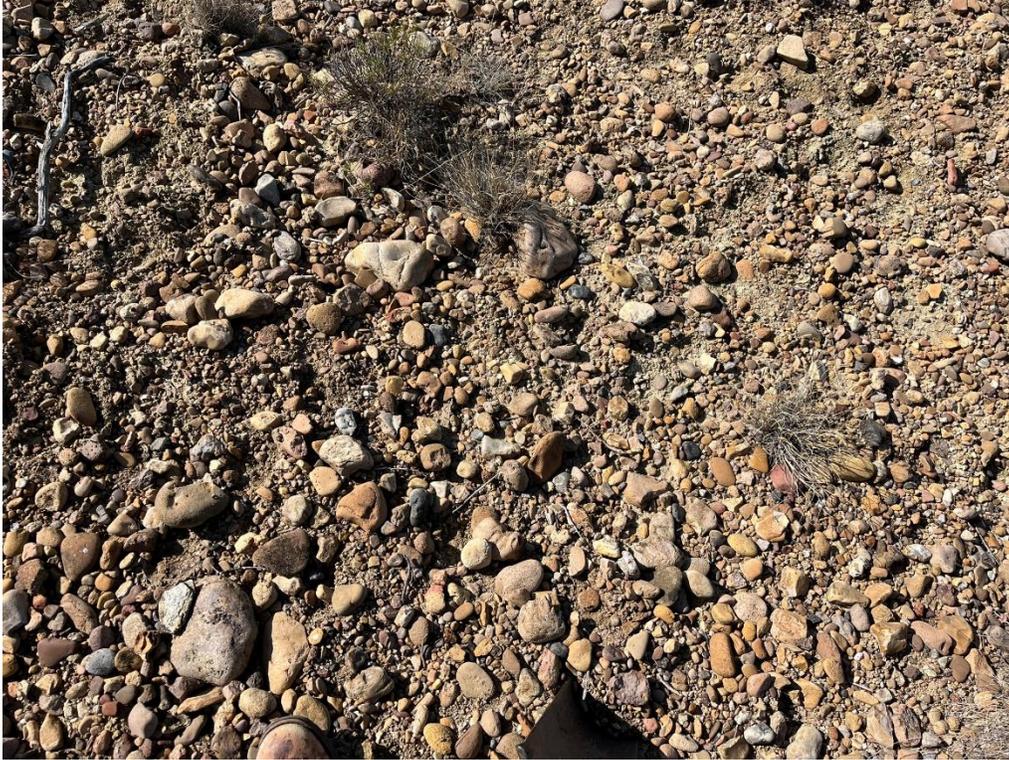
Figure 9. Uvalde gravels deposit with chipped stone intermixed in upland setting.

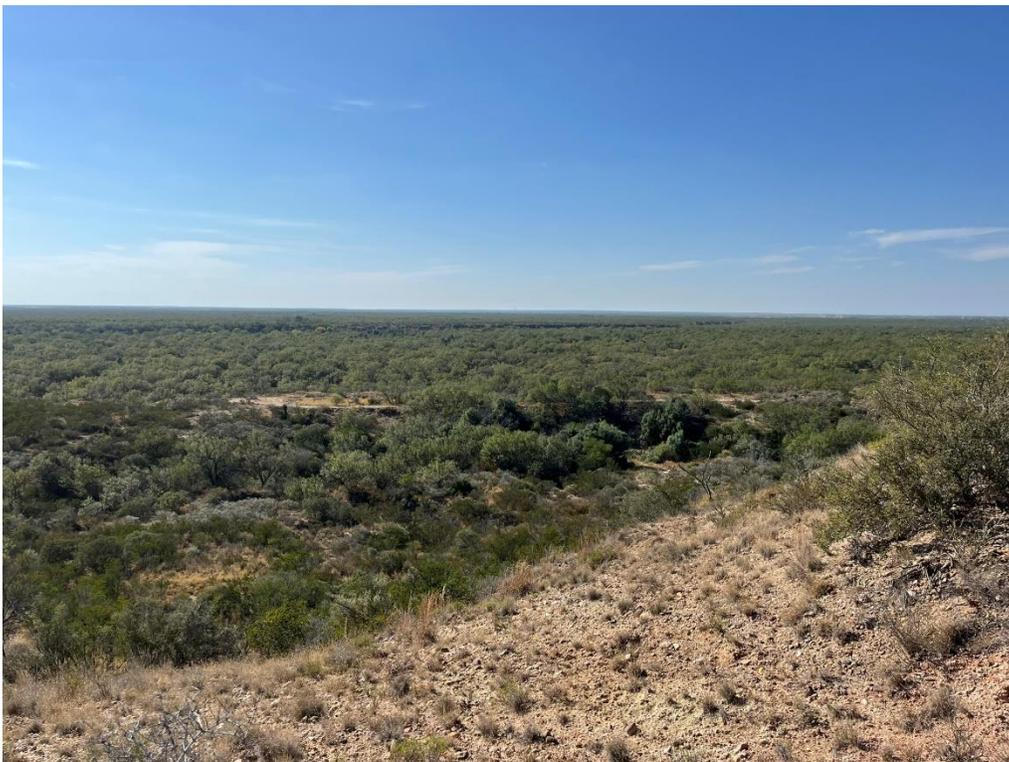
Figure 10. View across upland and floodplains from prominent high-elevation feature on the landscape.
