Pre-Demolition Asbestos-Containing Material and Lead-Based Paint Survey Report

**Site: Former Residence
8207 S. South Shore Dr.
Chicago, Illinois 60617**

Survey Date: March 14, 2025

Project No.: A165500004

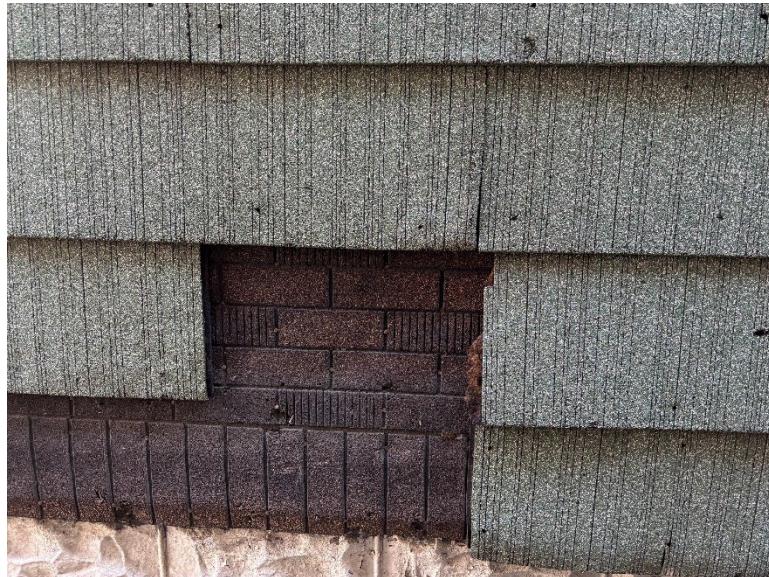
Photo 1: Exterior Brown Shingle Siding (ACM), Exterior of House

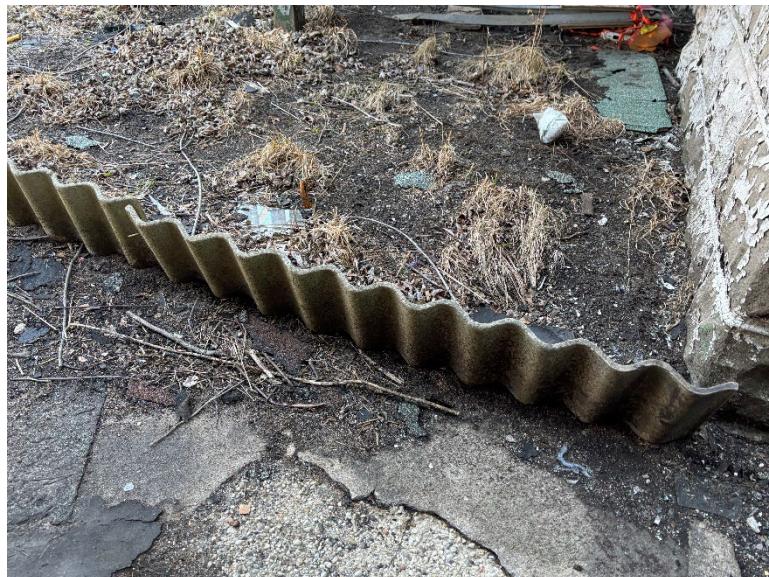
- Transite sheeting (landscape fence) in the front yard;
- 12"x12" floor tile, tan in the 2nd floor kitchen under the linoleum floor sheeting;
- Associated mastic for 12"x12" floor tile, tan in the 2nd floor kitchen;

These asbestos-containing materials were all in good condition.

Photo 2: Transite landscape fencing (ACM), Exterior West side of House

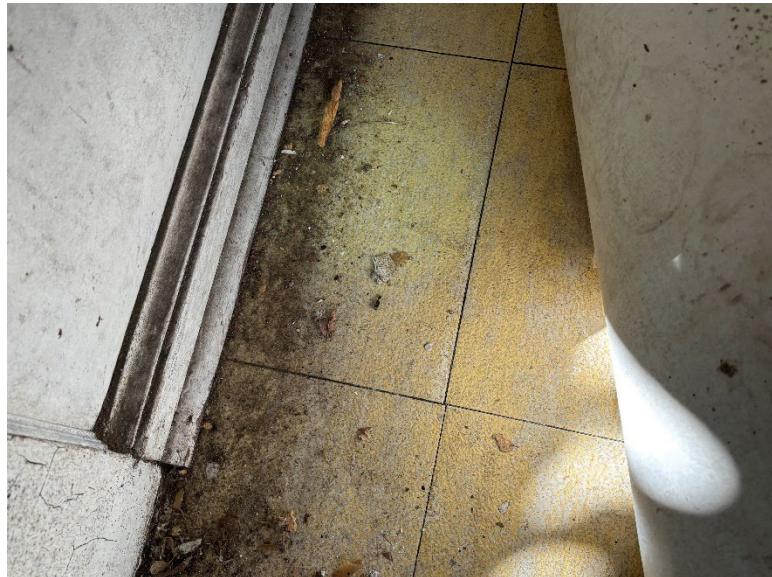
Photo 3: 12"x12" Floor Tile, Tan (ACM) and Associated Mastic (ACM) in 2nd floor Kitchen under linoleum sheeting
