Notable Building and Leasehold Improvements & Repairs 2016 thru 2020

In 2016, after decades of lackadaisical management services, 580 South High Company began self-managing the building. Soon, the building was 100% rented for the first time in ages. With increased revenue, numerous long needed major and minor restorations, repairs and improvements have been made to the circa 1979, building and more projects are ongoing. The following is a summary of work to date.

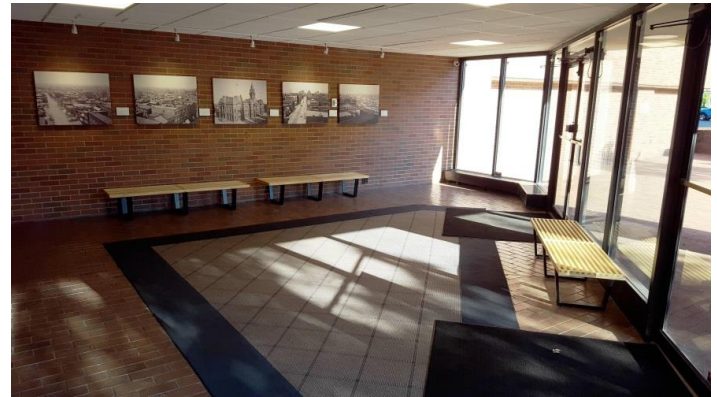
Upper main lobby renovation includes all new suspended ceiling with grids and acoustical tiles. Large dimmable flat LED light panels replaced inefficient old lighting. Historical photos of High Street and the old Courthouse were custom printed onto gallery wrapped canvases. Accent track lighting was added to the ceiling to highlight this artwork. Museum type description cards were hung next to each canvas. Classic designed Platform Benches by George Nelson (circa 1945) were installed in both the upper and lower lobbies. Lower level elevator lobby improvement also includes new suspended ceiling acoustical tiles, large LED light panels and new carpeting.

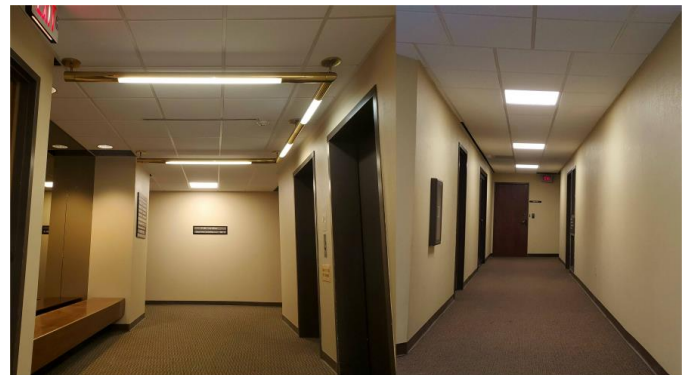
In 2019, the ceilings and lights in the lobbies and hallways on the first, second and third floors were demolished and replaced with the same tiles and LED panel lights as those in the main lobby. Building tenants greatly appreciated the upgrade from dark and dingy to bright, clean ceilings and hallways.

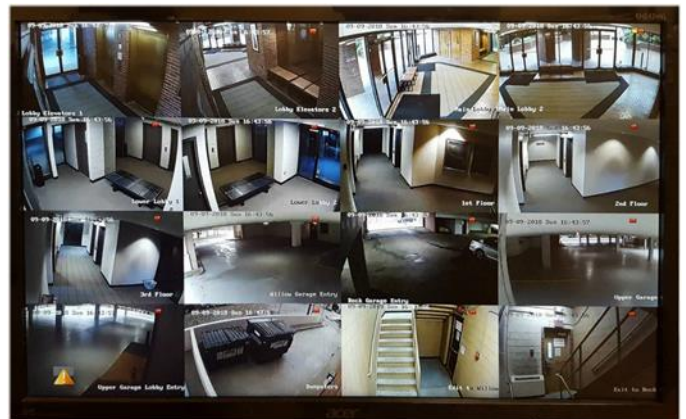
In recent years vagrants had become a real problem for 580 South High Street. A passed out woman was found in the men's restroom, people were urinating, defecating and sleeping on the front steps, in the parking garage and right in front of the main entry to the building. There had also been incidents of thefts and vandalism. Sixteen high definition cameras have been hard wired and placed throughout the interior and exterior of the building. All cameras are recorded to hard drives 24 hours a day and remote viewing is possible from anywhere. The video system with the addition of new signage, improved lighting and tamper proof cigarette butt containers has resulted in a significant drop in loitering and associated problems.

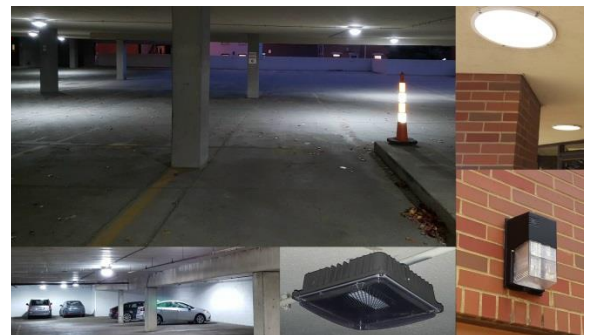
Many of the fixtures in the upper parking garage were not working and/or in very poor condition. New energy efficient LED low profile canopy lights were purchased and installed. Lighting by both main lobby entries and lower lobby south entry were also in poor condition. These lights, many not working, were powered by heavy and very old ballasts. All were replaced with new efficient LED surface mounted fixtures. Lighting by other outside exits and the dumpster area were replaced with LED photo sensor fixtures. Lower garage canopy LED lights installed nearly five years ago have experienced power supply or LED panel failures. These lights have been on 24 hours a day for five years and are at the end of their useful life. Maintenance repairs have been made over the last few years, but the process of replacing all 35 fixtures is now complete.

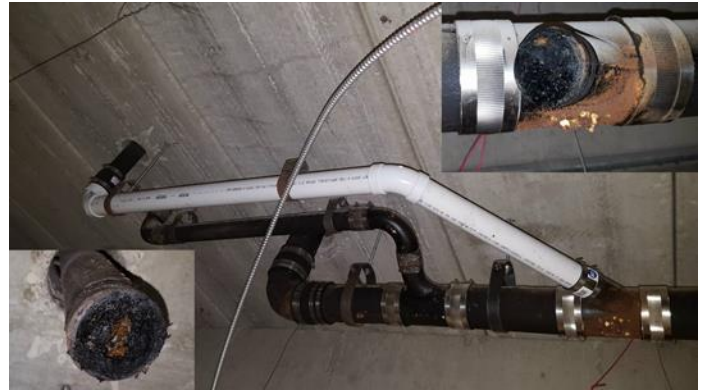
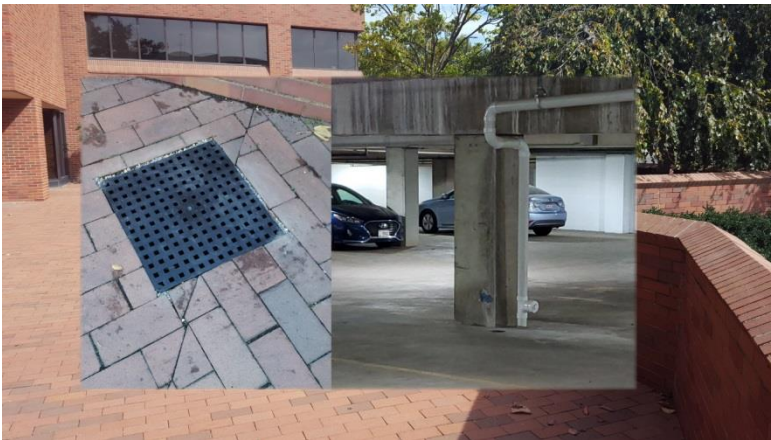
The building was built in 1979 with cast iron drain pipes. Clogged sink and toilet pipes have been a problem for many years. Past management companies have typically hired a “roto-rooter” service to clear pipes, but results have been short-lived and expensive as typical service calls cost over \$400.00. The problem is known as **tuberculation** and it comes from decades of corrosion deposits adhering to the insides of an iron pipe to the point that the water can no longer drain. The only viable, long term solution is to remove the cruddy, caked and rusted iron pipe and replace it with modern PVC pipe. Since early 2016, over 16 sink, toilet and other drains have been replaced. The work is extremely messy and requires great care since most pipes are in the ceiling above office spaces. However, great strides have been made and the building is draining better than it has in decades.

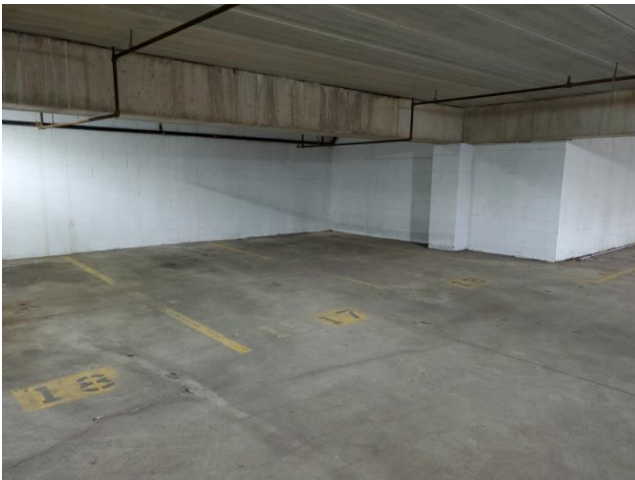
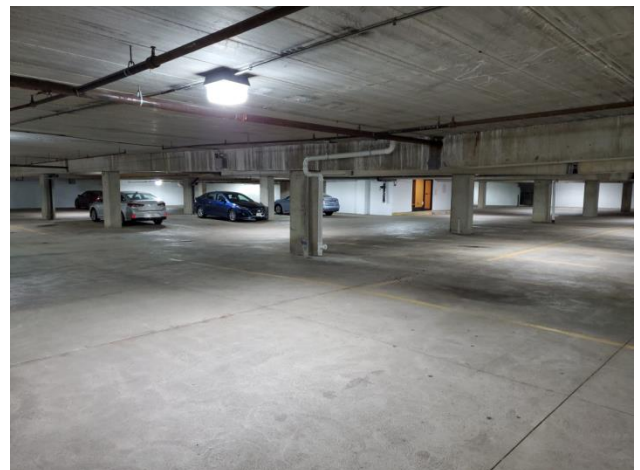
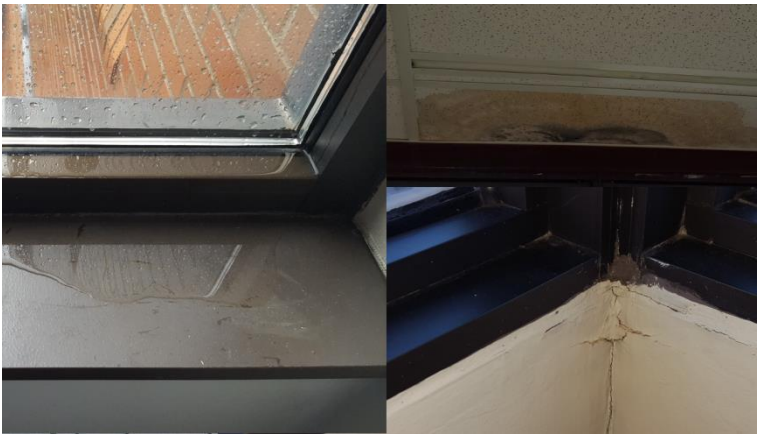
After the upper level garage floor was restored, it became clear that additional waterproofing was required under the paver patio in front of the building. The patio, which sits above the lower garage on the southwest corner, required new flashing, the removal of two large brick planters and the reconstruction of two drains and the nearby areas. In addition, all cast iron drain pipes from the upper garage were replaced with PVC pipes in the lower level. Water damaged beams were cleaned of debris and repaired to ensure safety. Hollow core panel soffits also repaired.

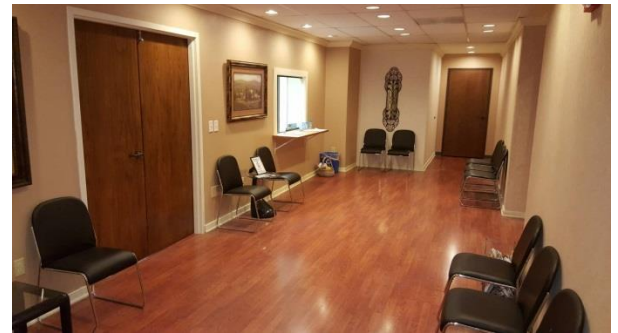
The front lobby required a new double door entry into reception area, a window with sliding glass and the addition of two doors to back hallways on either end of the lobby area. Doors on either side of the large main center reception area were also created for access to back offices. Built-in cubicles near these doors were demolished and walls repaired. New drywall was painted, ceiling tiles repaired/replaced and carpeting installed in hallways.

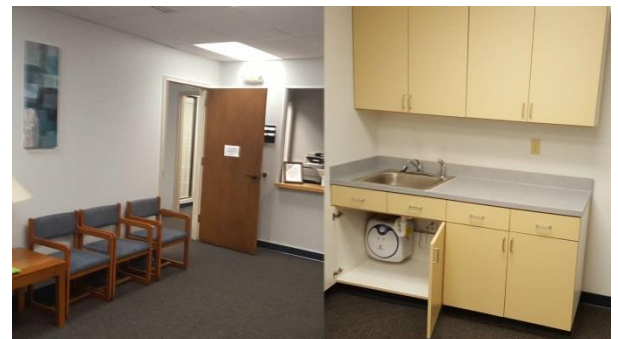
A new waiting room was created by removing unwanted walls and installing a new metal stud and sheet rock wall with a door. A similar wall and door moving project was undertaken in the back northwest area of the offices. A wall was also built in an old large data room thus creating two offices. A kitchen was created in an office. About twenty feet of new water and drain lines were installed along with kitchen cabinets, counter, sink and hot water tank. Suspended ceiling tiles and grids were repaired/replaced, walls throughout painted and new carpet installed.

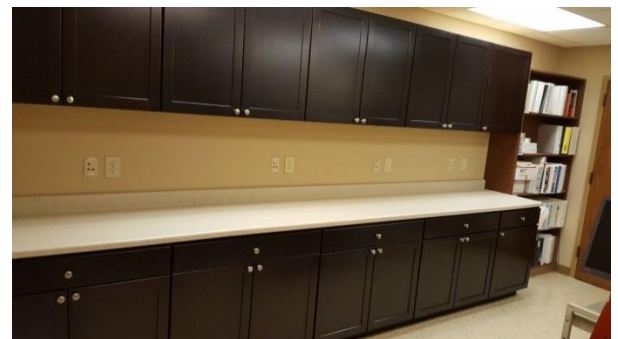
Tenant requested and financed remodeling to two work rooms. In room 142, built-in cabinets and countertops were removed, electric data lines moved to room 144. Walls were repaired, spackled, sanded and painted. New carpet installed. In room 144, built-in bookcases and countertop were removed. New cabinets and counters were installed with electric and data repositioned. Two of the removed bookcases were repaired, modified and installed in the conference room.
