Report Date: March 23, 2022
Field Assessment Date: March 11, 2022

Property Condition Report

1612 Frazier St
Conroe, Montgomery County, Texas 77301

AEI Project No. 458021
Client Reference No. NA
Client Reference Name: Frazier

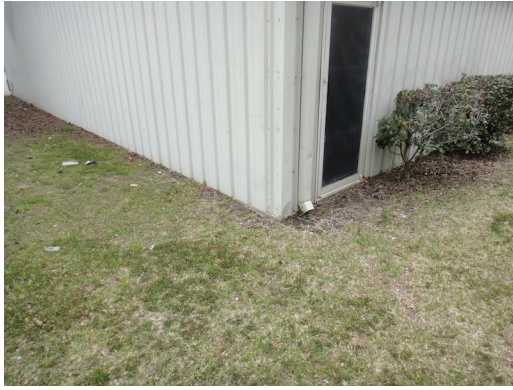
Evidence of significant or unusual ponding of storm water was reported along the southeast elevation of building two. Water does not drain away from the foundation in this area and is entering the building. Damaged floor and wall finishes were observed due to the water intrusion and suspect mold growth was observed. Approximately 200 SF of moisture damaged floor and wall finishes were observed. The ponding appears to be related to poor drainage patterns in the topography.

Poor drainage along southeast

AEI recommends that the overall site drainage system be reviewed by a Professional Engineer to determine the best course of action to prevent continued chronic ponding and determine estimated costs to resolve the observed problems. An opinion of cost for this work is included in the Tables.

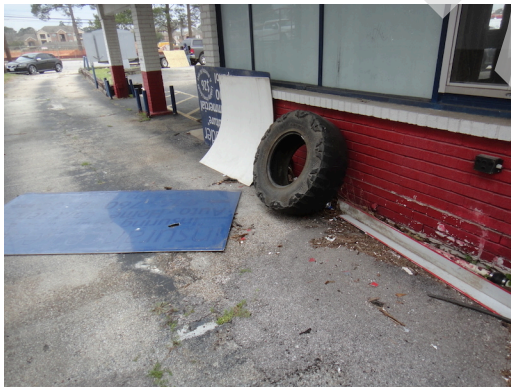
Trash and debris to be removed

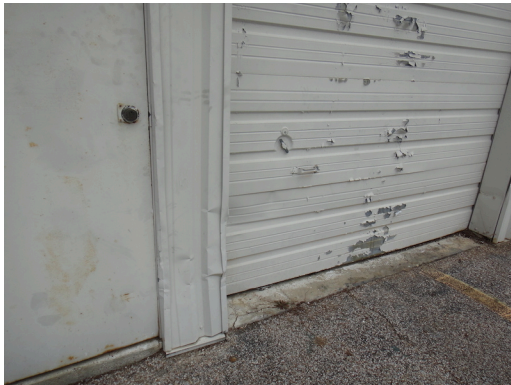
Fair to poor finishes

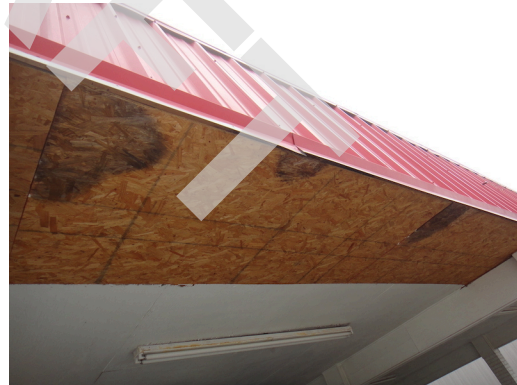
Damaged soffits

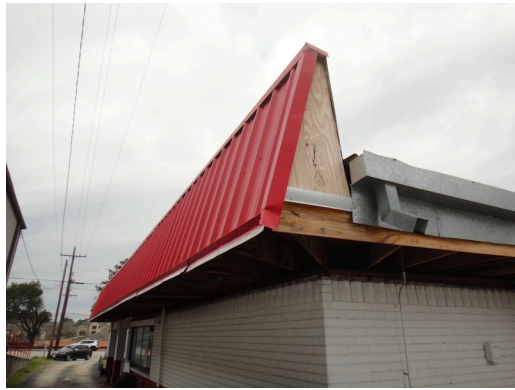
Roof parapet wall

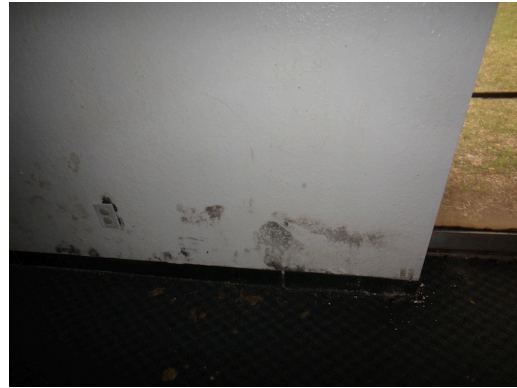
Moisture damage bldg 2

Refer to Section 3.1.1, 3.2.4 and 4.1 for additional discussion and recommendations regarding the water infiltration.

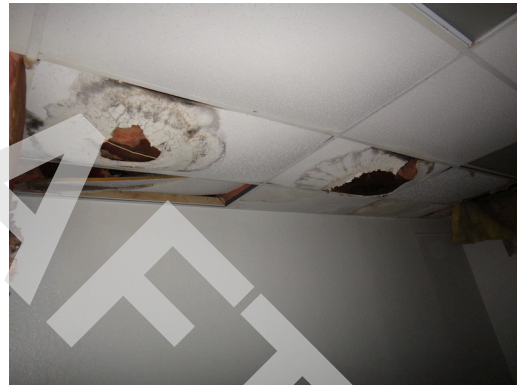
Past roof leaks bldg2

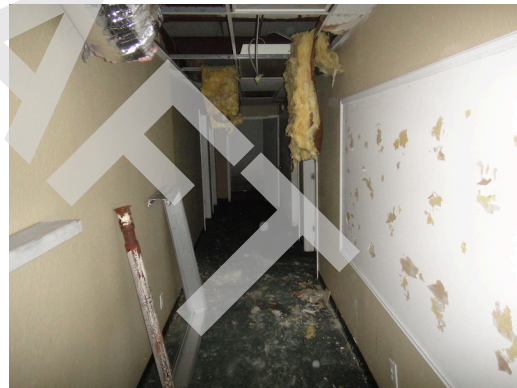
Bldg 2 interior poor

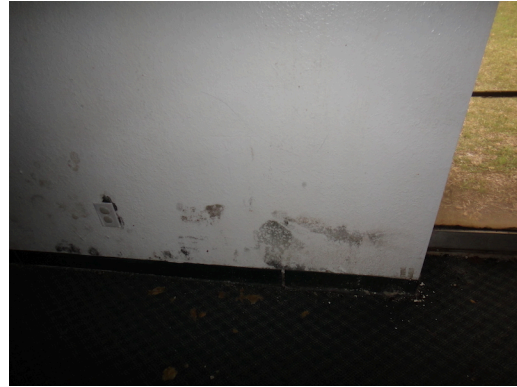
Moisture damage bldg 2

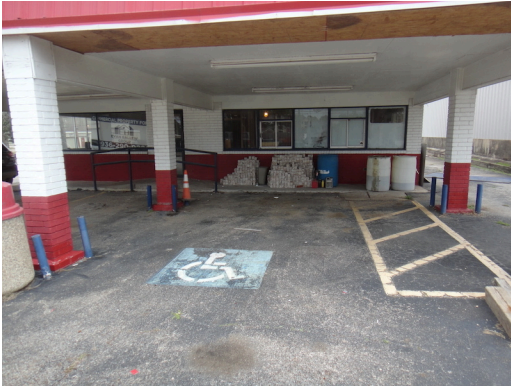
ADA signage needed
