PHASE I ENVIRONMENTAL SITE ASSESSMENT

Vacant Office / Warehouse Property
On a +/- 2.54 Acres of Land
2405 S. Franklin Street
Colbert, Oklahoma 74733

Project No. P230703CP1ESA

July 17, 2023

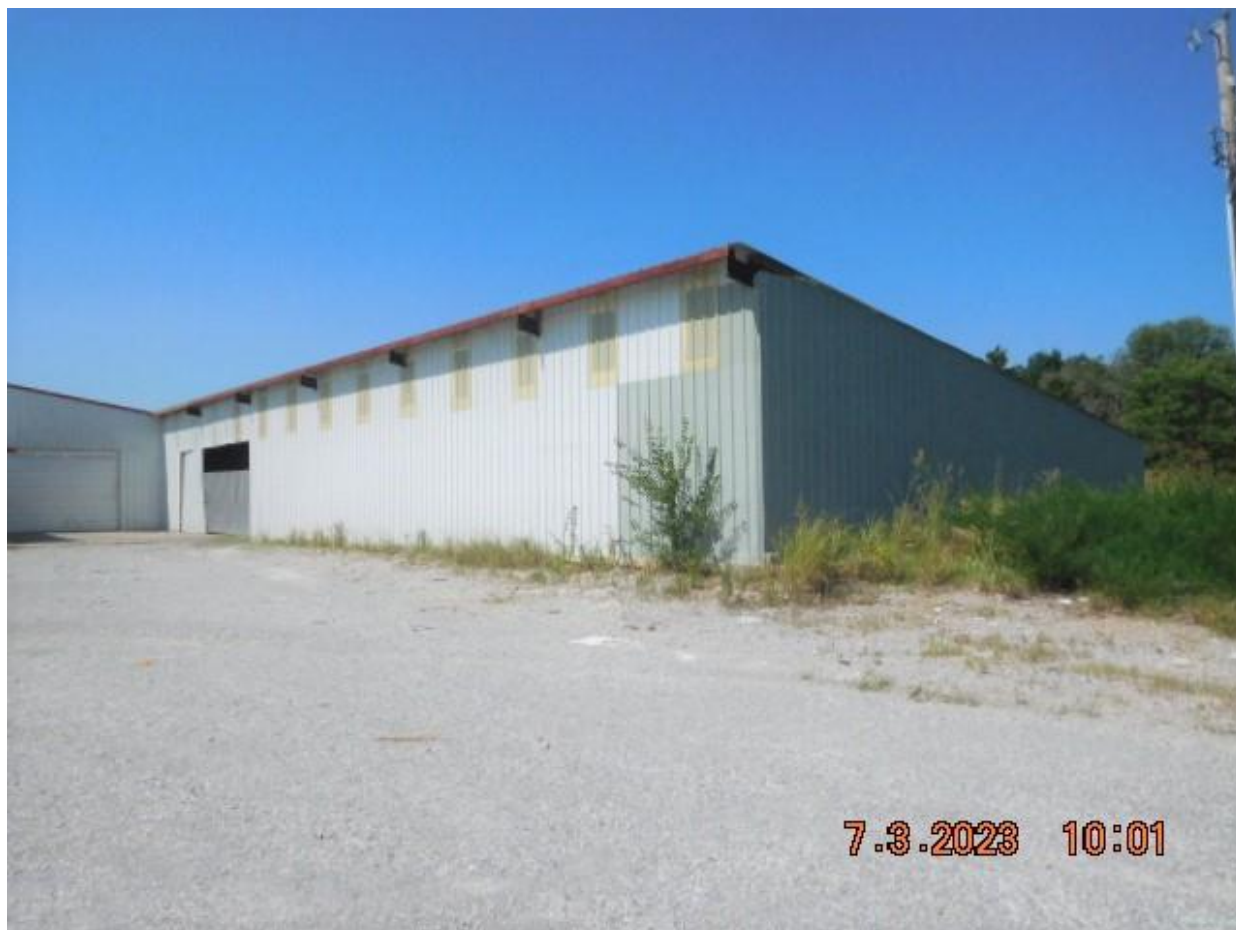
Photo of Target Property

Inspected on July 3, 2023
