Affordable Home and Building Inspections PROPERTY INSPECTION REPORT

707-709 Church St Honesdale, PA 18431

Date of Inspection: 9/8/2023 Time of Inspection: 10:00 am

Report #13842

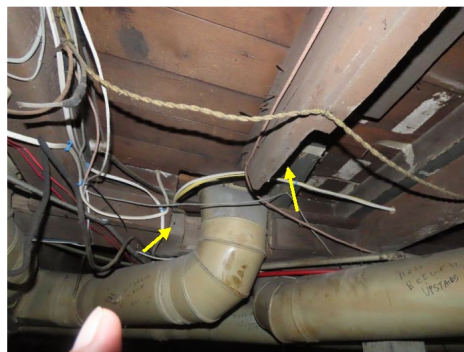
Sections of floor joists in the basement of 707 Church have been cut to accommodate ductwork. Corrective action needed.

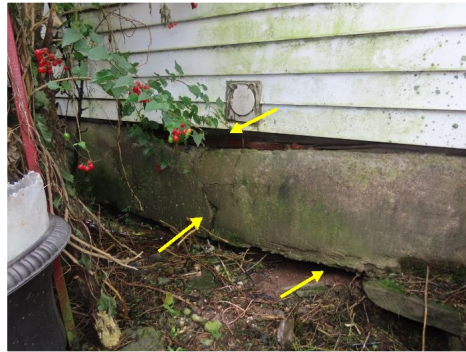
Observations: Areas of stacked stone is loose and bulging and appears to be common for the age of the home. Rear bump out of 709 church street rear apartment has significant cracking, erosion and damage noted to foundation. Further evaluation is needed to determine cost and scope of needed repairs.

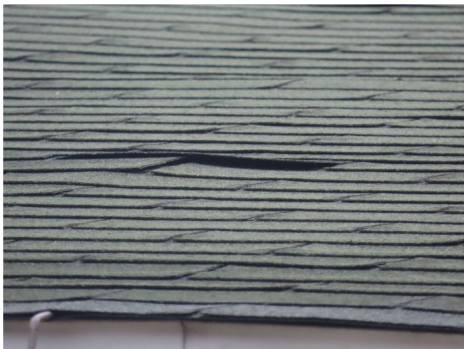
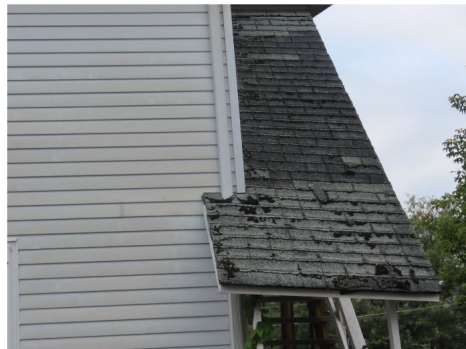
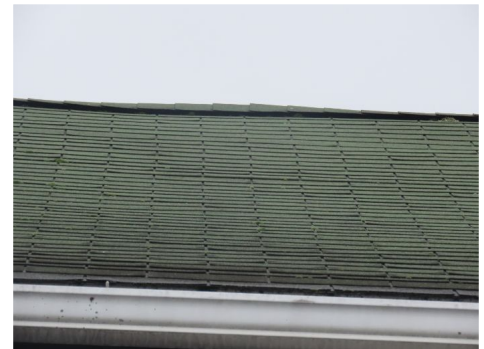
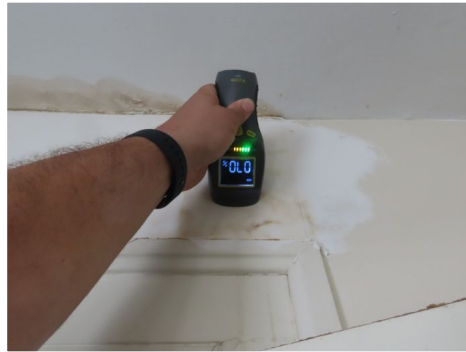
Observations: Older section of 3 tab shingle roof is showing signs of aging evidence by curling, deterioration and damaged shingles. Water stains in 707 church street apt.1 are wet at time of inspection and inspector can not determine if they are from an active roof leak as there is no access above these areas at time of inspection. Further evaluation needed to determine cost and scope of repairs/replacement.

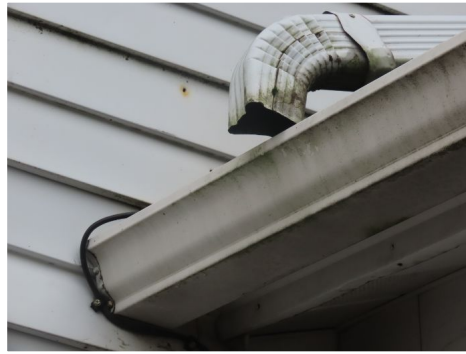
Gutters in areas around home are sagging and section of rear gutter is not properly draining into lower section of gutter. Corrective action needed to divert water away from foundation.

Recommend installing gutter extensions around home to divert water away from home.

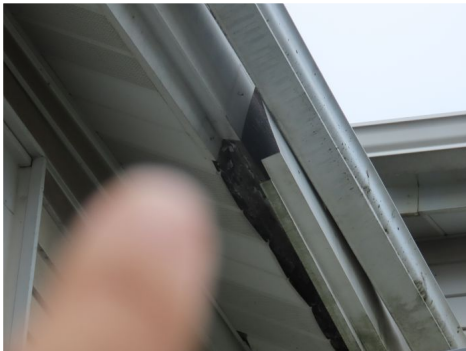
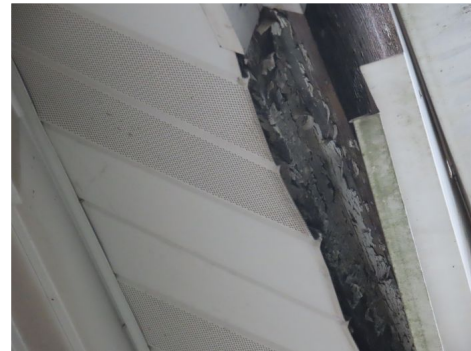
Observations: Soffit and fascia have delayed maintenance and water damage. Sections of fascia in rear are loose and falling off. Further evaluation is needed to determine if there is any unseen damage. Areas should be repaired and treated to prevent water and pest intrusion.

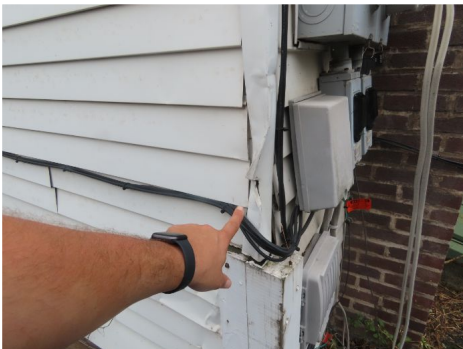
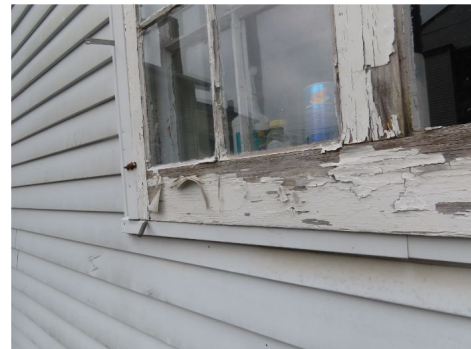
Observations: Delayed maintenance including water damage and peeling paint on siding and trim around home. Sections of aluminum siding in rear are dented/damaged. Repair areas and seal with wood protectant.

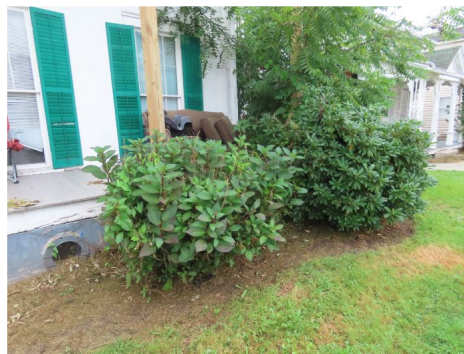
Condition: Heavy vegetation limits view of exterior and foundation. Thick growth may contain moisture and pests. It is recommended to trim/thin growth to avoid contact with home.

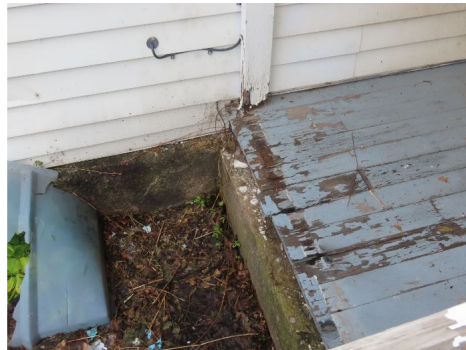
Observations: Delayed maintenance and water damage noted to boards on porches and stairs around home. Repairs are needed.

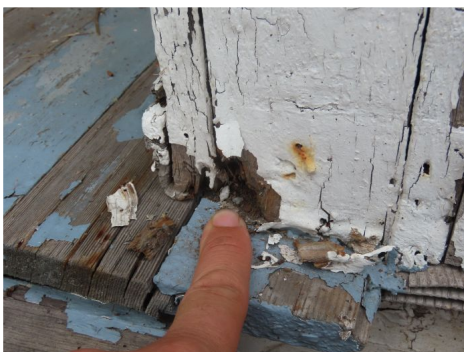
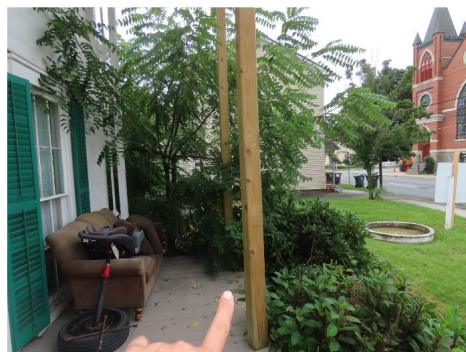
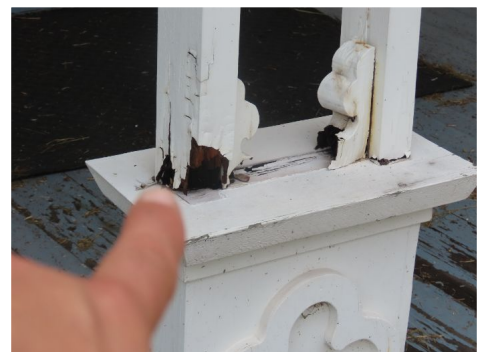
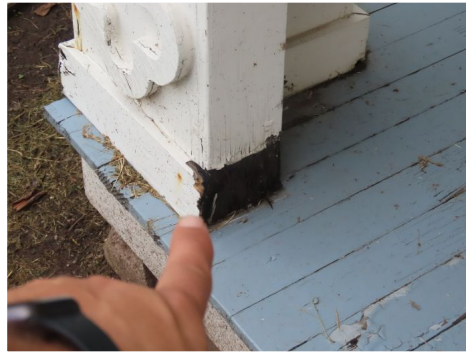
Observations: Roof support posts on multiple porches have significant water damage, rear landing posts have shifted and front newer posts for 709 church st have twisted. Concrete slab beneath 707 church st front porch has significant cracking and shifting. Large hole noted in concrete/brick beneath 709 church st front porch. Further evaluation and corrective action needed.

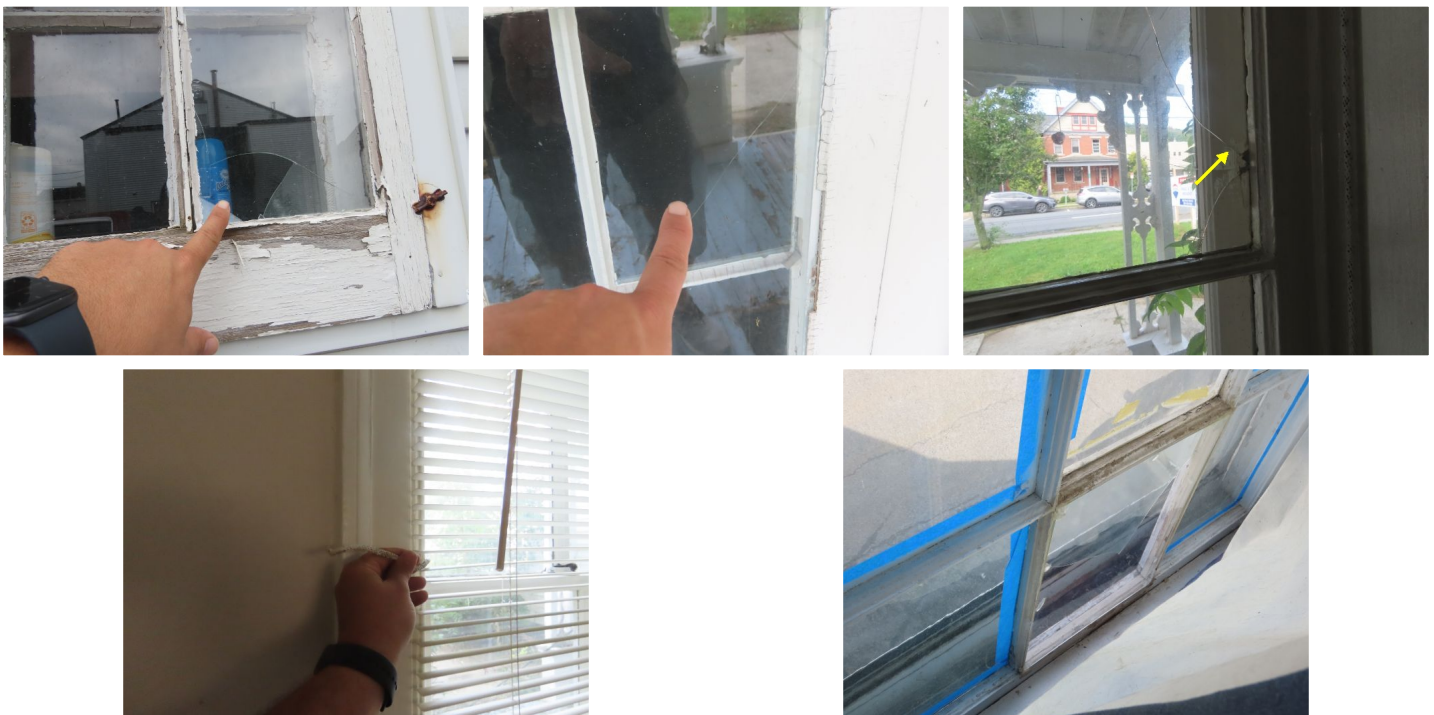
Older single pane windows throughout building have cracked glass, broken sash cords and/or do not operate. Repair/replacement needed.

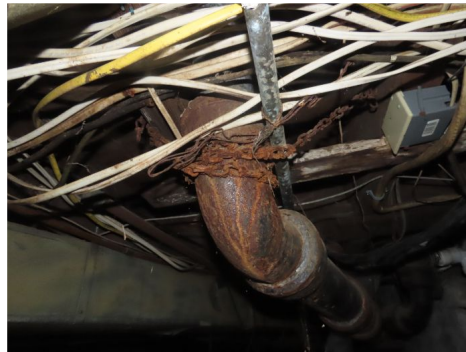
Cast iron main waste pipes are rusted. This is an indication of age and it is recommended to replace all cast iron with PVC.

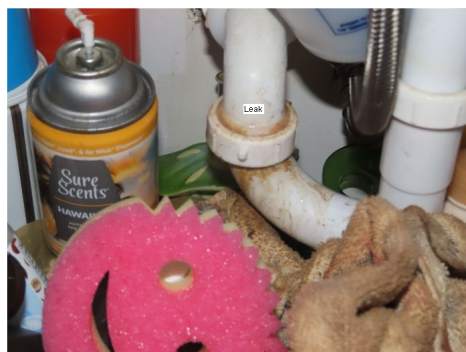
Observations: Trap leaking second floor bathroom 709 church st front apartment . Repairs needed.

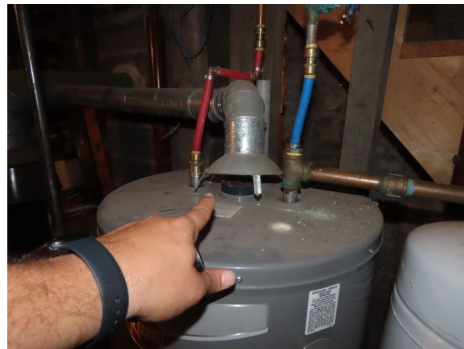
Observations: Water temperature is 120-125 degrees. Pressure relief (TPR) pipe extension tube is missing. The TPR extension is meant to reduce the chance of scalding water splashing on a person near the water heater. PVC and other unapproved plastics should not be used since they can easily melt. The common installation practice is for the tube to extend down to the floor within 6 to 8 inches over a drain or pan that collects expelled hot water. Recommend hiring a plumber to install a proper TPR extension tube.

Exhaust flue for water heater in basement of 709 church st is not properly secured. Corrective action needed.

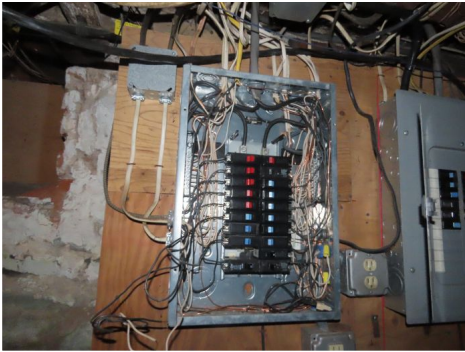
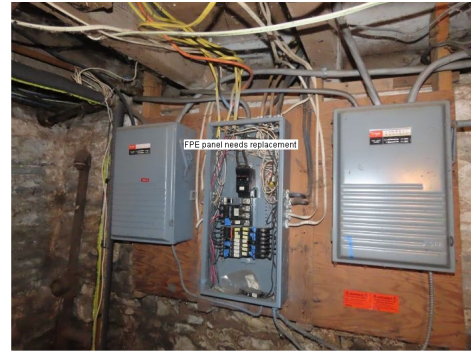
4 of the main panels do not have dead front covers installed and exposed wires are noted coming out of panel in basement of 707 church street. This is a safety and contact hazard and corrective action is needed.

Open/uncovered slot(s) in owners panel. This is a safety concern and contact hazard: install filler cover or breaker.

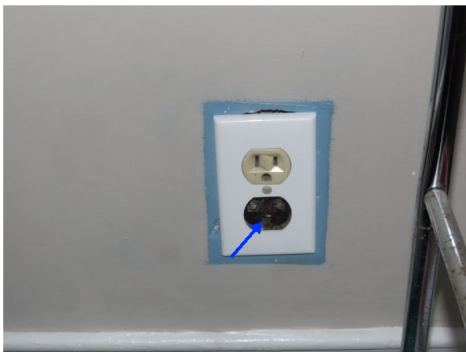
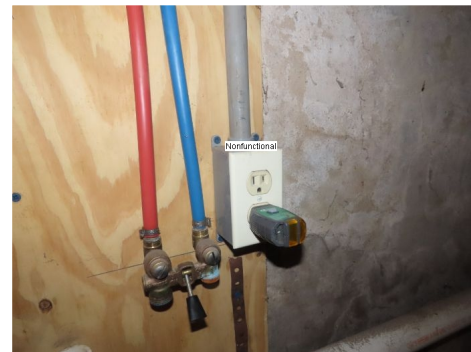
Observations: Electrical in 707 church st vacant apartment and basement can not be tested due to power being turned off. Outlet in living room of 709 church st front apartment is broken and washer outlet in basement of 709 church st is nonfunctional. Further evaluation and repairs needed.

Improperly wired 3-way switch for 709 church st basement lights. Light fixture in 709 church st front apartment bathroom flickers. Repairs needed by a qualified electrical contractor.

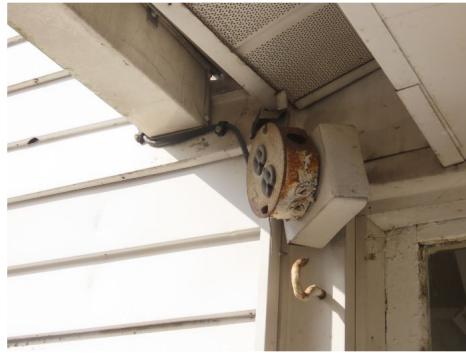
Observations: Exposed wires noted around building. Safety concern and contact hazard: Wire should be cover with wire molding or conduit. Old rusty outlet boxes noted around building should have proper weatherproof covers. Several exterior lights and outlets did not respond and may be connected to meters that have no power.

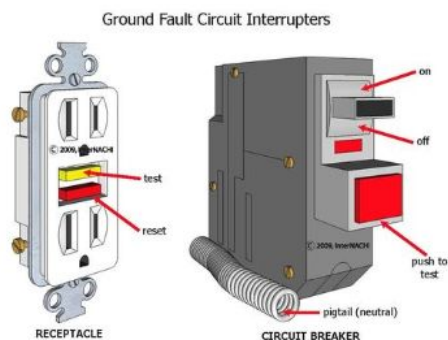
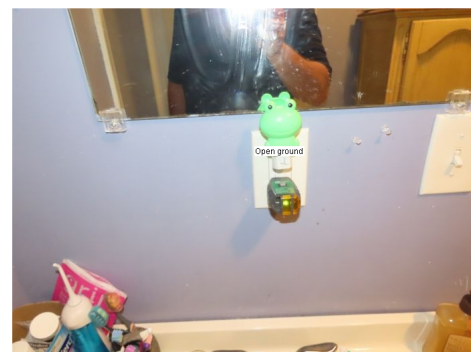
Observations: Lack of GFCI protection on exterior. Upgrading is recommended.

GFCI outlet located 709 church st front apartment bathroom is wired improperly - open ground and failed to trip. Replace outlets and test.

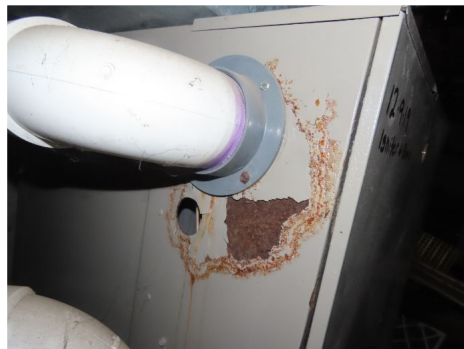
Observations: Cabinet is rusty and damaged mainly around intake/exhaust pipes. Repairs needed.

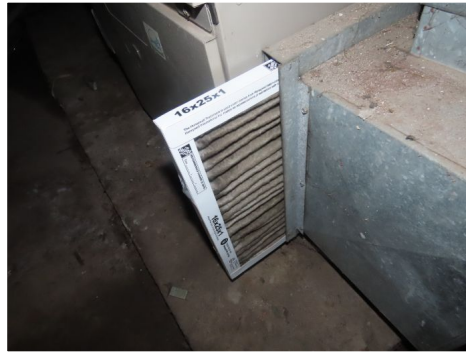
Observations: Air filter dirty and should be replaced

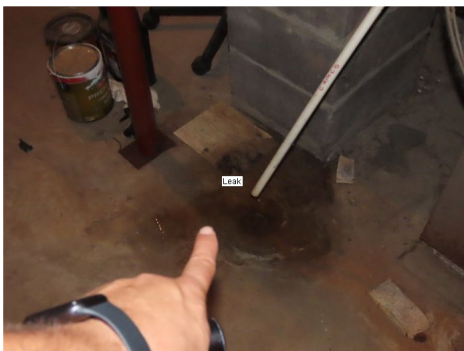
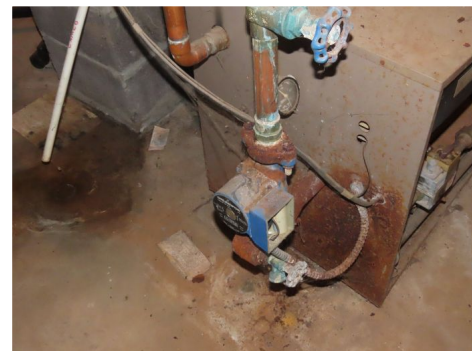
Observations: Pressure relief (TPR) is leaking. The TPR extension is meant to reduce the chance of scalding water splashing on a person near the water heater. PVC and other unapproved plastics should not be used since they can easily melt. The common installation practice is for the tube to extend down to the floor within 6 to 8 inches over a drain or pan that collects expelled hot water. Repairs are needed. Cabinet is rusty and front cover is missing. Repairs needed.

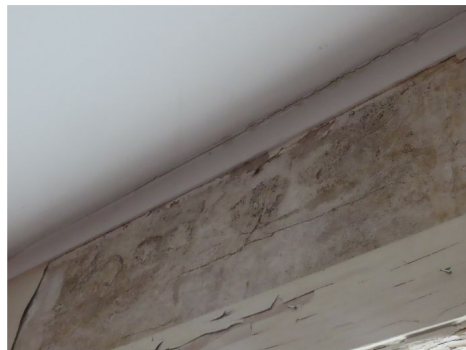
Observations: Organic substance is noted in bedroom of vacant apartment . If mold growth is a concern please seek further evaluation prior to closing.

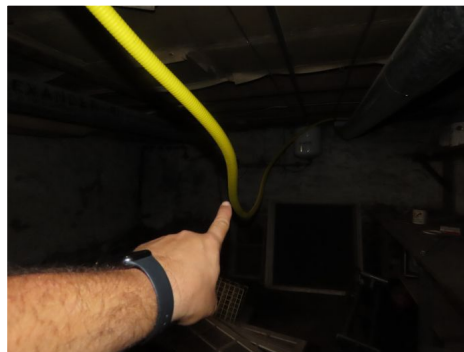
No drip leg or shut off valve is installed at the water heater unit in basement of 707 church st. A sediment trap or drip leg is a capped-off section of gas line which is installed in such a way that any debris or moisture in the gas line will be caught in the trap where it can be cleaned out easily. The reason for this is to ensure safe operation of an appliance by keeping debris out of the tiny orifices of the gas valves. Installation is recommended.
