Confidential Inspection Report 2178 Montecito Drive San Jose CA 95135

December 10, 2024

Prepared for: Joaquin Barreto

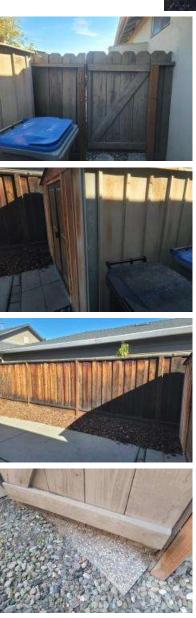
Type: Wood, leaning and damaged fencing noted, repairs needed.

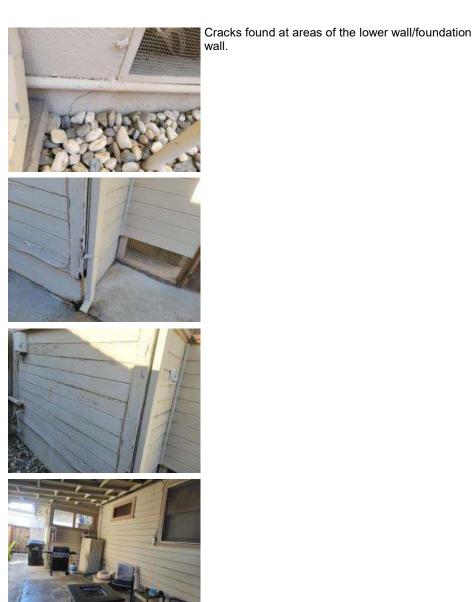
Weathering and decay noted in areas.

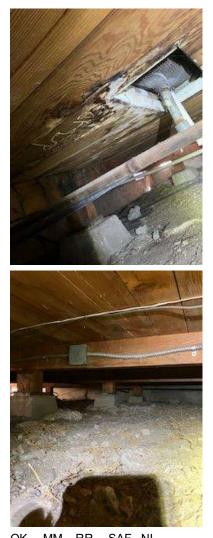
Water damage found at areas of the sub floor, damage may extend.

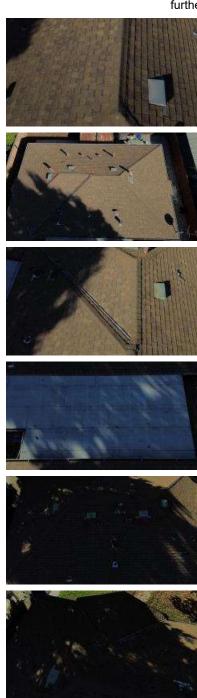
NOTE>> Signs that there may be leaks at the rear bedroom ceiling and walls may need to be addressed, A licensed roofing contractor should be called in to make further evaluation and to repair or replace as needed.

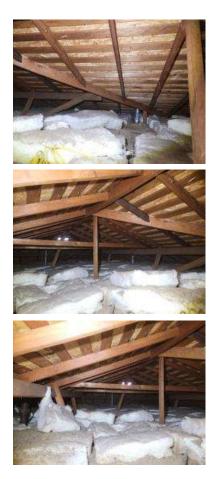
Unhooked vent noted above the main unit near the kitchen.

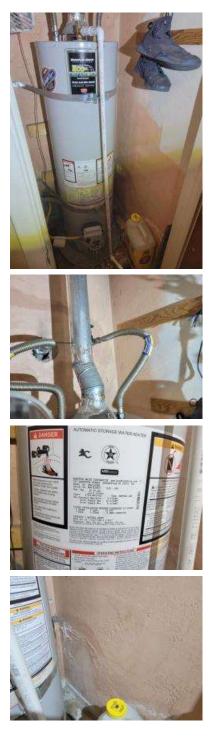
Missing firewall at the ceiling.

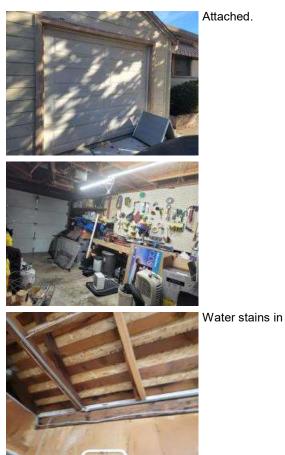
Water stains in various areas.
