RE: STRUCTURAL COMPLIANCE CERTIFICATION REPORT
NC25081 Brevan McAlpin – Post-Fire Structural Evaluation of Second-Floor Assembly

A structural inspection was performed by Lee Solutions & Services, PLLC (LSS PLLC) on March 13, 2025, at the property located at 719 Old Lenoir Rd, Hickory, NC 28601, focusing on the upper-level area identified as Suite 201 – Section C, which experienced prior fire exposure affecting the overhead roof system. This area is directly supported by the ground-level space identified as Suite 101, Section A, currently functioning as a gym (see Appendices B–C).

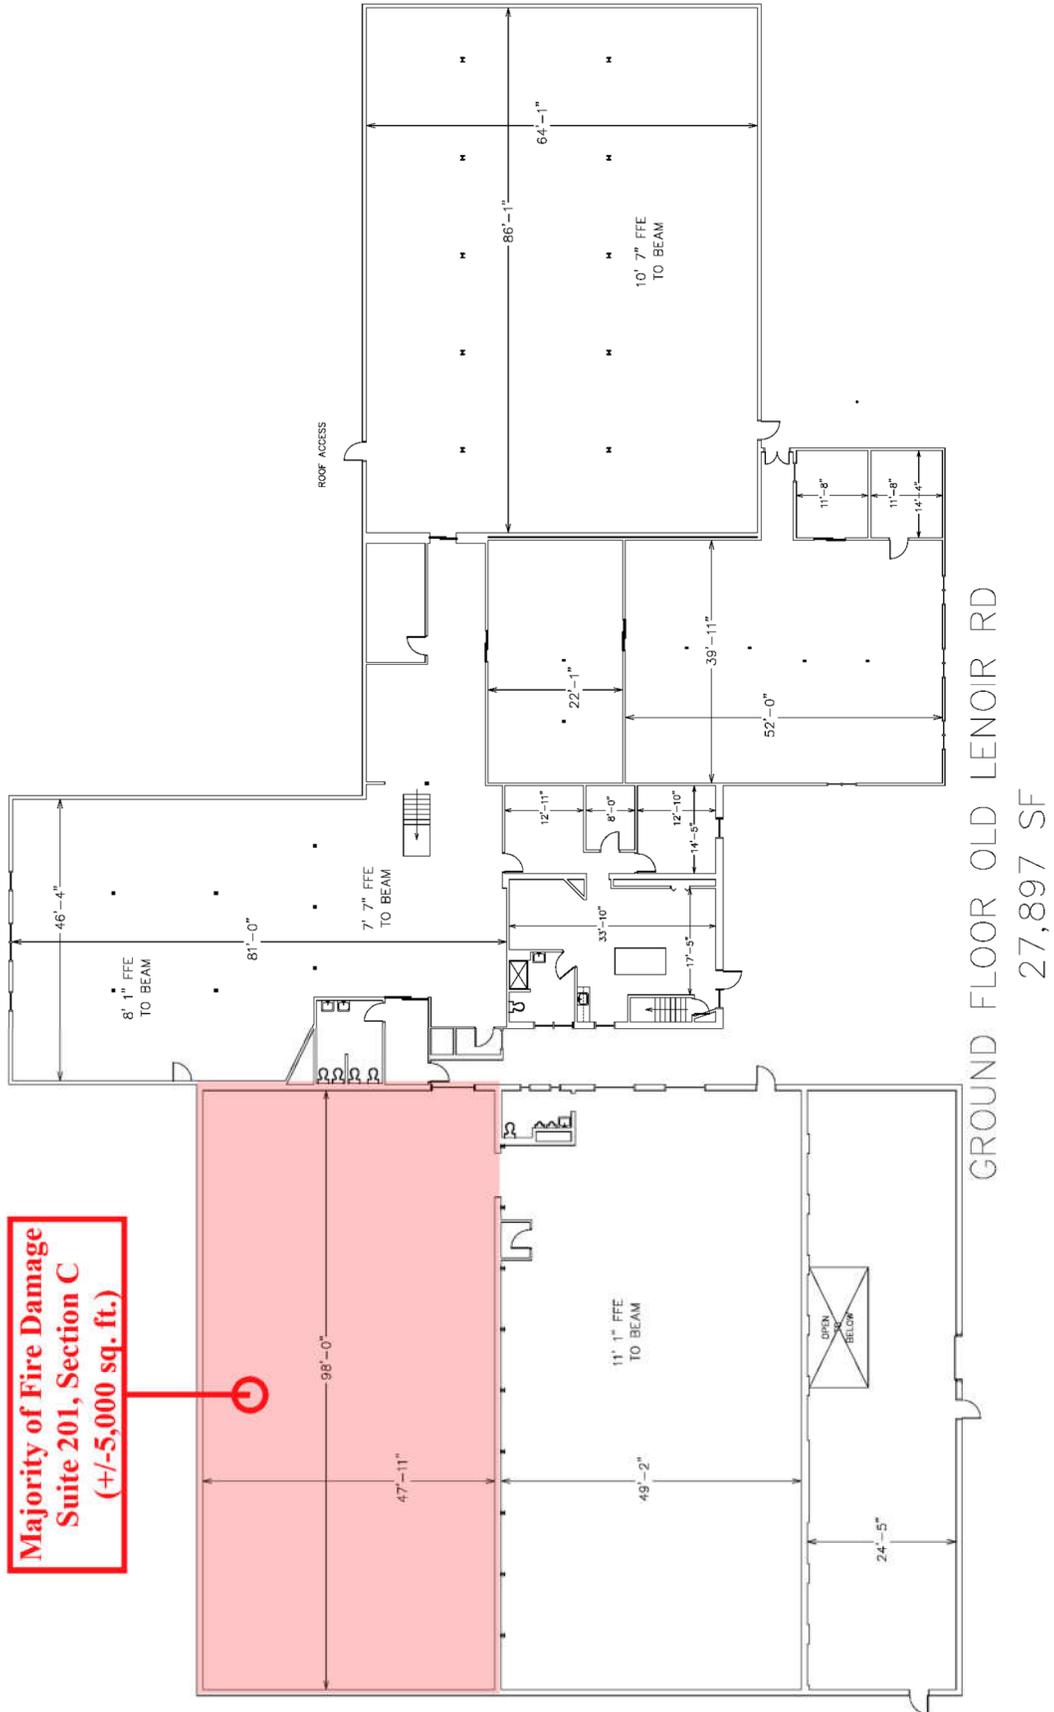
**APPENDIX C
AS-BUILT SECOND FLOOR PLAN (FIRE-DAMAGED) PREPARED BY CLIENT – DATED MARCH 13, 2025**

**Majority of Fire Damage
Suite 201, Section C
(+/-5,000 sq. ft.)**
