## Property Inspection Report

Report Number:  
**24-06-15TF**

Inspection Address:

**6310 Thornton Avenue**  
**Newark, CA**

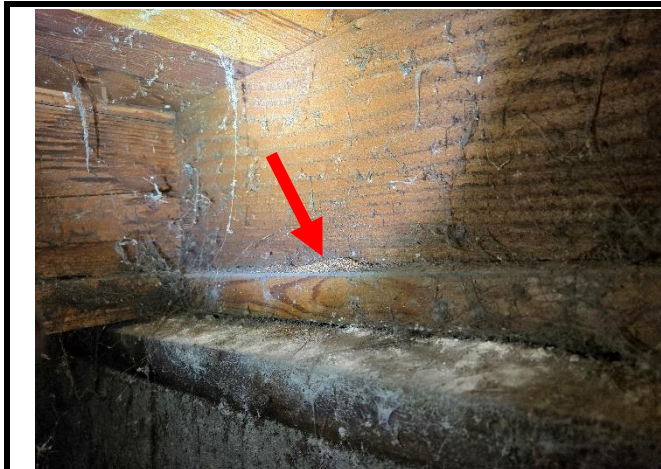
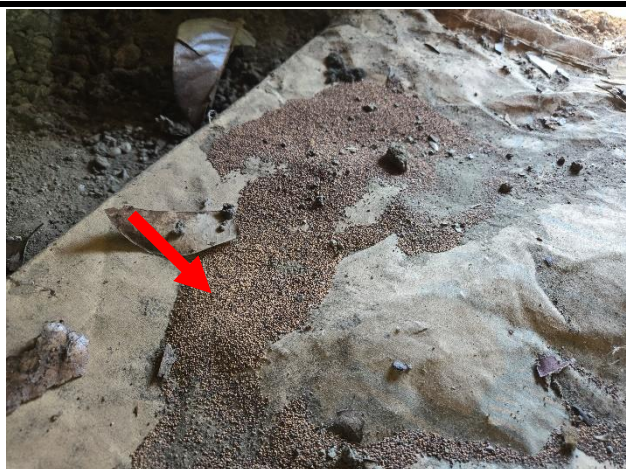
2. **There was evidence commonly associated with wood destroying pest and/or organism activity in the crawlspace. We recommend consultation with a licensed pest control operator. (See Photos 1 and 2 in the Inspection Photos section)**

**There was evidence commonly associated with wood destroying pest and/or organism activity in the crawlspace. We recommend consultation with a licensed pest control operator.**

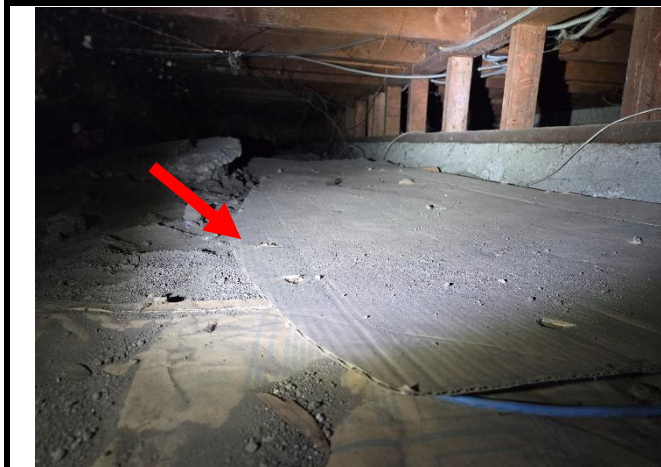
3. **Cellulose – wood, cardboard and/or paper – debris, was present in the underbuilding crawl space. This debris provides attractive food for wood destroying pests. We recommend removal of all of this debris. (See Photo 3 in the Inspection Photos section)**

**Cellulose – wood, cardboard and/or paper – debris, was present in the underbuilding crawl space. This debris provides attractive food for wood destroying pests. We recommend removal of all of this debris.**

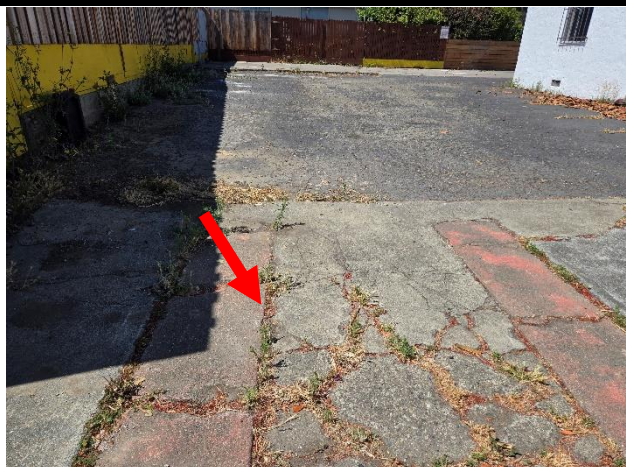
4. **Trip hazards were observed in the driveway. We recommend repair, if possible, or removal and replacement, of deteriorated sections of the driveway to eliminate trip hazards and reduce the potential for personal injury. Sometimes simply “ramping-up” concrete patching material at the changes in elevation can serve as a short term solution. (See Photo 4 in the Inspection Photos section)**

**Trip hazards were observed in the driveway. We recommend repair, if possible, or removal and replacement, of deteriorated sections of the driveway to eliminate trip hazards and reduce the potential for personal injury. Sometimes simply “ramping-up” concrete patching material at the changes in elevation can serve as a short term solution.**

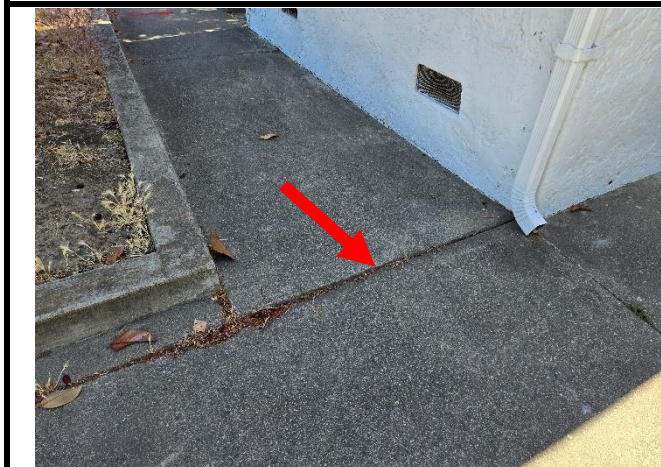
5. **Trip hazards were observed in the walkways. We recommend repair, if possible, or removal and replacement, of deteriorated sections of the walkways to eliminate trip hazards and reduce the potential for personal injury. Sometimes simply “ramping-up” concrete patching material at the changes in elevation can serve as a short term solution. (See Photo 5 in the Inspection Photos section)**

**Trip hazards were observed in the walkways. We recommend repair, if possible, or removal and replacement, of deteriorated sections of the walkways to eliminate trip hazards and reduce the potential for personal injury. Sometimes simply “ramping-up” concrete patching material at the changes in elevation can serve as a short term solution.**

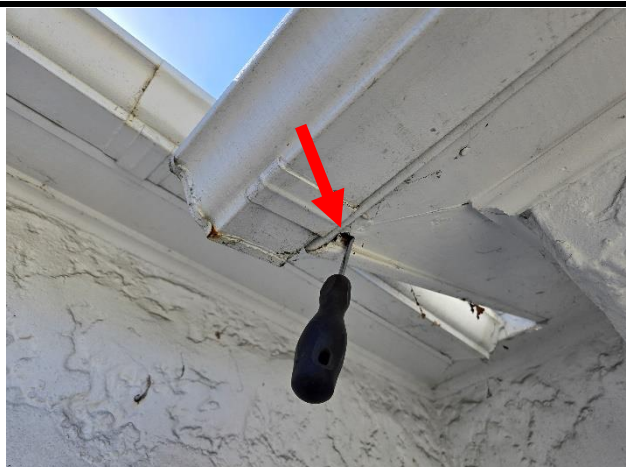
6. **There was evidence commonly associated with wood destroying pest and/or organism activity in the eaves on the front. We recommend consultation with a licensed pest control operator. Roofing repair may also be necessary during the course of the eave repairs. (See Photo 6 in the Inspection Photos section)**

**There was evidence commonly associated with wood destroying pest and/or organism activity in the eaves on the front. We recommend consultation with a licensed pest control operator. Roofing repair may also be necessary during the course of the eave repairs.**

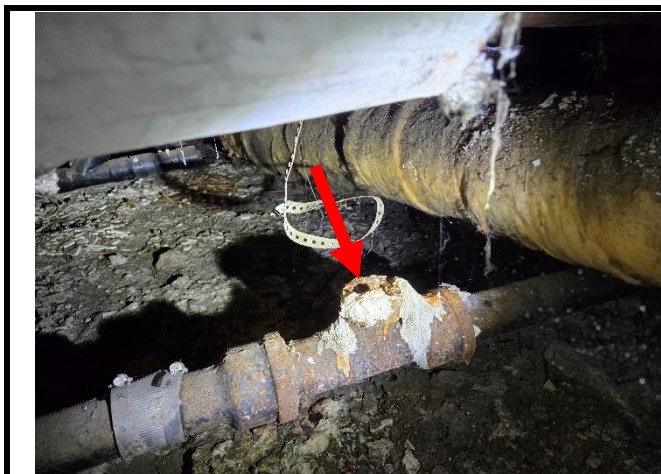
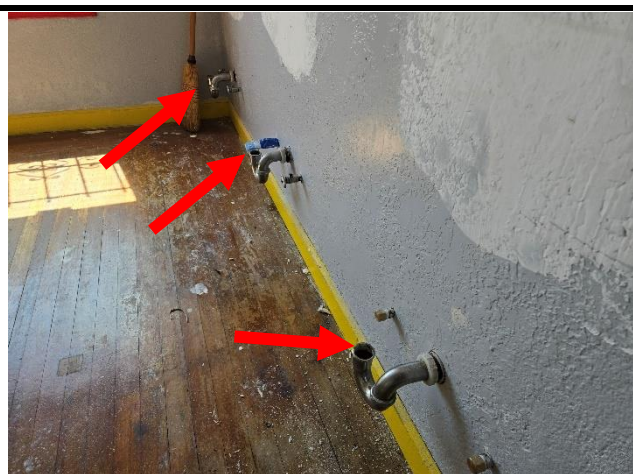
7. **There are several uncapped drains or vent pipes in the crawlspace and one bedroom. We recommend capping the pipes to prevent the escape of sewer gases. (See Photos 7 and 8 in the Inspection Photos section)**
8. **The gas service was shut off at the time of our inspection. We cannot offer opinions about the performance or general state of repair of the gas distribution system or gas appliances. We recommend inspection when service is restored.**

**There are several uncapped drains or vent pipes. We recommend capping the pipes to prevent the escape of sewer gases.**

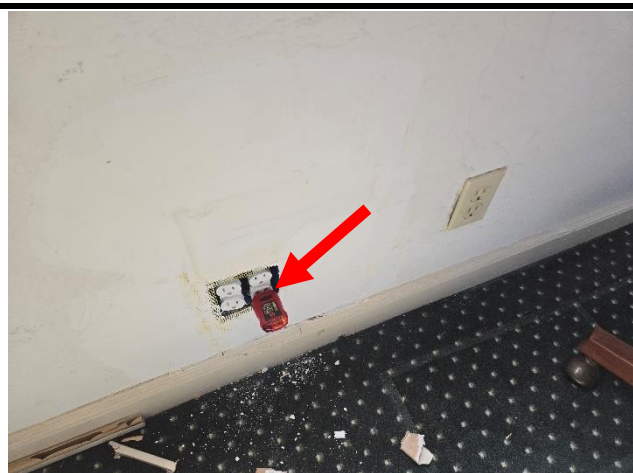
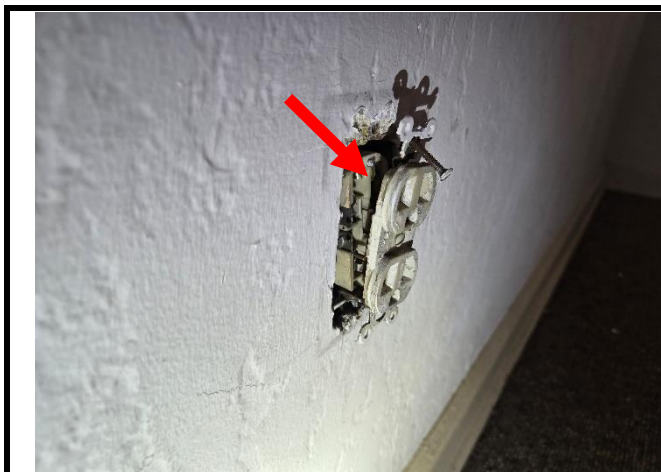
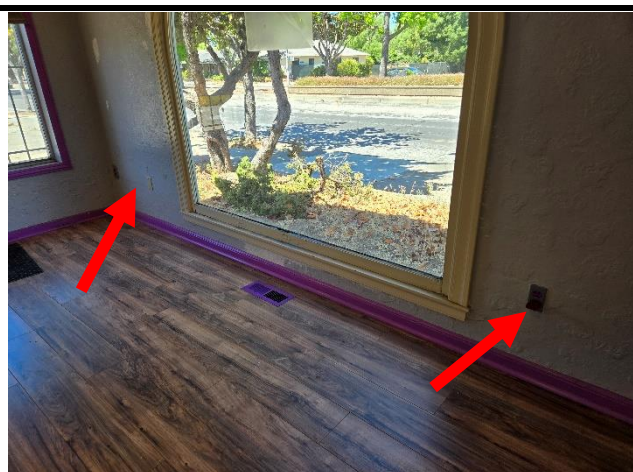
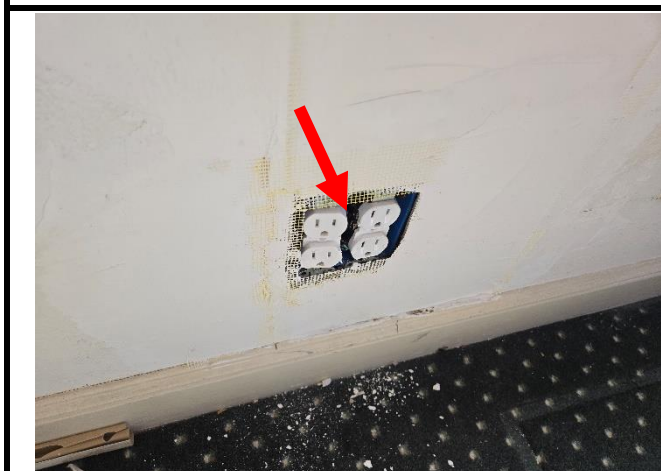
10. Inspection of a representative number of receptacles revealed many deficiencies. We recommend that all of the receptacles be checked and modified as necessary to reduce the risk to personal safety by a competent, licensed electrician. (See Photos 12 through 15 in the Inspection Photos section)

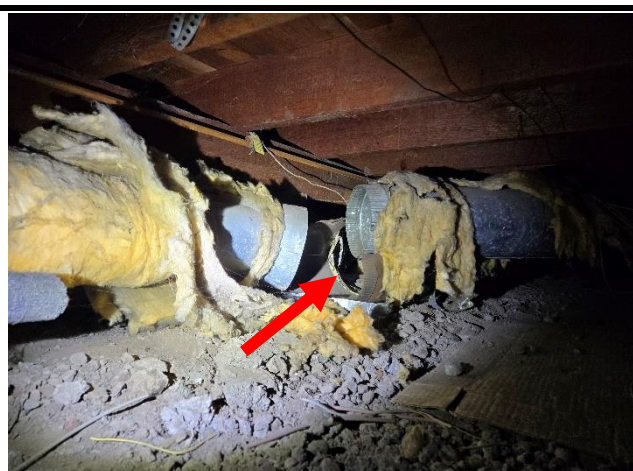
12. A joint in the ductwork in the crawlspace below the had come apart. This was resulting in a waste of energy. We recommend re-securing of all loose joints in the ductwork. (See Photo 16 in the Inspection Photos section)

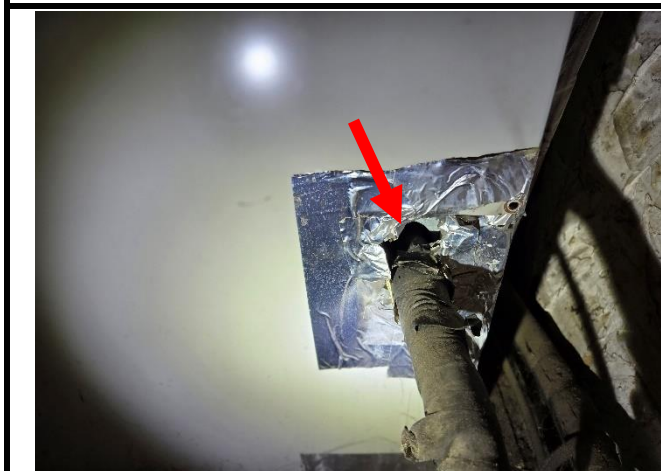
13. Air gaps around the refrigerant lines where they entered the air handler casing allowed conditioned air to escape into unconditioned space. This was wasteful not only of treated air, but also of energy, raising the cost of operating the air conditioning system unnecessarily. We recommend sealing all gaps in the air handler case to prevent the escape of conditioned air. (See Photo 17 in the Inspection Photos section)

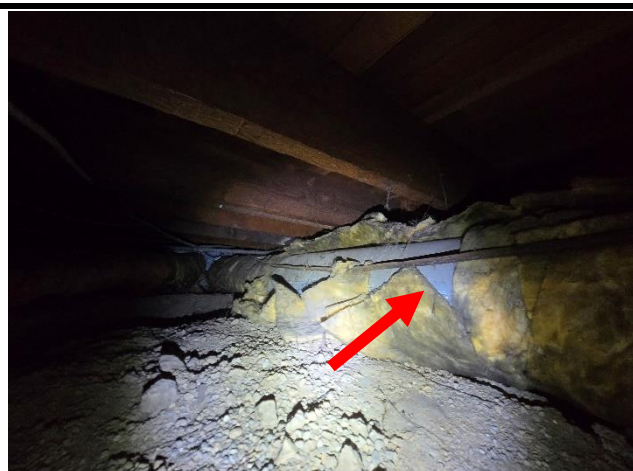
14. The insulation on several of the ducts was missing and/or loose in the crawlspace. Repair to minimize heat loss should be considered, or complete replacement of the ducting system for even higher energy efficiency. (See Photo 18 in the Inspection Photos section)

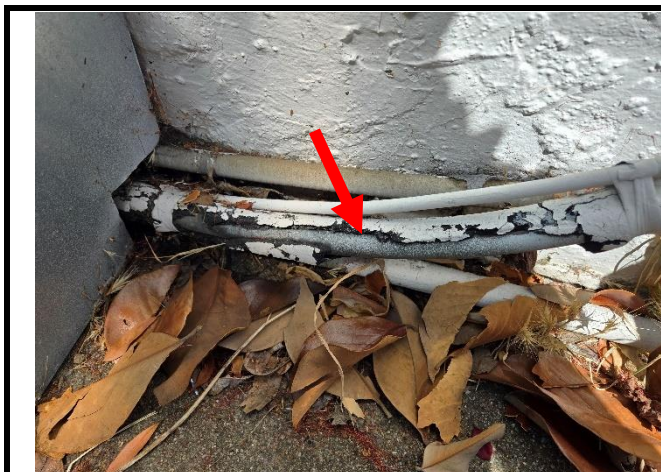
15. Insulation was deteriorated and missing from one or more portions of the refrigerant lines on the exterior. All missing insulation should be replaced to minimize condensate dripping and restore the energy efficiency of the system. (See Photo 19 in the Inspection Photos section)

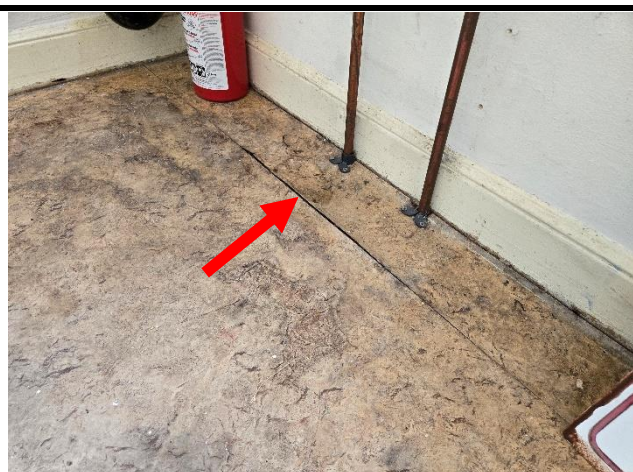
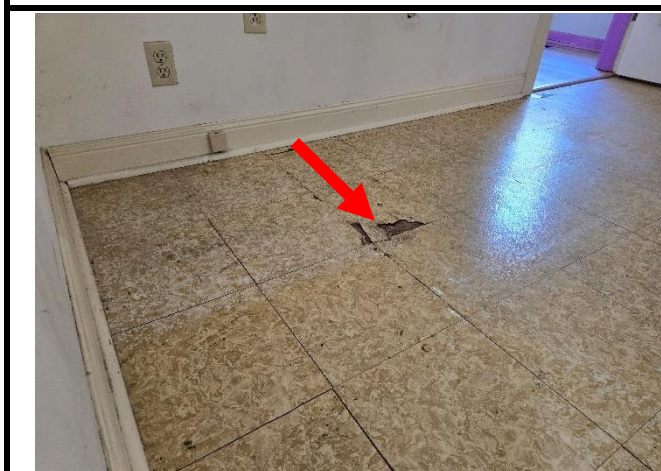
16. The floors were damaged in the kitchen and laundry room. The flooring in these areas should be replaced and all concealed damage repaired. (See Photos 20 and 21 in the Inspection Photos section)

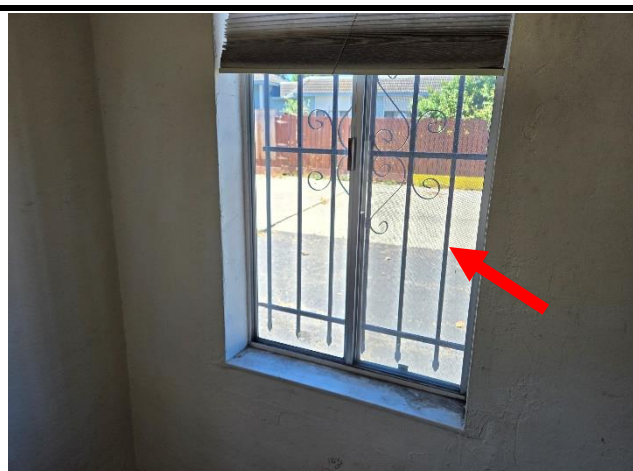
17. Metal security bars had been installed on some of the windows. Their design does not meet current standards. This is a significant hazard. All window bars should be removed or modified to meet current standards. (See Photo 22 in the Inspection Photos section)
