Inspection Pros

**891 Bell Street  
Lafayette CA 94549**

Client(s): Portue  
Inspection Date: 10/10/2025  
Inspector: Scott Ersamer ,

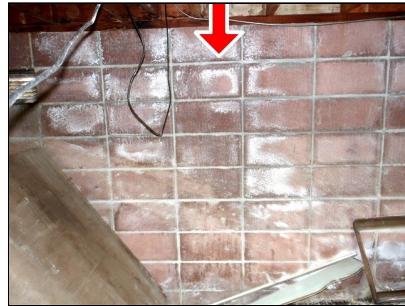
- ◆ The property features a concrete block foundation instead of poured concrete. This is an approved construction method and no particular deficiencies were observed, however this material may not be as structurally sound as concrete. If more information is desired, we recommend referral with a licensed foundation contractor and/or a licensed structural engineer.

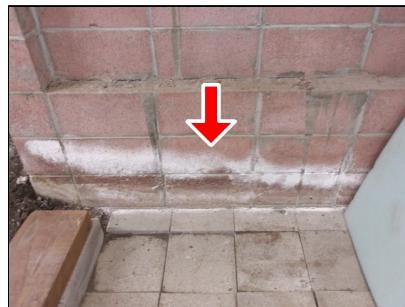
- ☒ 22. We observed a white, powdery material on portions of the building's raised concrete block foundation walls. This is known as efflorescence, and it occurs as a result of moisture being absorbed into the foundation, and then evaporating out of it. This condition can cause surface deterioration, or "spalling" of the surfaces, however it is generally a cosmetic consideration. Efflorescence typically occurs when excessive water collects at the foundation. We recommend attention to grading and drainage to help minimize future efflorescence, and to help maximize the service life.

- ◆ We observed a white, powdery material on portions of the building's raised concrete block foundation walls. This is known as efflorescence, and it occurs as a result of moisture being absorbed into the foundation, and then evaporating out of it. This condition can cause surface deterioration, or "spalling" of the surfaces, however it is generally a cosmetic consideration. Efflorescence typically occurs when excessive water collects at the foundation. We recommend attention to grading and drainage to help minimize future efflorescence, and to help maximize the service life.

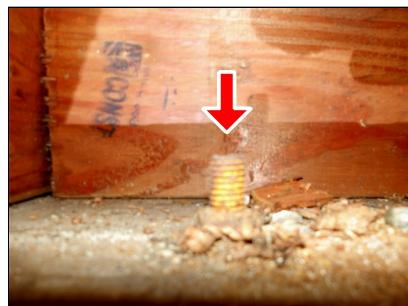
- ☒ 23. Foundation anchor bolts are fasteners that connect the wood framing to the concrete foundation, and limit the ability of the framing to move independently of the foundation in the event of seismic activity. Anchor bolts are in place as would be typical for the age of the structure. If more information, further evaluation and/or upgrading is desired, we referral with a qualified seismic retrofit specialist.

- ◆ Foundation anchor bolts are fasteners that connect the wood framing to the concrete foundation, and limit the ability of the framing to move independently of the foundation in the event of seismic activity. Anchor bolts are in place as would be typical for the age of the structure. If more information, further evaluation and/or upgrading is desired, we recommend referral with a qualified seismic retrofit specialist.

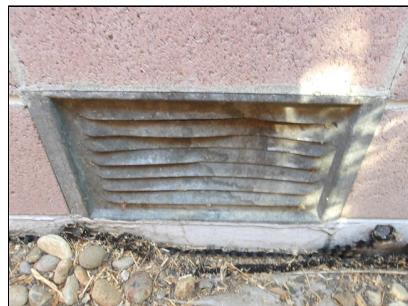
- ☒ ◆ The crawl space ventilation openings had louvered vents installed. Louvered vents restrict air circulation more than screened vents, and are more likely to be clogged with weeds or debris. We recommend that replacement with screened vents be considered for improved air flow.

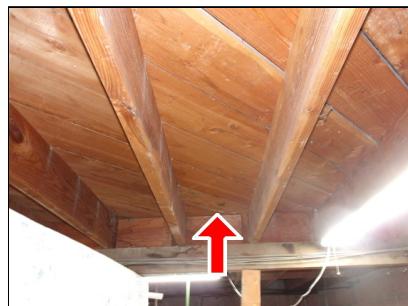
- ☒ ◆ There was no subfloor insulation installed in the subarea. Upgrading should be considered for improved energy efficiency and interior comfort.

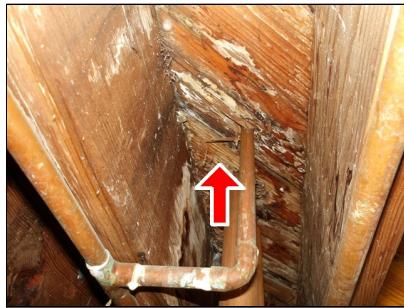
♦ Water stains were observed on the subflooring and/or framing under the kitchen and bathrooms - as seen from the crawl space. The areas were dry at the time of this inspection, and no damage was evident. We recommend review of the most current structural pest/wood destroying organism control inspection report for possible additional information, periodic inspection for evidence of active leakage and repairs made if deemed necessary.

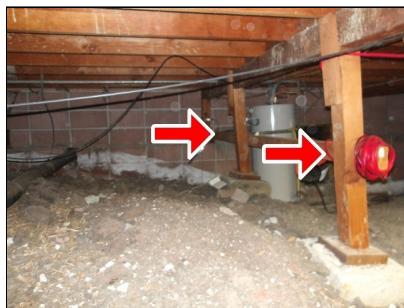
1. A few of the building's support piers and/or concrete pier pads located in the crawl space have shifted or settled. This may affect their ability to perform as designed. We recommend referral with a qualified licensed general contractor and/or the appropriate trades person(s) or specialist(s) for further evaluation and repair as deemed necessary to ensure that they provide full support. Estimated repair costs \$1000 - \$5000.

♦ A few of the building's support piers and/or concrete pier pads located in the crawl space have shifted or settled. This may affect their ability to perform as designed. We recommend referral with a qualified licensed general contractor and/or the appropriate trades person(s) or specialist(s) for further evaluation and repair as deemed necessary to ensure that they provide full support. Estimated repair costs \$1000 - \$5000.

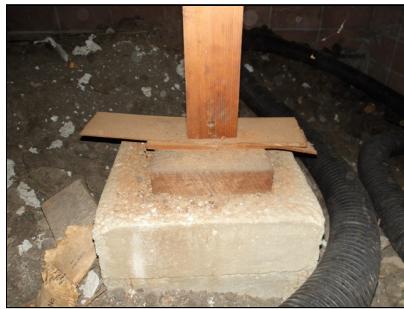
♦ A few of the building's support piers located in the crawl space have been amateurishly shimmed. No particular deficiencies were noted, however upgrading or modification by a qualified licensed general contractor and/or the appropriate trades person(s) or specialist(s) should be considered to ensure proper function.

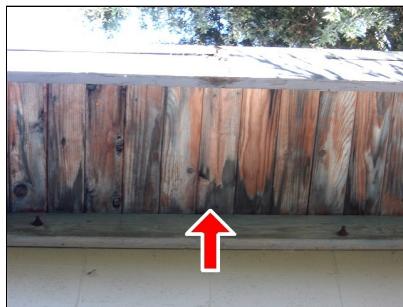
- ☒ ◆ Stains were observed on the underside of the roof eaves. These conditions may be the result of past roof leakage, however there could be other causes. We recommend referral with a licensed roofing contractor for further evaluation and repair if deemed necessary. We also recommend that they be prepped and refinished for a better appearance.

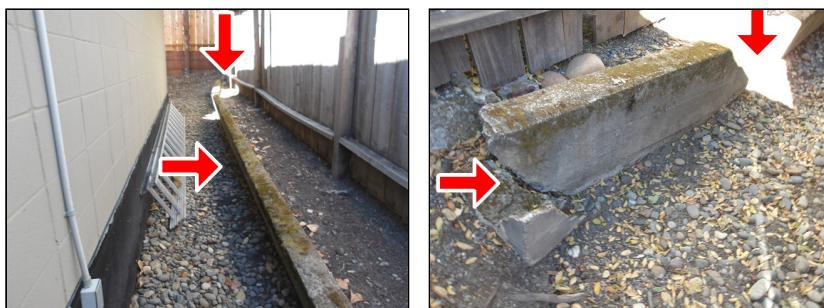
- ☒ 35. The retaining wall in place along the right side of the building is leaning, cracked and damaged. We recommend referral with a qualified licensed general contractor for repair or replacement.

- ☒ ◆ The retaining wall in place along the right side of the building is leaning, cracked and damaged. We recommend referral with a qualified licensed general contractor for repair or replacement.

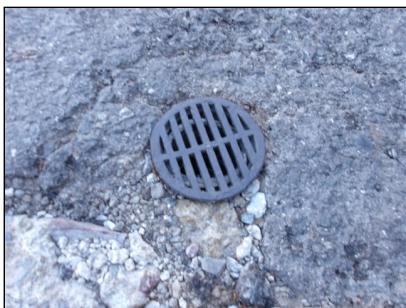
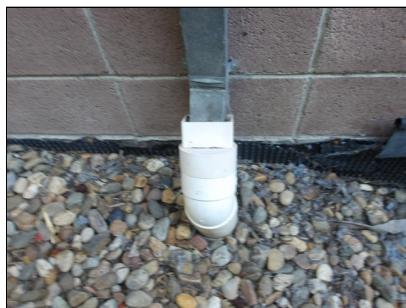
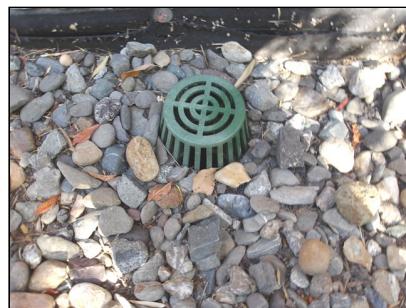
- ◆ There is an underground drainage system installed for this property. It was not water-tested during the inspection, and we make no representations as to its condition or effectiveness. We recommend referral with the seller(s) and occupants for possible additional information, and monitoring during rainy periods. If further evaluation is desired, we recommend referral with a qualified drainage specialist.

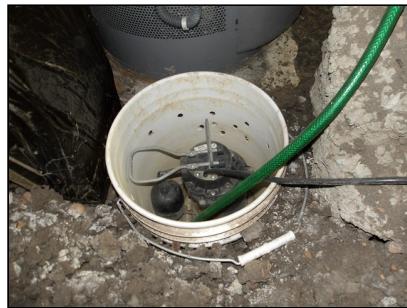
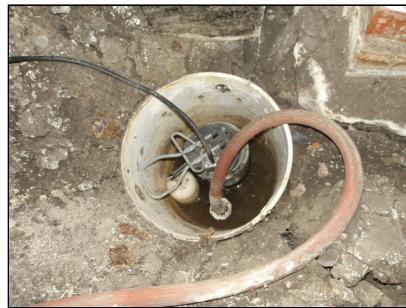
- ◆ We were informed that there is some type of underground "french" drain system in place. Because it is inaccessible for inspection, we were unable to verify its presence, and condition. We recommend referral with the seller(s) and the person(s) or company that performed the work for possible additional information. If further evaluation is desired, we recommend referral with a qualified drainage specialist.
- ◆ Two sump pumps have been installed in the crawl space to remove occasional water entry. The pumps were not observed under actual working conditions, however the pump motors were found to be operating. We recommend that proper operation be verified during periods of rain.

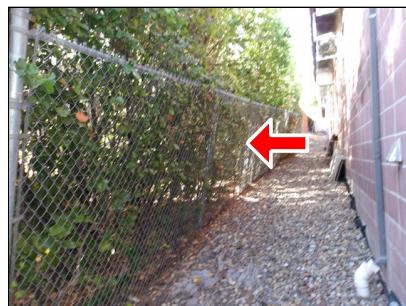
- ◆ Sections of the fencing in place along the rear of the property were loose, wobbly and/or leaning. We recommend that the fence be resupported, repaired or replaced as deemed necessary to ensure proper function and to help maximize the service life.

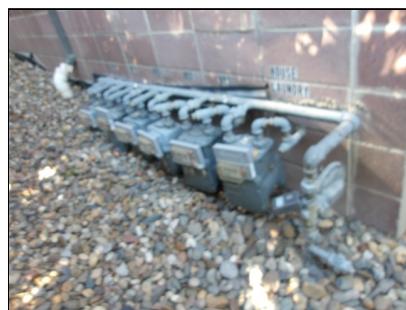
- ☒ ◆ There was no gas valve shut off wrench observed near the gas meters. We recommend that a wrench be attached to, or stored near the meters so the gas can be shut off in the event of an emergency. An automatic seismic shut off valve should also be considered for maximum safety in the event of an earthquake.

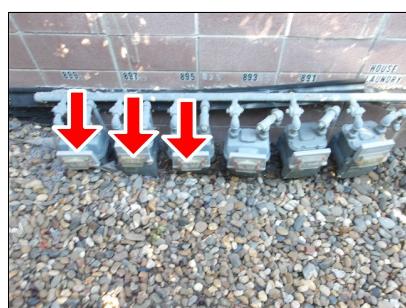
- ☒ ◆ The base of some of the gas meter housings are in contact with the soil. This condition can lead to corrosion and deterioration. We recommend all soil contact be eliminated and maintained.

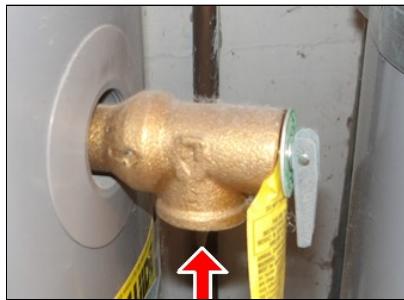
4. The house, #891, #893 and #897 water heater temperature & pressure relief (TPR) valves lacked a discharge drain pipe. We recommend that discharge pipes be installed by a qualified water heater specialist or licensed plumber and routed to the exterior or another location conforming to local requirements. Estimated installation costs \$100 - \$350 each.

♦ The house, #891, #893 and #897 water heater temperature & pressure relief (TPR) valves lacked a discharge drain pipe. We recommend that discharge pipes be installed by a qualified water heater specialist or licensed plumber and routed to the exterior or another location conforming to local requirements. Estimated installation costs \$100 - \$350 each.

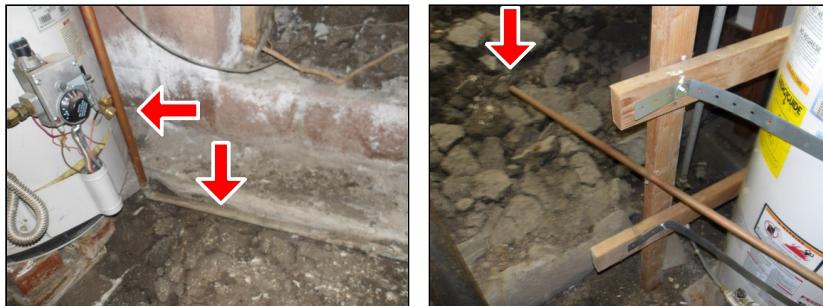
♦ The #895, #897 and #899 water heater temperature & pressure relief (TPR) valve discharge lines terminate in the crawl space. We recommend that discharge pipes be modified by a qualified water heater specialist or licensed plumber and routed to the exterior or another location conforming to local requirements.

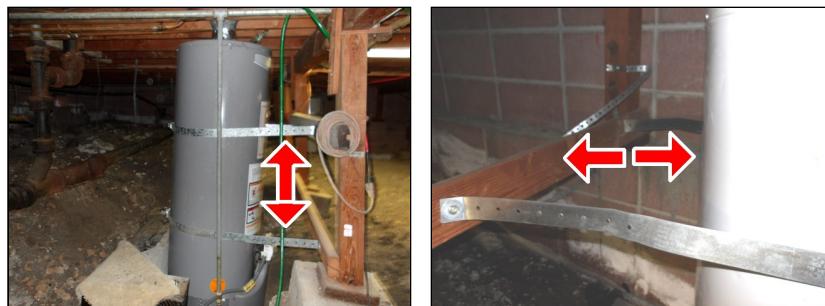
5. #897: The water heater was strapped in the lower and upper third of the tank, however the straps do not encircle the tank and there is a large gap observed between the tank and the framing. We recommend that the strapping be modified and reconfigured in accordance with present standards by a qualified water heater specialist or licensed plumber to help prevent movement in the event of seismic activity. Estimated repair cost \$100 - \$350.

♦ #897: The water heater was strapped in the lower and upper third of the tank, however the straps do not encircle the tank and there is a large gap observed between the tank and the framing. We recommend that the strapping be modified and reconfigured in accordance with present standards by a qualified water heater specialist or licensed plumber to help prevent movement in the event of seismic activity. Estimated repair cost \$100 - \$350.

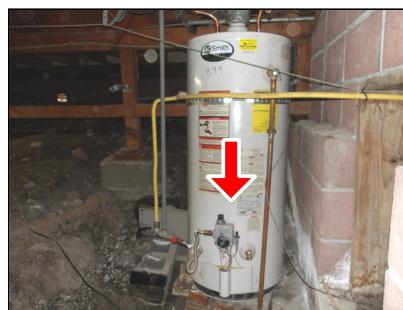
6. #899: There was no strap installed in the lower third of the water heater tank, the strap does not encircle the tank and there is a large gap observed between the tank and the framing. We recommend that the strapping be modified and reconfigured in accordance with present standards by a qualified water heater specialist or licensed plumber to help prevent movement in the event of seismic activity. Estimated repair cost \$100 - \$350.

♦ #899: There was no strap installed in the lower third of the water heater tank, the strap does not encircle the tank and there is a large gap observed between the tank and the framing. We recommend that the strapping be modified and reconfigured in accordance with present standards by a qualified water heater specialist or licensed plumber to help prevent movement in the event of seismic activity. Estimated repair cost \$100 - \$350.

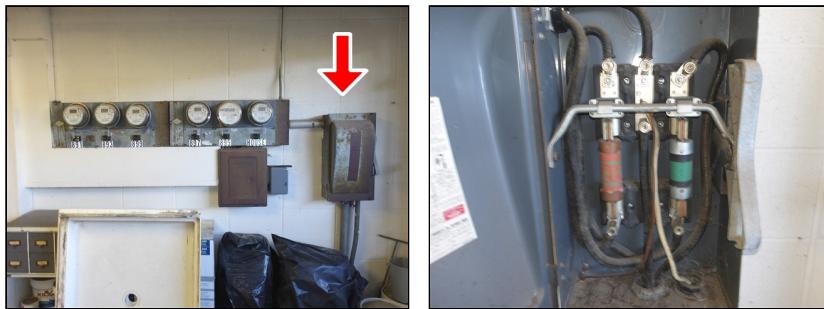
♦ The main electrical panel utilizes an outdated knife-type disconnect that has no "dead front" cover to protect the wiring and prevent accidental contact. We recommend that consideration be given to replacing the panel with a modern panel by a licensed electrician.

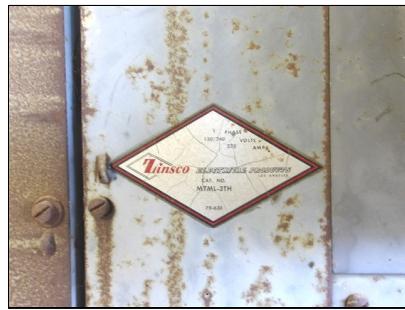
♦ The main electrical panels in place for each unit were manufactured by *Zinsco Electric*. Some of the equipment produced by this company has been associated with product defects, and failure of their overcurrent protection devices (circuit breakers). Although there was no evidence of overheating or failure of the breakers, we cannot predict the likeliness of failure and recommend referral with a licensed electrician for further evaluation, and replacement of this equipment should be considered and anticipated.

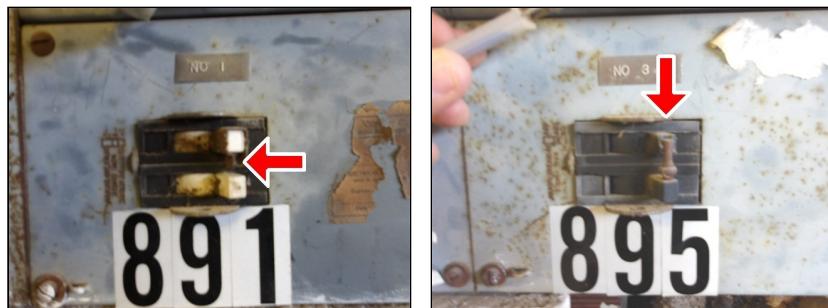
7. #891, #895: The breakers were damaged and/or not tied together. We recommend referral with a licensed electrician for further evaluation and repair as deemed necessary to ensure proper function and maximum safety. Estimated repair/replacement cost \$250 - \$500 each.

♦ #891, #895: The breakers were damaged and/or not tied together. We recommend referral with a licensed electrician for further evaluation and repair as deemed necessary to ensure proper function and maximum safety. Estimated repair/replacement cost \$250 - \$500 each.

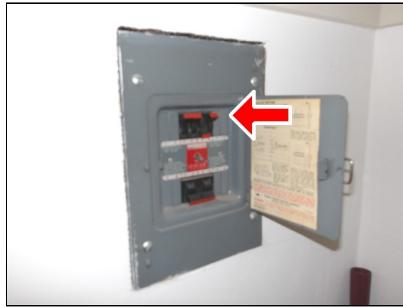
- ▣ ♦ #893: One of the circuit breakers located in the electrical subpanel was shut off at the time of this inspection. We did not activate the breaker, or energize the circuit because doing so could create a hazard. We recommend asking the occupant(s) or seller(s) why the breaker is in the OFF position, and referral with a licensed electrician if further evaluation is desired.

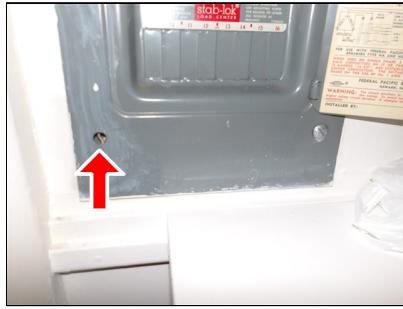
- ▣ ♦ #895: One of the electrical subpanel panel cover screws was missing. We recommend replacement with an approved blunt-end screw to ensure proper function.

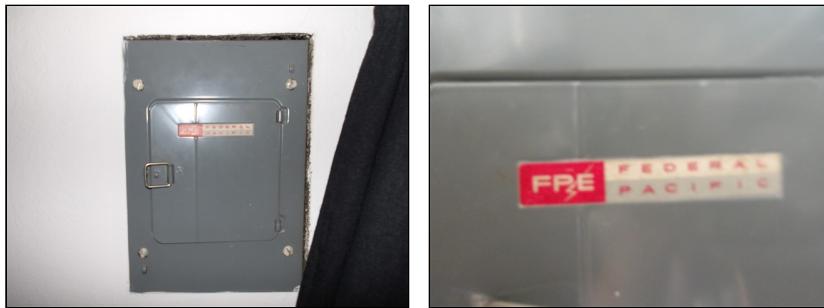
- ▣ ♦ The electrical subpanels were manufactured by Federal Pacific Electric (FPE). Some of the equipment produced by this company has been associated with product defects, including failure of the overcurrent devices (circuit breakers) and rare cases of fires. Therefore these panels should be considered potentially unreliable and hazardous. Although there was no evidence of overheating or failure of the breakers, we cannot predict the likeliness of failure and strongly recommend referral with a licensed electrician for further evaluation, and that replacement of this equipment be considered and anticipated.

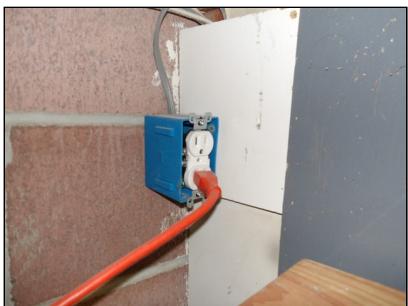
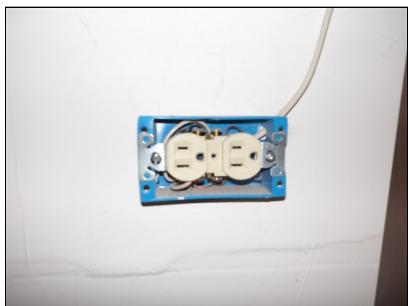
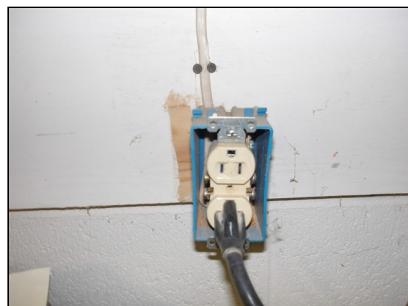
♦ The cover plates were missing at some of the electrical receptacles located in the garage and in the adjacent office/storage areas. We recommend that they be fitted with approved cover plates to protect the wiring from accidental contact and physical damage. Estimated replacement cost \$3 - \$5 for each cover + labor.

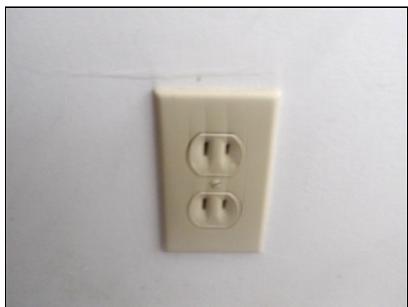
♦ There are some remaining ungrounded two prong electrical receptacles. This is typical in buildings of this age, however we recommend that all of the ungrounded two prong electrical receptacles be upgraded and grounded in the course of ongoing improvements for user convenience and maximum safety.

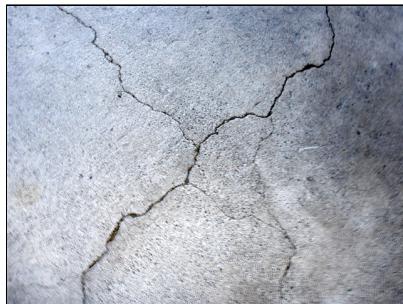
☒ ♦ Cracks were observed in the garage and carport concrete slab floors. This is not unusual, however we recommend the cracks be sealed or patched to help prevent potential water entry and subsequent cracking and/or other damage. If more information, further evaluation and/or repair is desired, we recommend referral with a licensed concrete contractor.

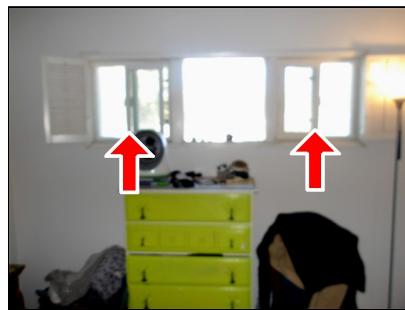
♦ #895: We observed what appears to be evidence of condensation between the panes of glass in the front bedroom windows. This suggests a failed seal between the glass panes. We recommend that all failed insulated glass units be replaced by a licensed window contractor to restore proper function and for a better appearance. estimated replacement cost \$500 - \$1500 each.

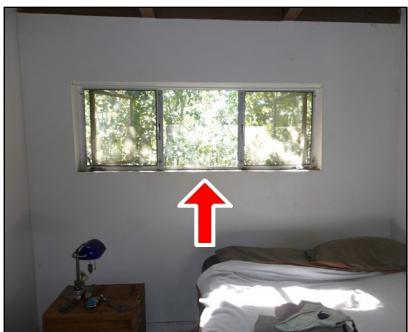
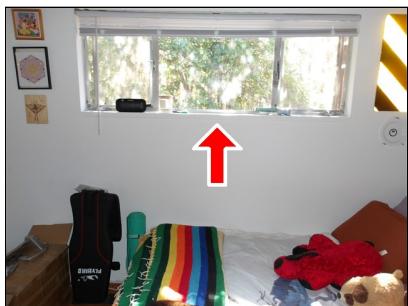
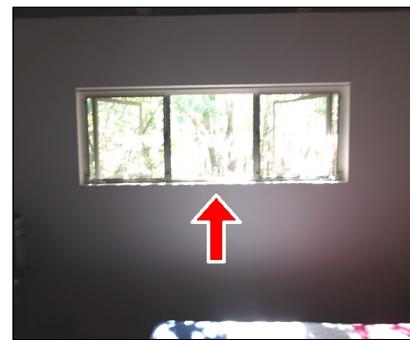
♦ The bedroom windows in the are more than 44" above the floor - which is the current standard for egress in the event of an emergency. Additionally, the windows in the bedroom are too small by present standards. Current requirements are a minimum of 20" x 24", to provide a means of a escape in the event of a fire, and exterior access by a fire-fighter. If more information is desired, we recommend referral with a general contractor or the local Building Department. Upgrading should be considered for maximum safety.

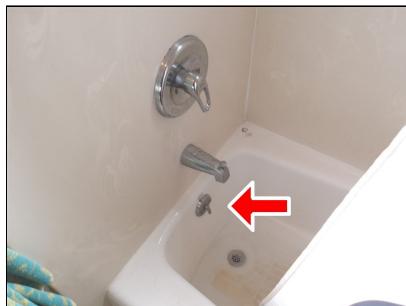
☒ ◆ #897: The bathtub drain stop was not operational. We recommend adjustment or repair as deemed necessary to restore proper function.

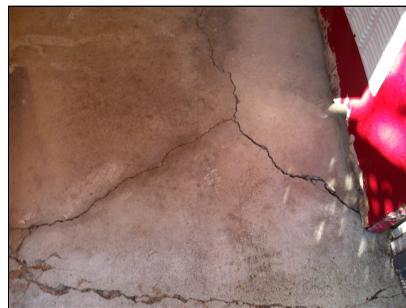
♦ Cracks were observed in the laundry room concrete slab floor. These are primarily cosmetic considerations, and we only recommend patching or repair for a better appearance and to help maximize the service life.
