PROPERTY CONDITION REPORT

Client(s): Mike Erickson
Property: 20265 Lake Chabot Rd,
Castro Valley, CA 94546
Realtor: Phillip Fair
Date: 8/9/2024
Inspector: Rick DeBoard - Certification #1051
Report #: PCA8210

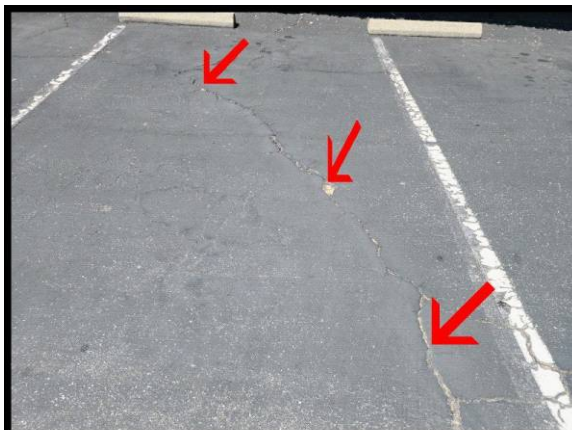
Cracks

We recommend sealing cracks in the parking area to extend the life of the asphalt. This is a minor cost item.

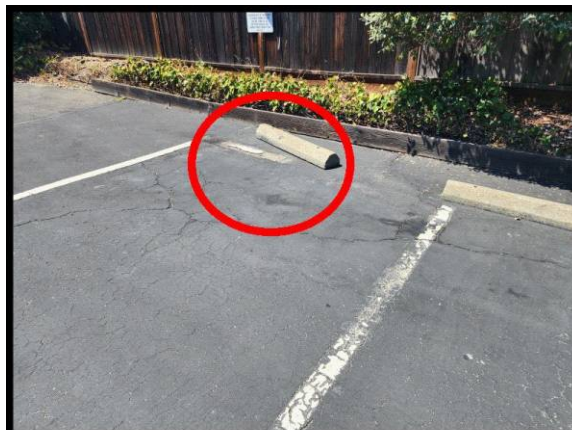
Bumper

One bumper is misplaced. You should anticipate the need to replace or repair within the next 5 years. However, we have not listed this item in the Projected Maintenance Expenses section of this report, as we believe the expense is likely to be less than \$3,000.

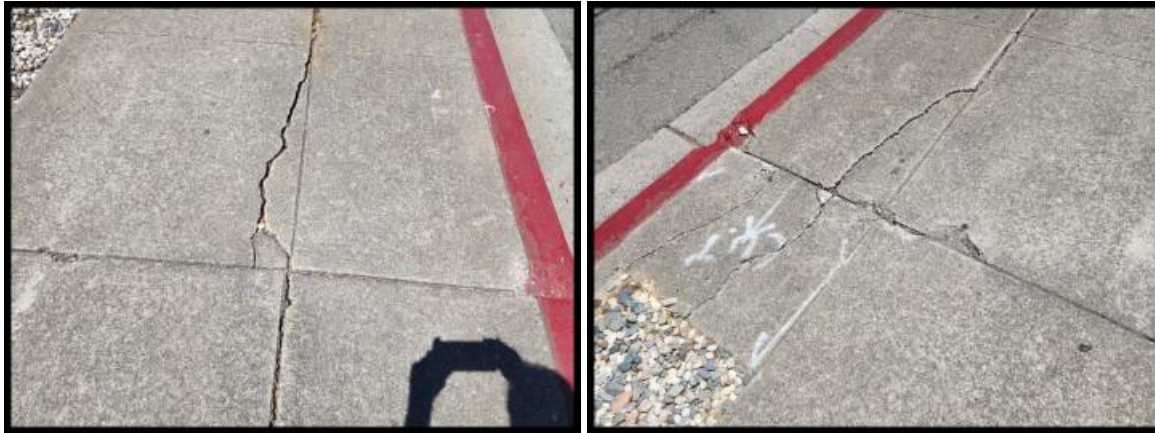
Cracks were noted which are larger than typical at the public walkway. You should anticipate the need to replace or repair within the next 5 years. However, we have not listed this item in the Projected Maintenance Expenses section of this report, as we believe the expense is likely to be less than \$3,000.

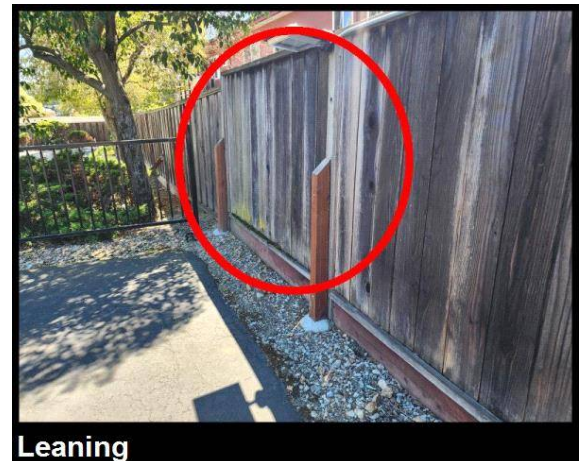
Fence is leaning at the southwest corner of the property. You should anticipate the need to replace or repair within the next 5 years. However, we have not listed this item in the Projected Maintenance Expenses section of this report, as we believe the expense is likely to be less than \$3,000.

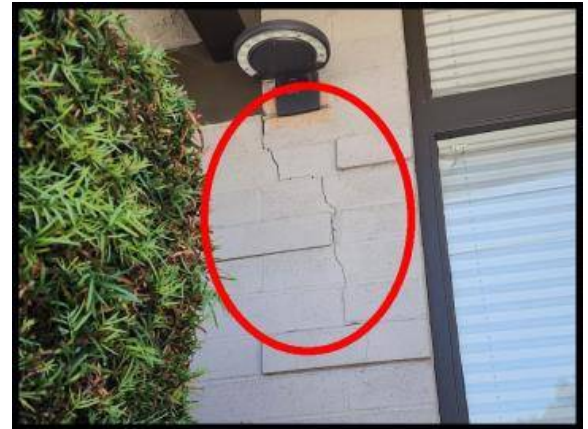
Diagonal cracks were noted in the upper masonry wall at the southeast corner of the building. We recommend further evaluation by a properly qualified structural engineer.

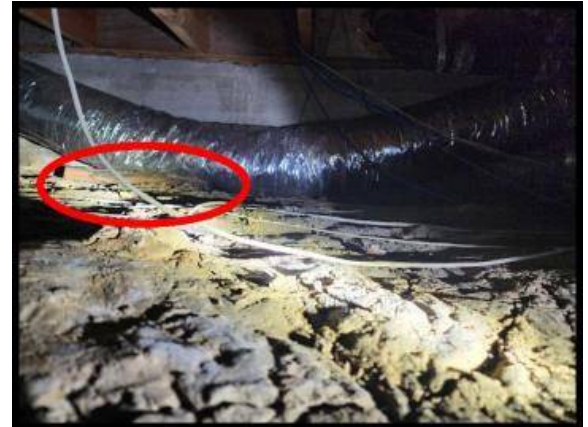
Evidence of wood destroying pests was noted in the area of the underfloor crawlspace (wood fragments lying on the soil).. We recommend a pest inspection be performed by a properly licensed pest control operator.

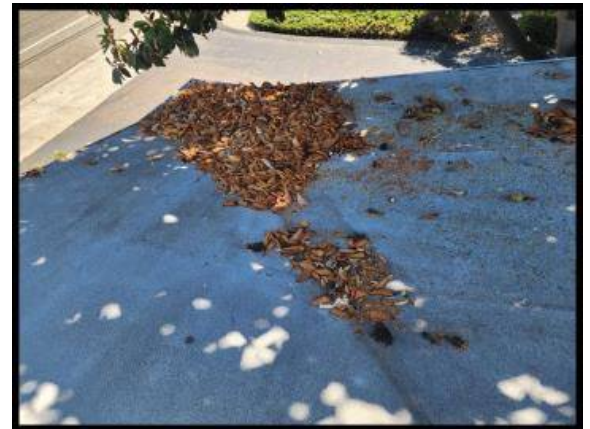
There is an accumulation of leaves and debris on the roofing surface. We recommend cleaning of the roof surfaces be

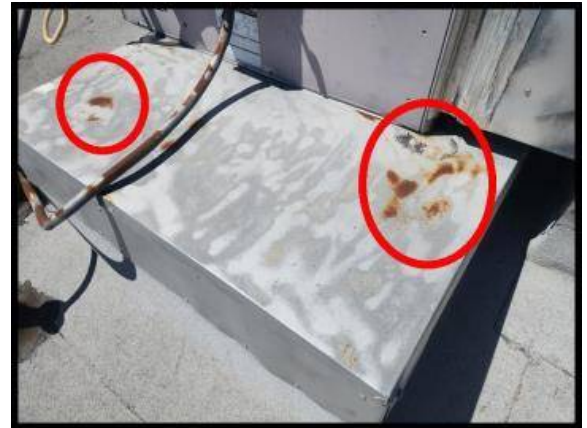
Some flashings are showing signs of rust. The recommended treatment for preventative maintenance of flashings is to wire brush the rusted surfaces, apply rust inhibitive paint and then a final coat of paint. This is a minor cost item.

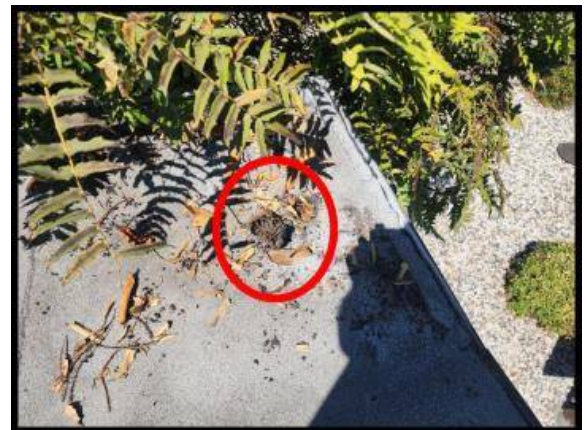
Drain scuppers have no screens or grates installed, which allows them to be clogged with debris. We recommend that all drains be equipped with grates or screens. This is a minor cost item.

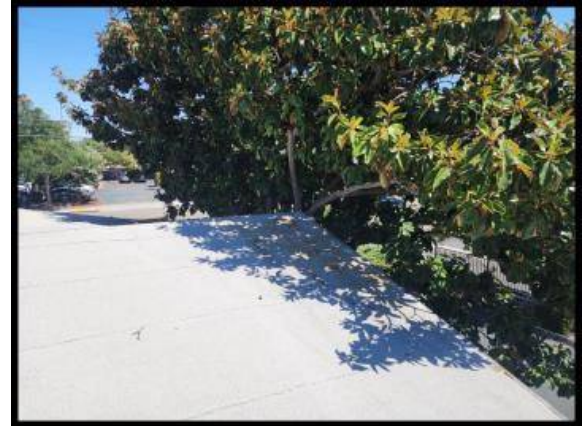
Trees or shrubbery are over hanging the roof surface, we recommend that overhanging trees be trimmed back where they are likely to come into contact with roof or eaves. This item should be added to your list of regularly scheduled maintenance procedures, no cost estimates are given.

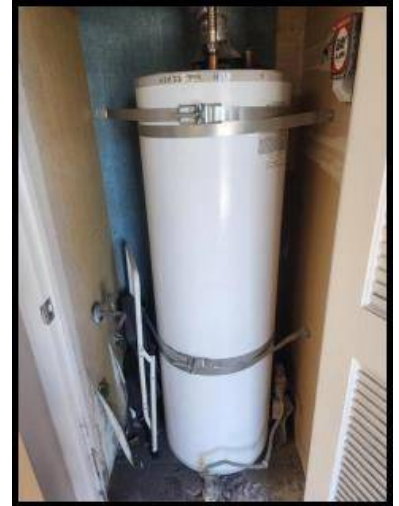
Average water heater life in the United States is 8-10 years, although they can exceed this life expectancy by many years if they are drained annually. You should anticipate the need to replace or repair within the next 5 years.

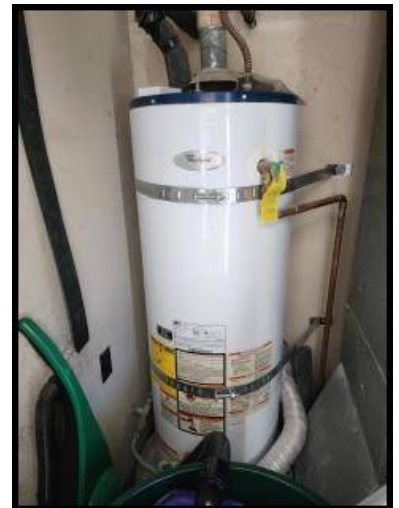
8.6 Water Heater #2

Located at the upstairs janitors closet. Manufactured by Whirlpool. Capacity is 40 gallons. This heater is powered by Natural Gas. This unit appears to be 14 - 16 years old. Fair condition. A Safety Relief Valve was noted, but TESTING OF THESE DEVICES IS NOT A PART OF THIS INSPECTION. Combustion venting is good. Exhaust venting is good. Unit is braced according to current standards. This unit is internally insulated.

Average water heater life in the United States is 8-10 years, although they can exceed this life expectancy by many years if they are drained annually. You should anticipate the need to replace or repair within the next 5 years.

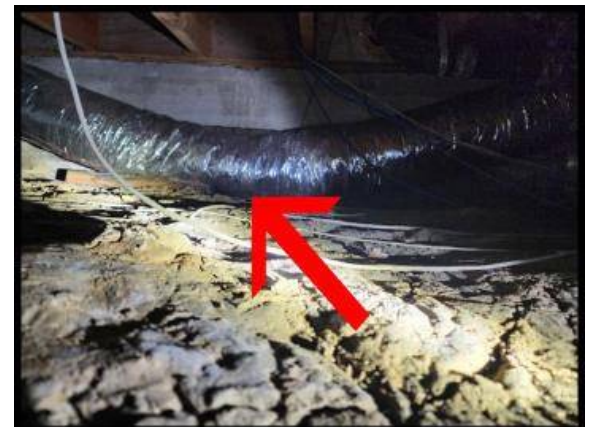
1. Soil is in contact with some ducts in the crawlspace. This condition will accelerate deterioration of ducts.
2. You should be aware that according to the new California Title 24 requirements, a "tight duct" test must be performed upon replacement of the heating/cooling units. It is likely that older ducts such as these would not pass this test and therefore they may need replacement or repairs.

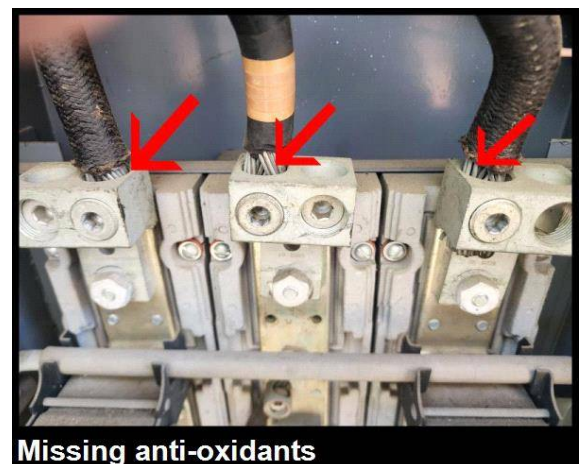
1. There are two "Federal Pacific" brand panels (Stablok type) installed at this property. We do not typically open these panels, as the only thing that holds in the breakers is the dead cover. When the dead cover is removed, the breakers can fall out. There have been many challenges with this brand panel over the years, (including, but not limited to failure of the breakers to trip when necessary), and we strongly recommend that you have this panel replaced by a properly qualified electrician. Visit http://www.codecheck.com/cc/ccimages/PDFs/FPE_2012.pdf for more information.

2. Antioxidant is missing at aluminum connections at one of the panels.
3. Two of the panels have the space immediately in front of them restricted by furniture or some other type of permanent obstruction, which is a violation of the required 36" dedicated free space in front of all electrical equipment. This requirement is for the safety of electrical technicians and maintenance personnel. In order to correct this condition, the panel(s) or the obstruction in front of the panel(s) will need to be moved to a different location.

We found the following safety concerns regarding the panels:

2. Antioxidant is missing at aluminum connections at one of the panels.
3. Two of the panels have the space immediately in front of them restricted by furniture or some other type of permanent obstruction, which is a violation of the required 36" dedicated free space in front of all electrical equipment. This requirement is for the safety of electrical technicians and maintenance personnel. In order to correct this condition, the panel(s) or the obstruction in front of the panel(s) will need to be moved to a different location.
Cost-to-Cure = \$5,000.

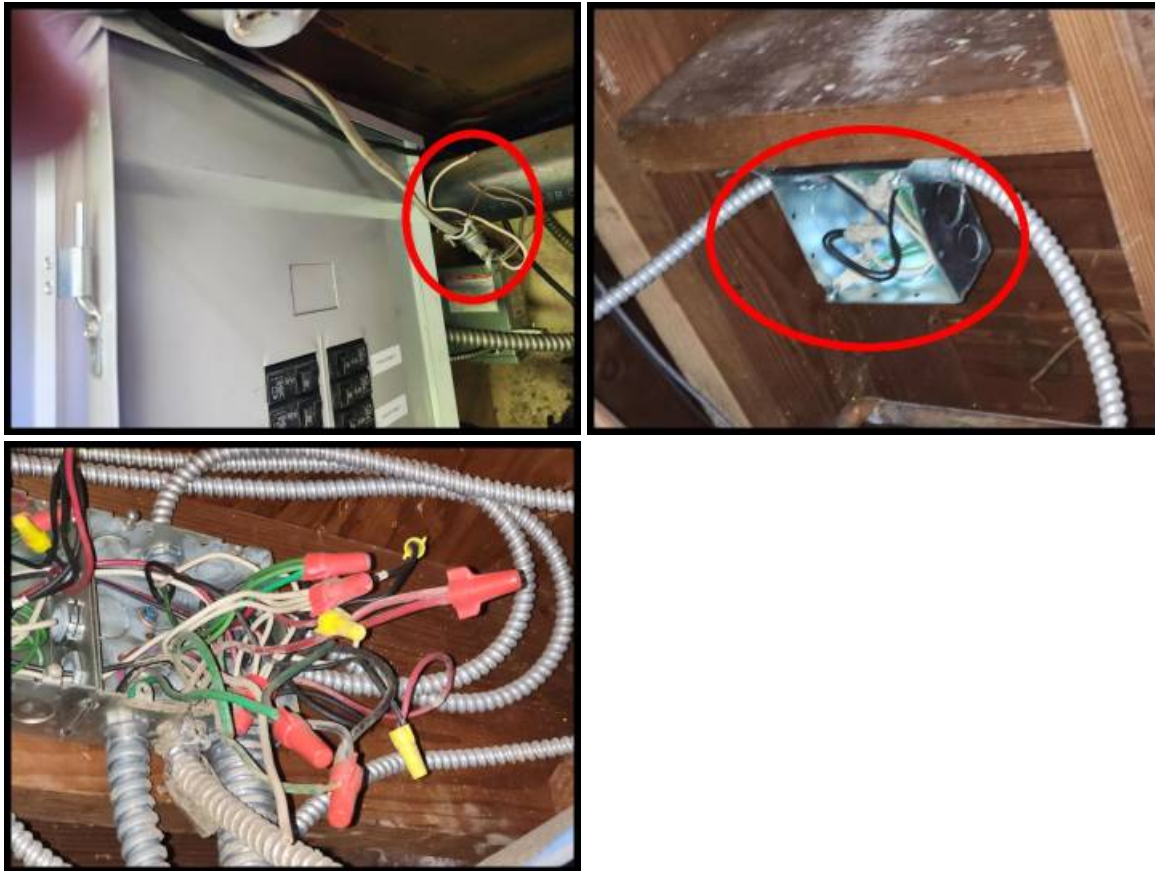
1. Junction or ceiling boxes were noted to be without covers at underfloor crawlspace. Although covers are inexpensive to purchase and install, they are very important because they contain any sparks within

the box in the event that wire connections become loose.

2. Connections were noted which were made without the use of junction boxes inside the north exterior compressor shed. This can be a potential fire hazard, because without junction boxes the sparks which are created by loose connections can easily ignite nearby flammable substances.

1. Junction or ceiling boxes were noted to be without covers at underfloor crawlspace. Although covers are inexpensive to purchase and install, they are very important because they contain any sparks within the box in the event that wire connections become loose.
2. Connections were noted which were made without the use of junction boxes inside the north exterior compressor shed. This can be a potential fire hazard, because without junction boxes the sparks which are created by loose connections can easily ignite nearby flammable substances.

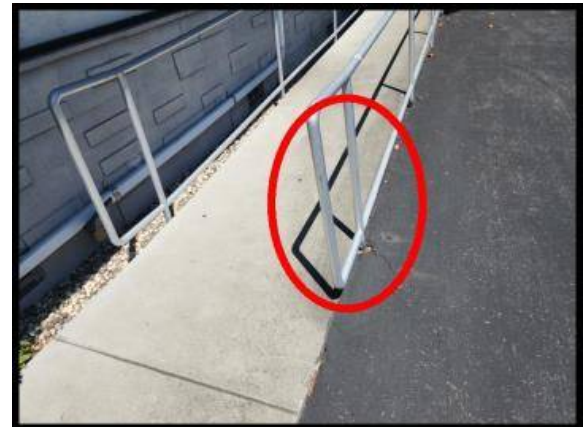
Handrails are loose at the east handicap ramp. This is a minor cost item.
