# WOOD DESTROYING PESTS AND ORGANISMS INSPECTION REPORT

#: 20214253

| BUILDING NO.<br>119 S | STREET<br>ADAMS STREET | CITY<br>GLENDALE | ZIP<br>91205 | Date of Inspection<br>09/04/2026 | NUMBER OF PAGES<br>1 of 10 |

**MULTI FAMILY 2 STORY UNIT WITH A DETACHED GARAGE, COMP ROOF, WOOD EXTERIOR, RAISED FOUNDATION BASEMENT AND WAS VACANT AT THE TIME OF THE INSPECTION**

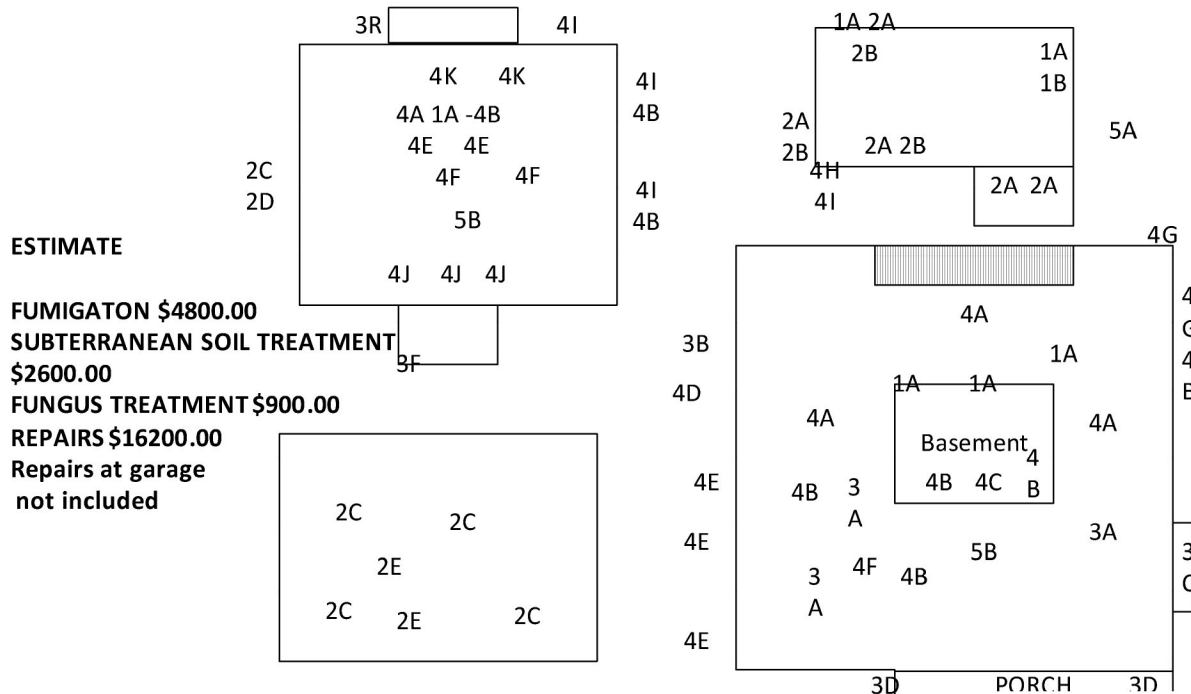
FINDING AND RECOMMENDATION: 1A Evidence of SUBTERRANEAN TERMITES in as indicated by 1A on the diagram. The evidence was located in or near: SUBFLOOR.

FINDING AND RECOMMENDATION: 1B Evidence of SUBTERRANEAN TERMITES in as indicated by 1B on the diagram. The evidence was located in or near: GARAGE.

FINDING AND RECOMMENDATION: 1C Evidence of SUBTERRANEAN TERMITE DAMAGE as indicated by 1C on the diagram. The damage was noted in or near: GARAGE.

FINDING AND RECOMMENDATION: 2A Evidence of DRYWOOD TERMITES as indicated by 2A on the diagram. Evidence noted in or near: GARAGE.-

DRYWOOD TERMITE DAMAGE indicated by 2B on diagram. The damage was noted in or near: GARAGE. Garage seems to be structurally compromised.

Evidence of DRYWOOD TERMITES as indicated by 2C on the diagram. Evidence noted in or near: PROPERTY.-

DRYWOOD TERMITE DAMAGE indicated by 2D on diagram. The damage was noted in or near: TRIM. -

DRYWOOD TERMITE DAMAGE indicated by 2E on diagram. The damage was noted in or near: ATTIC. -

SURFACE FUNGUS noted as indicated by 3A on diagram. The FUNGUS infection was noted in or near: SUBFLOOR.

Dry rot noted as indicated by 3B on diagram. The Dry Rot was noted in or near: SIDING TRIM.

Moisture damage as indicated by 3C on the diagram. The damage was in or near CHIMENEY & FASCIA.

Moisture damage as indicated by 3D on the diagram. The damage was in or near POST AND THRESHOLD.

Dry rot & termite damage noted as indicated by 3E on diagram. The damage was noted in or near: TRIM.

Dry rot & termite damage noted as indicated by 3F on diagram. The damage was noted in or near: POSTS.

CELLULOSE DEBRIS noted as 4A on the diagram.

EARTH TO WOOD CONTACT as indicated by 4B on the diagram. The contact was in or near: \_.

Moisture damage as indicated by 4C on the diagram. The damage was in or near BASEMENT.

Moisture damage as indicated by 4D on the diagram. The damage was in or near FOUNDATION WALL.

Exposed wood noted as indicated by 4E on the diagram.

Moisture damage as indicated by 4F on the diagram. The damage was in or near BATHTUB.

Moisture damage as indicated by 4G on the diagram. The damage was in or near SIDINGS.

Moisture damage as indicated by 4H on the diagram. The damage was in or near SUBFLOOR.

Evidence of a plumbing leak under the house as indicated by 4I on the diagram.

Soft Floor noted as indicated by 4J on the diagram.

*Damaged Foundation as indicated by 4K on the diagram. This is considered as conducive to infestation.*

Zero lot line exists as indicated by 5A on the diagram.

SUBAREA limited inspected due to low clearance as indicated by 5B on the diagram.

RECOMMENDATION: Topically treat subsoil with a registered termiticide for subterranean termites in accordance with the label.

RECOMMENDATION: Pressure treat infested area with a registered termiticide for subterranean termites in accordance with the label. Patch holes as practical if needed.

RECOMMENDATION: Owner to hire proper tradesman to repair as necessary.

RECOMMENDATION: Fumigate the structure for the control of Dry Wood Termites. The structure must be vacated for three (3) days. Refer to the fumigation notice for specific instructions. Vikane gas will be used for fumigation: (Active Ingredient -- Sulfuryl Fluoride -- with Chloropicrin as a Warning Agent. - Disclaimer: In order to prepare the property for fumigation, it's necessary for workmen to walk on the roof. We are informing you that possible damage may occur to the roof and/or tile roof. By giving the authorization to do the fumigation and/or termite work, you release My Termite Company from any responsibility for any damage to the roof and/or tile roof during the process of fumigation.- MY TERMITE CO. does NOT provide on-site security and does not assume any responsibility for the care and custody of the property in the event of vandalism or breaking and entering. -NOTE: In order for the fumigation to be performed, plant growth must be cut back and moved to create an approximately two feet clearance around the perimeter of the home. This is necessary to ensure sealing of tarping before the fumigation process can proceed. Fumigators are not allowed to move potted plants.

RECOMMENDATION: Owner to hire a licensed contractor to inspect and repair as necessary.

RECOMMENDATION: Patch with wood filler if wood members are not structurally weakened otherwise, remove and replace or reinforce with douglas fir or pine wood material and repair as required paint is not included. During the course of repair to damage timber, should damage extends into inaccessible areas a supplemental report will be issued.

RECOMMENDATION: Wire brush surface fungus and apply a registered fungicide in accordance with the label.

RECOMMENDATION: Patch with wood filler if wood members are not structurally weakened otherwise, remove and replace or reinforce with douglas fir or pine wood material and repair as required paint is not included.

RECOMMENDATION: Owner to hire a proper tradesman to inspect and correct this condition.

RECOMMENDATION: Remove all rakable size cellulose debris and discard.

RECOMMENDATION: Owner to hire a proper tradesman to break contact as appropriate.

RECOMMENDATION: We highly recommend to paint or treat the exposed wood to prevent or minimize termite infestation.

RECOMMENDATION: We recommend contacting an appropriate tradesman to correct this condition.

*RECOMMENDATION: We recommend to contact other trades to correct this condition.*

RECOMMENDATION: FURTHER INSPECTION after owner makes area accessible.

RECOMMENDATION: Periodic inspection and further inspection is recommended if any of these areas become accessible. Any future Wood destroying organisms would be outlined in a supplemental report. This company assumes no liability or responsibility for any damage or infestation in areas not inspected.
