## Title 5 Official Inspection Form

27 Douglas Road				
Property Address				
PSS, LLC				
Owner's Name				
Webster	MA	01570	12-14-2022	
City/Town	State	Zip Code	Date of Inspection

#### 27 Douglas Road, Webster

Title 5 Official Inspection Form, Section D.14

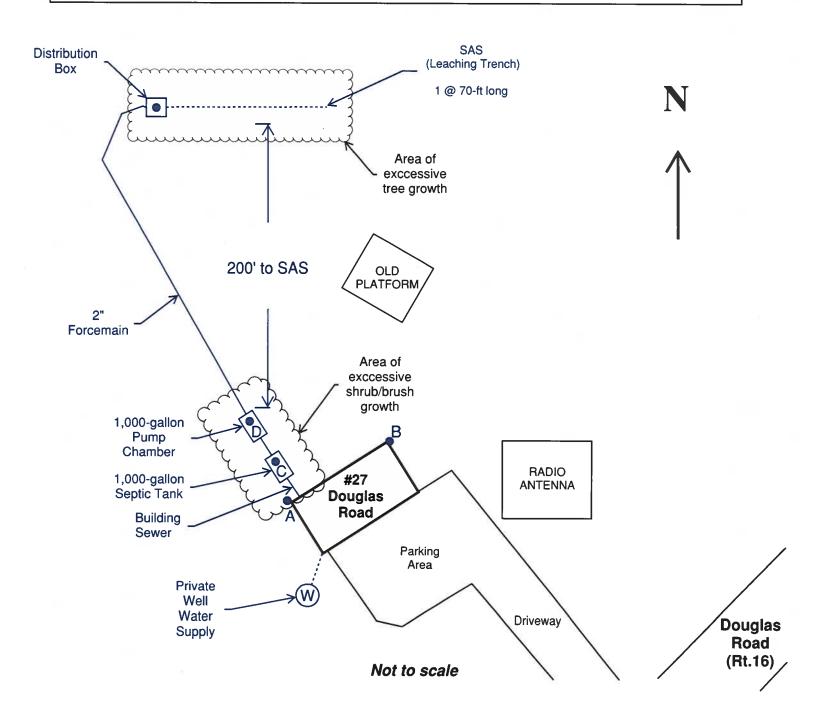
AC = 17'-0" BC = 55'-6" AD = 38'-6" BD = 68'-0"

A,B - Swing tie points.

C - 1,000-gallon Septic Tank Outlet Cover (12" dig, no riser).

D - 1,000-gallon Pump Chamber (24" dig).

E - Distribution Box (6" dig).
