NEW HOME INSPECTIONS

#2 (LEFT MIDDLE BUILDING)

835 Minnie St Jacksonville, FL 32204

NOVEMBER 7, 2024

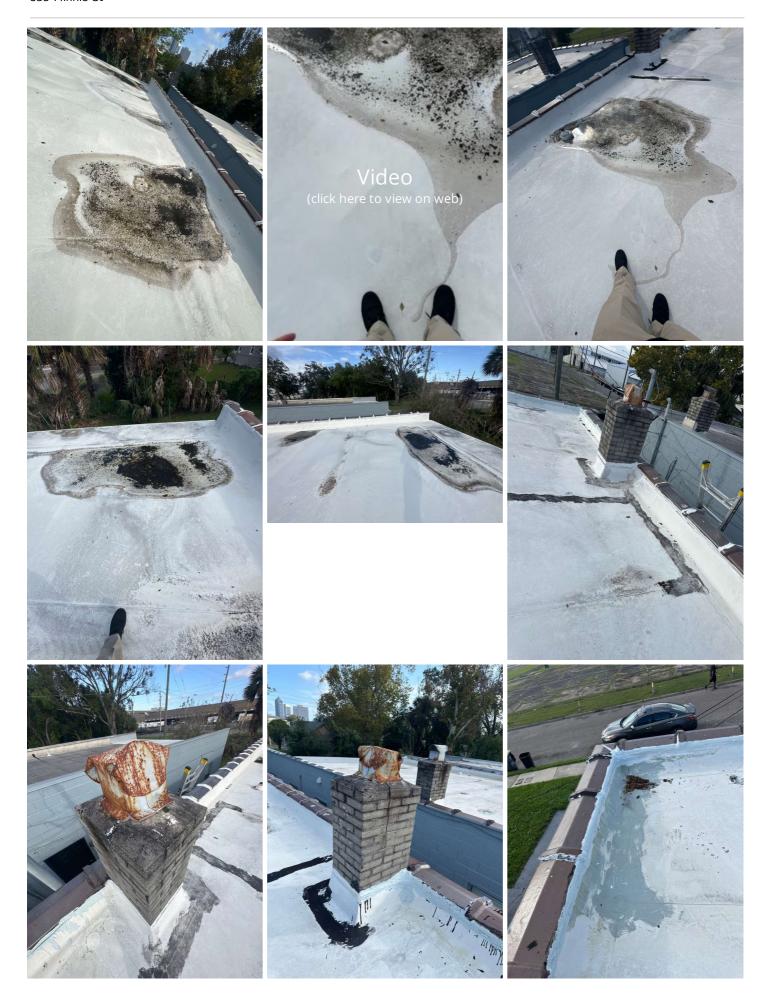
Water stains noted on the ceilings and walls in multiple areas. The stains had low moisture levels according to the moisture meter, but in my personal opinion this likely will leak during very excessive rains or in the some-what near future. The roof covering shows multiple repairs around the roof. Sealants were applied, as well as elastomeric or silicone roof coatings, but this was a lot of different areas. The chimneys are no longer active, but still need to be maintained. The rain caps show corrosion. There is multiple areas of standing water. While some standing water can be common for flat roofs, but was a lot of different areas and the roof covering is bubbling in areas and moves when stepped on. Recommend further evaluation by a roofing contractor and repair or replace as needed.

Recommend monitoring.

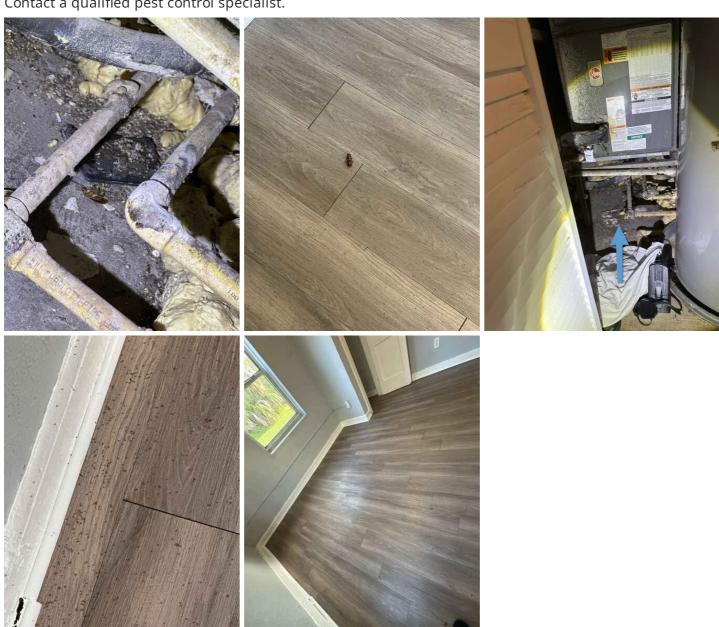
Dead roaches, ants and mouse traps noted in the home (both units). Recommend further evaluation by a pest control specialist.

Contact a qualified pest control specialist.

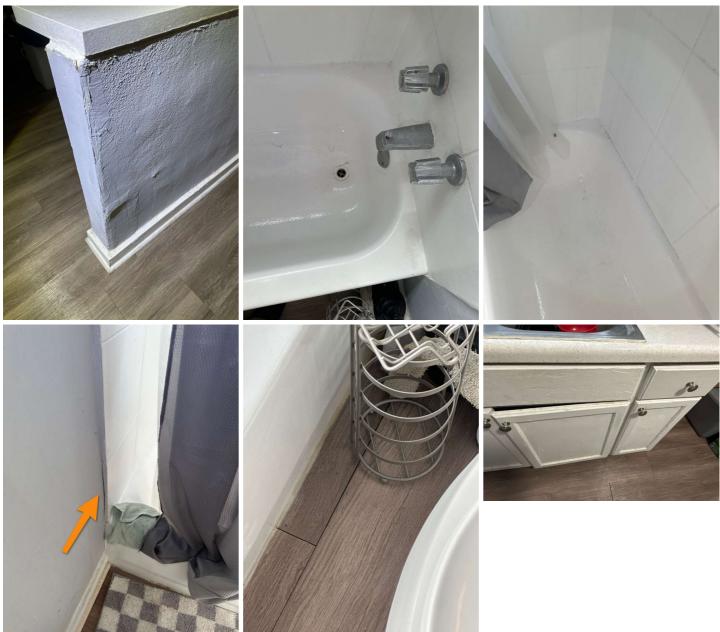
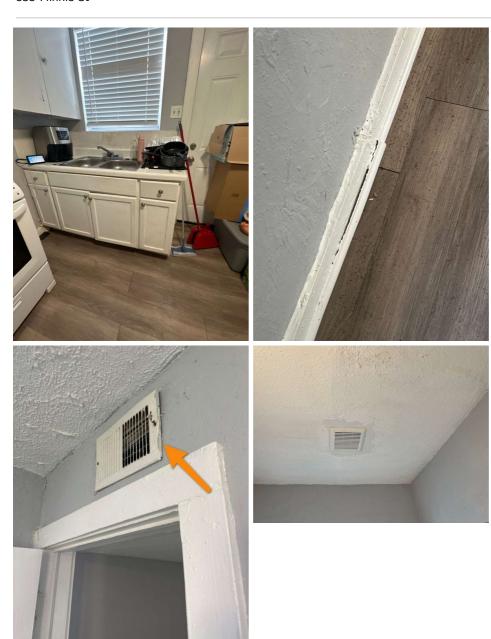
829

This is not a new home, so the home has general wear and tear that can be common for its age. You should be aware of the general condition. We inspect with realistic expectations for the age of the home, but here are some photos of some of the more noticeable wear and tear items that were noted.

Contact a qualified professional.
