#1 (LEFT BUILDING)

835 Minnie St
Jacksonville, FL 32204

NOVEMBER 7, 2024

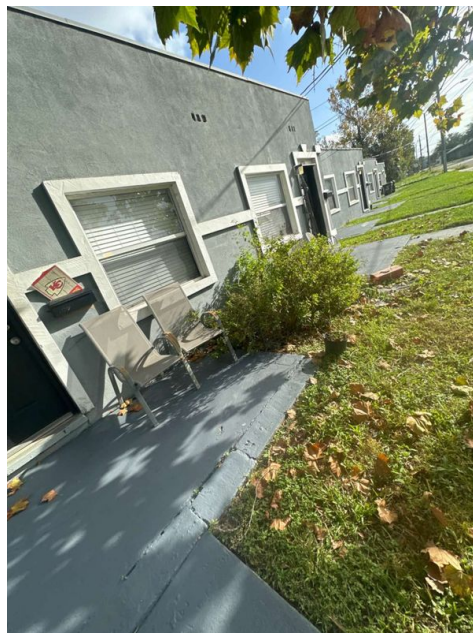
The concrete has settled at the exterior. The concrete is uneven or has sunken downwards in areas, which can cause a potential tripping hazard. Recommend repairing the concrete as needed or monitoring and being cautious of this.

Contact a qualified concrete contractor.

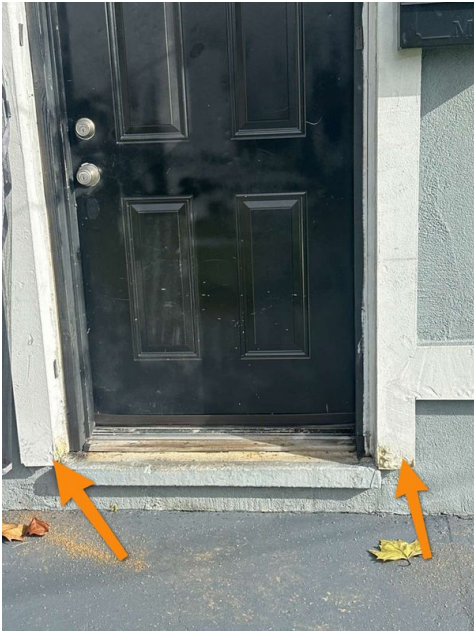
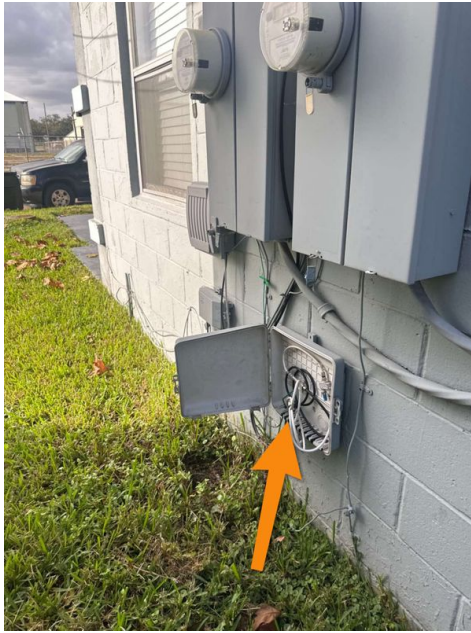
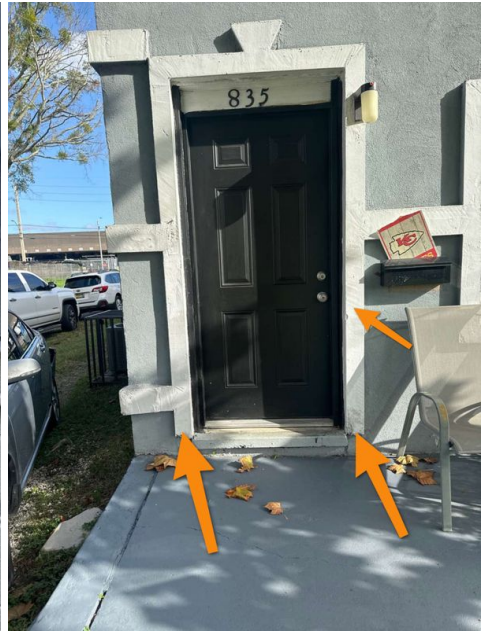
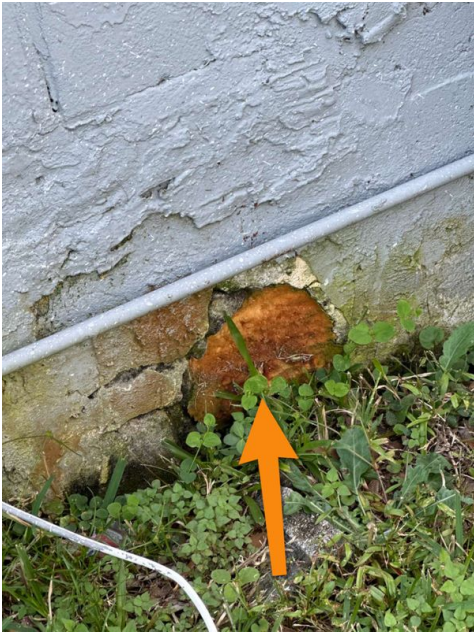
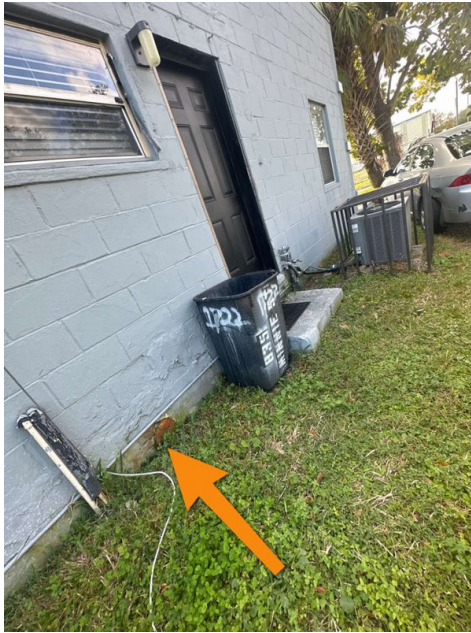
DAMAGE AT SIDING/TRIM

Damage was present to the siding and/or trim in the areas pictured below. Recommend repairing the siding to ensure proper drainage and to allow for normal wear and tear.

Contact a qualified professional.

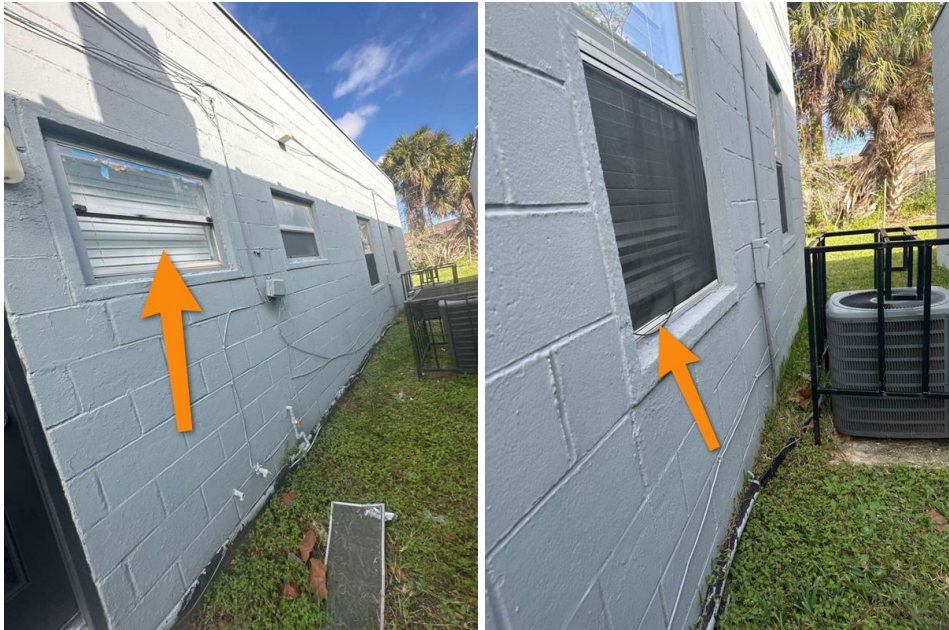
MISSING/TORN WINDOW SCREENS

Some missing or torn/loose window screens noted. Recommend repair as desired to reduce possible pest entry when the windows are open.

Contact a qualified professional.

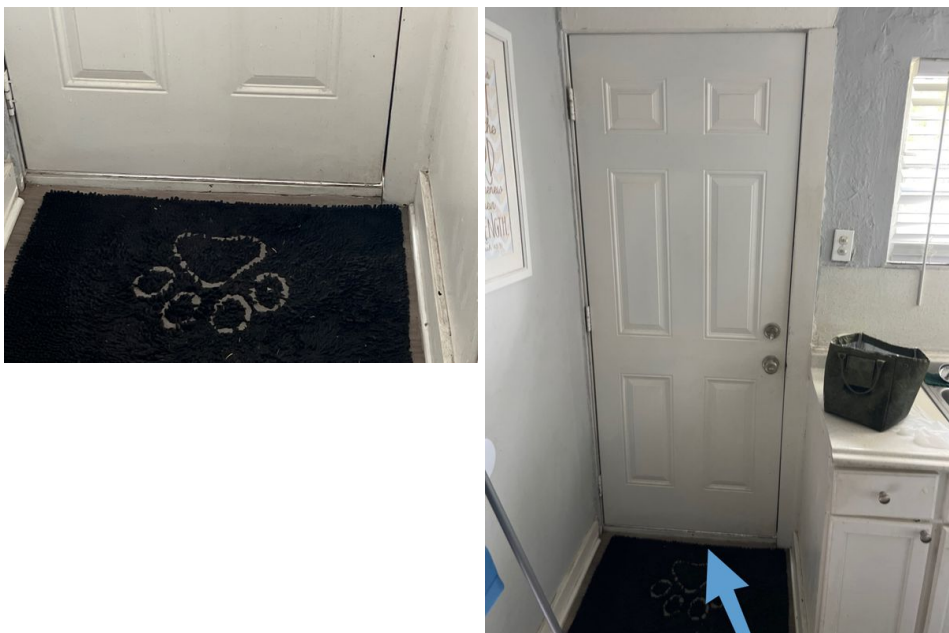
Visible daylight was noted coming from the seams of the exterior rated doors pictured below. Recommend adjusting, replacing or adding additional weather seals to reduce energy loss and pathways for pests.

Contact a handyman or DIY project

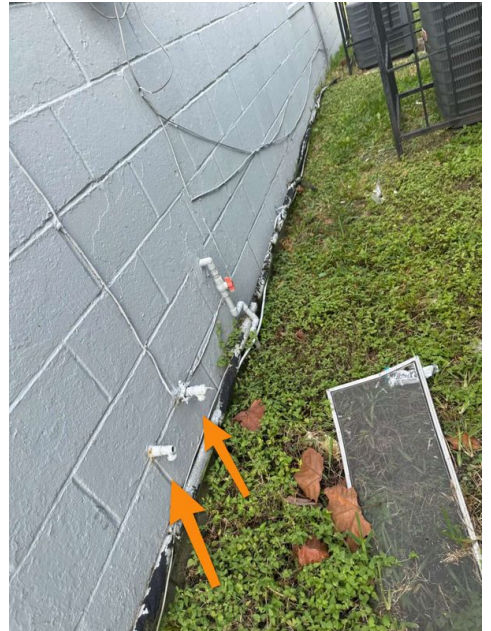
The hose bibbs at the right side of home were inoperable, likely due to the repiping of some of the plumbing components (the original pipes are disconnected, so the new pipes can be installed). This is typically okay, as it is assumed this is due to the supply pipe replacement. Recommend asking the seller for additional info.

Contact the seller for more info

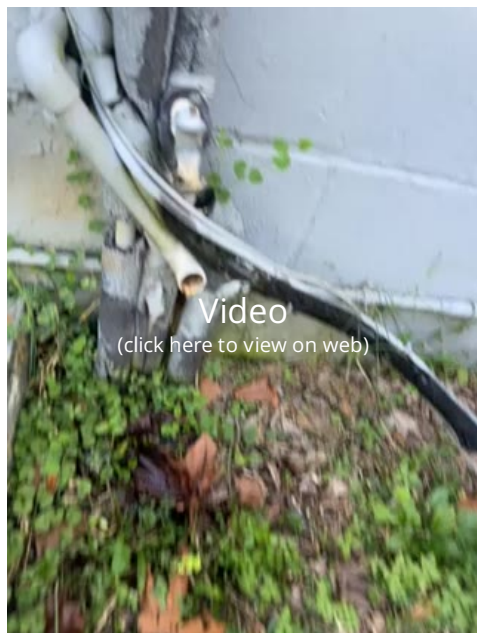
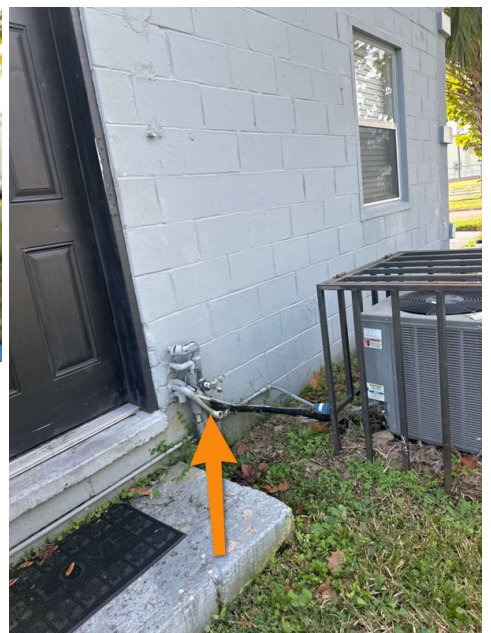
left side of home

The exterior hose spout was leaking during the inspection at the left side of the home. A continuous drip came out of the spout when the handle/valve was set to the off position. Recommend repair as needed to stop the leakage.

Contact a qualified professional.

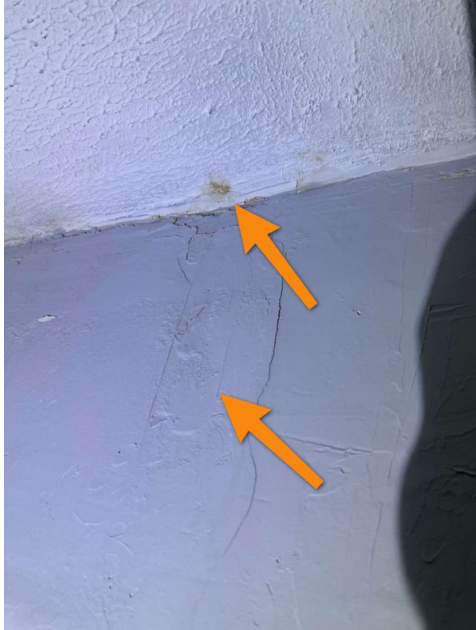
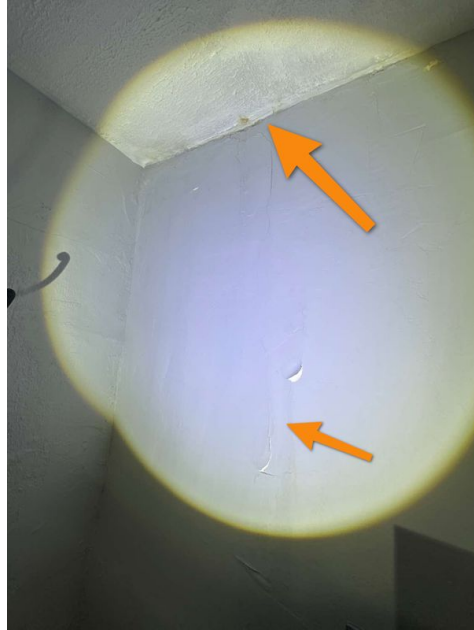
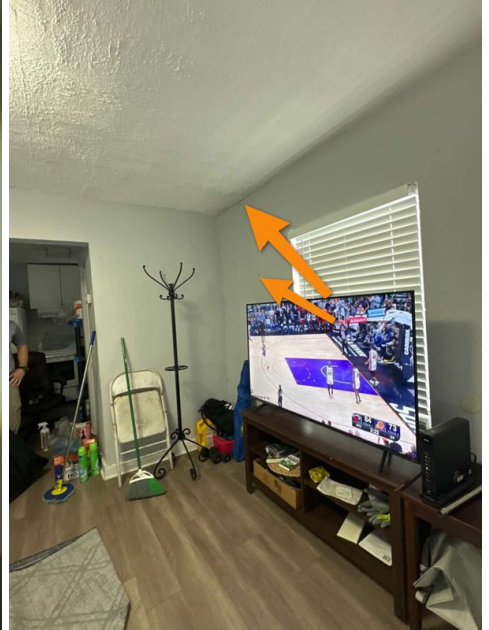
833

Water stains noted on the ceilings and walls in multiple areas. The stains had low moisture levels according to the moisture meter, but in my personal opinion this likely will leak during very excessive rains or in the some-what near future. The roof covering shows multiple repairs around the roof. Sealants were applied, as well as elastomeric or silicone roof coatings, but this was a lot of different areas. The chimneys are no longer active, but still need to be maintained. The rain caps show corrosion and at one chimney, excessive corrosion, leaving voids where water can enter. Recommend further evaluation by a roofing contractor and repair or replace as needed.

Contact a qualified roofing professional.

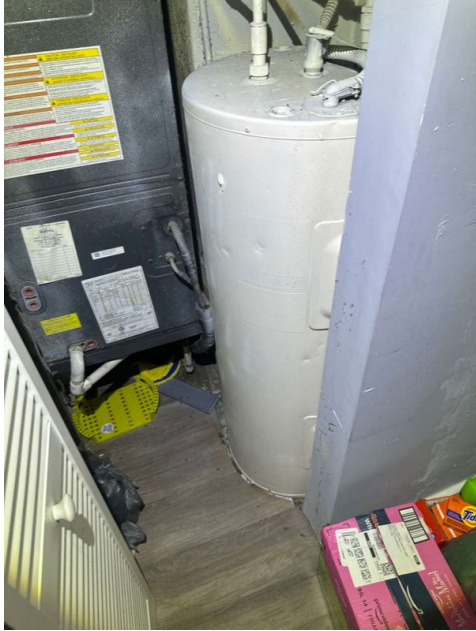
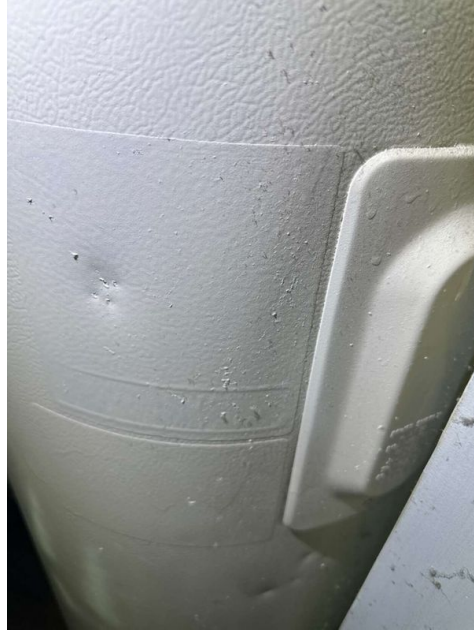
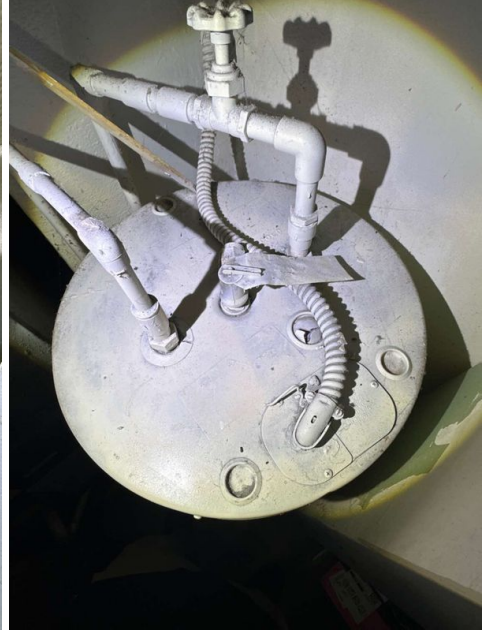
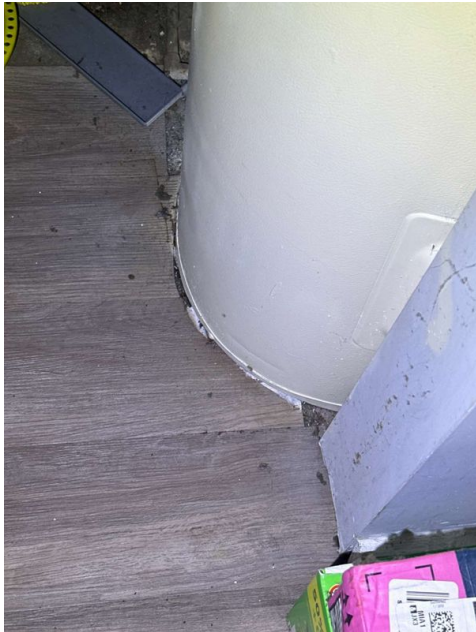
The water heater for unit 833 is older and was painted, which is typically only performed when the unit is very corroded and/or in poor condition. The labels were painted, so I could not see the manufacture date, but likely an older unit. There is also no pipe for the TPR valve and there is no drain pan for the unit. Recommend budgeting for replacement, as the insurance company will likely request a replacement.

Contact a qualified plumbing contractor.

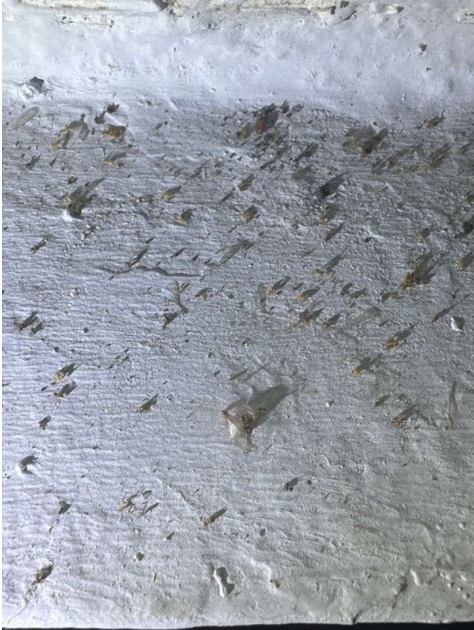
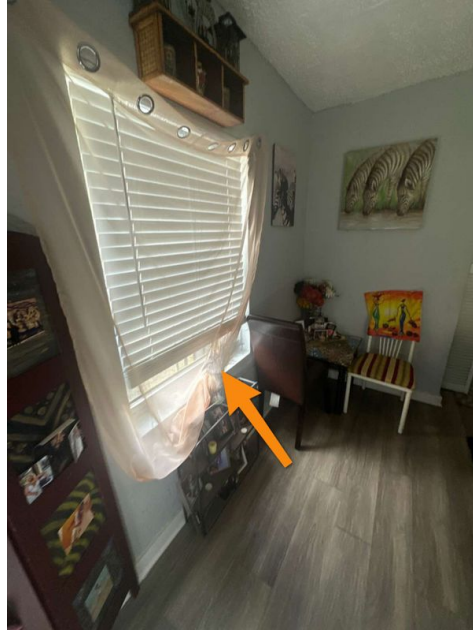
Termite swarmer wings found at the window sill at this building. No live termites were found, but the swarmer wings were found. This is likely similar for the other buildings during certain times of the year, so further evaluation by a pest control company with repairs made as needed is recommended.

Contact a qualified professional.

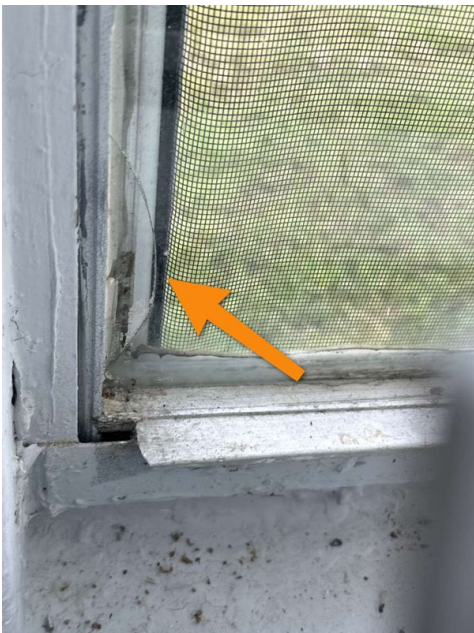
835

A cracked window pane noted in unit 835, pictured below. Recommend replacement by a qualified window contractor.

Contact a qualified professional.

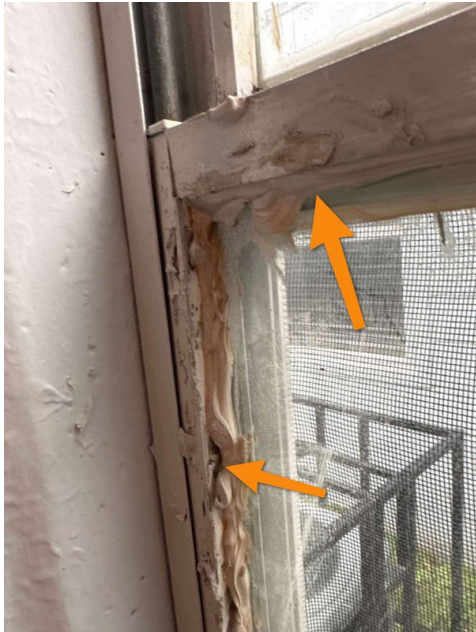
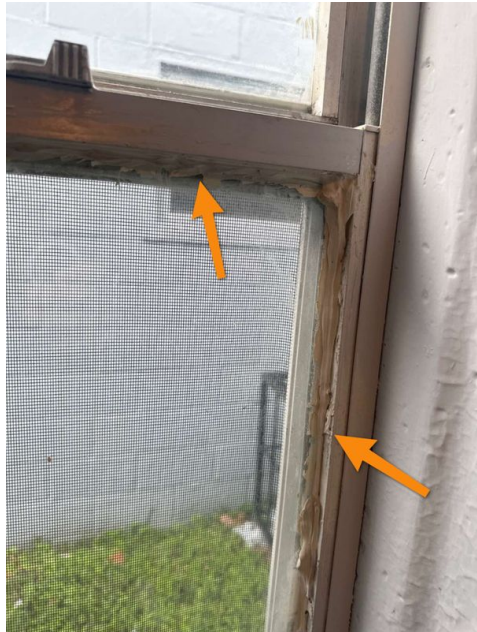
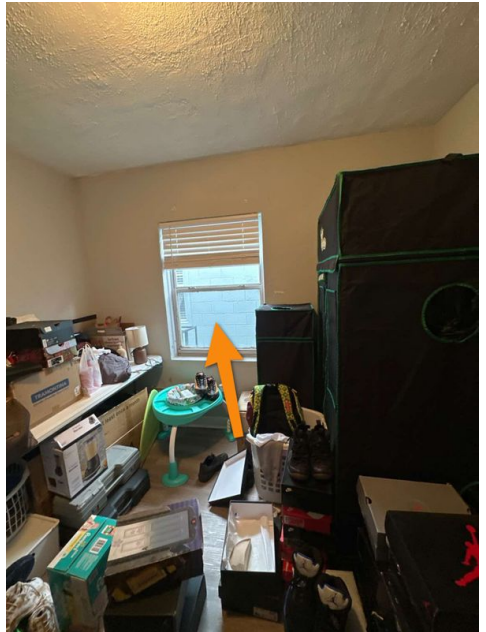
833

The windows have missing a piece/pieces of window pane trimming and were sealed or caulked to replace window panes. The windows are older, so were difficult to operate and will condensate, due to the single panes and aluminum frames. Recommend consider upgrading the windows in the near future.

Contact a qualified professional.

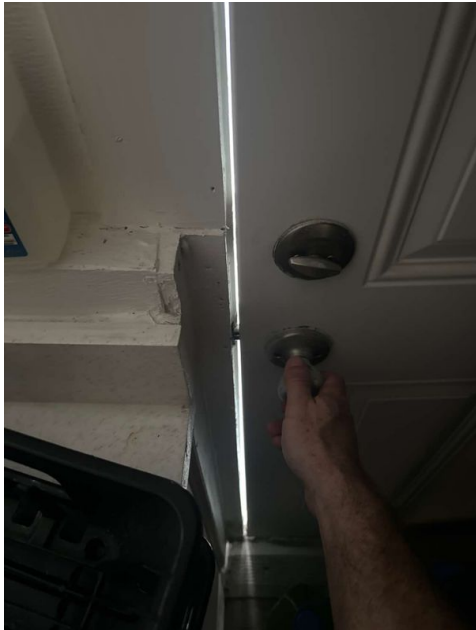
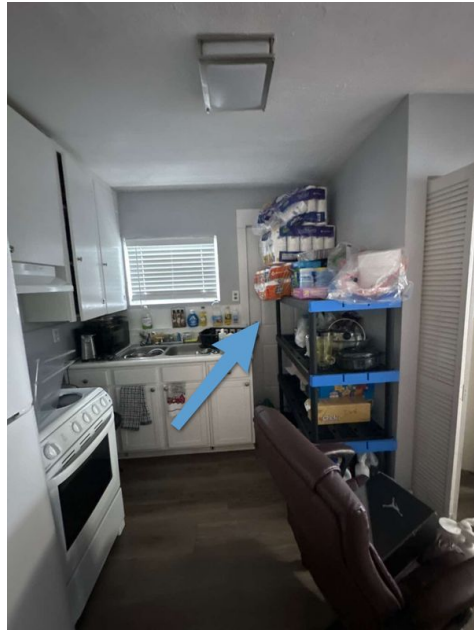
833

The door rubs against or hits the door frame when opened/closed (in the areas pictured below), making operation slightly difficult. Needs adjustment or repair to allow for a better clearance.

Contact a qualified handyman.

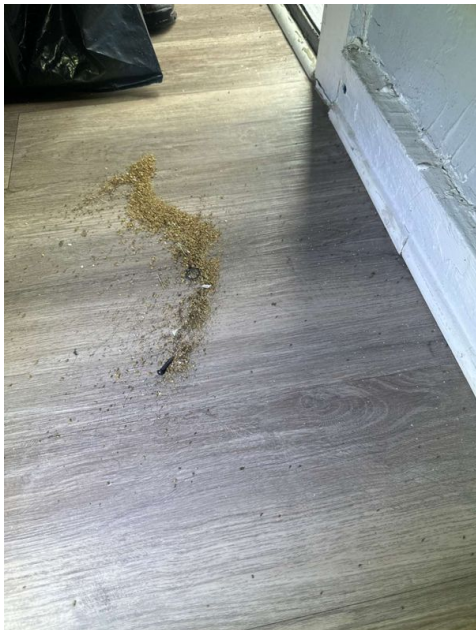
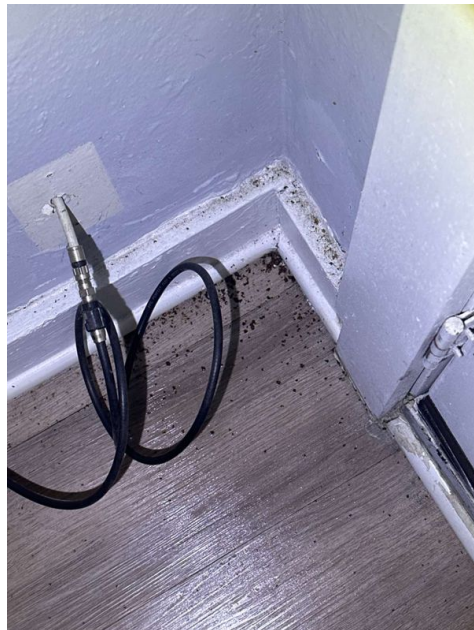
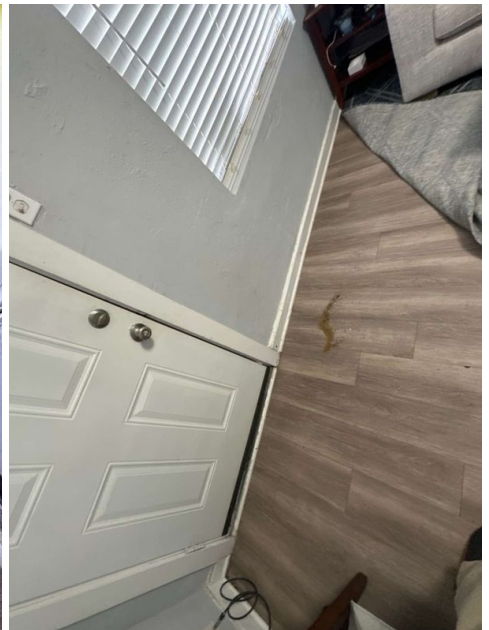
There was an excessive amount of ants in unit 833. The tenant put pest control down, but likely needs a pest control specialist for all units, since signs of pests were found in almost every unit.

Contact a qualified pest control specialist.

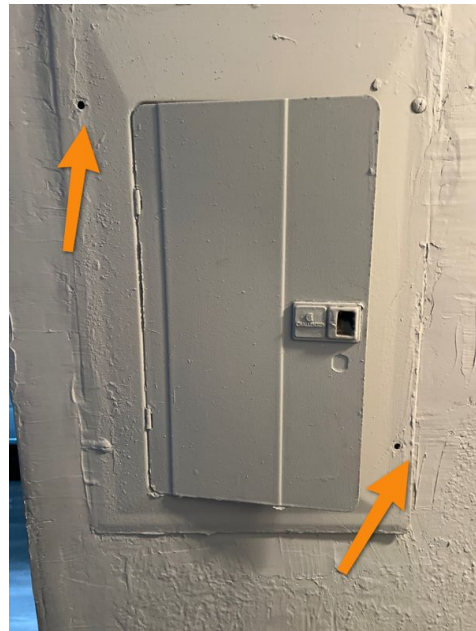
835

The breaker panel cover is missing a screw. Recommend installing a flat ended screw only, so the panel is fully secure in all areas.

Contact a qualified handyman.

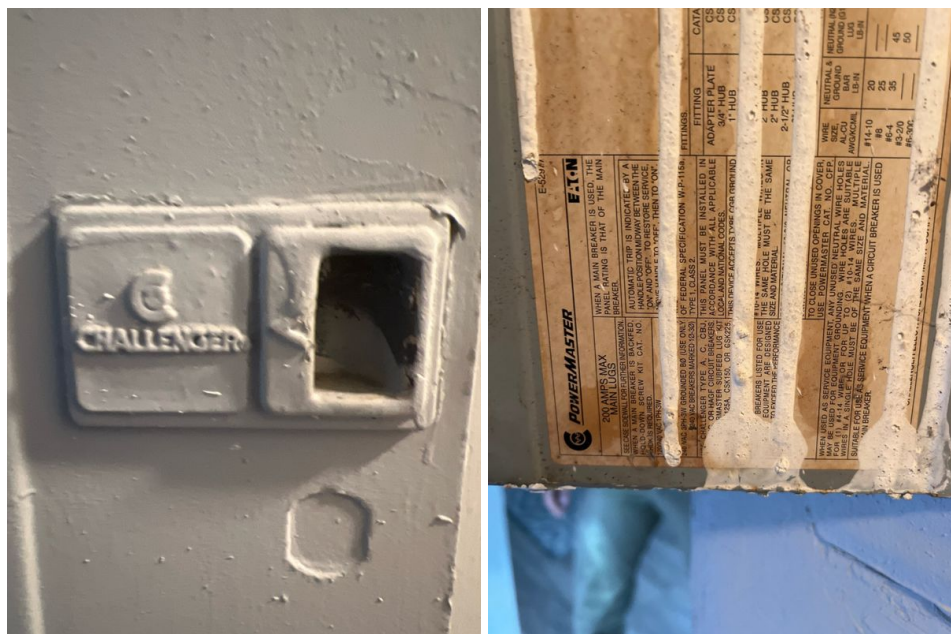
Unit is equipped with a challenger breaker panel, but also says eaton and has a mix of different breakers, but challenger breaker panels are typically not insurable, so the insurance company may request a breaker panel replacement due to the mixed materials and the breaker panel saying challenger. Recommend further evaluation and repair/replacement as needed by an electrician.

Contact a qualified professional.

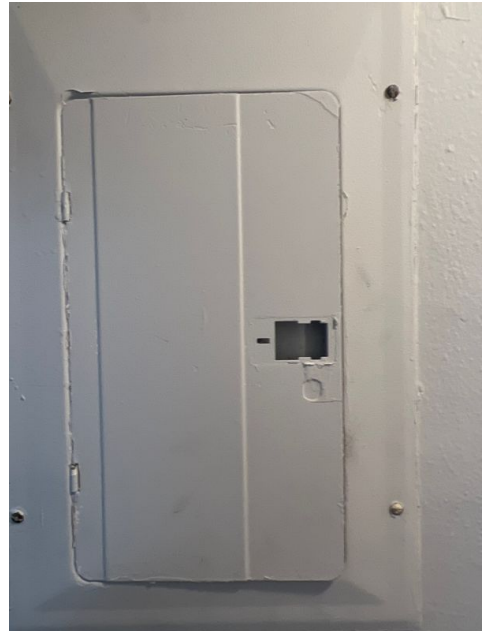
833

The latch or panel lock is missing at the breaker panels at one of the units.
Recommend repair as needed or as desired.

Contact a qualified professional.

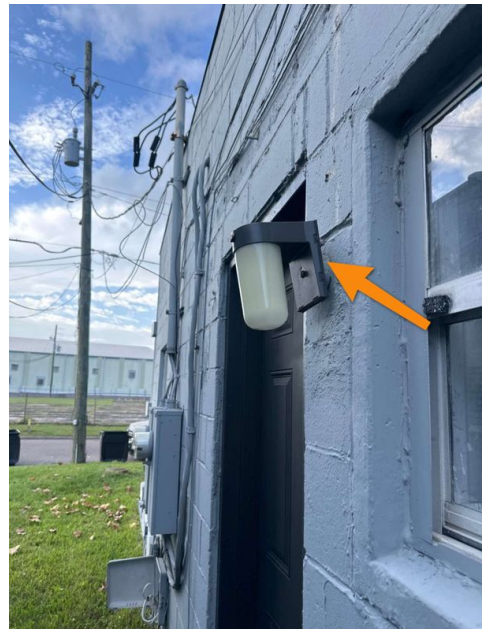
left side of home

The light fixture at the left side of the home is a little loose. Recommend repair, so the light is secure in its intended position.

Contact a qualified handyman.

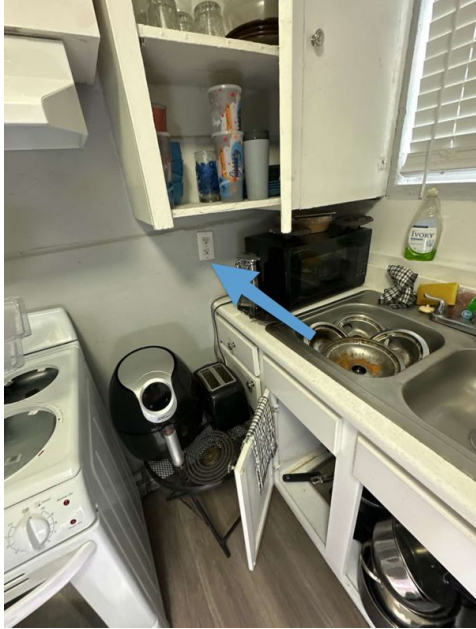
831

A few electrical outlets in the home were loose. This is typical and common wear overtime. Recommend securing the outlet to the junction box, so the outlets are secure. A DIY link is included below for informational purposes.

Contact a qualified handyman.

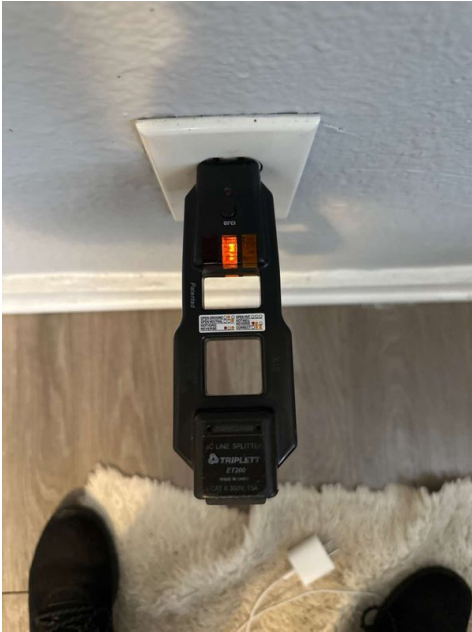
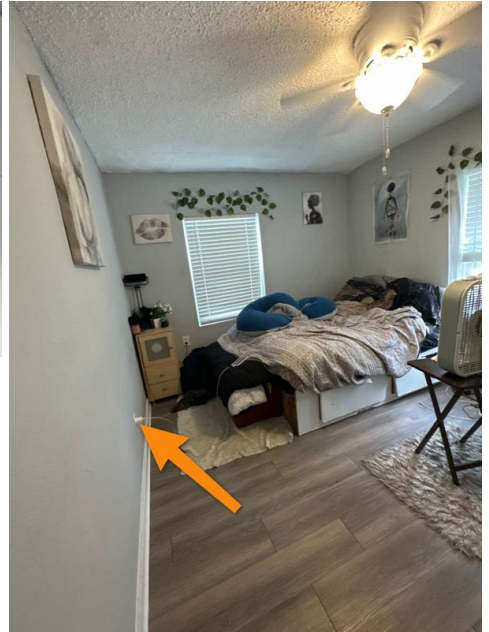
835

The electrical outlet pictured below showed an improper ground according to the receptacle tester. An open ground outlet can cause an electrical surge to the connected device resulting in damage or electrical shock. Recommend further evaluation and repair by a qualified electrical contractor.

Contact a qualified professional.

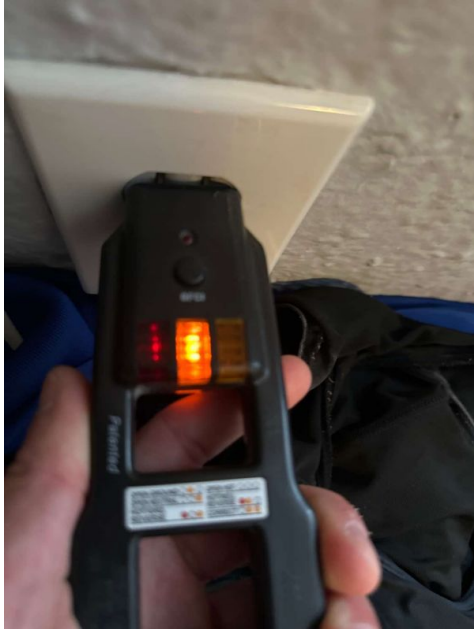
The bedroom electrical outlets in unit 835 shows reverse polarity. The hot and neutral appeared reversed according to the receptacle tester. Improper wiring can cause a potential electrical shock hazard in rare occurrences, but is typically a easy repair. Recommend further evaluation and repair by a qualified electrical contractor.

Contact a qualified electrical contractor.

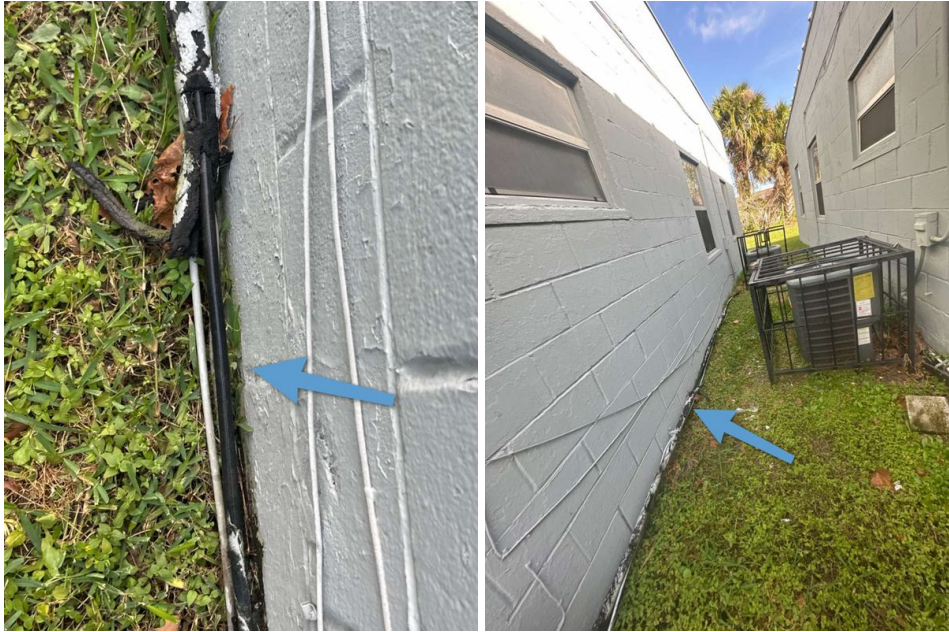
WORN INSULATION AT SUCTION LINE

Worn/damaged insulation noted in some areas at the HVAC suction line (pictured below). Recommend repairing/replacing the insulation on the suction line to help reduce condensation and improve energy efficiency.

Contact a handyman or DIY project
