# DESIGN PROPOSAL

June 24, 2025  
314 E Main Street, Ottumwa, IA  
Project #05325

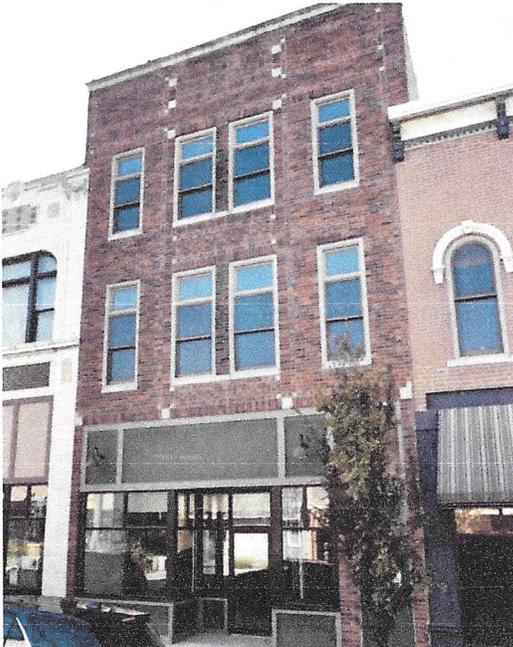
*Left: Existing building exterior. Right: Photo of upper floor interior showing damage.*

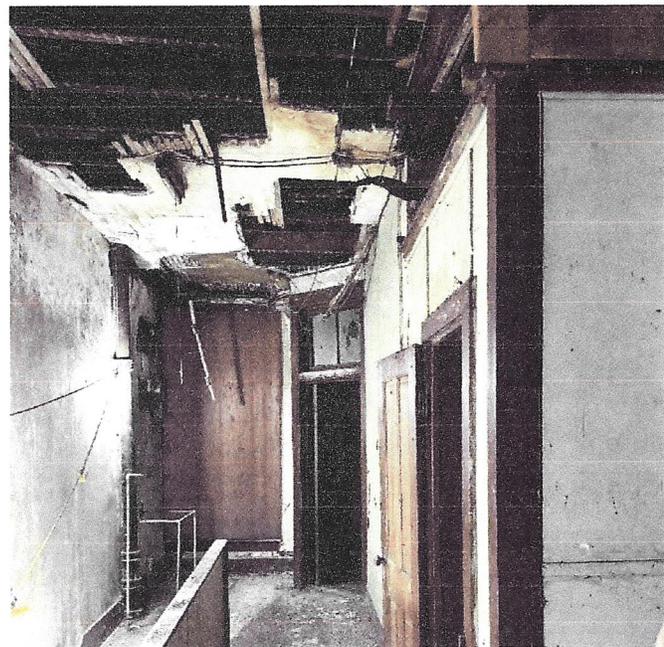
The building has experienced extensive water damage in the past from multiple roof leaks. Damage was visible on several joists, and in the floor and roof assemblies. Due to the deterioration and duration of vacancy, the building will require complete renovation to return to active use. We recommend removing all damaged interior finishes and updating MEP throughout the units to ensure proper functionality and mitigate any mold/water damage.

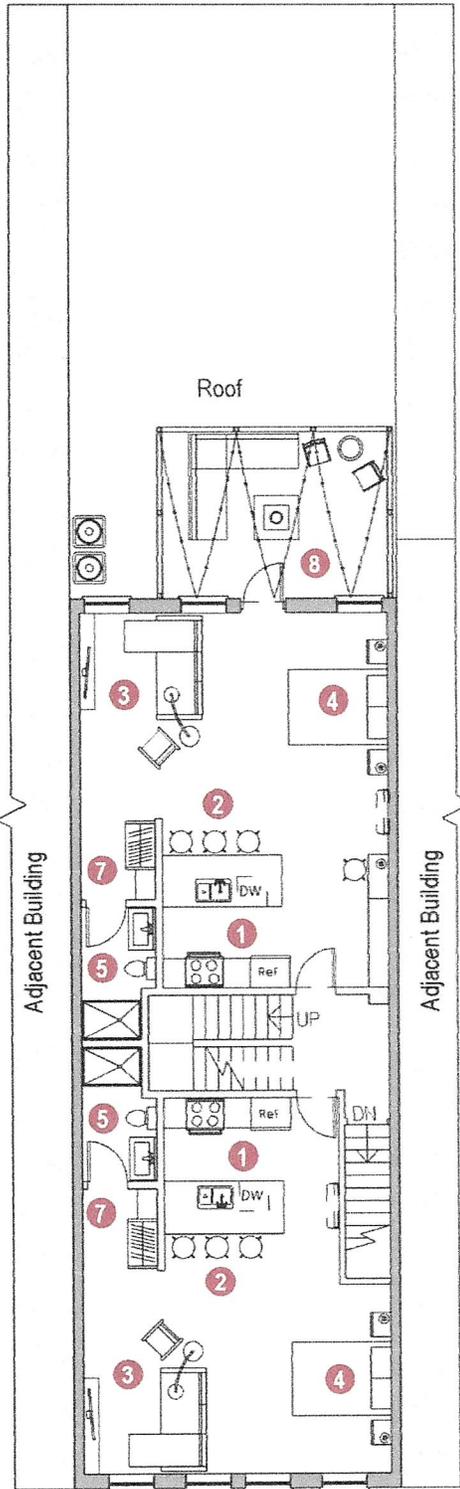
**PROPOSED 2ND FLOOR PLAN**  
Option B

- b) Option B: Creates four studio apartments. The stairwell from the 2<sup>nd</sup> to 3<sup>rd</sup> floor is relocated to allow a more efficient floor plan.

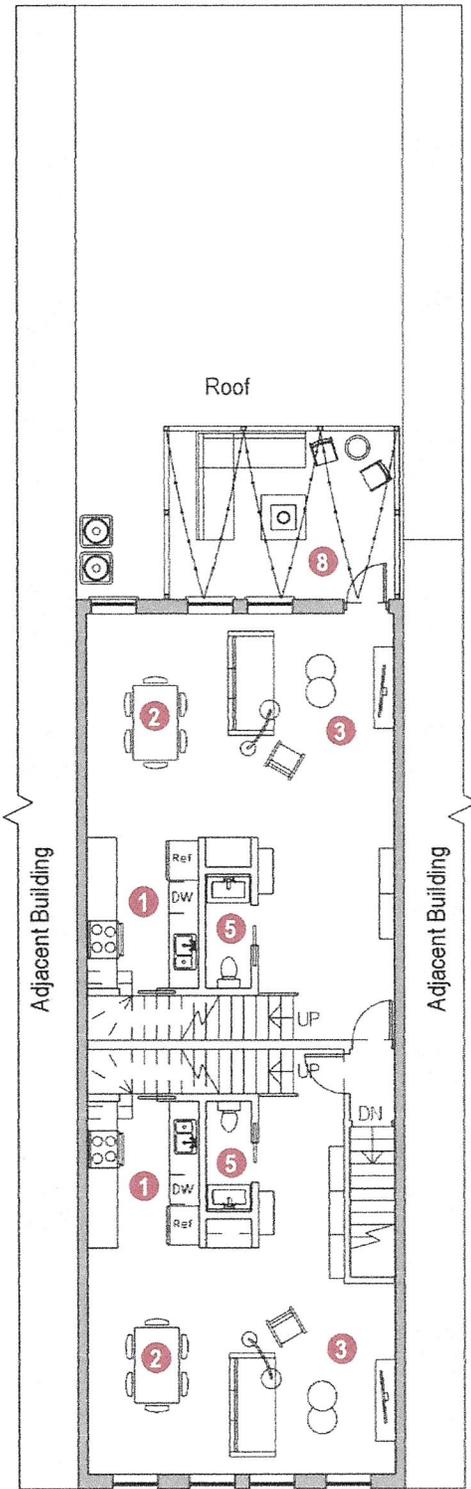
**PROPOSED 2ND FLOOR PLAN**  
Option A

- The square footage of the floor plates allows for two 2-bedroom or four small studio apartments. The proposed layouts show two options:
  - a) Option A: Creates two 2-bed, 1.5-bath “back-to-back” apartments. This layout provides a very high percentage of occupiable space, and places circulation in the center of the floor plan, with living areas along the exterior walls for window access. The new 3<sup>rd</sup> floor stairwells run parallel to the floor joists limiting reframing of the floorplate.
