PHASE I
ENVIRONMENTAL SITE ASSESSMENT

10.0 +/- ACRE SITE PROPOSED FOR
CONDOMINIUM DEVELOPMENT,
LOCATED ALONG NORTH SIDE OF
U. S. HIGHWAY 90
BILOXI, MISSISSIPPI

MORAN ENGINEERING, PLLC
ENGINEERS-PLANNERS-SURVEYORS-ENVIRONMENTAL
249 BEAUVOIR ROAD
BILOXI, MISSISSIPPI 39531
PHONE (228) 388-1950
FAX (228) 388-1971
e.mail-msa@moranseymour.com

February, 2005

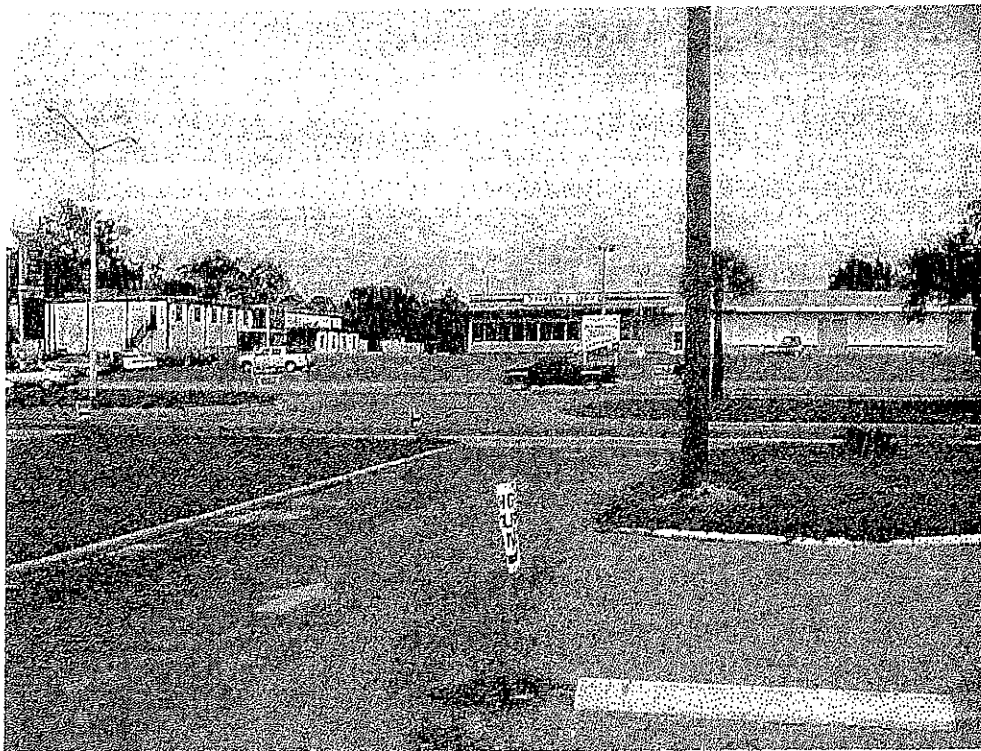
Photo 1: South area of property showing the Player's Club and Studio 90 and the front area parking lot

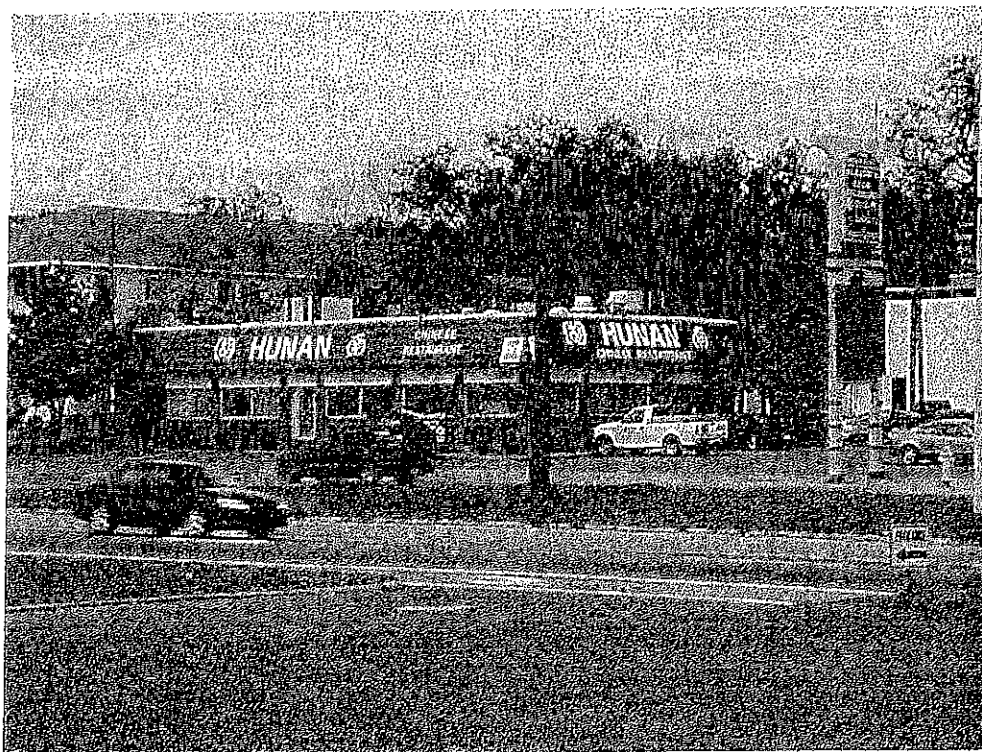
Phot 2: Hunan's Chinese Restaurant and a associated parking lot in the southwest area

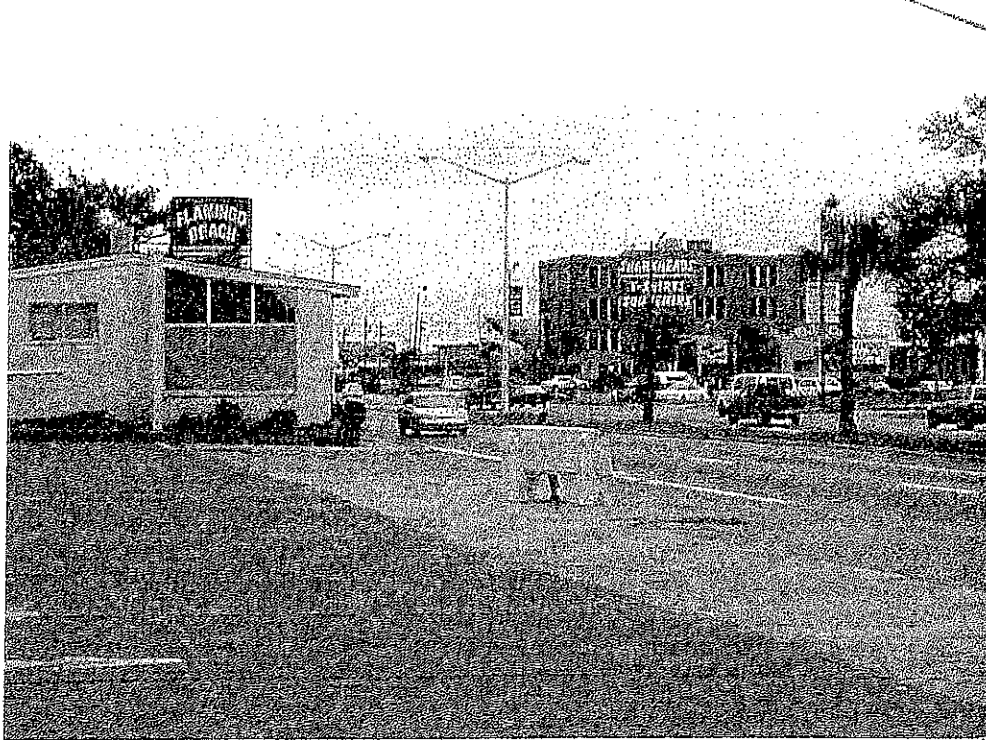
Photo 3: Adjacent property to the east (Flamingo Beach Motel) and other properties located along U.S. Highway 90 to the east of target site.

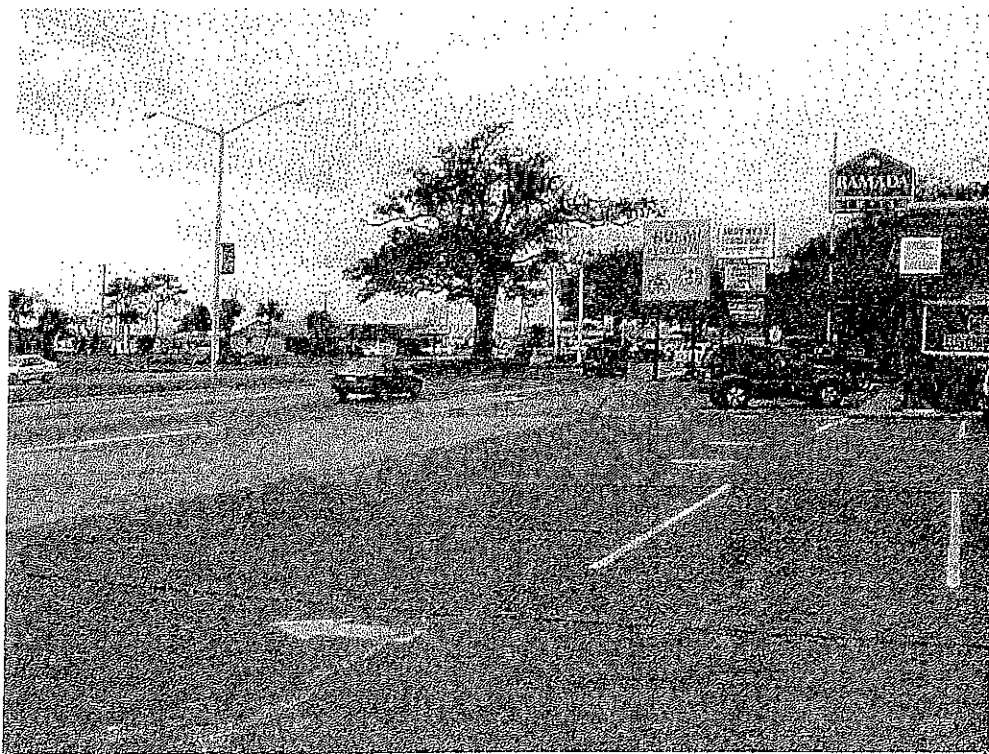
Photo 4: Adjacent property to the west (Ramada Limited Hotel) and other properties located along U.S. Hwy 90 to the west of target site.

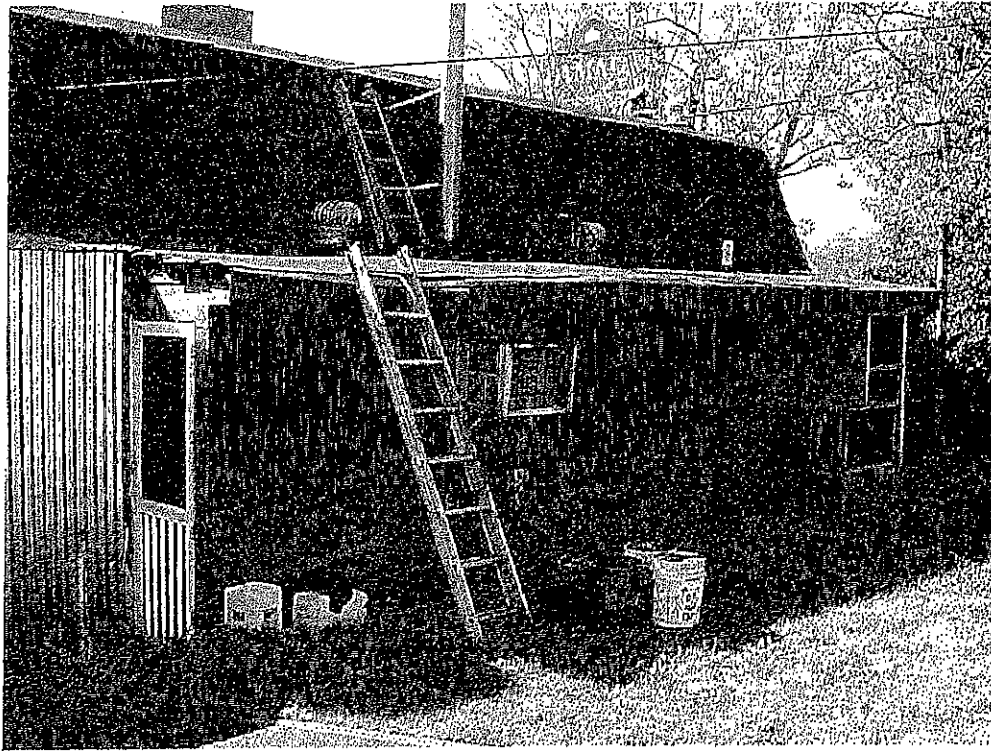
Photo 5: Exterior area of north side of Hunan Chiene Restaurant.

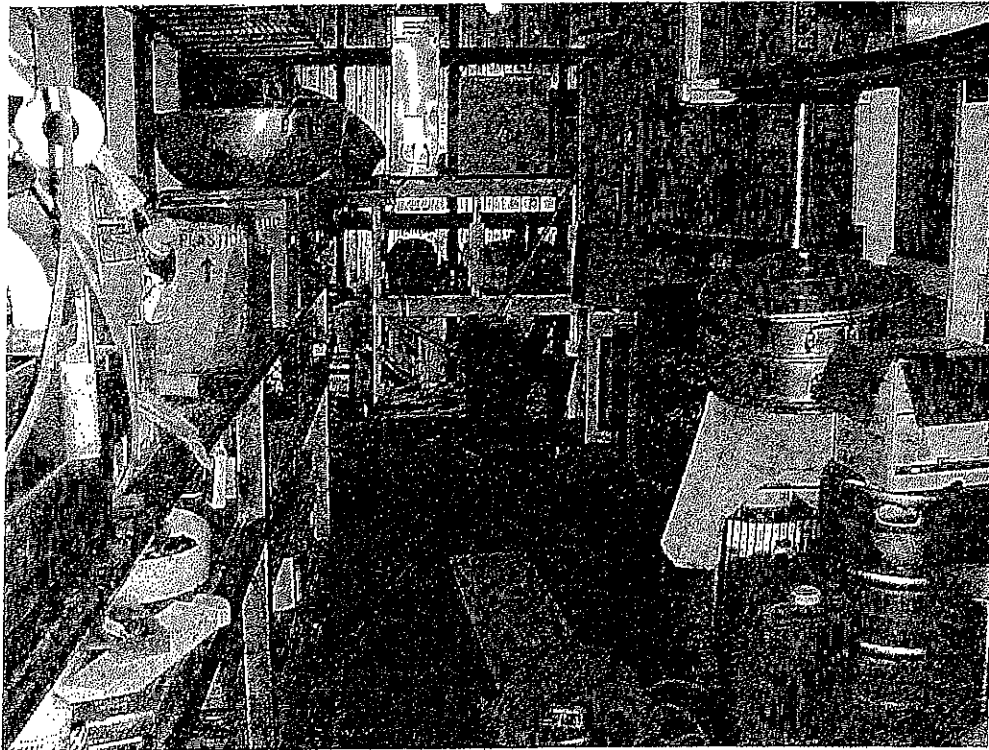
Photo 6: Interior storage area of Hunan Restaurant.

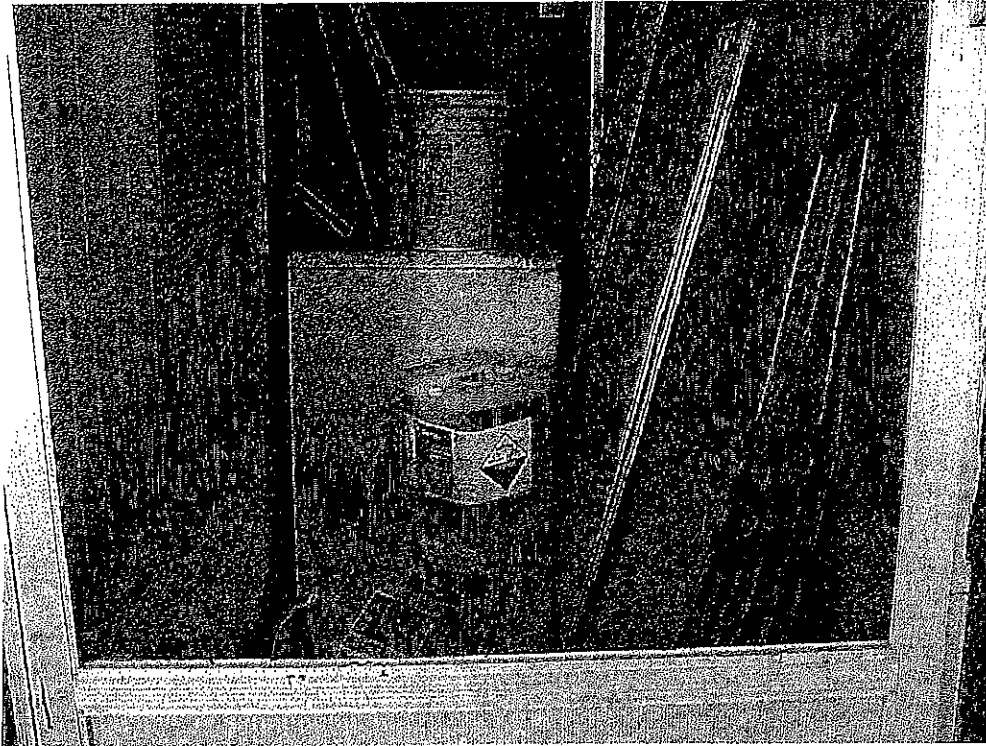
Photo 7: Storage area of Hunan's Restaurant.

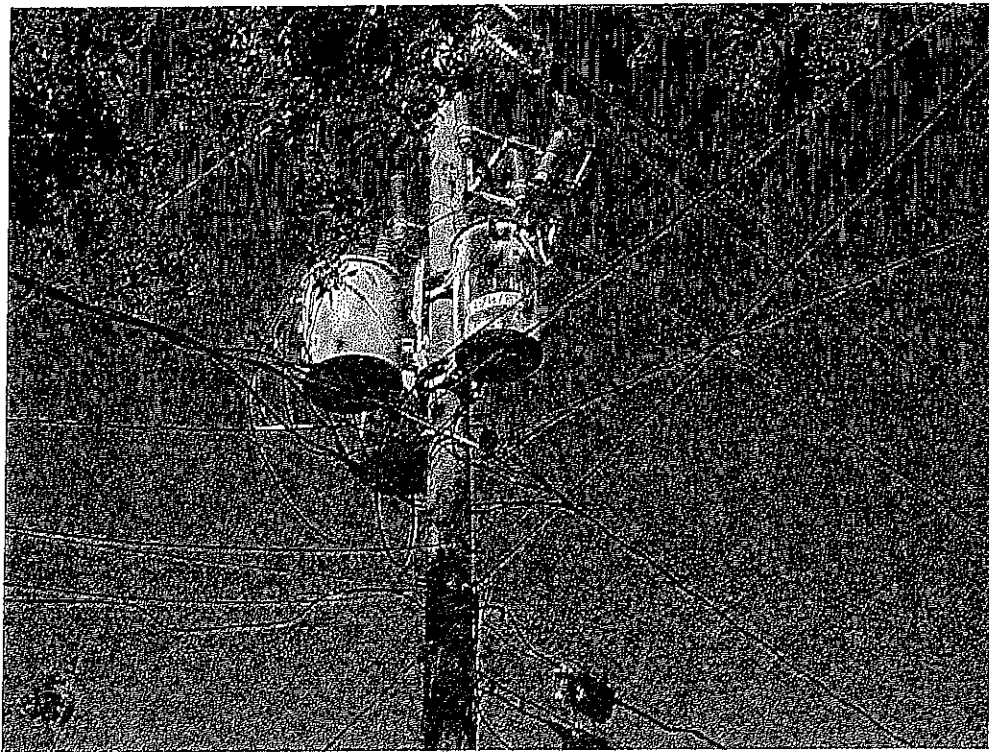
Photo 8: Pole mounted transformer located north of Hunan's Chinese Restaurant.

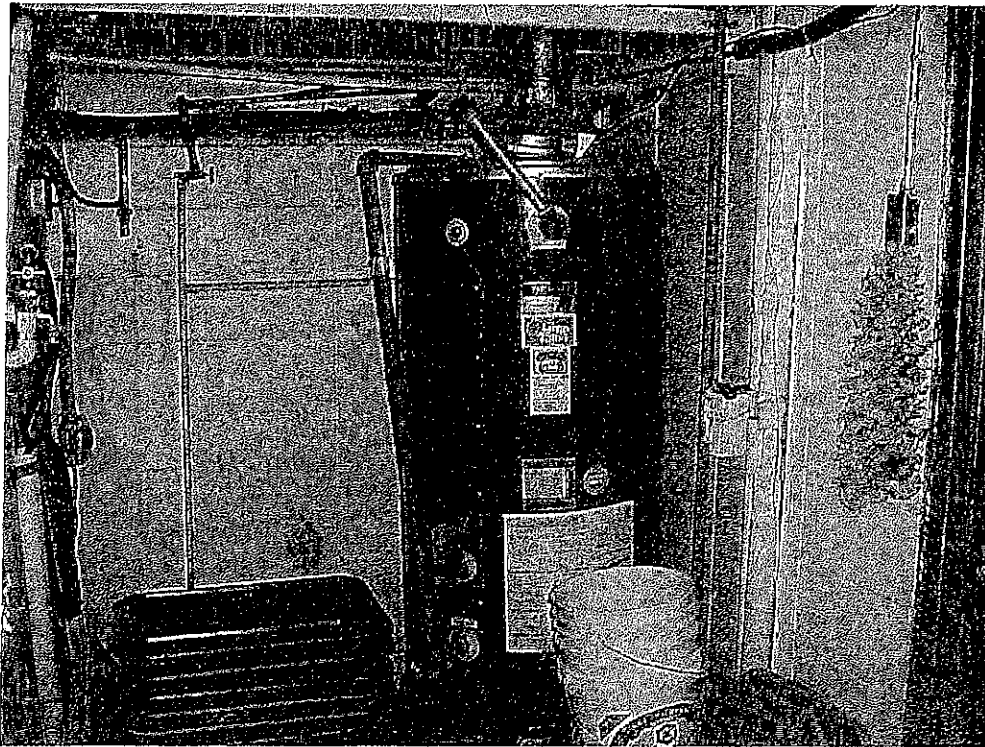
Photo 9: Hot water tank and storage area located next to kitchen of Hunan's Chinese Restaurant.

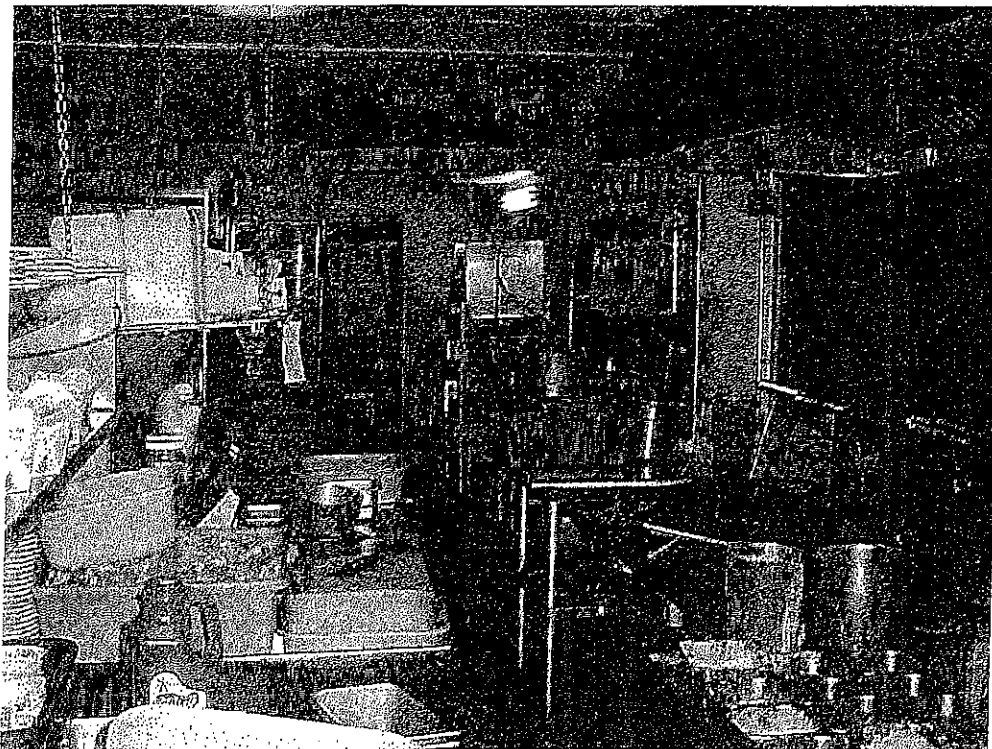
Photo 10: Kitchen area of Hunan's Restaurant, hot water tank shown in background.

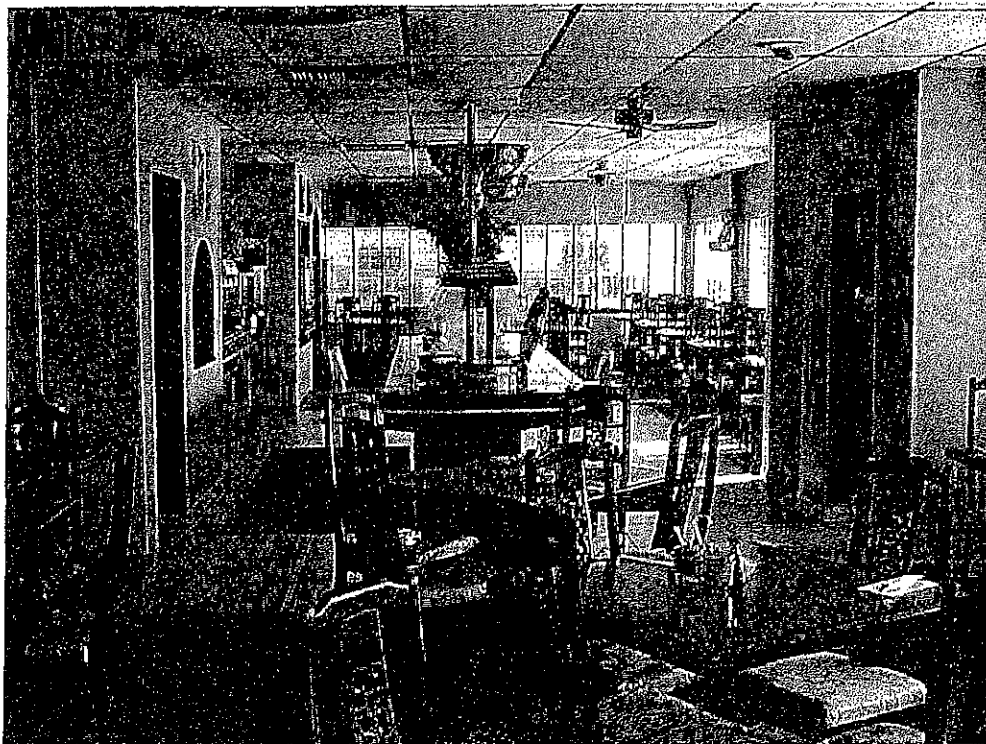
Photo 11: Dining area of Hunan's Restaurant.

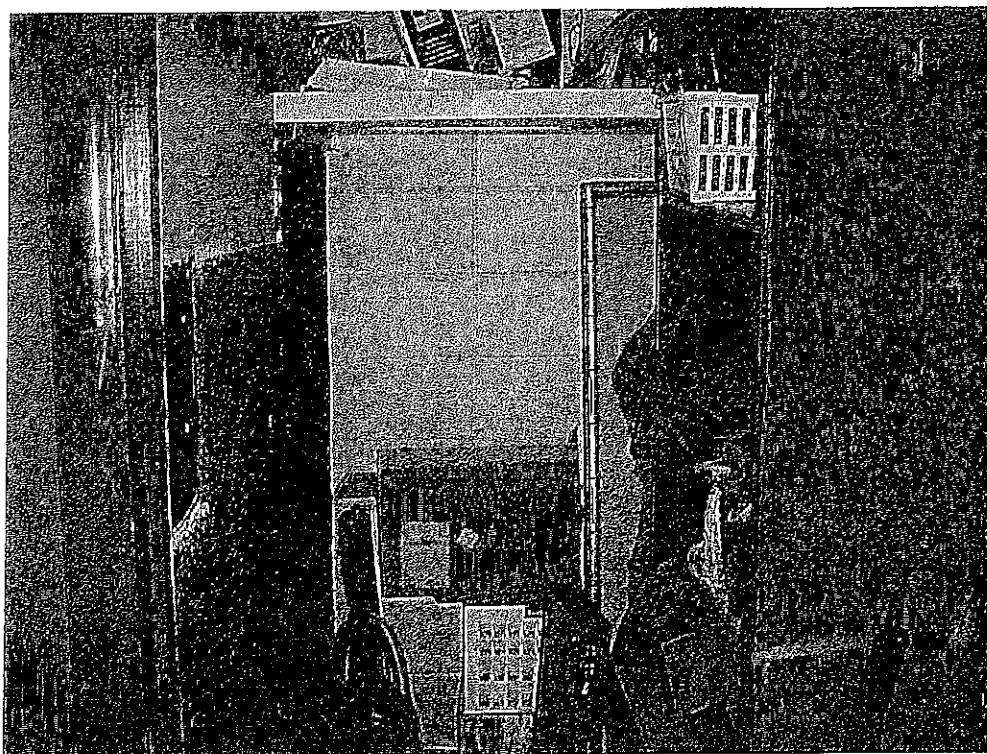
Photo 12: Storage closet off the main dining area of Hunan's Restaurant.

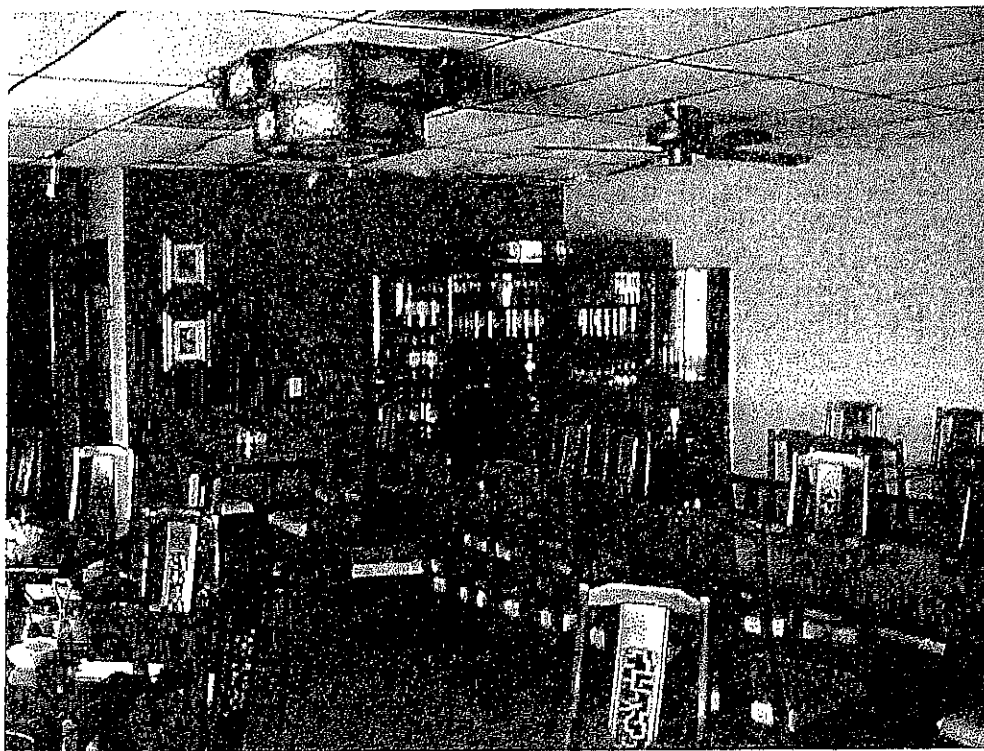
Photo 13: Dining area of Hunan's Restaurant

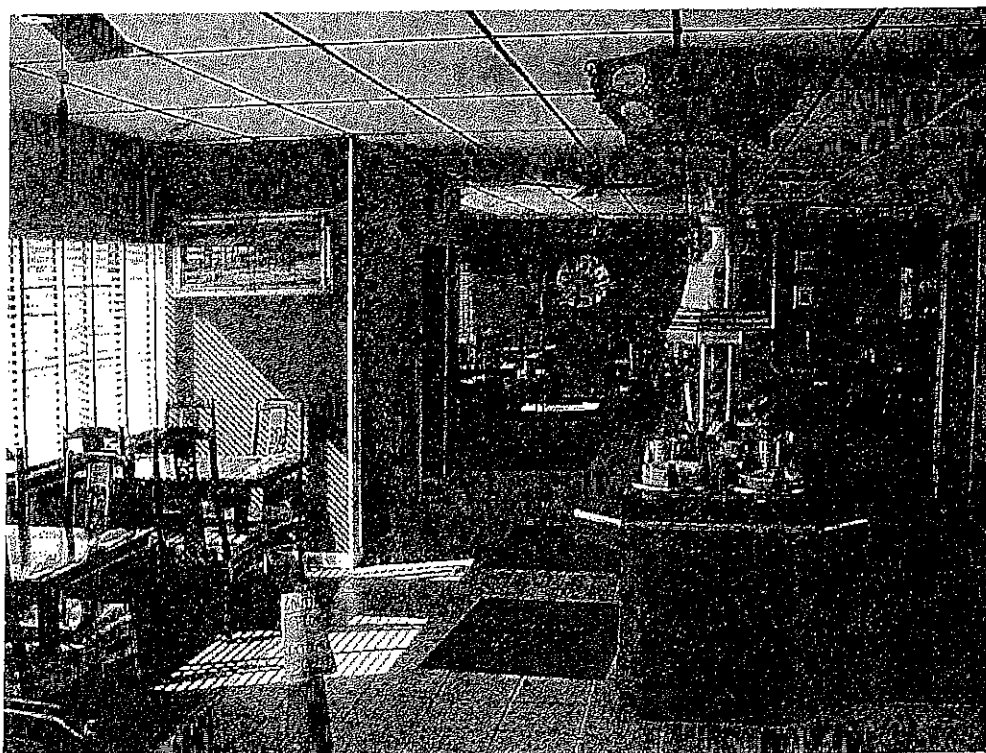
Photo 14: Dining area of Hunan's Restaurant.

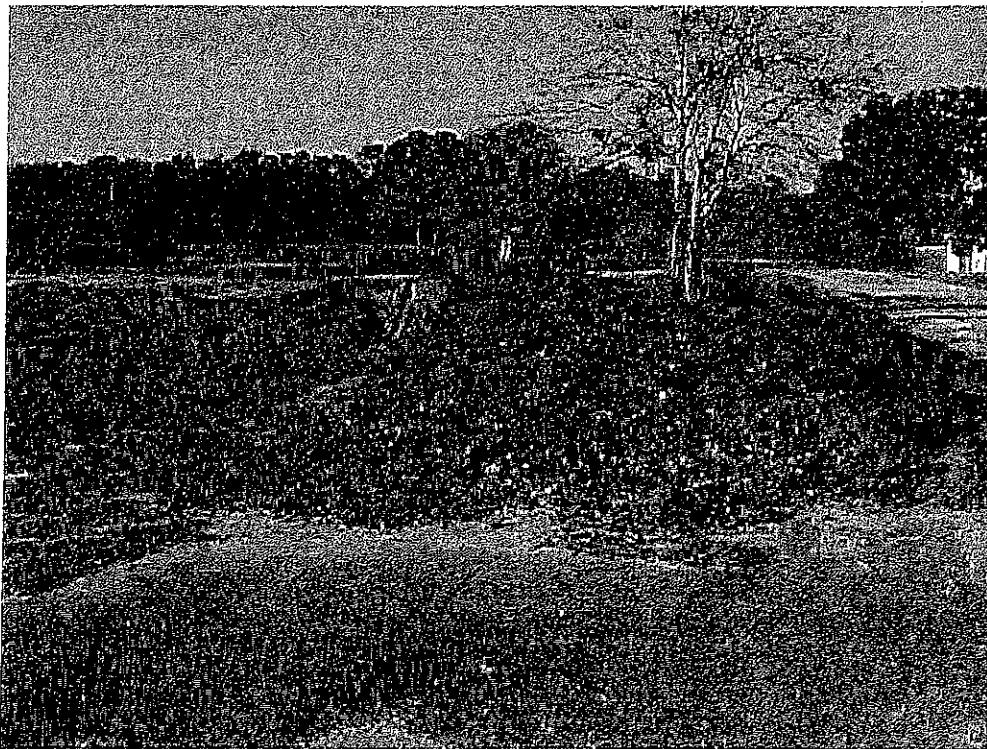
Photo 15: Northern half area of property as viewed facing north.

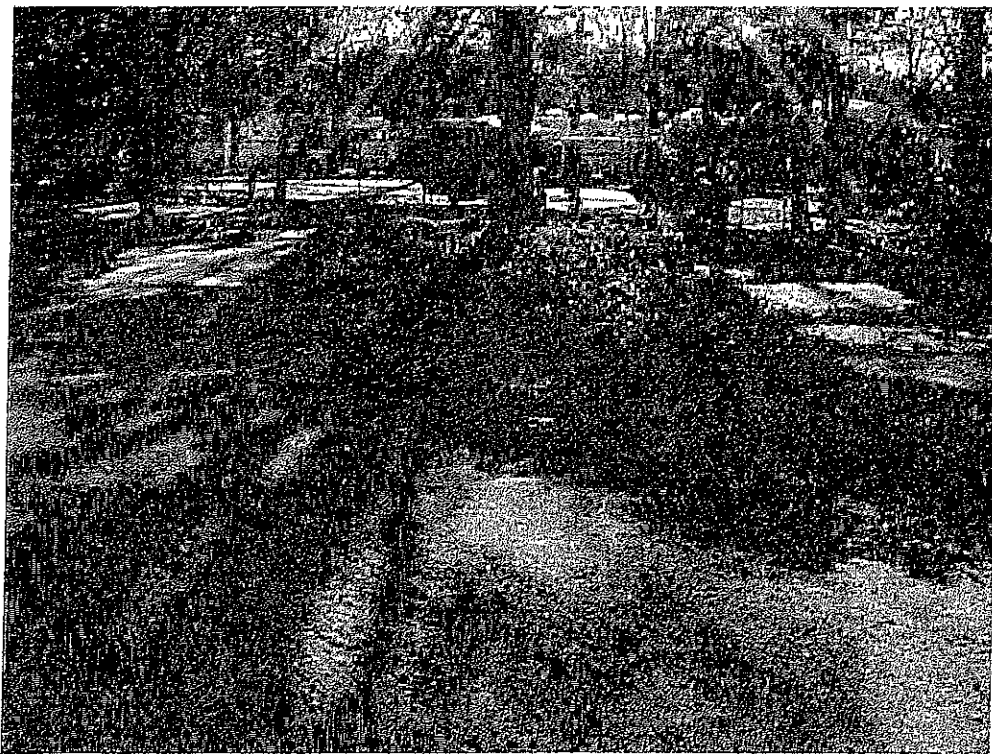
Photo 16: View of adjacent RV Park located to the west of subject site.

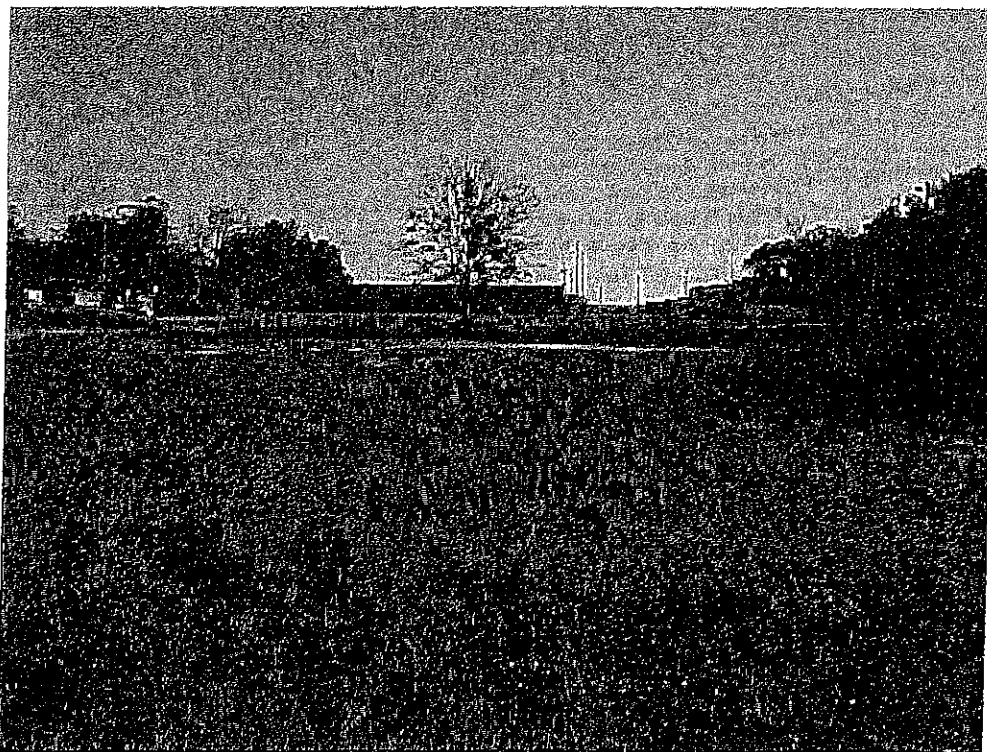
Photo 18: Overall view of subject property taken from north property facing south.

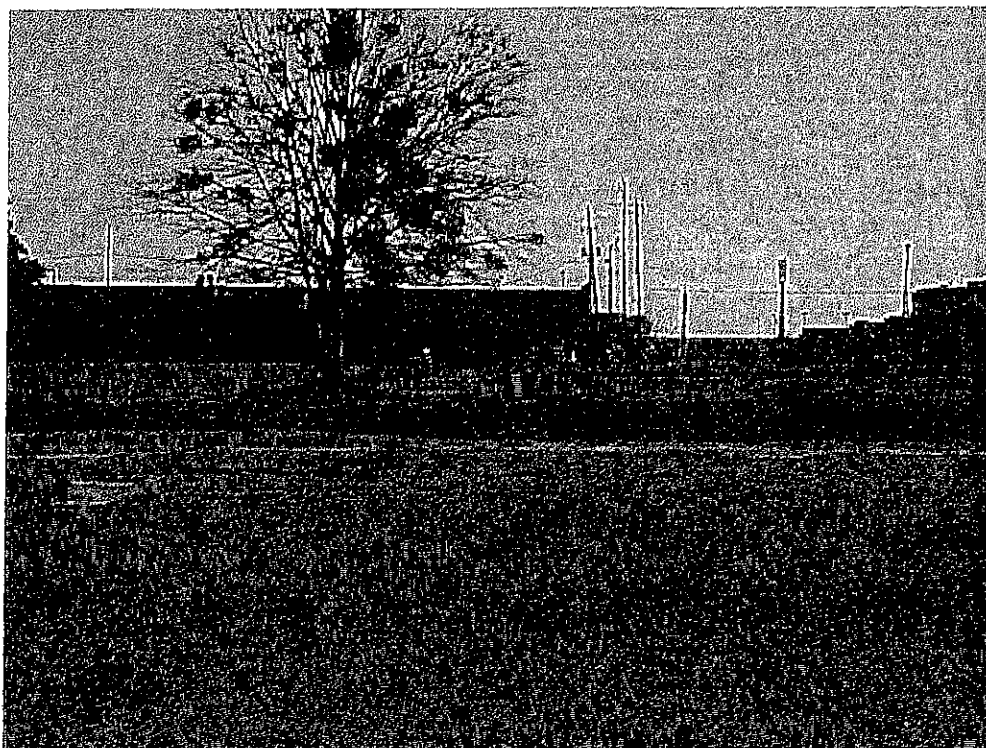
Photo 19: View of property facing south taken from a location at the mid point of the northern half of subject site.

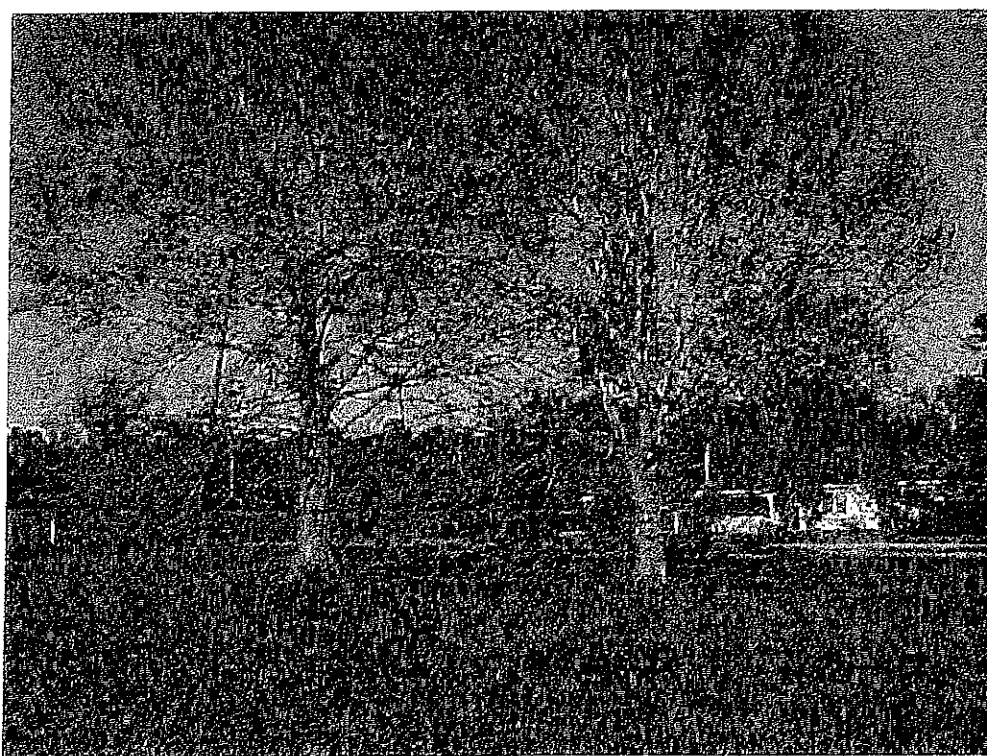
Photo 20: View of the northeast corner and the adjacent residential property.

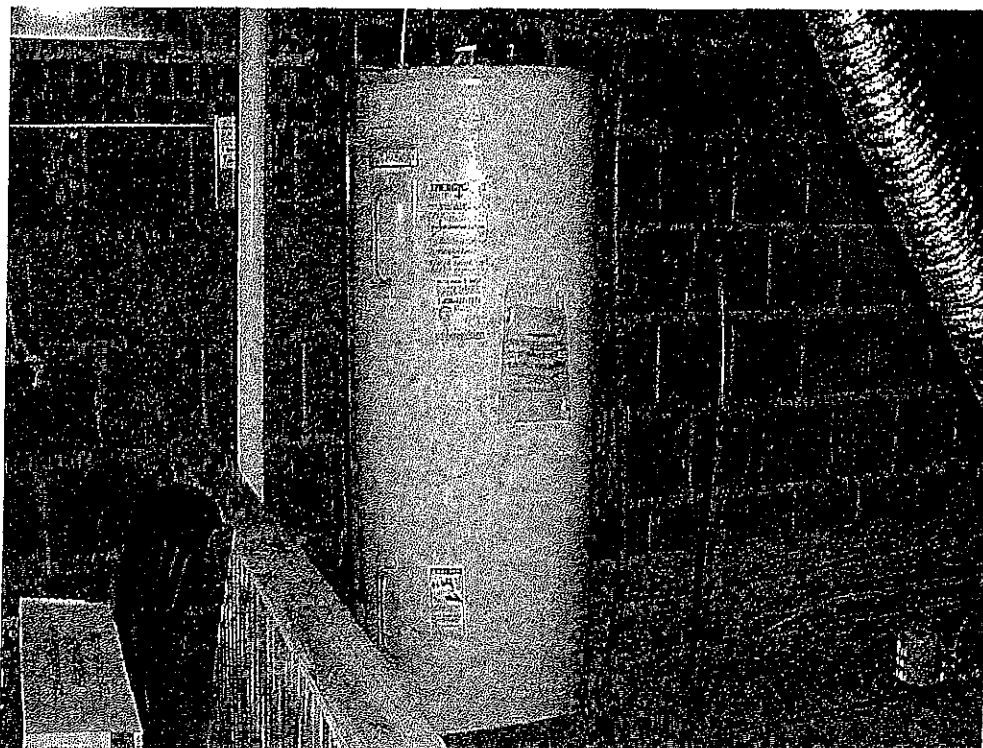
Photo 21: Hot water tank for Player's Club located on second floor.

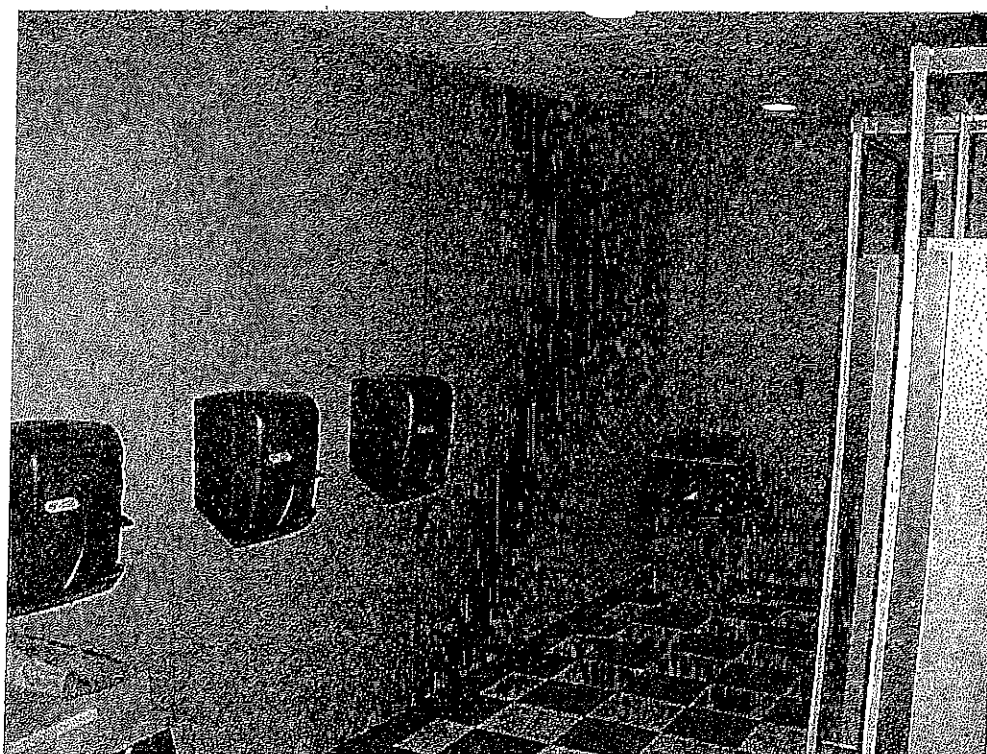
Photo 22: Mens bathroom facility for Player's Club.

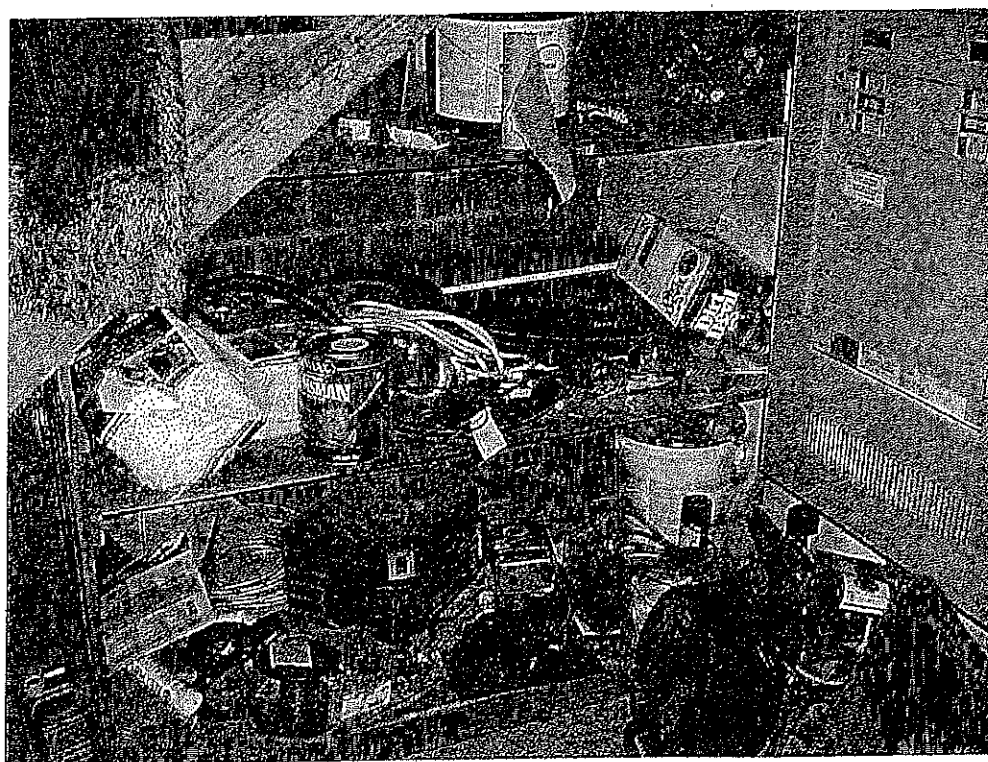
Photo 24: Storage area inside Player's Club facility.

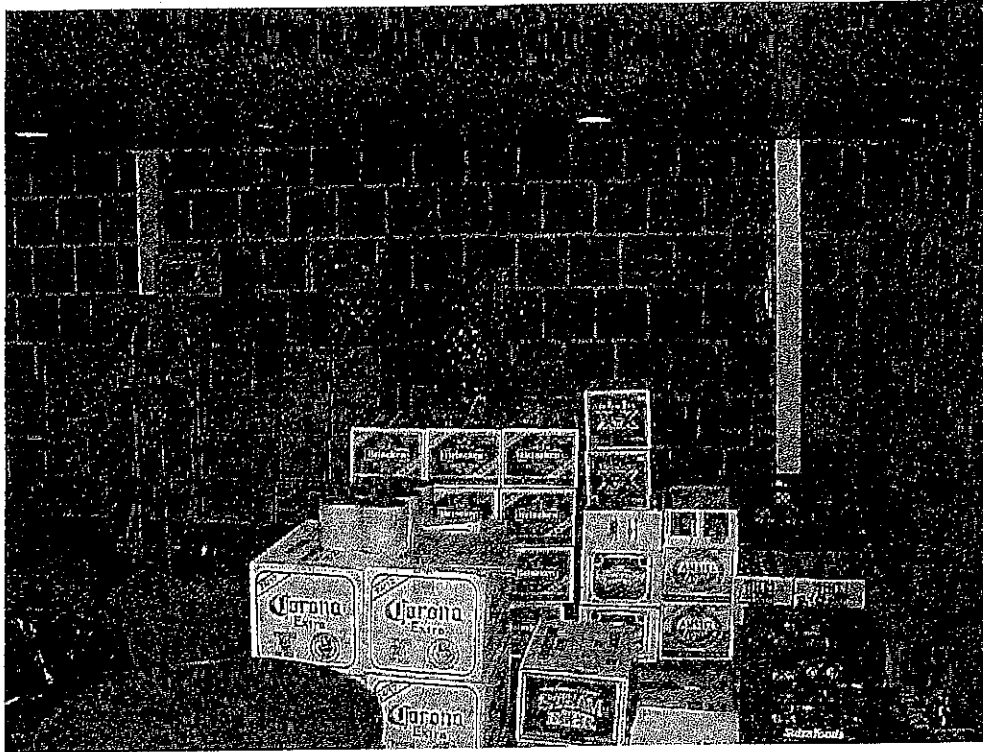
Photo 25: Beer storage area for the Player's Club facility.

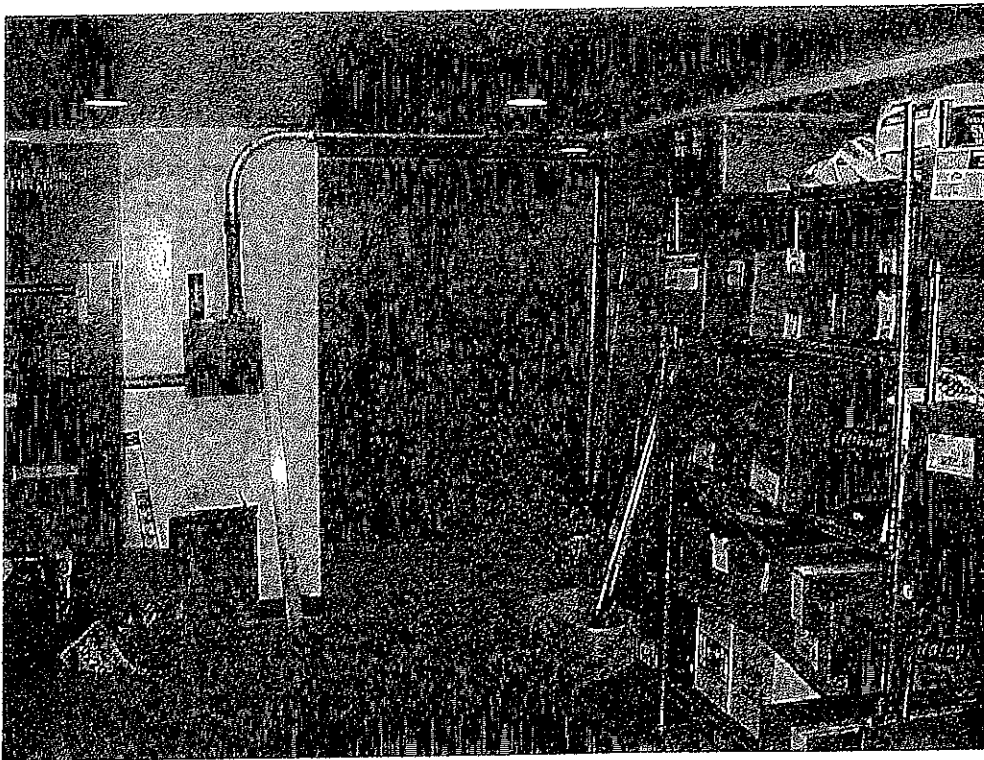
Photo 26: General dry storage area for the Player's Club facility.

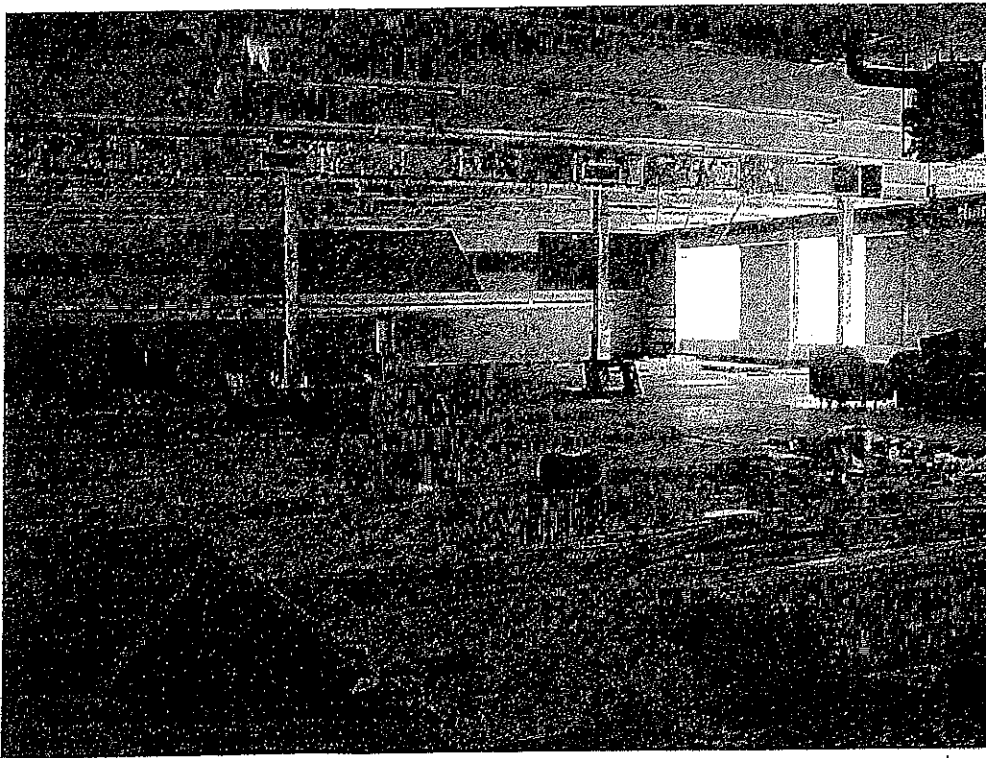
Photo 28: Overall view of inside area of building located adjacent to Player's Club.

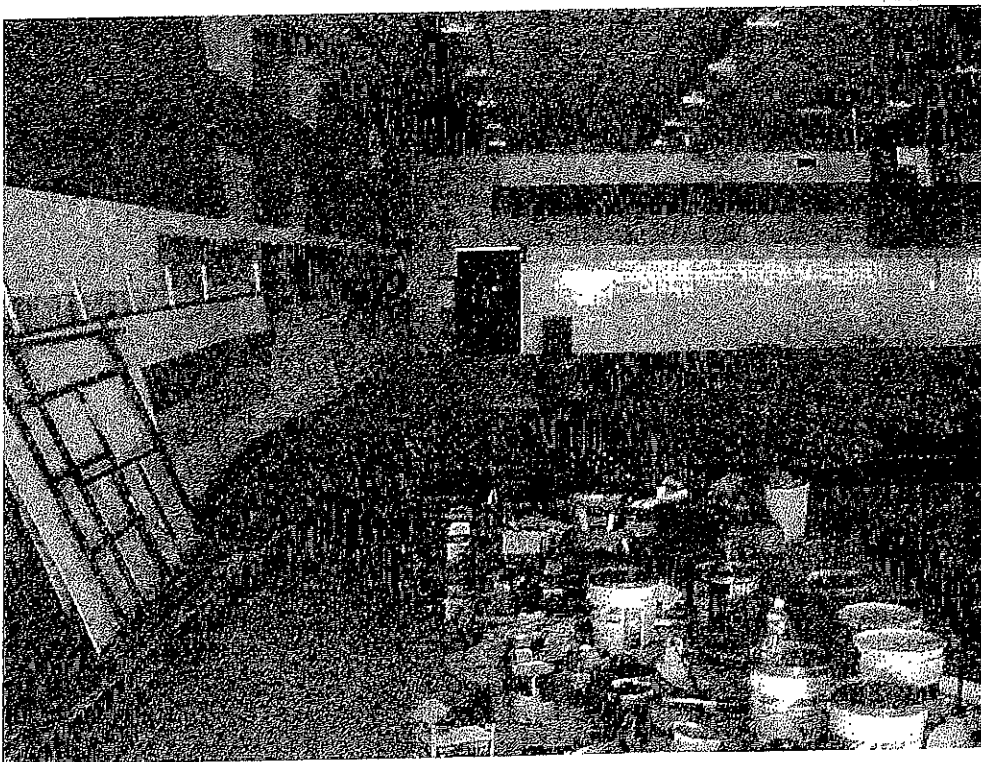
Photo 30: Overall view of inside area of building located adjacent to Player's Club.

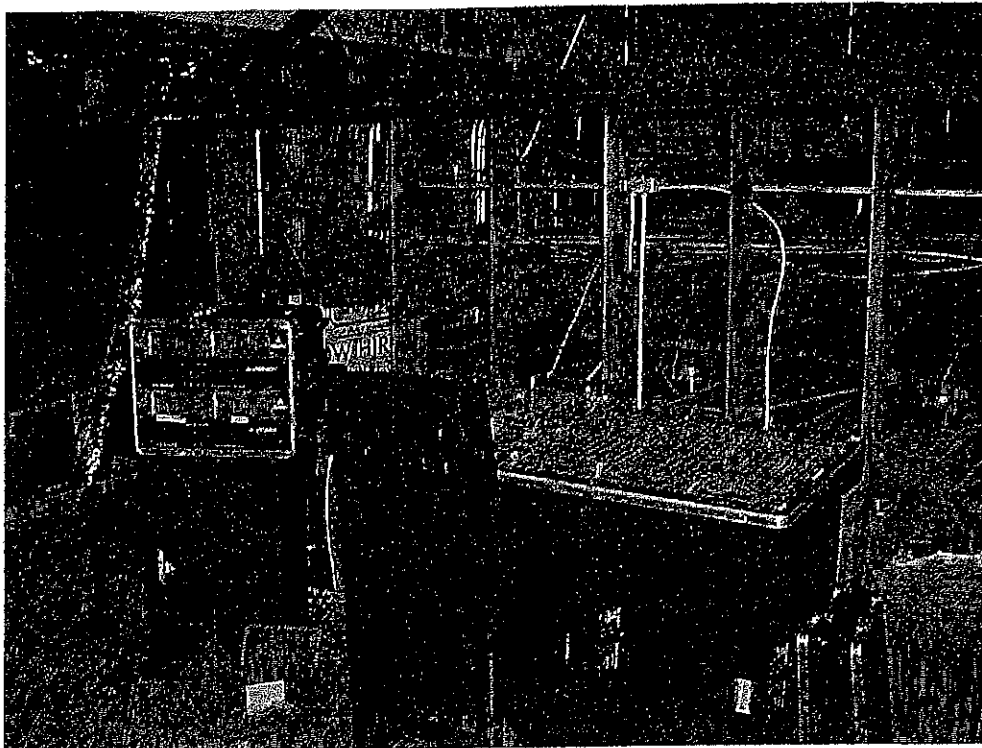
Photo 31: Area on second floor of Player's Club (view of sound equipment).

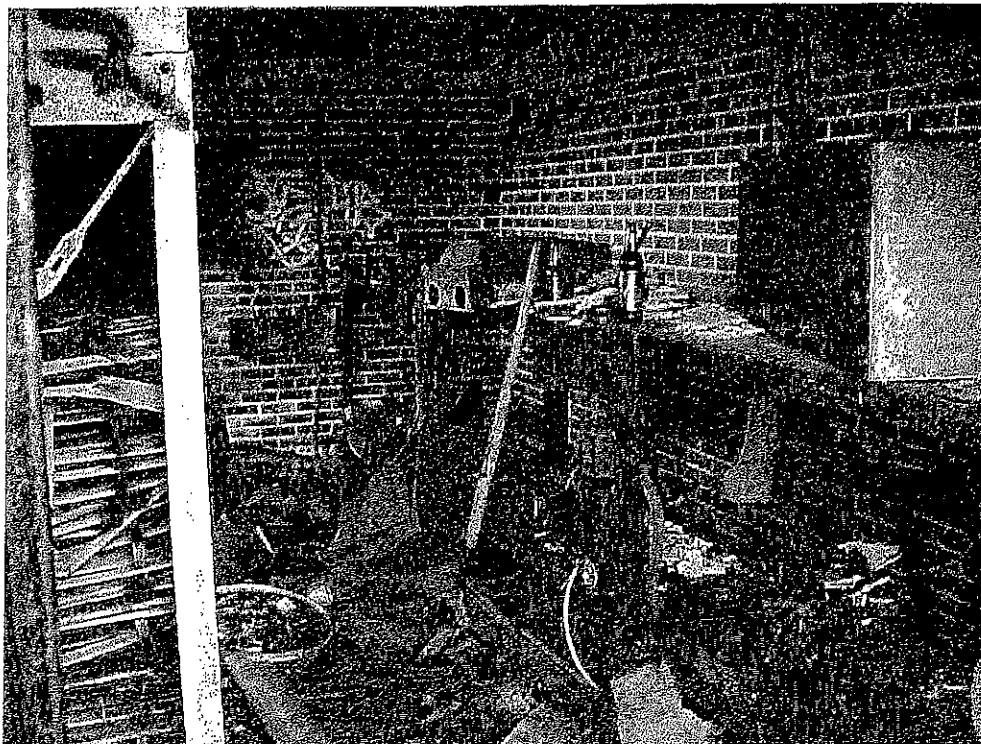
Photo 33: Exterior area behind the adjacent building to Player's Club.

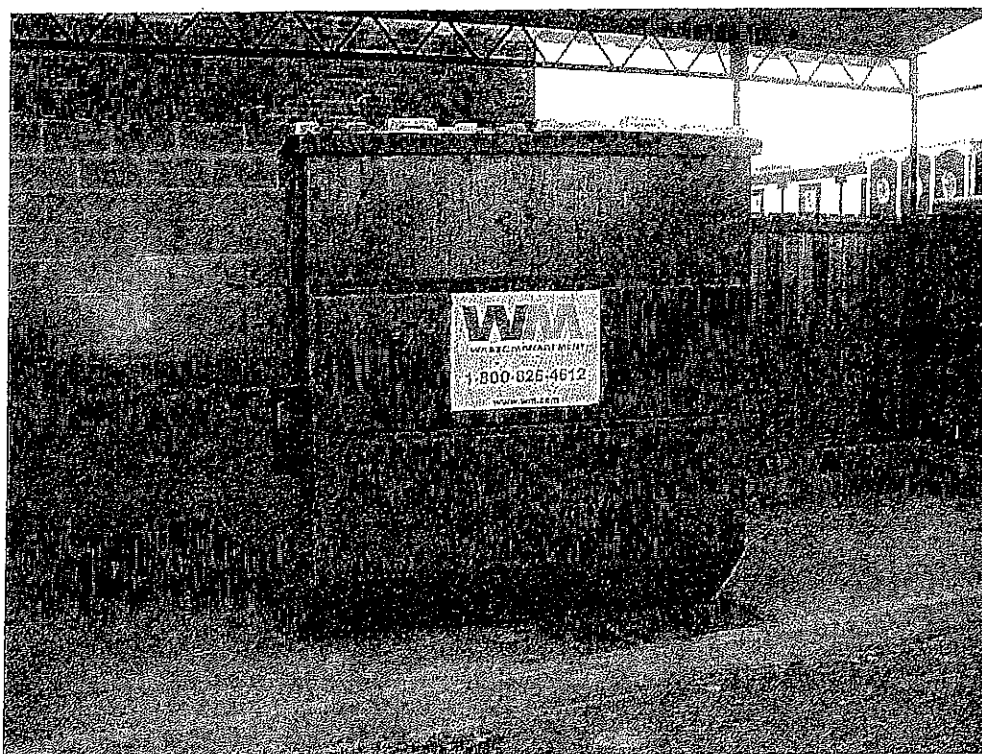
Photo 34: Garbage dumpster located to the rear of Player's Club.

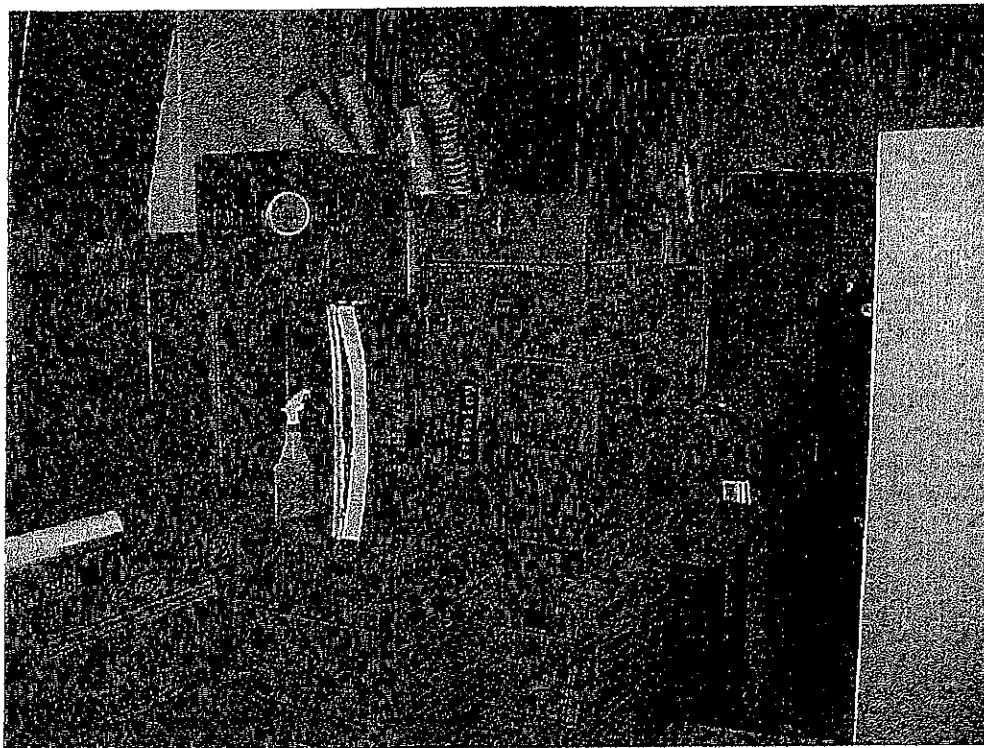
Photo 38: Studio 90 dance club storage area
