PHASE I
ENVIRONMENTAL SITE ASSESSMENT

10.0 +/- ACRE SITE PROPOSED FOR
CONDOMINIUM DEVELOPMENT,
LOCATED ALONG NORTH SIDE OF
U. S. HIGHWAY 90
BILOXI, MISSISSIPPI

MORAN ENGINEERING, PLLC
ENGINEERS-PLANNERS-SURVEYORS-ENVIRONMENTAL
249 BEAUVOIR ROAD
BILOXI, MISSISSIPPI 39531
PHONE (228) 388-1950
FAX (228) 388-1971
e.mail-msa@moranseymour.com

February, 2005

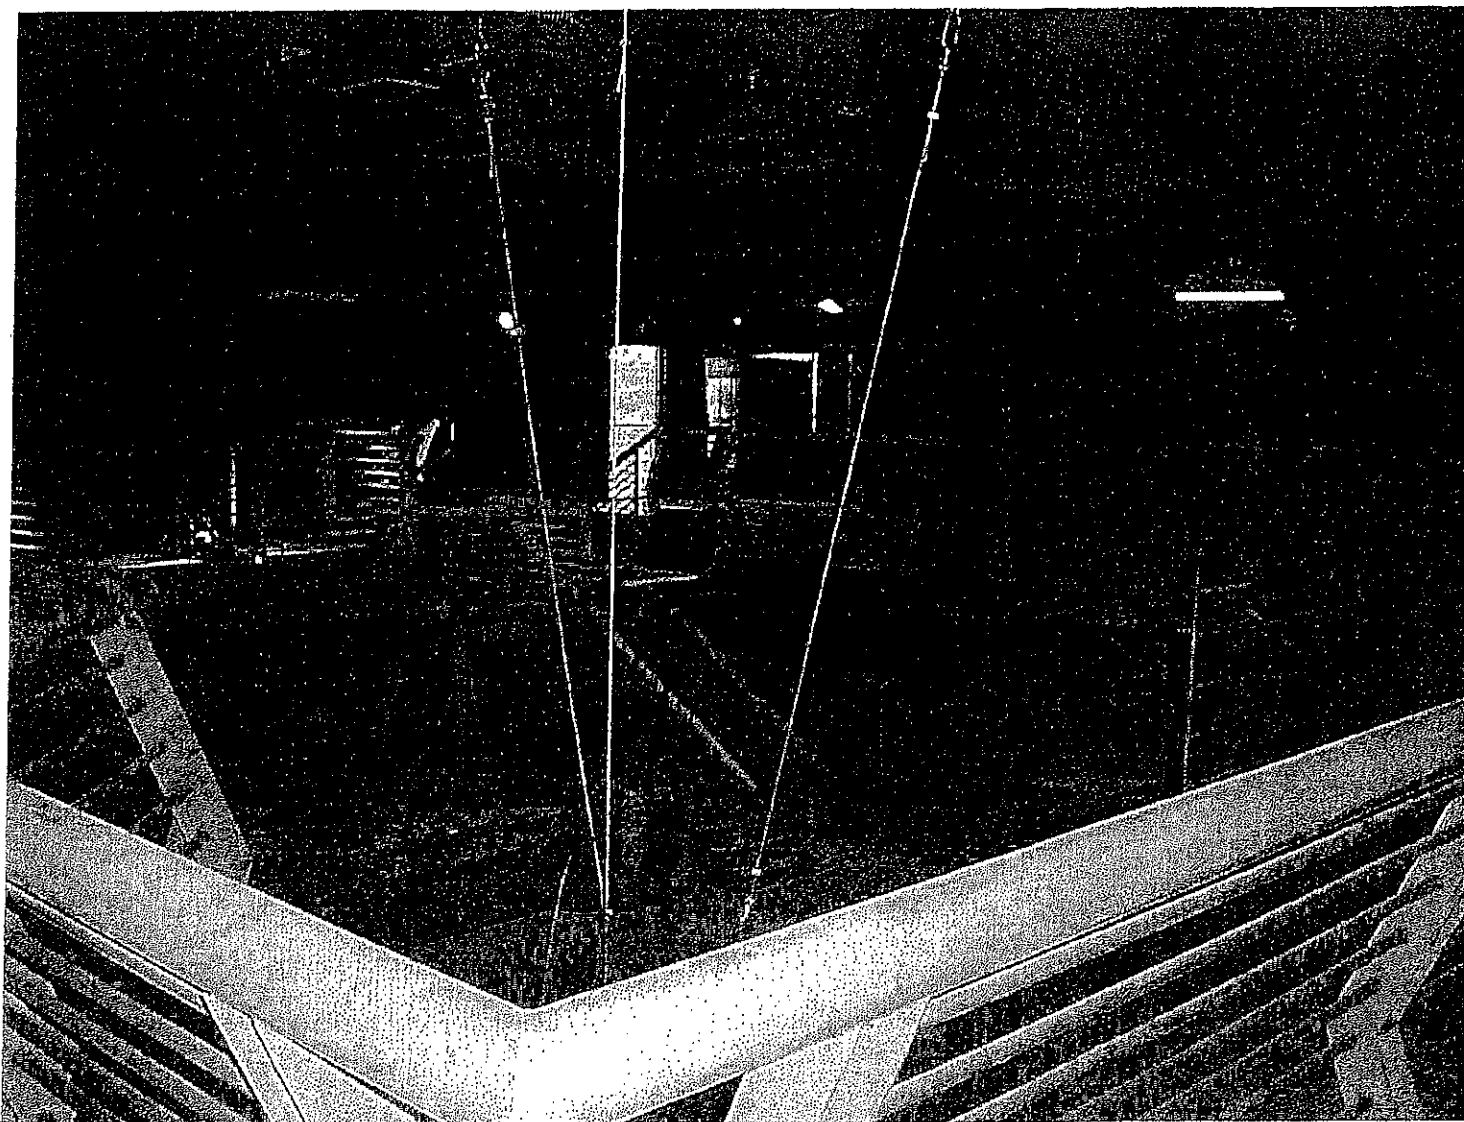
Photo 35: Interior view of dance floor at Studio 90 dance club.
