# WOOD DESTROYING PESTS AND ORGANISMS INSPECTION REPORT

| BUILDING NO.<br><b>20265</b> | STREET, CITY, STATE, ZIP<br><b>Lake Chabot Road, Castro Valley CA 94546</b> | Date of Inspection<br><b>8/16/2024</b> | No. of Pages<br><b>11</b> |

| Firm Registration No. <b>PR 4539</b> | Report No. <b>47516</b> | Escrow No. |

| General Description:<br><b>Commercial building</b> | Inspection Tag Posted:<br><b>Subarea</b> |

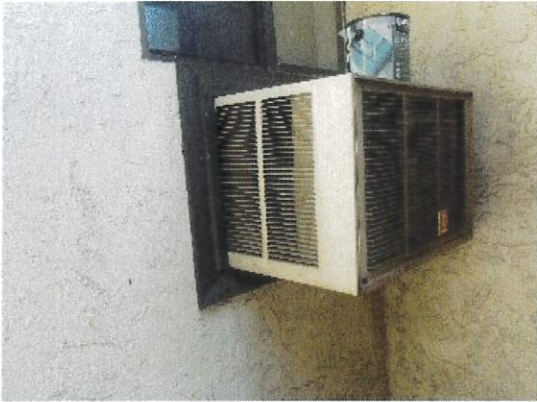
**Item #1**

ITEM 1 **FINDING:** The 1x4 trims at the A/C unit are damaged by fungus.

**RECOMMENDATION:** Remove and reconstruct damaged wood member(s) with new materials. Paint areas of repair to match existing as close as possible. An exact match is not guaranteed. Should damage extend into inaccessible areas a supplemental report will be issued.

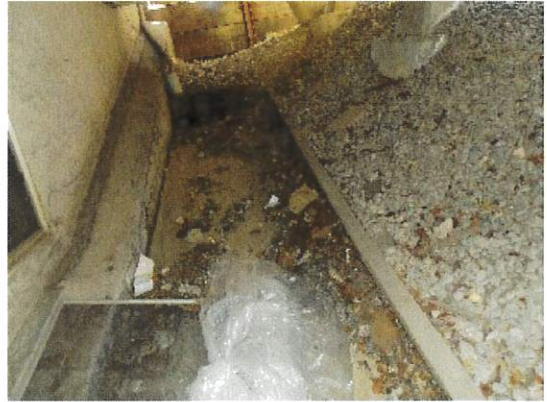
**Item #5**

ITEM 5 FINDING: The retaining wall is damaged by fungus.

RECOMMENDATION: This condition is addressed to the appropriate licensed contractor for repairs.

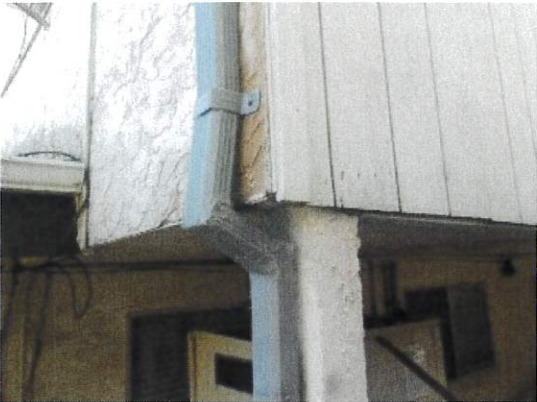
**Item #3**

ITEM 3 FINDING: The TI-11 siding is damaged by fungus.

RECOMMENDATION: Remove approximately 16 sq. ft. of siding. Install appropriate flashing when applicable and reconstruct damaged wood member(s) with new materials. Paint areas of repair to match existing as close as possible. An exact match is not guaranteed. Should damage continue into inaccessible areas a supplemental report will be issued.

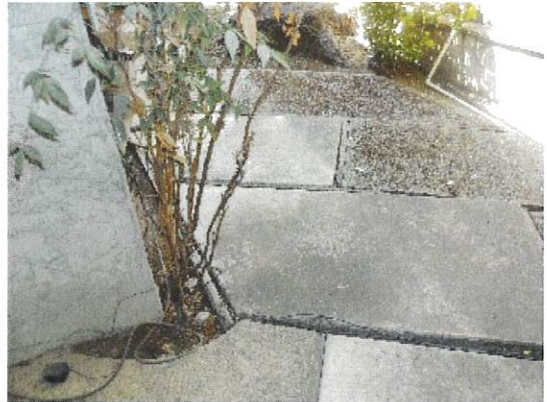
**Item #6**

ITEM 6 FINDING: The screed woods are damaged by fungus.

RECOMMENDATION: Remove damaged portions of screed woods and fill voids with concrete mortar.

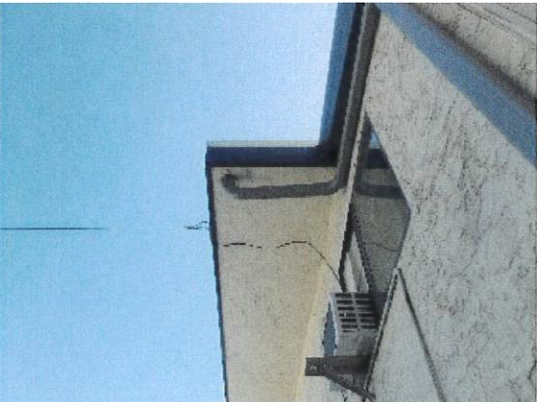
**Item #4**

ITEM 4 FINDING: The fascia board is infected with an isolated area of fungus.

RECOMMENDATION: Remove the infected area and treat resulting void with Tim-Bor, a registered fungicide, according to label instructions. Patch repair and paint areas of repair to match existing as close as possible. An exact match is not guaranteed.

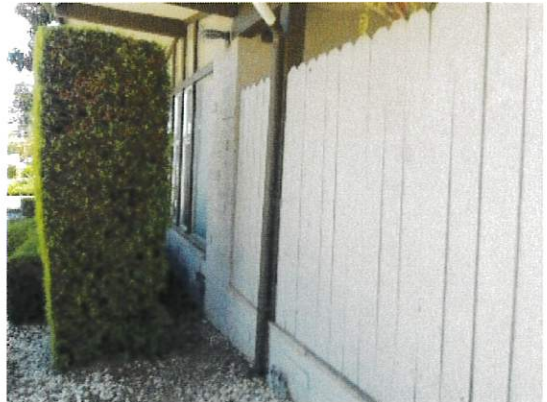
**Item #7**

ITEM 7 FINDING: The 6x6 support post is damaged by fungus.

RECOMMENDATION: Remove and reconstruct damaged wood member(s) with new materials. Paint areas of repair to match existing as close as possible. An exact match is not guaranteed. Should damage extend into inaccessible areas a supplemental report will be issued.

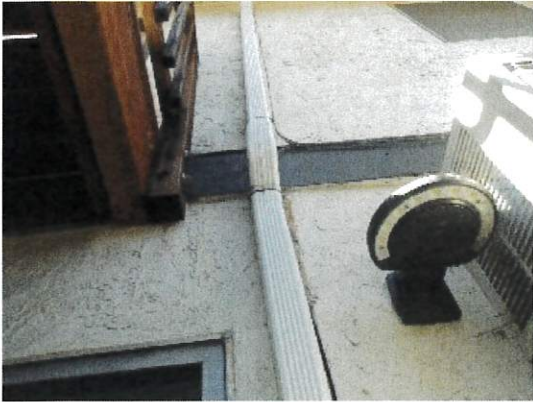
**Item #9**

- ITEM 9 **FINDING:** The bally band is infected/damaged by old drywood termites. This damage/infection is minor and in our opinion there is no structural weakening.

- RECOMMENDATION:** Patch repair and paint areas of repair to match existing as close as possible. An exact match is not guaranteed.  
\*\*\*\*\* This is a Section 1 Item \*\*\*\*\*

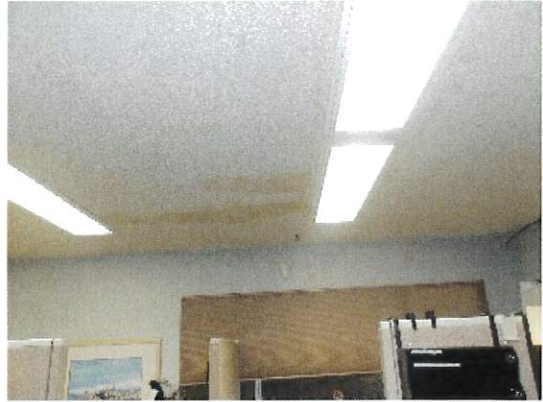
**Item #13**

- ITEM 13 **FINDING:** Old water stains noted on the ceiling covering where indicated on the diagram. No other adverse condition noted.
- RECOMMENDATION:** Periodic inspections are advised.

- NOTE:** Should owners/interested parties desire additional information regarding this area, upon request remove section(s) of the sheetrock to reveal the condition of the internal framing. A supplemental report will be issued. This will be done at an additional charge.  
\*\*\*\*\* This is a Section 2 Item \*\*\*\*\*

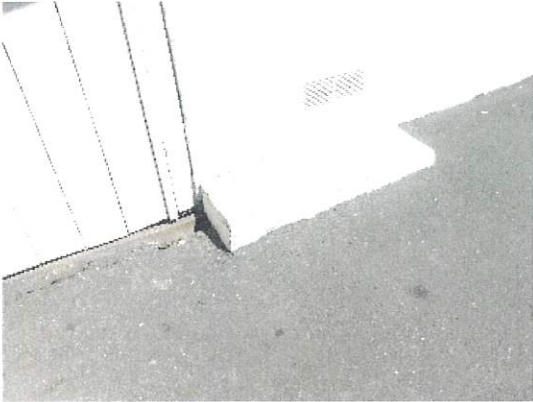
**Item #11**

- ITEM 11 **FINDING:** Form material is in earth-wood contact.
- RECOMMENDATION:** Remove form material as practical. Treat any remaining form material with Tim-Bor, a registered fungicide, according to label instructions.  
\*\*\*\*\* This is a Section 2 Item \*\*\*\*\*

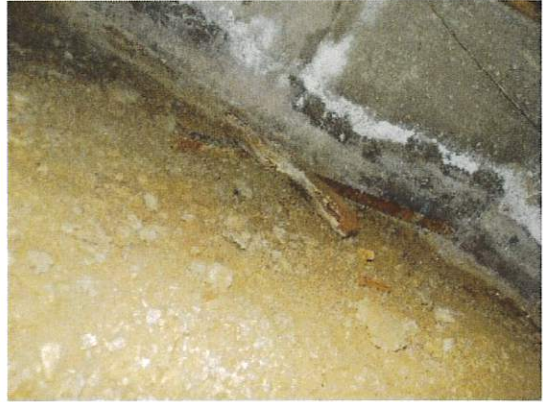
**Item #16**

- ITEM 16 **FINDING:** Cellulose debris scattered on the subarea soil is infected by fungus.
- RECOMMENDATION:** Remove and dispose of cellulose debris of rakeable size.  
\*\*\*\*\* This is a Section 1 Item \*\*\*\*\*

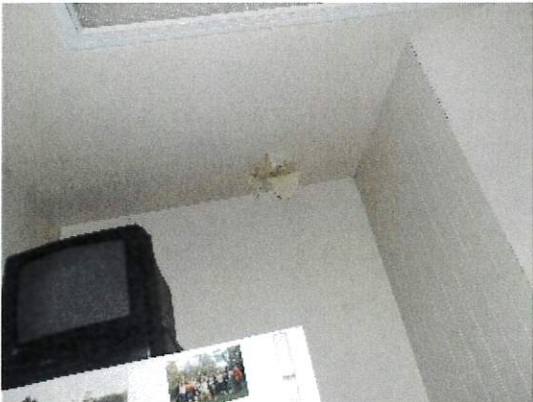
**Item #12**

- ITEM 12 **FINDING:** The ceiling in the break room is moisture/water damaged. This condition appears to be from a past roof leak.
- RECOMMENDATION:** Repair the sheetrock as necessary. Should damage continue into inaccessible areas a supplemental report will be issued.  
\*\*\*\*\* This is a Section 2 Item \*\*\*\*\*

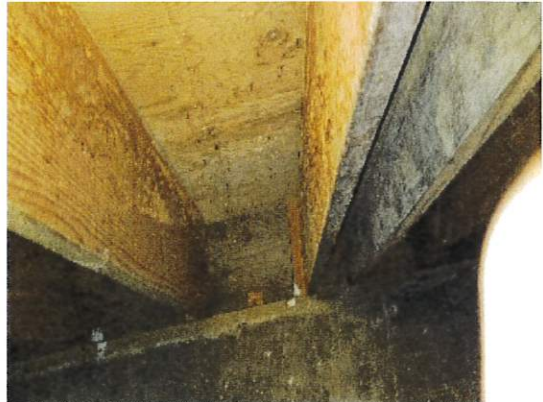
**Item #17**

- ITEM 17 **FINDING:** The subfloor framing is infected with surface fungus.
- RECOMMENDATION:** Wire-brush the infected area and treat with Tim-Bor, a registered fungicide, according to label instructions.  
\*\*\*\*\* This is a Section 1 Item \*\*\*\*\*

- ITEM 18 **FINDING:** The subarea is lacking perimeter ventilation which is contributing to the damp/muddy soil condition addressed in item #17.
- RECOMMENDATION:** Install mechanical ventilation to increase the air circulation within the subarea.  
\*\*\*\*\* This is a Section 2 Item \*\*\*\*\*

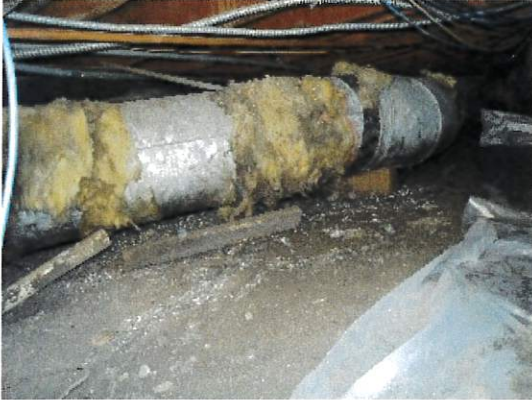
**Item #21**

- ITEM 21 **FINDING:** The wood blocking below the air duct is in earth-wood contact and damaged by fungus.
- RECOMMENDATION:** Remove blocking and secure air duct in the appropriate manner.  
\*\*\*\*\* This is a Section 1 Item \*\*\*\*\*
