Inspection Report

Property Address:
2005 9th street
Los Osos CA 93402

8/5/2024

Harper Homes: Home Inspection Services

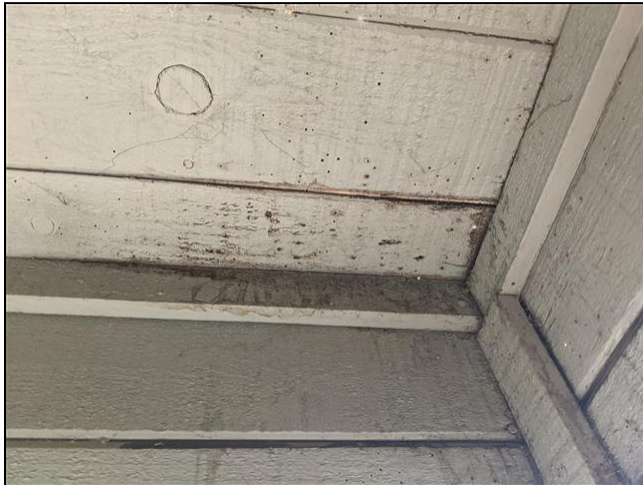
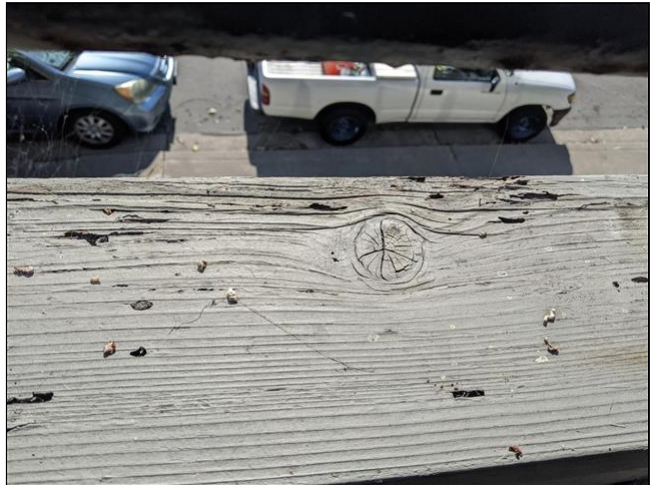
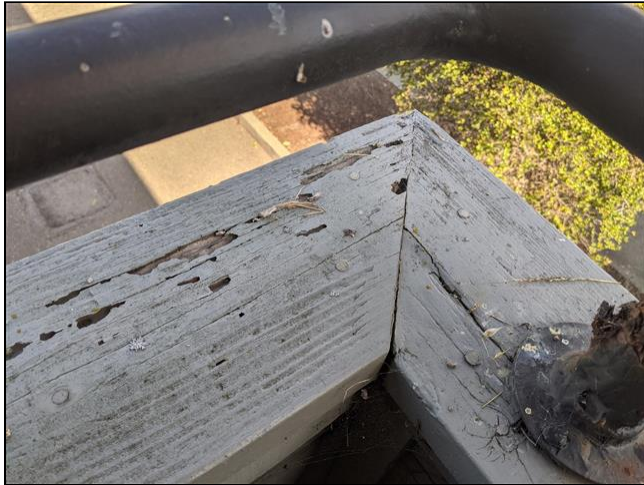
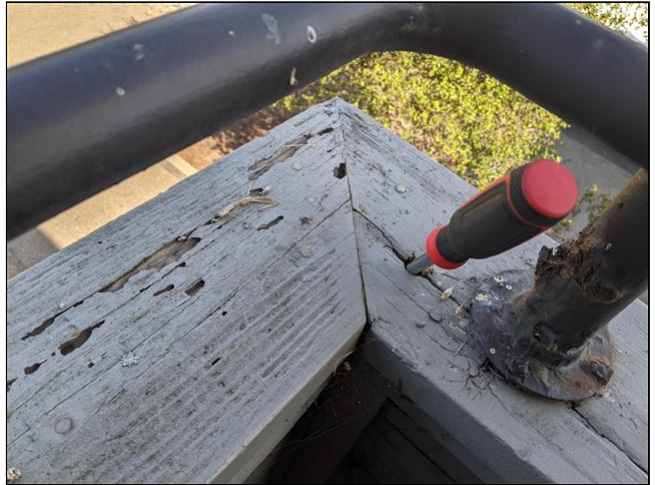
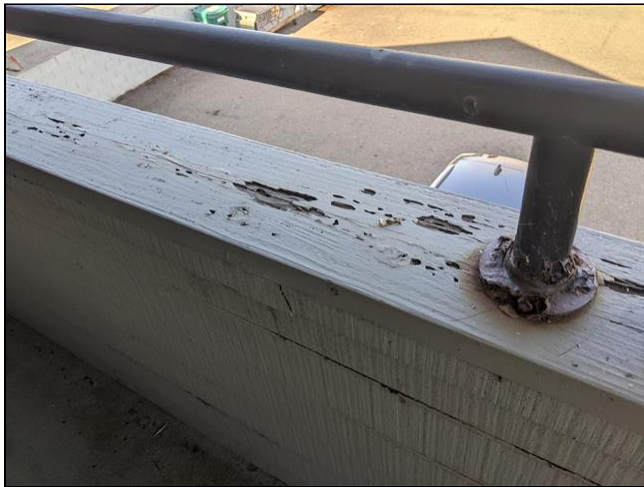
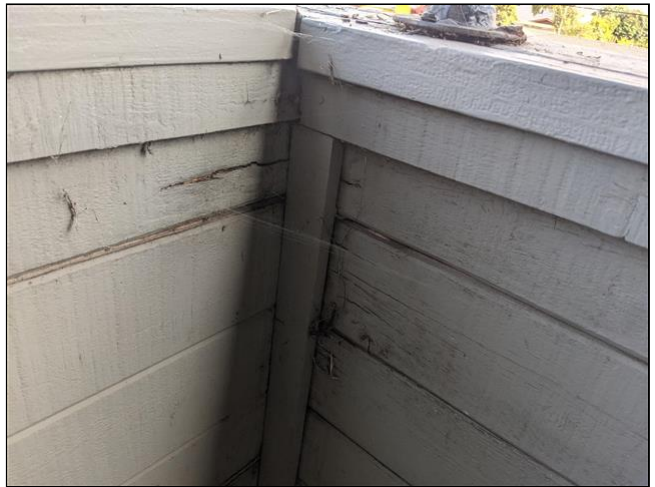
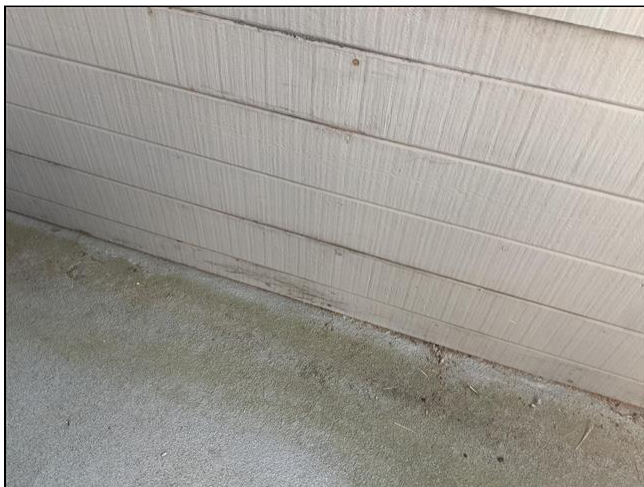
Moisture damage noted deck at multiple locations. Recommend further evaluation by a structural pest control operator and make repairs as prescribed.

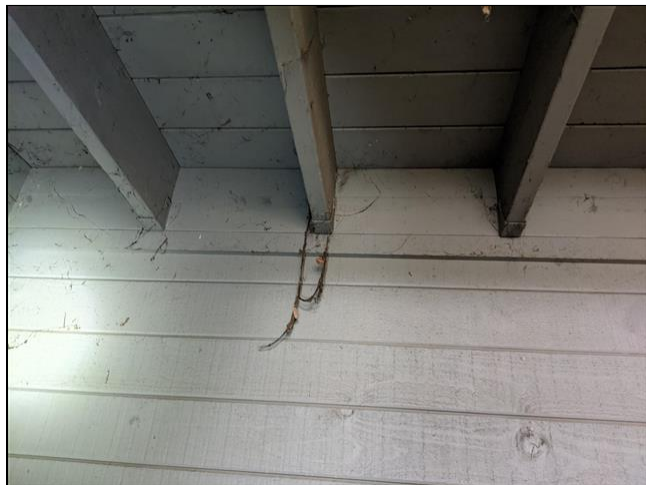
1.1 Item 8(Picture)

Wood deck ledger board is nailed to the side of the structure, but not bolted, as is currently required. Recommend deck connection to the home be improved by a licensed contractor to ensure intended support for the deck.

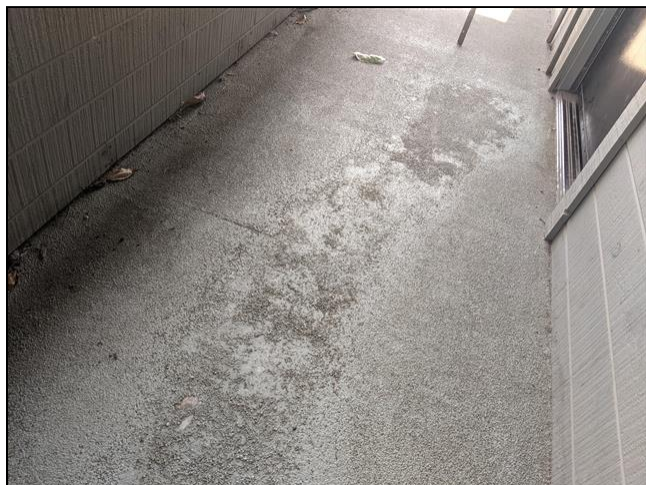
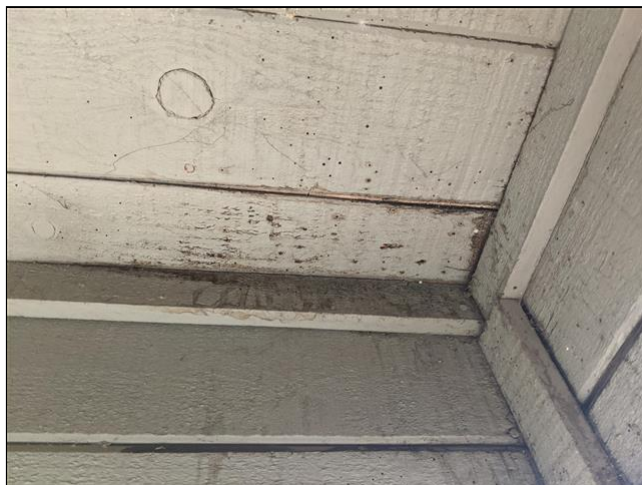
The waterproof deck in the property is showing visible signs of deterioration and evidence of leaking. It is crucial to address these issues promptly to prevent further damage to the structure and potential water ingress into the building. We recommend consulting with a qualified contractor specializing in waterproofing to assess the extent of damage, determine the cause of leakage, and propose necessary repairs or replacements to restore the deck's integrity and prevent future issues.

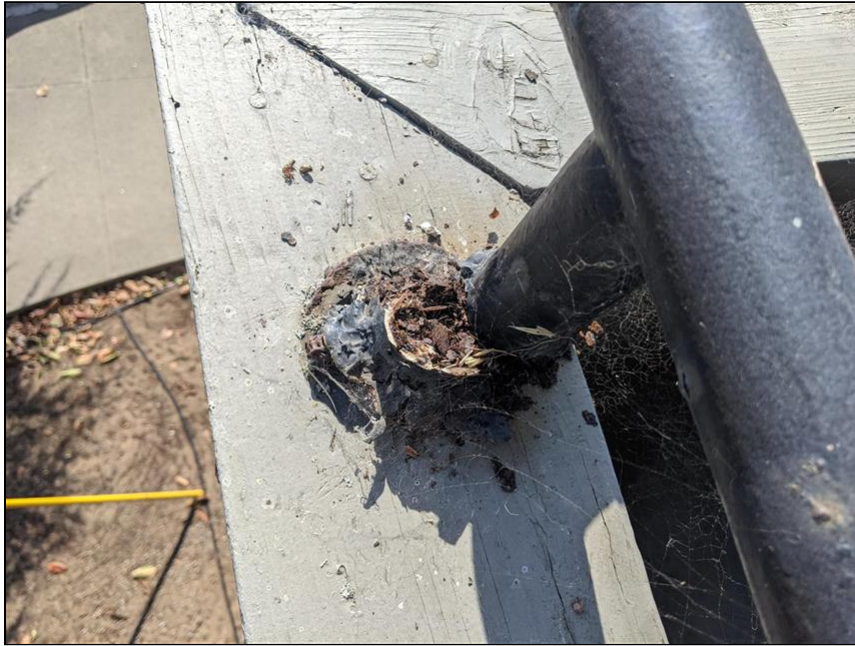
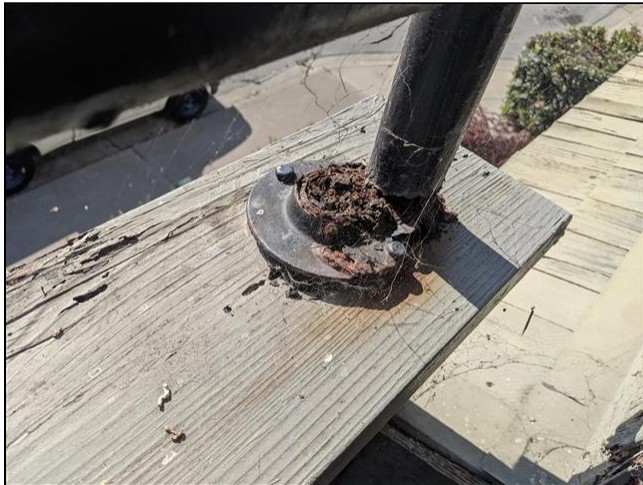
The guardrail for the second story deck is rusted, damaged and displaced. Repairs/replacement is needed to ensure safety of the deck.

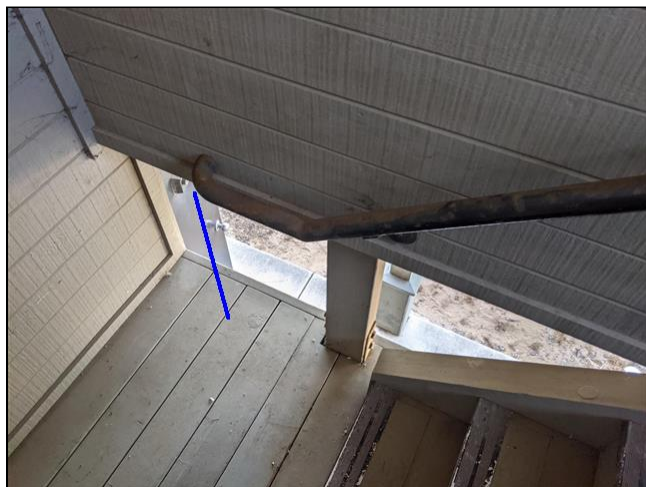
1.2 Item 1(Picture)

Guardrail spacing exceeds 4" at the stairwell. While this may have been acceptable at the time of construction, upgrading to meet current standards is recommended.

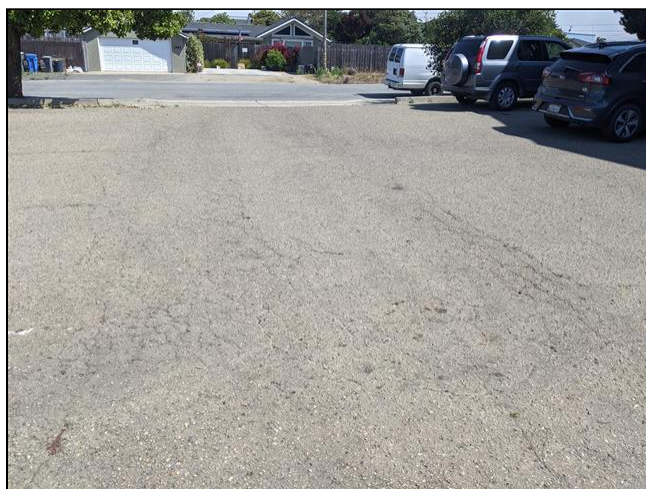
1.3 Item 1(Picture)

Asphalt cracks noted on the driveway. Recommend cracks be properly sealed in these areas to prevent further or excessive damage to the asphalt driveway.

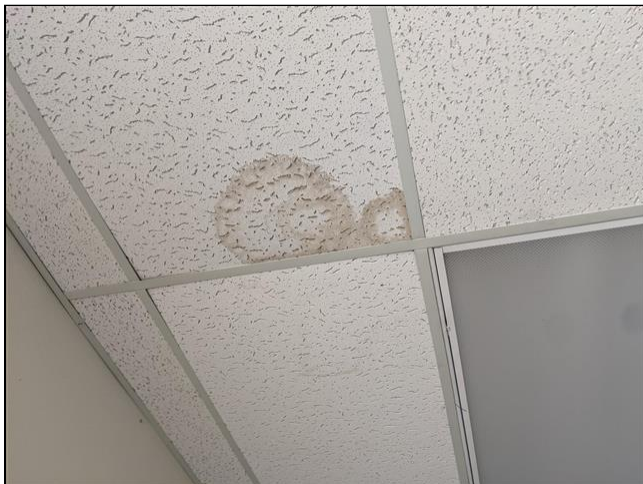
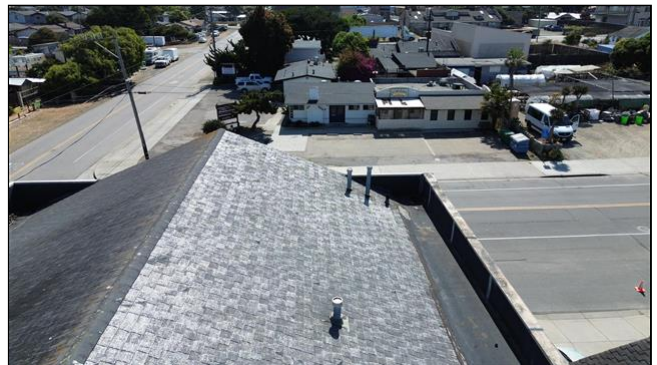
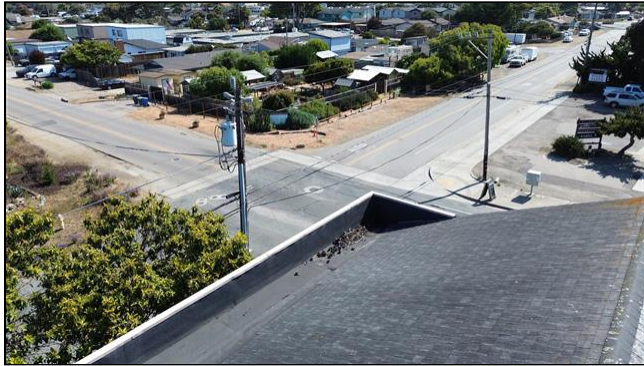
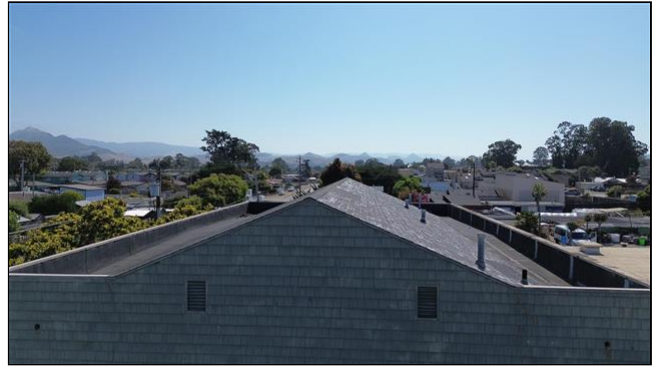
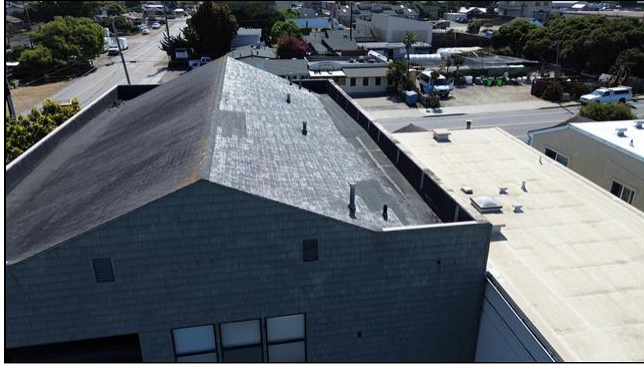
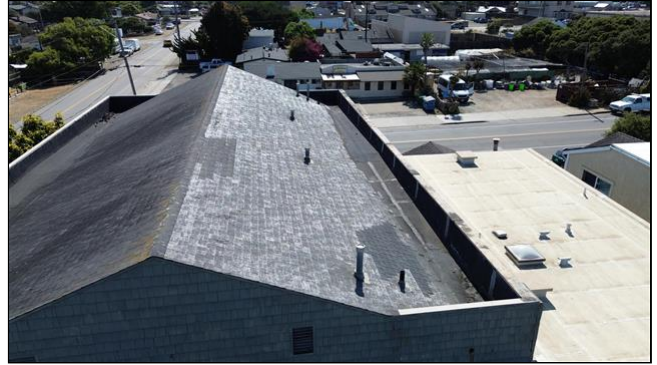
Areas of the roofing material are weathered and in need of replacement. Evidence of leaking was noted. Recommend further evaluation with cost to replace and remaining life determined by a licensed roofing contractor.

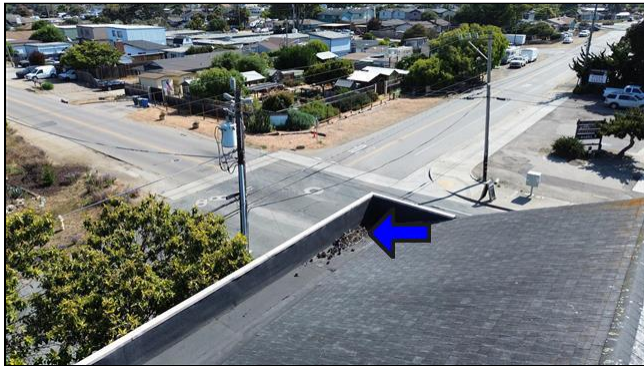
2.0 Item 7(Picture)

Debris on the roof should be removed and an annual maintenance schedule established. This will greatly extend the life expectancy of the roof in these areas.

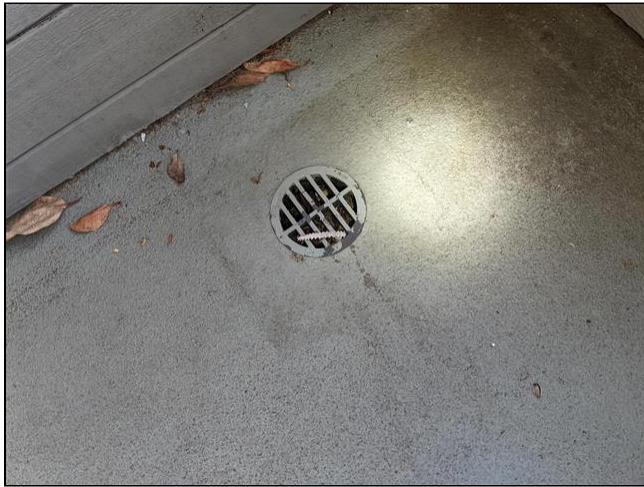
2.1 Item 1(Picture)

The deck drains contain debris in areas and need cleaned and an annual maintenance schedule established to allow intended drainage runoff water away from the building.

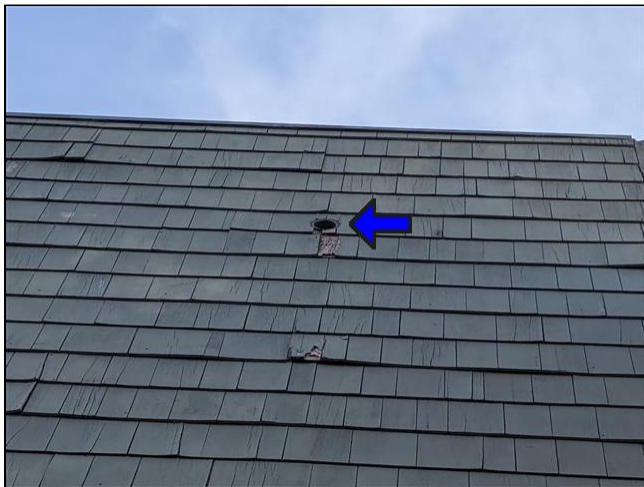
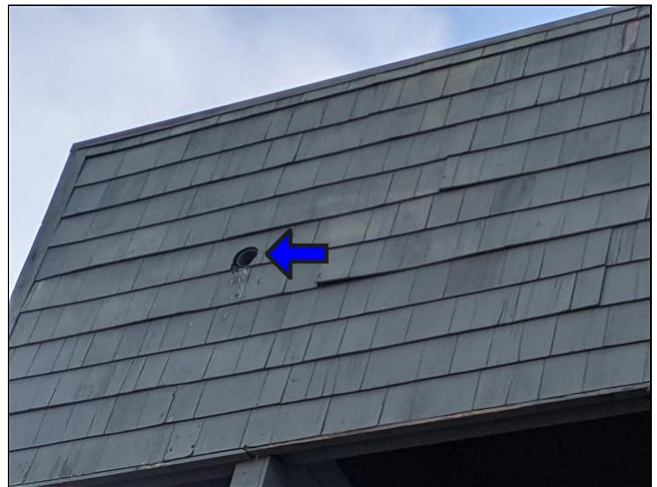
The roof drains should be extended further from the siding to allow water to drain without running down the siding.

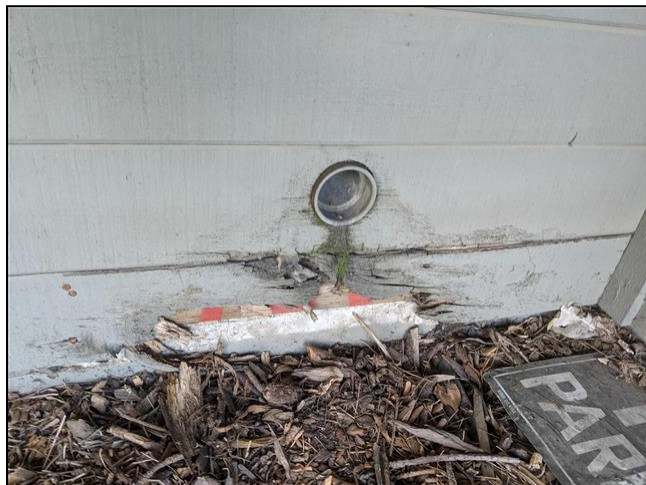
2.1 Item 4(Picture)

Moisture damage was noted at the drainage runoff at the rear side of the home and it appears the drain is not draining and functioning properly. Repairs are needed to prevent further damage and deterioration.

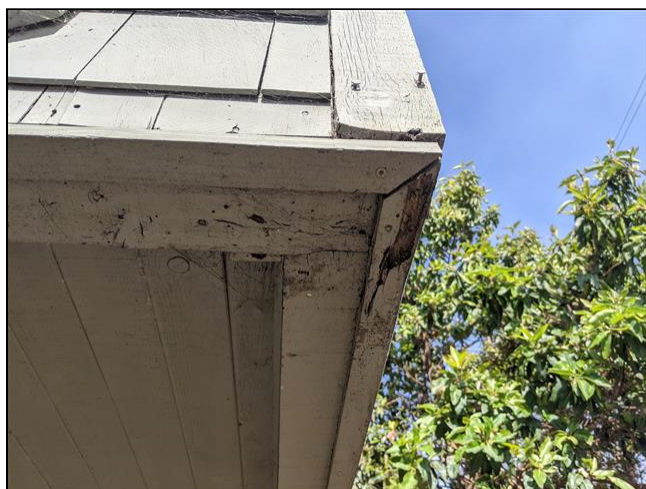
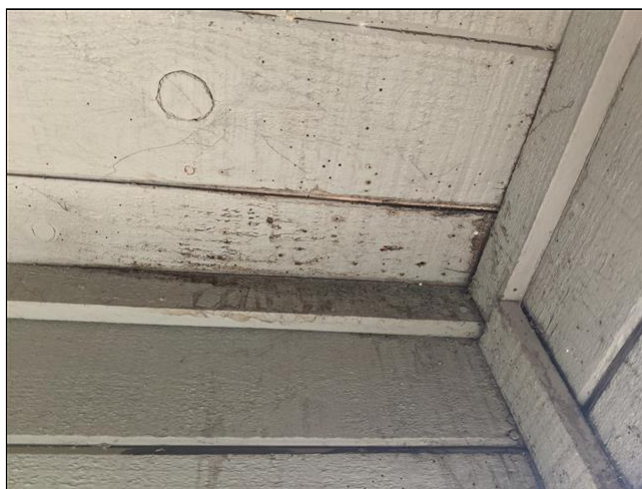
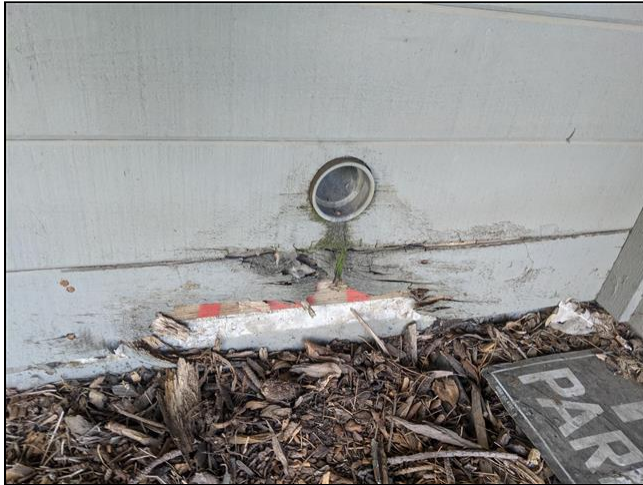
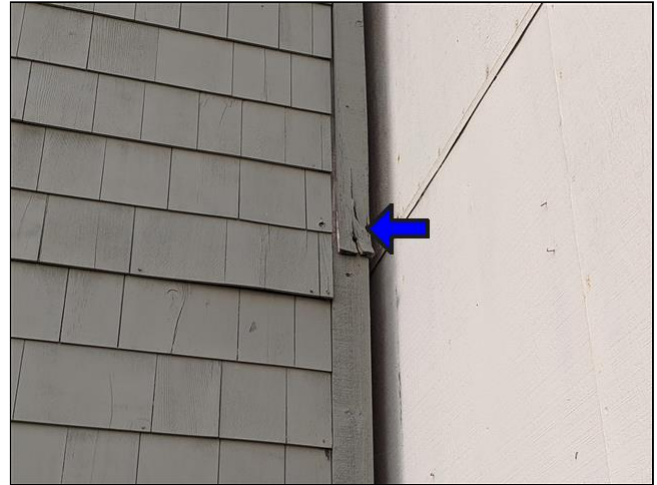
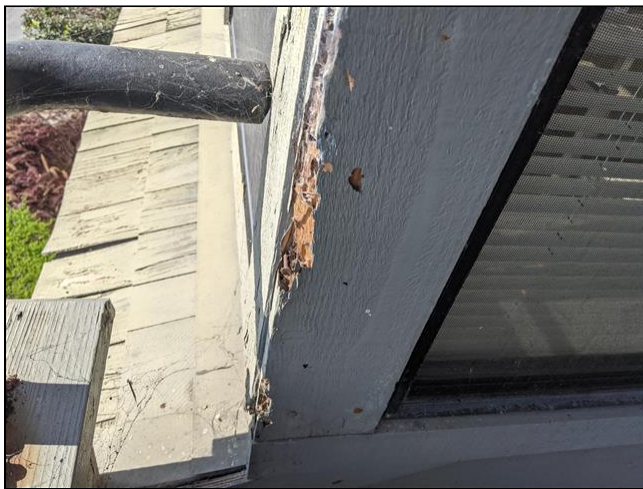
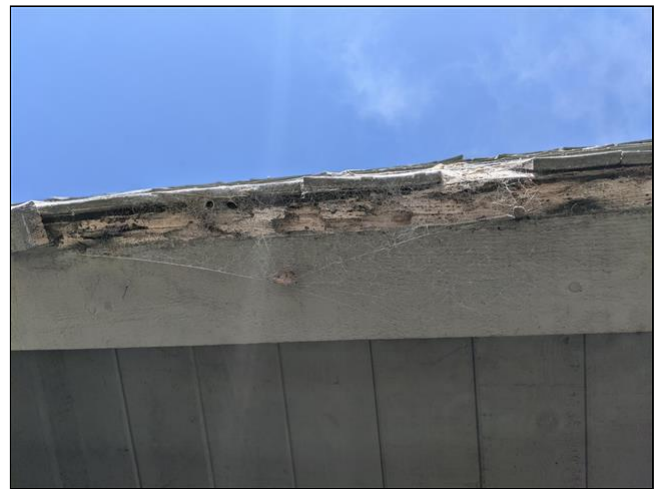
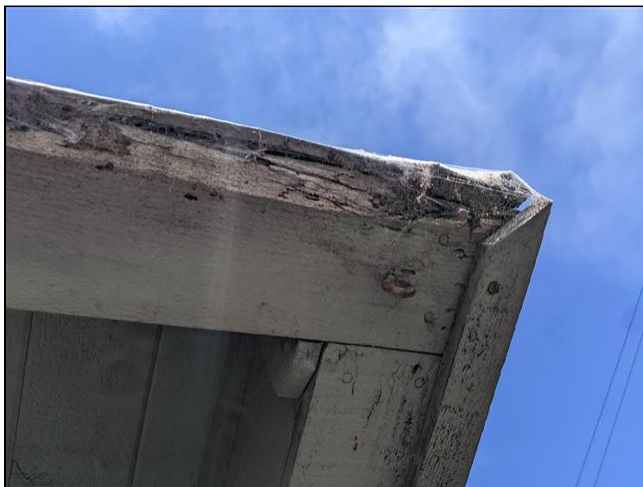
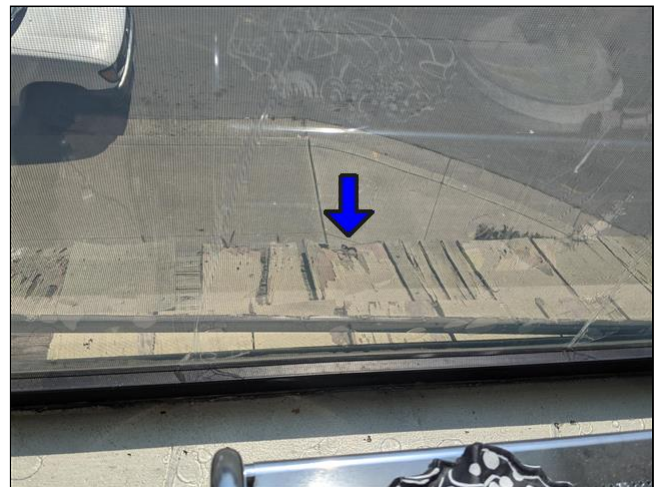
Moisture damage noted at the trim and siding at multiple locations around the home. Recommend further evaluation by a structural pest control operator and make repairs as prescribed.

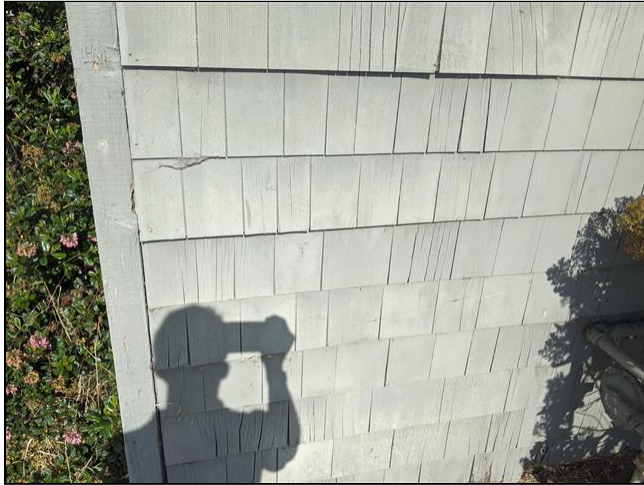
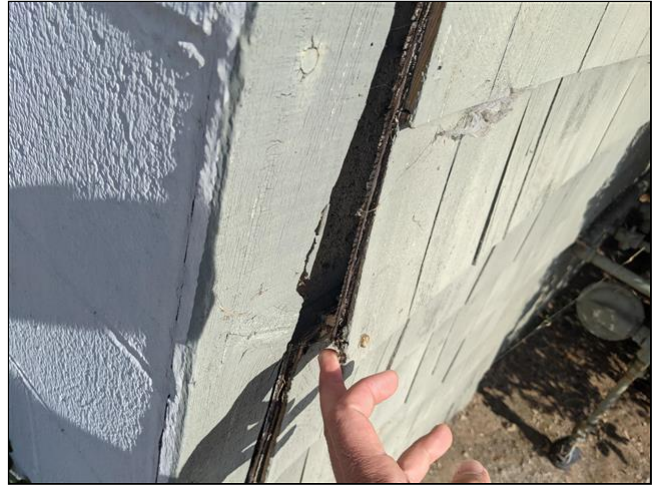
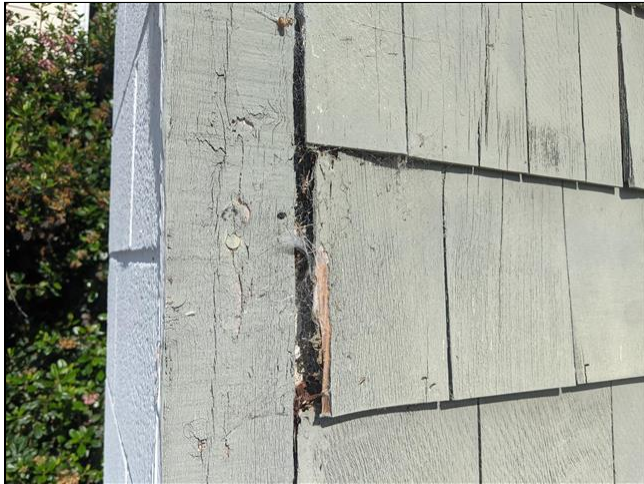
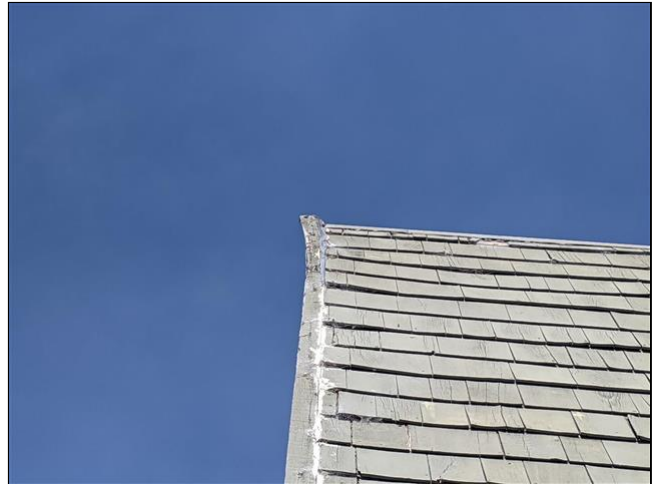
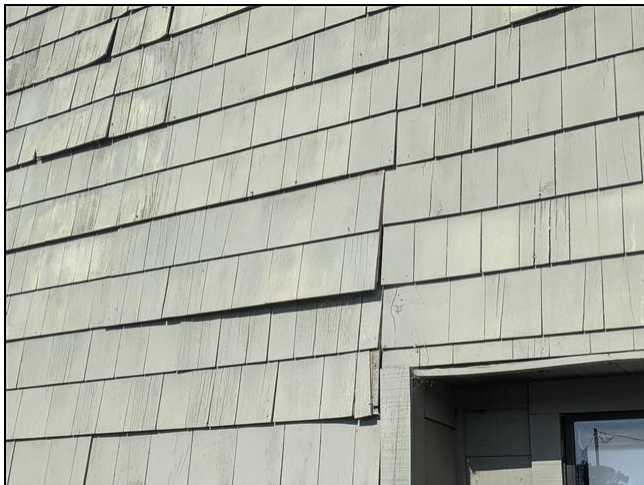
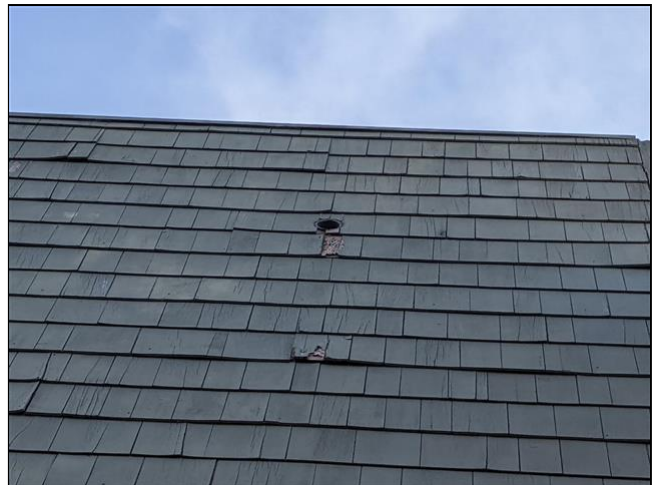
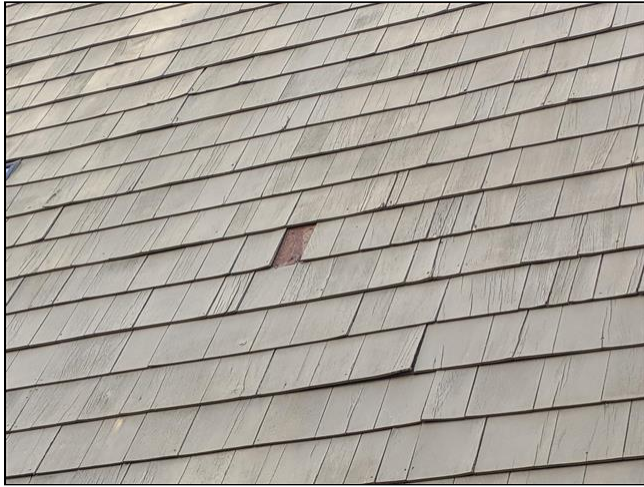
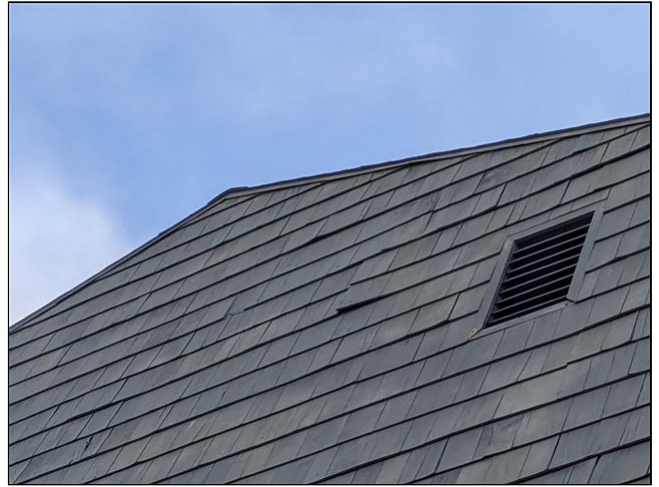
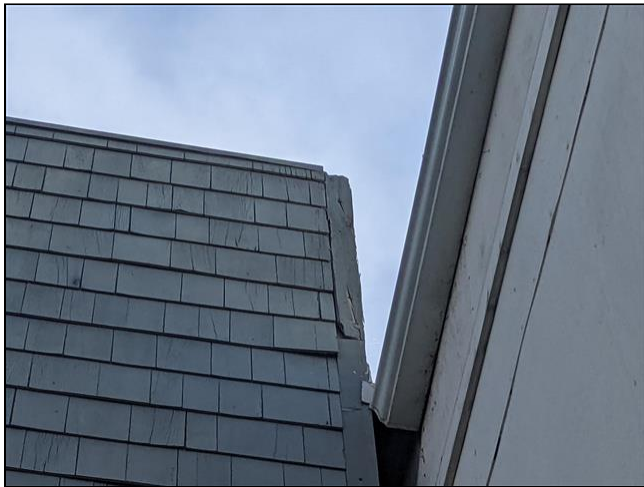
Multiple areas around the building has damaged, missing, lifting and displaced sections of siding. Repairs are needed to ensure function of the siding and to prevent further deterioration.

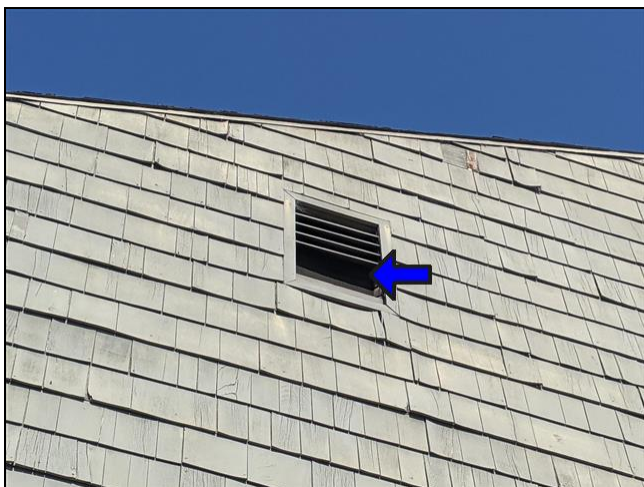
2.2 Item 18(Picture)

The gable vent is damaged and repairs are needed to prevent unwanted pest intrusion.

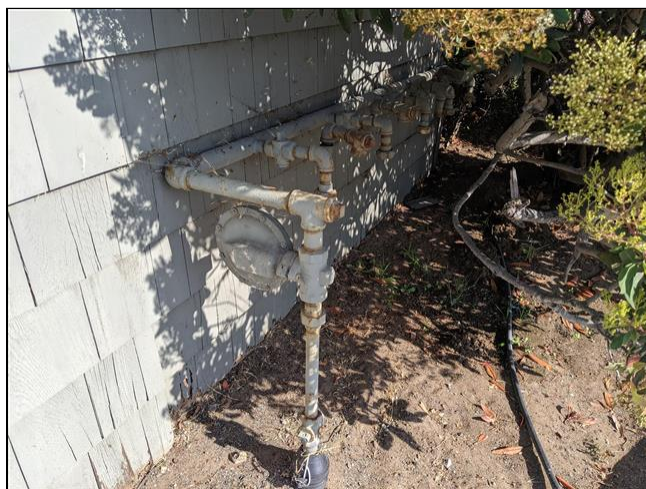
4.2 Item 1(Picture)

Gas lines appear to have installed at the front of the property, however no gas meters or gas service was noted.

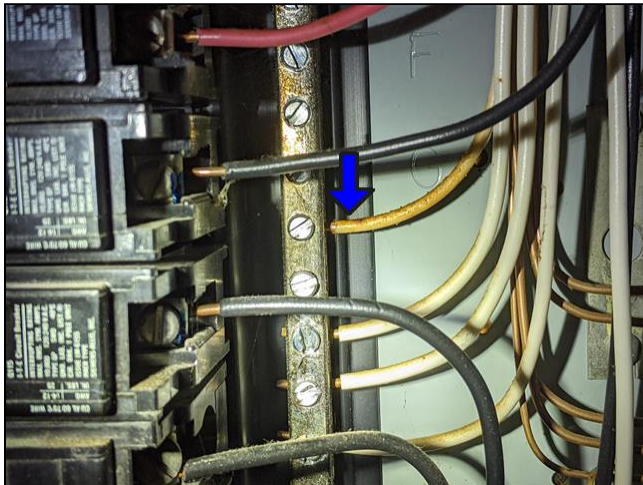
5.1 Item 1(Picture)

Overheated wire noted at the sub panel in unit A due to a loose connection. Recommend repairs made at this connection and all connections be checked for proper tightening by a licensed electrician.

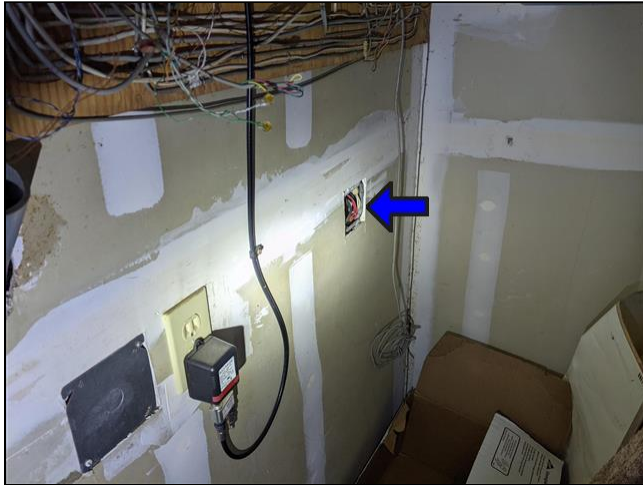
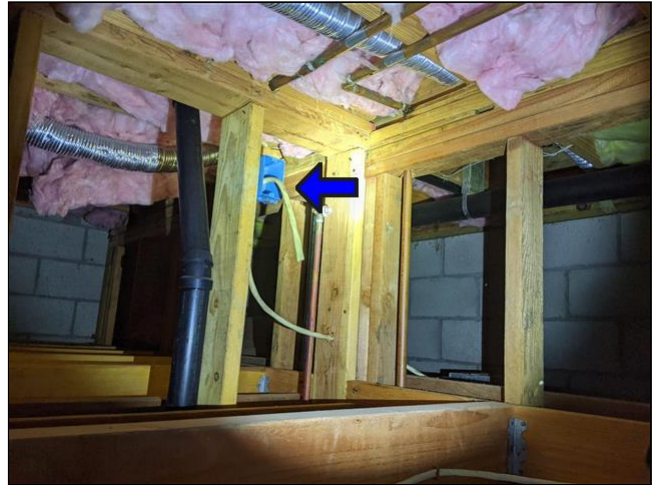
Junction box cover plate missing at the utility room and above the mens bathroom and needs installed to prevent accidental contact and contain heat in the event of a circuit failure.

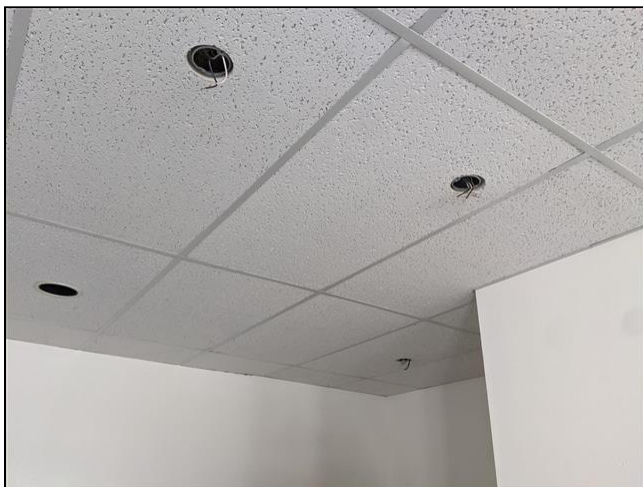
5.5 Item 1(Picture)

Light fixture not installed and wires exposed at the unit C. Recommend proper installation of a light fixture or junction box cover added.

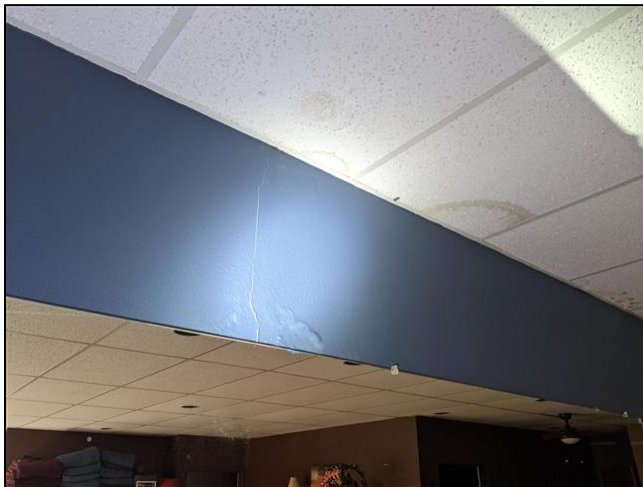
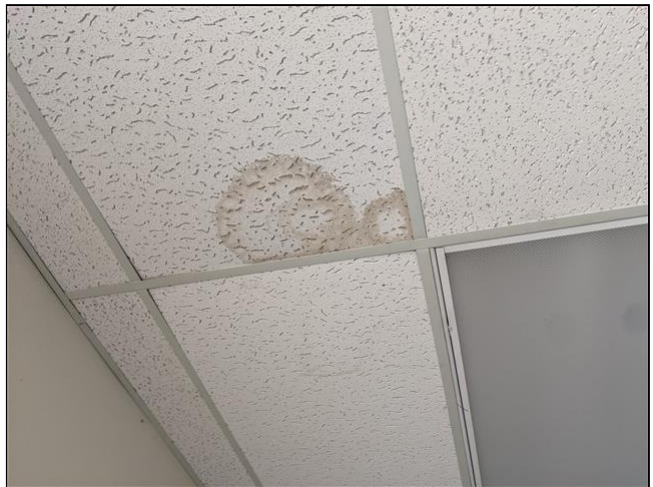
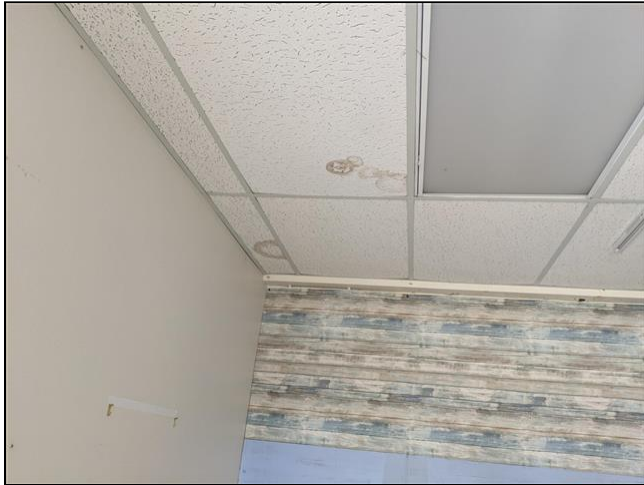
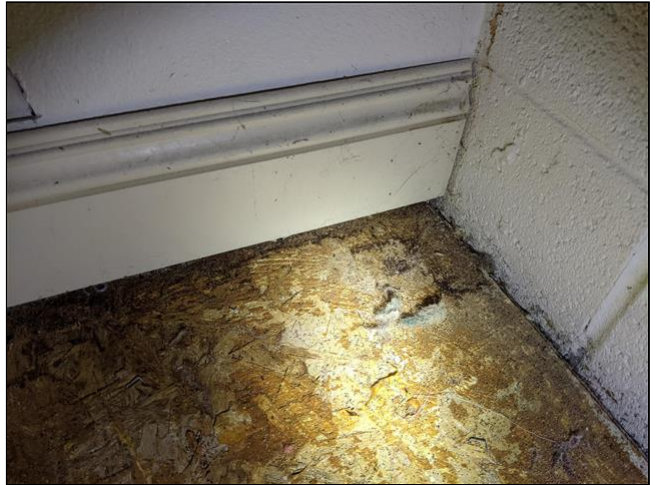
Moisture stains noted on the ceiling and walls in unit A and unit D. Recommend the roof and flashings be further evaluated in these areas to determine the cause and remedy of this moisture intrusion.

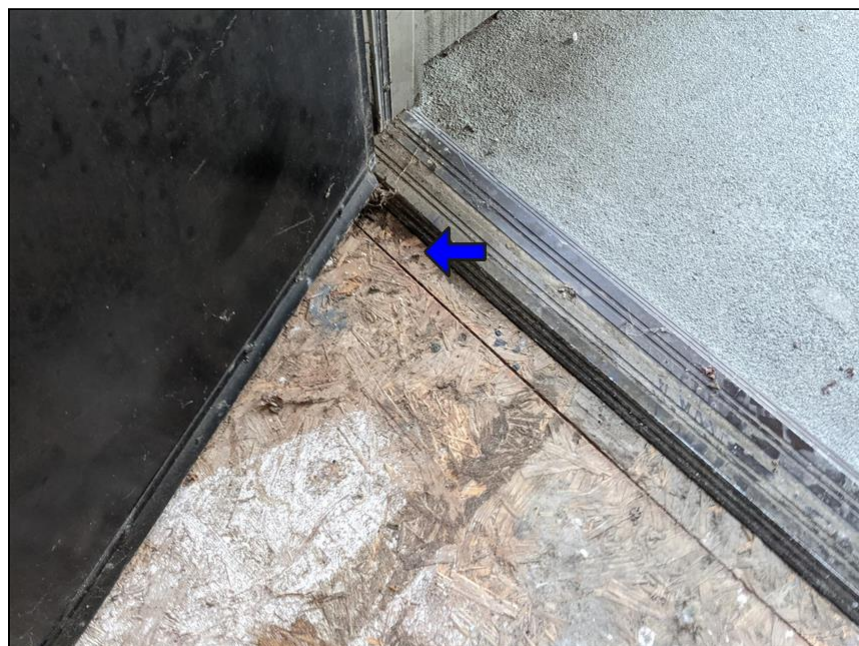
7.1 Item 1(Picture)

Moisture damage at the sub-floor was noted near the front door of unit F. Recommend further evaluation by a structural pest control operator and make repairs as prescribed.

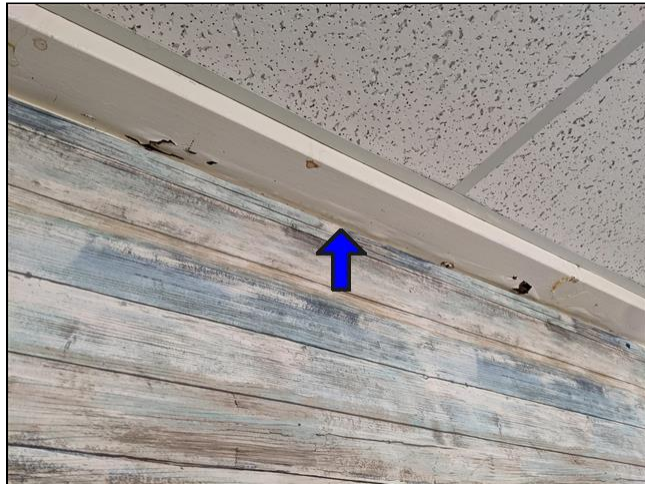
8.1 Item 1(Picture)

Apparent wood destroying pest activity noted in the building at multiple locations. Recommend further evaluation by a structural pest control operator and make repairs as prescribed.

Moisture damage noted at framing in unit D at multiple locations around the home. Recommend further evaluation by a structural pest control operator and make repairs as prescribed.
