1362 SW 2nd Street, Miami, FL 33135

Reference: 40 Year Re-Certification
Two-Story Residential Building
Folio No.: 01-4102-006-2220
1362 SW 2 ST, MIAMI, FL 33135
Bldg. No.: 1 / Sq. Ft.: 3,811

James Hanskat, P.E., has performed structural and electrical inspections of the above-referenced property located in Miami-Dade County, Florida.

Structural Photolog

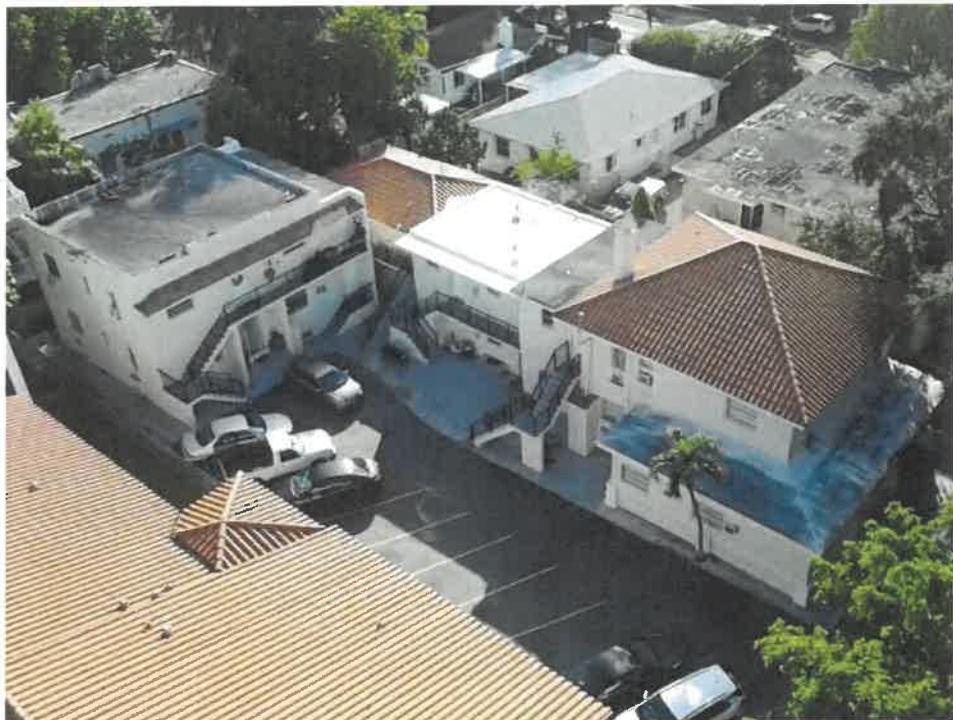
5. Present Condition of Overall Structure

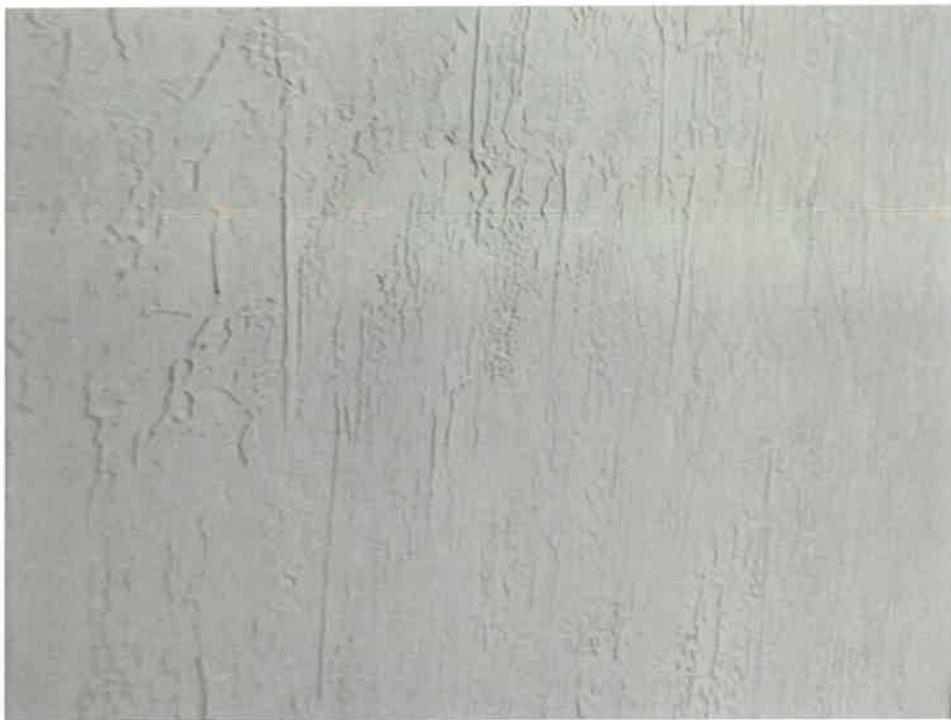
5.c. View of Surface Conditions

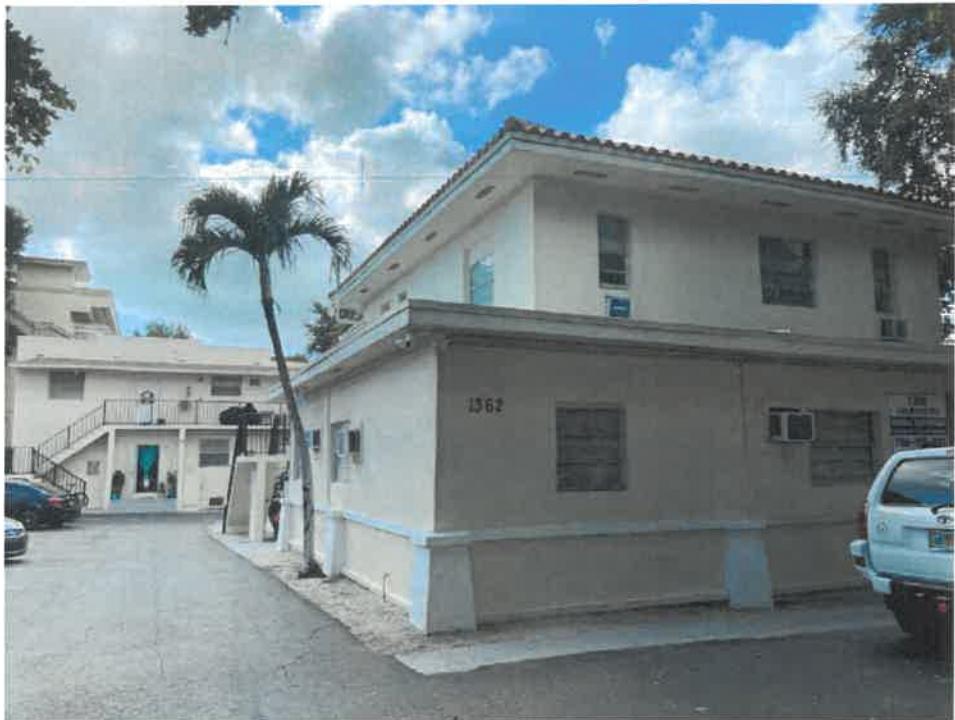
6. View of Masonry Bearing Wall

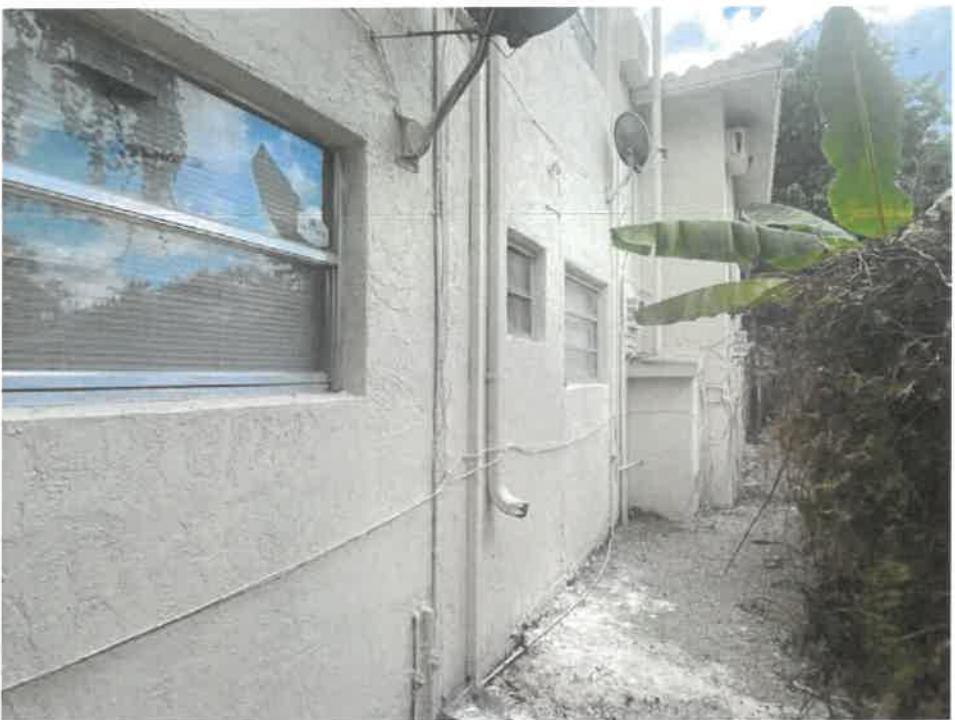
6.g. View of Exterior Masonry Finishes

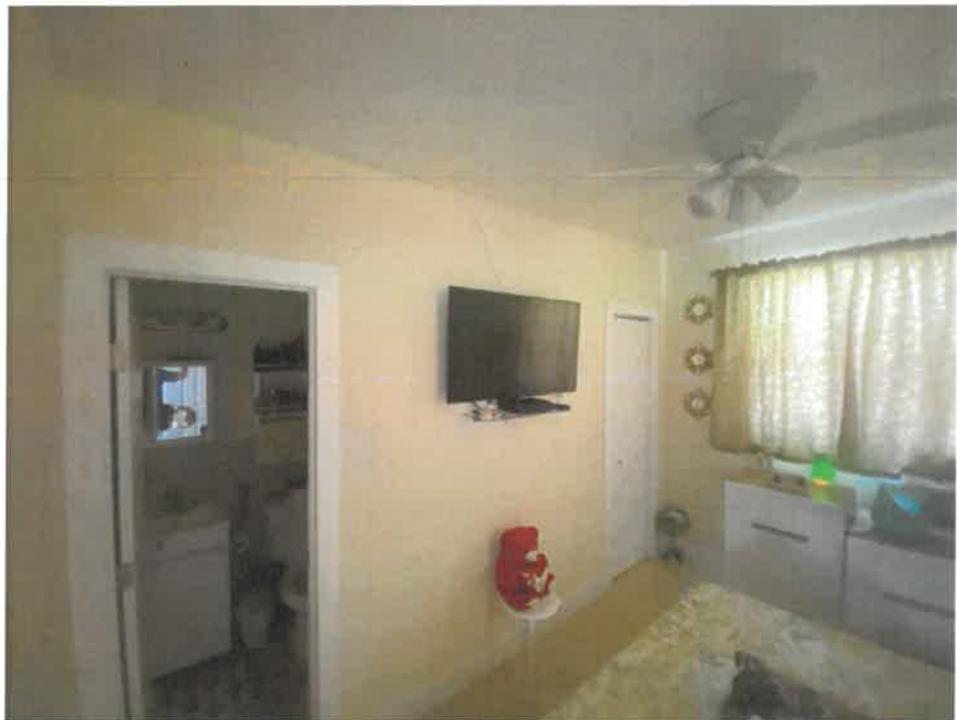
6.h. View of Interior Masonry Finishes

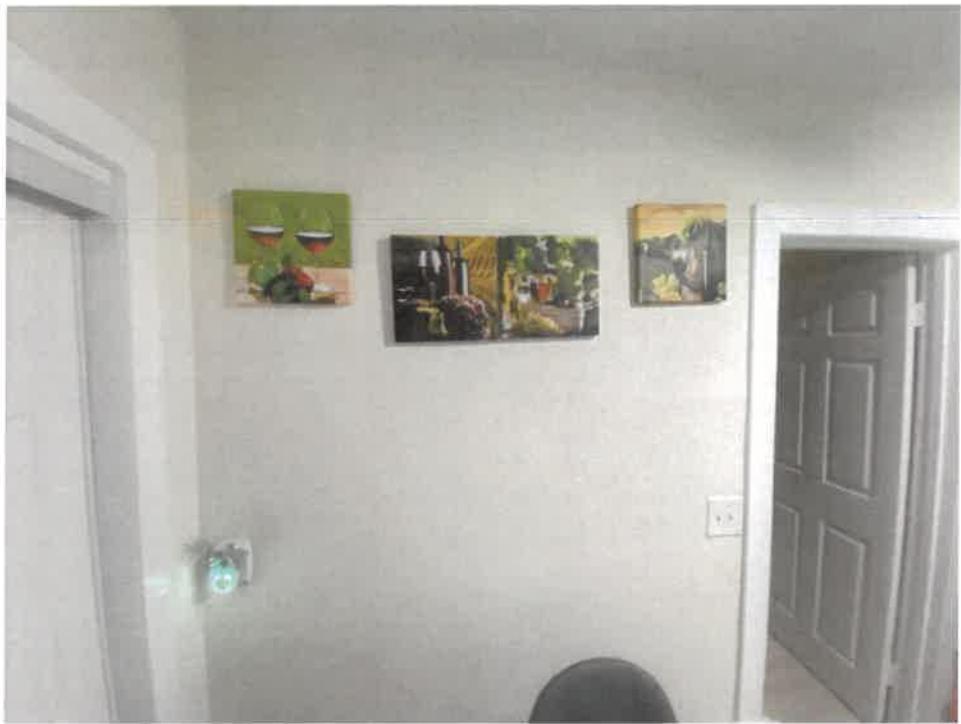
6.h.4. Interior Paint Only

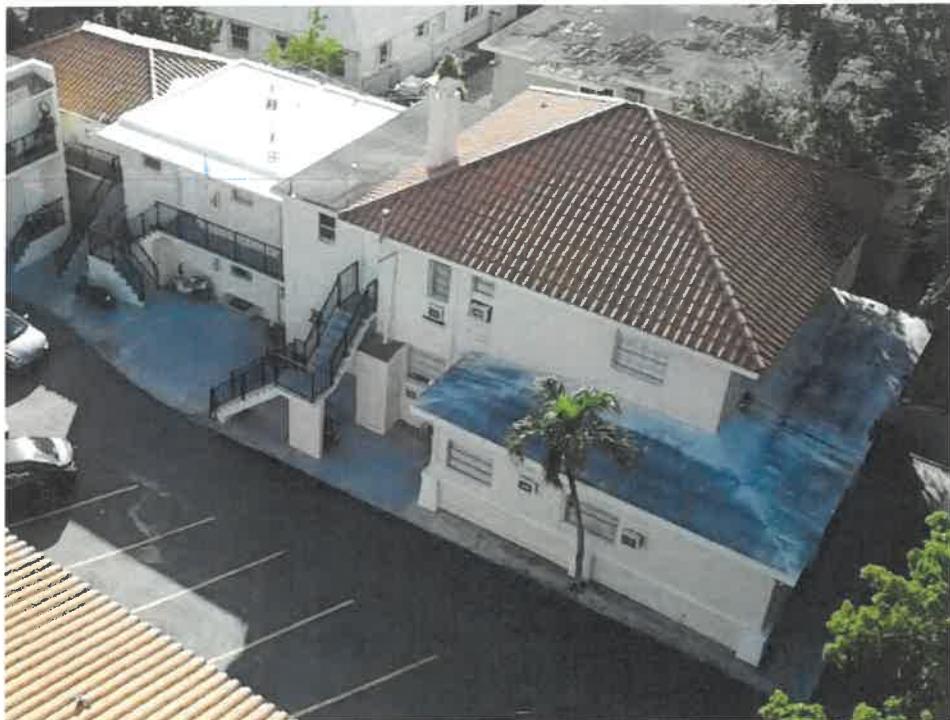
7.a.1. Type & Condition Roof System

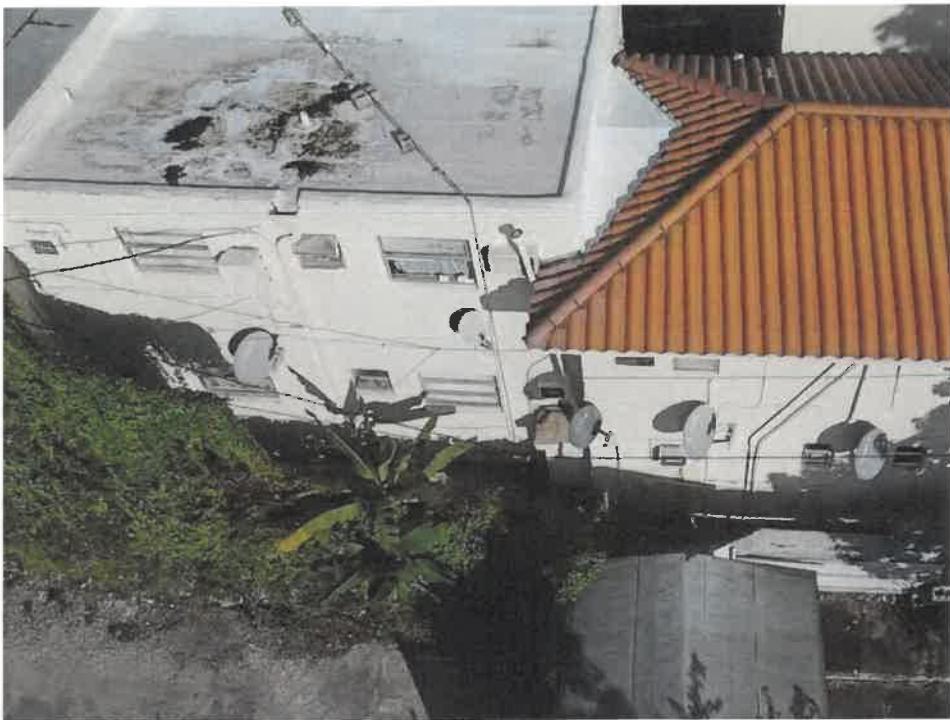
7.a.3. View of Roof Drains

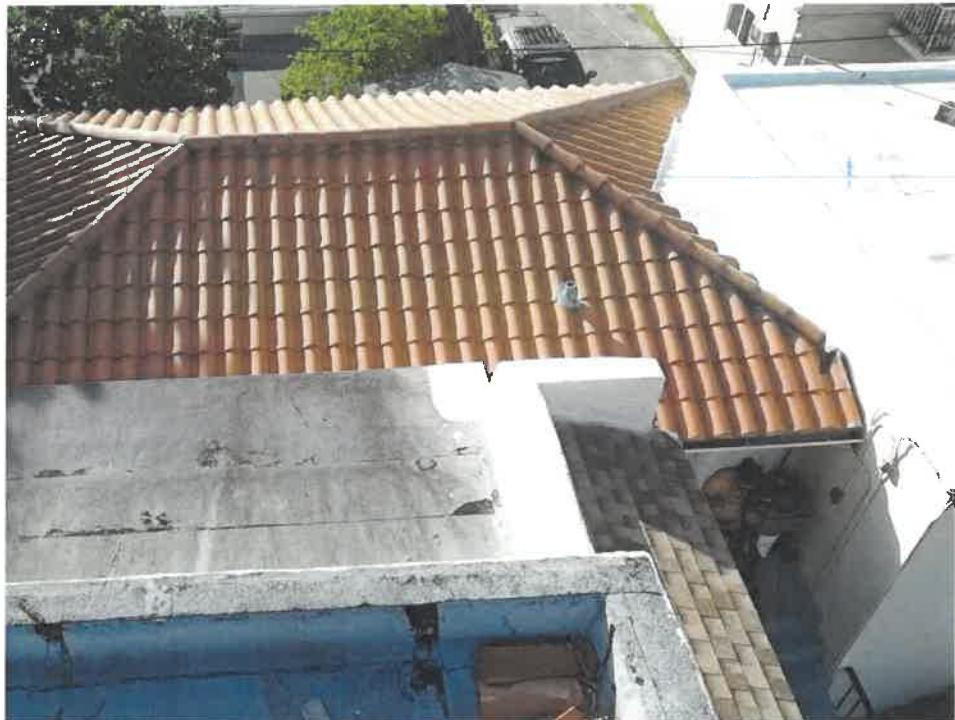
7.a.4. View of Parapet Wall

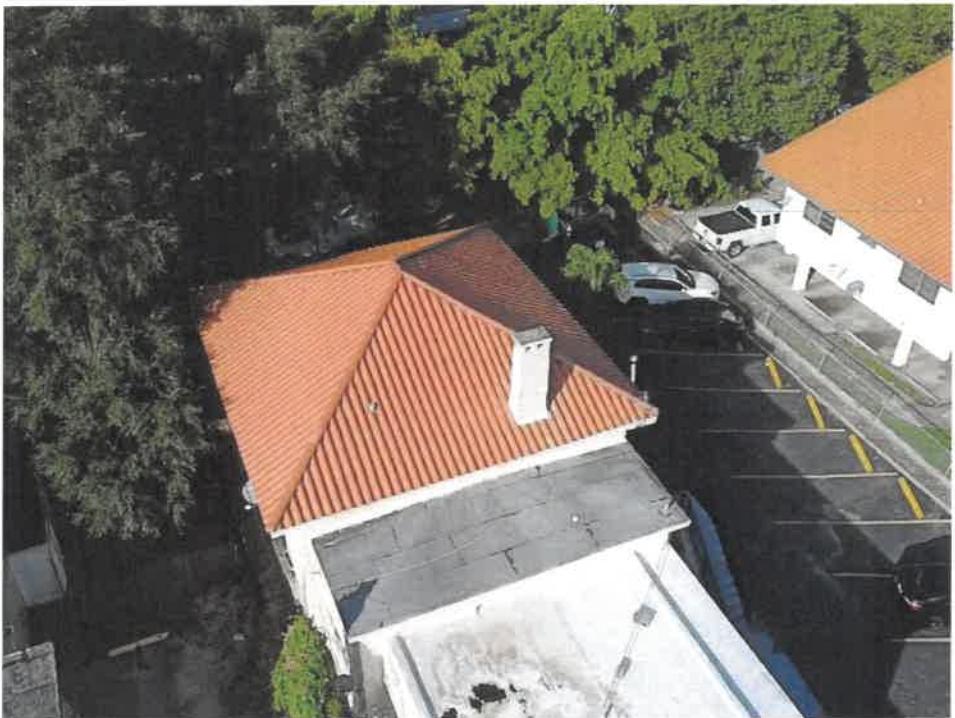
7.a.6. View of Roof Membrane/Covering

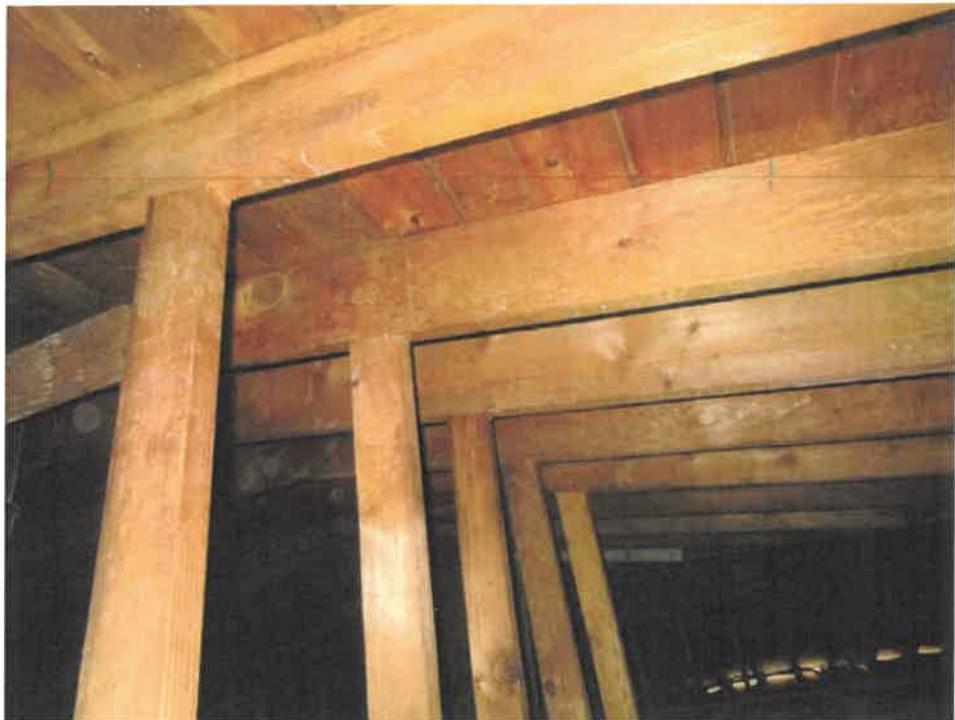
7.a.7. View of Roof Framing Members

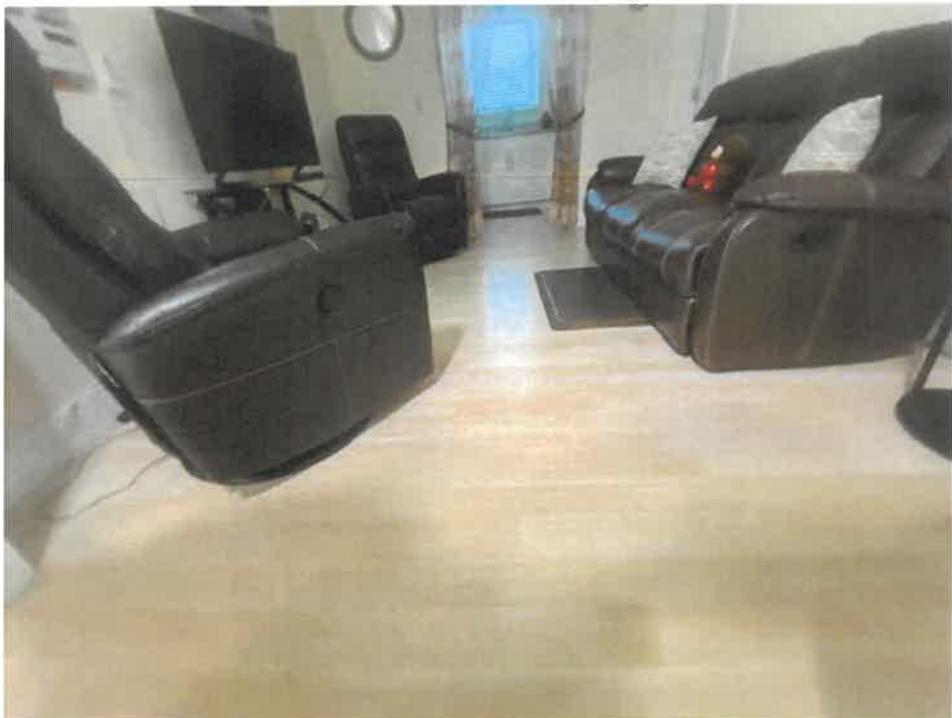
7.b.1. Type & Condition of Floor System(s)

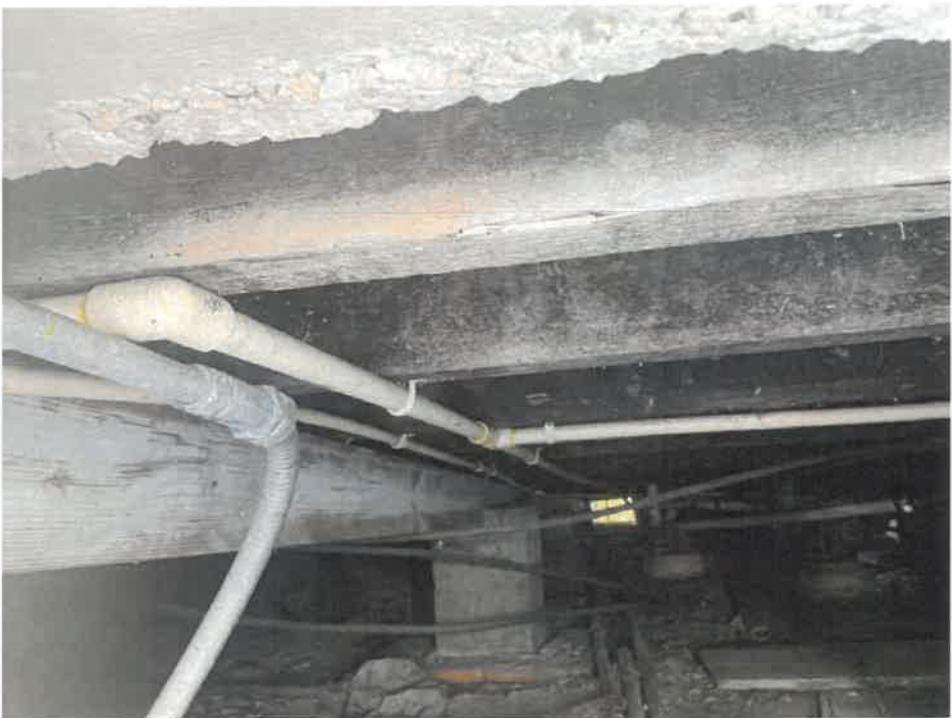
7.b.1. Type & Condition of Floor System(s)

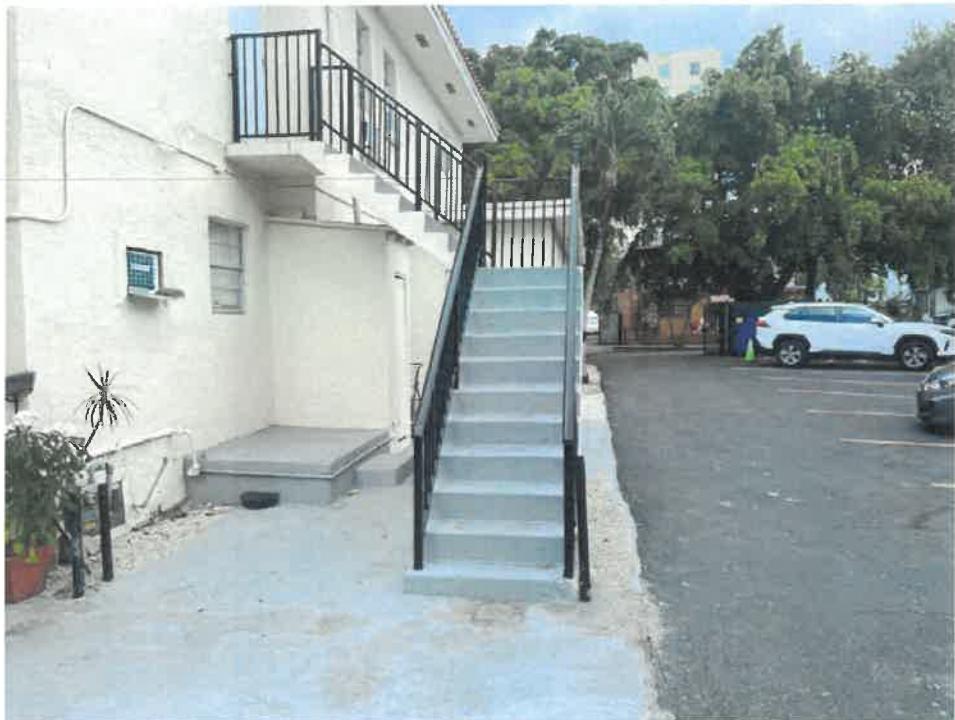
7.b.3. View of Stairs & Landings

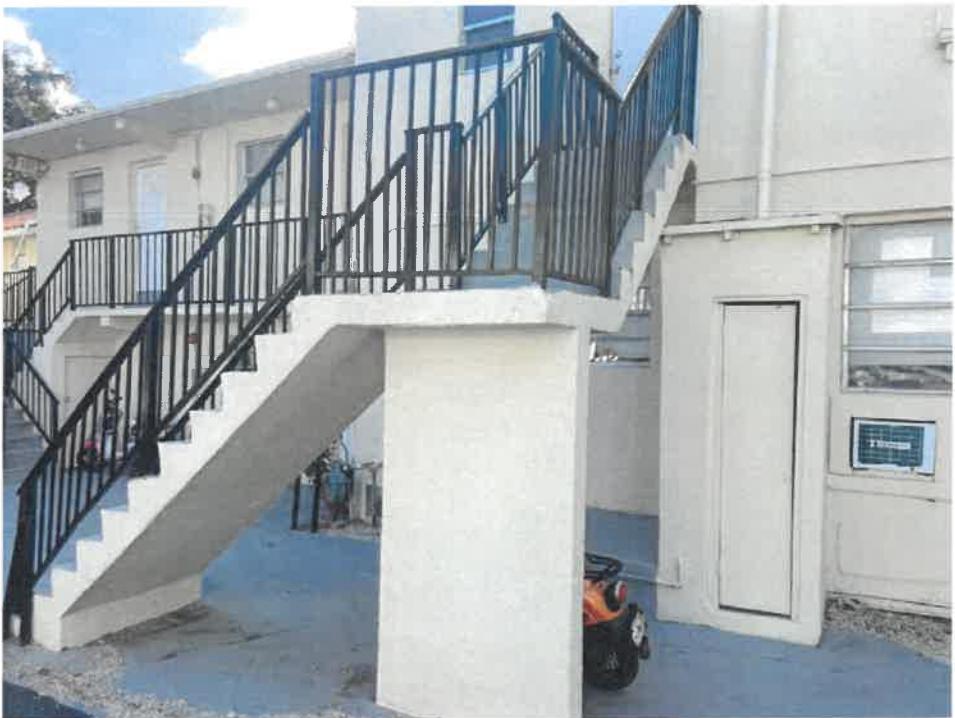
7.b.5. View of Guardrails & Handrails

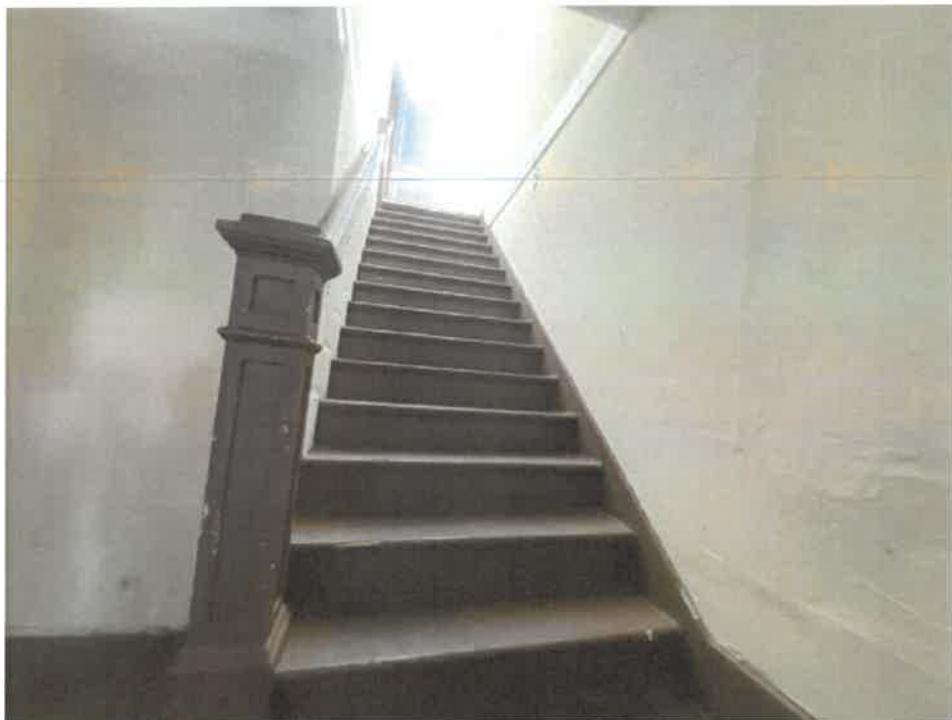
7.b.3. View of Stairs & Landings

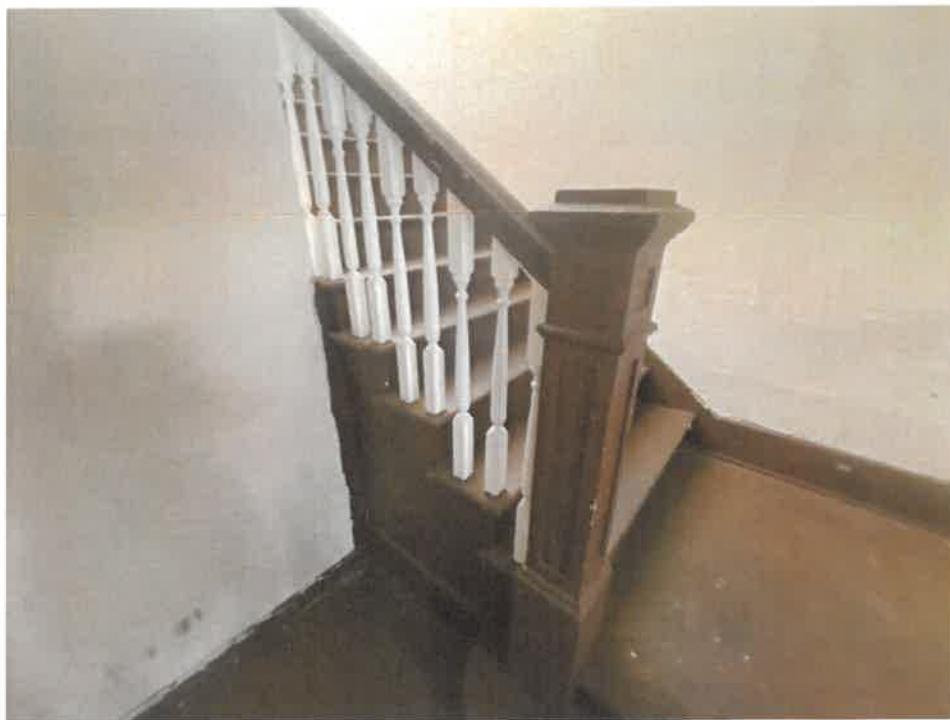
7.b.5. View of Guardrails & Handrails

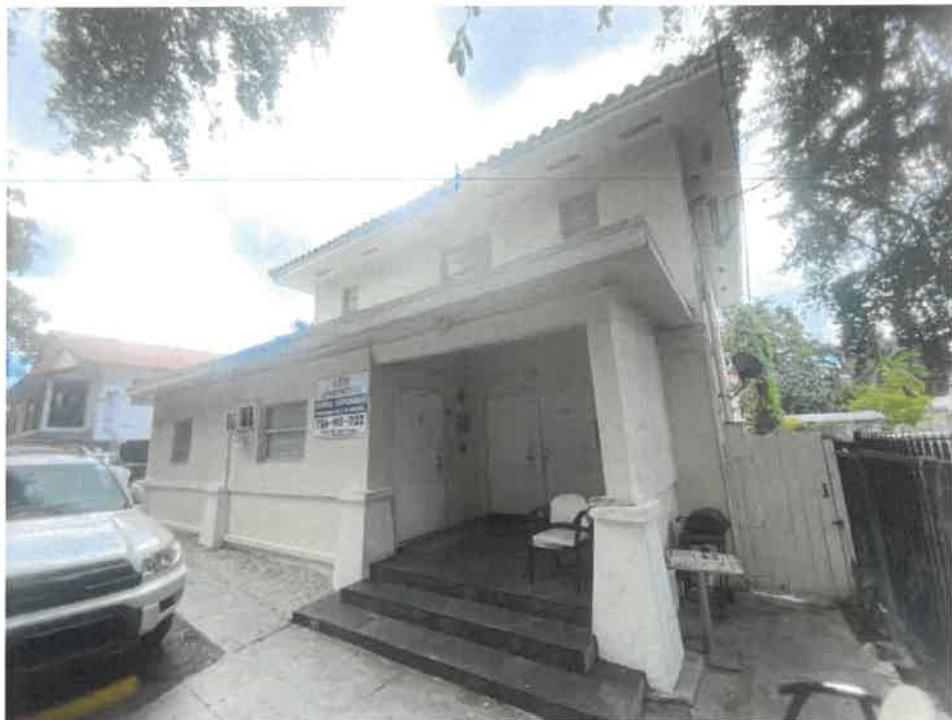
9.a. View of Concrete Framing System

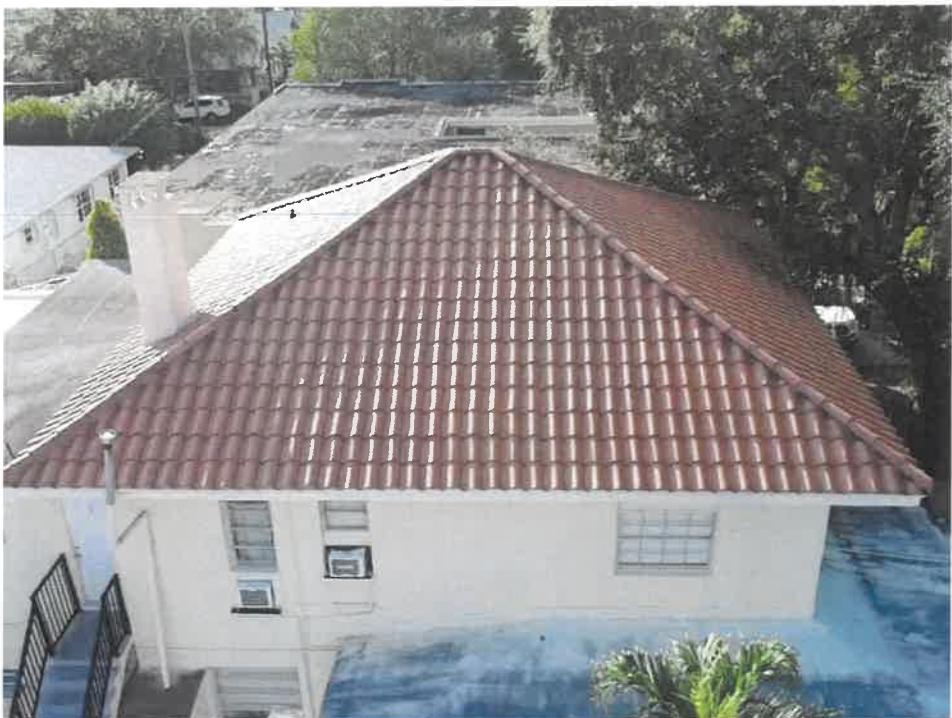
10.a. View of Windows

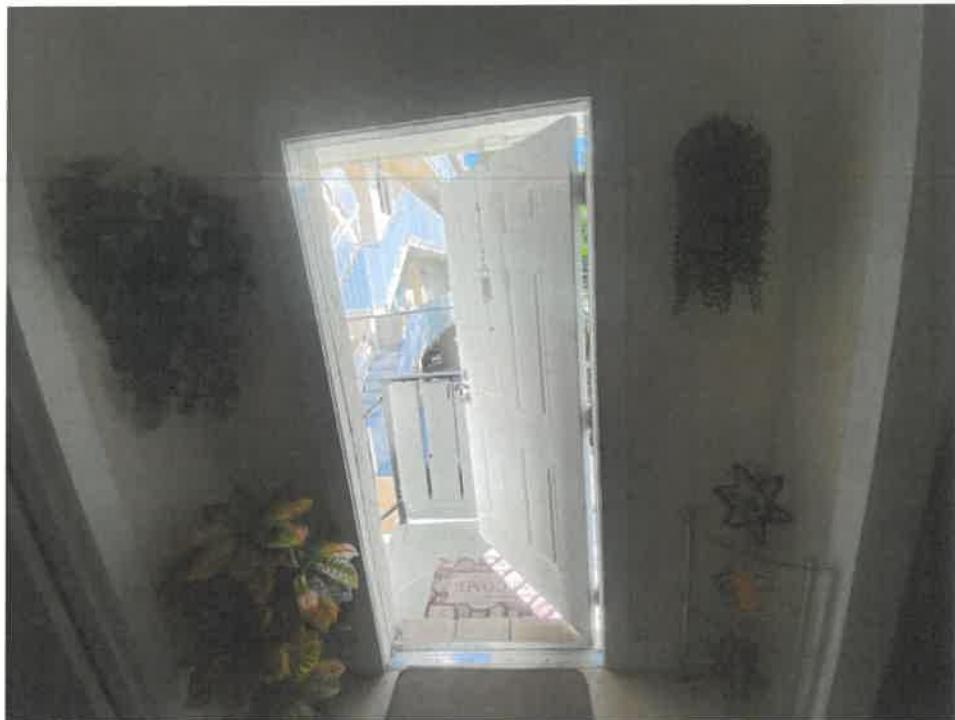
10.c.1. View of Exterior Doors

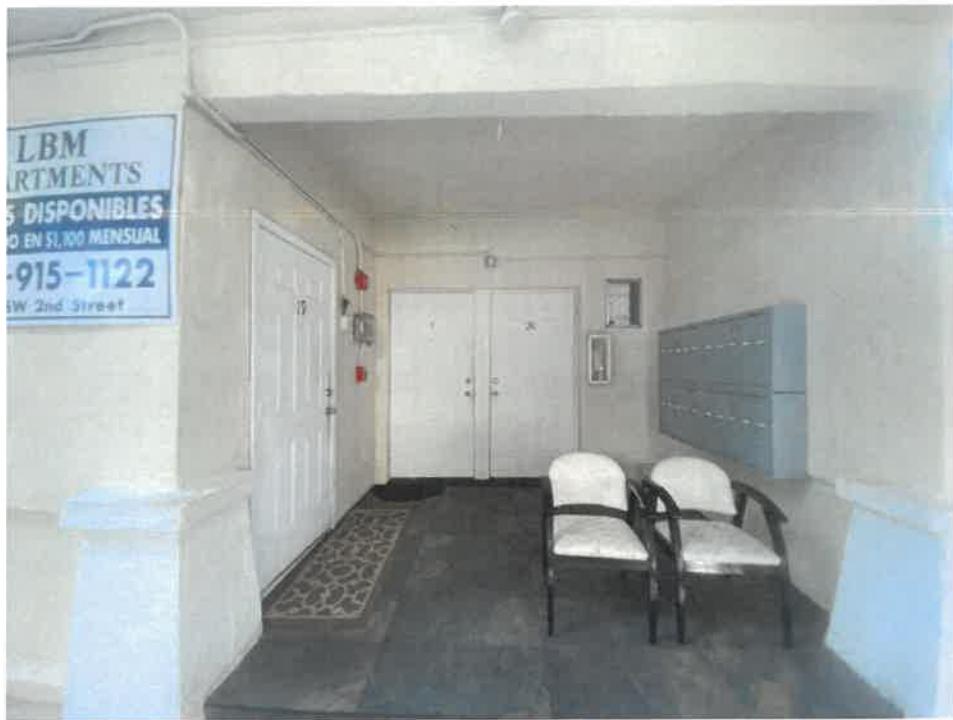
10.c.1. View of Exterior Doors

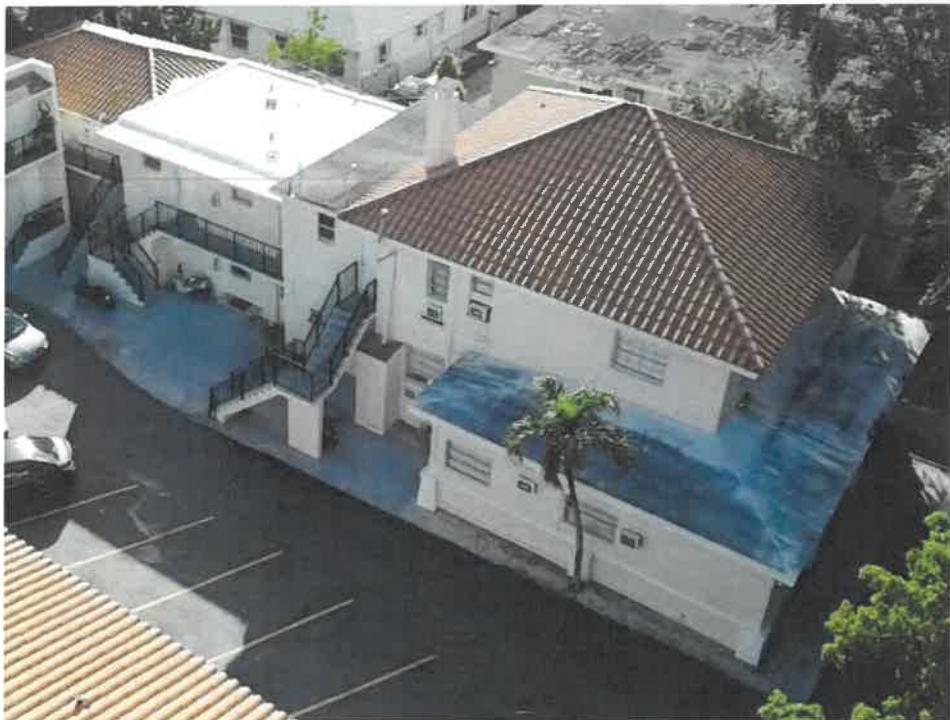
11.a. View of Wood Framing

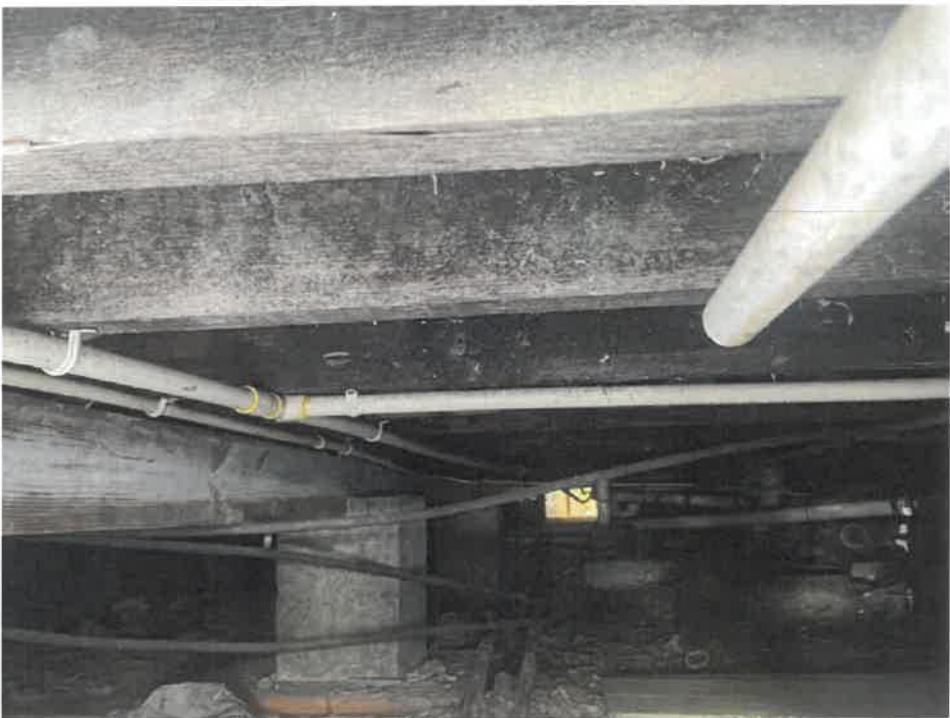
11.b.2. View of Wood Floors

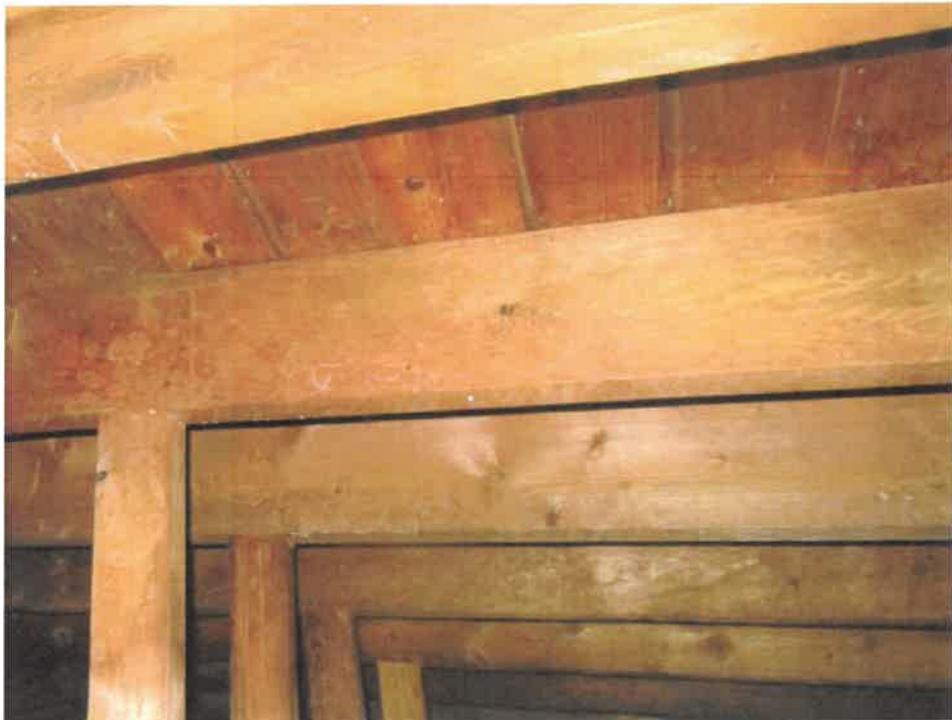
11.b.3. View of Wood Roof Members

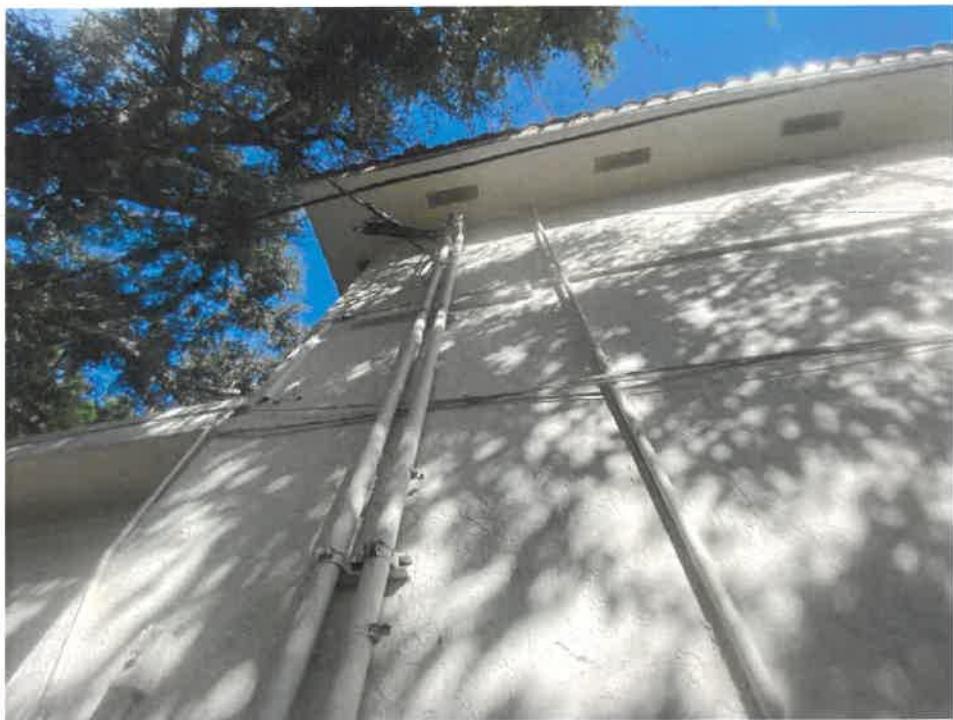
11.f. View of Ventilation

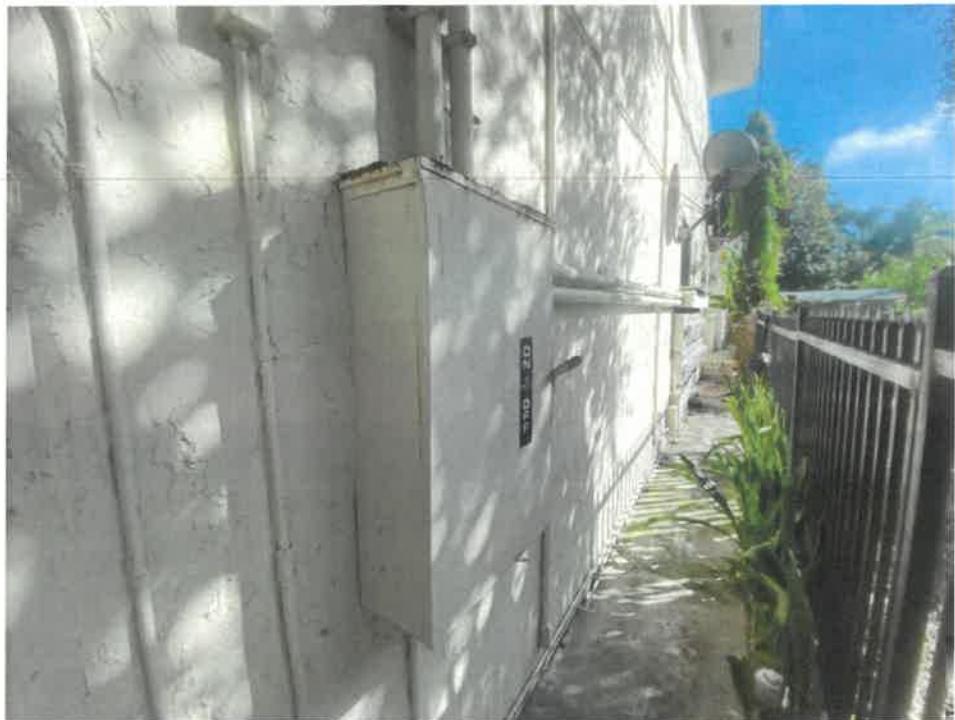
3. View of Electrical Services

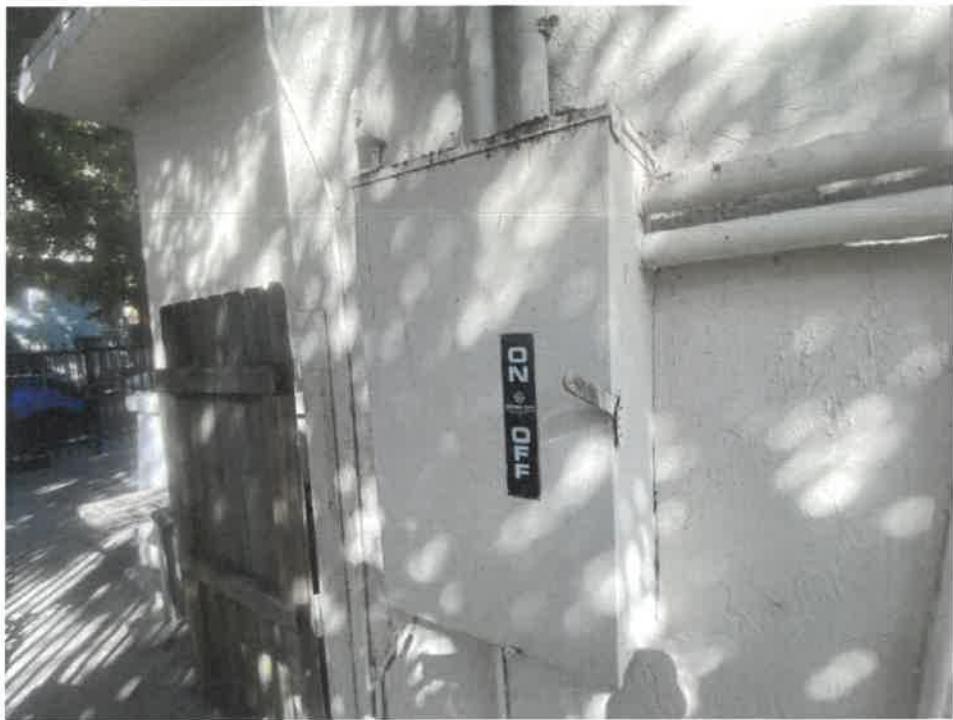
3. View of Electrical Services

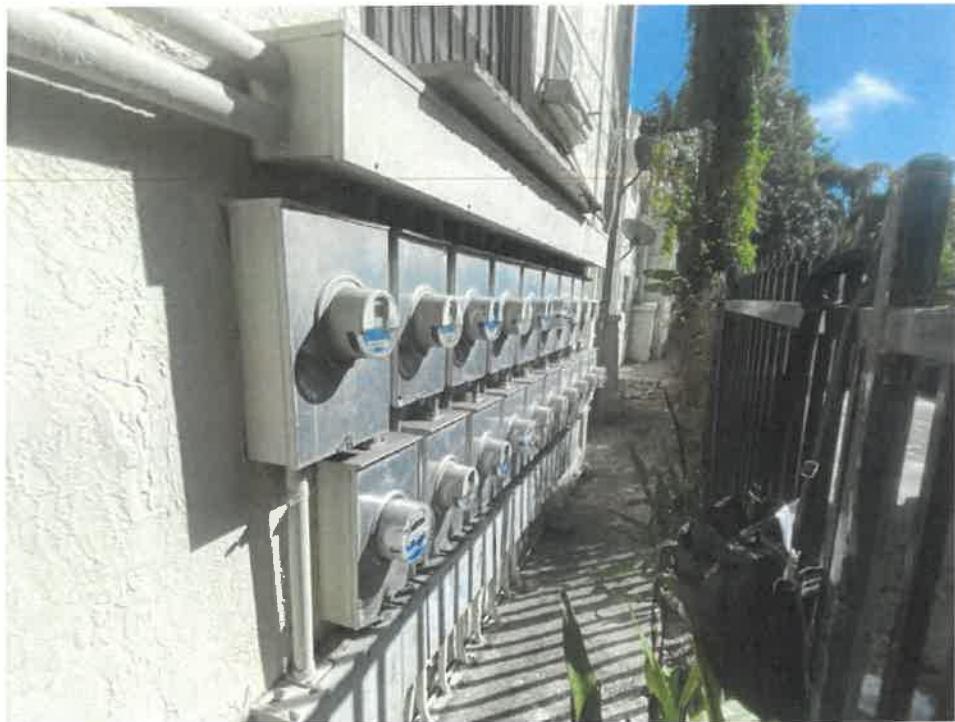
4. View of Metering Equipment

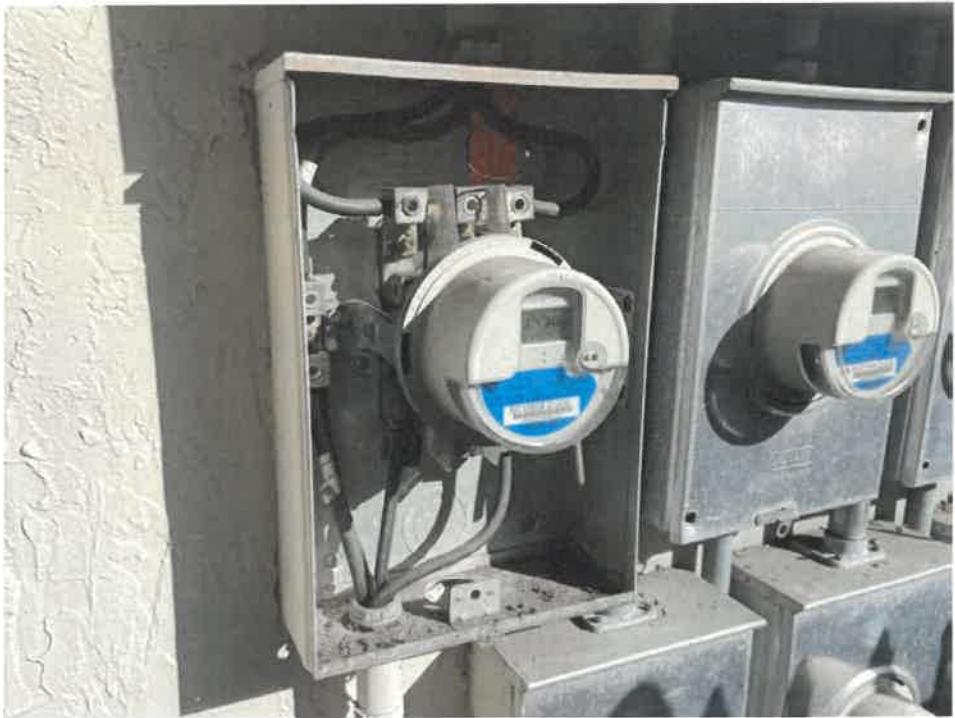
4. View of Metering Equipment

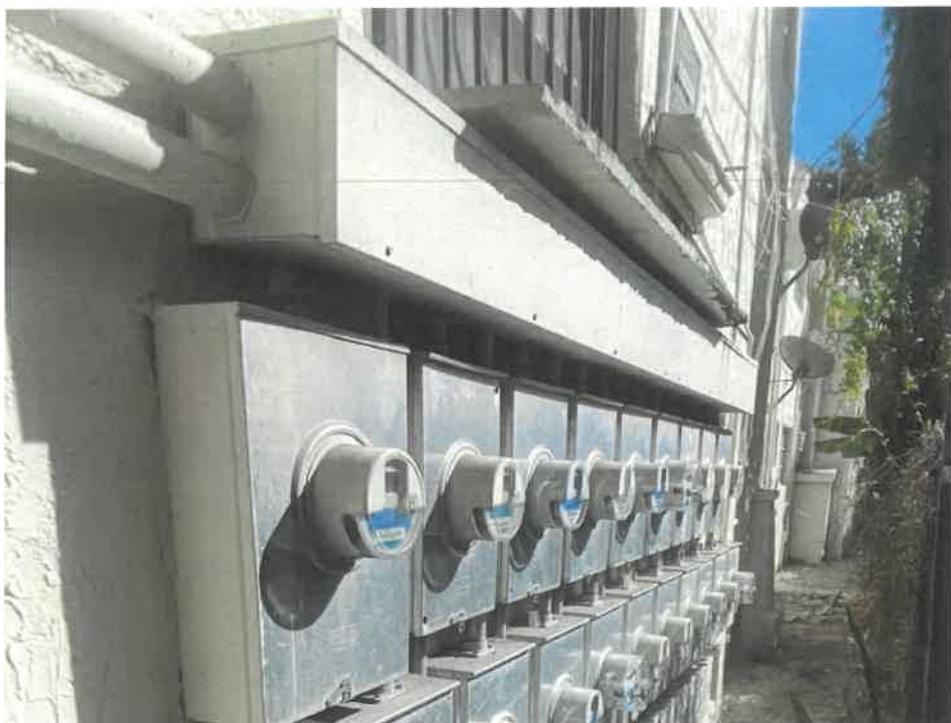
6. View of Electrical Gutters, Wireways

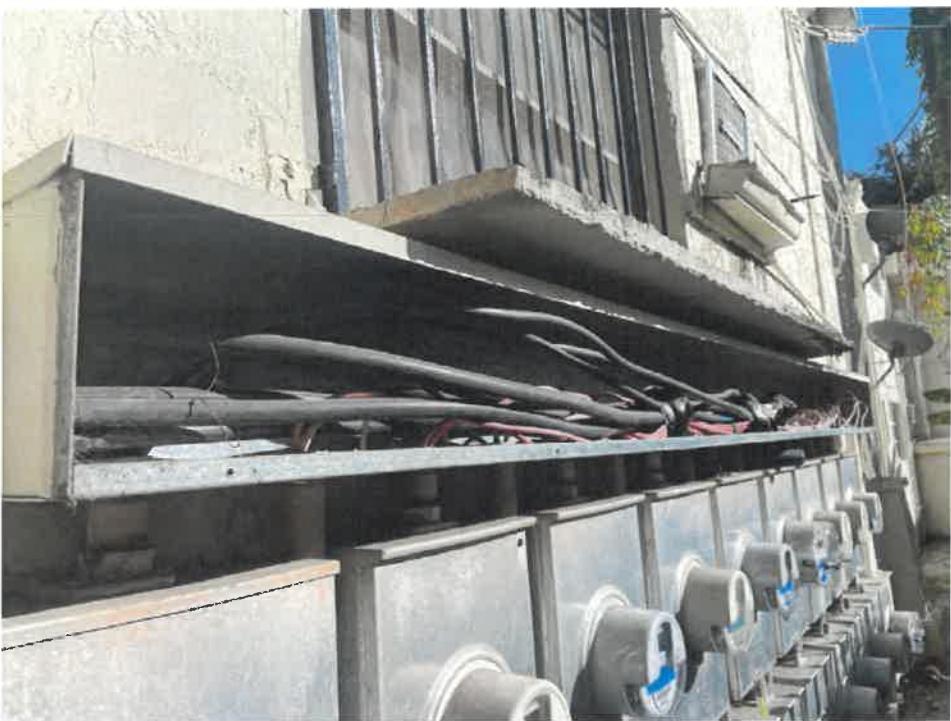
6. View of Electrical Gutters, Wireways

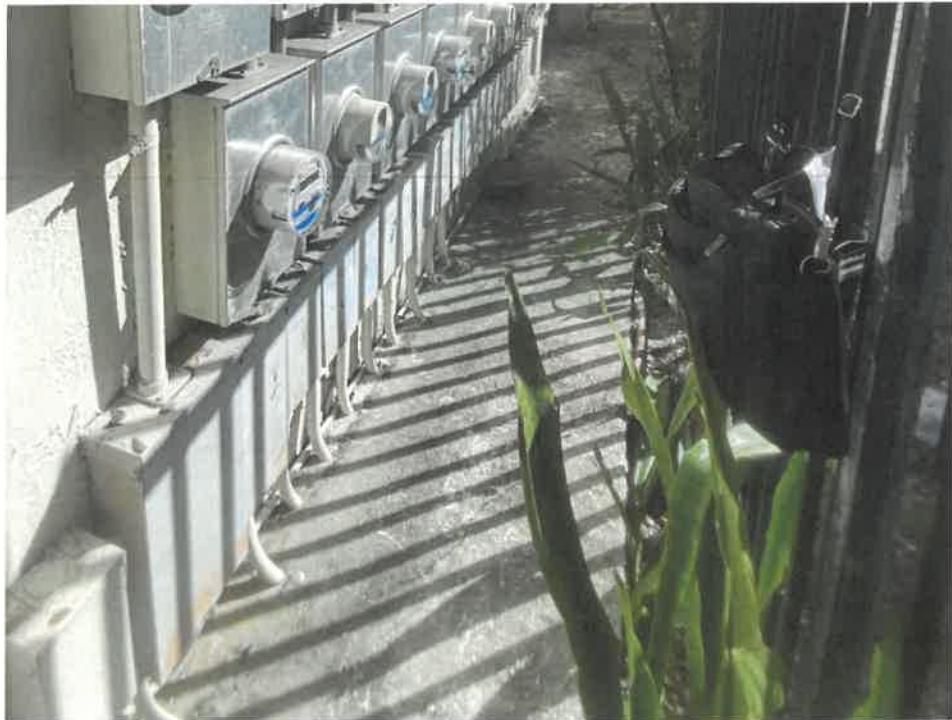
7. View of Electrical Panels

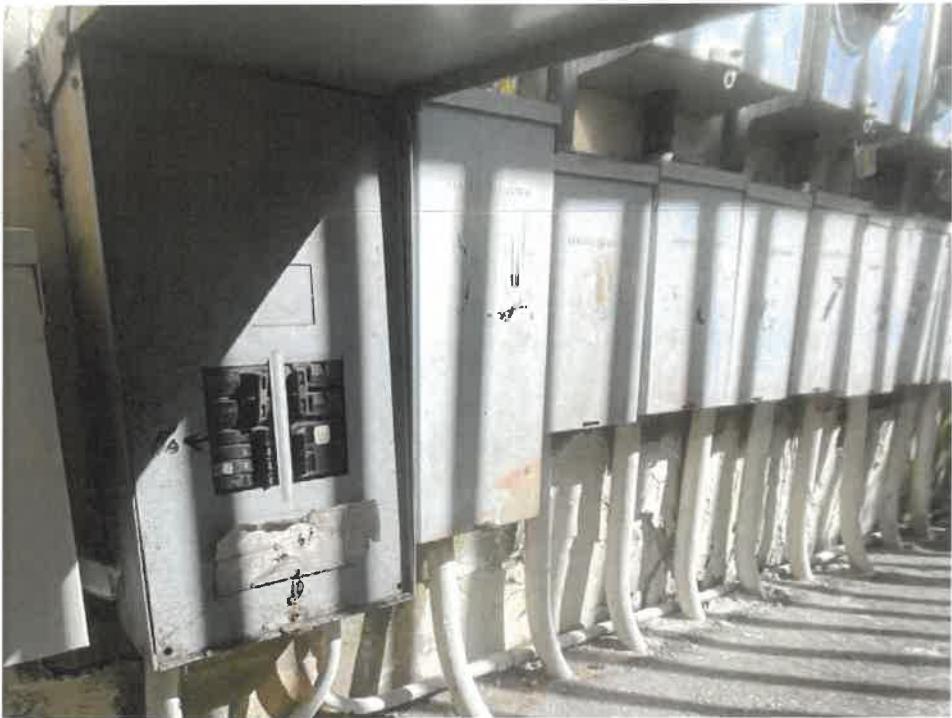
7.1. View of Electrical Panel
