1362 SW 2nd Street, Miami, FL 33135

Reference: 40 Year Re-Certification
Two-Story Residential Building
Folio No.: 01-4102-006-2220
1362 SW 2 ST, MIAMI, FL 33135
Bldg. No.: 1 / Sq. Ft.: 3,811

James Hanskat, P.E., has performed structural and electrical inspections of the above-referenced property located in Miami-Dade County, Florida.

Structural Photolog

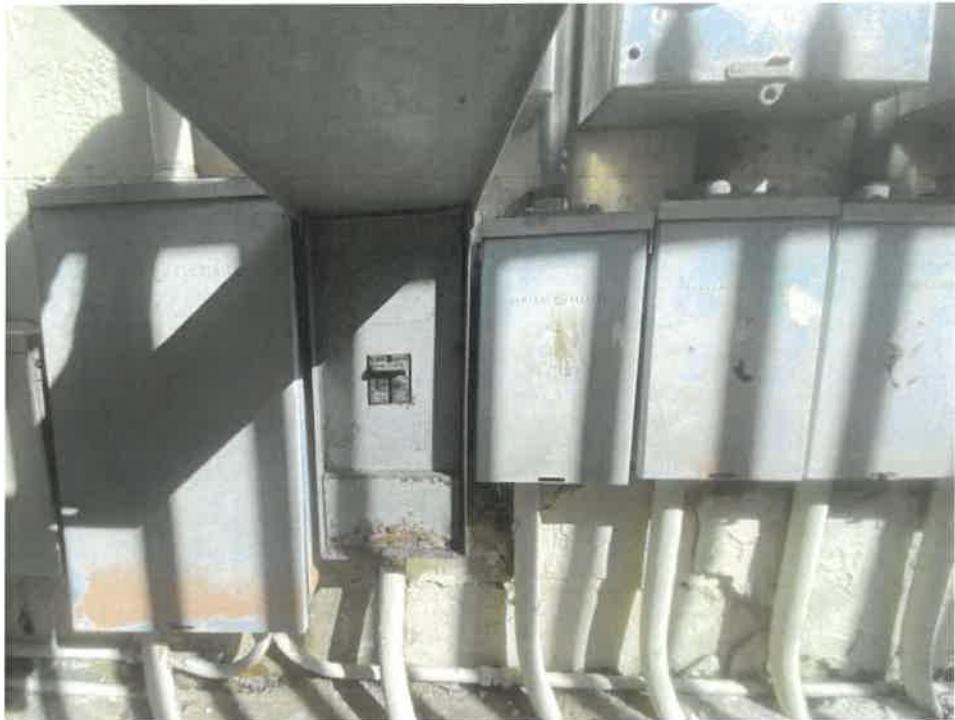
7.2. View of Electrical Panel

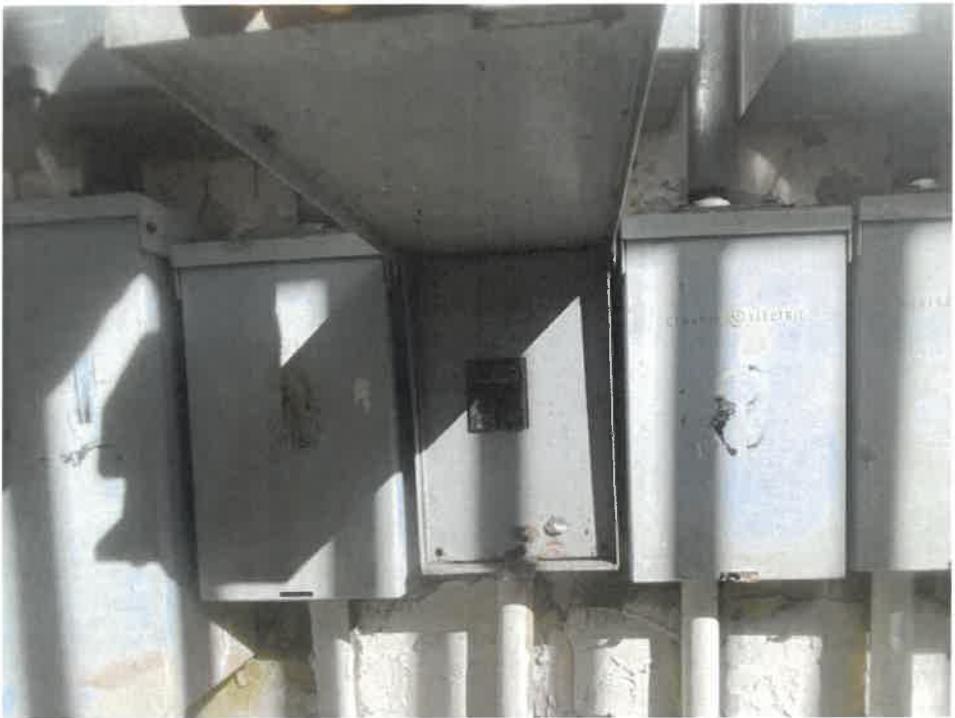
7.3. View of Electrical Panel

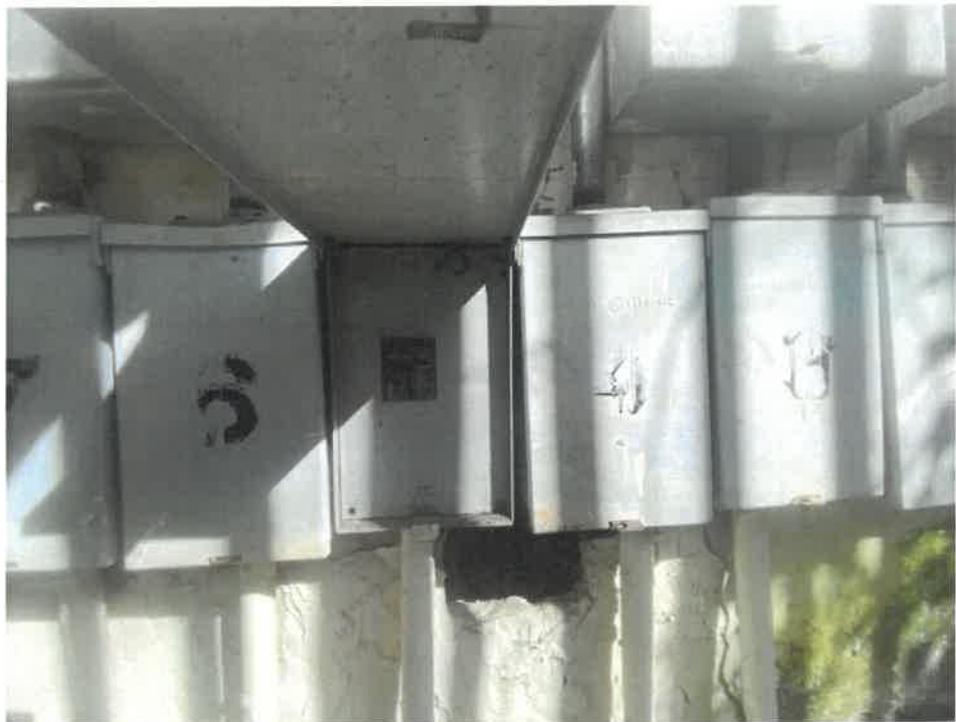
7.4. View of Electrical Panel

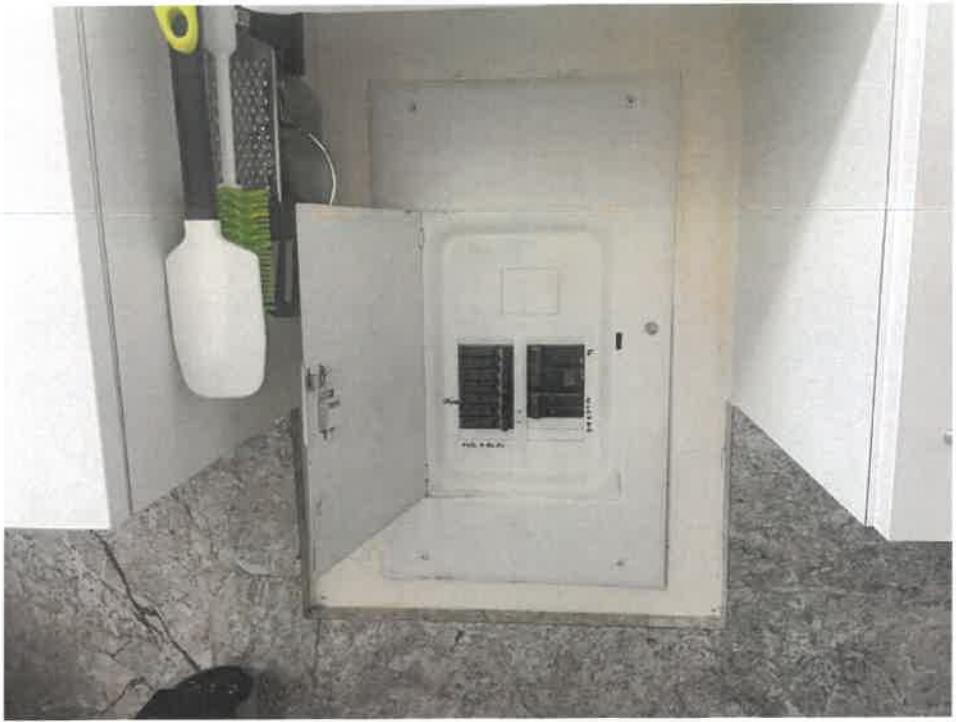
7.5. View of Electrical Panel

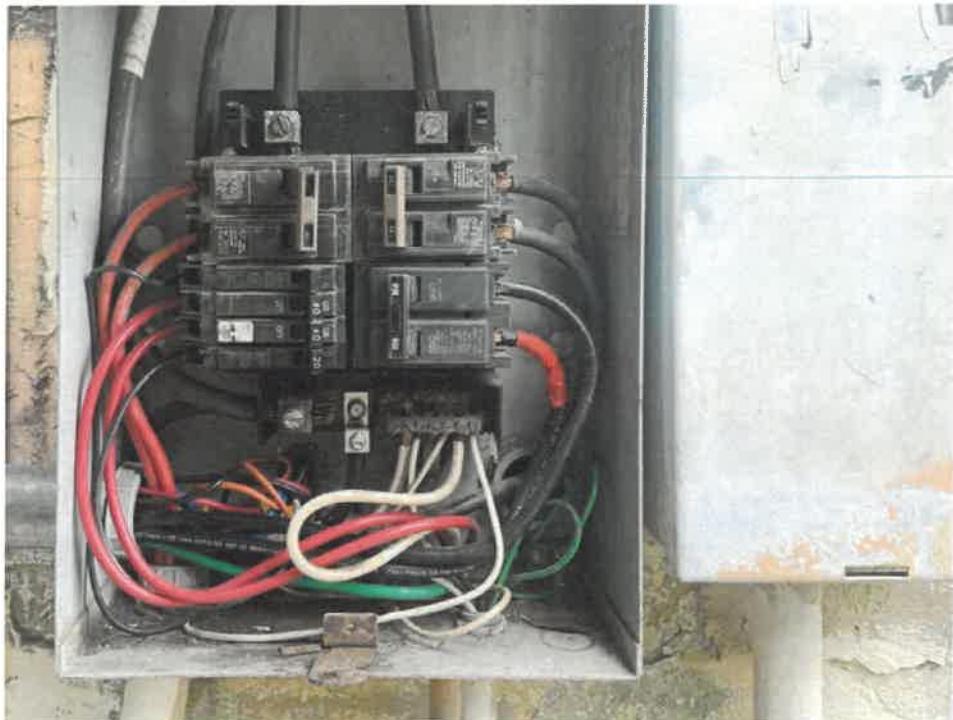
8. View of Branch Circuits (Exiting panel enclosure)

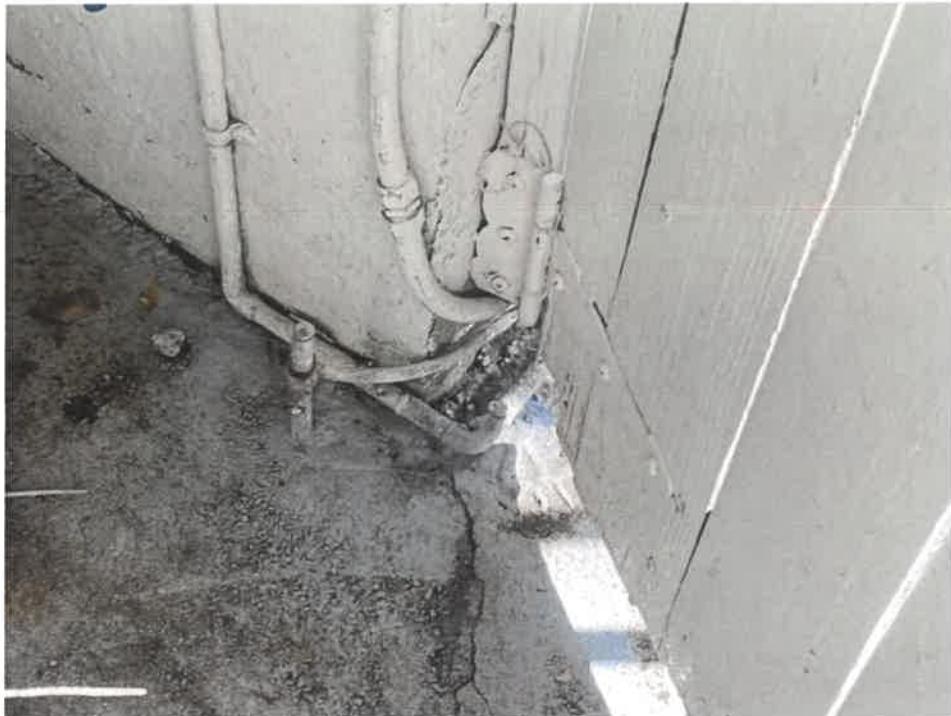
9. View of Grounding of Service

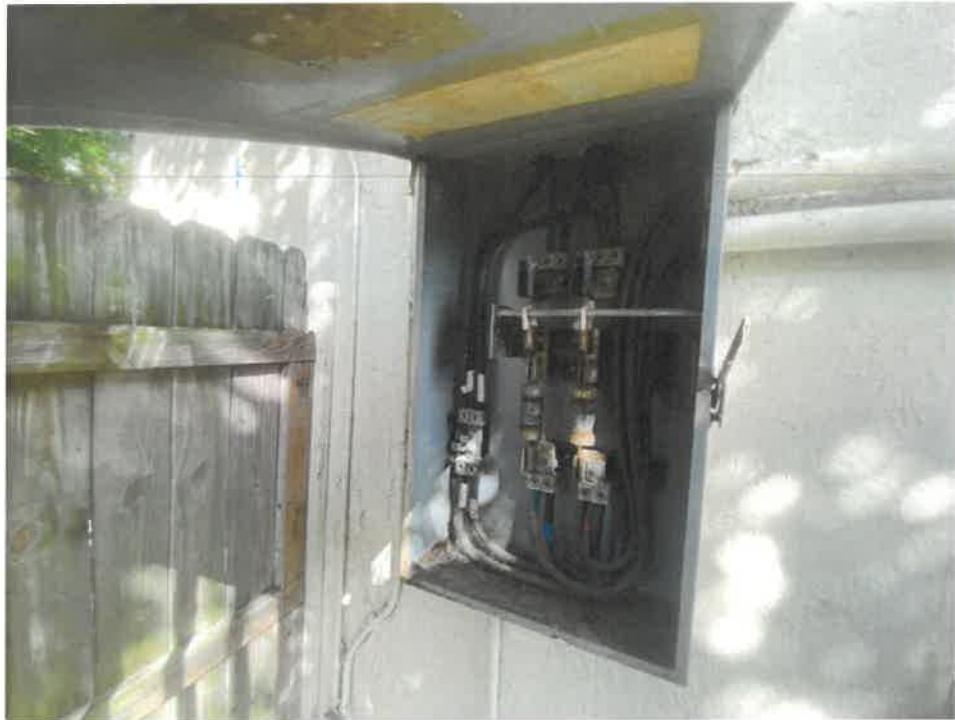
10. View of Grounding of Branch Circuit Equipment

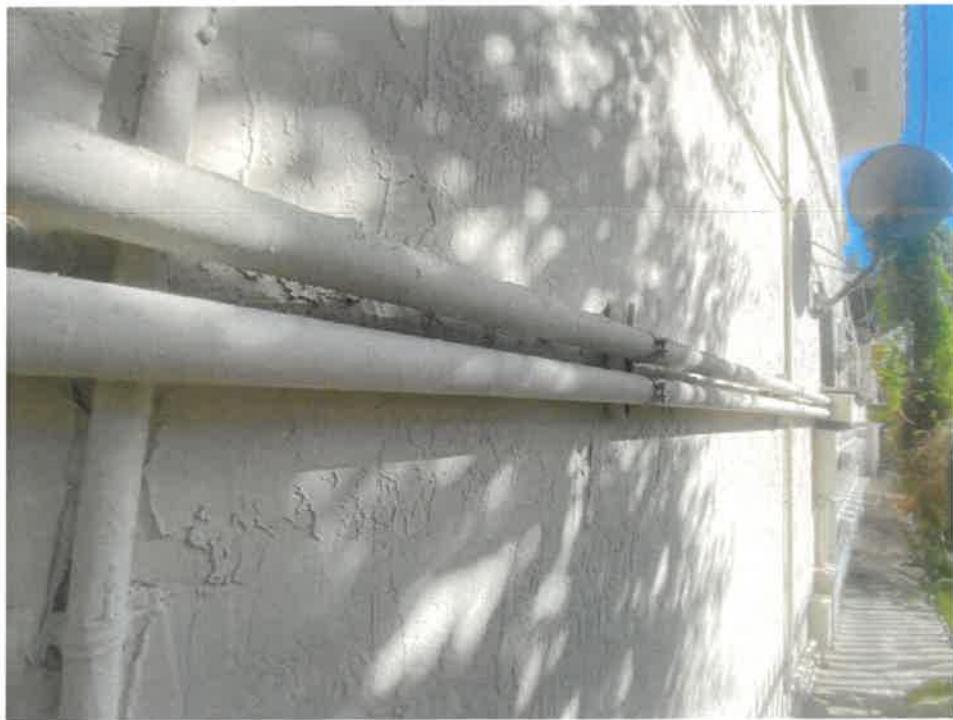
11. View of Service Conduit/Raceways

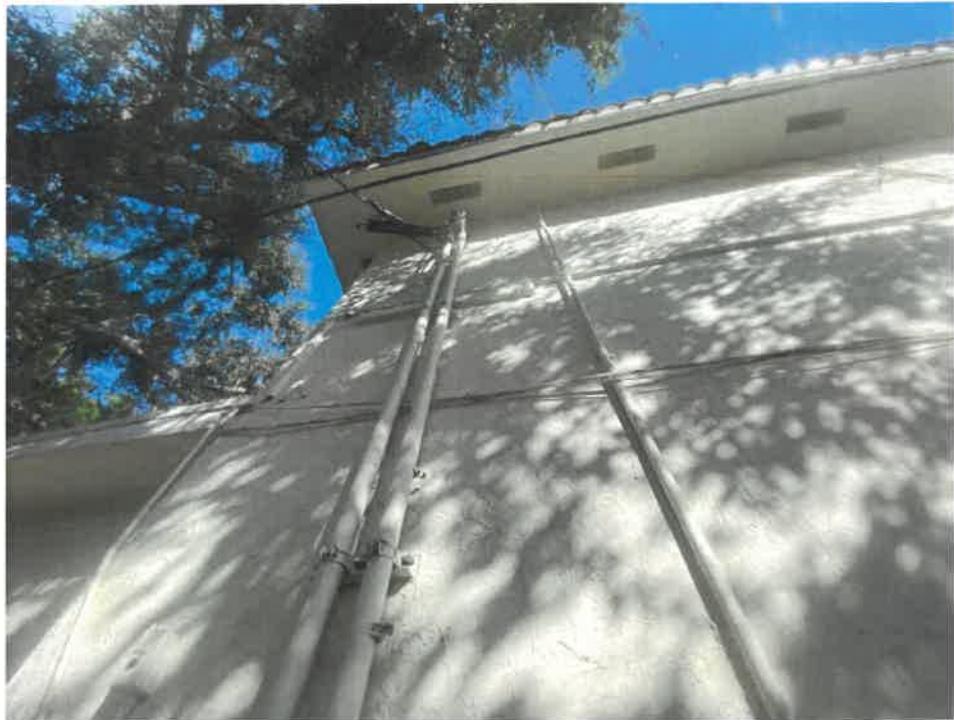
11. View of Service Conduit/Raceways

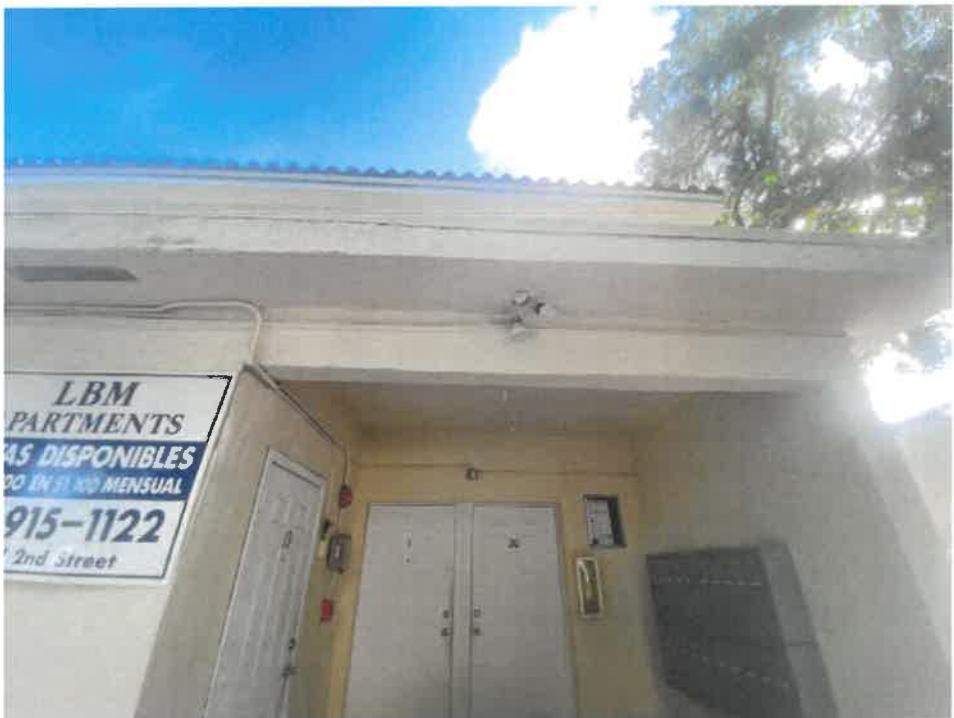
12. View of General Conduit/Raceways

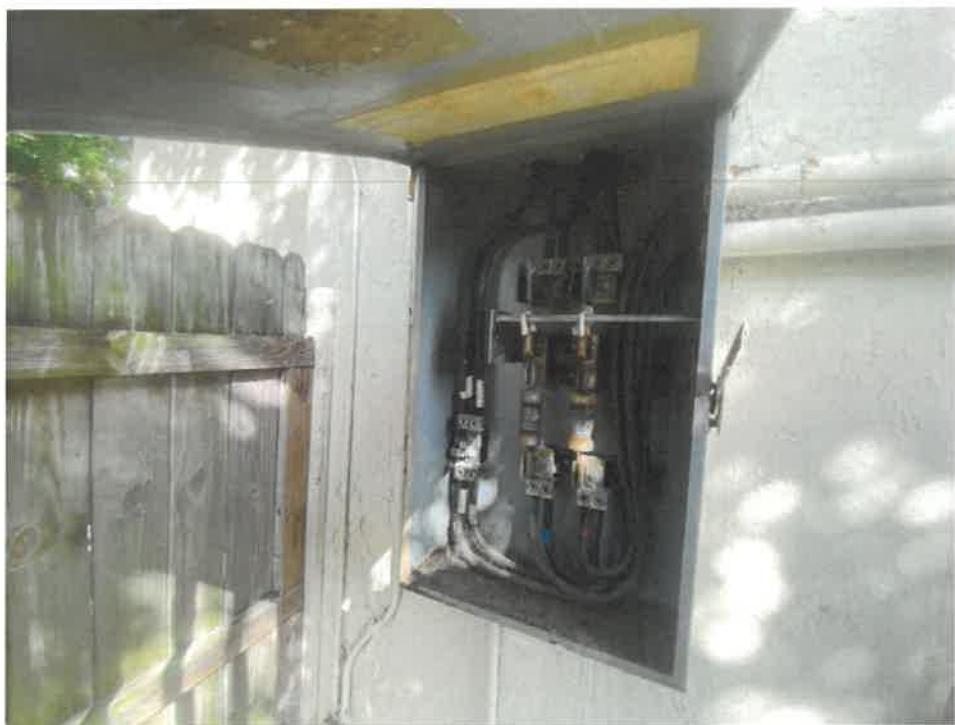
13. View of Wires and Cables

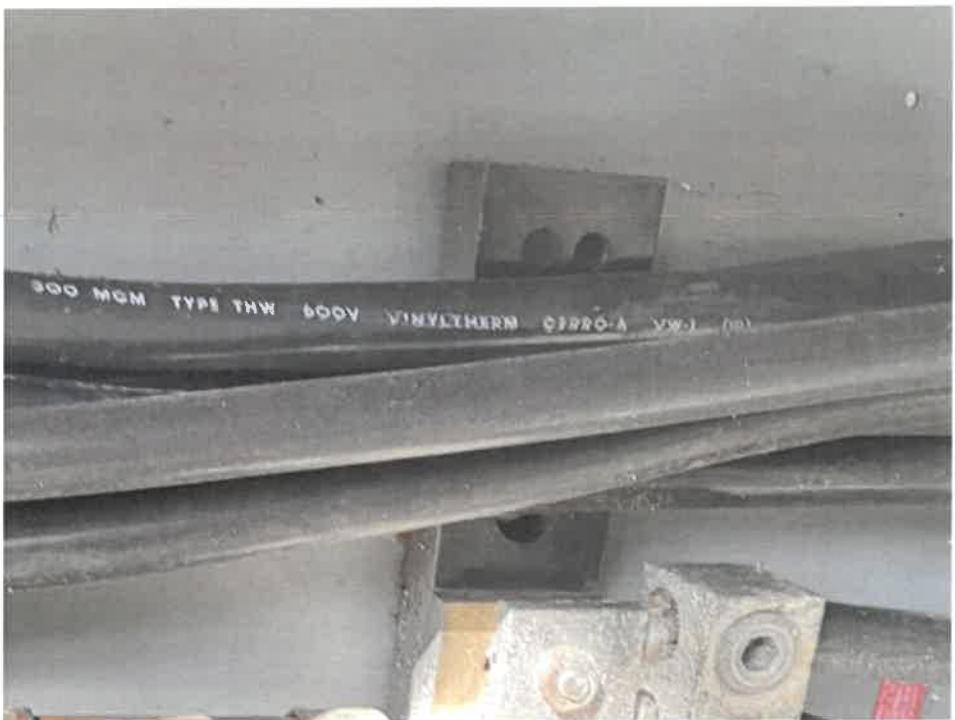
13. View of Wires and Cables

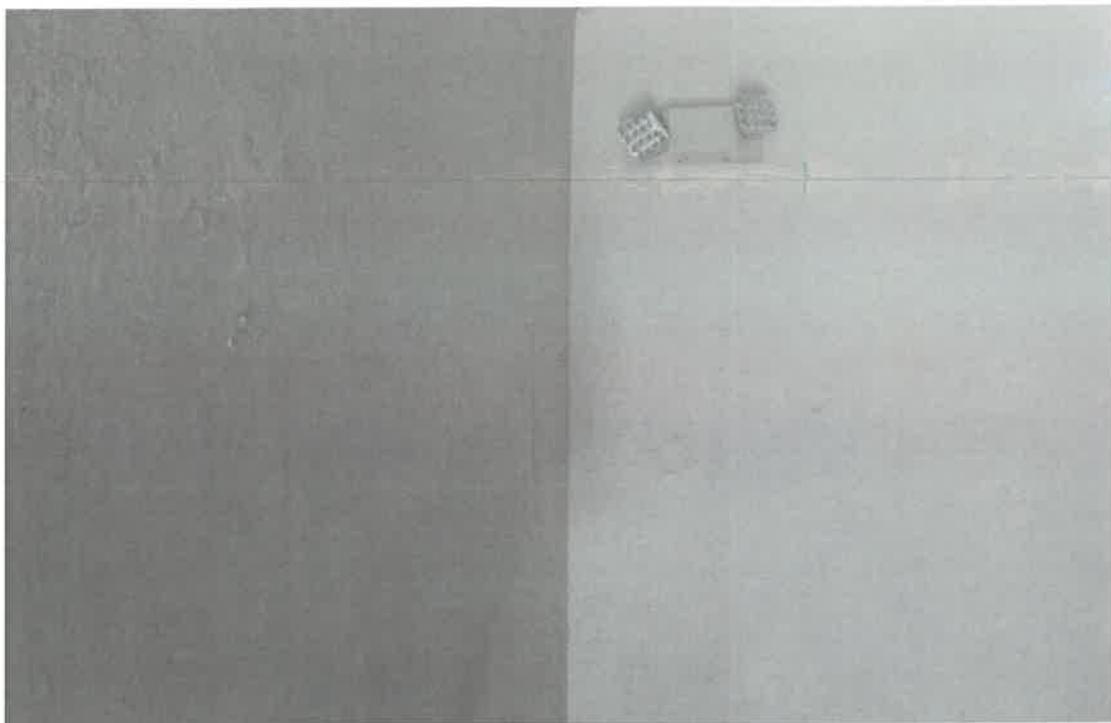
18. View of Emergency Lighting

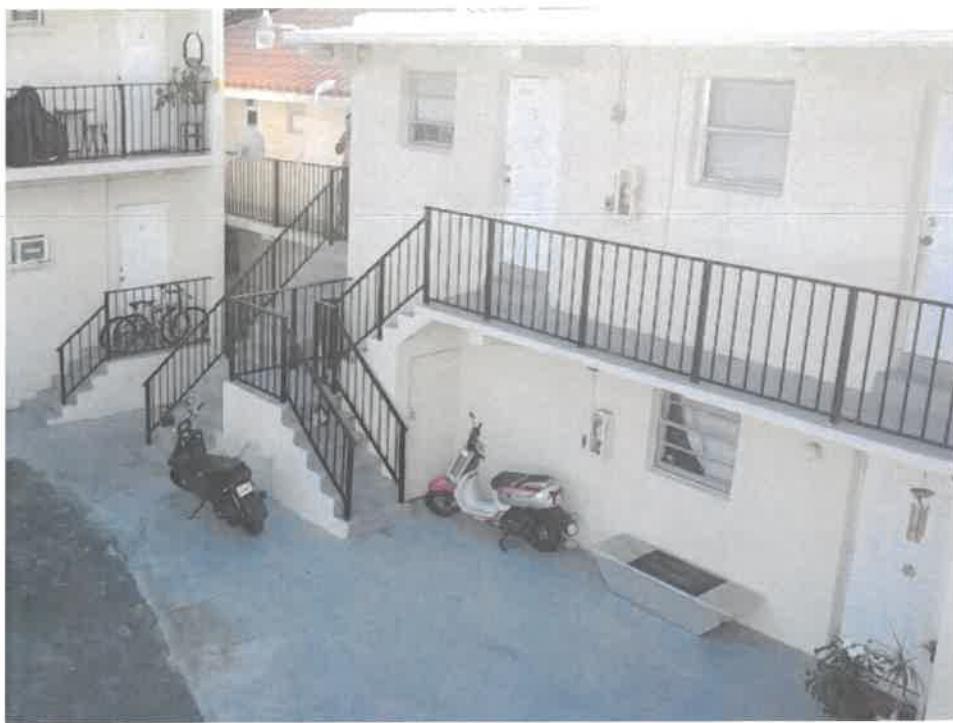
19. View of Building Egress Illumination

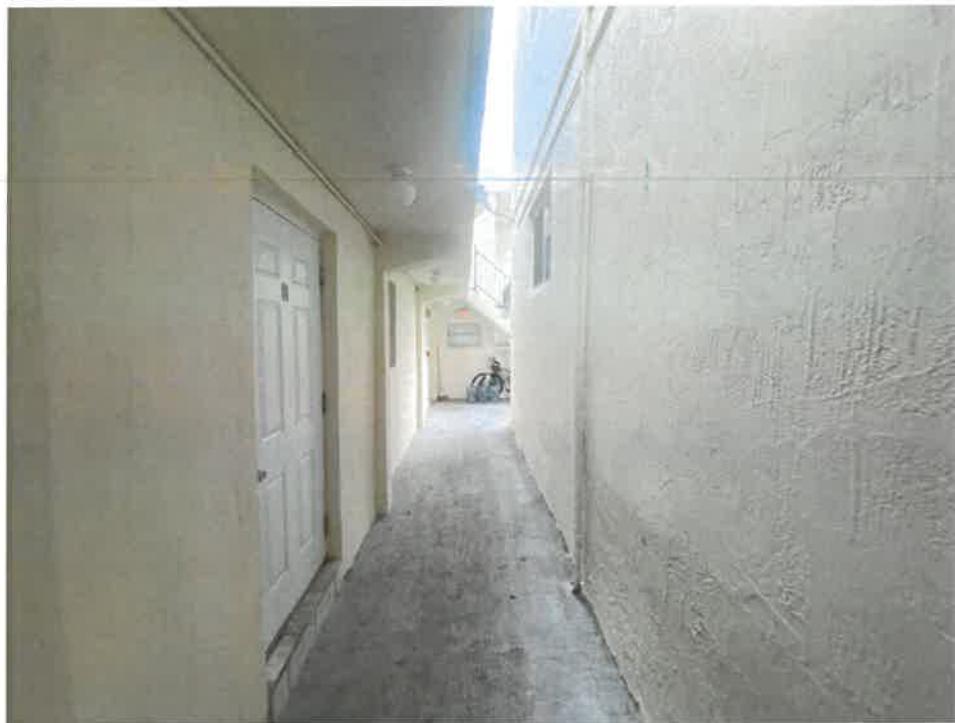
19. View of Building Egress Illumination

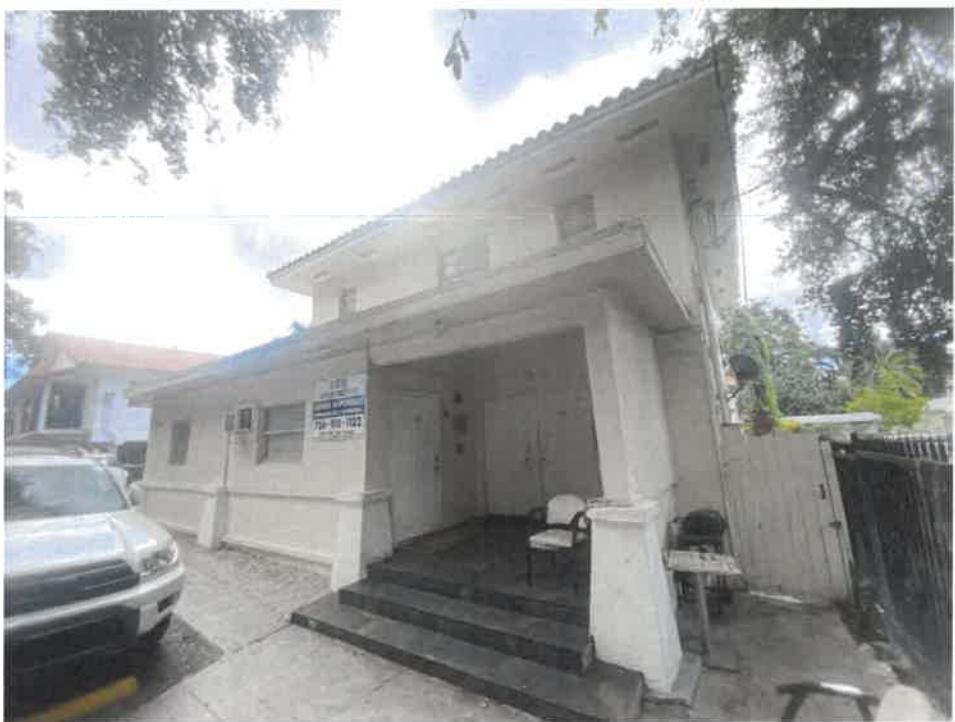
19. View of Building Egress Illumination

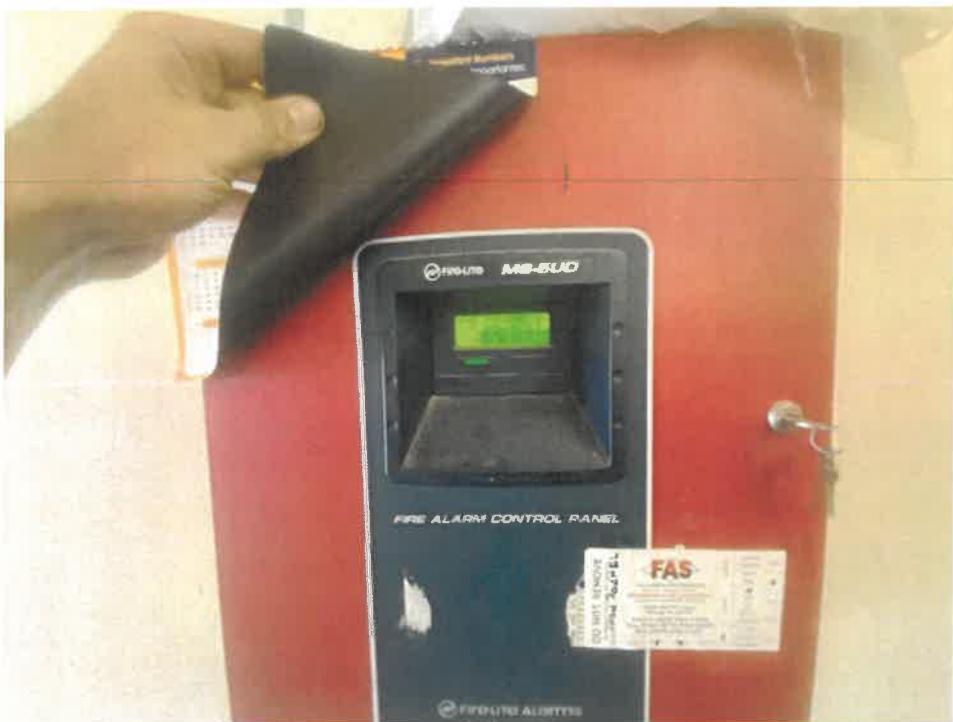
20. View of Fire Alarm System

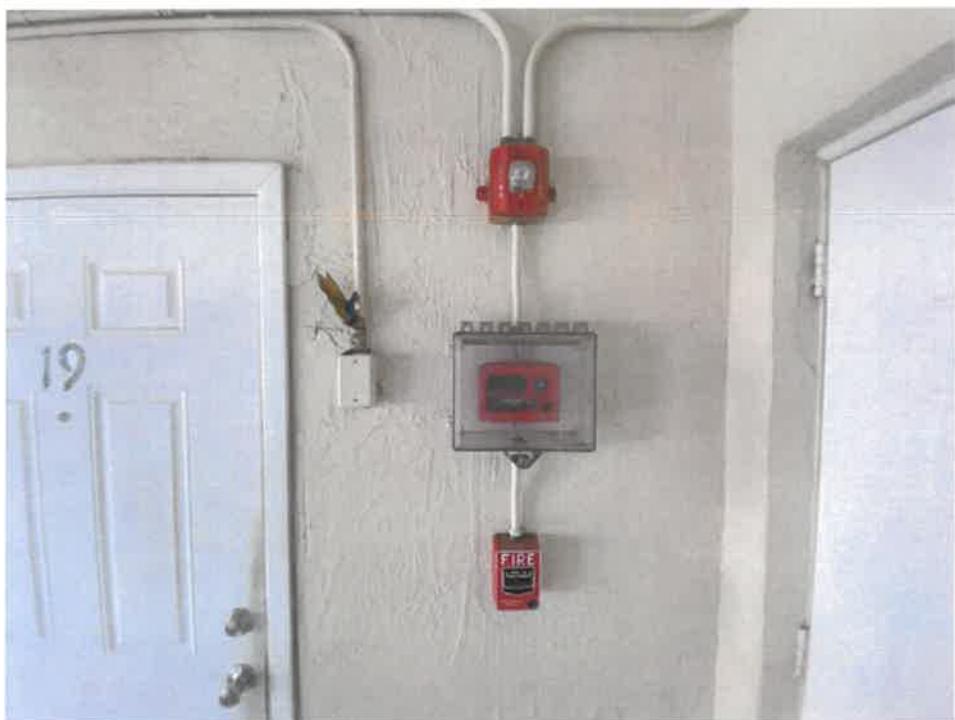
20. View of Fire Alarm System

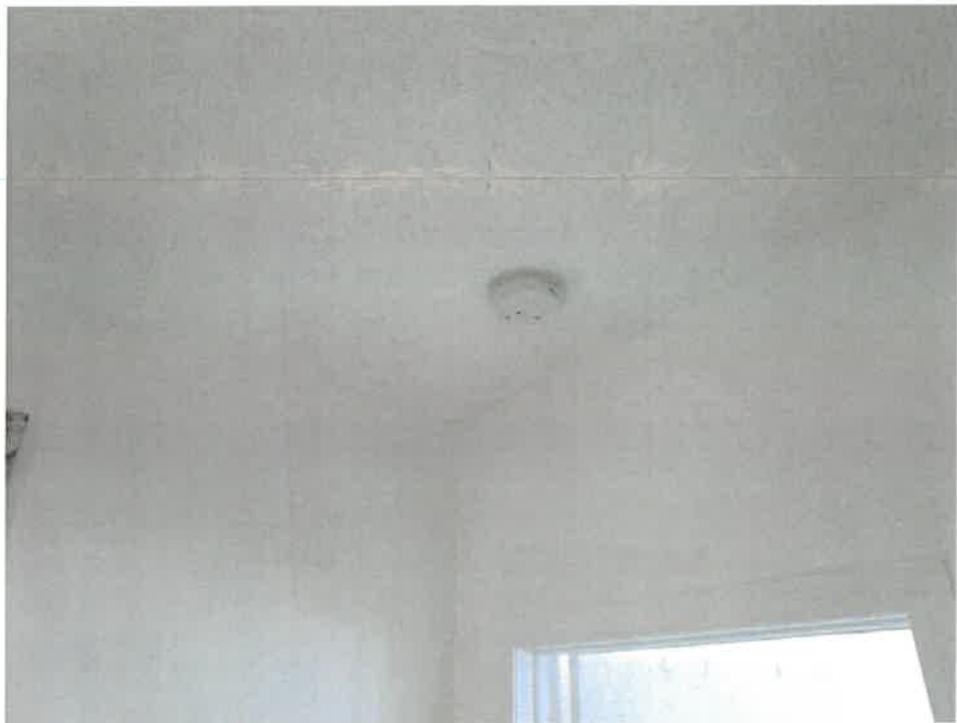
21. View of Smoke Detectors

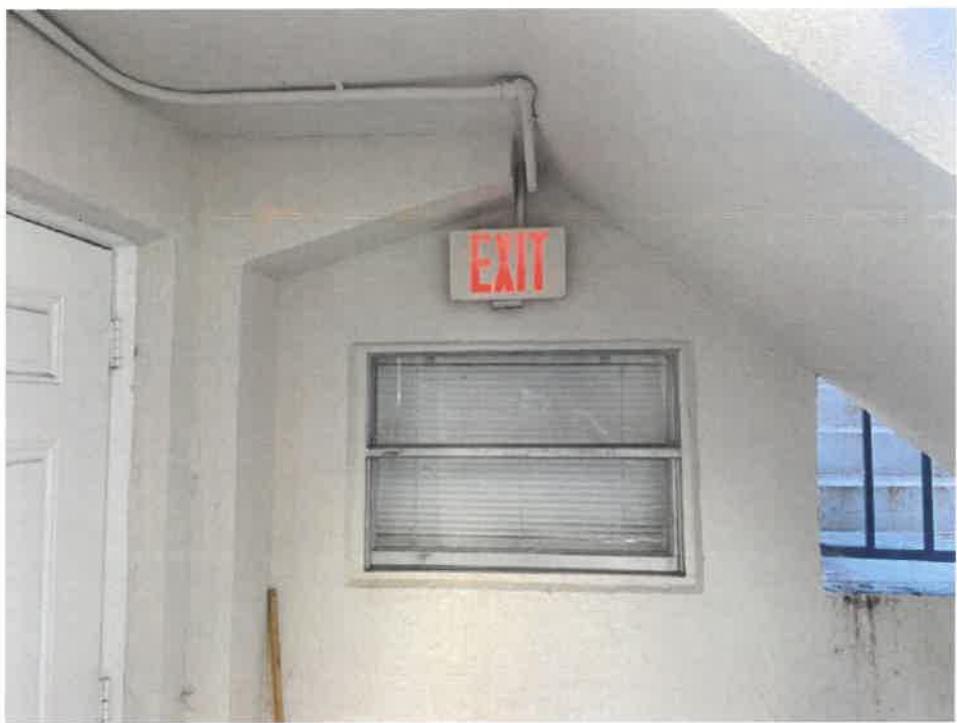
22. View of Exit Lights

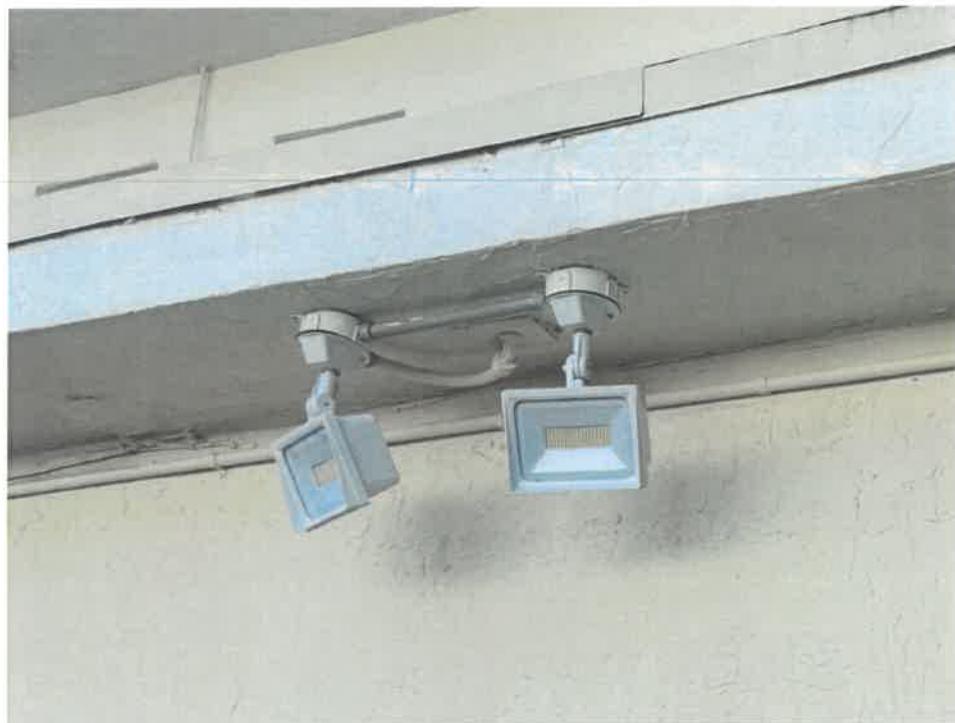
24. Wiring in Open or Under Cover Parking Garage Areas

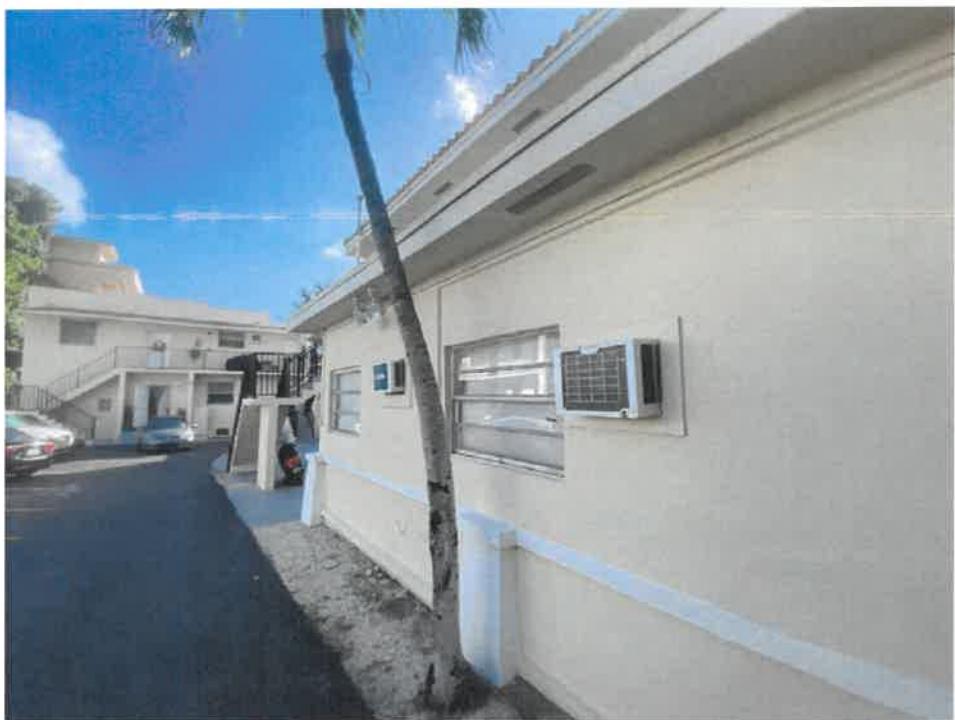
25. Open or Under Cover Parking Garage Egress Illumination
