## **Sewer Line Inspection Report**

## **Estate of Carol O'Brian**

119 S. Adams Street Glendale, CA 91205

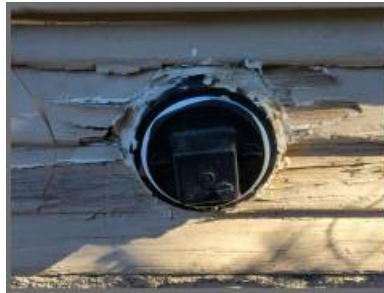
The main sewer line was accessed through a 3 inch building drain cleanout found near the left front corner of the main house.

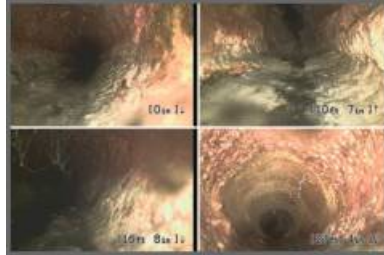
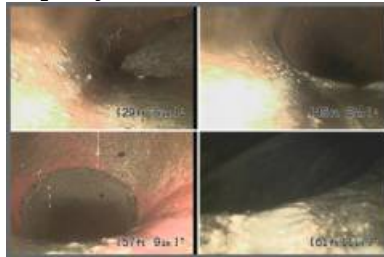
**Needs Attention:** The cast iron of the main sewer line system is in a very deteriorated state with signs of excessive rust and corrosion of the inner walls, it would appear based on its visual condition that this section of the system is near the end of its useful life. The system also has an excessive root intrusion that will need to be cleared out so the system can have a normal drainage flow. As the system is now the roots may collect solid debris to the point of a complete blockage. These roots are also blocking the view to the inner walls of the pipe, so no data can be given about the condition of the piping in this area, while there were no obvious signs of damage, that doesn't mean there isn't anything being hidden by the roots (SEE VIDEO).

**THE AGED CAST IRON:** There are areas that appear to be entering the beginning stages of failure and should be considered for upgrade soon.

The line will need to be cleaned and for this system I would recommend a hydro-jetting, which is a very effective cleaning method for the pipe. It utilizes a high pressure water system to cut the roots and remove the soil from the inner walls of the pipe, while also washing them down the line. This type of cleaning will allow for maximum visibility of the inner walls of the pipe so that the proper repair recommendations can be made, if necessary.

Once the system has been cleared a follow up video examination will need to be performed to assess the main sewer line's condition along the root intruded area.

As with any older cast iron system it is advised to have the line video inspected every year to monitor its rate of deterioration to be able to more accurately predict a future replacement date. It is also advised to have the line video inspected after any significant seismic activity as damage can occur with earth movement.

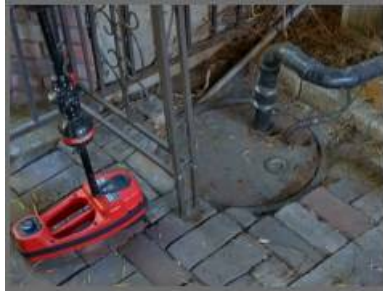
**NOTE:** The supply line to the system was given a brief inspection on the request of the client and agent. Roots have entered the ABS supply line at the tank connection.

The point of root intrusion has been located in the area indicated in the photo (red & black device). The pipe is 2 1/2 feet deep at this location.

For repairs to the sewage ejection system ABS supply line, it is recommended to contact a licensed sewage ejection system plumber.
