Home Inspection Report

W3828 Walrath Rd, Glen Flora, WI 54526

Monday, July 28, 2025

Smart Start Home Inspections LLC

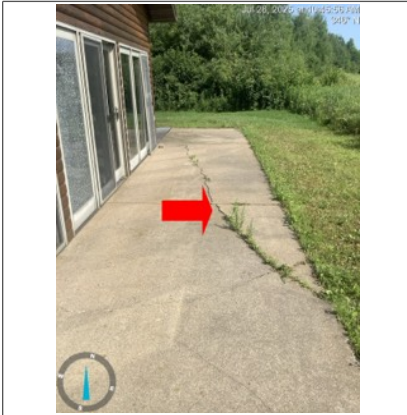
Settlement cracks present in service walk with trip hazards present - safety concern - recommend repair to prevent injury to occupants.

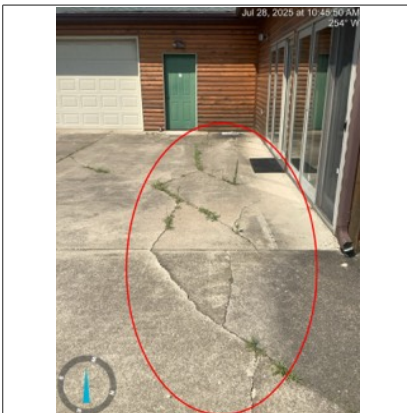
Settlement cracks present in driveway with trip hazards present - safety concern - recommend repair to prevent injury to occupants.

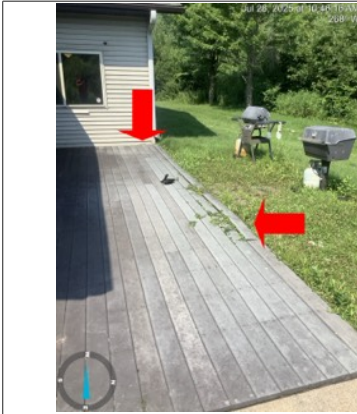
Loose/warped boards present - potential trip hazard - recommend repair to prevent injury to occupants.

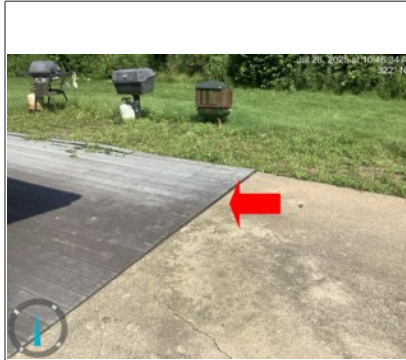
Lip between service walk and patio - potential trip hazard - recommend repair to prevent injury to occupants.

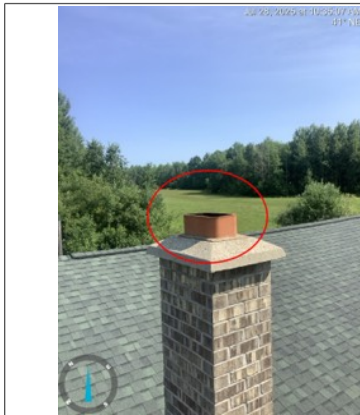
Recommend installing a rain cap/spark arrestor to prevent moisture or animal entry into the chimney/home.

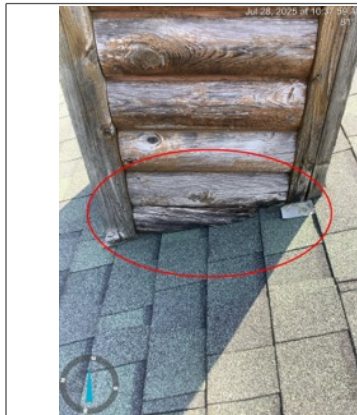
Siding deteriorated on chimney - recommend repair/replacement of damaged sections to prevent the spread of deterioration.

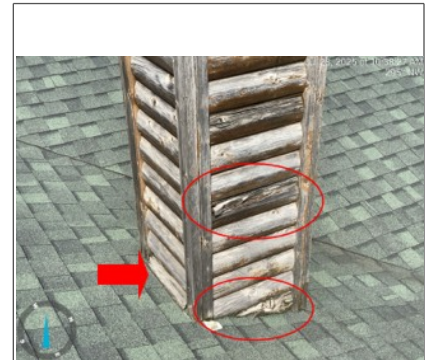
Siding deteriorated on chimney - recommend repair/replacement of damaged sections to prevent the spread of deterioration.

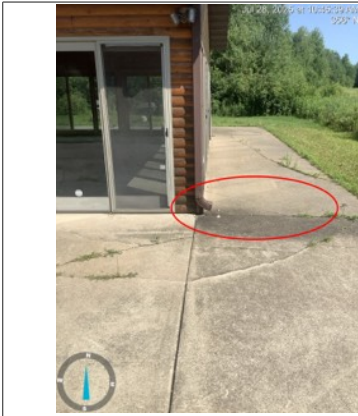
Recommend installing downspout extensions to properly disperse rainwater away from the home and reduce moisture levels around the foundation/slab.

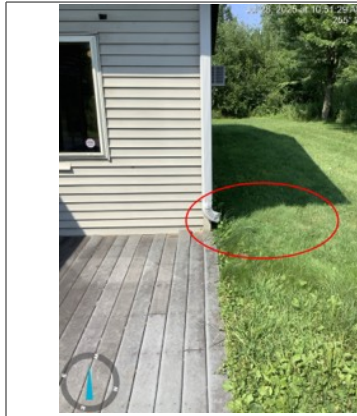
Recommend installing downspout extensions to properly disperse rainwater away from the home and reduce moisture levels around the foundation/slab.

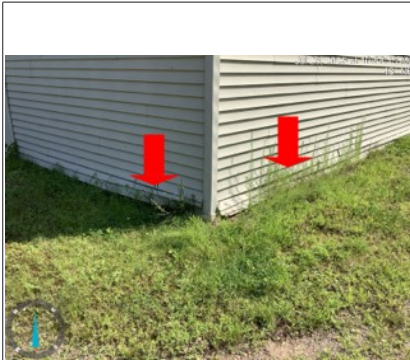
Siding is damaged/loose in several areas - recommend repair to prevent further damage/deterioration of siding or exterior of the home.

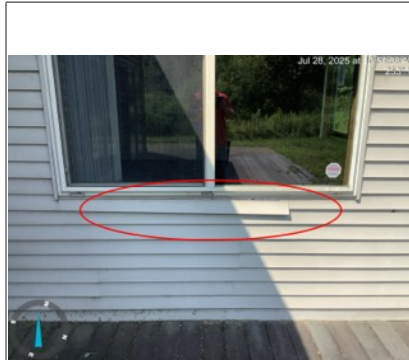
Siding is damaged/loose in several areas - recommend repair to prevent further damage/deterioration of siding or exterior of the home.

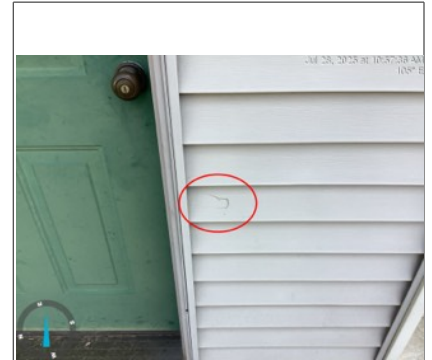
Holes in siding - recommend repair/properly sealing openings to prevent moisture or insect intrusion/damage.

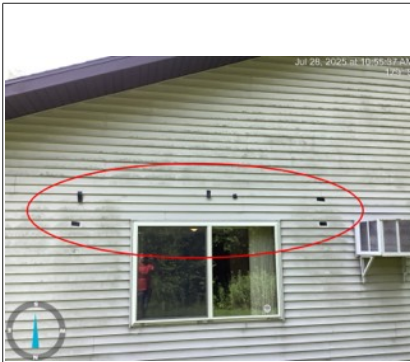
Holes in siding - recommend repair/properly sealing openings to prevent moisture or insect intrusion/damage.

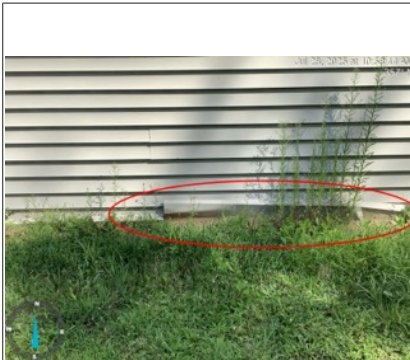
Damaged trim near the base of the walls around the home - recommend repair to prevent/replacement to prevent further damage/deterioration.

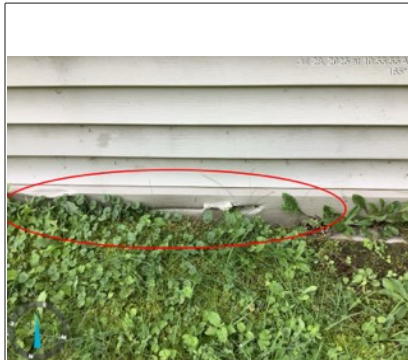
Damaged trim near the base of the walls around the home - recommend repair to prevent/replacement to prevent further damage/deterioration.

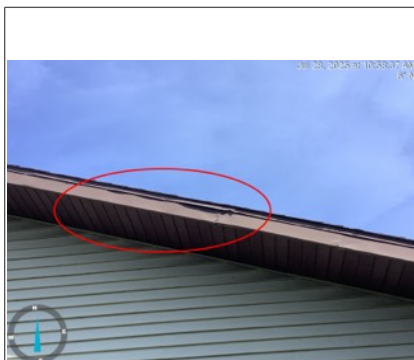
Fascia is overall satisfactory with repair needed - damage present on the south side of garage - recommend repair/replacement of damaged area.

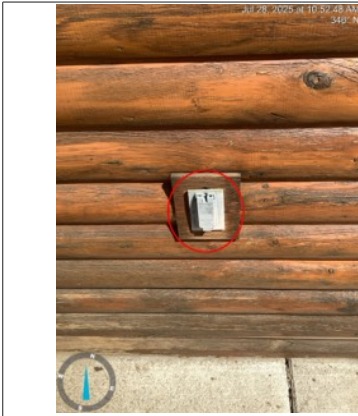
Loose weatherproof cover for receptacles near garage service door - safety concern - recommend securing cover to prevent moisture insect intrusion/damage.

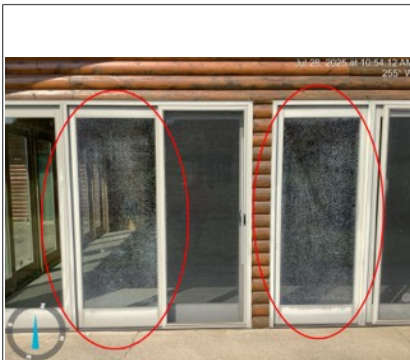
Multiple patio doors have broken glass - recommend repair/replacement of damaged doors.

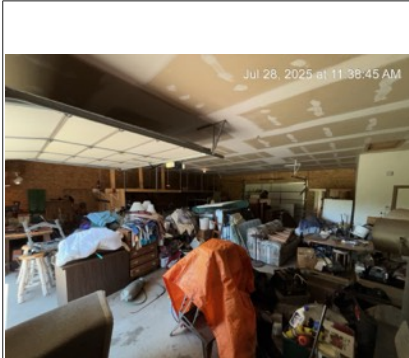
Limited visibility of garage components due to owner's belongings - limited inspection.

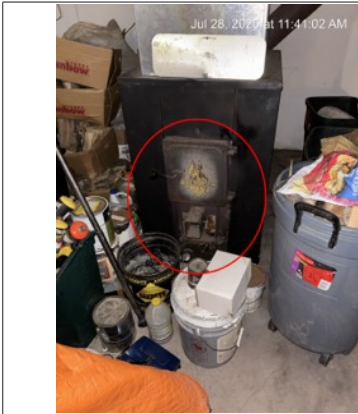
Ignition source within 18" of the garage floor - safety concern - recommend removing wood stove from inside of the garage.

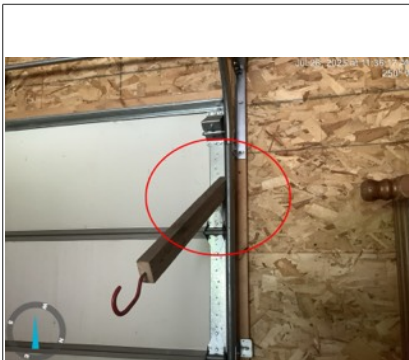
Unable to test west door due to the track being blocked - not tested.

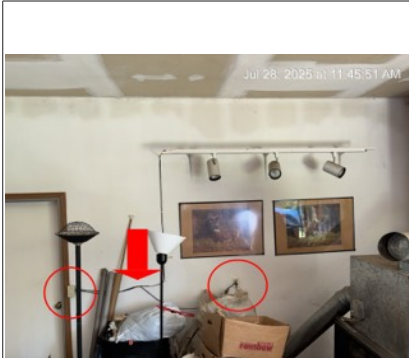
Handyman extension cord wiring present for wall lighting - safety concern - recommend removing to prevent injury to occupants.

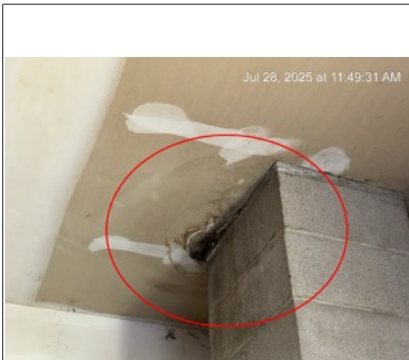
Moisture stains on ceiling near chimney - tested dry during the inspection - recommend monitoring for moisture buildup with repairs made as necessary.

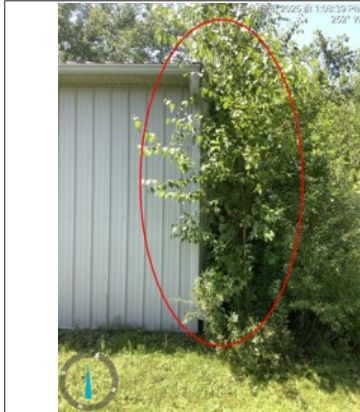
Limited visibility of north and west sides of the building due to vegetation - recommend trimming vegetation away from the shed to prevent damage to the exterior components.

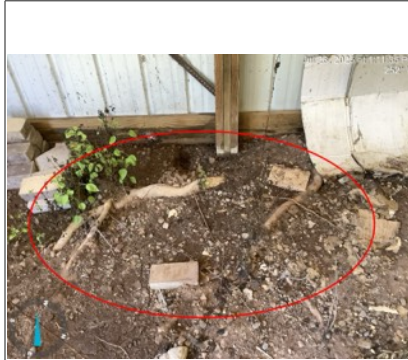
Limited visibility of north and west sides of the building due to vegetation - recommend trimming vegetation away from the shed to prevent damage to the exterior components.
(Tree roots inside of shed)

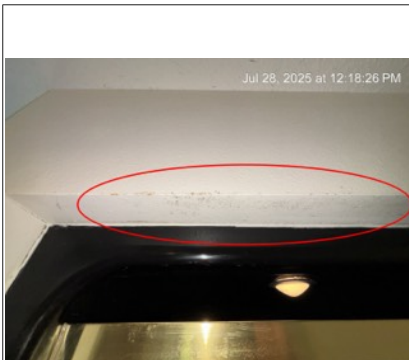
Mildew buildup on ceiling near shower stall - recommend cleaning to prevent spread or organic growth.

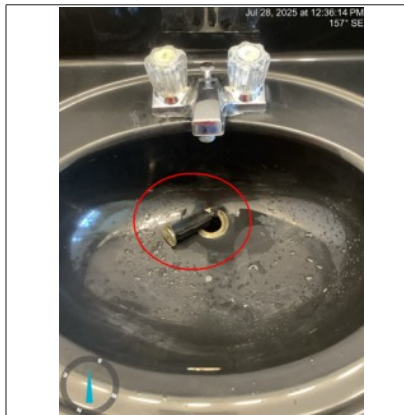
Sink drain stop is disconnected - recommend repair.

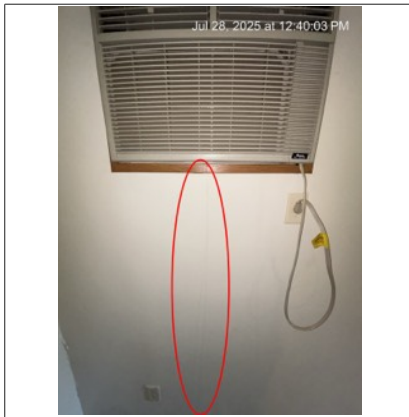
Moisture from AC condensation running down the wall - recommend repair to prevent deterioration of exterior wall.

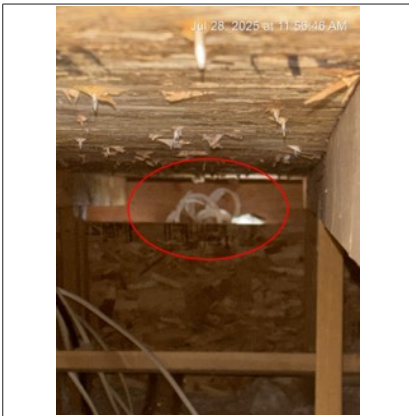
Exhaust fan pipe appears to be damaged on the west side of the home - recommend repair to prevent moisture buildup in the attic area.

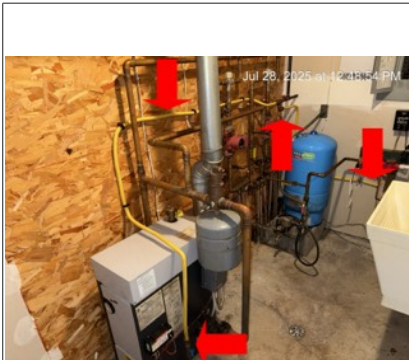
Comments CSST gas line is not properly bonded - safety concern - recommend electrician repair to current code.

CSST gas line is not properly bonded - safety concern - recommend electrician repair to current code.
