Inspection Report

Property Address:
3735- 3741 Madison Ave.
San Diego California 92116

Date: 2/5/2025	Time: 08:45 AM	Report ID: J020525A
Property: 3735- 3741 Madison Ave. San Diego California 92116	Customer:	Real Estate Professional: Compass

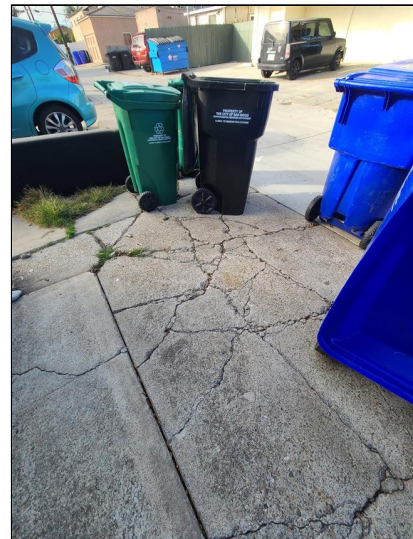
**Unlevel Surfaces- Trip Hazards.** There were areas at the driveways which had unlevel and some cracks and raised surfaces noted. **Some of these cracks were offset and may pose as trip hazards.** It is recommended that adjustments be made to create a smooth walking surface at these locations.

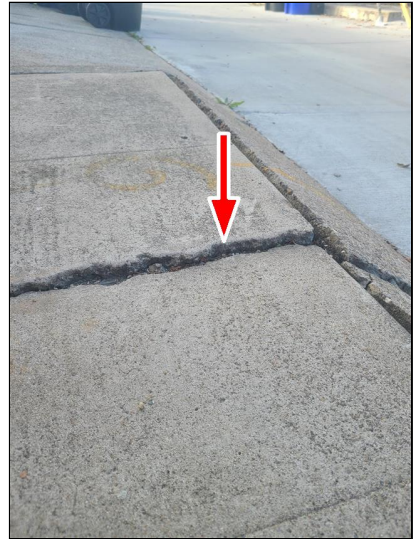
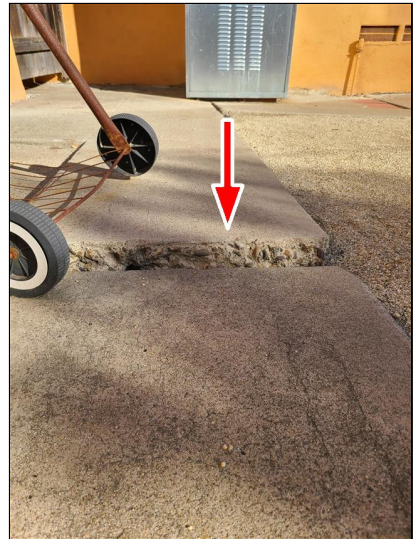
(2) **Unlevel Surfaces- Trip Hazards.** There were areas at the front entry of units #3739 and #3735 which had unlevel and raised surfaces noted . **There were unlevel surfaces at the backside of the garages as well.** These areas may pose as a trip hazard. It is recommended that adjustments be made to create a smooth walking surface at these locations.

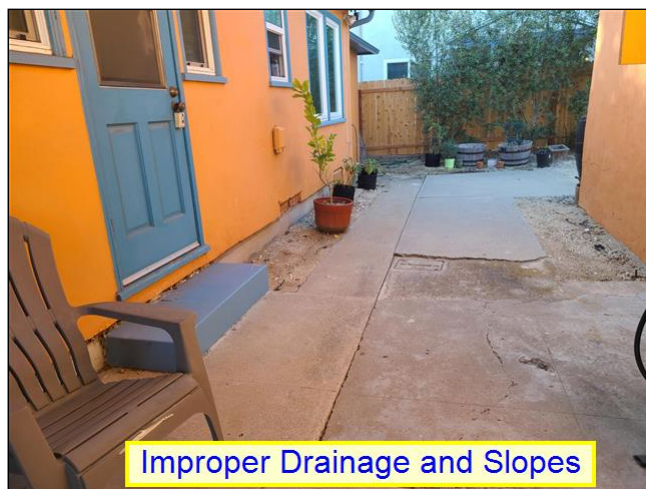
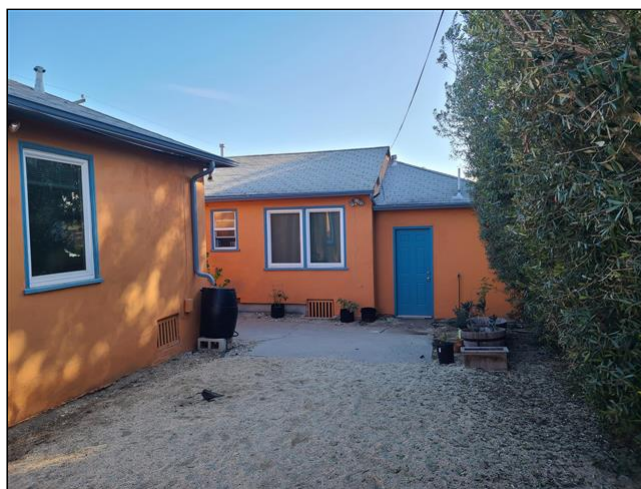
**Improper Drainage and Slopes.** There are areas around the house where the drainage is poor. There are areas that have no directional slope as well as areas that direct water towards the house. There were no visible surface drains noted at these locations. It is important that all water shed away from the house and foundation. Ideally there should be a minimum slope of 6 inches within the first 10 feet of the house. It is recommended that swales, french drains or other means of drainage be provided to keep water away from house and foundation.

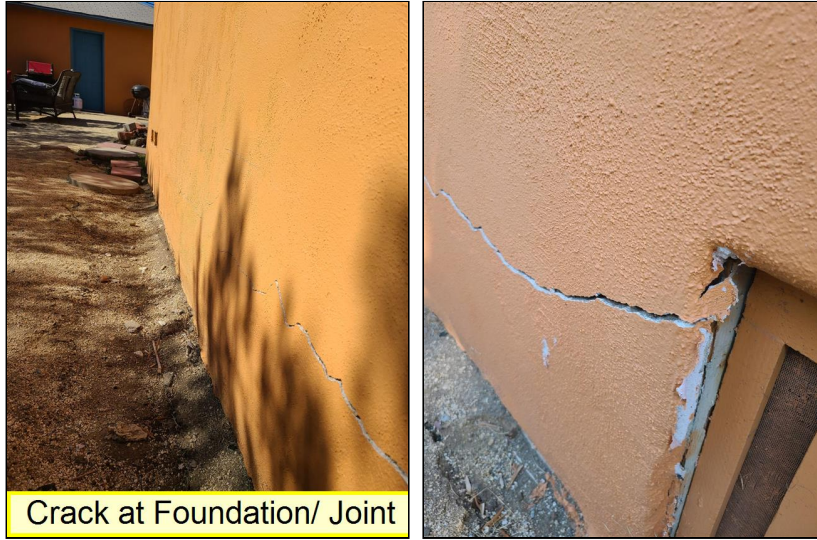
Crack at Foundation/ Joint

(1) **NOTE: Crack at Foundation/ Wall Joint.** There was a large horizontal crack noted at the front of the house. This crack appears to fall at the joint between the wall and the foundation. Cracks at these locations are typical in homes of this age. There were no visible signs suggesting foundation problems or issues at this location. This is noted for your information only.

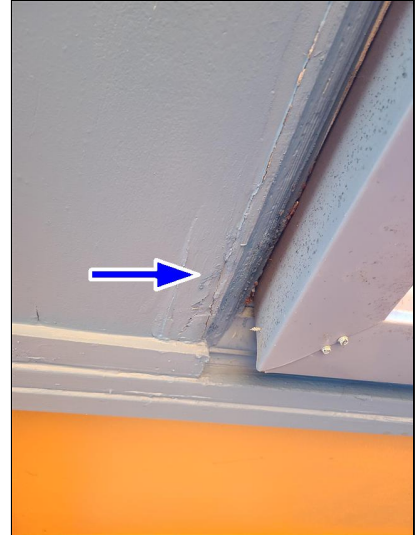
Wood Damage

(2) **Eave Damage.** There was some wood damage at some of the eaves at the rear of **unit #4548**. It is recommended that you read your termite report thoroughly and that any damaged wood be repaired or replaced by a licensed contractor if needed.

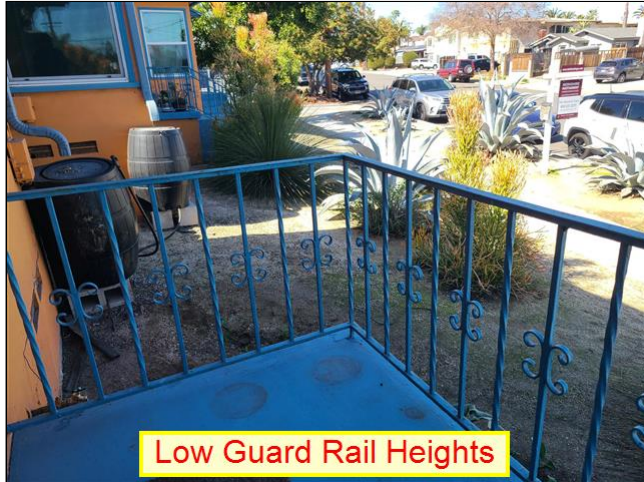
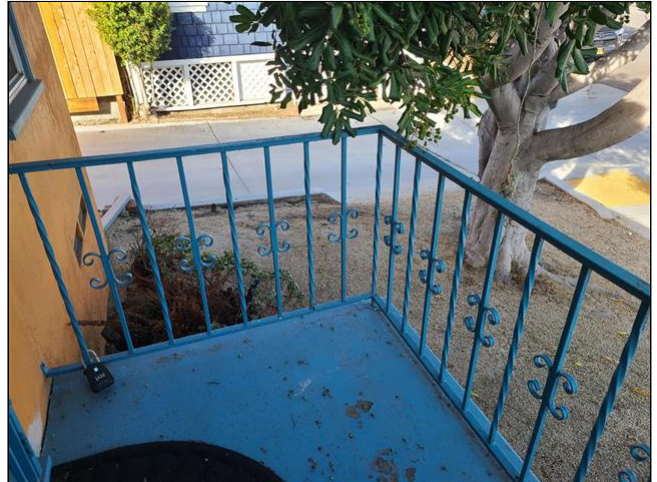
(2) **Low Guard Rail Heights.** The guard rail at the exterior stairs/ porches of units #3741, #3739 and #3735 do not meet today's height requirements. **Although this may have been proper at the time of construction it is recommended that all guard rail have a minimum rail height of 42 inches.** The current height of the railing falls below 42 inches. **For safety purposes it is recommended that this be altered to meet the standard safety requirements.**

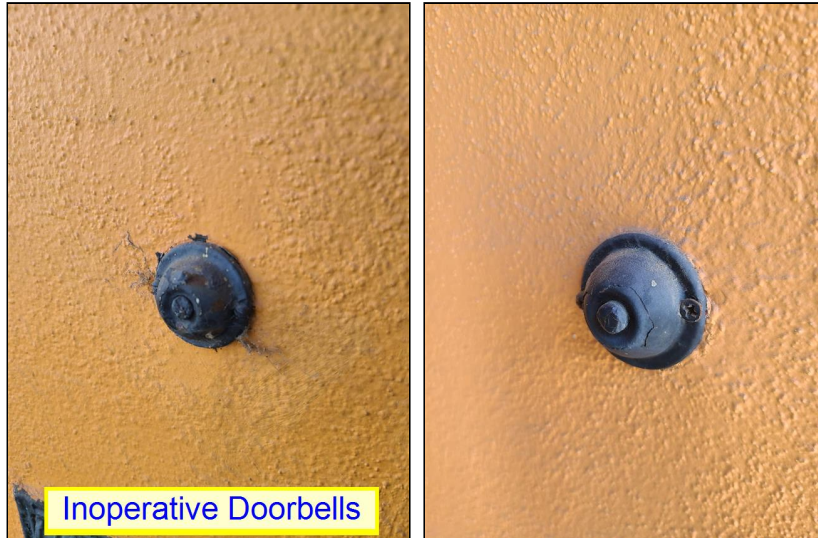
(3) **Inoperative Doorbells**. The door bell did not operate at two of the units at the time of inspection. **These were noted at units #3739 and #3741. It is recommended that this be repaired by a qualified person.**

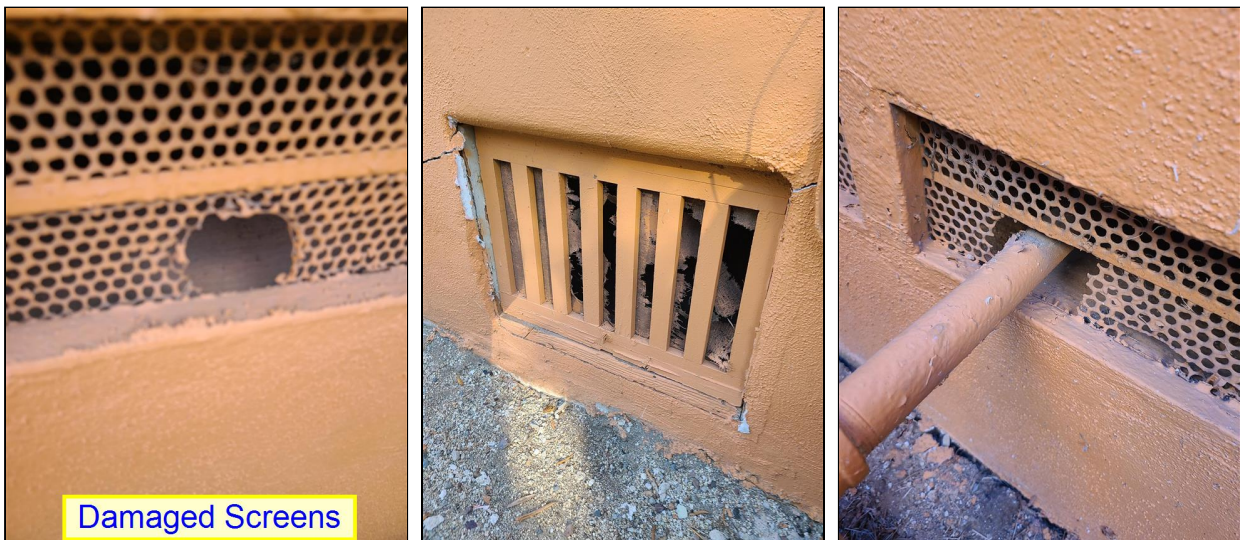
📍 (1) **Damaged Screens- Crawlspace**. There were a few vent screens that are damage or torn at the crawlspaces. The vent screens are designed to allow air into the crawlspace to help circulate the airflow in this area, yet keep out unwanted insects and pests. **It is recommended that this screen be repaired or replaced so unwanted wasps, hornets and bees rodents and animals do not enter this crawl space.**

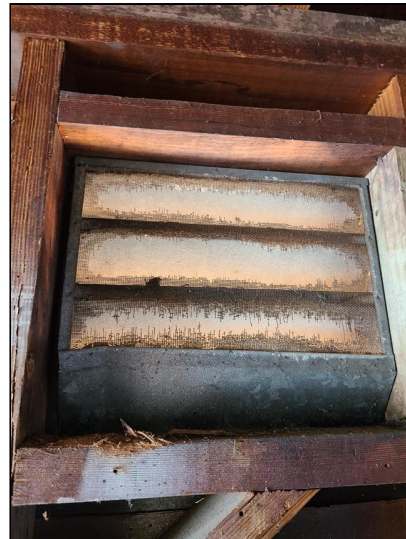
(2) **Missing/ Damaged Screen.** There was a missing or damaged screen noted at the garage. Screens help ventilate your garage and keep out unwanted bugs, cats, opossums, rodents and other creatures who may want to explore or reside within your garage. **It is recommended that all missing or damaged screen are repaired or replaced as needed.**

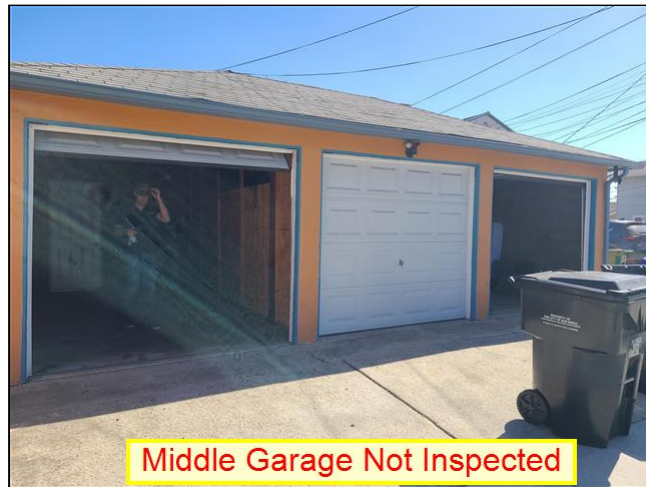
(2) **Middle Garage Not Inspected.**
 The middle garage, at the rear alley was not inspected. Access to this garage was not granted and the interior of this garage was not inspected. **It is recommended that this be further evaluated once access has been achieved.**

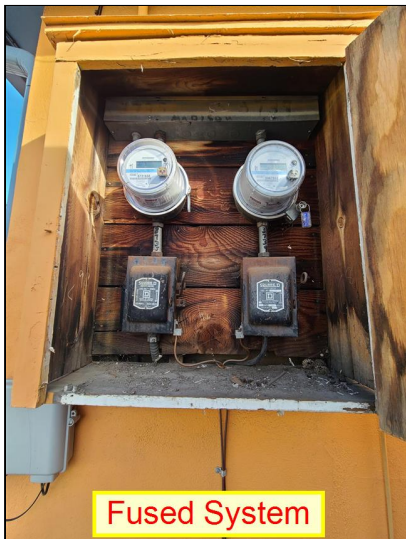
Fused System

(2) **Fused System.** The main disconnects for the **rear duplex** is on a fused system. **This is an older style of disconnecting means that is considered outdated.** You may wish to convert this to a more modern breaker type system. **It is recommended that the electrical system be further evaluated and updated as needed by a licensed electrician.**

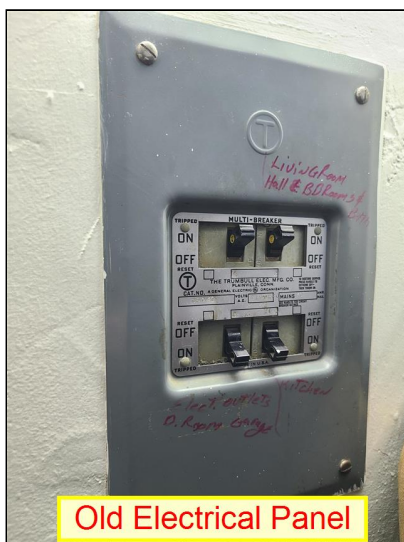
Old Electrical Panel

(3) **Old Electrical Panel.** The sub-panel within **unit #4548** was an older Trumbell panel. This is an old panel that is considered to have reached it's life expectancy. It is recommended that this panel be replaced with that of a newer model by a licensed electrician.

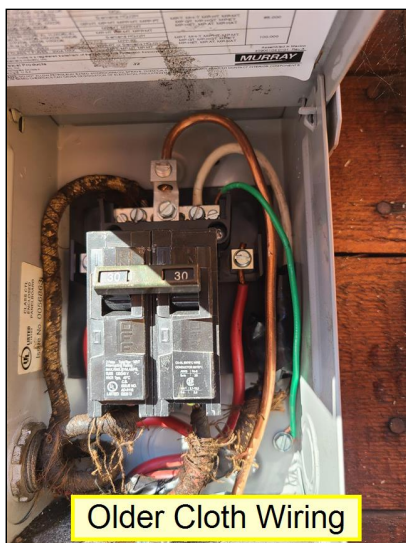
(1) **NOTE: Older Cloth Sheathed Wiring.** Due to the age of this house, some locations still have the **original UNGROUNDED** (cloth sheathed wiring). This wiring is not provided with a source of grounding. There were no visible defects found with this wiring. **Due to the age of this wiring, it is considered to have reached the end of it's useful life.** It is recommended that an electrician be called out to further evaluate the system and discuss the costs and benefits of a newer electrical system.

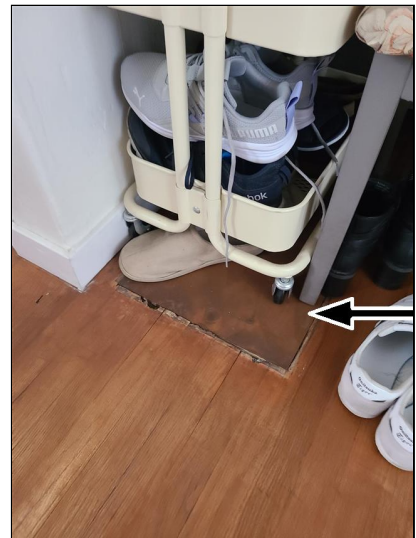
(1) **Patching Noted.** It appears that there was some patching of the wood floors in a few of these units. The floor heaters were removed and plywood has been installed. There was a color difference noted at the flooring in the family room. The cause or reason for this was not able to be determined at the time of the inspection. This is noted for your information and it is recommended that you ask the current owner about this area.

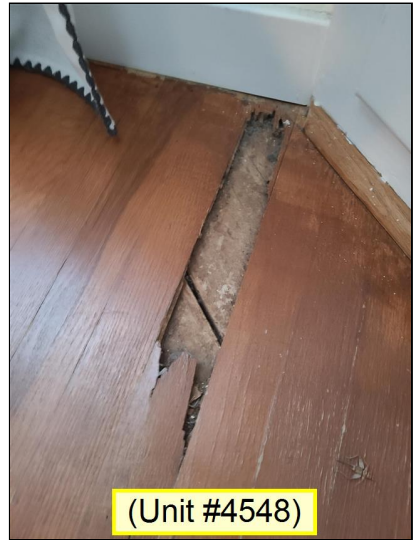
(2) **Wood Floor Damage**. There was some damage to the wood flooring noted in the bedroom of **unit #3741** as well as in the dining area of **unit #4548**. It is recommended that you read your termite report and that these areas be further evaluate and repaired as needed by a licensed contractor.

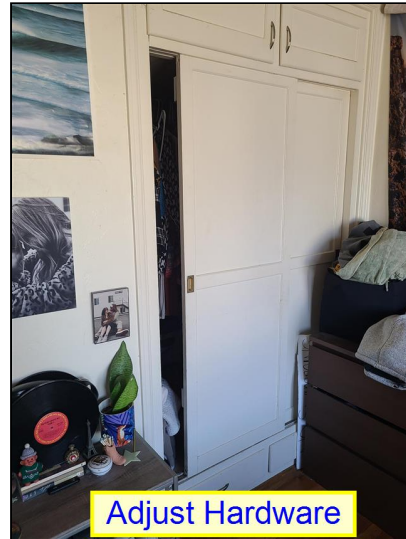
(2) **Adjust Hardware.** The door for the bedroom #1 closet, in unit #3739, did not properly function. The striker latch was not functioning at the door. It is recommended that this be repaired as needed by a qualified person.

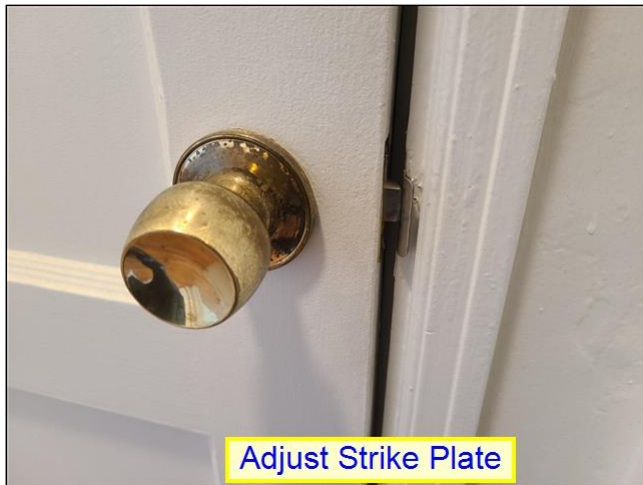
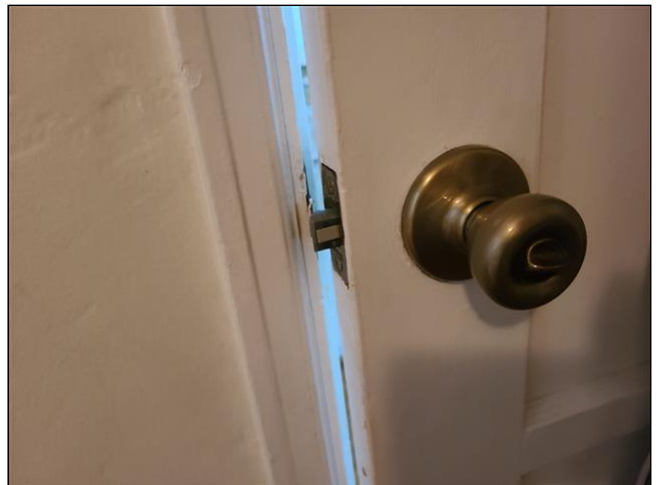
(3) **Adjust Strike Plate.** The door at the hallway closet of unit #3741, and bedroom of unit #4548 do not latch shut properly. The strike plate for the door is not adjusted properly or is missing and does not allow the door to latch shut. Recommend adjusting the strike plate so the door can latch shut.

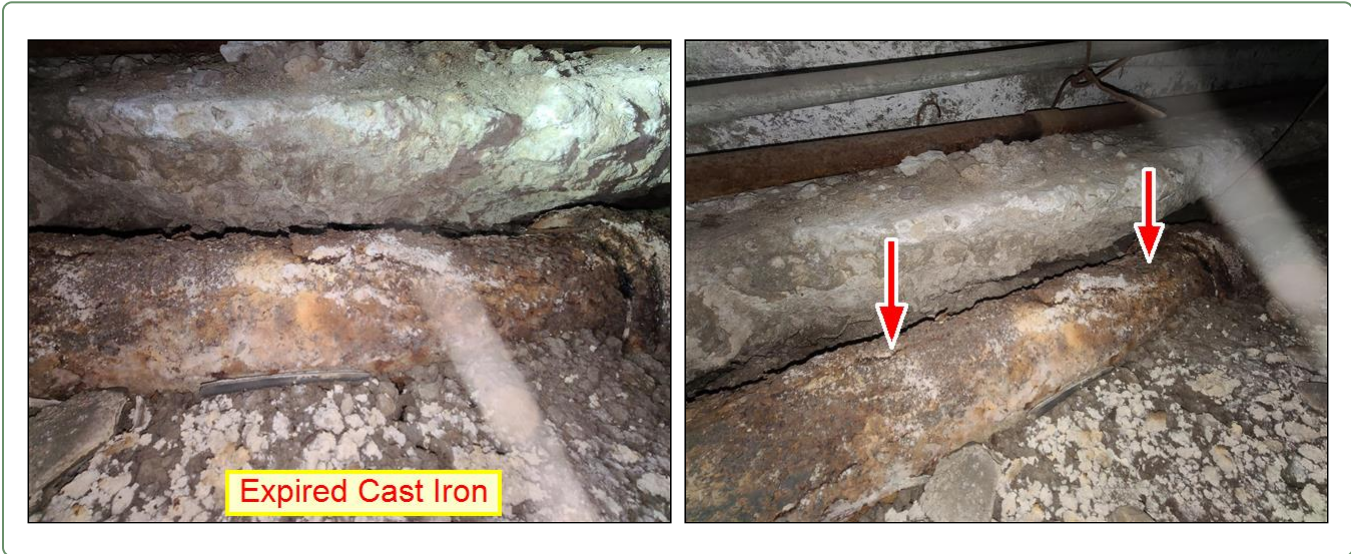
(4) **Deteriorated Pipes.** Several sections of the cast Iron pipes have deteriorated and started to flake and crack at the **underside of the duplex.** These lines have reached their expected life expectancy and **should be replaced.** **It is recommended that all deteriorated pipes be replaced by a licensed plumber.**

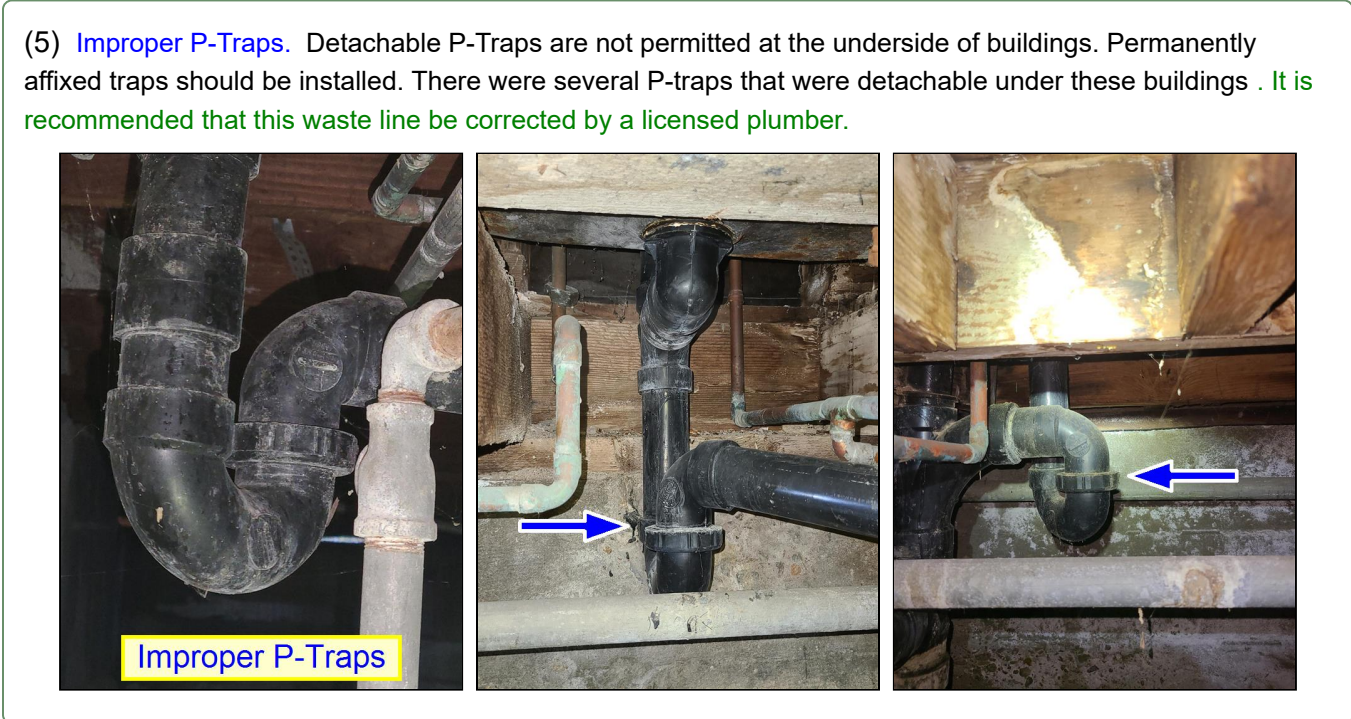
(5) **Improper P-Traps.** Detachable P-Traps are not permitted at the underside of buildings. Permanently affixed traps should be installed. There were several P-traps that were detachable under these buildings . It is recommended that this waste line be corrected by a licensed plumber.

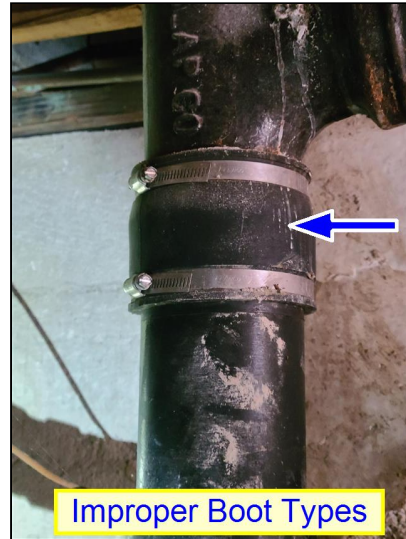
(6) **Improper Boot Types.** The plumbing hub or boots at the pipe connections at the underside of the building were of the wrong type. These are designed for underground use. The type with a metal shroud are needed at these locations. **Improper boots can cause the rubber to tear over time increasing the risk of leaks.** It is recommended that these be further evaluated and repaired as needed by a licensed plumber.

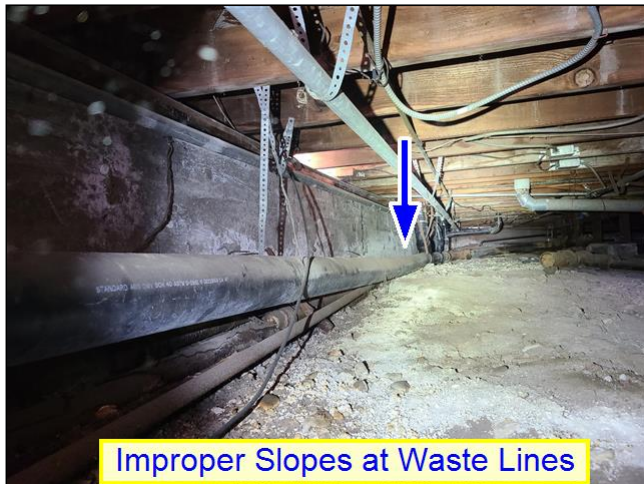
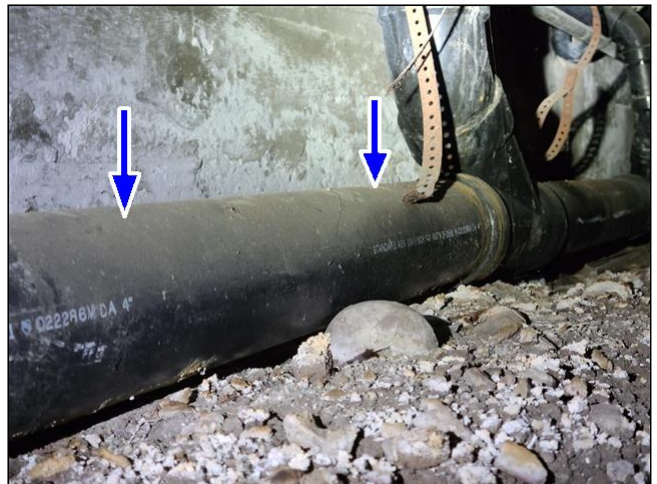
(7) **Improper Slopes at Waste Lines.** There are waste lines at the underside of the duplex that do not have proper directional slopes. **Waste lines should always maintain a downward slope.** In this application there are sections of the plumbing that did not appear to have proper slopes. This can cause water and debris to remain within the pipe at this location. It is recommended that these areas be further evaluated and that the slopes at these locations be corrected by a licensed plumber.

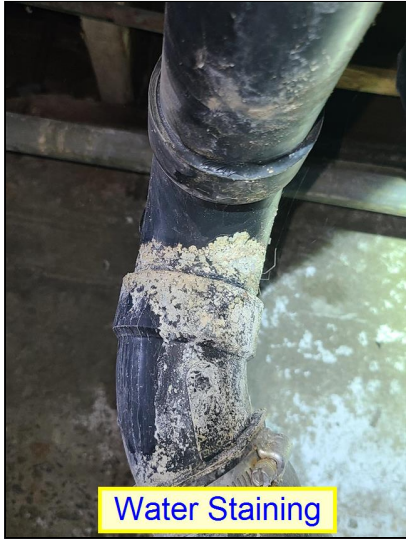
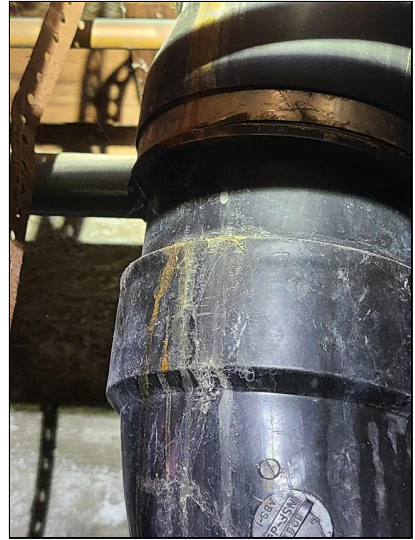
(8) **Water Staining.** There were water marks and corrosion noted on the waste lines at this location. This indicates that there have been leaks at this location in the past. **There were currently no leaks at this pipe at the time of the inspection, but it is possible this may leak if not corrected.** It is recommended that the connections be further evaluated and repaired if needed to ensure no leaks develop.

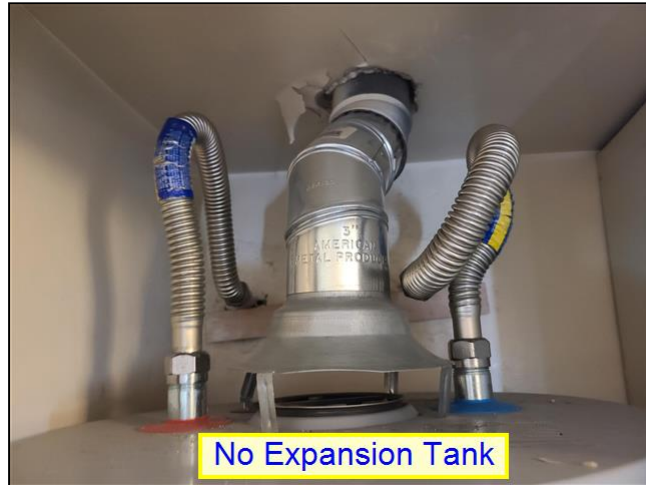
🏠 (5) **No Expansion Tank.** The newer water heater, provided for this property, was not provided with an expansion tank. Water heaters installed on a closed system (with a water pressure regulator or backflow preventer) are typically required to have expansion tanks installed **depending on the municipality.** This is the help reduce stress in the pipes from water expansion. When water is heated it can increase by about 2% volume causing pressure to build in the plumbing system, when a faucet is opened in the home it causes a rapid drop in pressure and can result in deterioration of the plumbing system in the home, fixtures and the water heater. **Typically a 2 gallon expansion tank is suggested for 40-50 gallon water heaters.** It is recommended that you check with the municipality to determine if an expansion tank should have been installed on this system.

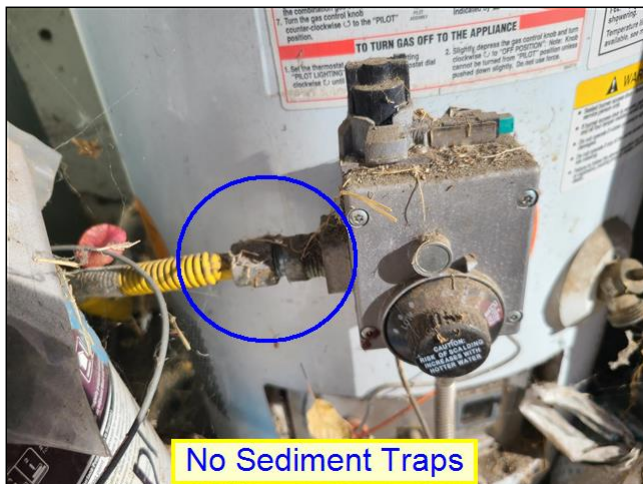
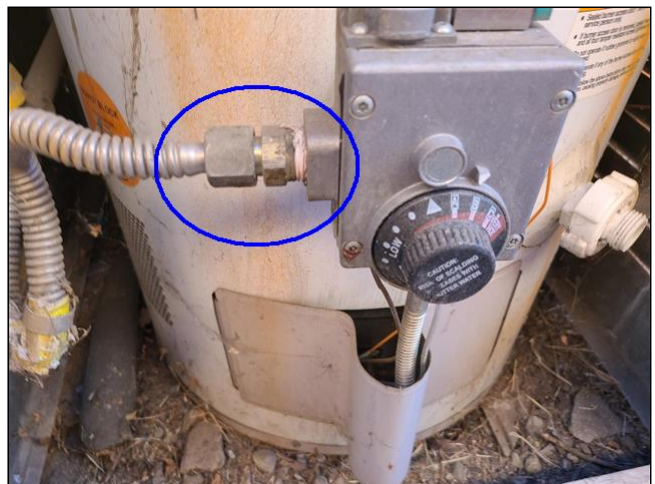
🏠 (6) **No Sediment Traps.** There was currently no sediment traps on the gas lines leading into the hot water heaters. It is recommended by the manufacturer that a sediment trap be installed at this heater. It is recommended that a trap be installed by a licensed plumber.

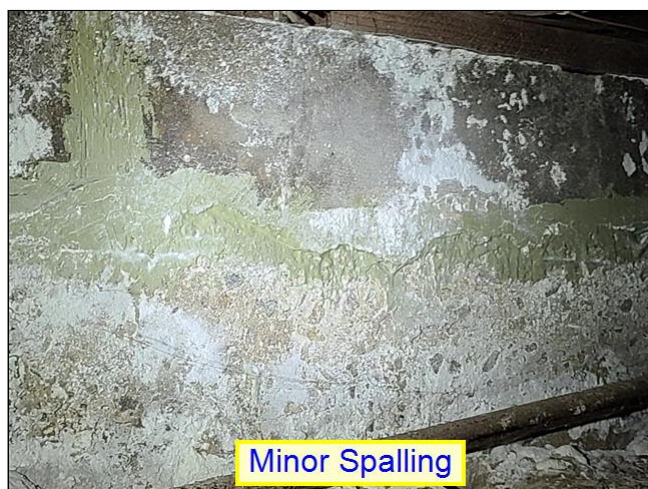
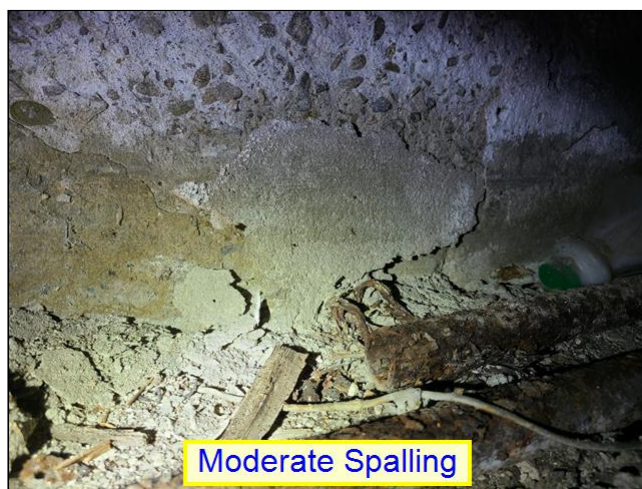
(8) **Minor Spalling.** There were a few areas in which there was minor spalling noted at the underside of **unit #3741 and moderate spalling under unit #3739 duplex** . Spalling is when the surface concrete begins to delaminate or flake away from the wall. Eventually this can lead to deterioration and weakening of the foundation. **It is recommended that the spalling of the foundation be checked periodically, and if these areas dramatically worsen over time, that a licensed concrete specialist be called out for further analysis and repair.**

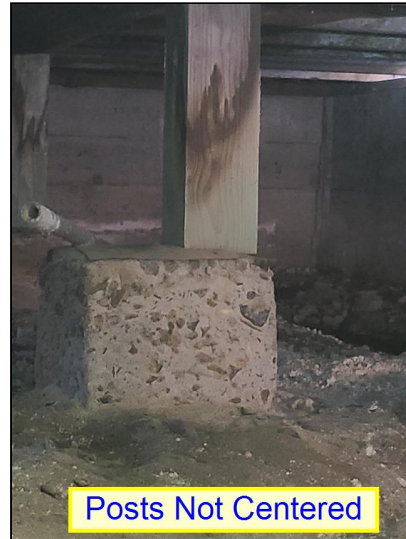
(3) **Posts Not Centered** . There are foundation post, at the underside of the house which have shifted and are no longer centered on foundation block. It is recommend that all foundation posts are properly centered and secured to both the foundation blocks as well as the girders.

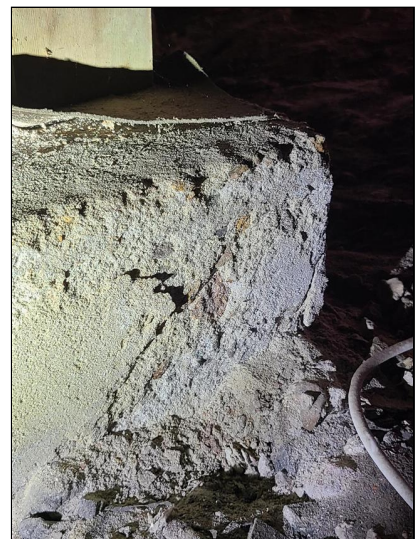
(4) **Deterioration of Piers**. There are a few piers at the underside of **unit #3741** have some moderate deterioration. It is recommended that a licensed foundation contractor be called out for further evaluation and repair.

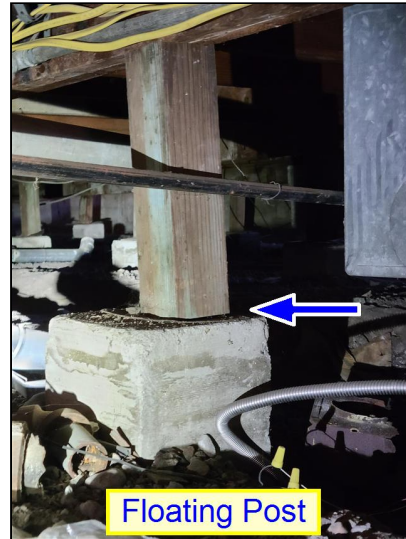
(5) **Floating Post**. There was a post at the underside of the duplex that was not in contact with the pier. The post was "Floating". It is recommended that this be further evaluated and repaired as needed by a licensed foundation specialist.
