# **Property Condition Report**

**12 Suite Apartment Building**  
**17105 Madison Ave.**  
**Lakewood, Ohio 44107**

**October 28, 2024**

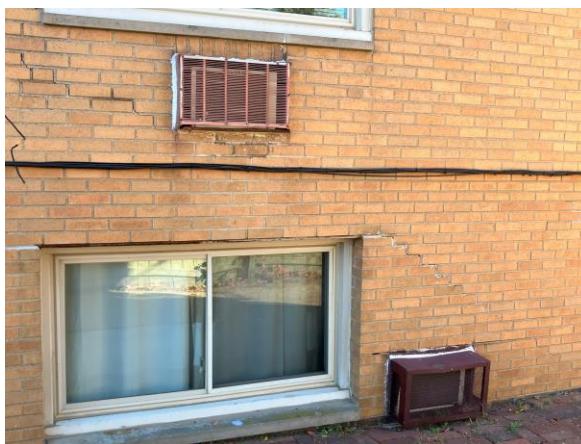
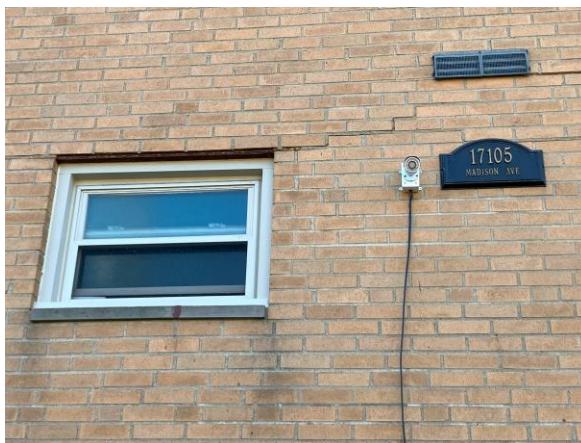
- 1) Tuckpointing/repair of certain spots on building exterior walls due to typical lintel rust and expansion. Left unaddressed, these voids will collect moisture which will become ice during the winter and eventually cause damage which would allow water penetration.

Some examples of minor tuckpointing needed:

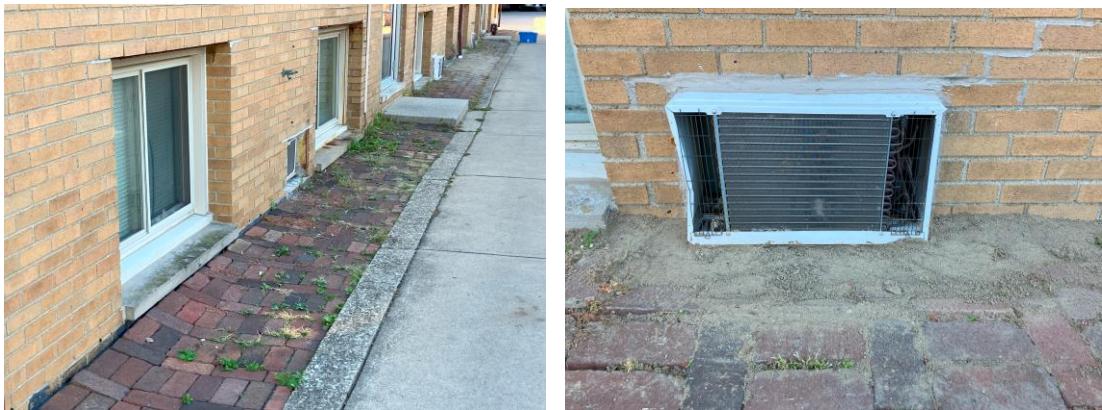
2) Brick area between drive and building wall. Some areas appear to be sunken and unable to shed water away from the building, and there appears to have been an area that was excavated, possibly for a downspout repair that was alluded to by a tenant. Removing all bricks and replacing with concrete sloped away from the building is recommended.

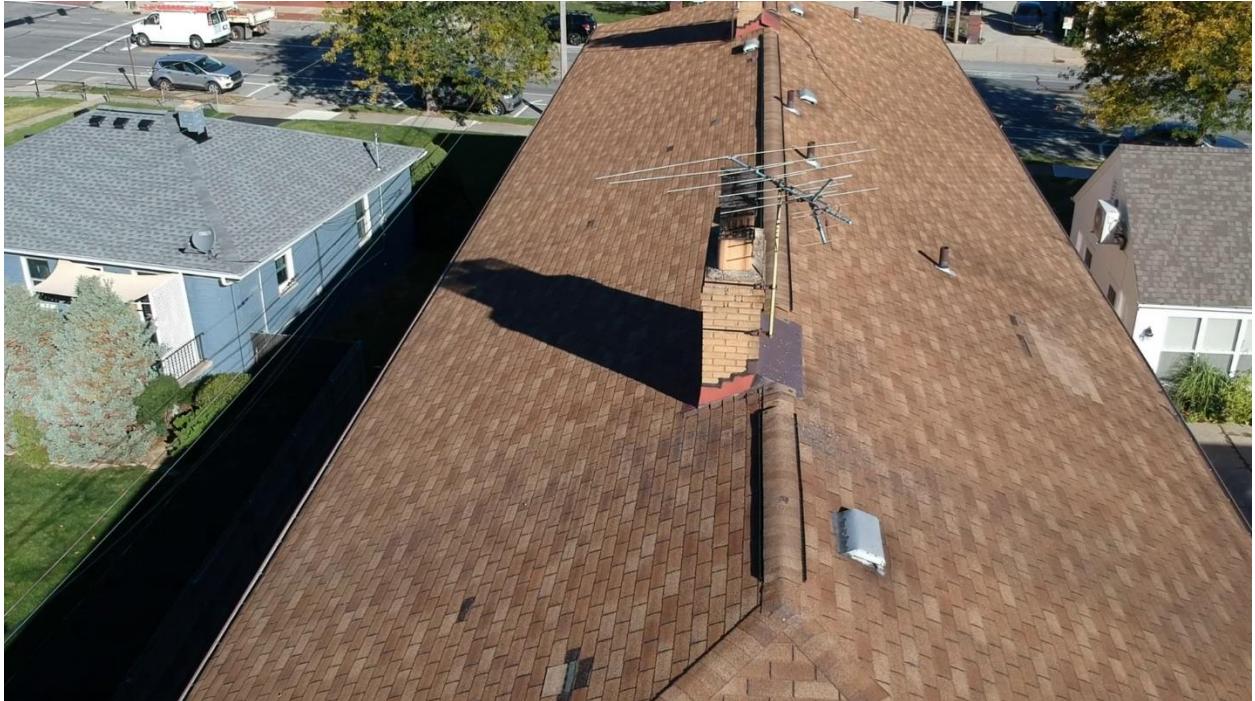
3) Missing and discolored shingles. There are 3 areas of concern on the roof. There are several shingles where tabs have been blown off, which is not unusual, and all but one location appears to have all of the underlying tabs intact which, while not ideal, still keeps water from penetrating.

Overall view of roof

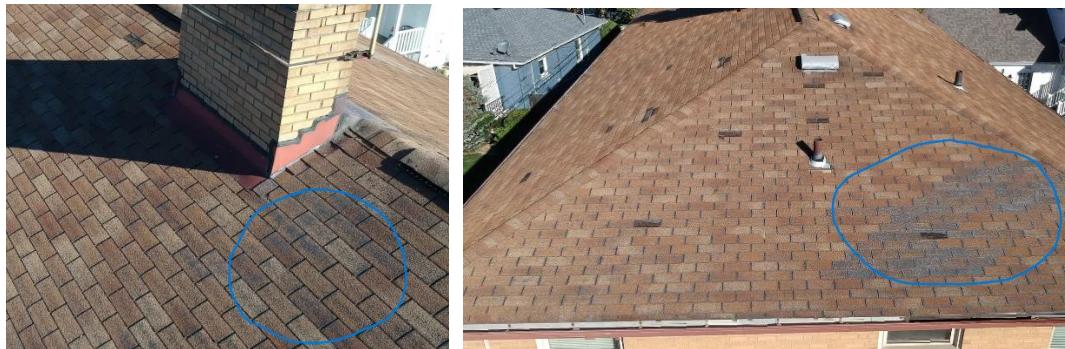
3 (continued) The second item regarding the roof are two discolored areas as shown below.

The discoloration appears to be on the surface and is indicative of tree sap and other detritus being deposited there. Researching old Google street views, there are clearly large trees to the east of the building and overhanging the building. There is also evidence on site of them overgrowing the fence and of them having been removed from that area.

Therefore it does not appear that there has been any permanent damage that would affect the roof integrity.

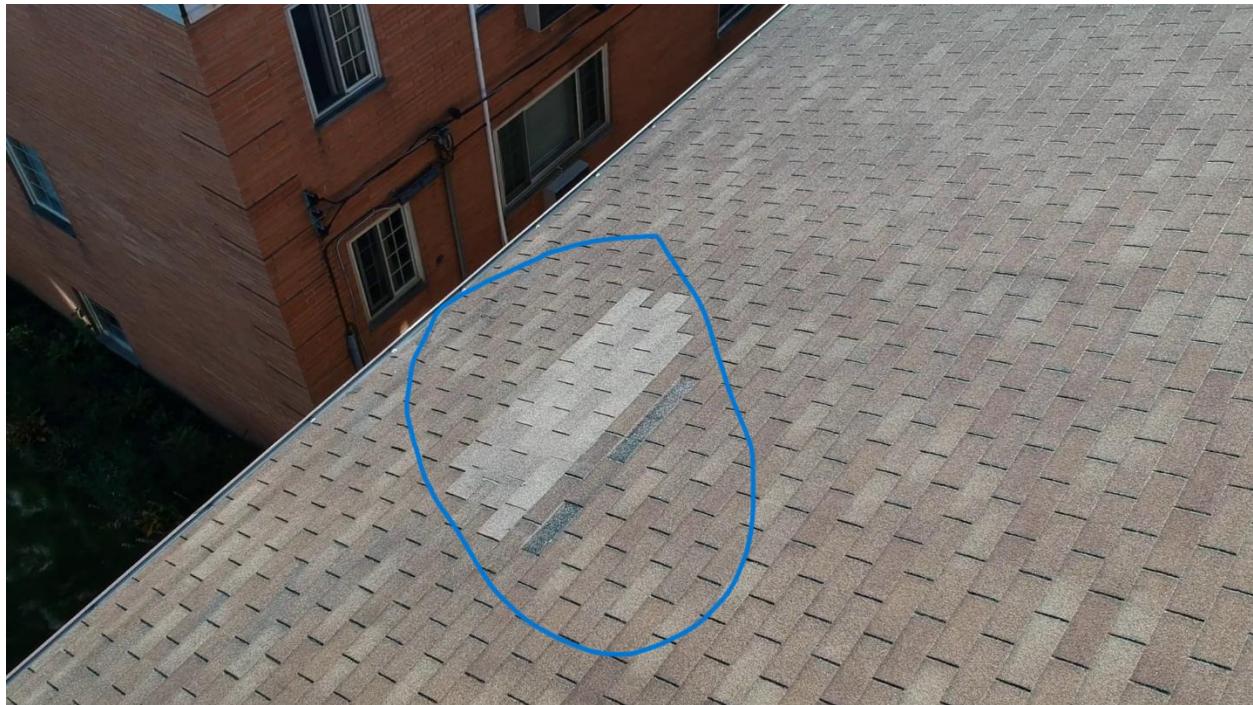
The third area of the roof appears to have had shingles replaced but, as it is exactly in the area where the tree was overhanging the building, is likely due to tree branches affecting the roof.

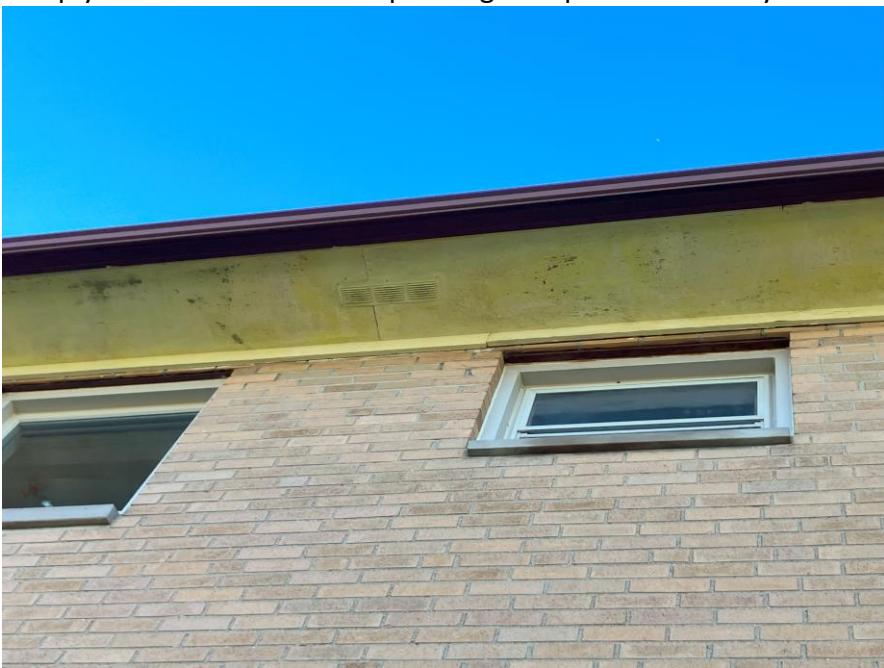
4) The plywood soffits will need painting or replaced with vinyl.

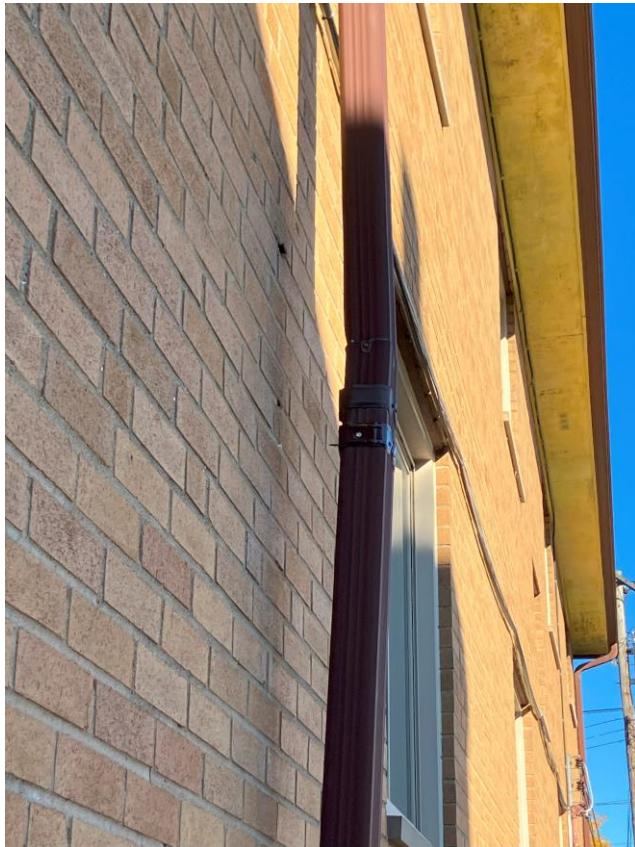
5) Re-attach downspout on east wall.

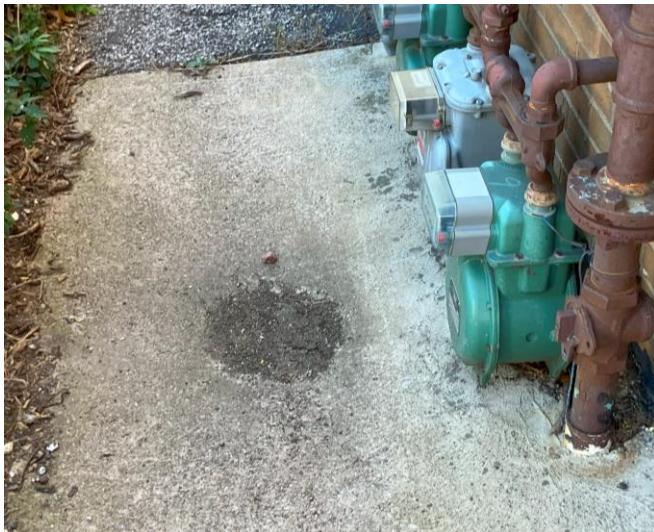
6) Clean catch basin near gas meters

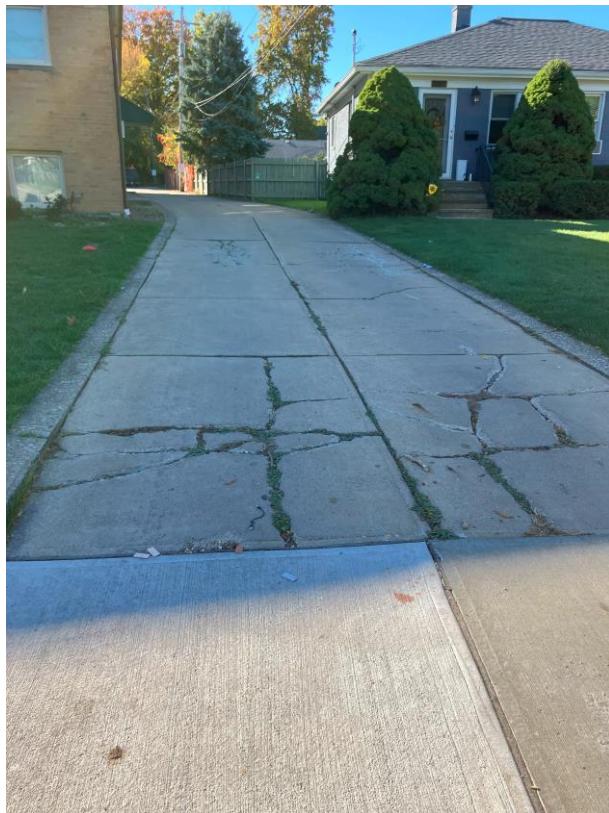
7) Remove and re-pour approx. 25' of driveway. It does not pose an immediate concern, but could be a trip hazard.

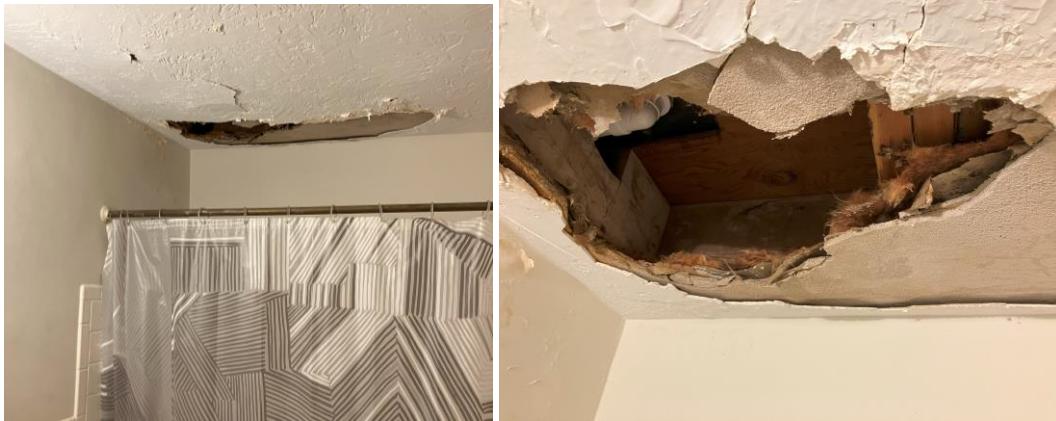
- 8) Garage doors are inoperable, damaged, or missing.
- 9) Garage roof shows signs of possible leaking. Likely cause is rear gutter, which also needs work.
- 10) Ceiling in apartment 7 needs repair due to damage from bathroom above.

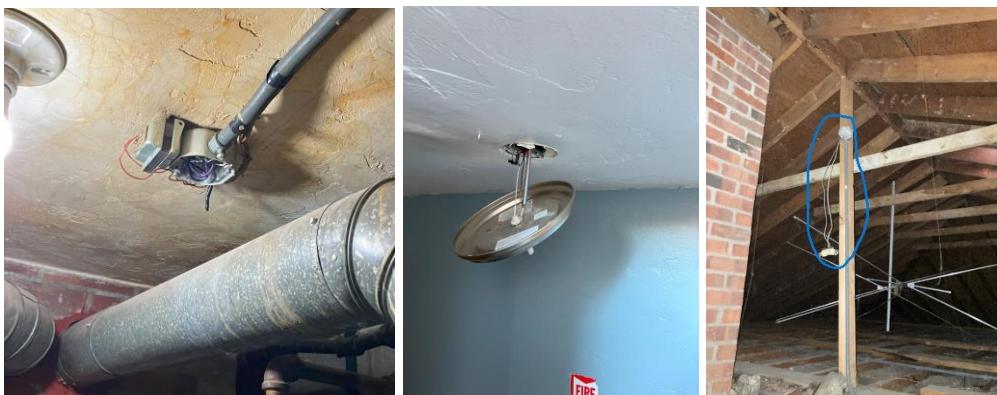
- 11) Repair/relace misc. electrical items in attic, mechanical rooms, and stairwells.
