SafeHome Inspections, LLC

Commercial Inspection

44/46 Main St

Inspected on Mon, Nov 30 2020 at 9:30 AM

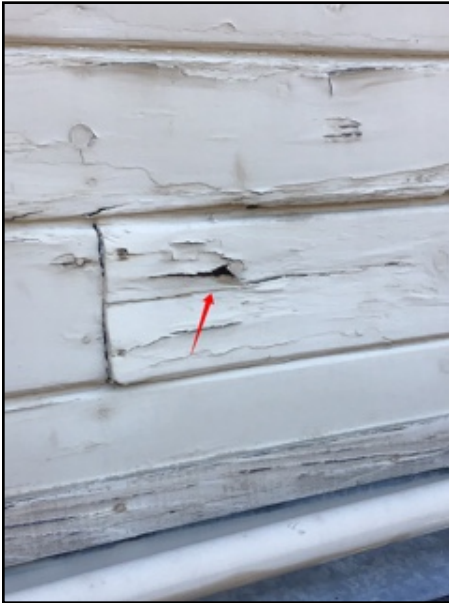
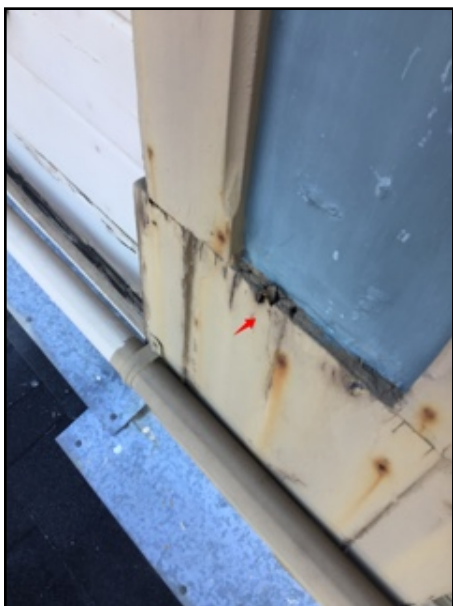
Figure 4-1

Water damaged siding at the front of the structure. Recommend removing and replacing water damaged areas to prevent further damage. Recommend seeking the pest inspection report for further evaluation.

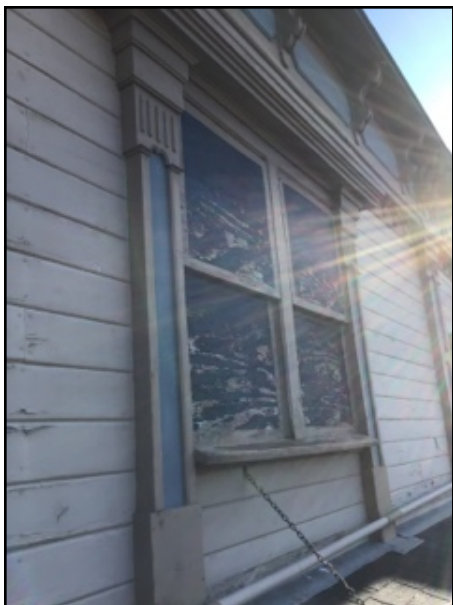
Figure 5-1

Single hung windows at the front of the structure have been boarded up. Recommend seeking a window specialist for further evaluation.

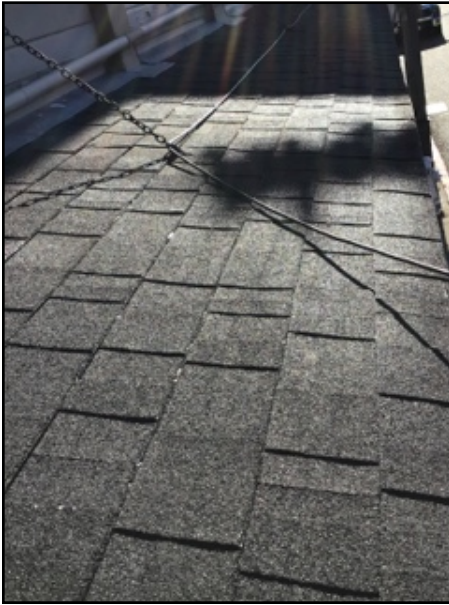
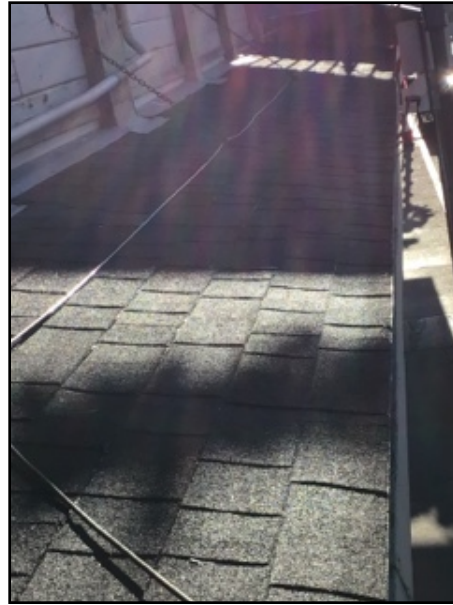
Figure 7-1

Worn/damaged composition shingle roofing at the front of the structure. Recommend seeking a roof inspection company for further evaluation.

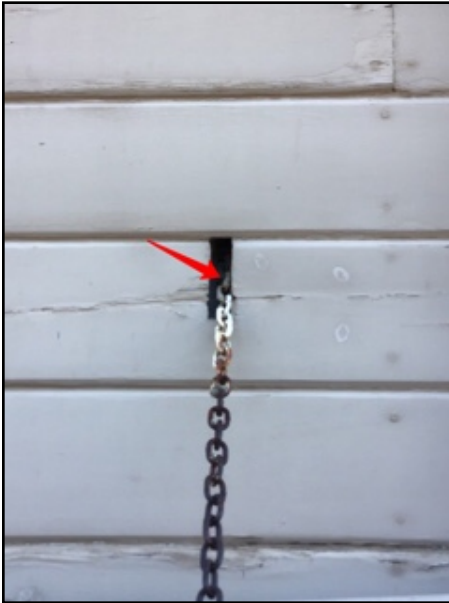
Figure 8-1

Open penetrations into the siding at the front of the structure. Recommend sealing open penetrations to prevent water damage/intrusion. Recommend seeking the appropriate tradesmen for further evaluation.

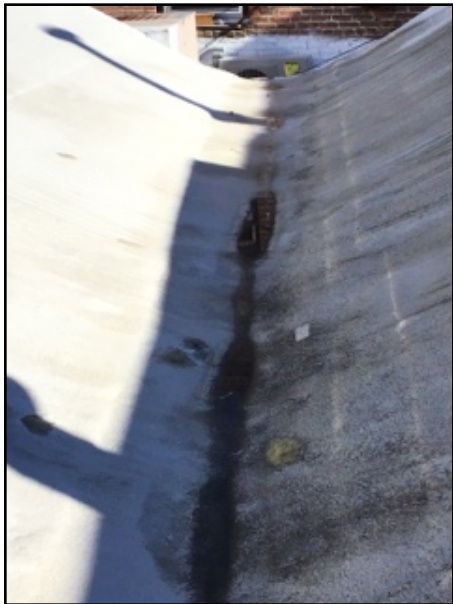
Figure 9-1

**Comment 9:**
Pooling/ponding water noted on roof. Recommend seeking a licensed roof inspection company for further evaluation.

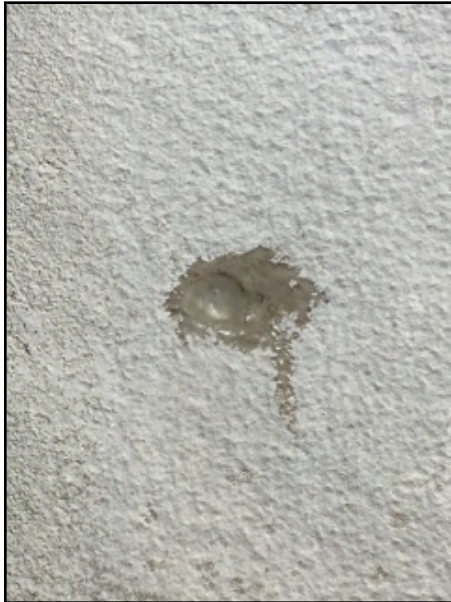
Figure 10-1

Past repairs noted on the roof. Recommend seeking a licensed roofing company for further evaluation.

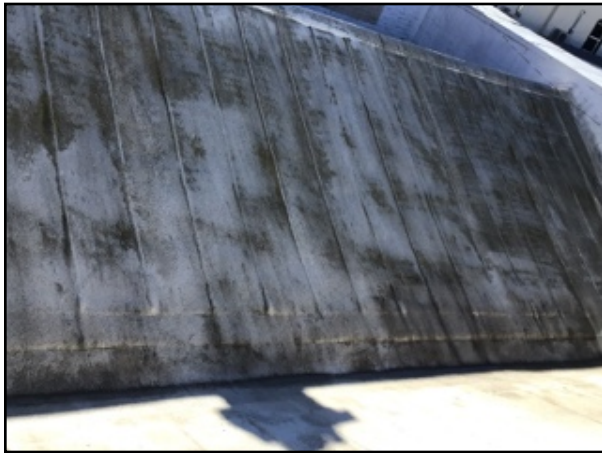
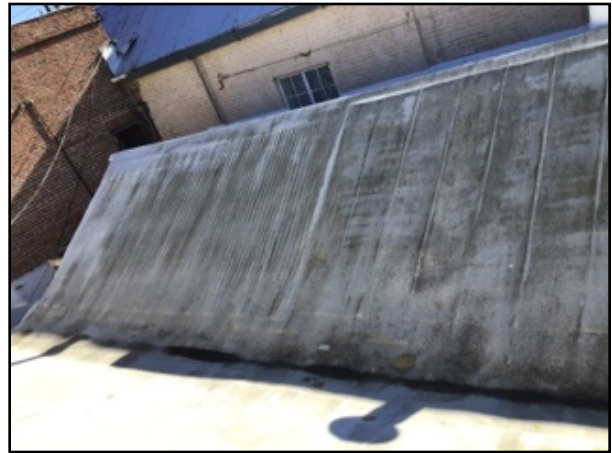
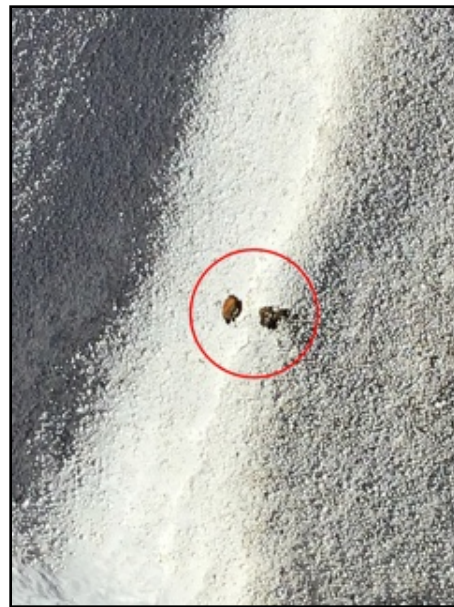
Figure 11-1

Worn/damaged spray foam roofing at the front and rear of the structure.
Recommend seeking a licensed roof inspection company for further evaluation.

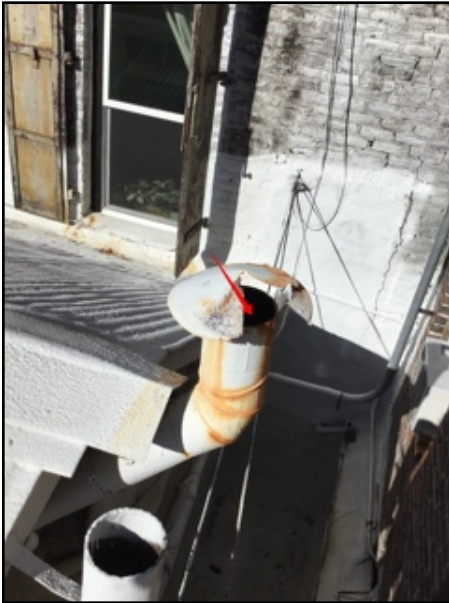
Figure 12-1

Damaged cap for flue at the rear of the roof. Recommend installing new cap to prevent intrusion/damage. Recommend seeking the appropriate tradesmen for further evaluation.

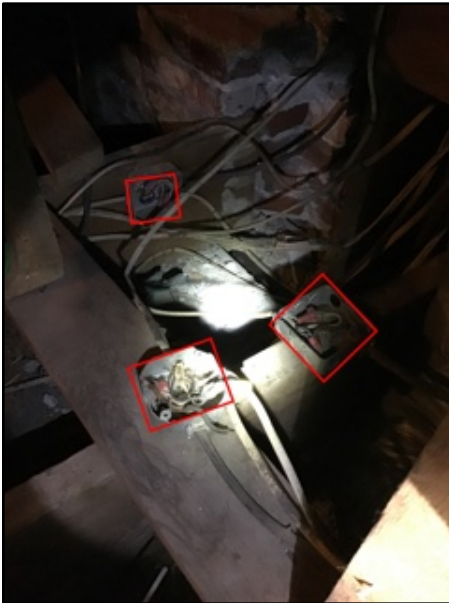
Figure 13-1

Open junction boxes in attic. Recommend installing covers to prevent personal harm or damage. Recommend seeking a handyman for further evaluation.

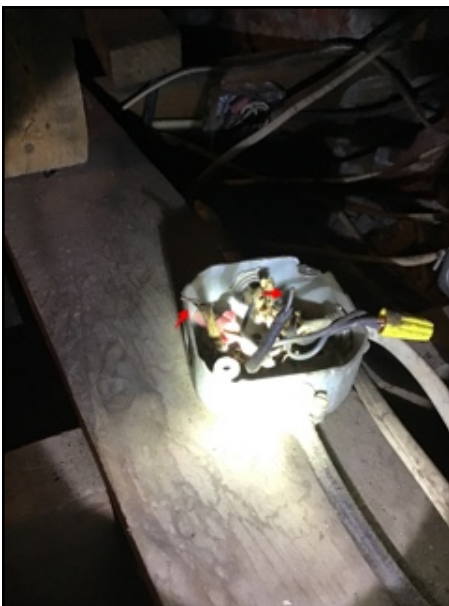
Figure 14-1

Uncapped/exposed electrical wires at junction box and conduit to the left and right sides of the stairs. Recommend capping wires to prevent damage or personal harm. Recommend seeking the appropriate tradesmen for further evaluation.

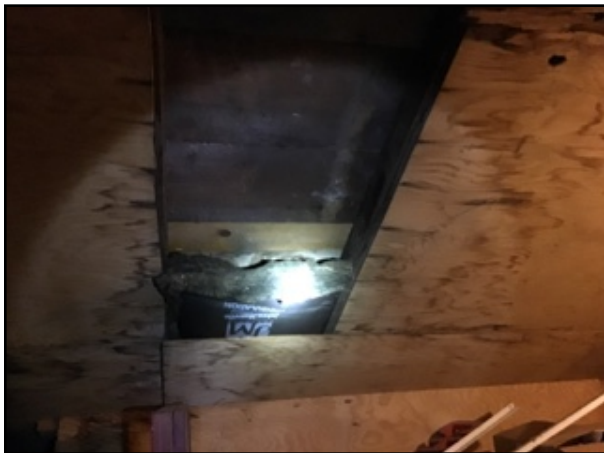
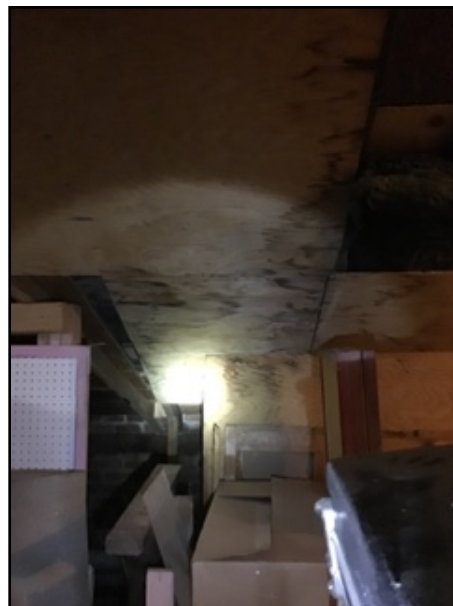
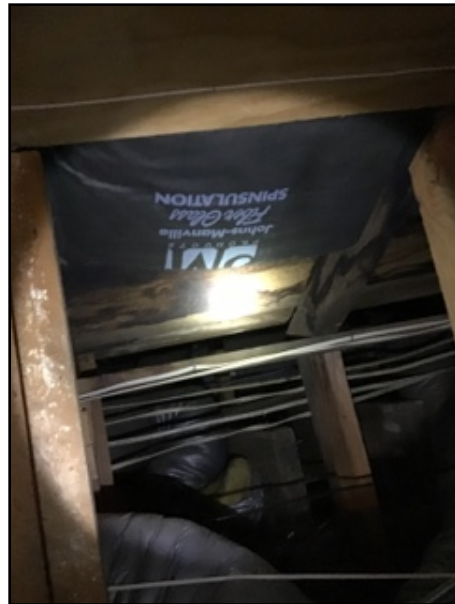
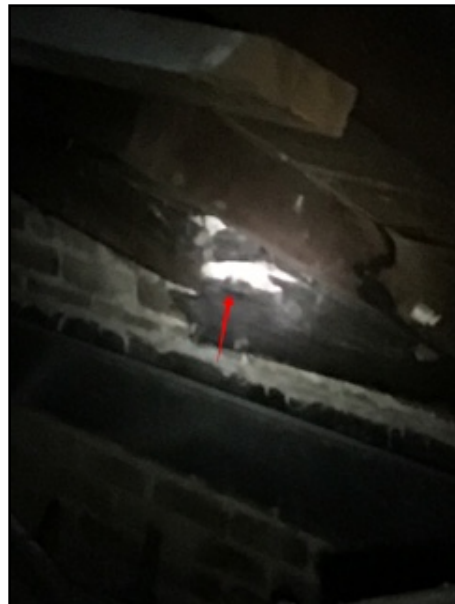
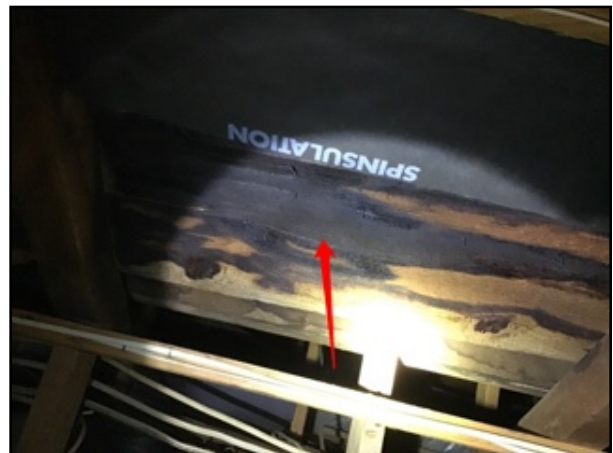
Figure 15-1

Water damage/stains/dark discoloration noted in attic. Recommend fixing leaks to prevent water damage/intrusion. Recommend seeking the appropriate tradesmen for further evaluation.

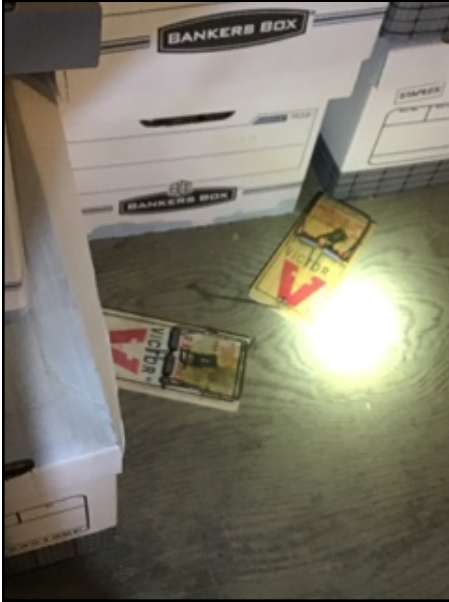
Figure 16-1

Evidence of rodents in attic. Recommend seeking the appropriate tradesmen for further evaluation.

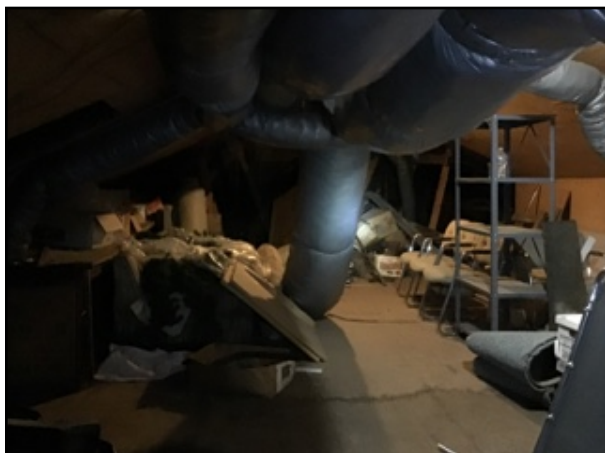
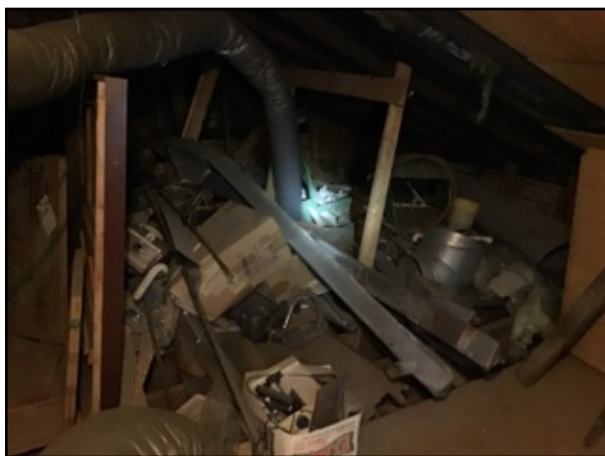
Figure 17-1

Portions of the attic space were not inspected due to being blocked by rafter webbing, ducts and insulation. Recommend seeking the appropriate specialist for further evaluation.

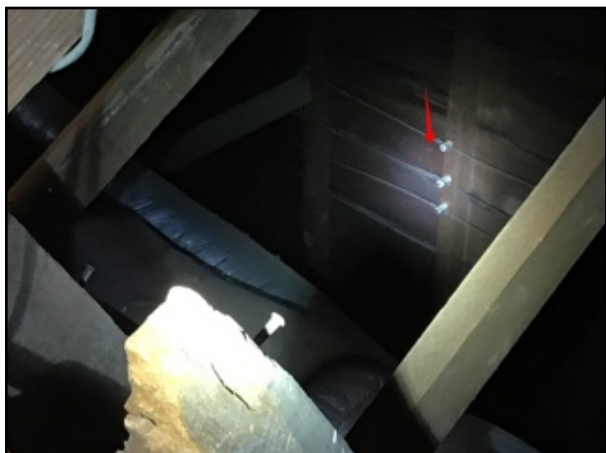
Figure 18-1

Outdated/obsolete electrical knob and tube in attic space. Recommend updating electrical. Recommend seeking a licensed electrician for further evaluation.

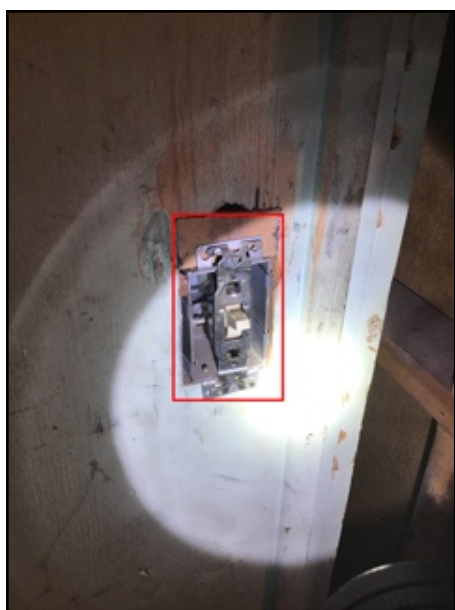
Figure 19-1

Missing light switch cover on the stairs to attic space. Recommend installing cover plate to prevent damage or personal harm. Recommend seeking the appropriate tradesmen for further evaluation.

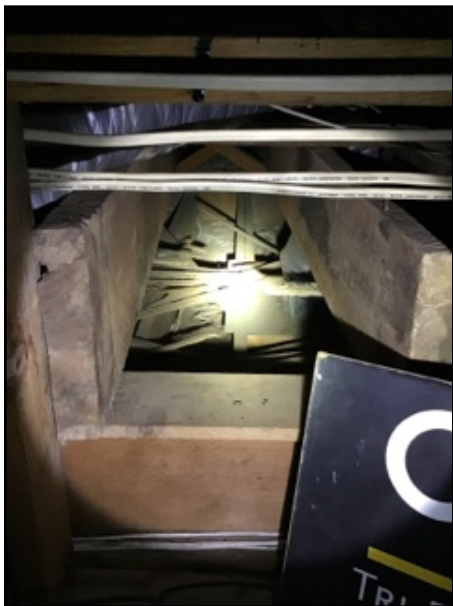
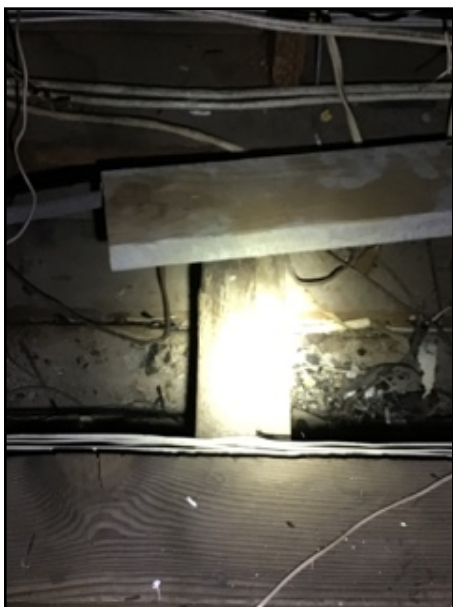
Figure 20-1

Low insulation in attic. Recommend installing insulation to the appropriate height. Recommend seeking the appropriate tradesmen for further evaluation.

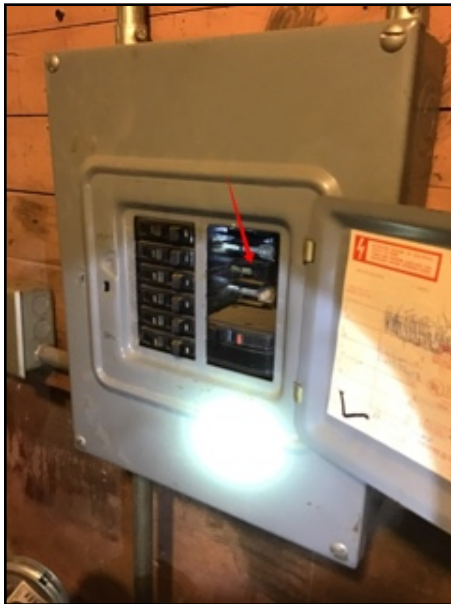
Figure 25-1

Comment 25:
Opening in sub electrical panel in heater closet. Recommend installing plastic grommets to prevent personal harm or property damage. Recommend seeking the appropriate tradesmen for further evaluation.

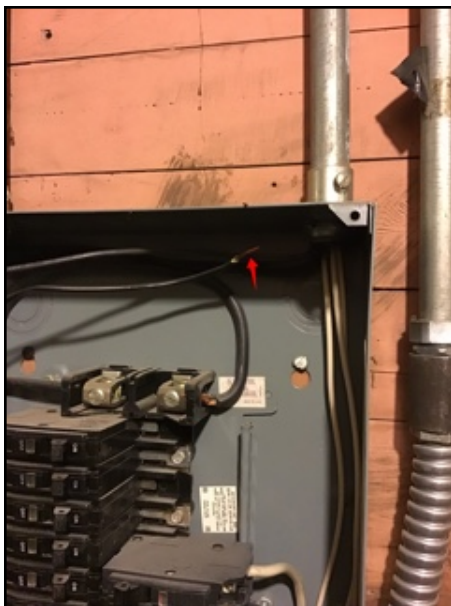
Figure 26-1

Uncapped wire in sub electrical panel at the rear of the structure. Recommend capping wires to prevent personal harm or damage. Recommend seeking an electrician for further evaluation.

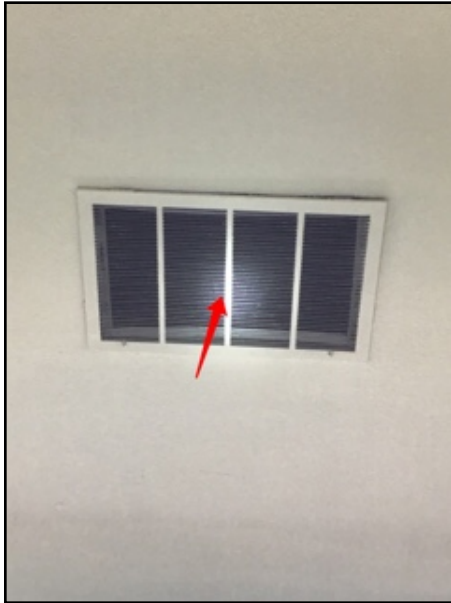
Figure 27-1

Dirty air filters for the heating system. Replace dirty filters to prevent stress on the system and promote healthy airflow. Recommend seeking a handyman for further evaluation.

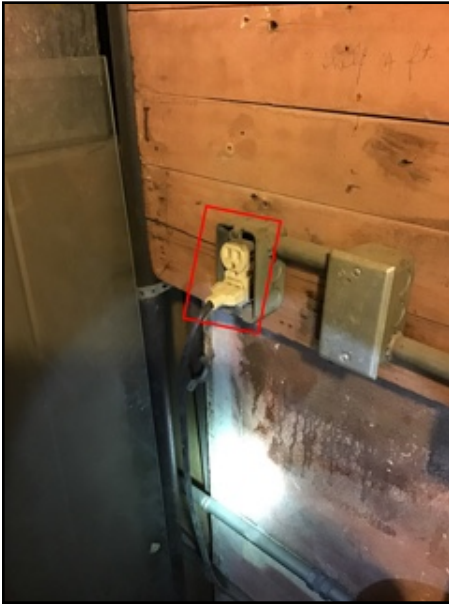
Figure 28-1

Missing outlet cover near heating unit and electrical/heating closet. Recommend installing cover to prevent damage or personal harm. Recommend seeking the appropriate tradesmen for further evaluation.

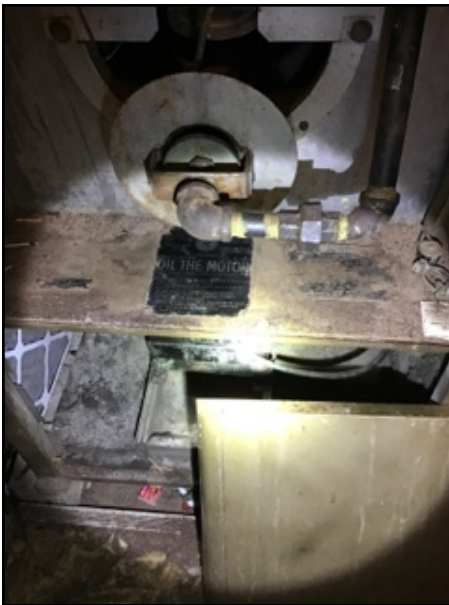
Figure 29-1

Missing data tag for heating unit in heater/electrical closet. Recommend seeking a licensed HVAC company for further evaluation.

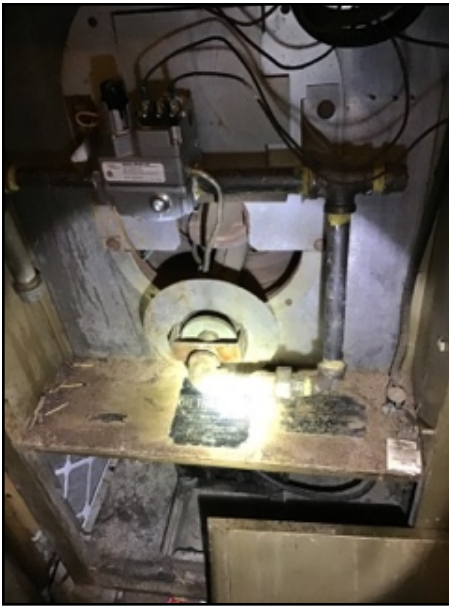
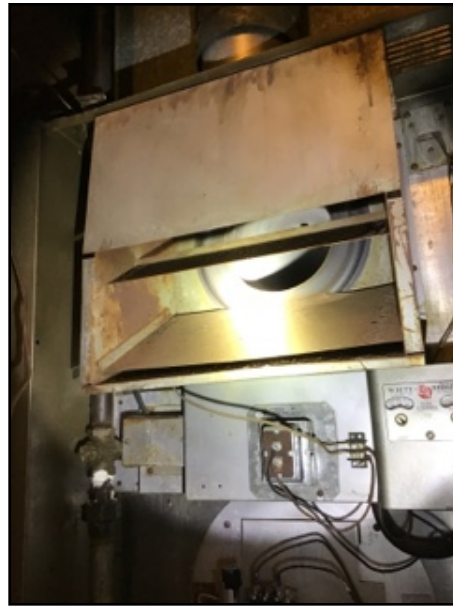
Figure 31-1

Excessive rust and dirt on heating unit. Recommend having unit serviced and inspected by a licensed hvac company.

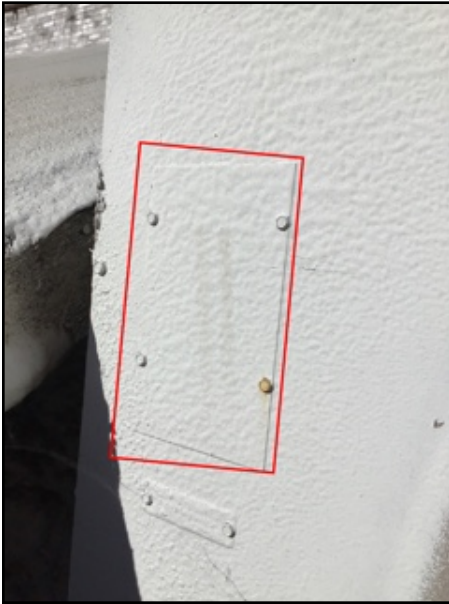
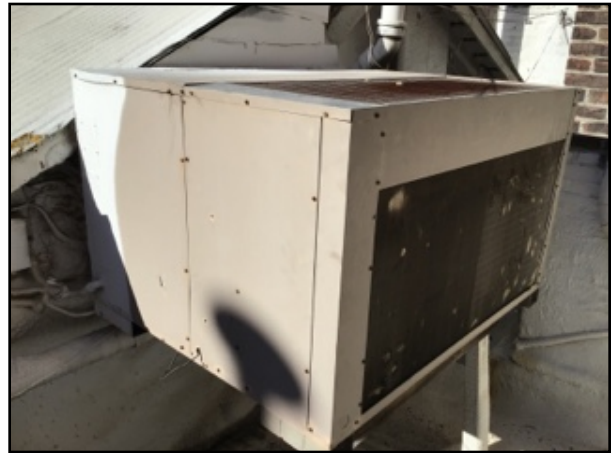
Figure 33-1

Painted over data plate at AC unit at the rear of the roof. Recommend seeking a licensed HVAC company for further evaluation.

At the time of the inspection, there were no maintenance tags on the cooling unit. Recommend having unit serviced before use. Recommend seeking a licensed HVAC company for further evaluation.

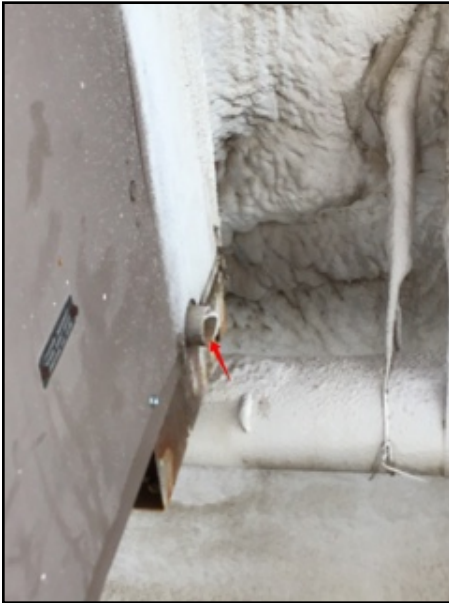
Figure 34-1

Missing/damaged condensation line at AC at the rear of the roof. Recommend adding condensation line and extending it to a drain to prevent intrusion/damage. Recommend seeking a licensed HVAC company for further evaluation.

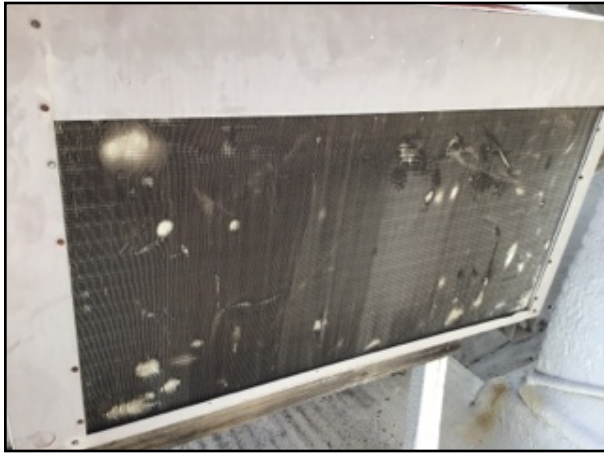
Figure 35-1

Damaged coils on AC unit at the rear of the roof. Recommend seeking a hvac company for further evaluation.

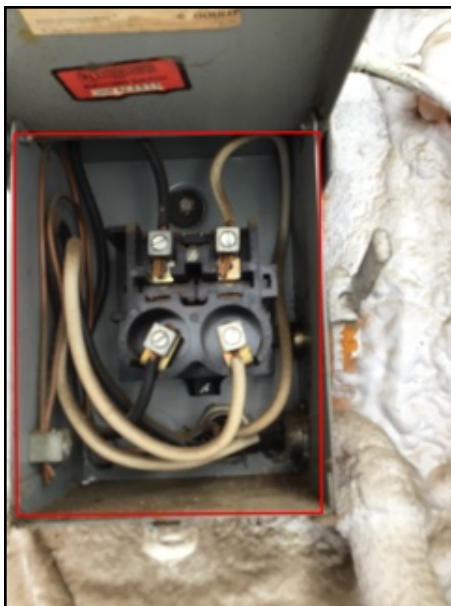
Figure 36-1

Missing dead front at the sub electrical panel on cooling unit at the rear of the roof. Recommend replacing dead front to prevent damage or personal harm. Recommend seeking the appropriate tradesmen for further evaluation.

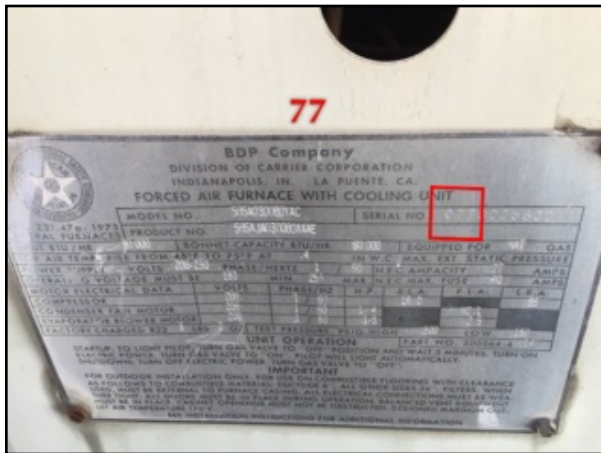
Figure 37-1

Data tag for package unit. Older package unit. Recommend having unit evaluated by a professional. Recommend seeking an hvac company for further evaluation.

At the time of the inspection, there were no maintenance tags on the package unit. Recommend having unit serviced before use. Recommend seeking a licensed HVAC company for further evaluation.

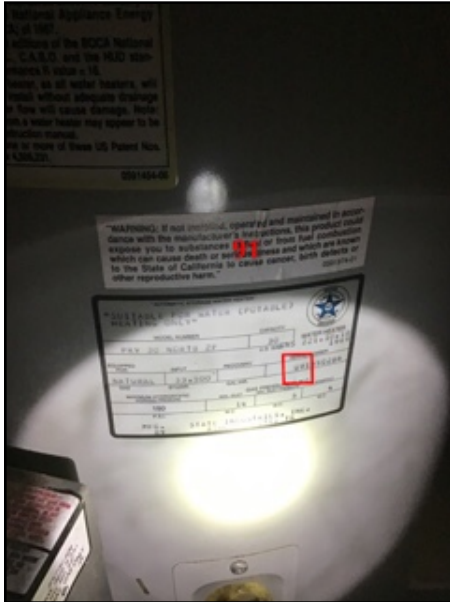
Figure 39-1

**Comment 39:**
Data tag for the water heater. The water heater is an older unit. Recommend seeking a plumber for further evaluation.

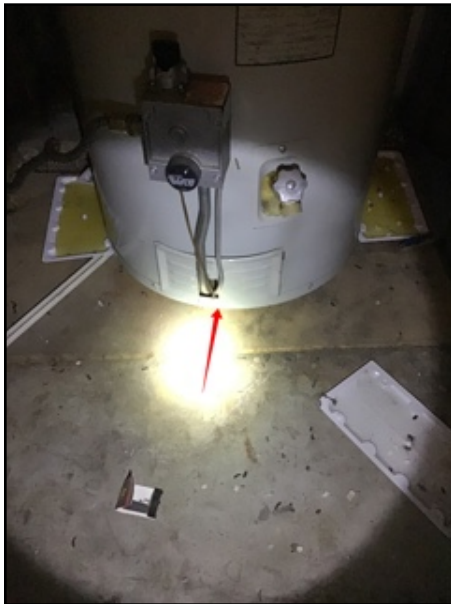
Figure 40-1

**Comment 40:**
Missing pan for water heater. Recommend installing pan to prevent water damage/intrusion. Recommend seeking the appropriate tradesmen for further evaluation.

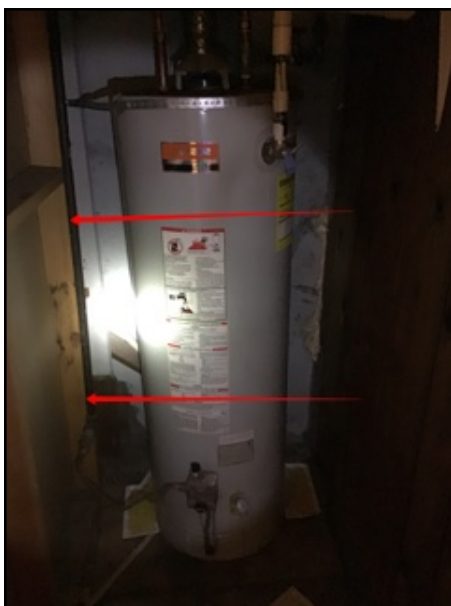
Figure 41-1

Water heater is improperly strapped. Requires 2 3/4" perforated 24 gauge straps and bracing behind it at the top and bottom. Recommend seeking the appropriate tradesmen for further evaluation.

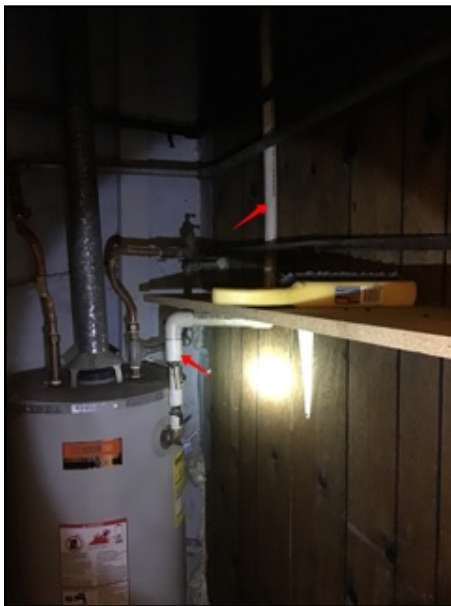
Figure 42-1

Temperature pressure relief pipe for the water heater is installed incorrectly with the wrong type of material. Recommend installing correct rated TPR valve piping to prevent water damage or possible harm. Recommend seeking the appropriate tradesmen for further evaluation.

Temperature pressure relief valve for the water heater isn't installed correctly because it runs uphill. Recommend seeking the appropriate tradesmen for further evaluation.

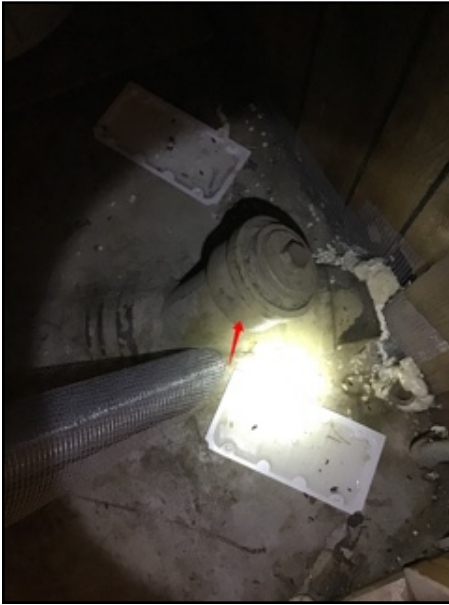
Figure 43-1

Outdated/rusted Cast-iron and galvanized plumbing around the structure. Service life of galvanized/cast iron plumbing is anywhere from 50 to 100 years. Recommend having plumbing inspected to determine life expectancy. Recommend seeking a licensed plumber for further evaluation.

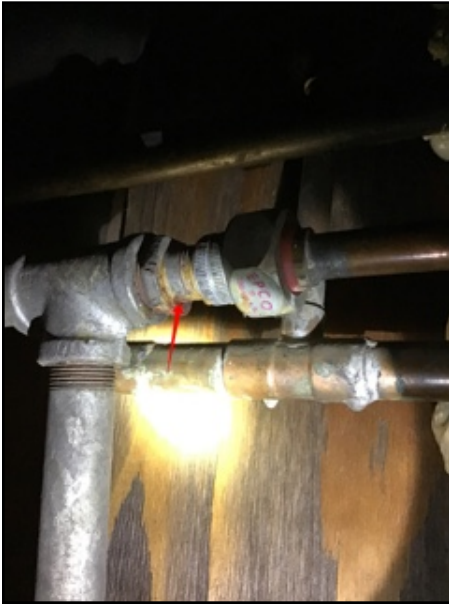
Figure 44-1

Rusted Non-dielectric union on water heater. A non-Dielectric union is where galvanized and copper meet. This has the potential to cause (electrolysis) which causes pin sized holes in the plumbing and could result in water damage. Recommend seeking a plumber for further evaluation.

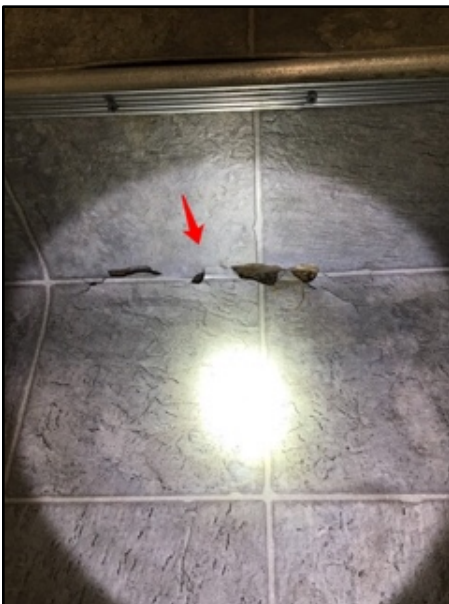
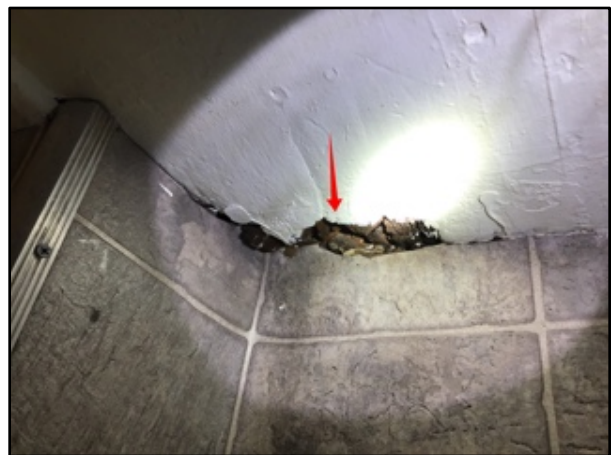
Figure 46-1

Water damaged stairs and wall at front bathroom at unit 44. Recommend removing and replacing water damaged areas to prevent further damage. Recommend seeking a pest inspection company for further evaluation.

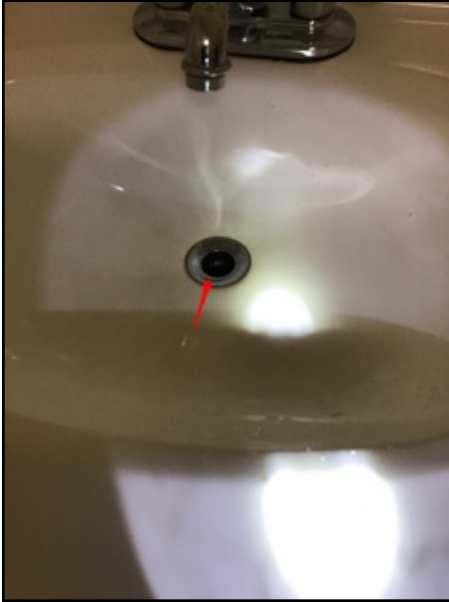
Figure 47-1

Missing sink stop in front unit 44 bathroom sink. Recommend seeking a handyman for further evaluation.

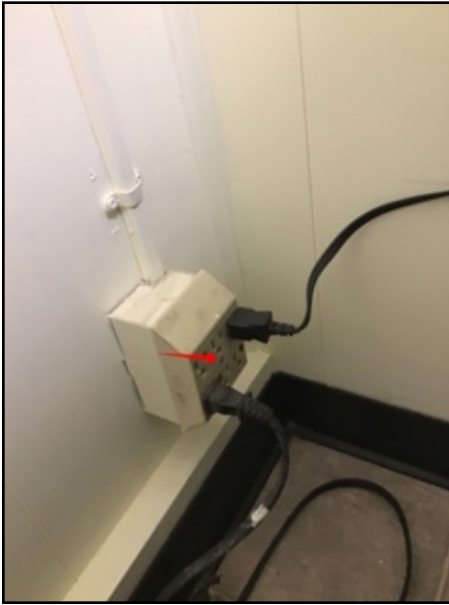
Figure 48-1

3 prong outlets in front unit 44 bathroom near water source. Recommend upgrading to a GFCI to prevent personal harm. Recommend seeking the appropriate tradesmen for further evaluation.

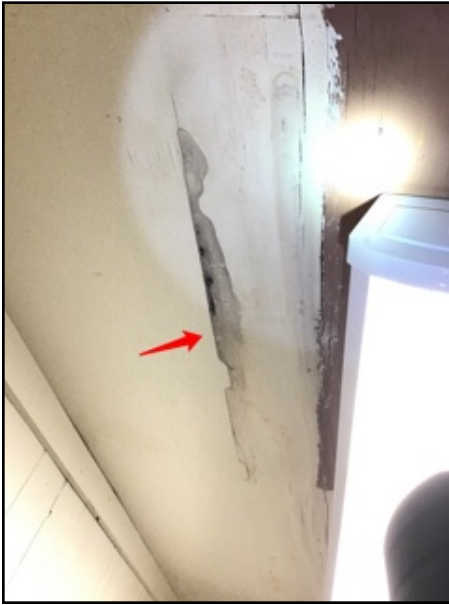
Figure 49-1

Water stains/dark discoloration noted on ceiling in rear bathroom unit 46.
Recommend seeking the appropriate tradesmen for further evaluation.

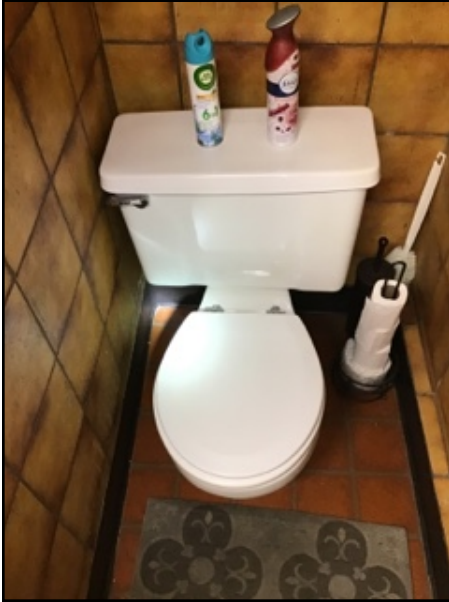
Figure 50-1

Loose toilet in rear bathroom unit 46. Recommend tightening down toilet to prevent damage or personal harm. Recommend seeking a handyman for further evaluation.

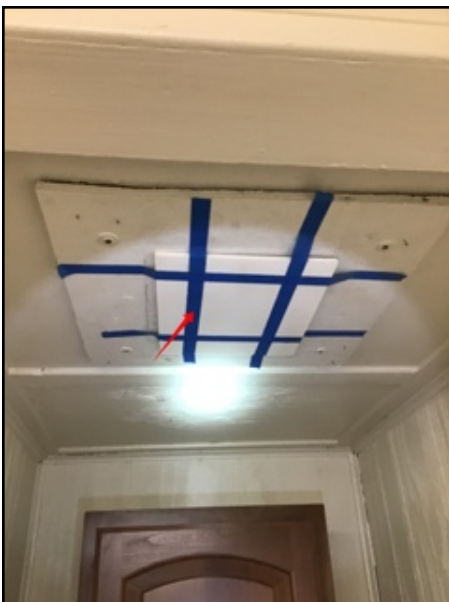
Figure 51-1

Missing ventilation in rear bathroom unit 46. Recommend seeking the appropriate tradesmen for further evaluation.

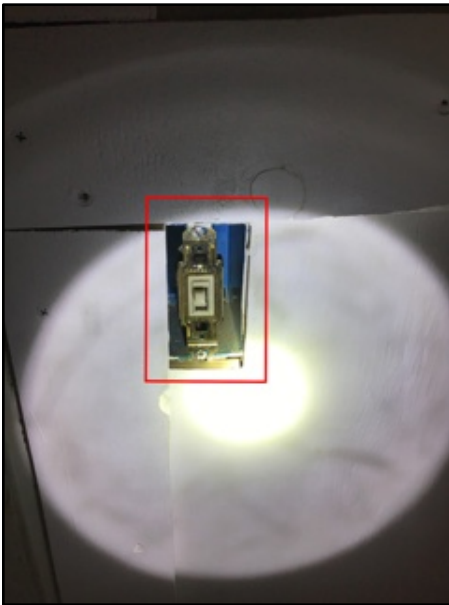
Figure 52-1

Missing switch cover in kitchen. Recommend installing cover plate to prevent damage or personal harm. Recommend seeking a handyman for further evaluation.

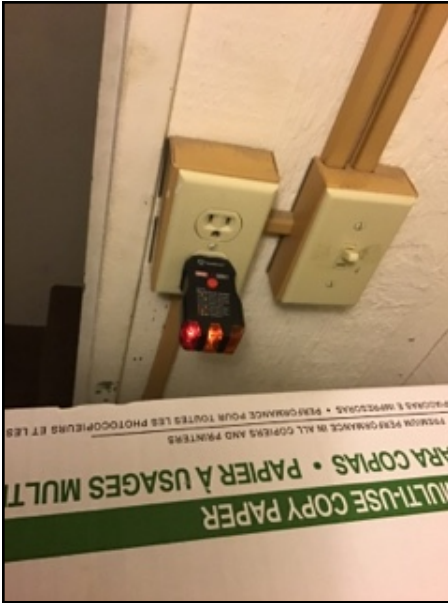
Figure 53-1

Improperly installed three prong outlet in the hallway of unit 44 near stairs to kitchen and second story. Recommend installing outlet properly to prevent damage or personal harm. Recommend seeking an electrician for further evaluation.

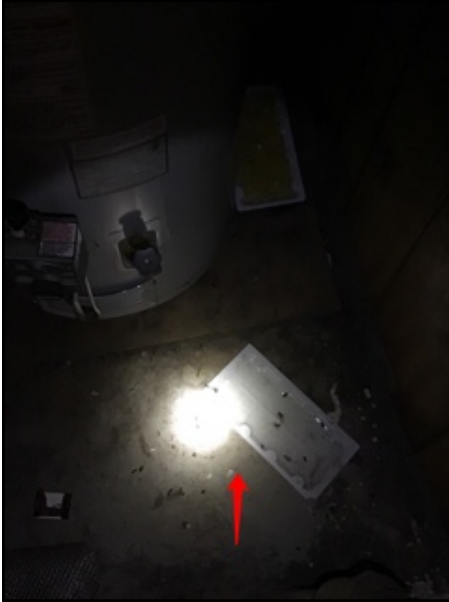
Figure 55-1

**Comment 55:**
Evidence of rodents on the interior. Recommend seeking a pest inspection company for further evaluation.

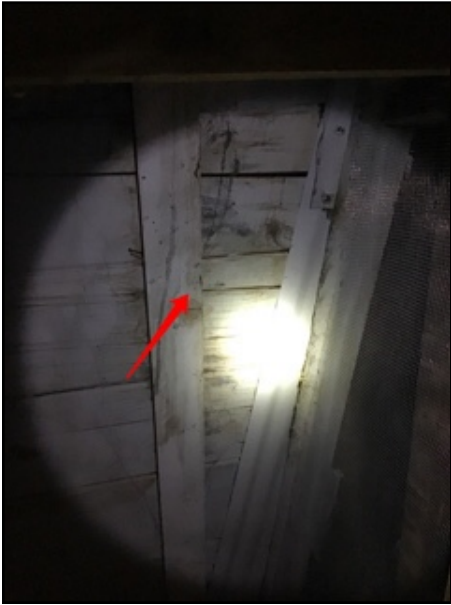
Figure 56-1

**Comment 56:**
Water stains/dark discoloration noted in in water heater/heater closets, kitchen area and ceiling of unit 46. Recommend fixing leaks to prevent water damage/intrusion. Recommend seeking the appropriate tradesmen for further evaluation.

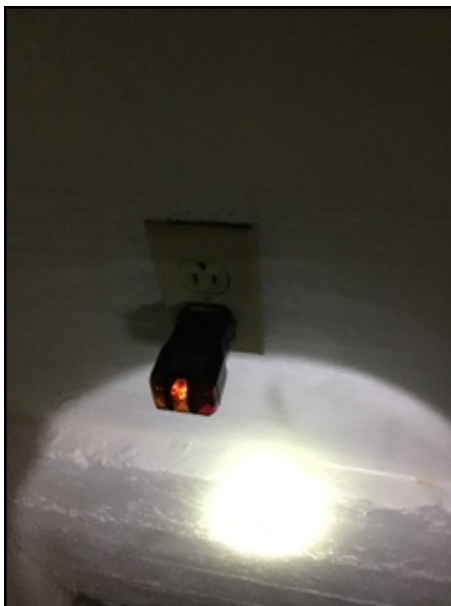
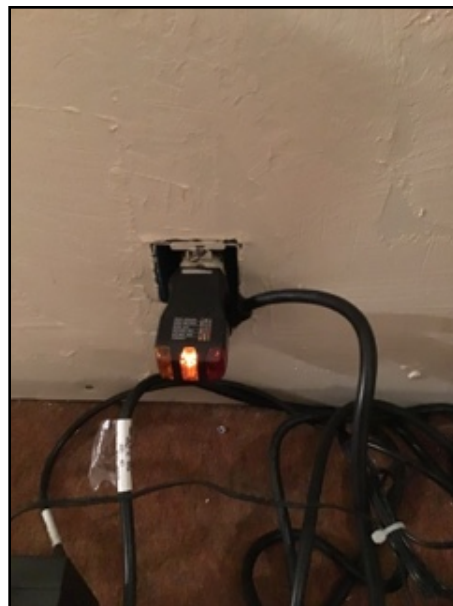
Figure 57-1

Ungrounded 3 prong outlets in various areas of the structure. Recommend grounding three prong outlets or reverting back to two prong ungrounded to prevent damage or personal harm. Recommend seeking an electrician for further evaluation.

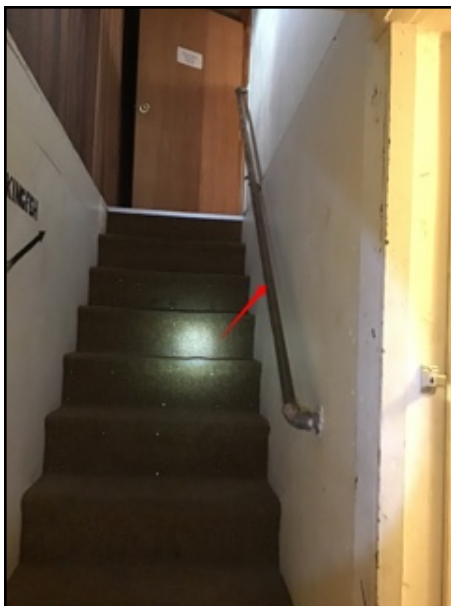
Figure 58-1

Loose handrail on stairs leading to second story. Recommend tightening down handrail to prevent damage or personal harm. Recommend seeking the appropriate tradesmen for further evaluation.

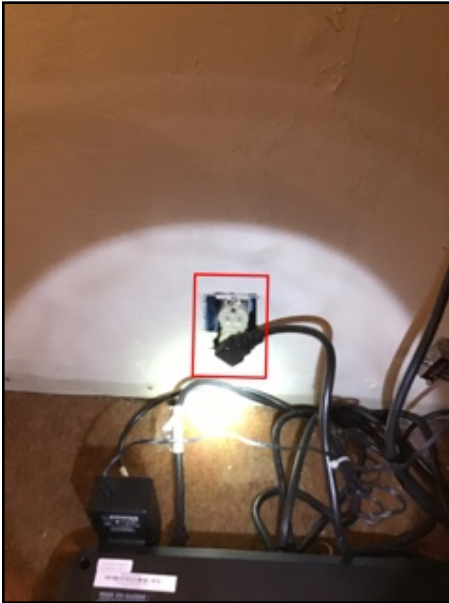
Figure 59-1

Missing outlet/light switch covers and various areas of the interior. Recommend installing outlet covers to prevent damage or personal harm. Recommend seeking a handyman for further evaluation.

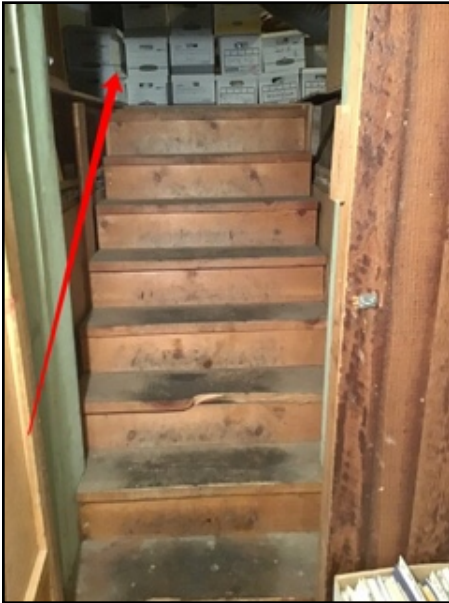
Figure 60-1

Missing handrail on stairs from second story to attic space. Recommend installing handrail to prevent damage or personal harm. Recommend seeking the appropriate tradesmen for further evaluation.

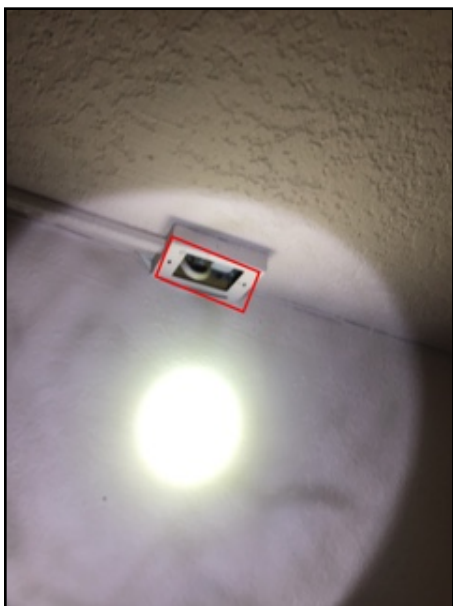
Figure 61-1

Open junction box in downstairs near bathroom. Recommend installing a cover to prevent personal harm or damage. Recommend seeking a handyman for further evaluation.

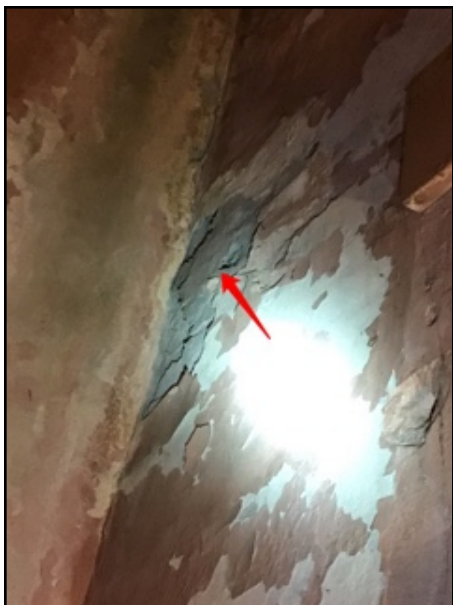
Figure 62-1

Spalling noted on walls in electrical room/heater closet. Recommend seeking a licensed contractor for further evaluation.

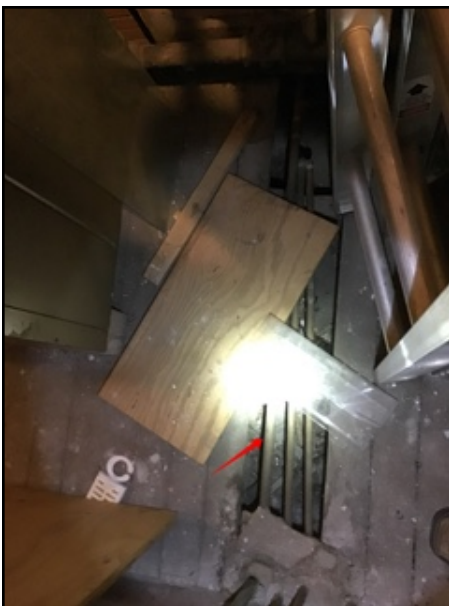
Figure 63-1

Missing flooring in electrical/heater room. Recommend installing floor to prevent personal harm or damage. Recommend seeking the appropriate tradesmen for further evaluation.
