Property Inspection Report

Inspection Address
1148 53rd Street
Oakland, CA 94608

September 25, 2025

Tarkington Home Inspections
Cell (510) 566-2195
www.THInow.com

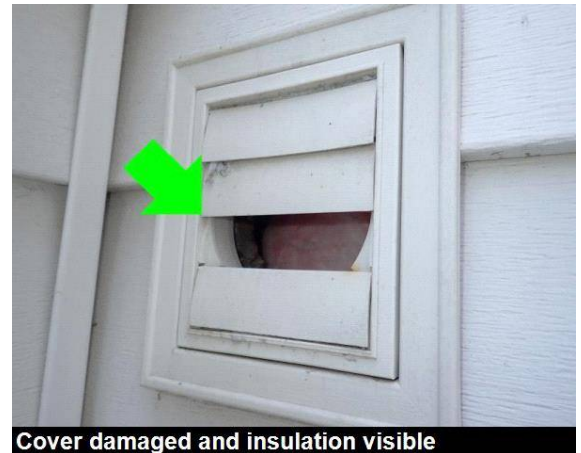
A dryer exhaust cover at the rear is damaged and insulation was visible. This may allow water into the wall and we recommend repair.

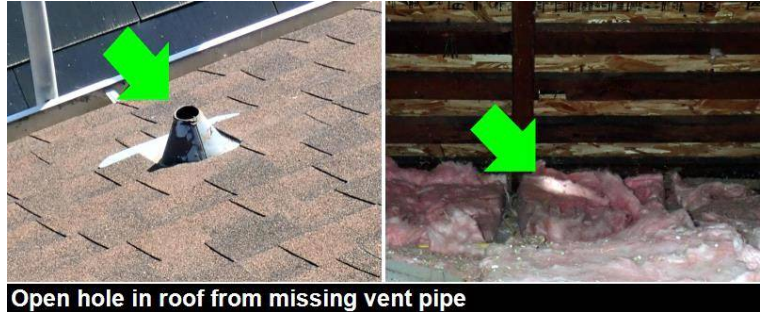
5.6 PIPING PENETRATIONS

The vent pipe is missing in a pipe flashing at the right side, leaving an open hole into the attic. We recommend repair to prevent water entry into the attic.

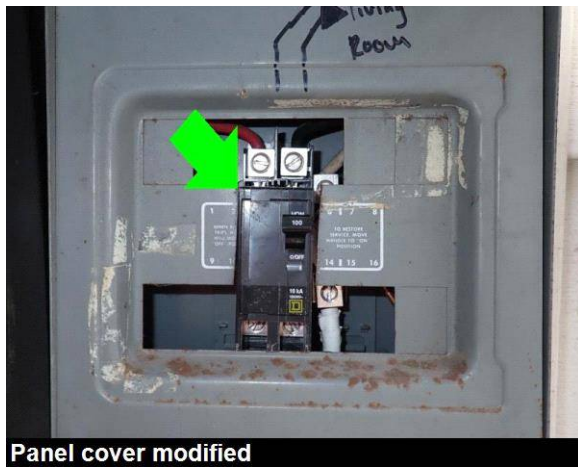
8.5 PANEL COVER

Several panel screws are missing from the Unit 1148 panel and we recommend they be installed.

The Unit 1148 panel bus bar has been replaced and the faceplate cut to allow a new main breaker to be installed. There are now openings in the faceplate of the Unit 1148 panel. We recommend the panel cover openings be covered, or a new panel installed, to prevent accidental access to the panel interior and a possible shock.

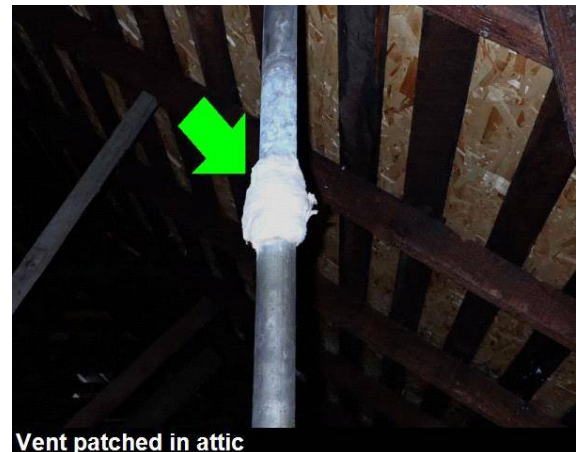
Repairs were noted to waste pipe in the basement and attic. We recommend a history of repairs be obtained from the sellers.

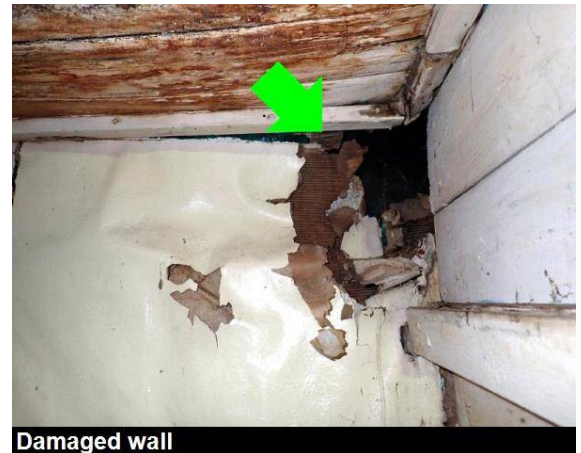
There are stains and damage to the walls and ceiling in the rear addition closet, which appeared dry at the time of our inspection. We recommend the damaged walls and ceiling be replaced and then these areas be monitored periodically for leakage in the future and repairs made if new leakage occurs.

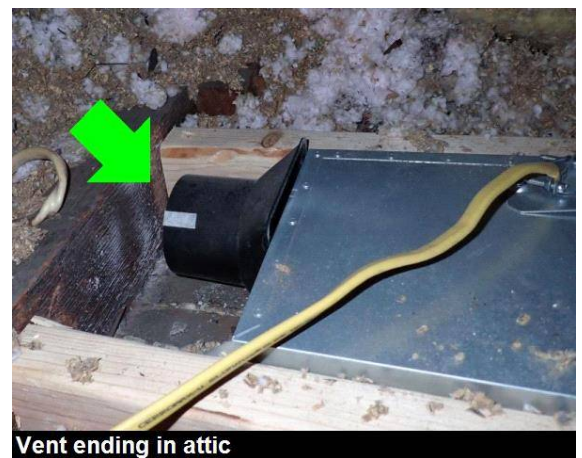
The fan vents into the attic. We recommend a proper extension duct be installed to vent moisture to the building exterior.
