Home Systems Data, Inc
7305 E Peakview Ave
Centennial, CO 80111
303-773-6102
J. Vince Busnardo
ASHI CHI #247100

Phillippe, Thomas
1650 Pennsylvania St
Denver, CO 80203

Inspected 2/17/26 9:00 AM, Buyer and Agent, Vacant, Built 1896, Sunny 45+-, Faces West,
420inspection+170radon=\$590.00 This Report Is Non Transferable

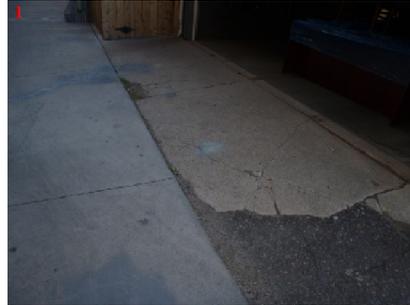
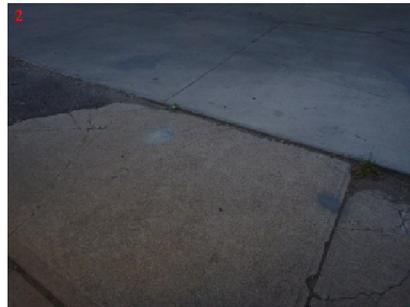
Driveway

Cracks and deterioration present.
Uneven areas present a tripping hazard.
Recommend corrections by a qualified contractor.

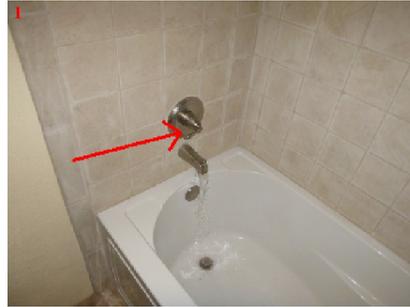
Bathtub Faucets

Only hot water from the tub control, scald hazard.
Recommend correction.

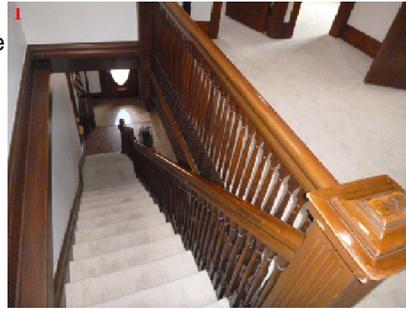
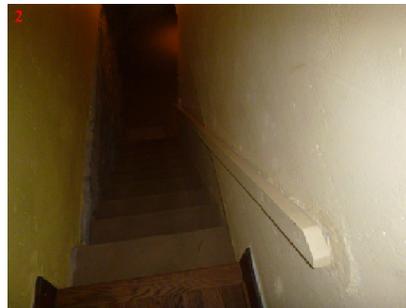
Main staircase railing is original. It does not meet current standards as it is too low and is not graspable at mid point where it touches side rail. Use caution.

The bsmt staircase handrail is not graspable for much of its run, replacement advised.

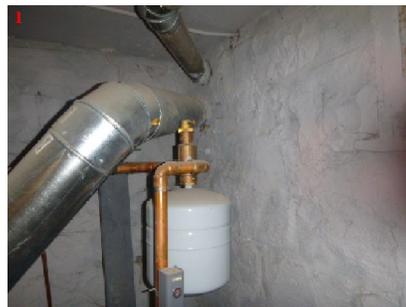
Expansion Tank

Recommend expansion tank be properly strapped to reduce fatigue and stress on pipes.

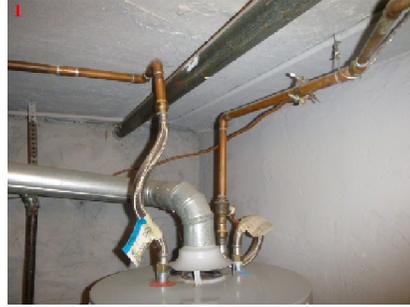
No pressure expansion device (TXV or expansion tank) found on the cold water pipe feeding the water heater. These help relieve pressure from heating the water. They are required in certain conditions.

BuildFax does not show a permit for water heater install.

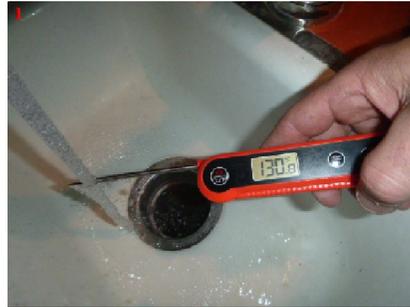
Water Temperature

Water temperature tested at 130.8°, 120.0° is advised.

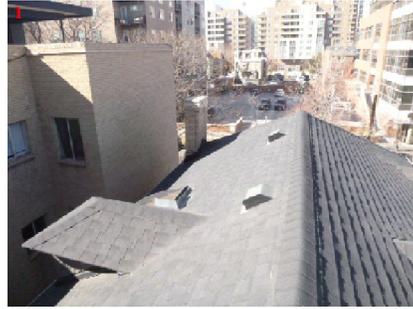
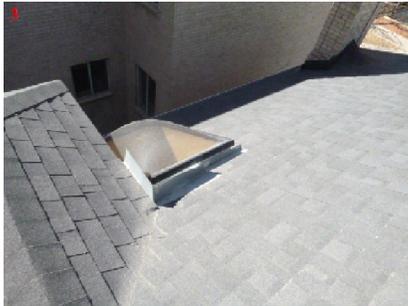
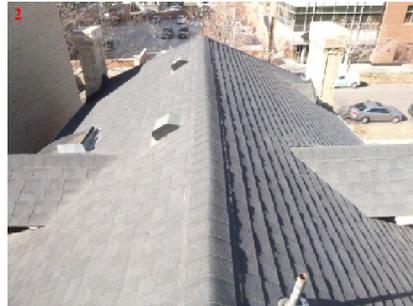
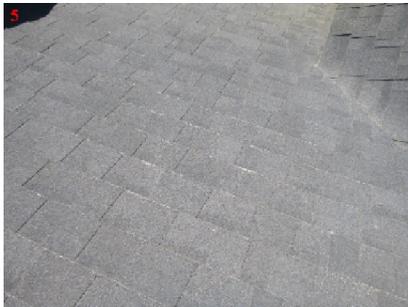
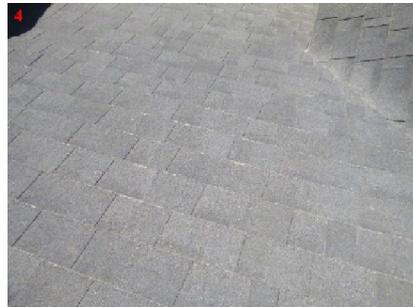
Incorrect flashing/cricket above the skylight.

General age deterioration.

Recommend roof be evaluated, corrected, and certified for five years by a licensed roofing contractor due to, but not limited to, the following conditions.

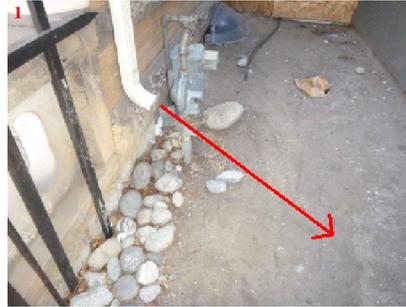
Runoff Drains

Improper, clogged, damaged, etc. extensions can cause water intrusion into bsmt/crawl space, and can cause damage to foundation.
Recommend extensions take water at least 4-5ft from foundation.
Recommend extensions rather than splash blocks.

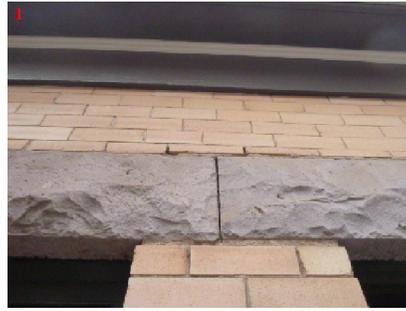
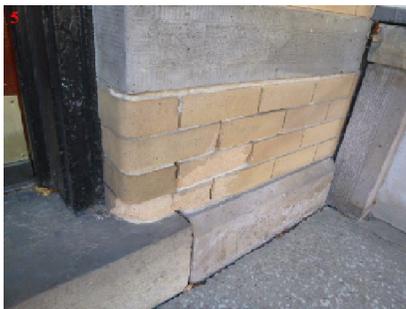
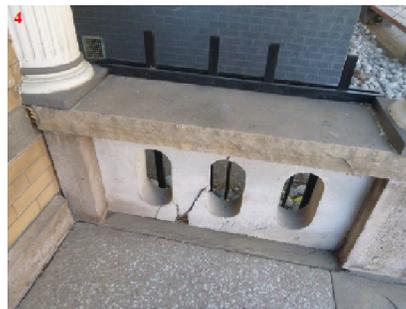
Mortar deterioration in several locations.

A few brick cracks and damage.

Precast stone at front porch is damaged.

Recommend all masonry be serviced by a certified masonry contractor familiar with historic masonry due to but not limited to the following.

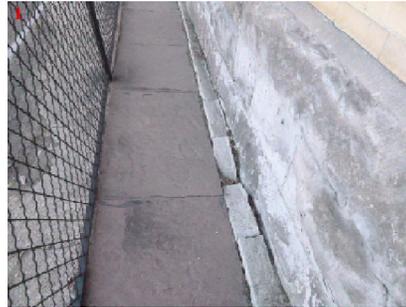
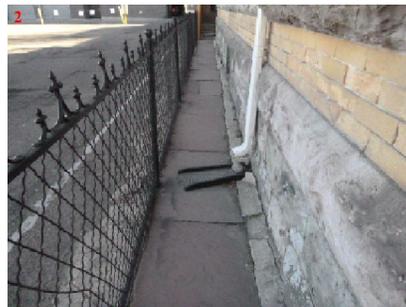
Walks

Stone sidewalk along north side is settled and shifted, sloped toward building.
Potential for moisture intrusion to bsmt and foundation.
Recommend corrections.

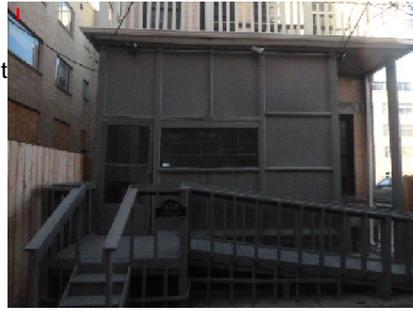
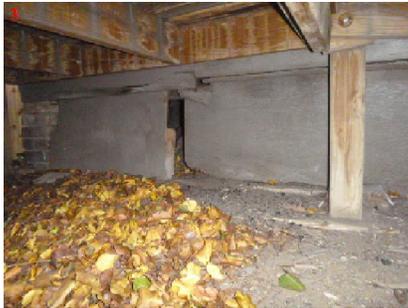
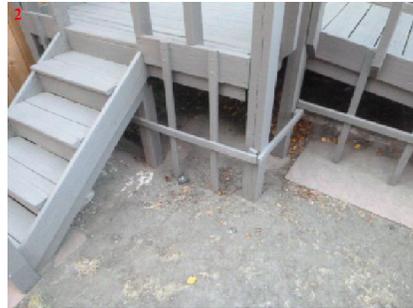
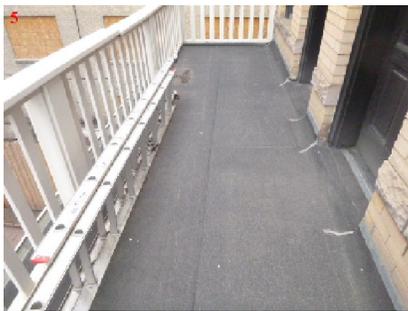
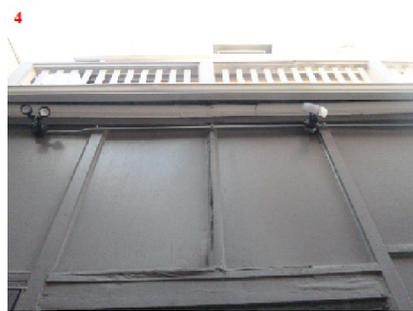
Decks

The back addition is built half on a stone foundation and half like a deck.
The section built like a deck is sagging/failing and will need significant work or removal and replacement.
Evidence of leaking.
Soft spots in its balcony/roof when walked across.
Recommend a qualified contractor make corrections.

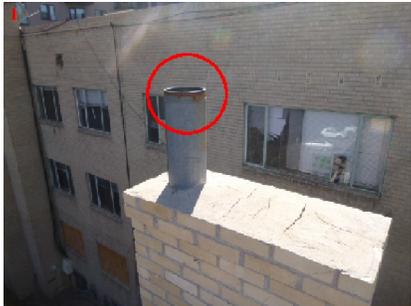
Chimney Cap

The boiler and water heater flue is missing its termination cap above the chimney.
Recommend corrections by a licensed HVAC contractor.

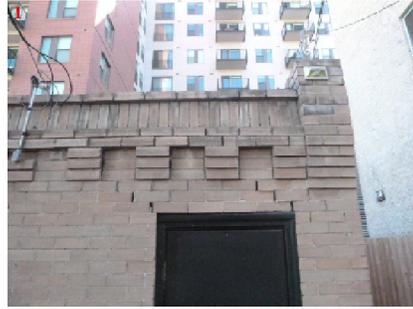
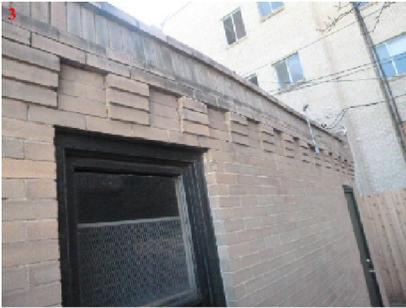
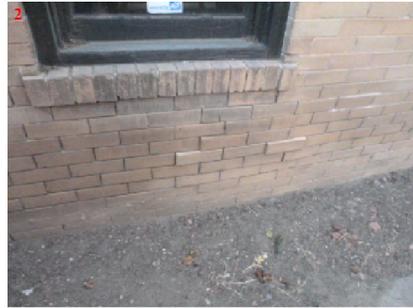
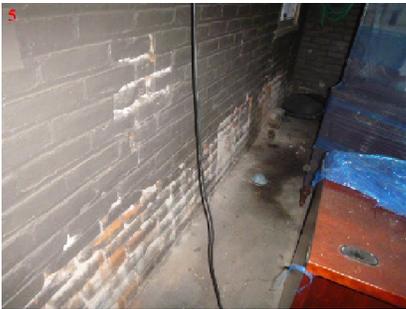
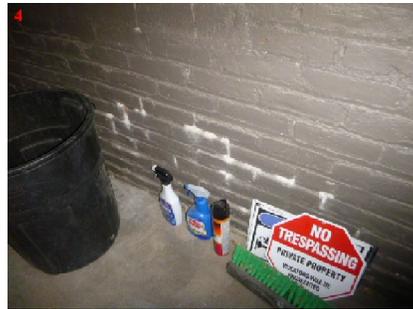
Garage Exterior Walls

The west wall of the garage is damaged from the inside out, looks like a car drove into it.
Recommend the wall be corrected by a certified masonry contractor.

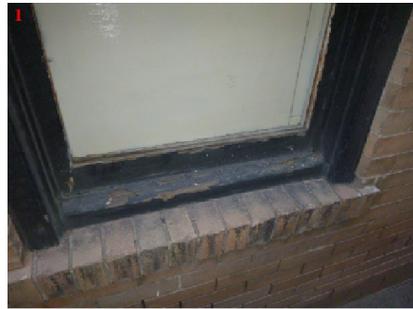
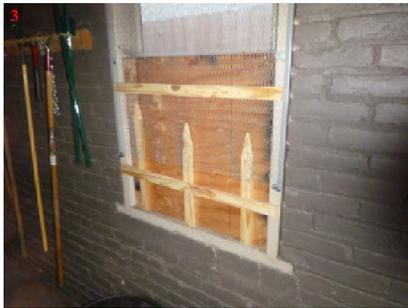
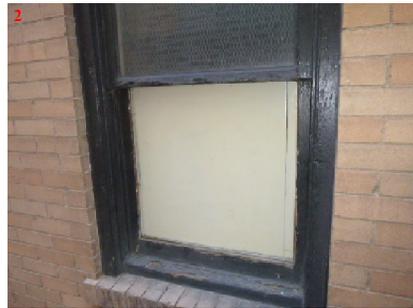
Garage Windows

Garage south window has glass missing and is boarded over.

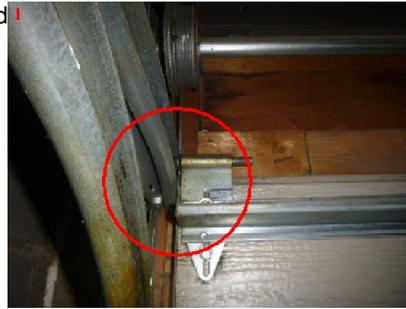
The garage door needs service. It is not centered in the opening and is pinching/crushing the cable at the north side. Recommend service by a certified garage door contractor.

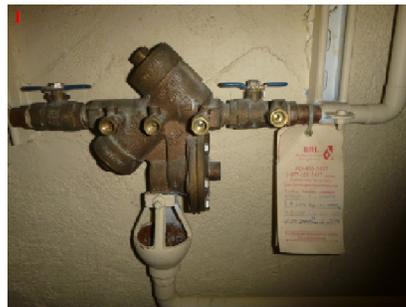
Back flow preventer certification is expired.

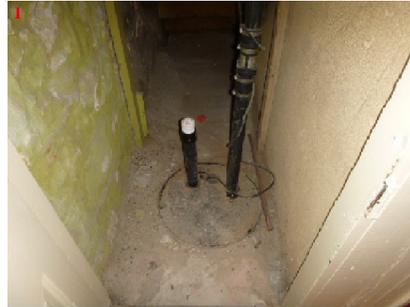
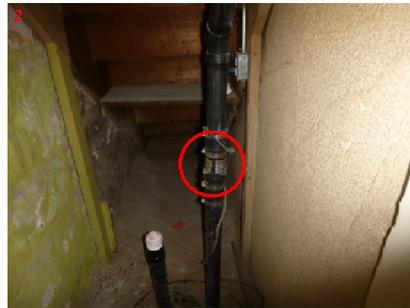
Sewage ejection pumps require servicing, recommend inquiry with qualified plumbing contractor for service recommendations.

Sewage ejection pump does not have an alarm to alert user of a failed or clogged pump. Recommend an alarm be installed.

Tank was not opened, unverified pump type.

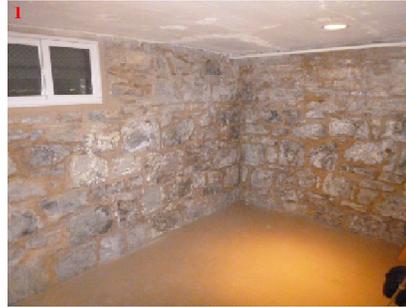
Basement Foundation Walls

Evidence of water intrusion, recommend improving exterior drainage.

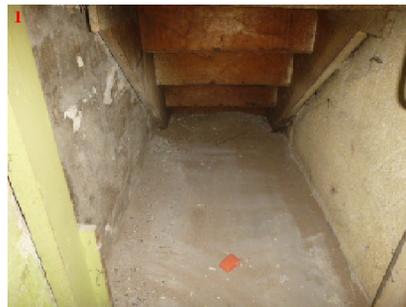
Basement Floor

Bsmt stairs are touching debris and dirt under them, potential for moisture and critter issues. Recommend cleaning/clearing away.

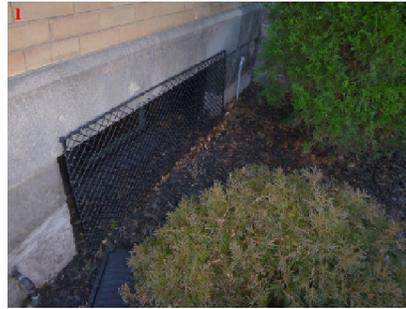
Window Wells

Soil grade and sidewalks are higher than some windows, soil touching front bsmt window.

Recommend corrections to meet egress needs and reduce potential from moisture and critter issues.

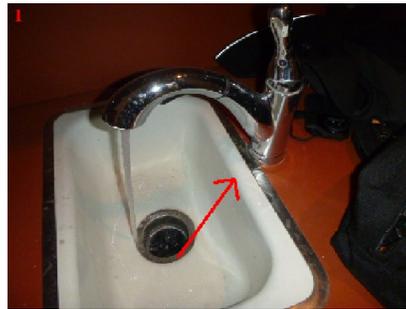
Kitchen Sink Faucet

Sink faucet is loose at countertop mount.

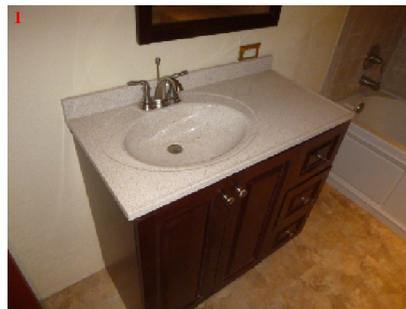
Bathroom Countertop

Countertop is not secured to vanity at bsmt bathroom.

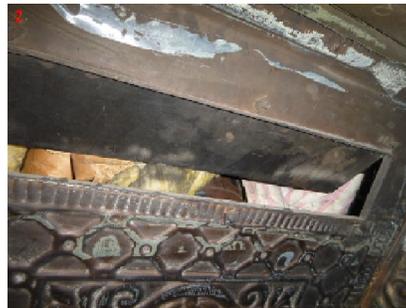
Interior Fire Place 2

Recommend a level 2 inspection (as defined by NFPA or CSIA standards) for all solid fuel burning devices at the time of sale by a certified contractor.
Parlor fireplace is original coal burner. Do not burn wood.
Flue is stuffed with insulation.

Parlor fireplace is original coal burner. Do not burn wood.

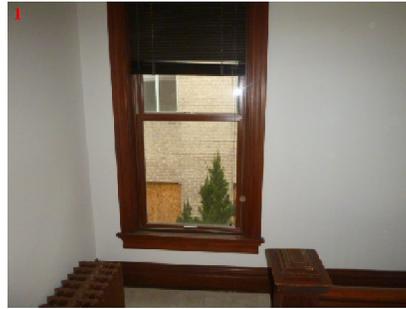
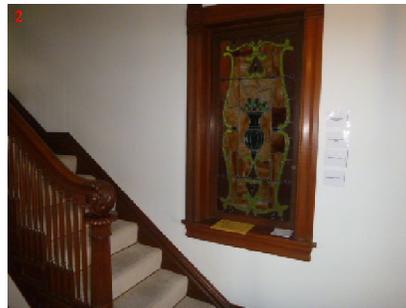
Windows

Window at the top of the main staircase does not stay open on its own. Recommend repair.

The stained glass window at the bottom of the ain staircase is not safety rated.

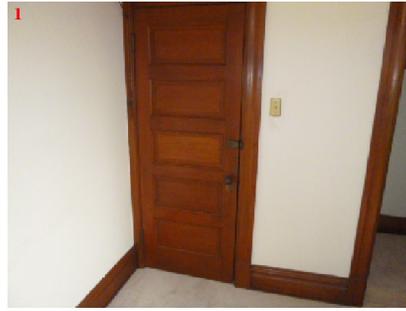
Doors throughout are racked, drag on jambs, do not latch, etc.
Indication of historic movement.
Recommend corrections as needed.

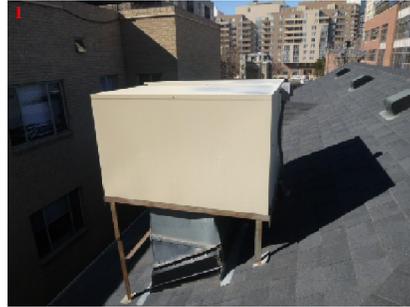
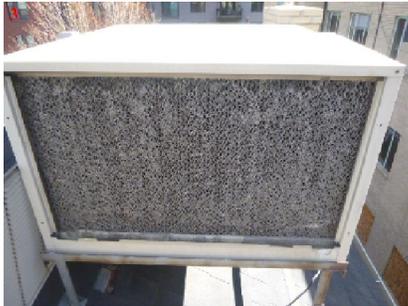
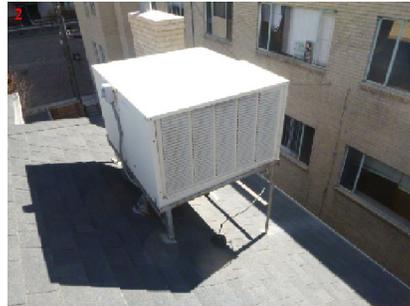
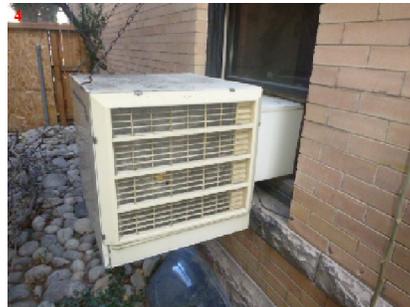
COOLING SYSTEM

Two evaporative coolers, both are shut down for the season. Pads should be replaced before this cooling season starts. Roof top unit is a commercial type while the window unit is more residential. Roof top unit is controlled by a thermostat at the top floor hall. Window unit is controlled at front of unit. Windows in the building must be slightly opened when running coolers or cooling affect will not occur and will feel muggy.

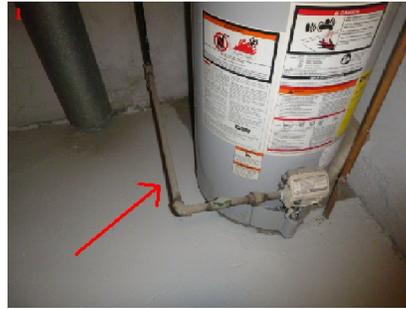
Water Heater Fuel

Recommend flexible gas connector be added at water heater by a licensed plumbing contractor to allow for movement of the floor without pressure on the gas lines.

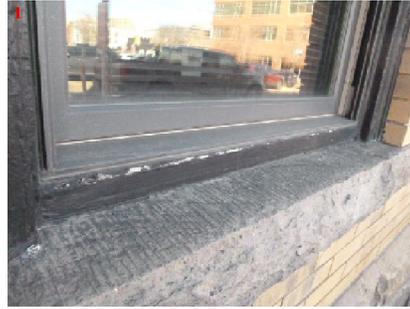
Trim Work

Some loose paint and deterioration noted.
Recommend prep and paint where needed.

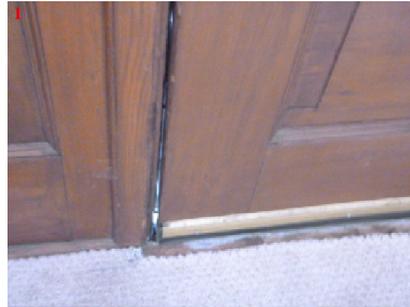
Weather Stripping

Weather strips at exterior doors could be improved for increased efficiency.

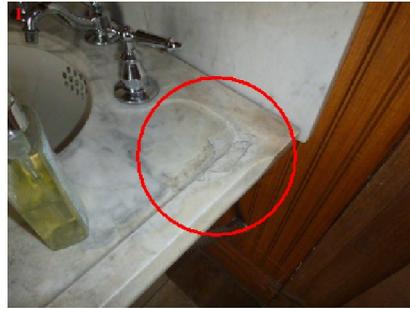
Bathroom Countertop

Deterioration of countertop at the top floor bathroom.

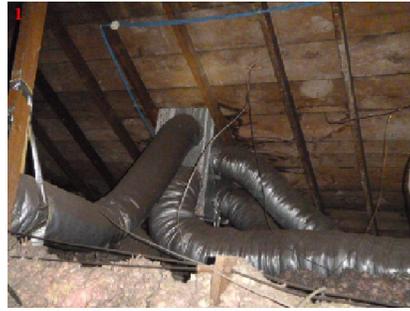
Attic Sheathing

Old water stains around evaporative cooler, monitor for leaks and correct if needed.

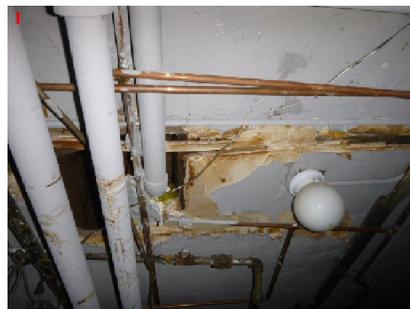
Old water damage in boiler room ceiling, dry at time of inspection. The break room is above this and suspect past leaks. Concealed conditions including microbial growth may exist.

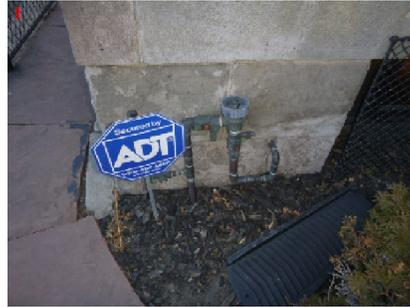
Sprinkler System

Sprinklers not inspected per standards of practice.
Recommend sprinkler anti-siphon valve, sprinkler heads, and zones boxes be at least five feet from foundation.
Sprinkler system should be winterized no later than mid-Oct but before first freeze.
Sprinklers are shut off, unable to determine if proper winterization was done.
