Building Inspection Report

2552 Bushnell Avenue - Dayton, Ohio

Inspection Date: 8/6/24

Report Number: 862552

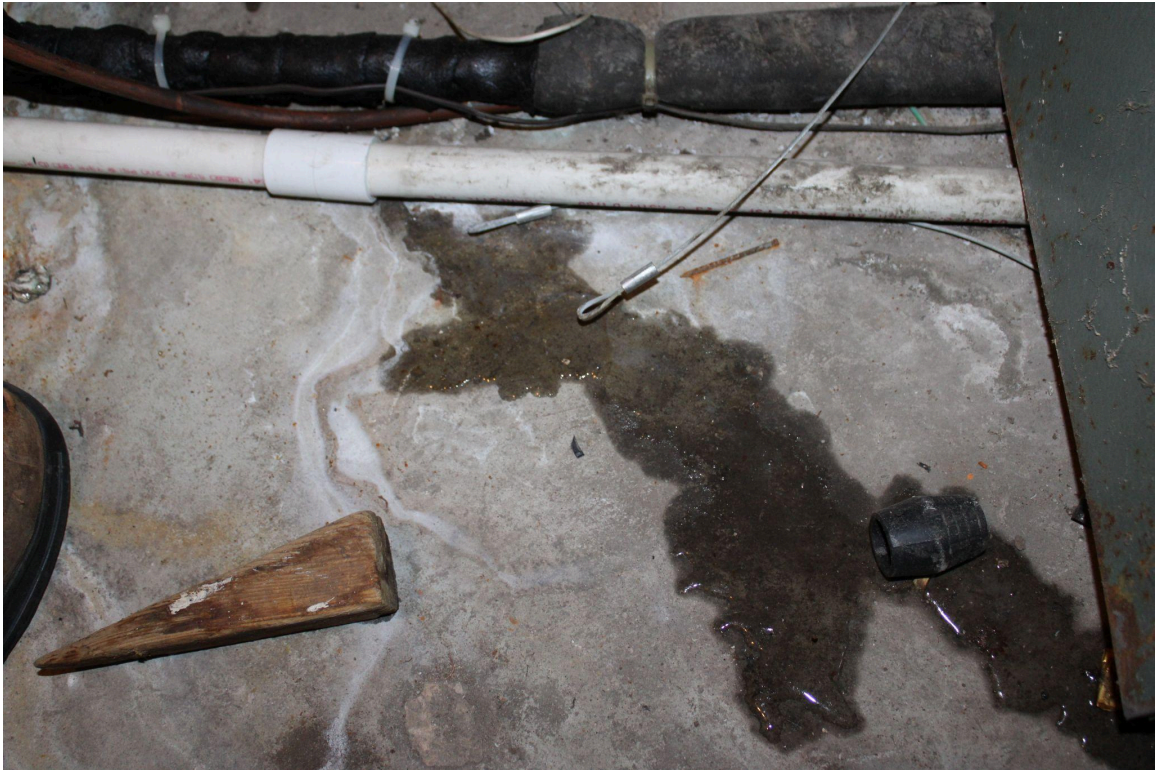
- Observed the condensate drain line for Furnace #2 was leaking. Recommend consulting an HVAC contractor for estimate of proper repair. See photo below in the Cooling Section.

Unit #2 condensate drain line leak.

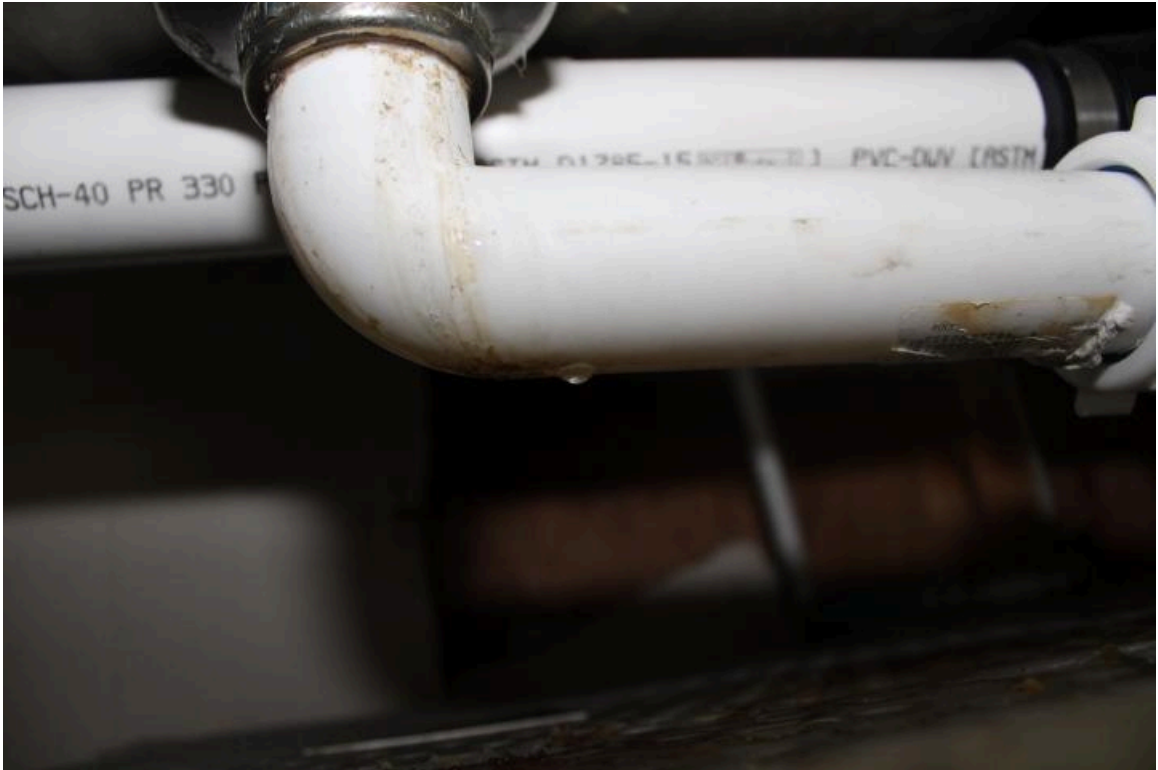
- Observed a leak on the kitchen sink drain. Recommend consulting a plumber for an estimate of proper repair. See photo below in Plumbing Section.
- Observed that the top breaker on the left side of the main electric service panel was a 40 amp double pole breaker that appears to be protecting a wire only rated for 30 amps. Recommend consulting an electrical contractor for further evaluation/repairs as recommended.

Leak on the kitchen sink drain.

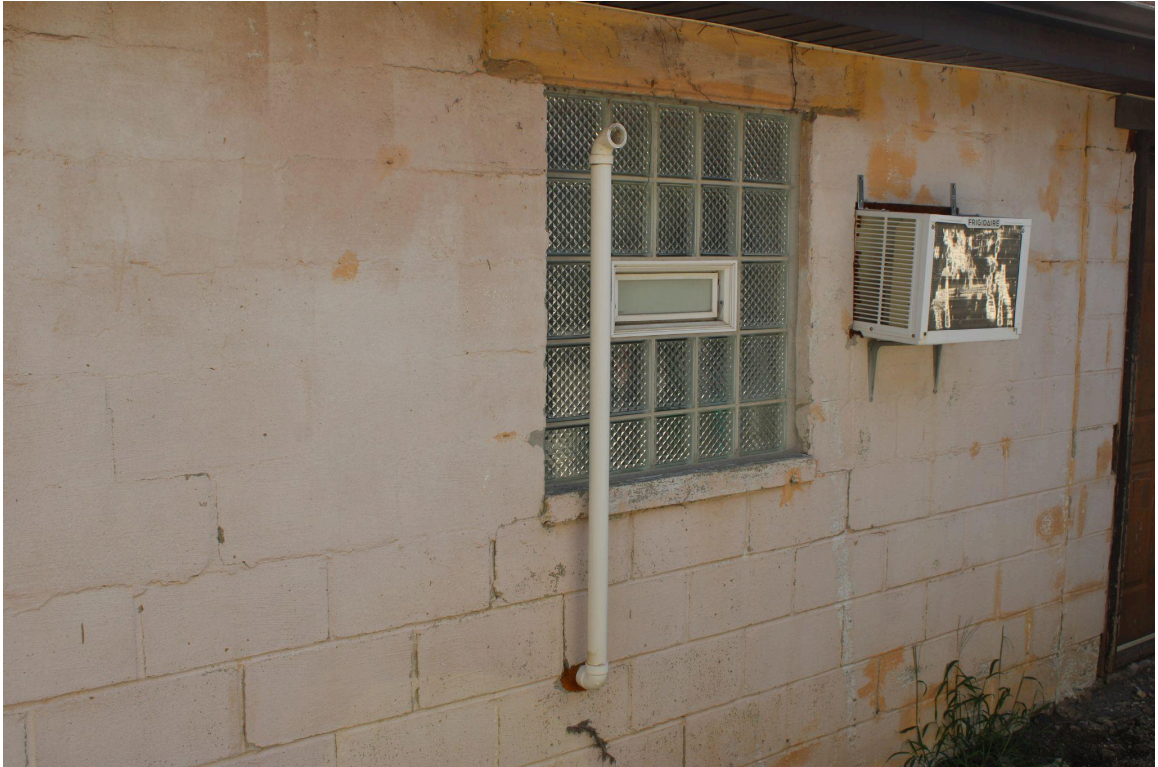
- Average water pressure.
- Plumbing supply, drain, and vent pipes within the wall and floor structure were not visible.
- Observed a plumbing vent located in the courtyard area which does not appear to have enough clearance to ensure proper ventilation. Recommend consulting with a plumbing contractor for estimate of proper repairs. See photo below in the Plumbing Section.

Improper plumbing vent in courtyard.

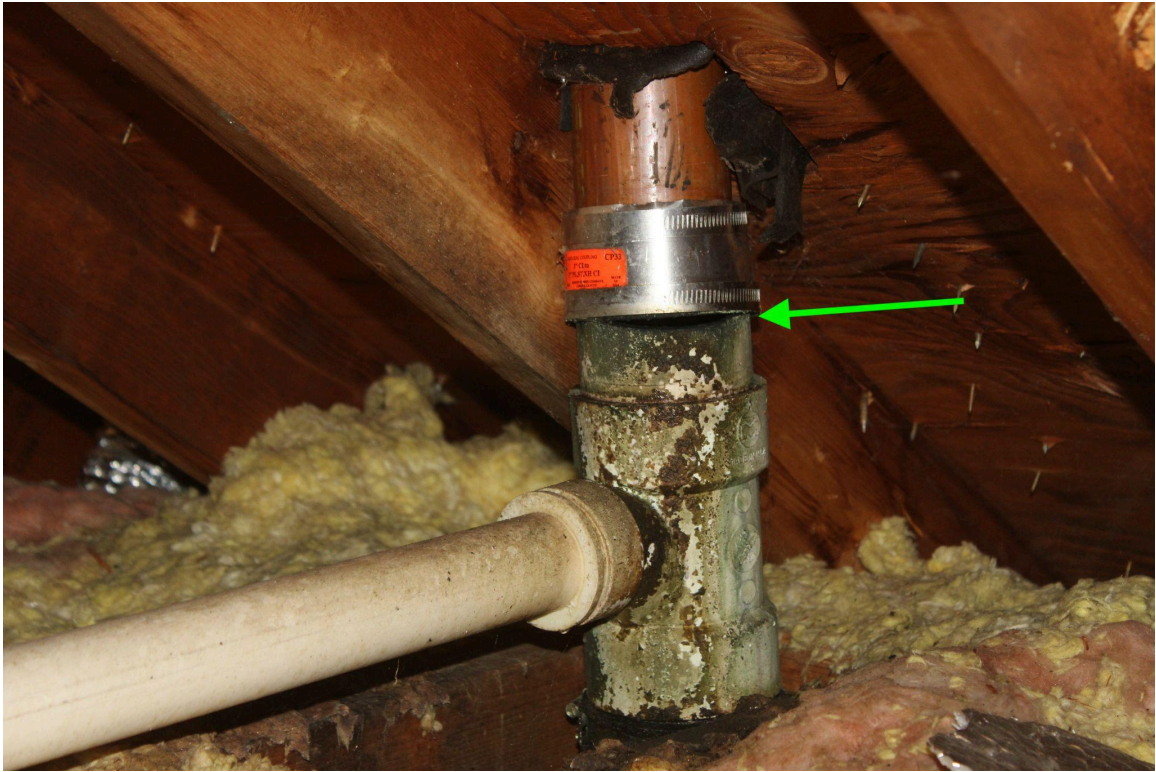
- Observed an improperly sealed coupling located in the attic area over the men's bathroom, allowing the potential for harmful sewage gasses to draft into the home. Recommend consulting a plumbing contractor for estimate of proper repairs. See photo below in the Plumbing Section.

Plumbing vent gap over men's restroom.
