Property and Environmental Closeout

**First Student #20218B, 4443 Claude St., Moose Creek, AK
99701**

Inspector	Paul Platillero
Date of Inspection	August 17, 2021

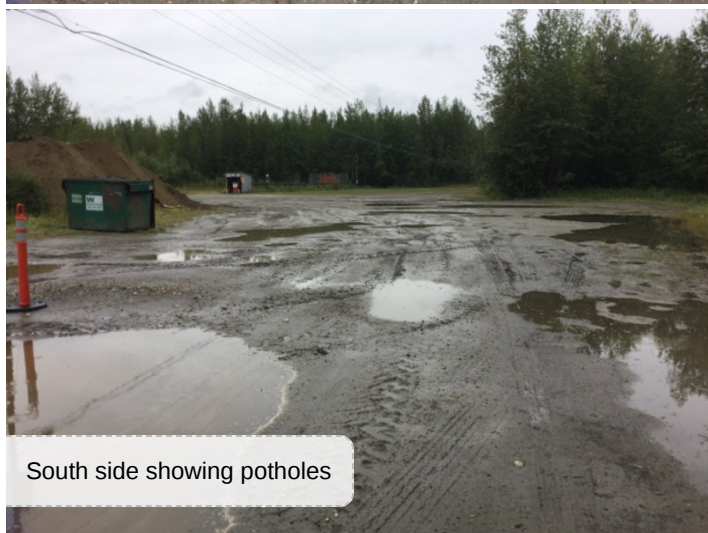
South side showing potholes

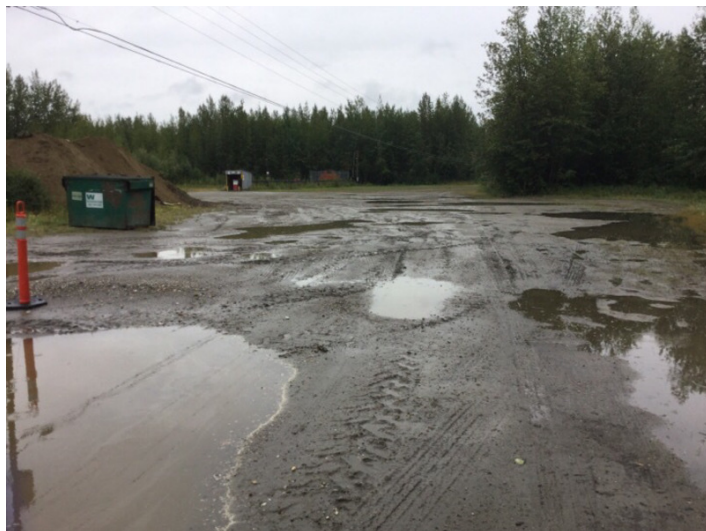
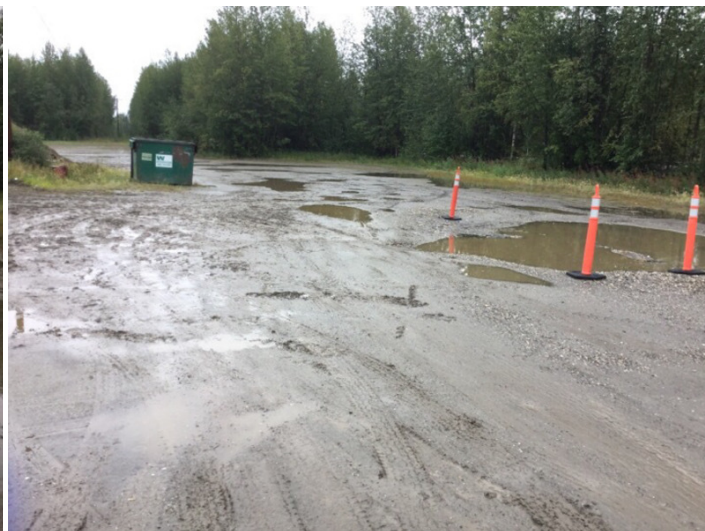
Erosion and Pothole Photos

Significant erosion or potholes in parking or equipment storage areas observed?	Yes
--	-----

FINDING	RESPONSIBLE PARTY
Lot significantly damaged (i.e., erosion, potholes, etc.)	Minor potholes; no planned activities
Fueling AST(s) may require removal	To be determined
Product drums/containers present require removal or reallocation	Operating company to remove
Wastes present require removal/disposal	Operating company to remove
Outstanding notice(s) of violation, compliance inquiry letter(s), consent order(s), or administrative order(s) related to environmental matters	No further action required; AULs have been instituted at the location

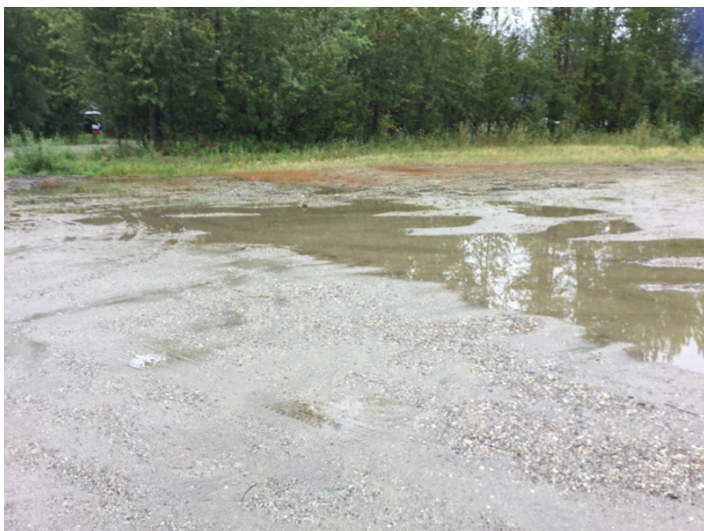
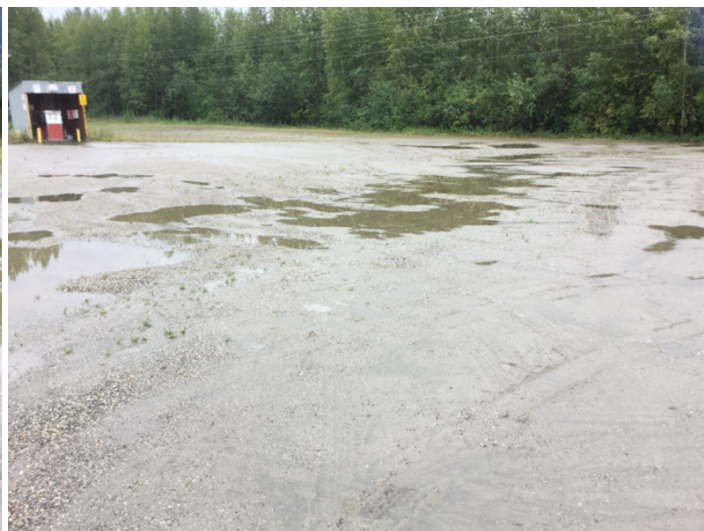
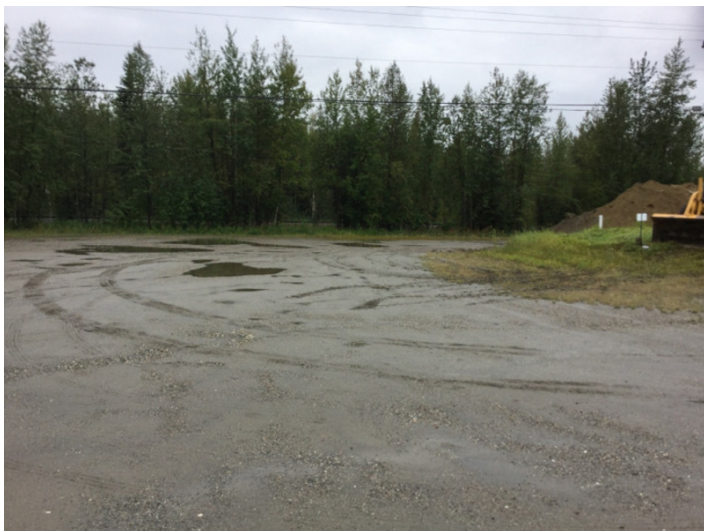
Grading, Drainage, or Flooding Issue Photos

Describe grading, drainage, or flooding issues	Potholes outside, roof leaks
--	------------------------------

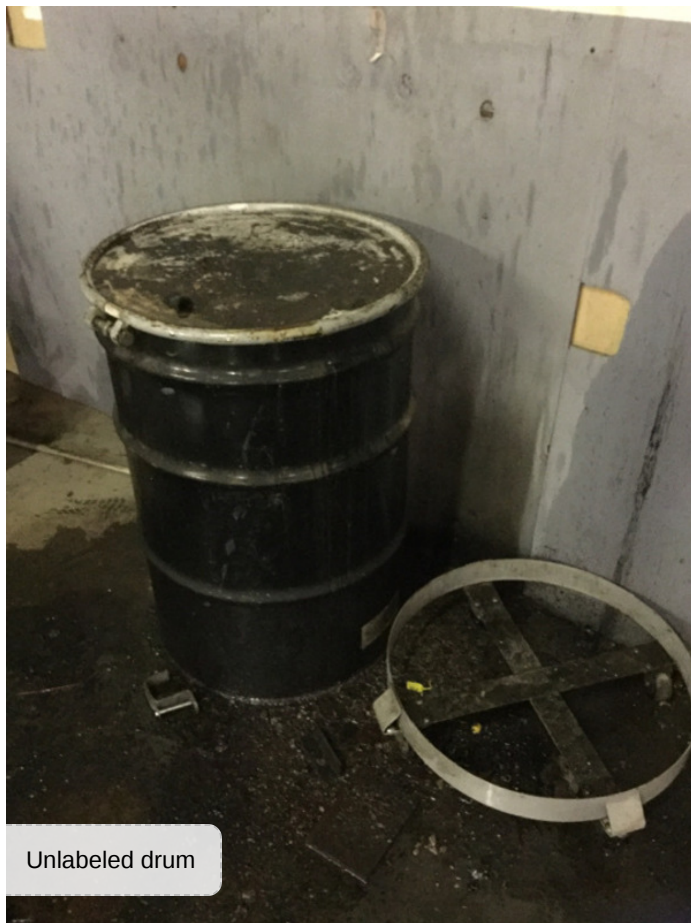
Unlabeled drum

Waste Stream	Unknown waste
Amount Requiring Removal	1-55 gal drum
Designated Vendor to Remove	Waste Management
Approximate Collection/Removal Date	October 29, 2021
Additional Comments	Drum is not labeled

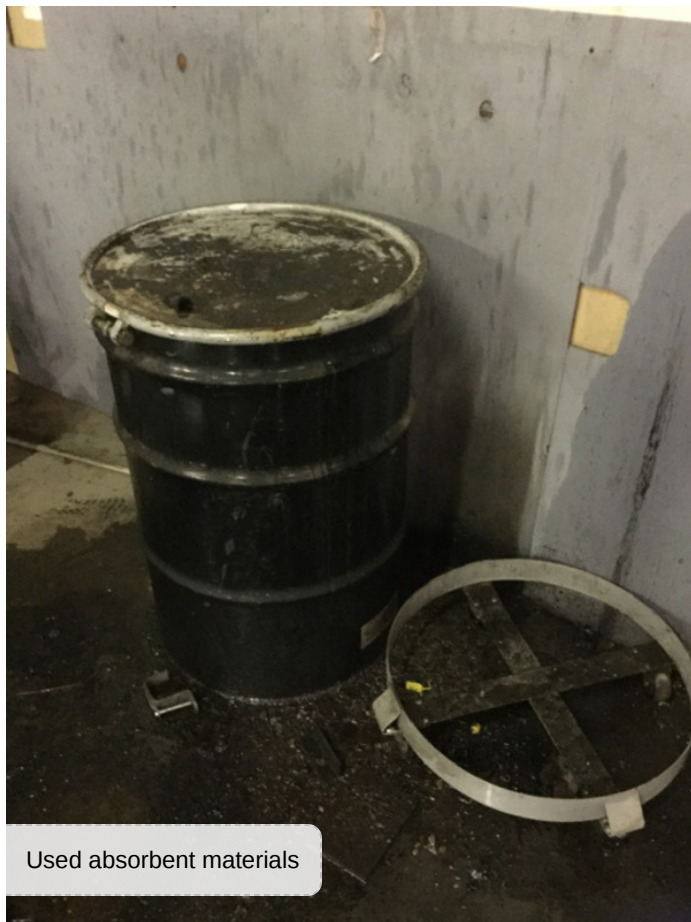
Used absorbent materials
